## 2023 - 2024 Ventilation Assessment

## Saint Paul Public Schools Galtier Elementary

Assessment Date:  
Wednesday, April 12, 2023

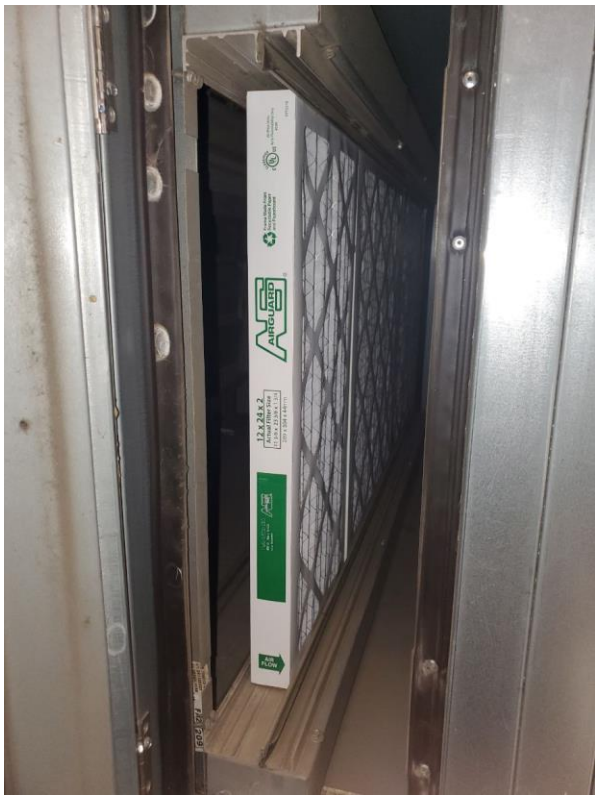
Dirty or poorly fitting filters were observed in unit AHU 05 during the ventilation inspection.

AHU 05  
Mixed Main Filter Fit

**Recommendation:** The operations and maintenance program for filter changes should be reviewed and revised to ensure proper filter changes to optimize filtration capacity.

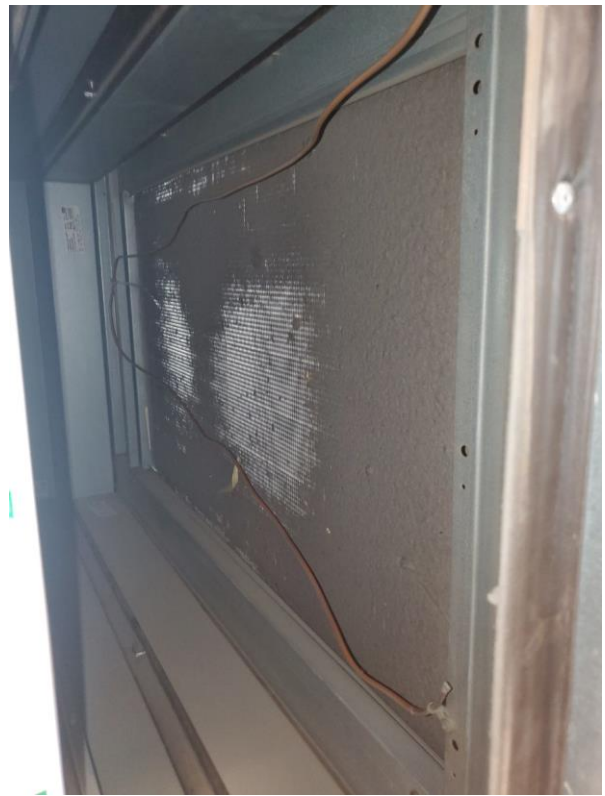
Dirty Coils were observed on unit AHU 05 during the ventilation inspection.

AHU 05  
Heating Coils

**Recommendation:** Impacted/dirty coils can result in poor ventilation air supply as well as be a source for mold and bacterial growth on the coils. Coils should be cleaned annually, or as needed, as identified in the operations and maintenance program.
