## 2023 - 2024 Ventilation Assessment

## Saint Paul Public Schools Global Arts Plus Upper

Assessment Date:  
Wednesday, April 19, 2023

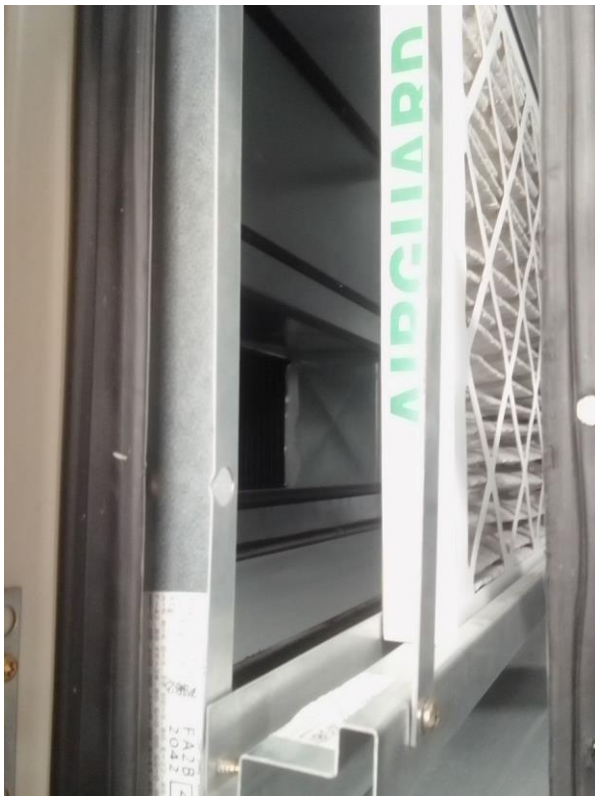
Dirty or poorly fitting filters were observed in unit AHU4 during the ventilation inspection.

Return Main Filter Fit

**Recommendation:** The operations and maintenance program for filter changes should be reviewed and revised to ensure proper filter changes to optimize filtration capacity.

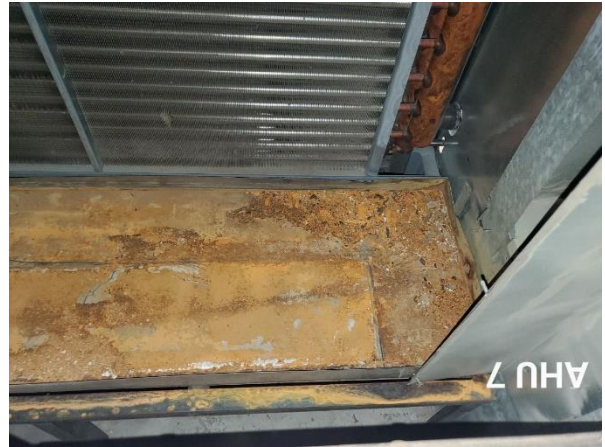
The drain pan for unit AHU7 was plugged or damaged at the time of the site inspection.

Drain Pans

**Recommendation:** Damage to the drain pan should be repaired, or the drain pan should be inspected more frequently to ensure that it does not become plugged.

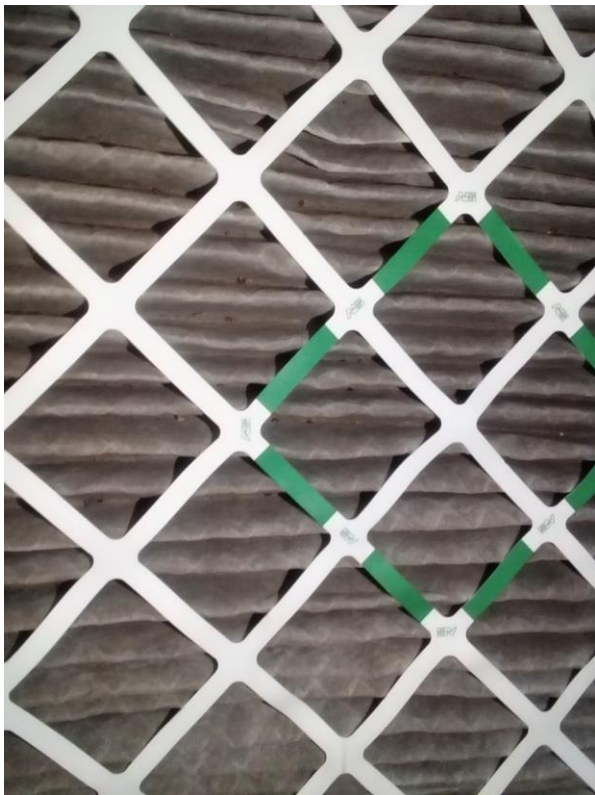
AHU11

Outdoor Pre-Filter Cleanliness
