2023 - 2024 Ventilation Assessment

Saint Paul Public Schools Ramsey Middle School

Assessment Date:
Thursday, April 6, 2023

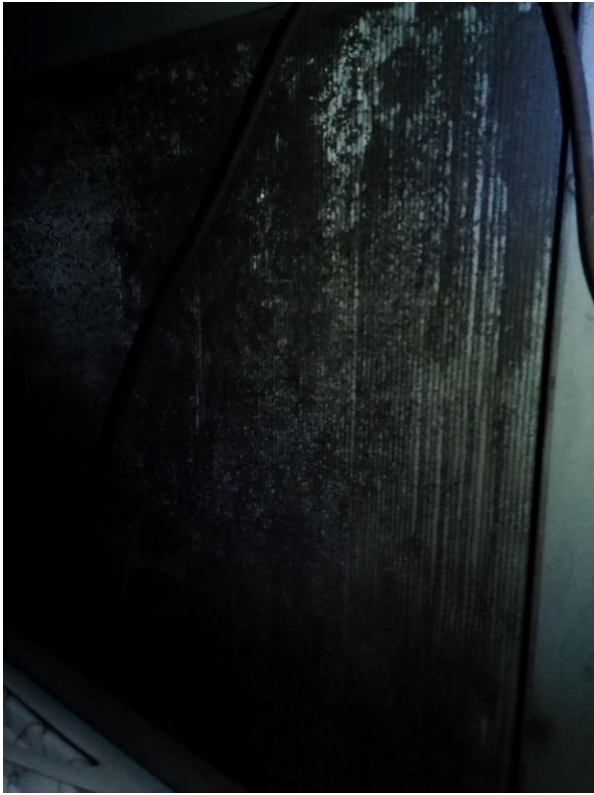
Dirty Coils were observed on unit HVU 01 during the ventilation inspection.

HVU 01
Heating Coils

Recommendation: Impacted/dirty coils can result in poor ventilation air supply as well as be a source for mold and bacterial growth on the coils. Coils should be cleaned annually, or as needed, as identified in the operations and maintenance program.
