2023 - 2024 Ventilation Assessment

Saint Paul Public Schools Highland Park Senior High School

Assessment Date:
Tuesday, April 18, 2023

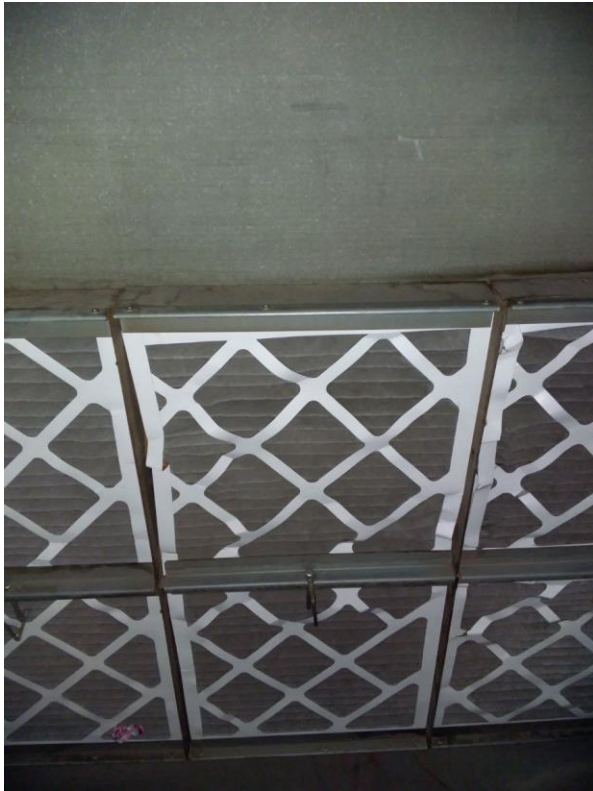
Unit Designation:	AHU-1A	
Location of Unit:	West mechanical room	
Areas Served:	See attached map 1st floor west	
System Enhancements:	None	
Supply System	Outdoor Air	Cleanliness and Observations
Type <ul style="list-style-type: none"> Supply System - Constant Volume Heating - Hot Water Cooling - None Energy Recovery Unit (ERU) - None 	Outdoor air intake is inaccessible Outdoor air intake is located on an exterior wall. It is not known if there are nearby pollution sources.	Outdoor air filters are not present. Return air filters are not present. Mixed air pre-filters are not present. Mixed air main filters are somewhat dirty and on the border of needing replacement (scoring 3 out of 5) and fit well. Mixed air main filters are installed correctly. Drain pans are not applicable or not present. Drain pan condition is not known.
Filter Type - Mixed <ul style="list-style-type: none"> Pre-filter: None Main filter: Pleated, MERV 11 	Outdoor air intake is in good condition.	Heating coils are clean. Heat wheels are not present. Exterior ducting is visible. Exterior ducting insulation is not present. Interior ducting is not visible. Interior ducting insulation is in an unknown condition. Interior ducting is of unknown cleanliness. Air handling room is free of trash/chemicals. Outside damper is open, and its condition is good. Return damper is open, and its condition is good. The general condition of the unit is good.

Mixed Main Filter Cleanliness

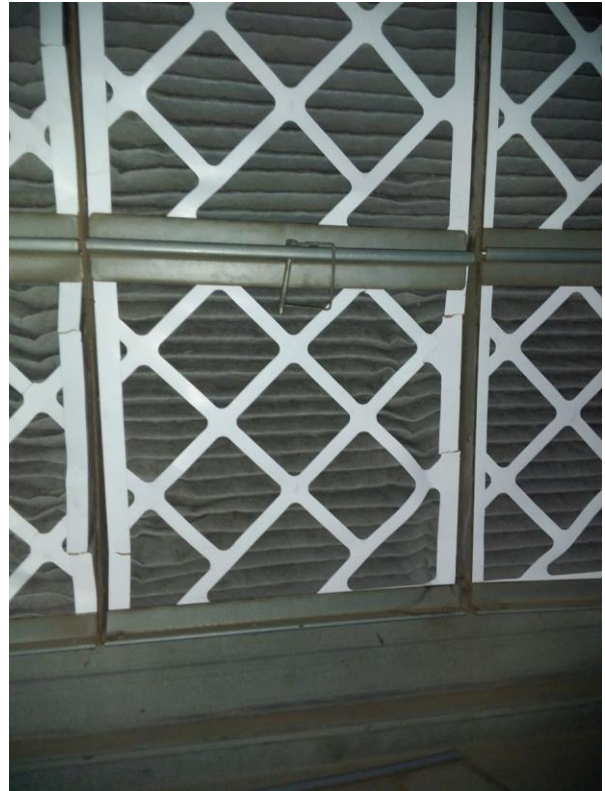
Unit Designation:	AHU-1B	
Location of Unit:	East mechanical room	
Areas Served:	See attached map 1st floor east	
System Enhancements:	None	
Supply System	Outdoor Air	Cleanliness and Observations
Type <ul style="list-style-type: none"> Supply System - Constant Volume Heating - Hot Water Cooling - None Energy Recovery Unit (ERU) - None 	<p>Outdoor air intake is inaccessible</p> <p>Outdoor air intake is located on an exterior wall.</p> <p>It is not known if there are nearby pollution sources.</p>	<p>Outdoor air filters are not present.</p> <p>Return air filters are not present.</p> <p>Mixed air pre-filters are not present. Mixed air main filters are somewhat dirty and on the border of needing replacement (scoring 3 out of 5) and fit well. Mixed air main filters are installed correctly.</p> <p>Drain pans are not applicable or not present. Drain pan condition is not known.</p>
Filter Type - Mixed <ul style="list-style-type: none"> Pre-filter: None Main filter: Pleated, MERV 11 	<p>Outdoor air intake is in good condition.</p>	<p>Heating coils are clean.</p> <p>Heat wheels are not present.</p> <p>Exterior ducting is visible. Exterior ducting insulation is not present.</p> <p>Interior ducting is not visible. Interior ducting insulation is in an unknown condition. Interior ducting is of unknown cleanliness.</p> <p>Air handling room is free of trash/chemicals.</p> <p>Outside damper is open, and its condition is good.</p> <p>Return damper is open, and its condition is good.</p> <p>The general condition of the unit is good.</p>

Mixed Main Filter Cleanliness

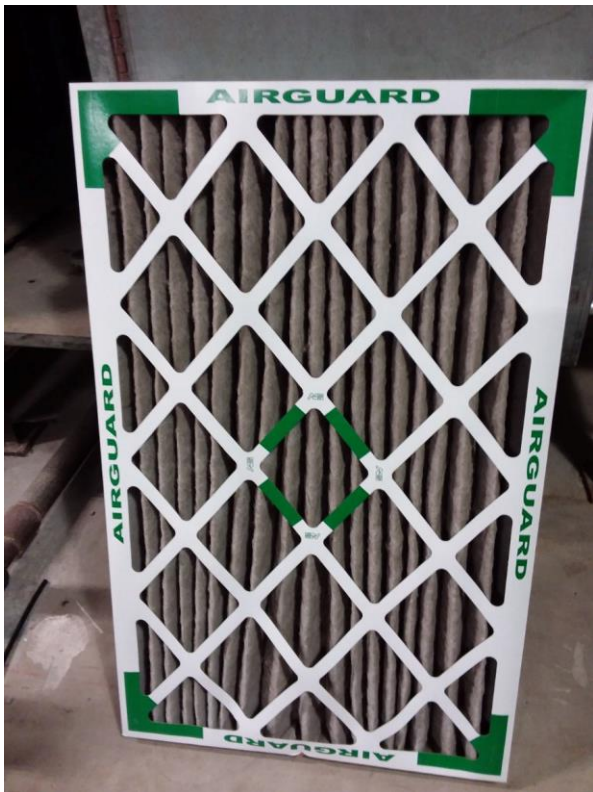
Unit Designation:	AHU-02	
Location of Unit:	Mechanical room 2402	
Areas Served:	See attached map 1405	
System Enhancements:	None	
Supply System	Outdoor Air	Cleanliness and Observations
Type <ul style="list-style-type: none"> • Supply System - Constant Volume • Heating - Hot Water • Cooling - None • Energy Recovery Unit (ERU) - None 	<p>Outdoor air intake is inaccessible</p> <p>Outdoor air intake is located on the roof.</p> <p>It is not known if there are nearby pollution sources.</p> <p>Outdoor air intake is in good condition.</p>	<p>Outdoor air filters are not present.</p> <p>Return air filters are not present.</p> <p>Mixed air pre-filters are not present. Mixed air main filters are somewhat dirty and on the border of needing replacement (scoring 3 out of 5) and fit well. Mixed air main filters are installed correctly.</p> <p>Drain pans are not applicable or not present. Drain pan condition is not known.</p> <p>Heating coils are inaccessible.</p> <p>Heat wheels are not present.</p> <p>Exterior ducting is visible. Exterior ducting insulation is not present.</p> <p>Interior ducting is not visible. Interior ducting insulation is in an unknown condition. Interior ducting is of unknown cleanliness.</p> <p>Air handling room is free of trash/chemicals.</p> <p>Outside damper is open, and its condition is good.</p> <p>Return damper is closed, and its condition is good.</p> <p>The general condition of the unit is good.</p>

Mixed Main Filter Cleanliness

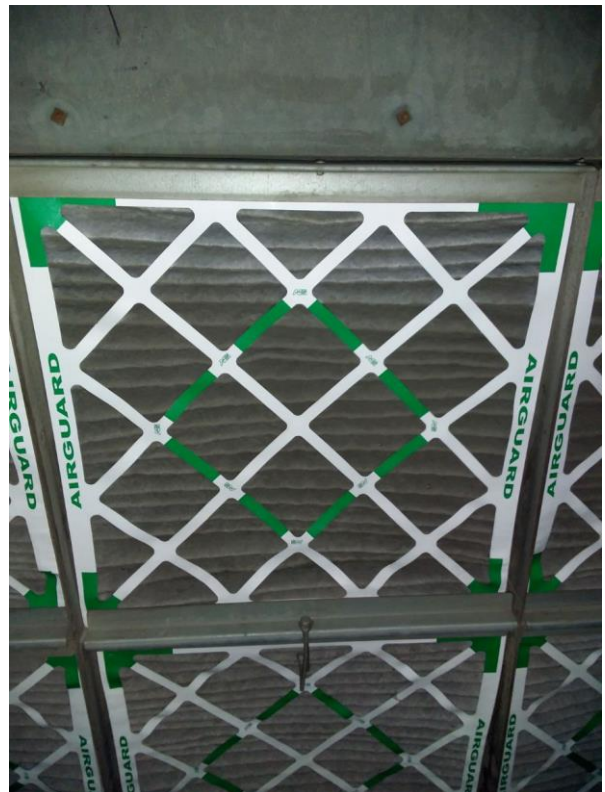
Unit Designation:	AHU-2A	
Location of Unit:	West mechanical room	
Areas Served:	See attached map 2nd floor west	
System Enhancements:	None	
Supply System	Outdoor Air	Cleanliness and Observations
Type <ul style="list-style-type: none"> Supply System - Constant Volume Heating - Hot Water Cooling - None Energy Recovery Unit (ERU) - None 	<p>Outdoor air intake is inaccessible</p> <p>Outdoor air intake is located on an exterior wall.</p> <p>It is not known if there are nearby pollution sources.</p>	<p>Outdoor air filters are not present.</p> <p>Return air filters are not present.</p> <p>Mixed air pre-filters are not present. Mixed air main filters are somewhat dirty and on the border of needing replacement (scoring 3 out of 5) and fit well. Mixed air main filters are installed correctly.</p> <p>Drain pans are not plugged. Drain pan condition is good.</p>
Filter Type - Mixed <ul style="list-style-type: none"> Pre-filter: None Main filter: Pleated, MERV 11 	<p>Outdoor air intake is in good condition.</p>	<p>Heating coils are clean.</p> <p>Heat wheels are not present.</p> <p>Exterior ducting is visible. Exterior ducting insulation is not present.</p> <p>Interior ducting is not visible. Interior ducting insulation is in an unknown condition. Interior ducting is of unknown cleanliness.</p> <p>Air handling room is free of trash/chemicals.</p> <p>Outside damper is open, and its condition is good.</p> <p>Return damper is open, and its condition is good.</p> <p>The general condition of the unit is good.</p>

Mixed Main Filter Cleanliness

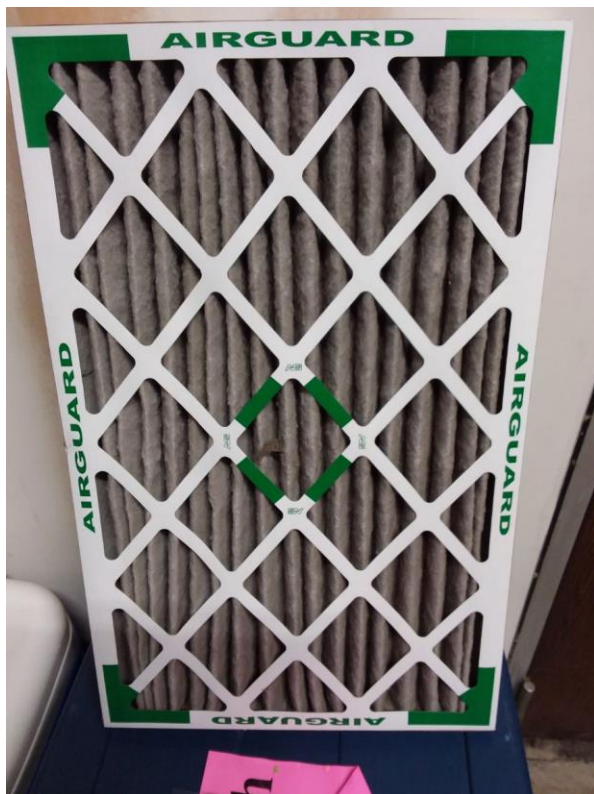
Unit Designation:	AHU-3	
Location of Unit:	Mechanical room 2402	
Areas Served:	See attached map 1401/2401	
System Enhancements:	None	
Supply System	Outdoor Air	Cleanliness and Observations
Type <ul style="list-style-type: none"> Supply System - Constant Volume Heating - Hot Water Cooling - None Energy Recovery Unit (ERU) - None 	<p>Outdoor air intake is inaccessible</p> <p>Outdoor air intake is located on the roof.</p> <p>It is not known if there are nearby pollution sources.</p> <p>Outdoor air intake is in good condition.</p>	<p>Outdoor air filters are not present.</p> <p>Return air filters are not present.</p> <p>Mixed air pre-filters are not present. Mixed air main filters are somewhat dirty and on the border of needing replacement (scoring 3 out of 5) and fit well. Mixed air main filters are installed correctly.</p> <p>Drain pans are not applicable or not present. Drain pan condition is not known.</p> <p>Heating coils are inaccessible.</p> <p>Heat wheels are not present.</p> <p>Exterior ducting is visible. Exterior ducting insulation is not present.</p> <p>Interior ducting is visible. Interior ducting insulation is not present. Interior ducting is of unknown cleanliness.</p> <p>Air handling room is free of trash/chemicals.</p> <p>Outside damper is open, and its condition is good.</p> <p>Return damper is open, and its condition is good.</p> <p>The general condition of the unit is good.</p>

Mixed Main Filter Cleanliness

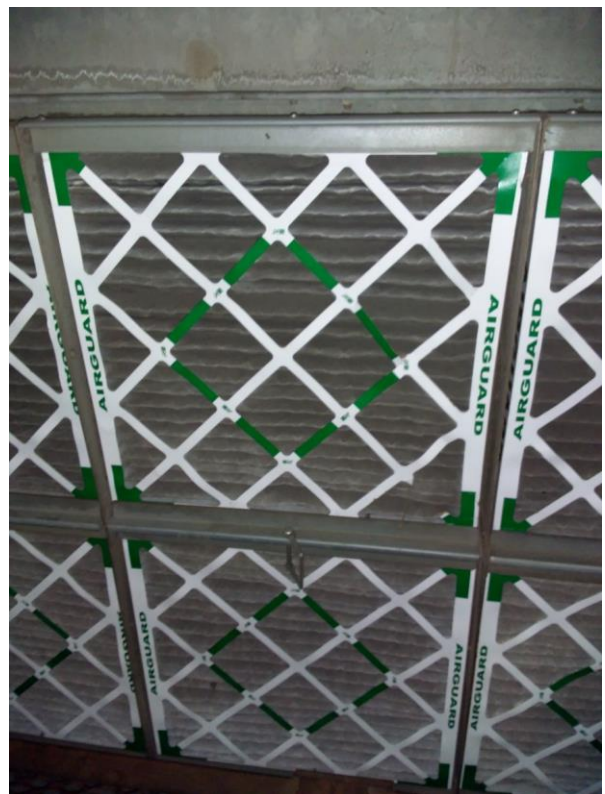
Unit Designation:	AHU-3A	
Location of Unit:	West mechanical room	
Areas Served:	See attached map 3rd floor west	
System Enhancements:	None	
Supply System	Outdoor Air	Cleanliness and Observations
Type <ul style="list-style-type: none"> Supply System - Constant Volume Heating - Hot Water Cooling - None Energy Recovery Unit (ERU) - None 	<p>Outdoor air intake is inaccessible</p> <p>Outdoor air intake is located on an exterior wall.</p> <p>It is not known if there are nearby pollution sources.</p>	<p>Outdoor air filters are not present.</p> <p>Return air filters are not present.</p> <p>Mixed air pre-filters are not present. Mixed air main filters are somewhat dirty and on the border of needing replacement (scoring 3 out of 5) and fit well. Mixed air main filters are installed correctly.</p> <p>Drain pans are not applicable or not present. Drain pan condition is not known.</p>
Filter Type - Mixed <ul style="list-style-type: none"> Pre-filter: None Main filter: Pleated, MERV 11 	<p>Outdoor air intake is in good condition.</p>	<p>Heating coils are clean.</p> <p>Heat wheels are not present.</p> <p>Exterior ducting is visible. Exterior ducting insulation is in poor condition.</p> <p>Interior ducting is not visible. Interior ducting insulation is in an unknown condition. Interior ducting is of unknown cleanliness.</p> <p>Air handling room is free of trash/chemicals.</p> <p>Outside damper is open, and its condition is good.</p> <p>Return damper is open, and its condition is good.</p> <p>The general condition of the unit is good.</p>

Mixed Main Filter Cleanliness

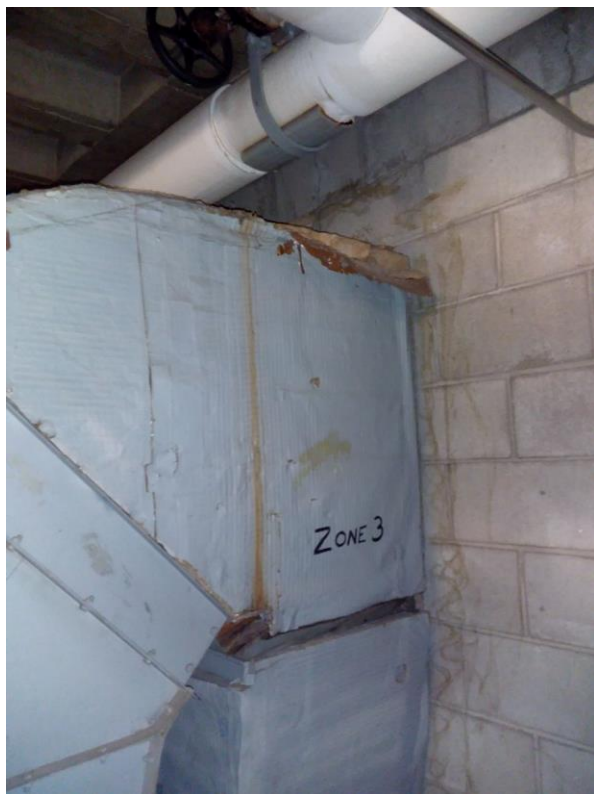
AHU-3A

The accessible ductwork for units AHU-16, AHU-17, AHU-3A, AHU-4A and AHU-4B was visibly dirty, damaged, or had evidence of moisture at the time of the site inspection.

Exterior Ducting

Recommendation: IEA recommends further inspection into the overall condition of the interior ductwork and level of dirt/debris quantified. If deemed a concern, it is recommended that the interior ducting be cleaned by a professional contractor to improve the impact on the IAQ for the supply spaces.

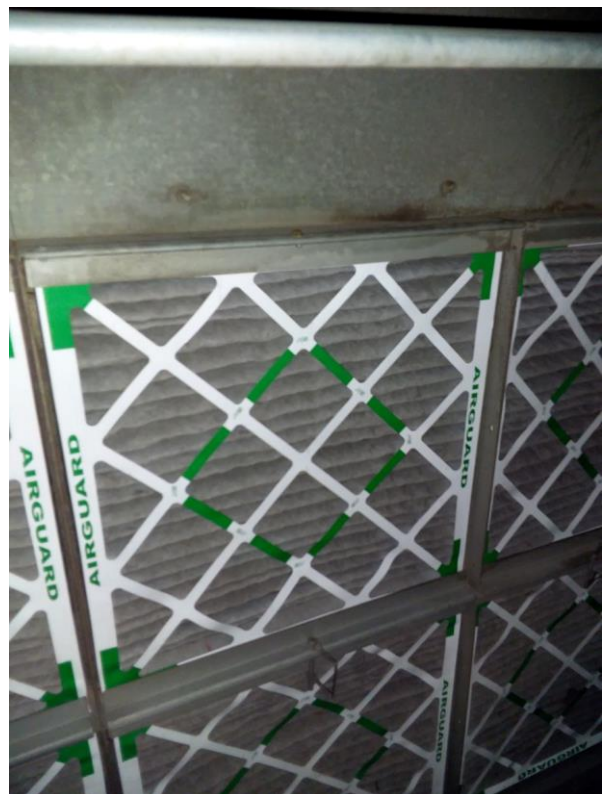
Unit Designation:	AHU-3B	
Location of Unit:	East mechanical room	
Areas Served:	See attached map 2nd floor east	
System Enhancements:	None	
Supply System	Outdoor Air	Cleanliness and Observations
Type <ul style="list-style-type: none"> • Supply System - Constant Volume • Heating - Hot Water • Cooling - None • Energy Recovery Unit (ERU) - None 	<p>Outdoor air intake is inaccessible</p> <p>Outdoor air intake is located on an exterior wall.</p> <p>It is not known if there are nearby pollution sources.</p>	<p>Outdoor air filters are not present.</p> <p>Return air filters are not present.</p> <p>Mixed air pre-filters are not present. Mixed air main filters are somewhat dirty and on the border of needing replacement (scoring 3 out of 5) and fit well. Mixed air main filters are installed correctly.</p> <p>Drain pans are not applicable or not present. Drain pan condition is not known.</p>
Filter Type - Mixed <ul style="list-style-type: none"> • Pre-filter: None • Main filter: Pleated, MERV 11 	<p>Outdoor air intake is in good condition.</p>	<p>Heating coils are clean.</p> <p>Heat wheels are not present.</p> <p>Exterior ducting is visible. Exterior ducting insulation is not present.</p> <p>Interior ducting is visible. Interior ducting insulation is not present. Interior ducting is of unknown cleanliness.</p> <p>Air handling room is free of trash/chemicals.</p> <p>Outside damper is open, and its condition is good.</p> <p>Return damper is open, and its condition is good.</p> <p>The general condition of the unit is good.</p>

Mixed Main Filter Cleanliness

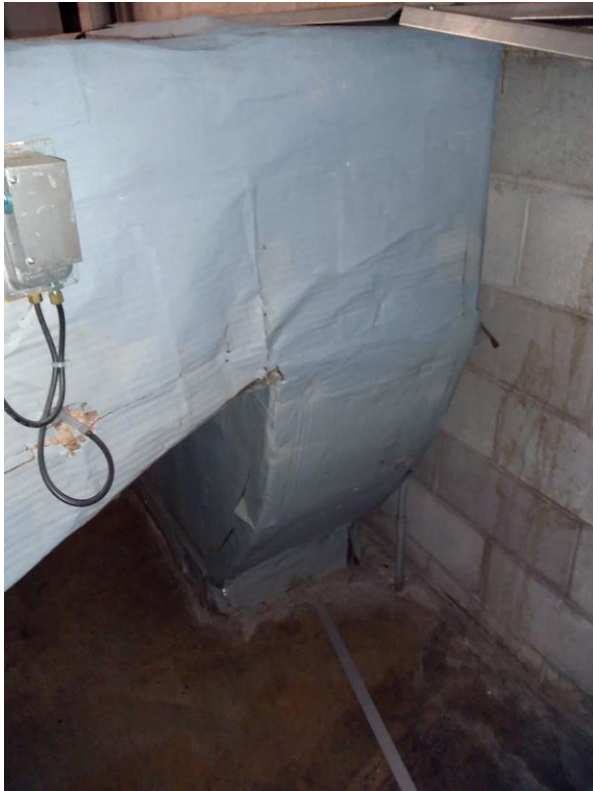
AHU-4A
Exterior Ducting

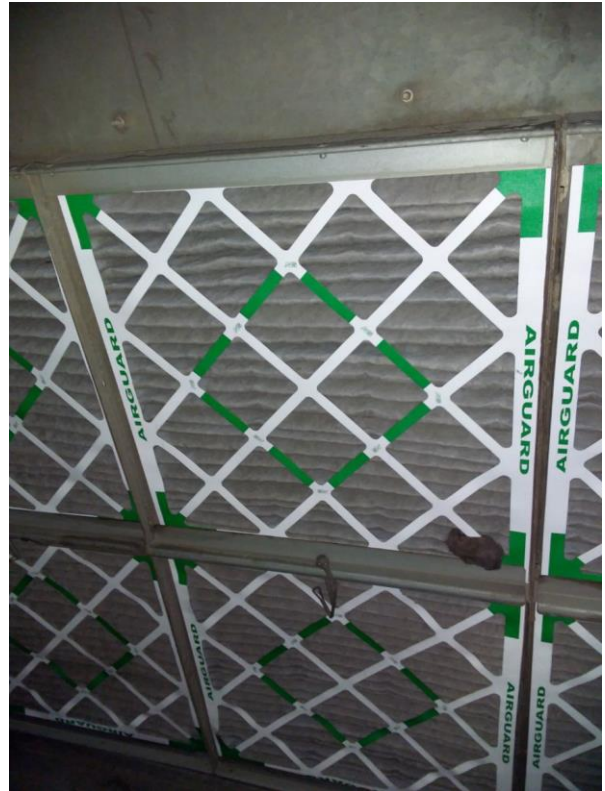
Unit Designation:	AHU-4B	
Location of Unit:	East mechanical room	
Areas Served:	See attached map 3RD FLOOR EAST	
System Enhancements:	None	
Supply System	Outdoor Air	Cleanliness and Observations
Type <ul style="list-style-type: none"> • Supply System - Constant Volume • Heating - Hot Water • Cooling - None • Energy Recovery Unit (ERU) - None 	<p>Outdoor air intake is inaccessible</p> <p>Outdoor air intake is located on an exterior wall.</p> <p>It is not known if there are nearby pollution sources.</p>	<p>Outdoor air filters are not present.</p> <p>Return air filters are not present.</p> <p>Mixed air pre-filters are not present. Mixed air main filters are somewhat dirty and on the border of needing replacement (scoring 3 out of 5) and fit well. Mixed air main filters are installed correctly.</p> <p>Drain pans are not applicable or not present. Drain pan condition is not known.</p>
Filter Type - Mixed <ul style="list-style-type: none"> • Pre-filter: None • Main filter: Pleated, MERV 11 	<p>Outdoor air intake is in good condition.</p>	<p>Heating coils are clean.</p> <p>Heat wheels are not present.</p> <p>Exterior ducting is visible. Exterior ducting insulation is in poor condition.</p> <p>Interior ducting is not visible. Interior ducting insulation is in an unknown condition. Interior ducting is of unknown cleanliness.</p> <p>Air handling room is free of trash/chemicals.</p> <p>Outside damper is open, and its condition is good.</p> <p>Return damper is open, and its condition is good.</p> <p>The general condition of the unit is good.</p>

AHU-4B
Mixed Main Filter Cleanliness

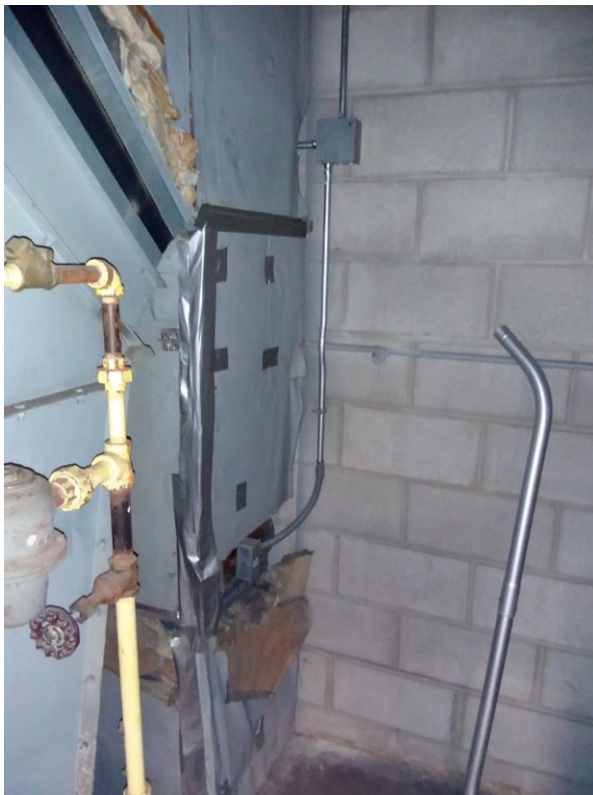
AHU-4B
Exterior Ducting

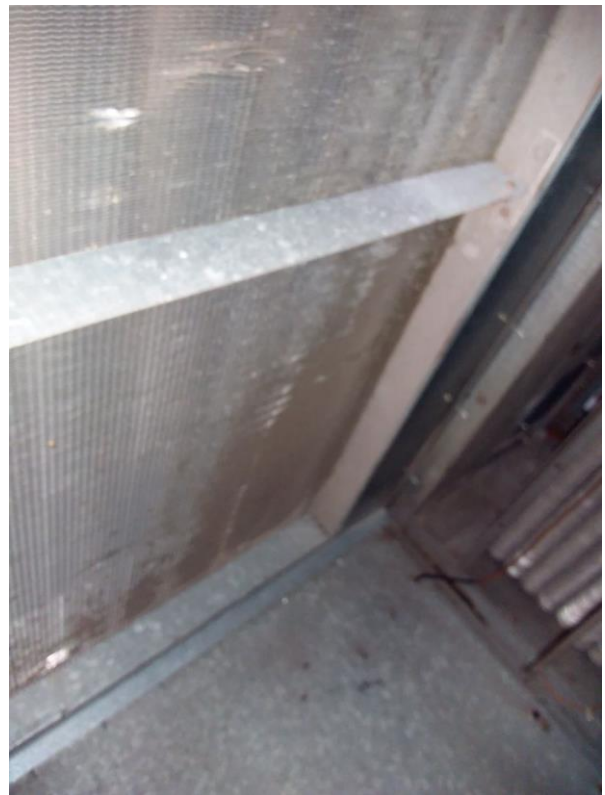
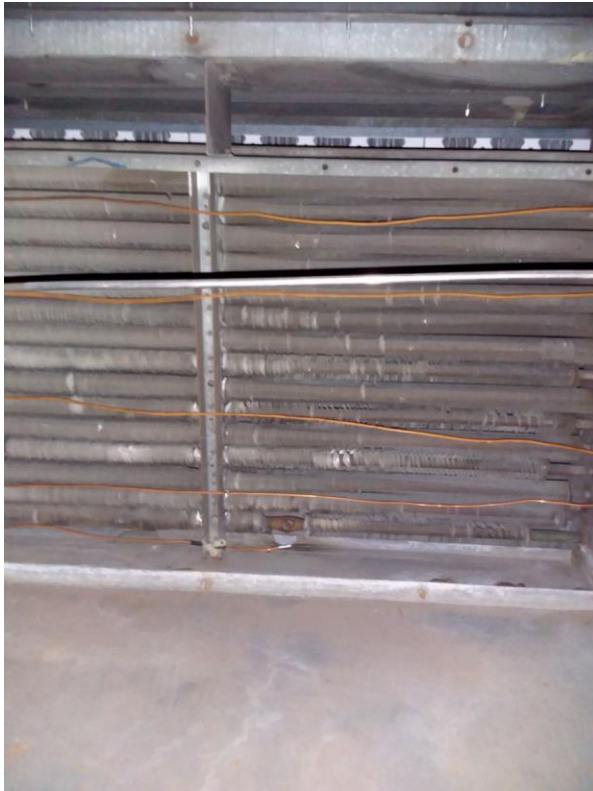
Dirty Coils were observed on units AHU-10 (100% RA), AHU-7 and RTU-04 during the ventilation inspection.

AHU-7
Heating Coils

Recommendation: Impacted/dirty coils can result in poor ventilation air supply as well as be a source for mold and bacterial growth on the coils. Coils should be cleaned annually, or as needed, as identified in the operations and maintenance program.

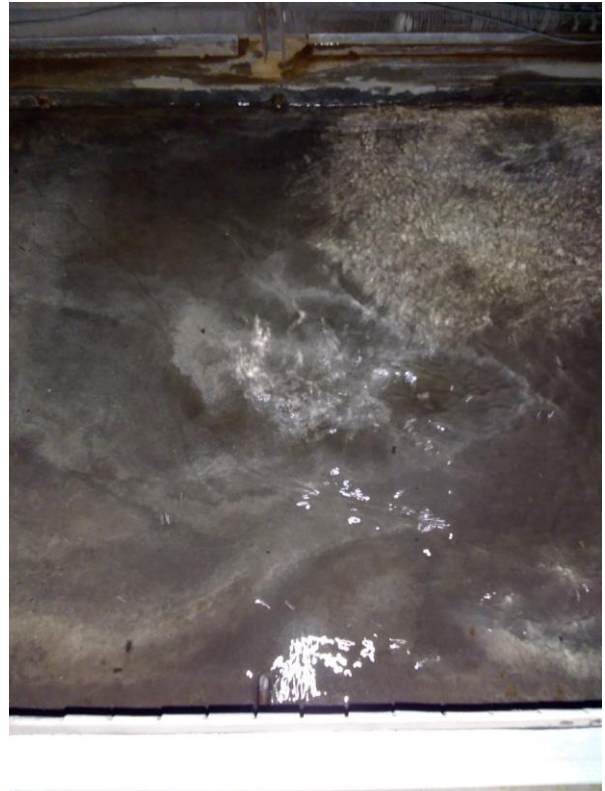
The drain pan for units AHU-14, AHU-8, RTU-03 and RTU-04 was plugged or damaged at the time of the site inspection.

AHU-8
Drain Pans

Recommendation: Damage to the drain pan should be repaired, or the drain pan should be inspected more frequently to ensure that it does not become plugged.

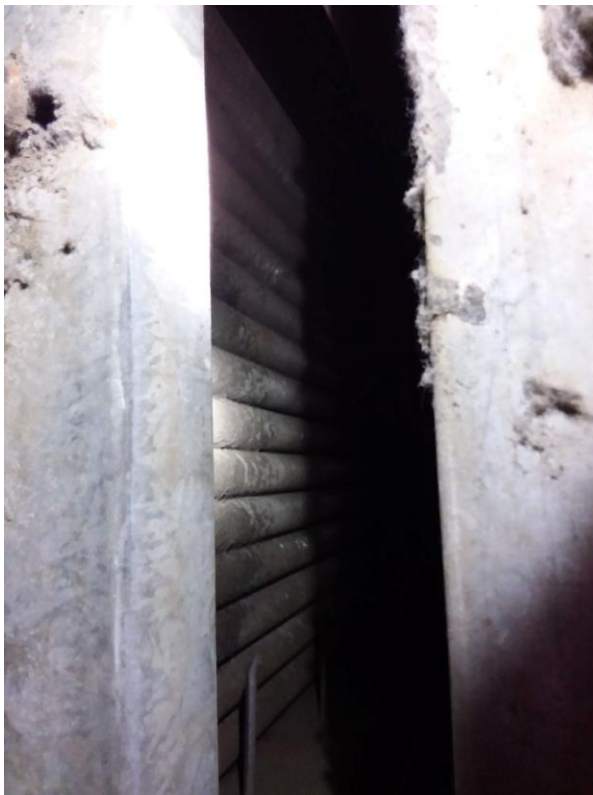
AHU-10 (100% RA)
Heating Coils

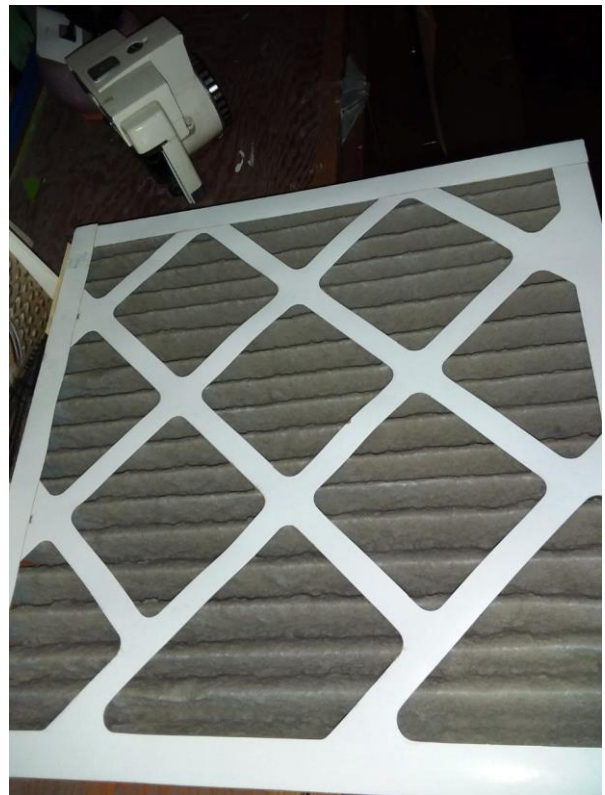
Unit Designation:	AHU-11	
Location of Unit:	0150 Ceiling	
Areas Served:	See attached map 150	
System Enhancements:	None	
Supply System	Outdoor Air	Cleanliness and Observations
Type <ul style="list-style-type: none"> • Supply System - Constant Volume • Heating - Hot Water • Cooling - None • Energy Recovery Unit (ERU) - None 	<p>Outdoor air intake is inaccessible</p> <p>Outdoor air intake is located in an unknown location.</p> <p>It is not known if there are nearby pollution sources.</p>	<p>Outdoor air filters are not present.</p> <p>Return air filters are not present.</p> <p>Mixed air pre-filters are not present. Mixed air main filters are somewhat dirty and on the border of needing replacement (scoring 3 out of 5) and fit well. Mixed air main filters are installed correctly.</p> <p>Drain pans are not applicable or not present. Drain pan condition is not known.</p>
Filter Type - Mixed <ul style="list-style-type: none"> • Pre-filter: None • Main filter: Pleated, MERV 11 	<p>Outdoor air intake is in good condition.</p>	<p>Heating coils are inaccessible.</p> <p>Heat wheels are not present.</p> <p>Exterior ducting is not visible. Exterior ducting insulation is in an unknown condition.</p> <p>Interior ducting is not visible. Interior ducting insulation is not present. Interior ducting is of unknown cleanliness.</p> <p>Air handling room is free of trash/chemicals.</p> <p>Outside damper is inaccessible, and its condition is not known.</p> <p>Return damper is inaccessible, and its condition is not known.</p> <p>The general condition of the unit is good.</p>

AHU-11
Mixed Main Filter Cleanliness

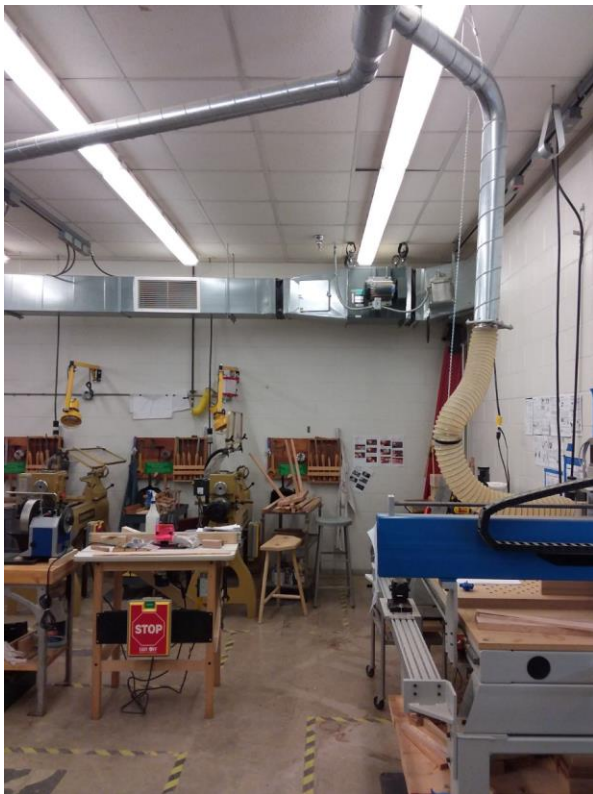
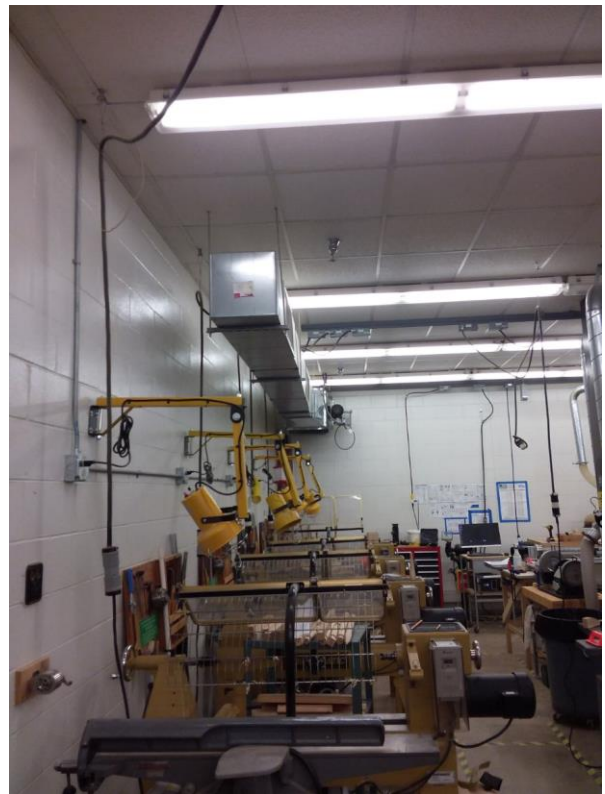
Unit Designation:	AHU-12	
Location of Unit:	0154 Ceiling	
Areas Served:	See attached map 154	
System Enhancements:	None	
Supply System	Outdoor Air	Cleanliness and Observations
Type <ul style="list-style-type: none"> Supply System - Constant Volume Heating - Hot Water Cooling - None Energy Recovery Unit (ERU) - None 	<p>Outdoor air intake is inaccessible</p> <p>Outdoor air intake is located on an exterior wall.</p> <p>It is not known if there are nearby pollution sources.</p>	<p>Outdoor air filters are not present.</p> <p>Return air filters are not present.</p> <p>Mixed air filters are of unknown cleanliness and fit is unknown. Mixed air filters are installed but it is unknown whether they are installed correctly.</p> <p>Drain pans are not applicable or not present. Drain pan condition is not known.</p>
Filter Type - Mixed <ul style="list-style-type: none"> Pre-filter: Inaccessible Main filter: Inaccessible 	<p>Outdoor air intake is in good condition.</p>	<p>Heating coils are inaccessible.</p> <p>Heat wheels are not present.</p> <p>Exterior ducting is visible. Exterior ducting insulation is not present.</p> <p>Interior ducting is not visible. Interior ducting insulation is in an unknown condition. Interior ducting is of unknown cleanliness.</p> <p>Air handling room is free of trash/chemicals.</p> <p>Outside damper is inaccessible, and its condition is not known.</p> <p>Return damper is inaccessible, and its condition is not known.</p> <p>The general condition of the unit is poor.</p>

The general condition of units AHU-12, AHU-14 and AHU-16 was poor.

AHU-12
General Condition

Recommendation: The units should be repaired or cleaned as needed.

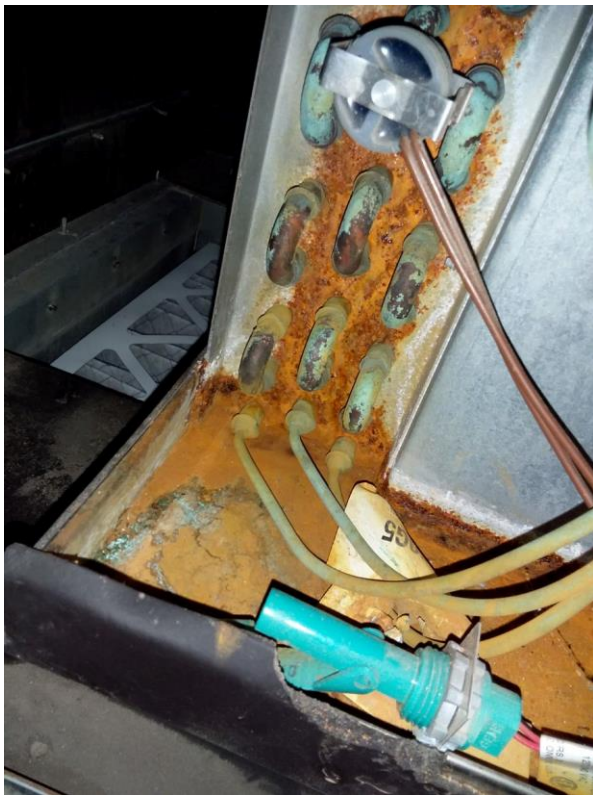
AHU-14
Drain Pans

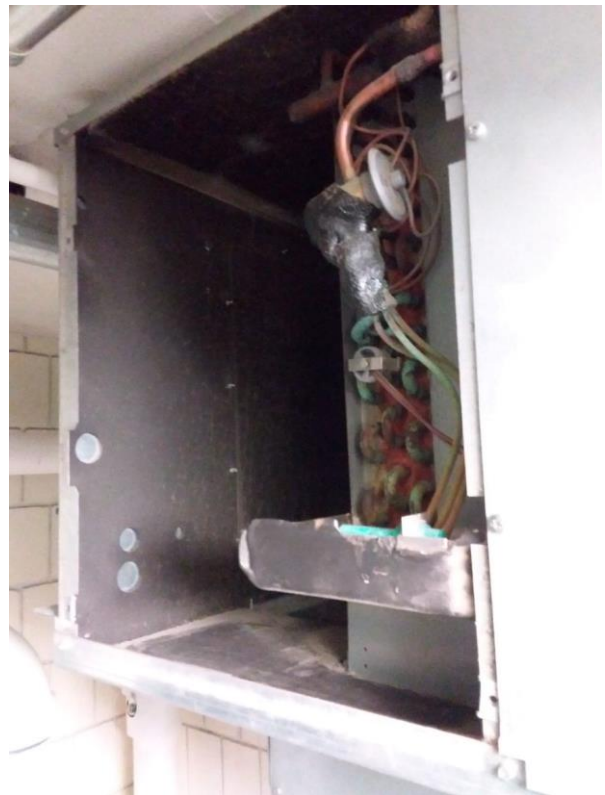
Unit Designation:	AHU-14	
Location of Unit:	Mechanical room 1302	
Areas Served:	See attached map 1302	
System Enhancements:	None	
Supply System	Outdoor Air	Cleanliness and Observations
Type <ul style="list-style-type: none"> Supply System - Constant Volume Heating - None Cooling - Dx Energy Recovery Unit (ERU) - None 	<p>Outdoor air intake is inaccessible</p> <p>Outdoor air intake is located in an unknown location.</p> <p>It is not known if there are nearby pollution sources.</p>	<p>Outdoor air filters are not present.</p> <p>Return air filters are not present.</p> <p>Mixed air pre-filters are not present. Mixed air main filters are clean and not in need of replacement (scoring 1 out of 5) and fit well. Mixed air main filters are installed correctly.</p> <p>Drain pans are not plugged. Drain pan condition is poor.</p>
Filter Type - Mixed <ul style="list-style-type: none"> Pre-filter: None Main filter: Pleated, N/A 	<p>Outdoor air intake is in good condition.</p>	<p>Cooling coils are clean.</p> <p>Heat wheels are not present.</p> <p>Exterior ducting is visible. Exterior ducting insulation is not present.</p> <p>Interior ducting is not visible. Interior ducting insulation is in an unknown condition. Interior ducting is of unknown cleanliness.</p> <p>Air handling room is free of trash/chemicals.</p> <p>Outside damper is unknown, and its condition is not known.</p> <p>Return damper is unknown, and its condition is not known.</p> <p>The general condition of the unit is poor.</p>

AHU-14
General Condition

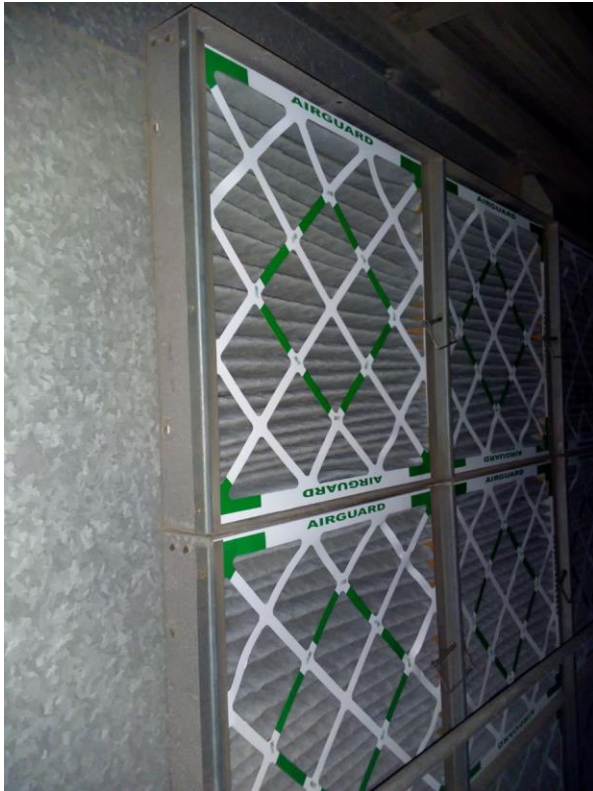
Unit Designation:	AHU-15	
Location of Unit:	Mechanical room 2506 near AUDITORIUM balcony	
Areas Served:	See attached map Auditorium	
System Enhancements:	None	
Supply System	Outdoor Air	Cleanliness and Observations
Type <ul style="list-style-type: none"> • Supply System - Constant Volume • Heating - Hot Water • Cooling - None • Energy Recovery Unit (ERU) - None 	<p>Outdoor air intake is inaccessible</p> <p>Outdoor air intake is located on the roof.</p> <p>It is not known if there are nearby pollution sources.</p> <p>Outdoor air intake is in good condition.</p>	<p>Outdoor air filters are not present.</p> <p>Return air filters are not present.</p> <p>Mixed air pre-filters are not present. Mixed air main filters are somewhat dirty and on the border of needing replacement (scoring 3 out of 5) and fit well. Mixed air main filters are installed correctly.</p> <p>Drain pans are not applicable or not present. Drain pan condition is not known.</p> <p>Heating coils are inaccessible.</p> <p>Heat wheels are not present.</p> <p>Exterior ducting is visible. Exterior ducting insulation is not present.</p> <p>Interior ducting is not visible. Interior ducting insulation is in an unknown condition. Interior ducting is of unknown cleanliness.</p> <p>Air handling room is free of trash/chemicals.</p> <p>Outside damper is open, and its condition is good.</p> <p>Return damper is open, and its condition is good.</p> <p>The general condition of the unit is good.</p>

Mixed Main Filter Cleanliness

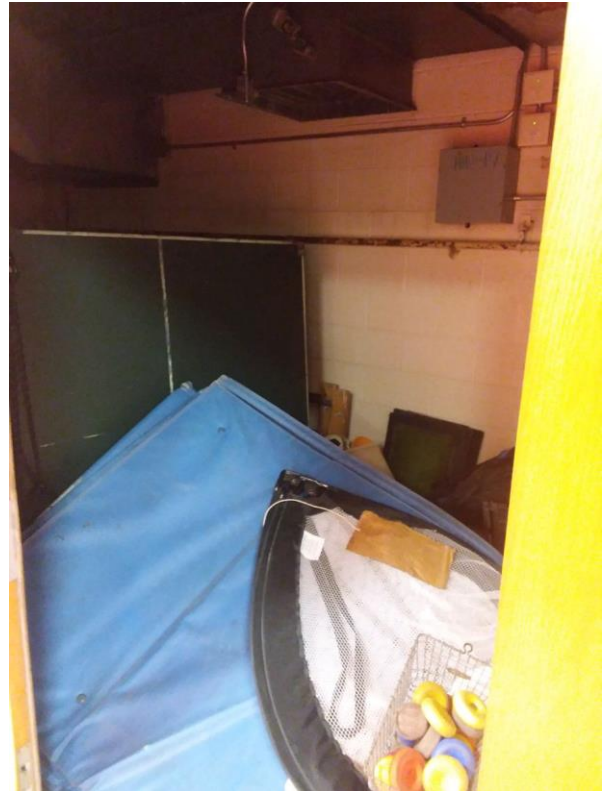
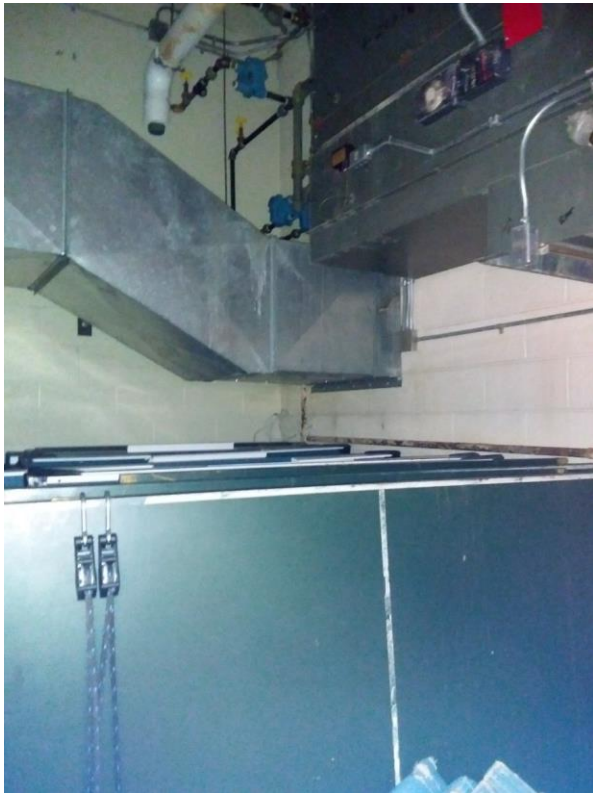
Unit Designation:	AHU-16	
Location of Unit:	Aux Gym/Wrestling Room	
Areas Served:	See attached map 1210 Teleconference room	
System Enhancements:	None	
Supply System	Outdoor Air	Cleanliness and Observations
Type <ul style="list-style-type: none"> Supply System - Constant Volume Heating - Hot Water Cooling - Dx Energy Recovery Unit (ERU) - None 	<p>Outdoor air intake is inaccessible</p> <p>Outdoor air intake is located on an exterior wall.</p> <p>It is not known if there are nearby pollution sources.</p>	<p>Outdoor air filters are not present.</p> <p>Return air filters are not present.</p> <p>Mixed air filters are of unknown cleanliness and fit is unknown. Mixed air filters are installed but it is unknown whether they are installed correctly.</p> <p>Drain pan plugged status is not known. Drain pan condition is not known.</p>
Filter Type - Mixed <ul style="list-style-type: none"> Pre-filter: Inaccessible Main filter: Inaccessible 	<p>Outdoor air intake is in good condition.</p>	<p>Heating coils are inaccessible and cooling coils are inaccessible.</p> <p>Heat wheels are not present.</p> <p>Exterior ducting is visible. Exterior ducting insulation is in poor condition.</p> <p>Interior ducting is not visible. Interior ducting insulation is in an unknown condition. Interior ducting is of unknown cleanliness.</p> <p>Air handling room is free of trash/chemicals.</p> <p>Outside damper is inaccessible, and its condition is good.</p> <p>Return damper is closed, and its condition is good.</p> <p>The general condition of the unit is poor.</p>

General Condition

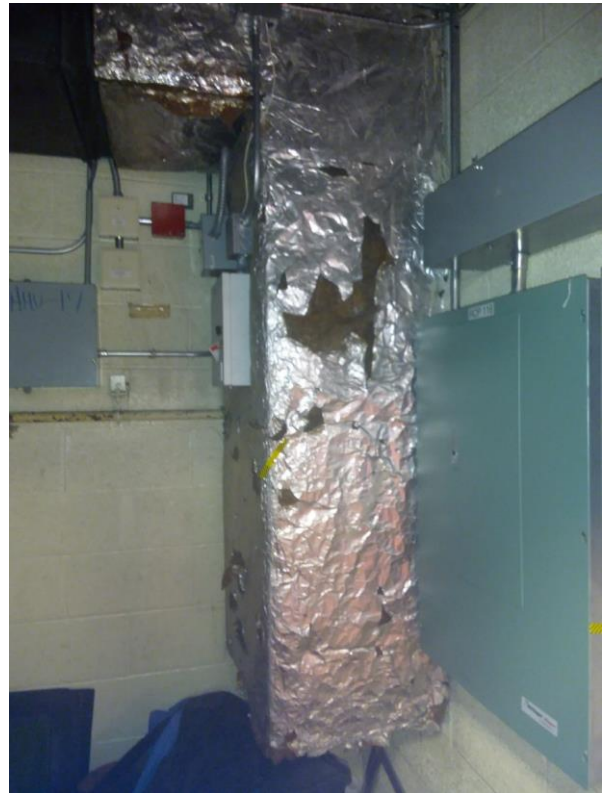
AHU-16

Exterior Ducting

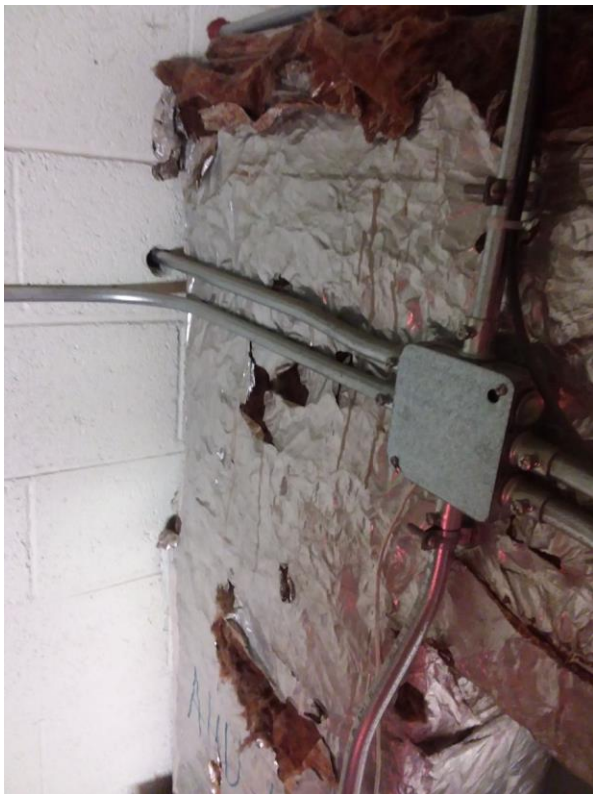
AHU-17
Exterior Ducting

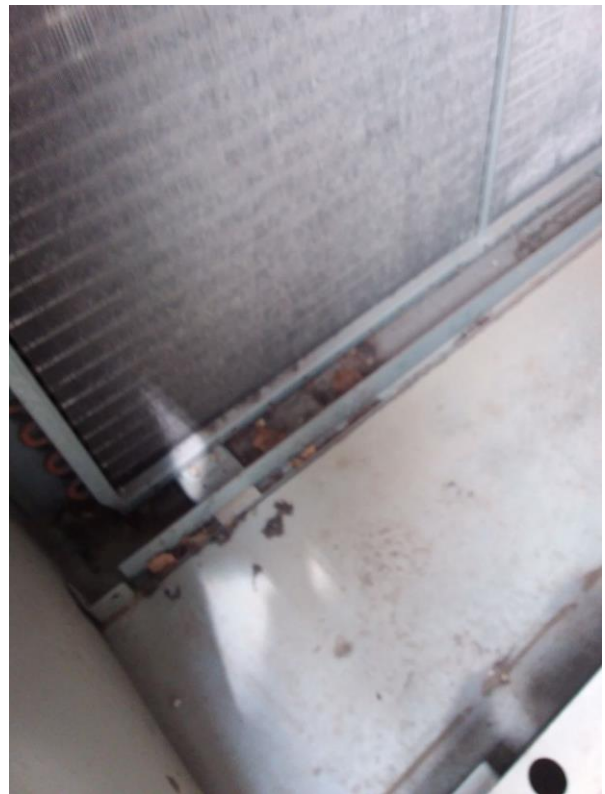
Unit Designation:	RTU-01	
Location of Unit:	Roof via Room 1212	
Areas Served:	See attached map Field house	
System Enhancements:	None	
Supply System	Outdoor Air	Cleanliness and Observations
Type <ul style="list-style-type: none"> Supply System - Constant Volume Heating - Hot Water Cooling - None Energy Recovery Unit (ERU) - None 	Outdoor air intake is accessible Outdoor air intake is located on the roof. No nearby pollution sources were found.	Outdoor air filters are not present. Return air filters are not present. Mixed air pre-filters are not present. Mixed air main filters are clean and not in need of replacement (scoring 1 out of 5) and fit well. Mixed air main filters are installed correctly. Drain pans are not plugged. Drain pan condition is good. Heating coils are clean.
Filter Type - Mixed <ul style="list-style-type: none"> Pre-filter: None Main filter: Pleated, MERV 11 	Outdoor air intake is in good condition.	Heat wheels are not present. Exterior ducting is visible. Exterior ducting insulation is not present. Interior ducting is not visible. Interior ducting insulation is in an unknown condition. Interior ducting is of unknown cleanliness. Air handling room is free of trash/chemicals. Outside damper is open, and its condition is good. Return damper is open, and its condition is good. The general condition of the unit is good.

RTU-01
Drain Pans

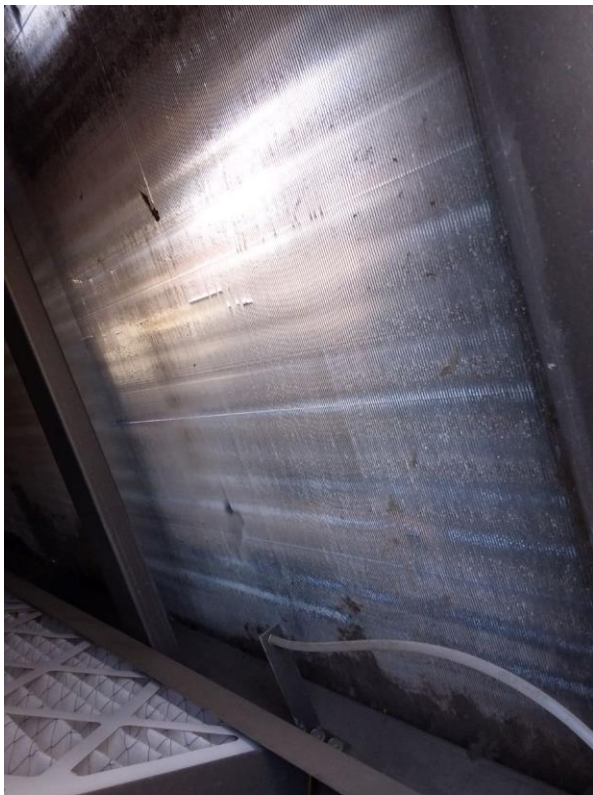
Unit Designation:	RTU-03	
Location of Unit:	North side of roof near West Penthouse Entrance	
Areas Served:	See attached map 3rd floor computer labs (north side)	
System Enhancements:	None	
Supply System	Outdoor Air	Cleanliness and Observations
Type <ul style="list-style-type: none"> Supply System - VAV Heating - None Cooling - Dx Energy Recovery Unit (ERU) - None 	Outdoor air intake is accessible	Outdoor air filters are not present.
Filter Type - Mixed <ul style="list-style-type: none"> Pre-filter: None Main filter: Pleated, MERV 11 	Outdoor air intake is located on the roof.	Return air filters are not present.
	No nearby pollution sources were found.	Mixed air pre-filters are not present. Mixed air main filters are clean and not in need of replacement (scoring 1 out of 5) and fit well. Mixed air main filters are installed correctly.
	Outdoor air intake is in good condition.	Drain pans are not plugged. Drain pan condition is poor.

RTU-03
Drain Pans

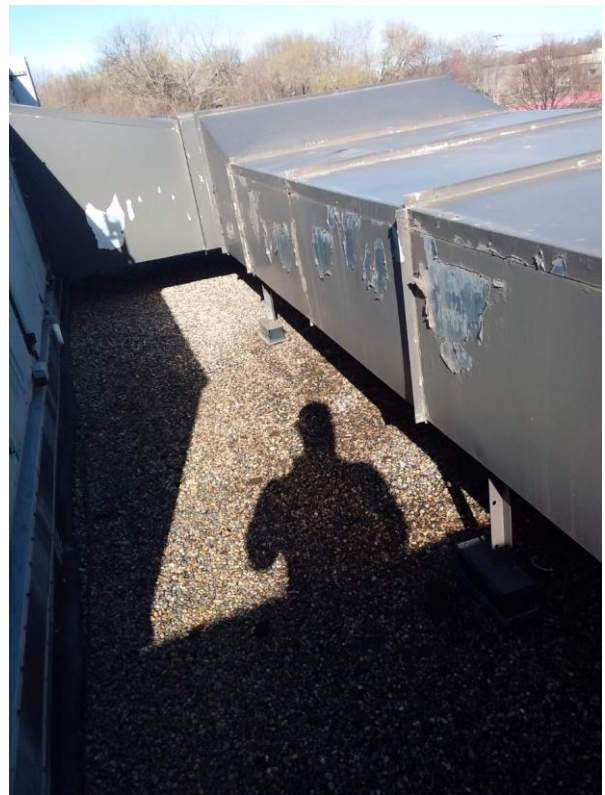
Cooling coils are clean.
		Heat wheels are not present.
		Exterior ducting is visible. Exterior ducting insulation is not present.
		Interior ducting is not visible. Interior ducting insulation is in an unknown condition. Interior ducting is of unknown cleanliness.
		Air handling room is free of trash/chemicals.
		Outside damper is closed, and its condition is good.
		Return damper is open, and its condition is good.
		The general condition of the unit is good.

RTU-03
General Condition

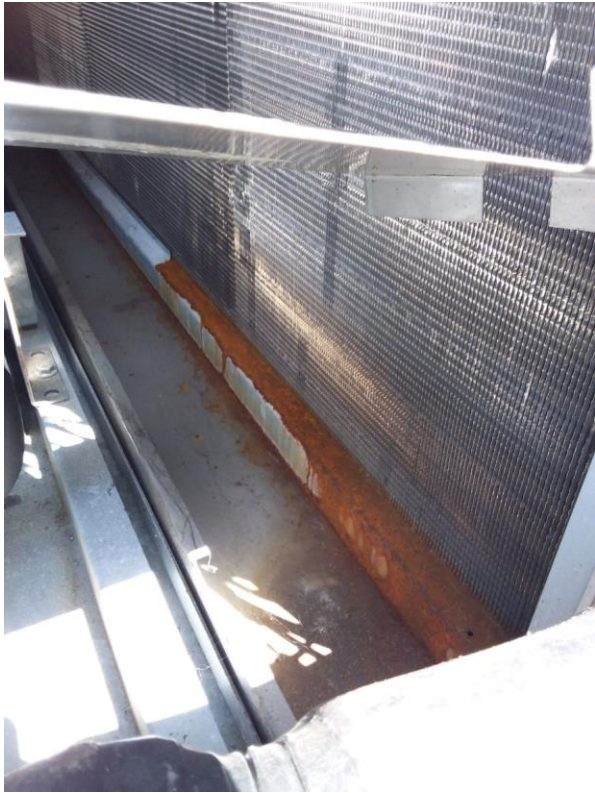
RTU-04
Drain Pans

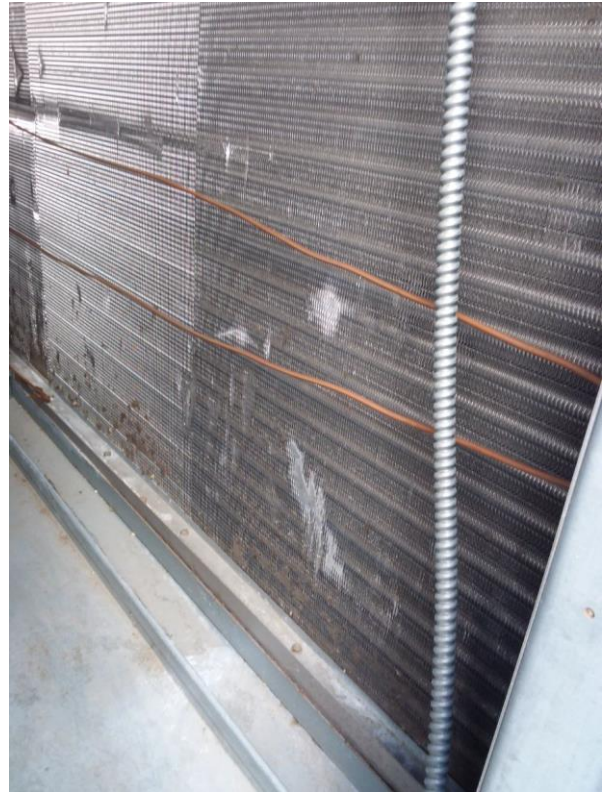
Unit Designation:	RTU-04	
Location of Unit:	Southwest Room via Room 1212	
Areas Served:	See attached map Main office	
System Enhancements:	None	
Supply System	Outdoor Air	Cleanliness and Observations
Type <ul style="list-style-type: none"> Supply System - VAV Heating - Hot Water Cooling - Dx Energy Recovery Unit (ERU) - None 	Outdoor air intake is accessible	Outdoor air filters are not present.
	Outdoor air intake is located on the roof.	Return air filters are not present.
	No nearby pollution sources were found.	Mixed air pre-filters are not present. Mixed air main filters are clean and not in need of replacement (scoring 1 out of 5) and fit well. Mixed air main filters are installed correctly.
Filter Type - Mixed		Drain pans are not plugged. Drain pan condition is poor.
<ul style="list-style-type: none"> Pre-filter: None Main filter: Pleated, MERV 11 	Outdoor air intake is in good condition.	Heating coils are clean and cooling coils are dirty.

RTU-04
Cooling Coils
