## 2023 - 2024 Ventilation Assessment

## Saint Paul Public Schools Horace Mann School

Assessment Date:  
Monday, April 24, 2023

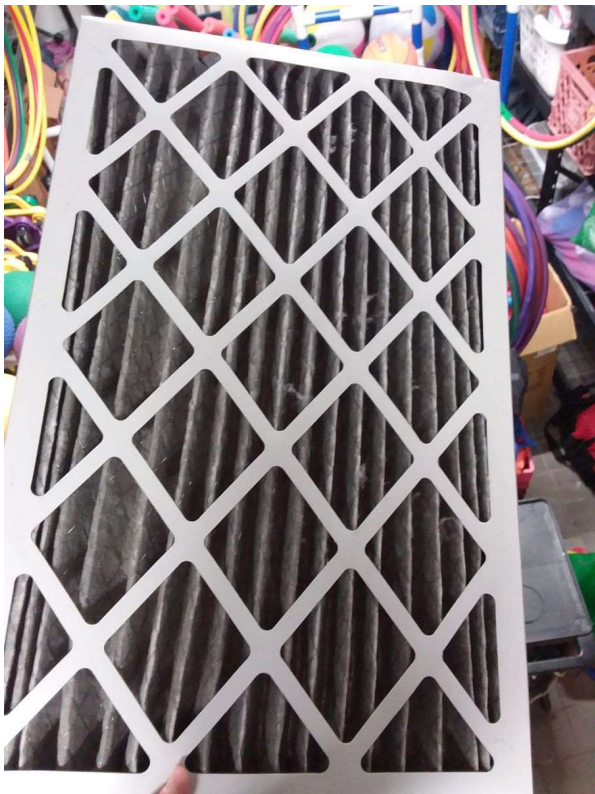
AHU-B1

| <b>Filter Type - Mixed</b> <ul style="list-style-type: none"> <li>Pre-filter: None</li> <li>Main filter: Pleated, MERV 11</li> </ul> | | |

Mixed Main Filter Cleanliness

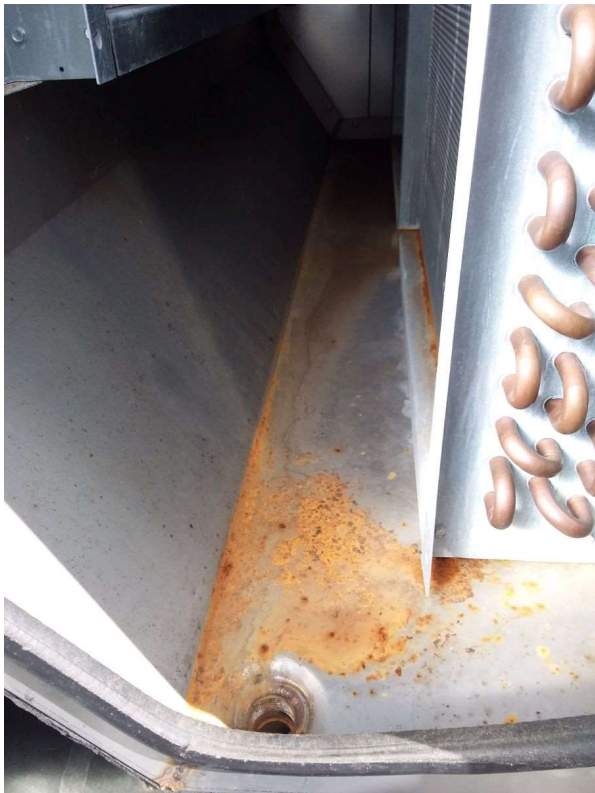
DOAS\_B2

| <b>Type</b> <ul style="list-style-type: none"> <li>Supply System - Constant Volume</li> <li>Heating - Hot Water</li> <li>Cooling - Dx</li> <li>Energy Recovery Unit (ERU) - Fixed Plate</li> </ul> | Outdoor air intake is accessible<br><br>Outdoor air intake is located on the roof.<br><br>No nearby pollution sources were found. | Outdoor air filters are not present.<br><br>Return air filters are not present.<br><br>Mixed air pre-filters are not present. Mixed air main filters are clean and not in need of replacement (scoring 2 out of 5) and fit well. Mixed air main filters are installed correctly.<br><br>Drain pans are not plugged. Drain pan condition is poor.<br><br>Heating coils are clean and cooling coils are clean. |

The drain pan for units DOAS\_B1, DOAS\_B2, DOAS\_C1 and RTU\_A2 was plugged or damaged at the time of the site inspection.

Drain Pans

**Recommendation:** Damage to the drain pan should be repaired, or the drain pan should be inspected more frequently to ensure that it does not become plugged.

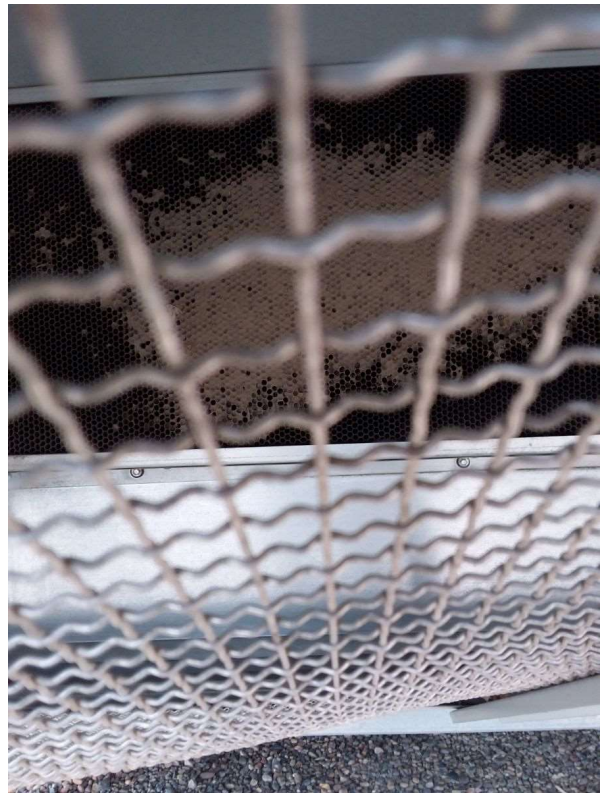
DOAS\_B2

| <b>Filter Type - Mixed</b> <ul style="list-style-type: none"> <li>Pre-filter: None</li> <li>Main filter: Pleated, MERV 11</li> </ul> | Outdoor air intake is in poor condition. | Heat wheels are clean.<br><br>Exterior ducting is not visible. Exterior ducting insulation is in an unknown condition.<br><br>Interior ducting is not visible. Interior ducting insulation is in an unknown condition. Interior ducting is of unknown cleanliness.<br><br>Air handling room is free of trash/chemicals.<br><br>Outside damper is open, and its condition is good.<br><br>Return damper is open, and its condition is good.<br><br>The general condition of the unit is good. |

Outdoor Intake

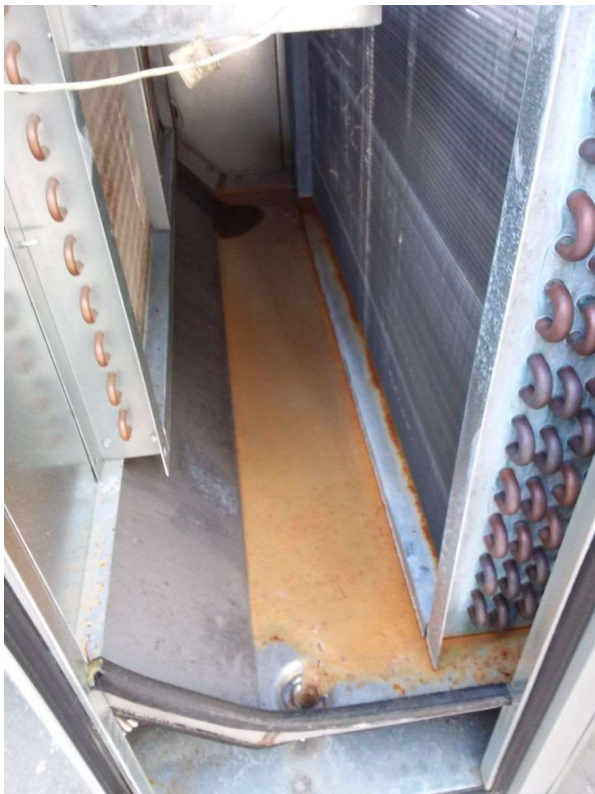
DOAS\_C1  
Drain Pans

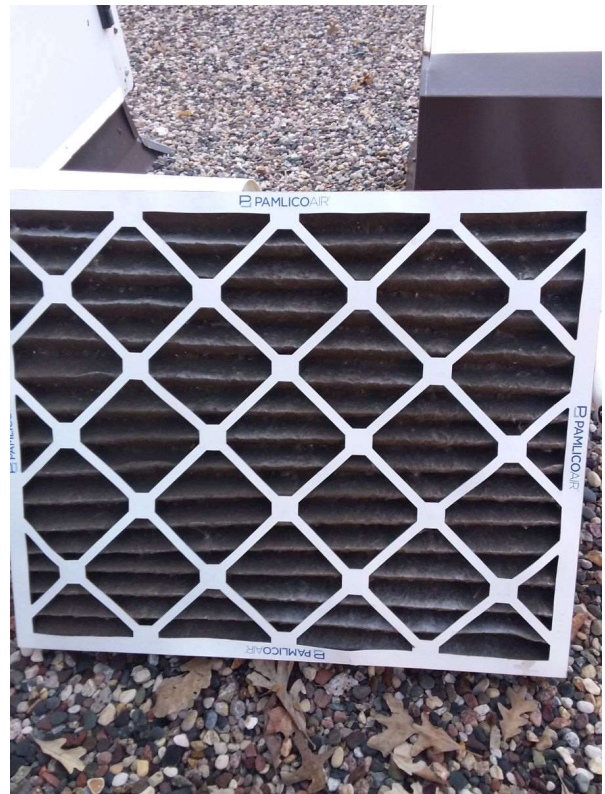
| <b>Type</b> <ul style="list-style-type: none"> <li>Supply System - Constant Volume</li> <li>Heating - Hot Water</li> <li>Cooling - None</li> <li>Energy Recovery Unit (ERU) - Wheel</li> </ul> | Outdoor air intake is accessible | Outdoor air pre-filters are not present. Outdoor air main filters are somewhat dirty and on the border of needing replacement (scoring 4 out of 5) and fit well. Outdoor air main filters are installed correctly. |

ERU\_B1 (ERV-1)  
Outdoor Main Filter Cleanliness

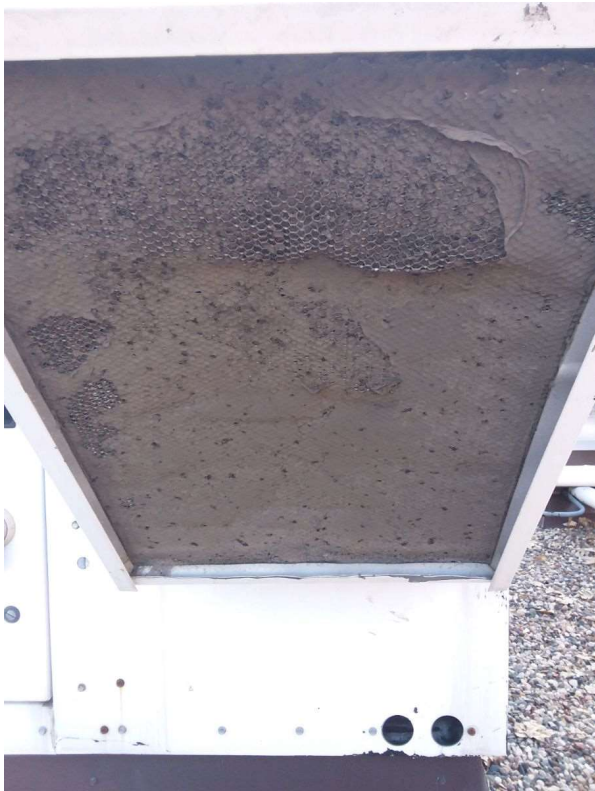
| <ul style="list-style-type: none"> <li>Pre-filter: None</li> <li>Main filter: Pleated, MERV 11</li> </ul> | Outdoor air intake is in poor condition. | Heating coils are clean.<br>Heat wheels are clean.<br>Exterior ducting is not visible. Exterior ducting insulation is in an unknown condition. |

ERU\_B1 (ERV-1)  
Outdoor Intake

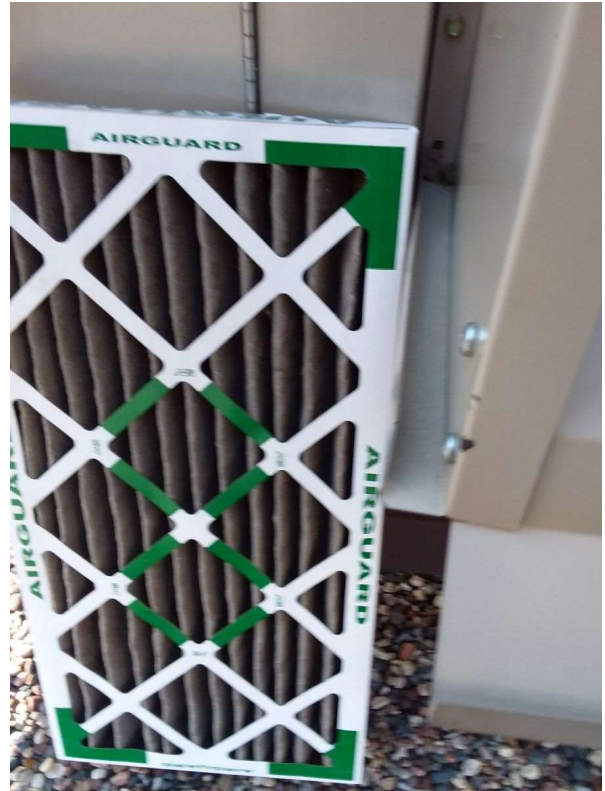
RTU\_A1  
Mixed Main Filter Cleanliness

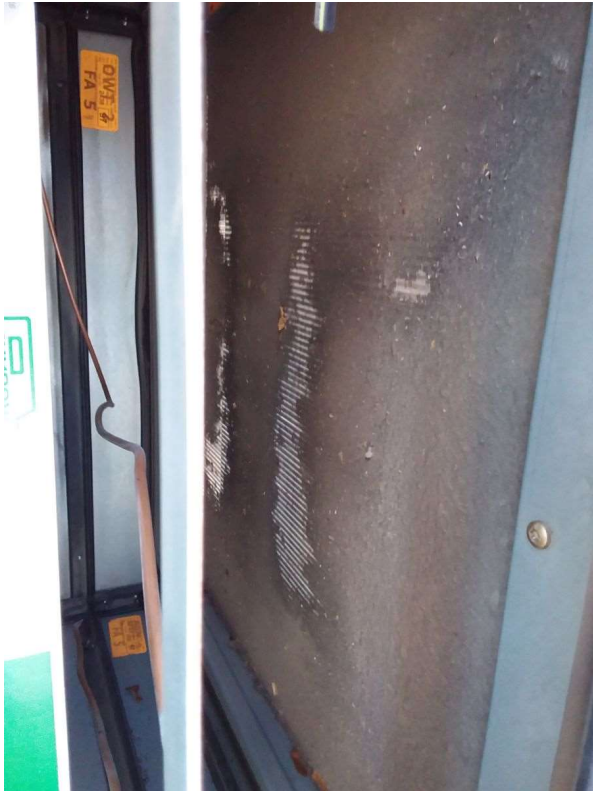
| <b>Type</b> <ul style="list-style-type: none"> <li>Supply System - Constant Volume</li> <li>Heating - Hot Water</li> <li>Cooling - None</li> <li>Energy Recovery Unit (ERU) - None</li> </ul> | Outdoor air intake is accessible<br><br>Outdoor air intake is located on the roof.<br><br>No nearby pollution sources were found. | Outdoor air filters are not present.<br><br>Return air filters are not present.<br><br>Mixed air pre-filters are not present. Mixed air main filters are somewhat dirty and on the border of needing replacement (scoring 3 out of 5) and fit well. Mixed air main filters are installed correctly.<br><br>Drain pans are not plugged. Drain pan condition is good.<br><br>Heating coils are dirty. |

Dirty Coils were observed on unit RTU\_A1 during the ventilation inspection.

RTU\_A1  
Heating Coils

**Recommendation:** Impacted/dirty coils can result in poor ventilation air supply as well as be a source for mold and bacterial growth on the coils. Coils should be cleaned annually, or as needed, as identified in the operations and maintenance program.

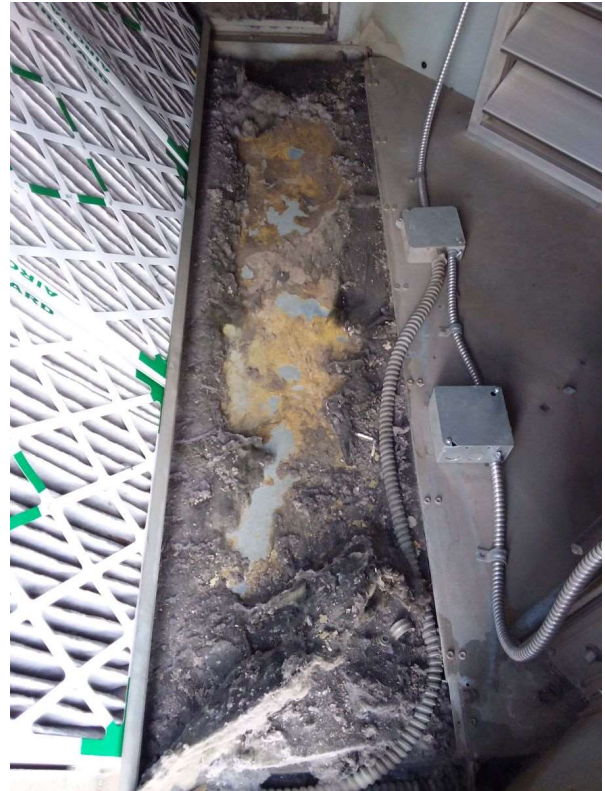
| <b>Filter Type - Mixed</b> <ul style="list-style-type: none"> <li>Pre-filter: None</li> <li>Main filter: Pleated, MERV 11</li> </ul> | Outdoor air intake is in good condition. | Heat wheels are not present.<br><br>Exterior ducting is not visible. Exterior ducting insulation is in an unknown condition.<br><br>Interior ducting is not visible. Interior ducting insulation is in an unknown condition. Interior ducting is of unknown cleanliness.<br><br>Air handling room is free of trash/chemicals.<br><br>Outside damper is open, and its condition is good.<br><br>Return damper is open, and its condition is good.<br><br>The general condition of the unit is poor. |

The general condition of unit RTU\_B1 was poor.

RTU\_B1  
General Condition

**Recommendation:** The units should be repaired or cleaned as needed.

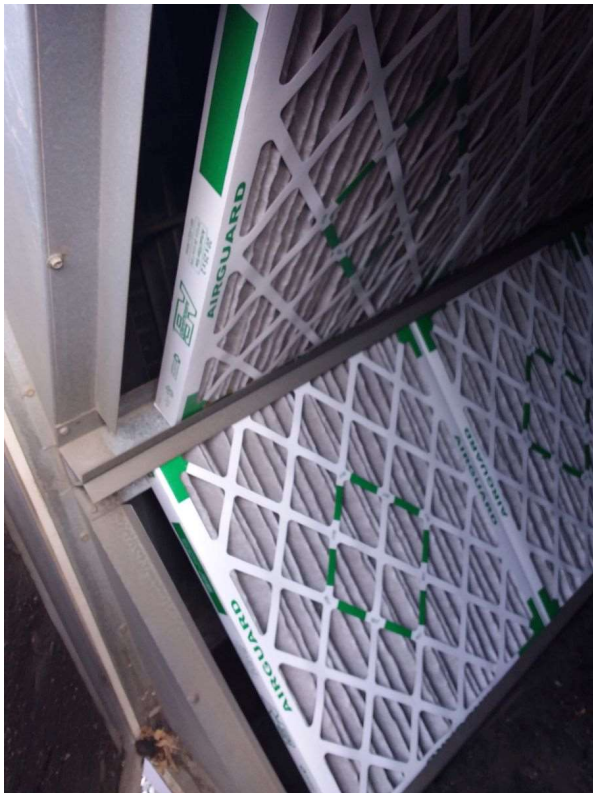
Dirty or poorly fitting filters were observed in unit RTU\_B3 during the ventilation inspection.

RTU\_B3  
Mixed Main Filter Fit

**Recommendation:** The operations and maintenance program for filter changes should be reviewed and revised to ensure proper filter changes to optimize filtration capacity.

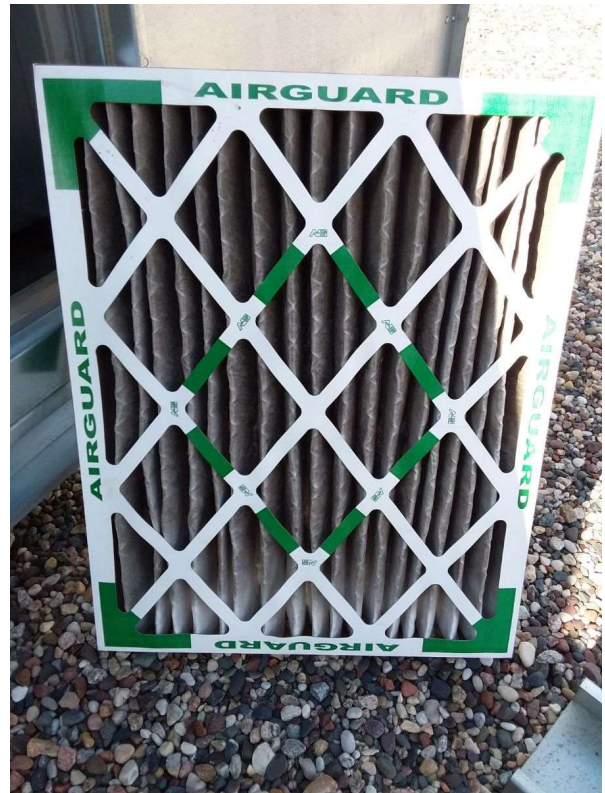
| <b>Type</b> <ul style="list-style-type: none"> <li>Supply System - Unknown</li> <li>Heating - None</li> <li>Cooling - None</li> <li>Energy Recovery Unit (ERU) - None</li> </ul> | Outdoor air intake is accessible | Outdoor air pre-filters are not present. Outdoor air main filters are somewhat dirty and on the border of needing replacement (scoring 3 out of 5) and fit well. Outdoor air main filters are installed correctly. |

MAU-1  
Outdoor Main Filter Cleanliness

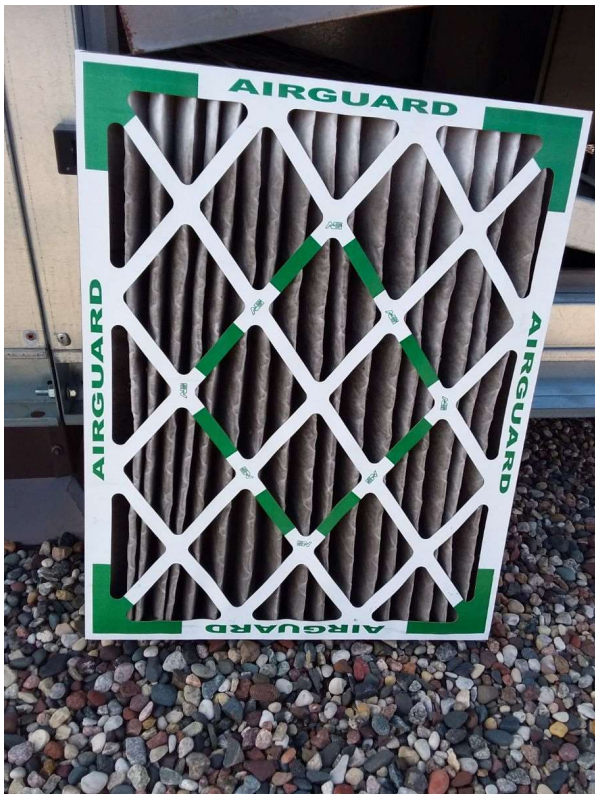
MAU-1

Mixed Main Filter Cleanliness
