IEA, INC.

2023 - 2024 Ventilation Assessment

Saint Paul Public Schools Mississippi Elementary School

Assessment Date:
Tuesday, April 4, 2023

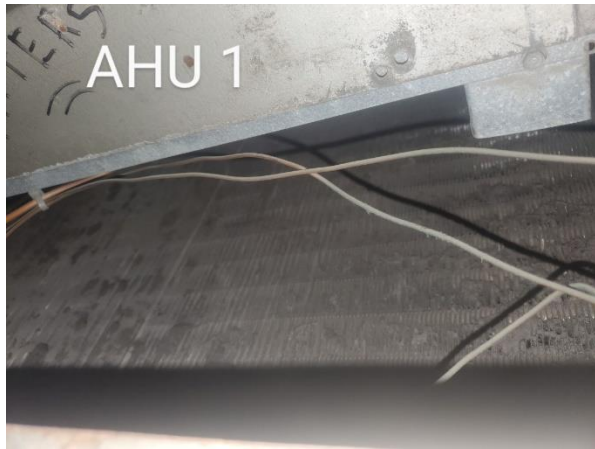
Unit Designation:	AHU 01	
Location of Unit:	Ceiling of 1108	
Areas Served:	Gymnasium	
System Enhancements:	None	
Supply System	Outdoor Air	Cleanliness and Observations
Type <ul style="list-style-type: none"> Supply System - VAV Heating - Steam Cooling - None Energy Recovery Unit (ERU) - None 	Outdoor air intake is inaccessible Outdoor air intake is located on an exterior wall. No nearby pollution sources were found.	Outdoor air pre-filters are not present. Outdoor air main filters are clean and not in need of replacement (scoring 2 out of 5) and fit well. Outdoor air main filters are installed correctly. Return air filters are not present. Drain pans are not applicable or not present. Drain pan condition is not known.
Filter Type - Outdoor <ul style="list-style-type: none"> Pre-filter: None Main filter: Pleated, MERV 11 	Outdoor air intake is in good condition.	Heating coils are dirty. Heat wheels are not present. Exterior ducting is visible. Exterior ducting insulation is not present. Interior ducting is not visible. Interior ducting insulation is in an unknown condition. Interior ducting is of unknown cleanliness. Air handling room is free of trash/chemicals. Outside damper is inaccessible, and its condition is good. Return damper is not present. The general condition of the unit is good.

Dirty Coils were observed on units AHU 01, AHU 02, UV 16, UV 21, UV 6 , UV10, UV-2, UV25, UV-3, UV-30 and UV-31 during the ventilation inspection.

AHU 01
Heating Coils

Recommendation: Impacted/dirty coils can result in poor ventilation air supply as well as be a source for mold and bacterial growth on the coils. Coils should be cleaned annually, or as needed, as identified in the operations and maintenance program.

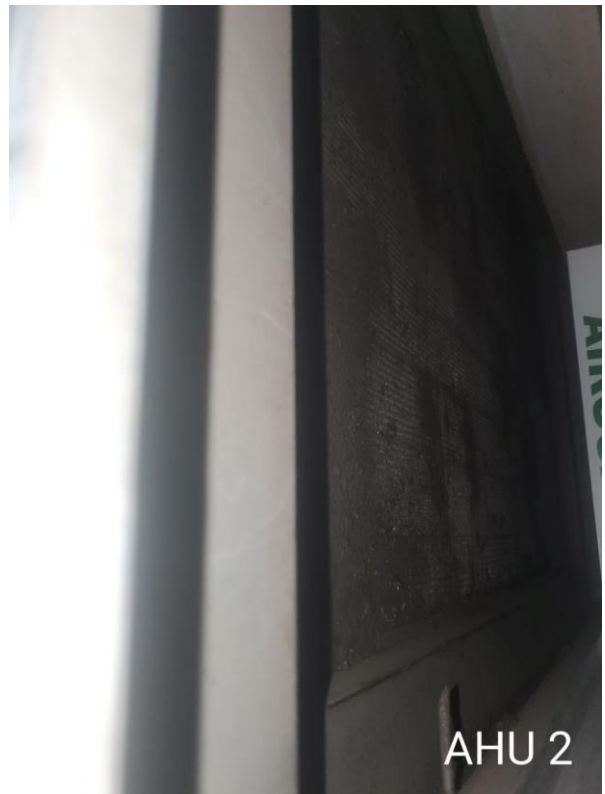
Unit Designation:	AHU 02	
Location of Unit:	in 1108, hanging from ceiling	
Areas Served:	See attached map.	
System Enhancements:	None	
Supply System	Outdoor Air	Cleanliness and Observations
Type <ul style="list-style-type: none"> Supply System - VAV Heating - Hot Water Cooling - None Energy Recovery Unit (ERU) - None 	<p>Outdoor air intake is inaccessible</p> <p>Outdoor air intake is located in an unknown location.</p> <p>It is not known if there are nearby pollution sources.</p>	<p>Outdoor air filters are not present.</p> <p>Return air filters are not present.</p> <p>Mixed air pre-filters are not present. Mixed air main filters are clean and not in need of replacement (scoring 2 out of 5) and fit well. Mixed air main filters are installed correctly.</p> <p>Drain pans are not applicable or not present. Drain pan condition is not known.</p>
Filter Type - Mixed <ul style="list-style-type: none"> Pre-filter: None Main filter: Pleated, MERV 11 	<p>Outdoor air intake is in good condition.</p>	<p>Heating coils are dirty.</p> <p>Heat wheels are not present.</p> <p>Exterior ducting is visible. Exterior ducting insulation is not present.</p> <p>Interior ducting is not visible. Interior ducting insulation is in an unknown condition. Interior ducting is of unknown cleanliness.</p> <p>Air handling room is free of trash/chemicals.</p> <p>Outside damper is open, and its condition is good.</p> <p>Return damper is open, and its condition is good.</p> <p>The general condition of the unit is good.</p>

AHU 02
Heating Coils

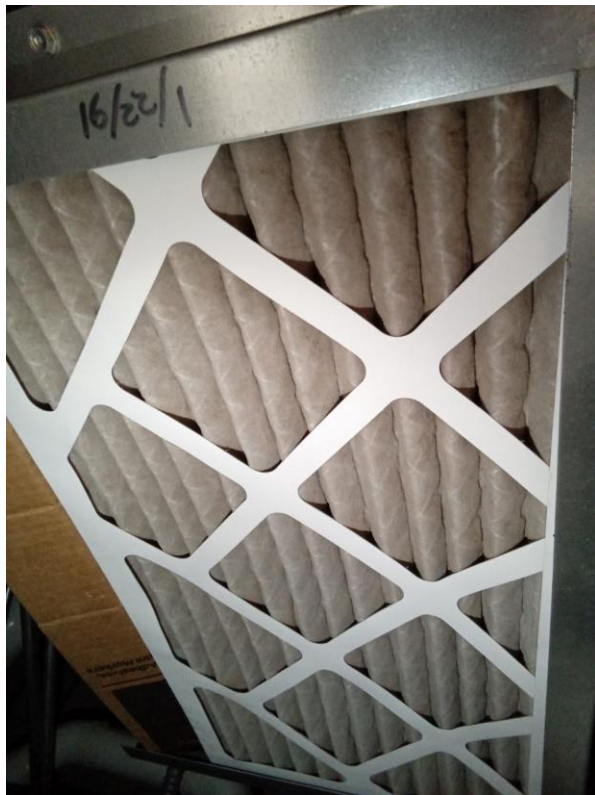
Unit Designation:	MUA 01	
Location of Unit:	Mechanical room Kitchen ceiling	
Areas Served:	Kitchen See attached maps	
System Enhancements:	None	
Supply System	Outdoor Air	Cleanliness and Observations
Type <ul style="list-style-type: none"> Supply System - VAV Heating - None Cooling - None Energy Recovery Unit (ERU) - None 	Outdoor air intake is inaccessible	Outdoor air filters are not present.
Filter Type - Return <ul style="list-style-type: none"> Pre-filter: None Main filter: Pleated, MERV 11 	Outdoor air intake is located in an unknown location.	Return air pre-filters are not present. Return air main filters are somewhat dirty and on the border of needing replacement (scoring 4 out of 5) and fit poorly. Return air main filters are installed correctly.
	It is not known if there are nearby pollution sources.	Drain pans are not applicable or not present. Drain pan condition is not known.
	Outdoor air intake is in good condition.	Heat wheels are not present.

Dirty or poorly fitting filters were observed in units MUA 01, UV 12, UV14, UV25 and UV-3 during the ventilation inspection.

MUA 01
Return Main Filter Cleanliness

Recommendation: The operations and maintenance program for filter changes should be reviewed and revised to ensure proper filter changes to optimize filtration capacity.

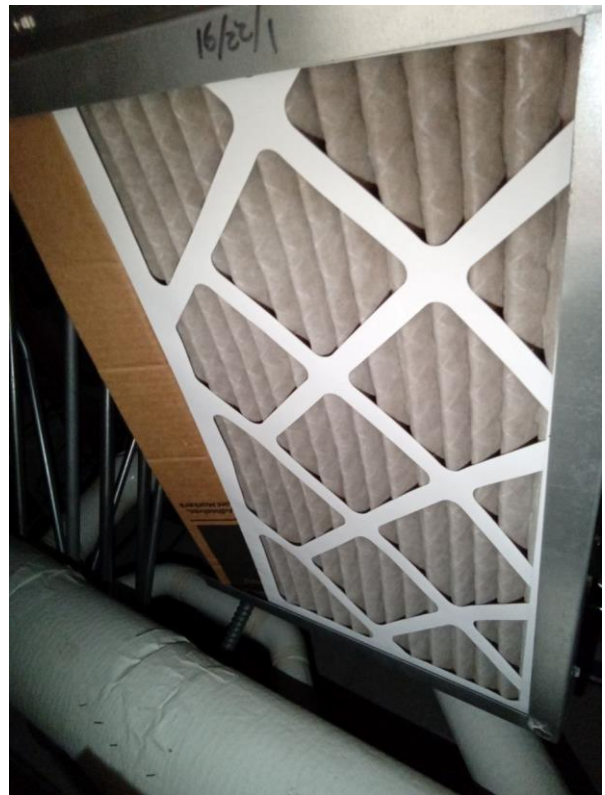
MUA 01
Return Main Filter Fit

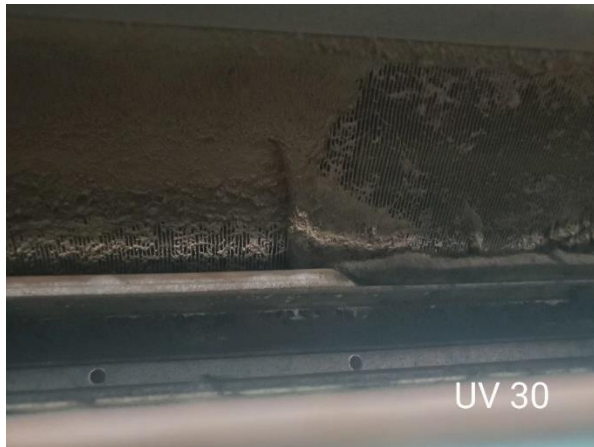
Unit Designation:	UV-30	
Location of Unit:	1310	
Areas Served:	1310	
System Enhancements:	None	
Supply System	Outdoor Air	Cleanliness and Observations
Type <ul style="list-style-type: none"> Supply System - VAV Heating - Steam Cooling - None Energy Recovery Unit (ERU) - None 	Outdoor air intake is accessible Outdoor air intake is located on an exterior wall. No nearby pollution sources were found.	Outdoor air filters are not present. Return air filters are not present. Mixed air pre-filters are not present. Mixed air main filters are clean and not in need of replacement (scoring 2 out of 5) and fit well. Mixed air main filters are installed correctly. Drain pans are not applicable or not present. Drain pan condition is not known.
Filter Type - Mixed <ul style="list-style-type: none"> Pre-filter: None Main filter: Pleated, MERV 11 	Outdoor air intake is in good condition.	Heating coils are dirty. Heat wheels are not present. Exterior ducting is not visible. Exterior ducting insulation is in an unknown condition. Interior ducting is not visible. Interior ducting insulation is in an unknown condition. Interior ducting is of unknown cleanliness. Air handling room is free of trash/chemicals. Outside damper is inaccessible, and its condition is good. Return damper is open, and its condition is good. The general condition of the unit is good.

UV-30
Heating Coils

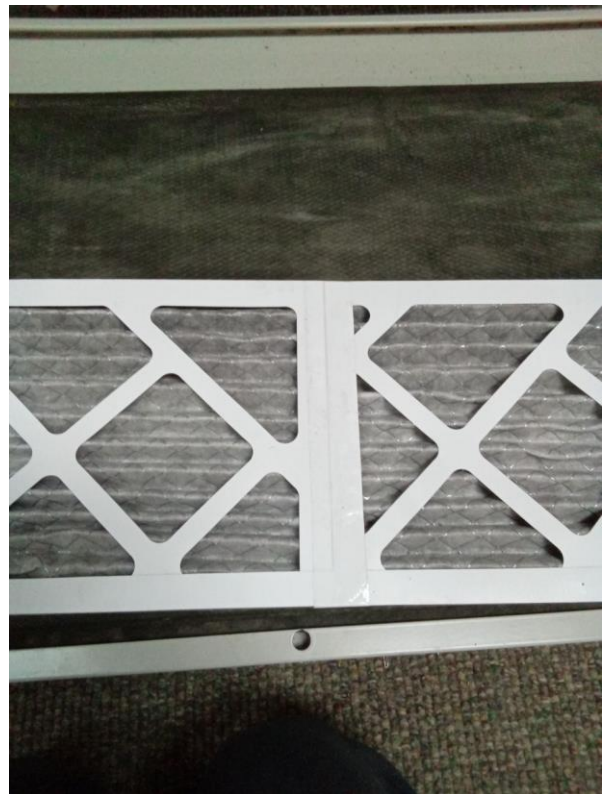
Unit Designation:	UV-31	
Location of Unit:	1314	
Areas Served:	1314	
System Enhancements:	Ultraviolet Light (UVC)	
Supply System	Outdoor Air	Cleanliness and Observations
Type <ul style="list-style-type: none"> Supply System - VAV Heating - Steam Cooling - None Energy Recovery Unit (ERU) - None 	Outdoor air intake is accessible Outdoor air intake is located on an exterior wall. No nearby pollution sources were found.	Outdoor air filters are not present. Return air filters are not present. Mixed air pre-filters are not present. Mixed air main filters are somewhat dirty and on the border of needing replacement (scoring 4 out of 5) and fit well. Mixed air main filters are installed correctly. Drain pans are not applicable or not present. Drain pan condition is not known.
Filter Type - Mixed <ul style="list-style-type: none"> Pre-filter: None Main filter: Pleated, MERV 11 	Outdoor air intake is in good condition.	Heating coils are dirty. Heat wheels are not present. Exterior ducting is not visible. Exterior ducting insulation is in an unknown condition. Interior ducting is not visible. Interior ducting insulation is in an unknown condition. Interior ducting is of unknown cleanliness. Air handling room is free of trash/chemicals. Outside damper is inaccessible, and its condition is good. Return damper is open, and its condition is good. The general condition of the unit is good.

UV-31
Mixed Main Filter Cleanliness

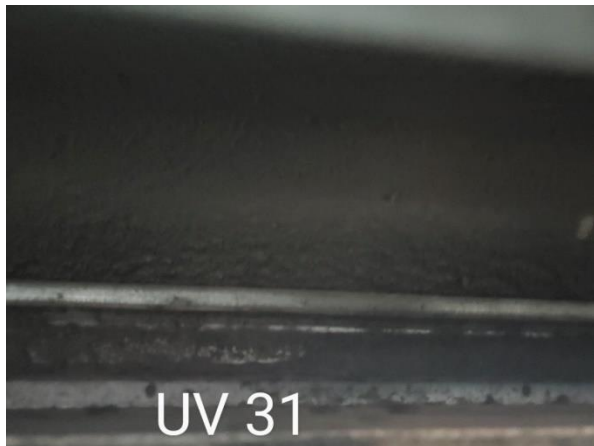
UV-31
Heating Coils

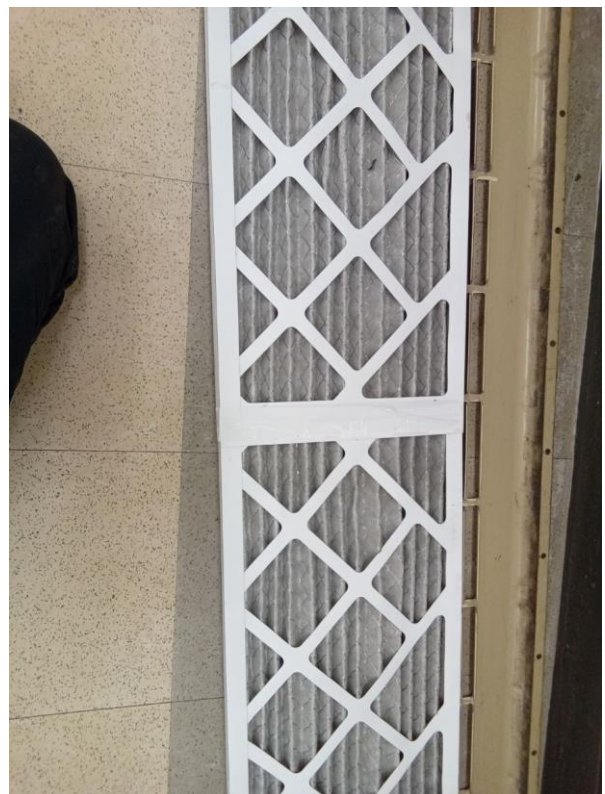
Unit Designation:	UV-2	
Location of Unit:	1215	
Areas Served:	1215	
System Enhancements:	None	
Supply System	Outdoor Air	Cleanliness and Observations
Type <ul style="list-style-type: none"> Supply System - VAV Heating - Steam Cooling - None Energy Recovery Unit (ERU) - None 	Outdoor air intake is accessible Outdoor air intake is located on an exterior wall. No nearby pollution sources were found.	Outdoor air filters are not present. Return air filters are not present. Mixed air pre-filters are not present. Mixed air main filters are somewhat dirty and on the border of needing replacement (scoring 3 out of 5) and fit well. Mixed air main filters are installed correctly. Drain pans are not applicable or not present. Drain pan condition is not known.
Filter Type - Mixed <ul style="list-style-type: none"> Pre-filter: None Main filter: Pleated, MERV 11 	Outdoor air intake is in good condition.	Heating coils are dirty. Heat wheels are not present. Exterior ducting is not visible. Exterior ducting insulation is in an unknown condition. Interior ducting is not visible. Interior ducting insulation is in an unknown condition. Interior ducting is of unknown cleanliness. Air handling room is free of trash/chemicals. Outside damper is inaccessible, and its condition is good. Return damper is inaccessible, and its condition is good. The general condition of the unit is good.

UV-2
Mixed Main Filter Cleanliness

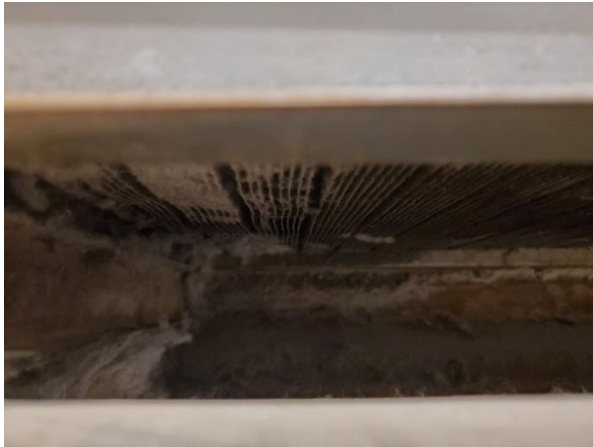
UV-2
Heating Coils

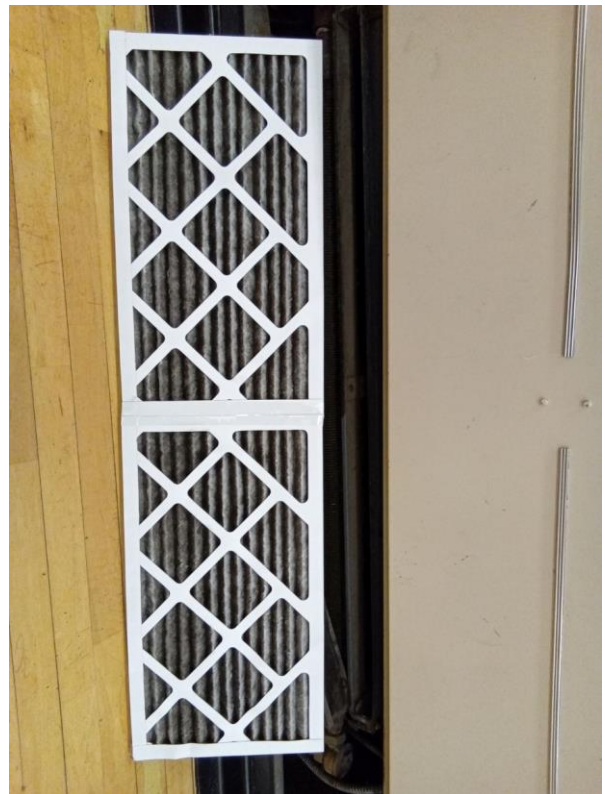
Unit Designation:	UV 6	
Location of Unit:	1214	
Areas Served:	1214	
System Enhancements:	None	
Supply System	Outdoor Air	Cleanliness and Observations
Type <ul style="list-style-type: none"> Supply System - VAV Heating - Steam Cooling - None Energy Recovery Unit (ERU) - None 	Outdoor air intake is accessible Outdoor air intake is located on an exterior wall. No nearby pollution sources were found.	Outdoor air filters are not present. Return air filters are not present. Mixed air pre-filters are not present. Mixed air main filters are somewhat dirty and on the border of needing replacement (scoring 4 out of 5) and fit well. Mixed air main filters are installed correctly. Drain pans are not applicable or not present. Drain pan condition is not known.
Filter Type - Mixed <ul style="list-style-type: none"> Pre-filter: None Main filter: Pleated, MERV 11 	Outdoor air intake is in good condition.	Heating coils are dirty. Heat wheels are not present. Exterior ducting is not visible. Exterior ducting insulation is in an unknown condition. Interior ducting is not visible. Interior ducting insulation is in an unknown condition. Interior ducting is of unknown cleanliness. Air handling room is free of trash/chemicals. Outside damper is inaccessible, and its condition is good. Return damper is open, and its condition is good. The general condition of the unit is good.

UV 6
Mixed Main Filter Cleanliness

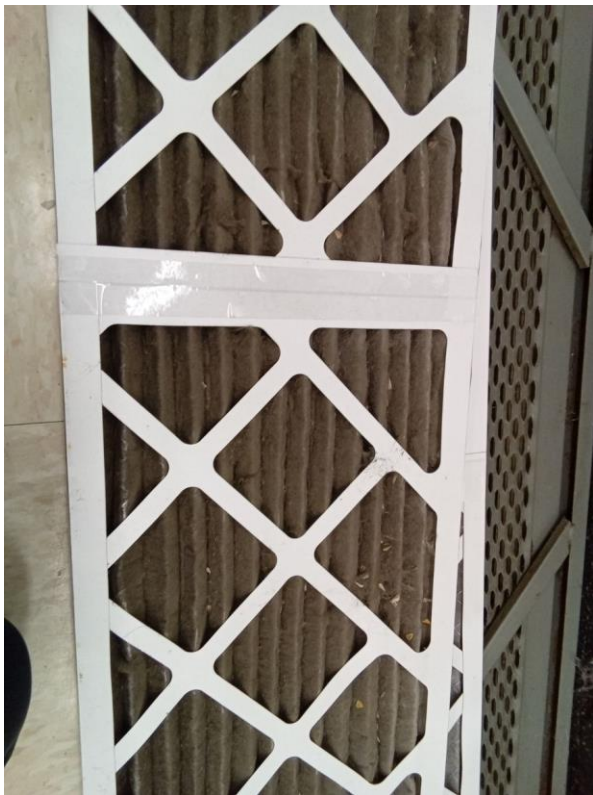
Unit Designation:	UV-3	
Location of Unit:	1219	
Areas Served:	1219	
System Enhancements:	None	
Supply System	Outdoor Air	Cleanliness and Observations
Type <ul style="list-style-type: none"> Supply System - VAV Heating - Steam Cooling - None Energy Recovery Unit (ERU) - None 	Outdoor air intake is accessible Outdoor air intake is located on an exterior wall. No nearby pollution sources were found.	Outdoor air filters are not present. Return air filters are not present. Mixed air pre-filters are dirty and in need of replacement (scoring 5 out of 5) and fit well. Mixed air pre-filters are installed correctly. Mixed air main filters are somewhat dirty and on the border of needing replacement (scoring 4 out of 5) and fit well. Mixed air main filters are installed correctly. Drain pans are not applicable or not present. Drain pan condition is not known.
Filter Type - Mixed <ul style="list-style-type: none"> Pre-filter: Pleated, MERV 11 Main filter: Pleated, MERV 11 	Outdoor air intake is in good condition.	Heating coils are dirty. Heat wheels are not present. Exterior ducting is not visible. Exterior ducting insulation is in an unknown condition. Interior ducting is not visible. Interior ducting insulation is in an unknown condition. Interior ducting is of unknown cleanliness. Air handling room is free of trash/chemicals. Outside damper is inaccessible, and its condition is good. Return damper is open, and its condition is good. The general condition of the unit is good.

UV-3
Mixed Pre-Filter Cleanliness

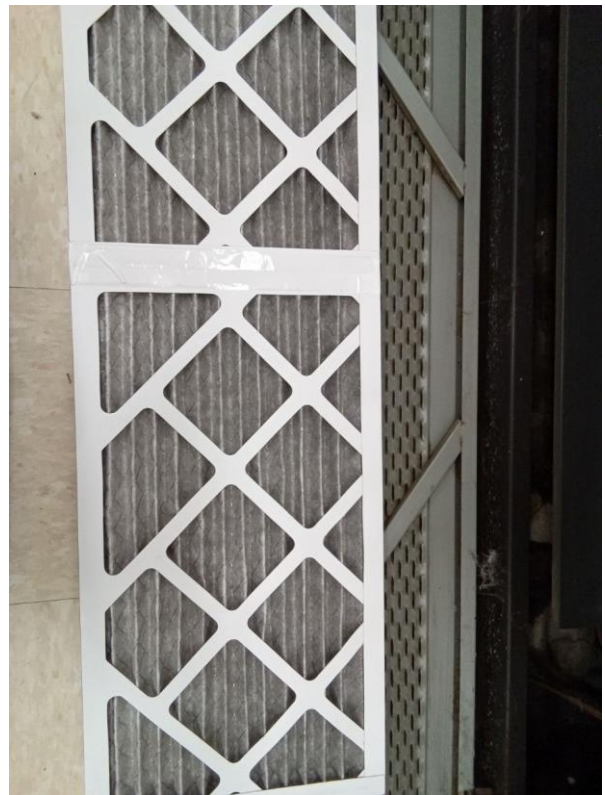
UV-3
Mixed Main Filter Cleanliness

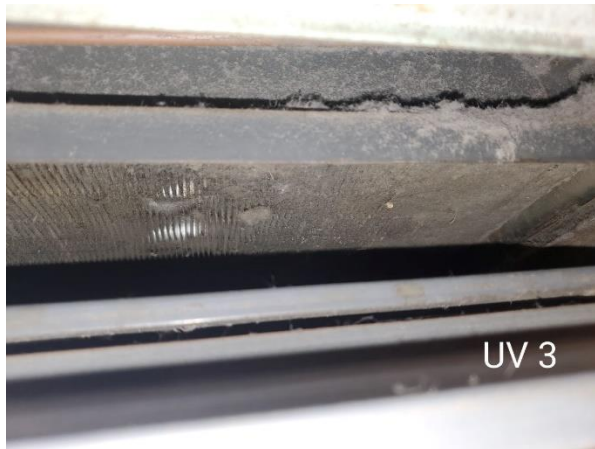
UV-3
Heating Coils

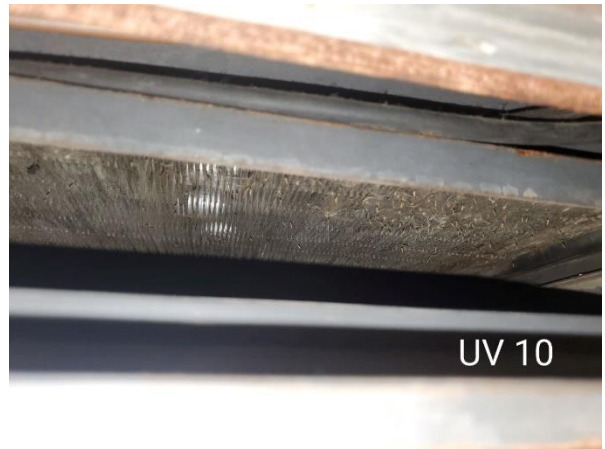
Unit Designation:	UV10	
Location of Unit:	1220	
Areas Served:	1220	
System Enhancements:	None	
Supply System	Outdoor Air	Cleanliness and Observations
Type <ul style="list-style-type: none"> Supply System - VAV Heating - Steam Cooling - None Energy Recovery Unit (ERU) - None 	Outdoor air intake is accessible Outdoor air intake is located on an exterior wall. No nearby pollution sources were found.	Outdoor air filters are not present. Return air filters are not present. Mixed air pre-filters are not present. Mixed air main filters are clean and not in need of replacement (scoring 2 out of 5) and fit well. Mixed air main filters are installed correctly. Drain pans are not applicable or not present. Drain pan condition is not known.
Filter Type - Mixed <ul style="list-style-type: none"> Pre-filter: None Main filter: Pleated, MERV 11 	Outdoor air intake is in good condition.	Heating coils are dirty. Heat wheels are not present. Exterior ducting is not visible. Exterior ducting insulation is in an unknown condition. Interior ducting is not visible. Interior ducting insulation is in an unknown condition. Interior ducting is of unknown cleanliness. Air handling room is free of trash/chemicals. Outside damper is inaccessible, and its condition is good. Return damper is open, and its condition is good. The general condition of the unit is good.

UV10
Heating Coils

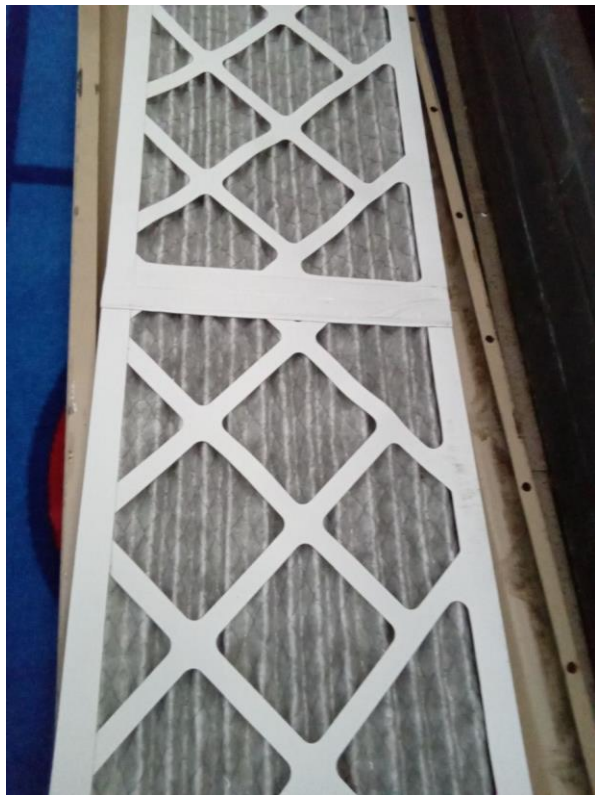
Unit Designation:	UV 21	
Location of Unit:	2218	
Areas Served:	2218	
System Enhancements:	None	
Supply System	Outdoor Air	Cleanliness and Observations
Type <ul style="list-style-type: none"> Supply System - VAV Heating - Steam Cooling - None Energy Recovery Unit (ERU) - None 	<p>Outdoor air intake is inaccessible</p> <p>Outdoor air intake is located on an exterior wall.</p> <p>No nearby pollution sources were found.</p>	<p>Outdoor air filters are not present.</p> <p>Return air filters are not present.</p> <p>Mixed air pre-filters are not present. Mixed air main filters are somewhat dirty and on the border of needing replacement (scoring 3 out of 5) and fit well. Mixed air main filters are installed correctly.</p> <p>Drain pans are not applicable or not present. Drain pan condition is not known.</p> <p>Heating coils are dirty.</p> <p>Heat wheels are not present.</p> <p>Exterior ducting is not visible. Exterior ducting insulation is in an unknown condition.</p> <p>Interior ducting is not visible. Interior ducting insulation is in an unknown condition. Interior ducting is of unknown cleanliness.</p> <p>Air handling room is free of trash/chemicals.</p> <p>Outside damper is inaccessible, and its condition is good.</p> <p>Return damper is open, and its condition is good.</p> <p>The general condition of the unit is good.</p>

UV 21
Mixed Main Filter Cleanliness

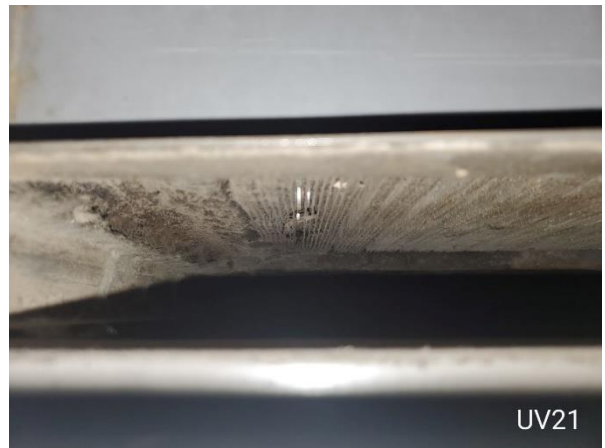
UV 21
Heating Coils

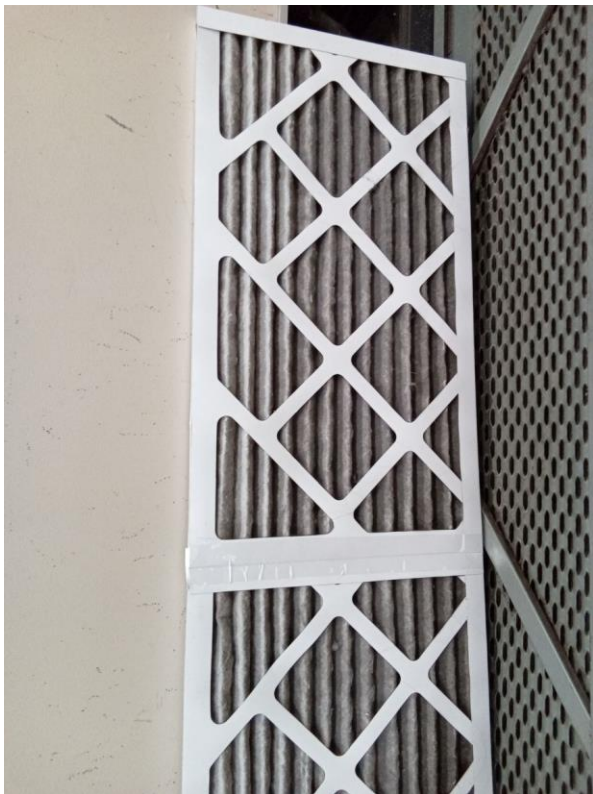
Unit Designation:	UV 16	
Location of Unit:	2221	
Areas Served:	2221	
System Enhancements:	None	
Supply System	Outdoor Air	Cleanliness and Observations
Type <ul style="list-style-type: none"> Supply System - VAV Heating - Steam Cooling - None Energy Recovery Unit (ERU) - None 	<p>Outdoor air intake is inaccessible</p> <p>Outdoor air intake is located on an exterior wall.</p> <p>No nearby pollution sources were found.</p>	<p>Outdoor air filters are not present.</p> <p>Return air filters are not present.</p> <p>Mixed air pre-filters are not present. Mixed air main filters are somewhat dirty and on the border of needing replacement (scoring 4 out of 5) and fit well. Mixed air main filters are installed correctly.</p> <p>Drain pans are not applicable or not present. Drain pan condition is good.</p> <p>Heating coils are dirty.</p> <p>Heat wheels are not present.</p> <p>Exterior ducting is not visible. Exterior ducting insulation is in an unknown condition.</p> <p>Interior ducting is not visible. Interior ducting insulation is in an unknown condition. Interior ducting is of unknown cleanliness.</p> <p>Air handling room is free of trash/chemicals.</p> <p>Outside damper is inaccessible, and its condition is good.</p> <p>Return damper is open, and its condition is good.</p> <p>The general condition of the unit is good.</p>

Mixed Main Filter Cleanliness

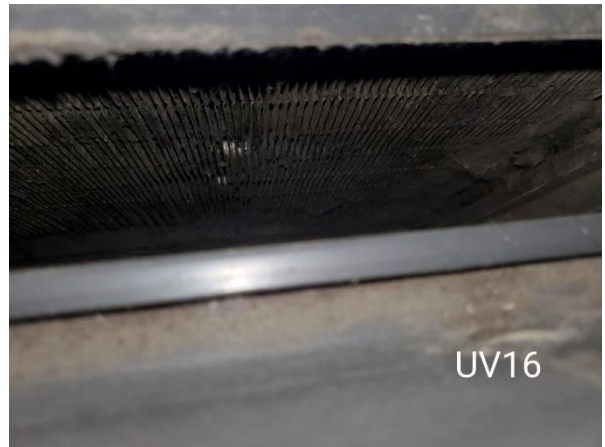
UV 16

Heating Coils

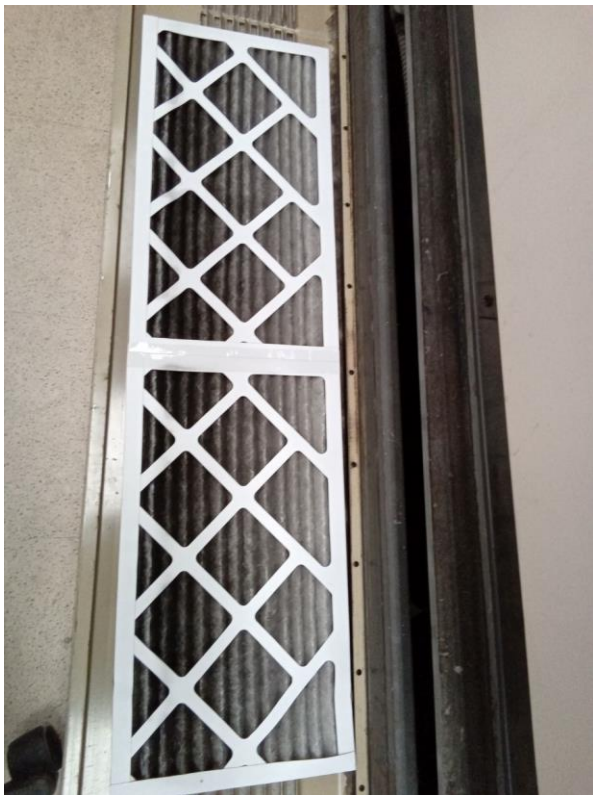
Unit Designation:	UV14	
Location of Unit:	2217	
Areas Served:	2217	
System Enhancements:	None	
Supply System	Outdoor Air	Cleanliness and Observations
Type <ul style="list-style-type: none"> Supply System - VAV Heating - Steam Cooling - None Energy Recovery Unit (ERU) - None 	<p>Outdoor air intake is inaccessible</p> <p>Outdoor air intake is located on an exterior wall.</p> <p>No nearby pollution sources were found.</p>	<p>Outdoor air filters are not present.</p> <p>Return air filters are not present.</p> <p>Mixed air pre-filters are not present. Mixed air main filters are dirty and in need of replacement (scoring 5 out of 5) and fit well. Mixed air main filters are installed correctly.</p> <p>Drain pans are not applicable or not present. Drain pan condition is not known.</p>
Filter Type - Mixed <ul style="list-style-type: none"> Pre-filter: None Main filter: Pleated, MERV 11 	<p>Outdoor air intake is in good condition.</p>	<p>Heating coils are clean.</p> <p>Heat wheels are not present.</p> <p>Exterior ducting is not visible. Exterior ducting insulation is in an unknown condition.</p> <p>Interior ducting is not visible. Interior ducting insulation is in an unknown condition. Interior ducting is of unknown cleanliness.</p> <p>Air handling room is free of trash/chemicals.</p> <p>Outside damper is inaccessible, and its condition is good.</p> <p>Return damper is open, and its condition is good.</p> <p>The general condition of the unit is good.</p>

Mixed Main Filter Cleanliness

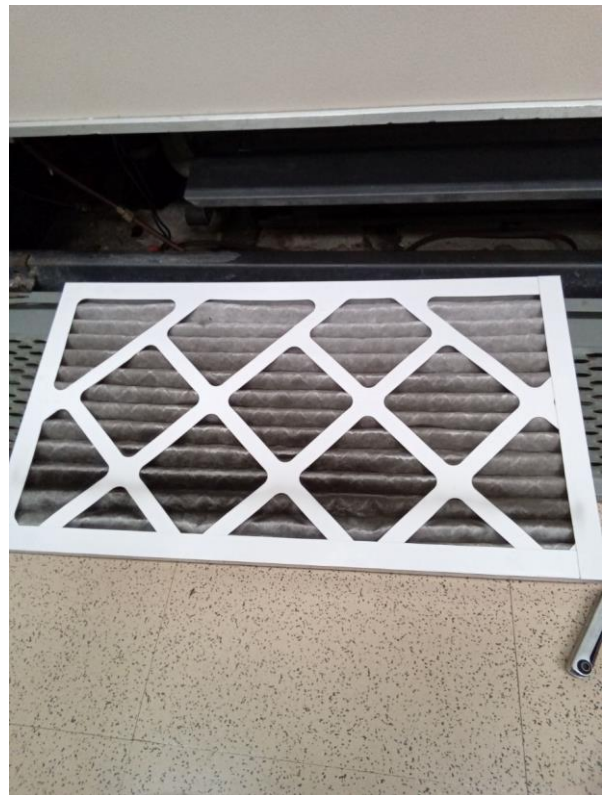
Unit Designation:	UV25	
Location of Unit:	2222	
Areas Served:	2222	
System Enhancements:	None	
Supply System	Outdoor Air	Cleanliness and Observations
Type <ul style="list-style-type: none"> Supply System - VAV Heating - Steam Cooling - None Energy Recovery Unit (ERU) - None 	<p>Outdoor air intake is inaccessible</p> <p>Outdoor air intake is located on an exterior wall.</p> <p>No nearby pollution sources were found.</p>	<p>Outdoor air filters are not present.</p> <p>Return air filters are not present.</p> <p>Mixed air pre-filters are not present. Mixed air main filters are dirty and in need of replacement (scoring 5 out of 5) and fit well. Mixed air main filters are installed correctly.</p> <p>Drain pans are not applicable or not present. Drain pan condition is not known.</p>
Filter Type - Mixed <ul style="list-style-type: none"> Pre-filter: None Main filter: Pleated, MERV 11 	<p>Outdoor air intake is in good condition.</p>	<p>Heating coils are dirty.</p> <p>Heat wheels are not present.</p> <p>Exterior ducting is not visible. Exterior ducting insulation is in an unknown condition.</p> <p>Interior ducting is not visible. Interior ducting insulation is in an unknown condition. Interior ducting is of unknown cleanliness.</p> <p>Air handling room is free of trash/chemicals.</p> <p>Outside damper is inaccessible, and its condition is good.</p> <p>Return damper is open, and its condition is good.</p> <p>The general condition of the unit is good.</p>

Mixed Main Filter Cleanliness

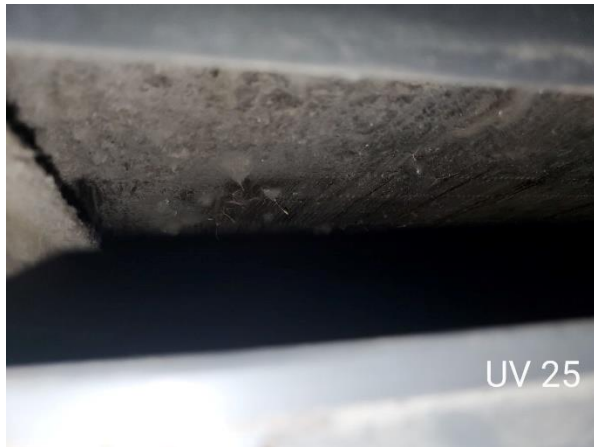
UV25
Heating Coils

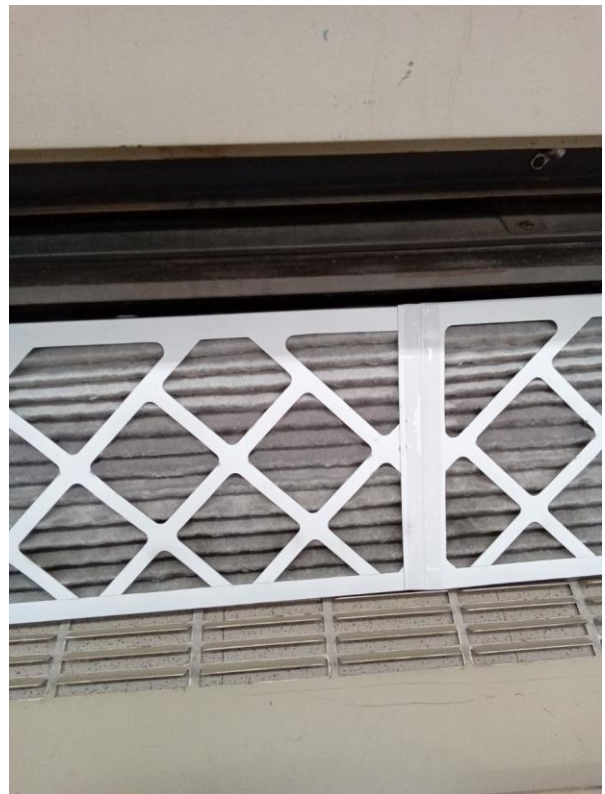
Unit Designation:	UV 19	
Location of Unit:	2214	
Areas Served:	2214	
System Enhancements:	None	
Supply System	Outdoor Air	Cleanliness and Observations
Type <ul style="list-style-type: none"> Supply System - VAV Heating - Steam Cooling - None Energy Recovery Unit (ERU) - None 	<p>Outdoor air intake is inaccessible</p> <p>Outdoor air intake is located on an exterior wall.</p> <p>No nearby pollution sources were found.</p>	<p>Outdoor air filters are not present.</p> <p>Return air filters are not present.</p> <p>Mixed air pre-filters are not present. Mixed air main filters are somewhat dirty and on the border of needing replacement (scoring 4 out of 5) and fit well. Mixed air main filters are installed correctly.</p> <p>Drain pans are not applicable or not present. Drain pan condition is not known.</p> <p>Heating coils are clean.</p> <p>Heat wheels are not present.</p> <p>Exterior ducting is not visible. Exterior ducting insulation is in an unknown condition.</p> <p>Interior ducting is not visible. Interior ducting insulation is in an unknown condition. Interior ducting is of unknown cleanliness.</p> <p>Air handling room is free of trash/chemicals.</p> <p>Outside damper is inaccessible, and its condition is good.</p> <p>Return damper is open, and its condition is good.</p> <p>The general condition of the unit is good.</p>

UV 19
Mixed Main Filter Cleanliness

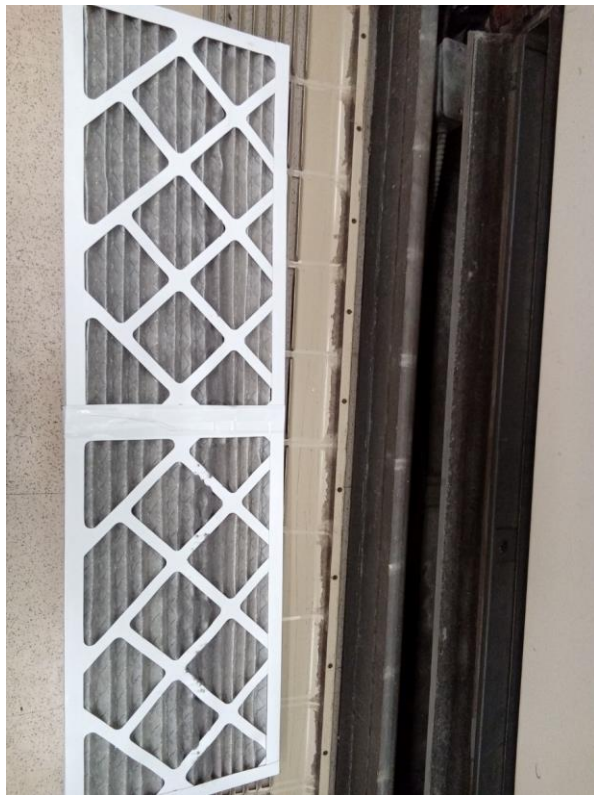
Unit Designation:	UV 12	
Location of Unit:	2213	
Areas Served:	2213	
System Enhancements:	None	
Supply System	Outdoor Air	Cleanliness and Observations
Type <ul style="list-style-type: none"> Supply System - VAV Heating - Steam Cooling - None Energy Recovery Unit (ERU) - None 	<p>Outdoor air intake is inaccessible</p> <p>Outdoor air intake is located on an exterior wall.</p> <p>Outdoor air intake has a nearby pollution source: Near parking lot</p>	<p>Outdoor air filters are not present.</p> <p>Return air filters are not present.</p> <p>Mixed air pre-filters are not present. Mixed air main filters are somewhat dirty and on the border of needing replacement (scoring 4 out of 5) and fit well. Mixed air main filters are installed incorrectly.</p> <p>Drain pans are not applicable or not present. Drain pan condition is not known.</p> <p>Heating coils are clean.</p> <p>Heat wheels are not present.</p> <p>Exterior ducting is not visible. Exterior ducting insulation is in an unknown condition.</p> <p>Interior ducting is not visible. Interior ducting insulation is in an unknown condition. Interior ducting is of unknown cleanliness.</p> <p>Air handling room is free of trash/chemicals.</p> <p>Outside damper is inaccessible, and its condition is good.</p> <p>Return damper is open, and its condition is good.</p> <p>The general condition of the unit is good.</p>

UV 12
Mixed Main Filter Cleanliness

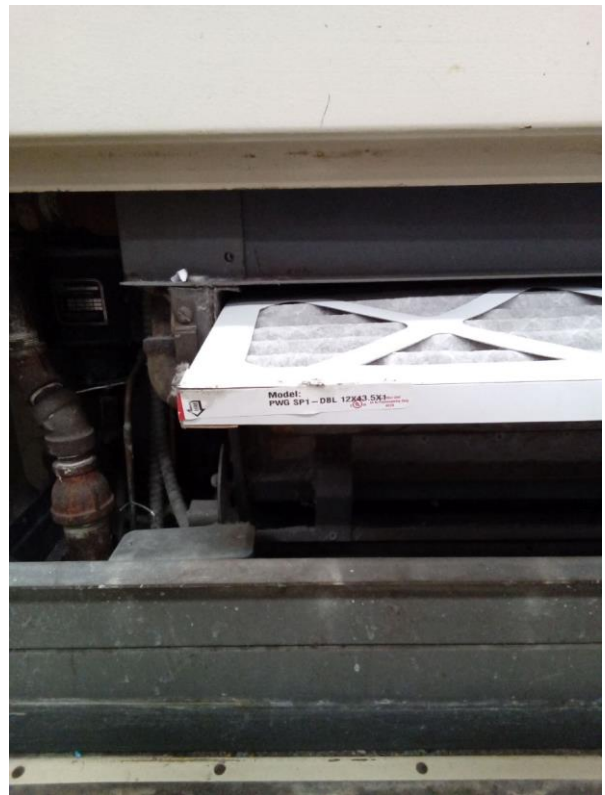
UV 12
Mixed Main Filter Installation
