IEA, INC.

2023 - 2024 Ventilation Assessment

Saint Paul Public Schools Saint Paul Music Academy

Assessment Date:
Wednesday, April 5, 2023

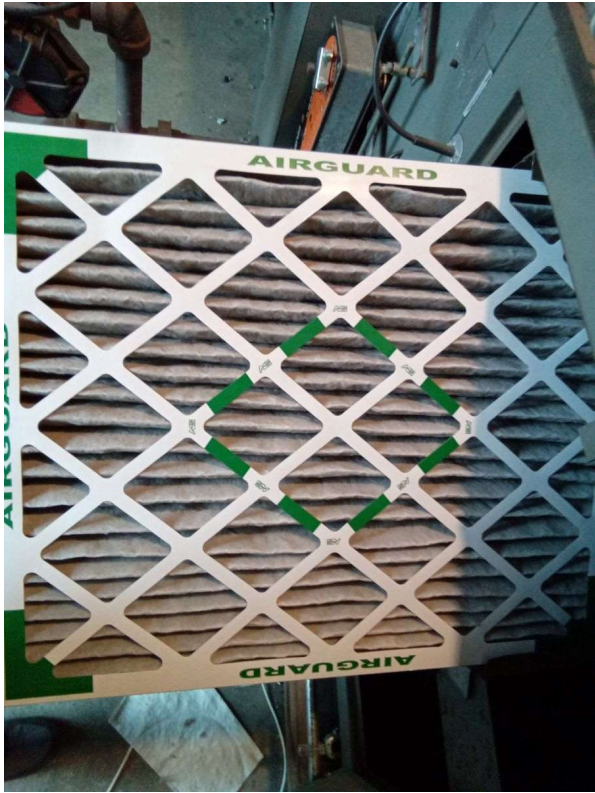
Unit Designation:	AHU 01	
Location of Unit:	Mechanical room Rooftop	
Areas Served:	Media Center See attached map	
System Enhancements:	None	
Supply System	Outdoor Air	Cleanliness and Observations
Type <ul style="list-style-type: none"> • Supply System - Constant Volume • Heating - Hot Water • Cooling - None • Energy Recovery Unit (ERU) - None 	Outdoor air intake is accessible Outdoor air intake is located on the roof. No nearby pollution sources were found.	Outdoor air filters are not present. Return air filters are not present. Mixed air pre-filters are not present. Mixed air main filters are somewhat dirty and on the border of needing replacement (scoring 3 out of 5) and fit well. Mixed air main filters are installed correctly. Drain pans are not applicable or not present. Drain pan condition is not known.
Filter Type - Mixed <ul style="list-style-type: none"> • Pre-filter: None • Main filter: Pleated, MERV 11 	Outdoor air intake is in good condition.	Heating coils are clean. Heat wheels are not present. Exterior ducting is visible. Exterior ducting insulation is not present. Interior ducting is visible. Interior ducting insulation is in good condition. Interior ducting is clean. Air handling room is free of trash/chemicals. Outside damper is open, and its condition is good. Return damper is open, and its condition is good. The general condition of the unit is good.

Mixed Main Filter Cleanliness

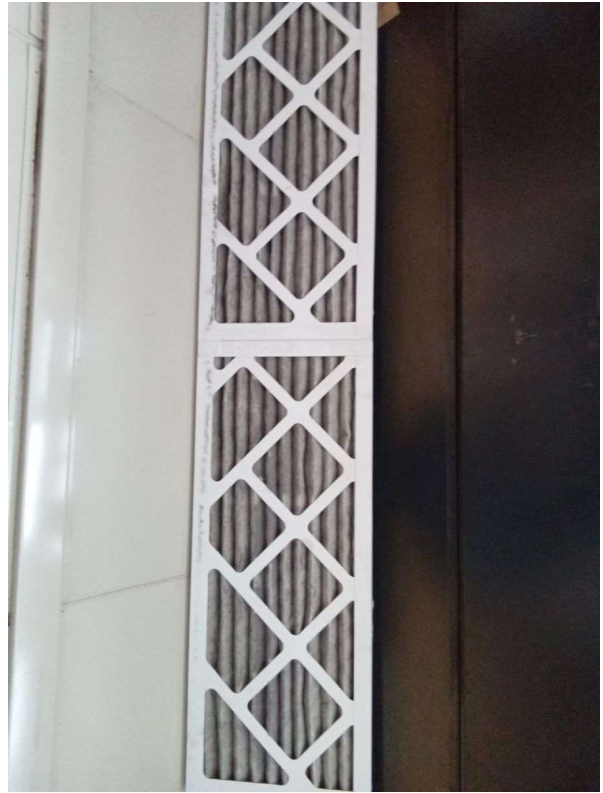
Unit Designation:	UV-1210	
Location of Unit:	1210	
Areas Served:	1210	
System Enhancements:	None	
Supply System	Outdoor Air	Cleanliness and Observations
Type <ul style="list-style-type: none"> • Supply System - VAV • Heating - Steam • Cooling - None • Energy Recovery Unit (ERU) - None 	<p>Outdoor air intake is accessible</p> <p>Outdoor air intake is located on an exterior wall.</p> <p>Outdoor air intake has a nearby pollution source: Close to road</p>	<p>Outdoor air filters are not present.</p> <p>Return air filters are not present.</p> <p>Mixed air pre-filters are not present. Mixed air main filters are somewhat dirty and on the border of needing replacement (scoring 3 out of 5) and fit well. Mixed air main filters are installed correctly.</p> <p>Drain pans are not applicable or not present. Drain pan condition is not known.</p> <p>Heating coils are clean.</p> <p>Heat wheels are not present.</p> <p>Exterior ducting is not visible. Exterior ducting insulation is in an unknown condition.</p> <p>Interior ducting is not visible. Interior ducting insulation is in an unknown condition. Interior ducting is of unknown cleanliness.</p> <p>Air handling room is free of trash/chemicals.</p> <p>Outside damper is open, and its condition is good.</p> <p>Return damper is open, and its condition is good.</p> <p>The general condition of the unit is good.</p>

Mixed Main Filter Cleanliness

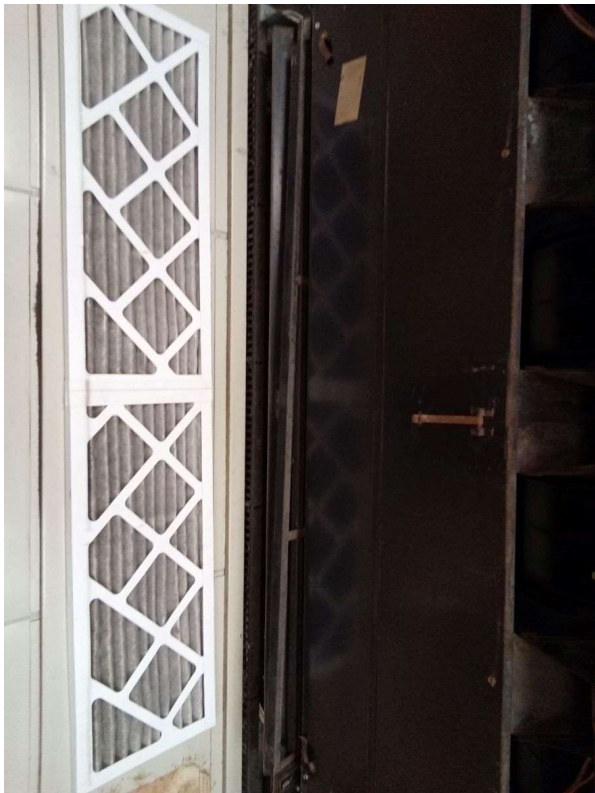
Unit Designation:	UV-1201	
Location of Unit:	1201	
Areas Served:	1201	
System Enhancements:	None	
Supply System	Outdoor Air	Cleanliness and Observations
Type <ul style="list-style-type: none"> • Supply System - VAV • Heating - Steam • Cooling - None • Energy Recovery Unit (ERU) - None Filter Type - Mixed <ul style="list-style-type: none"> • Pre-filter: None • Main filter: Pleated, MERV 11 	<p>Outdoor air intake is accessible</p> <p>Outdoor air intake is located on an exterior wall.</p> <p>Outdoor air intake has a nearby pollution source: Near road</p> <p>Outdoor air intake is in good condition.</p>	<p>Outdoor air filters are not present.</p> <p>Return air filters are not present.</p> <p>Mixed air pre-filters are not present. Mixed air main filters are somewhat dirty and on the border of needing replacement (scoring 3 out of 5) and fit well. Mixed air main filters are installed correctly.</p> <p>Drain pans are not applicable or not present. Drain pan condition is not known.</p> <p>Heating coils are clean.</p> <p>Heat wheels are not present.</p> <p>Exterior ducting is not visible. Exterior ducting insulation is in an unknown condition.</p> <p>Interior ducting is not visible. Interior ducting insulation is in an unknown condition. Interior ducting is of unknown cleanliness.</p> <p>Air handling room is free of trash/chemicals.</p> <p>Outside damper is open, and its condition is good.</p> <p>Return damper is open, and its condition is not known.</p> <p>The general condition of the unit is good.</p>

Mixed Main Filter Cleanliness

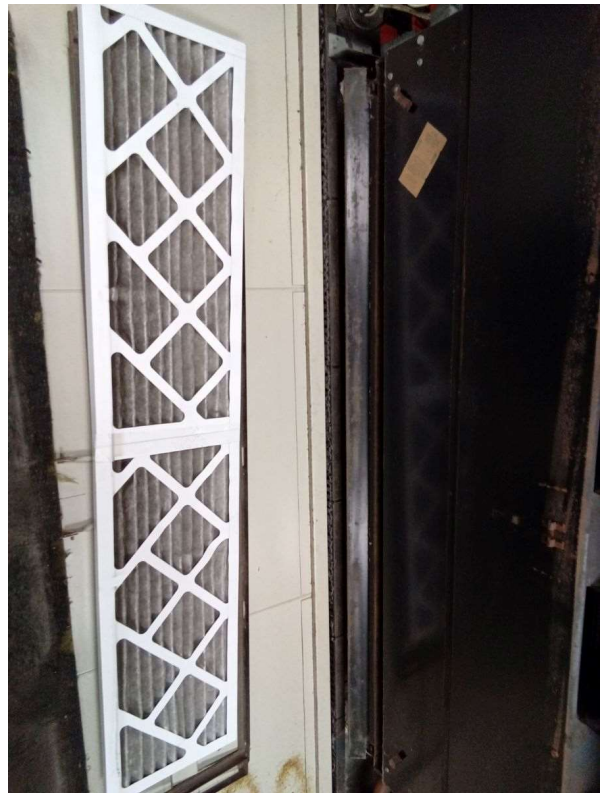
Unit Designation:	UV-20	
Location of Unit:	1104	
Areas Served:	1104	
System Enhancements:	None	
Supply System	Outdoor Air	Cleanliness and Observations
Type <ul style="list-style-type: none"> • Supply System - VAV • Heating - Steam • Cooling - None • Energy Recovery Unit (ERU) - None Filter Type - Mixed <ul style="list-style-type: none"> • Pre-filter: None • Main filter: Pleated, MERV 11 	<p>Outdoor air intake is accessible</p> <p>Outdoor air intake is located on an exterior wall.</p> <p>Outdoor air intake has a nearby pollution source: Near road</p> <p>Outdoor air intake is in good condition.</p>	<p>Outdoor air filters are not present.</p> <p>Return air filters are not present.</p> <p>Mixed air pre-filters are not present. Mixed air main filters are somewhat dirty and on the border of needing replacement (scoring 4 out of 5) and fit well. Mixed air main filters are installed correctly.</p> <p>Drain pans are not applicable or not present. Drain pan condition is not known.</p> <p>Heating coils are clean.</p> <p>Heat wheels are not present.</p> <p>Exterior ducting is not visible. Exterior ducting insulation is in an unknown condition.</p> <p>Interior ducting is not visible. Interior ducting insulation is in an unknown condition. Interior ducting is of unknown cleanliness.</p> <p>Air handling room is free of trash/chemicals.</p> <p>Outside damper is open, and its condition is good.</p> <p>Return damper is open, and its condition is good.</p> <p>The general condition of the unit is good.</p>

Mixed Main Filter Cleanliness

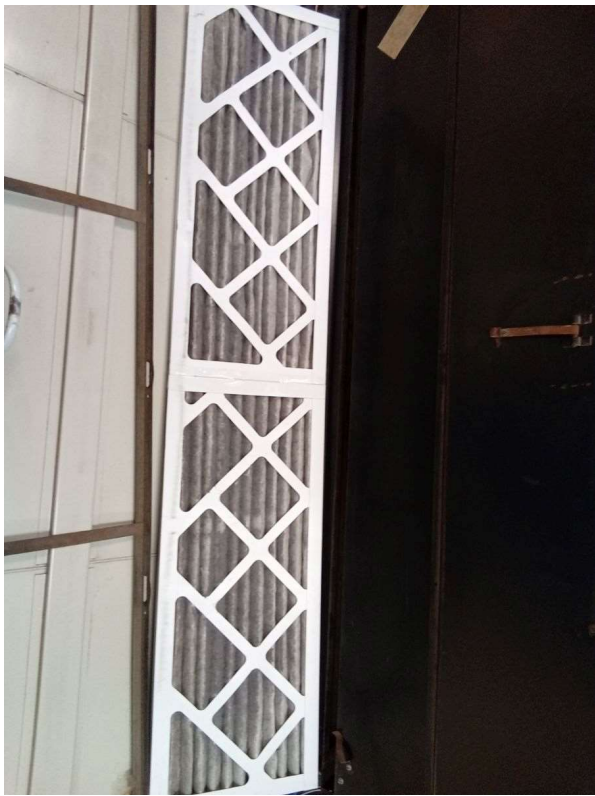
Unit Designation:	UV-2201	
Location of Unit:	2201	
Areas Served:	2201	
System Enhancements:	None	
Supply System	Outdoor Air	Cleanliness and Observations
Type <ul style="list-style-type: none"> • Supply System - VAV • Heating - Steam • Cooling - None • Energy Recovery Unit (ERU) - None 	Outdoor air intake is inaccessible	Outdoor air filters are not present. Return air filters are not present.
	Outdoor air intake is located on an exterior wall.	Mixed air pre-filters are not present. Mixed air main filters are somewhat dirty and on the border of needing replacement (scoring 4 out of 5) and fit well. Mixed air main filters are installed correctly.
	No nearby pollution sources were found.	Drain pans are not applicable or not present. Drain pan condition is not known.
Filter Type - Mixed <ul style="list-style-type: none"> • Pre-filter: None • Main filter: Pleated, MERV 11 	Outdoor air intake is in good condition.	Heating coils are clean. Heat wheels are not present. Exterior ducting is not visible. Exterior ducting insulation is in an unknown condition. Interior ducting is not visible. Interior ducting insulation is in an unknown condition. Interior ducting is of unknown cleanliness. Air handling room is free of trash/chemicals. Outside damper is open, and its condition is good. Return damper is open, and its condition is good. The general condition of the unit is good.

Mixed Main Filter Cleanliness

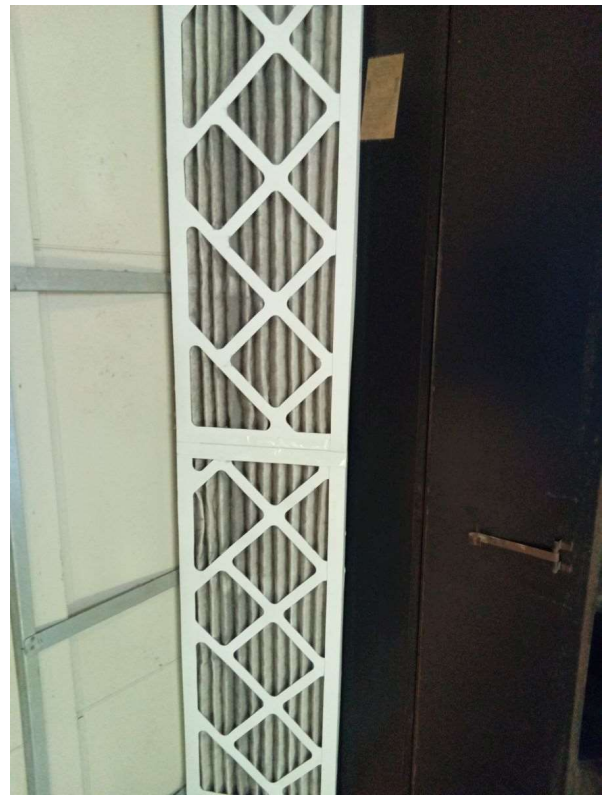
Unit Designation:	UV-2105	
Location of Unit:	2105	
Areas Served:	2105	
System Enhancements:	None	
Supply System	Outdoor Air	Cleanliness and Observations
Type <ul style="list-style-type: none"> • Supply System - VAV • Heating - Steam • Cooling - None • Energy Recovery Unit (ERU) - None 	<p>Outdoor air intake is inaccessible</p> <p>Outdoor air intake is located on an exterior wall.</p> <p>Outdoor air intake has a nearby pollution source: Above maintenance parking lot</p>	<p>Outdoor air filters are not present.</p> <p>Return air filters are not present.</p> <p>Mixed air pre-filters are not present. Mixed air main filters are somewhat dirty and on the border of needing replacement (scoring 3 out of 5) and fit well. Mixed air main filters are installed correctly.</p> <p>Drain pans are not applicable or not present. Drain pan condition is not known.</p>
Filter Type - Mixed <ul style="list-style-type: none"> • Pre-filter: None • Main filter: Pleated, MERV 11 	<p>Outdoor air intake is in good condition.</p>	<p>Heating coils are clean.</p> <p>Heat wheels are not present.</p> <p>Exterior ducting is not visible. Exterior ducting insulation is in an unknown condition.</p> <p>Interior ducting is not visible. Interior ducting insulation is in an unknown condition. Interior ducting is of unknown cleanliness.</p> <p>Air handling room is free of trash/chemicals.</p> <p>Outside damper is open, and its condition is good.</p> <p>Return damper is open, and its condition is good.</p> <p>The general condition of the unit is good.</p>

Mixed Main Filter Cleanliness

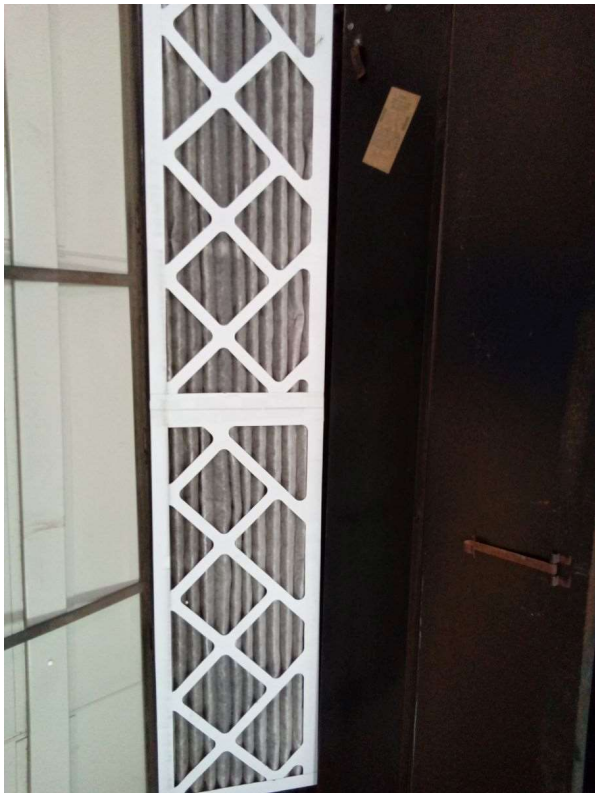
Unit Designation:	UV-2106	
Location of Unit:	2106	
Areas Served:	2106	
System Enhancements:	None	
Supply System	Outdoor Air	Cleanliness and Observations
Type <ul style="list-style-type: none"> • Supply System - VAV • Heating - Steam • Cooling - None • Energy Recovery Unit (ERU) - None 	<p>Outdoor air intake is inaccessible</p> <p>Outdoor air intake is located on an exterior wall.</p> <p>Outdoor air intake has a nearby pollution source: Above maintenance parking lot</p>	<p>Outdoor air filters are not present.</p> <p>Return air filters are not present.</p> <p>Mixed air pre-filters are not present. Mixed air main filters are somewhat dirty and on the border of needing replacement (scoring 4 out of 5) and fit well. Mixed air main filters are installed correctly.</p> <p>Drain pans are not applicable or not present. Drain pan condition is not known.</p>
Filter Type - Mixed <ul style="list-style-type: none"> • Pre-filter: None • Main filter: Pleated, MERV 11 	<p>Outdoor air intake is in good condition.</p>	<p>Heating coils are clean.</p> <p>Heat wheels are not present.</p> <p>Exterior ducting is not visible. Exterior ducting insulation is in an unknown condition.</p> <p>Interior ducting is not visible. Interior ducting insulation is in an unknown condition. Interior ducting is of unknown cleanliness.</p> <p>Air handling room is free of trash/chemicals.</p> <p>Outside damper is open, and its condition is good.</p> <p>Return damper is open, and its condition is not known.</p> <p>The general condition of the unit is good.</p>

Mixed Main Filter Cleanliness

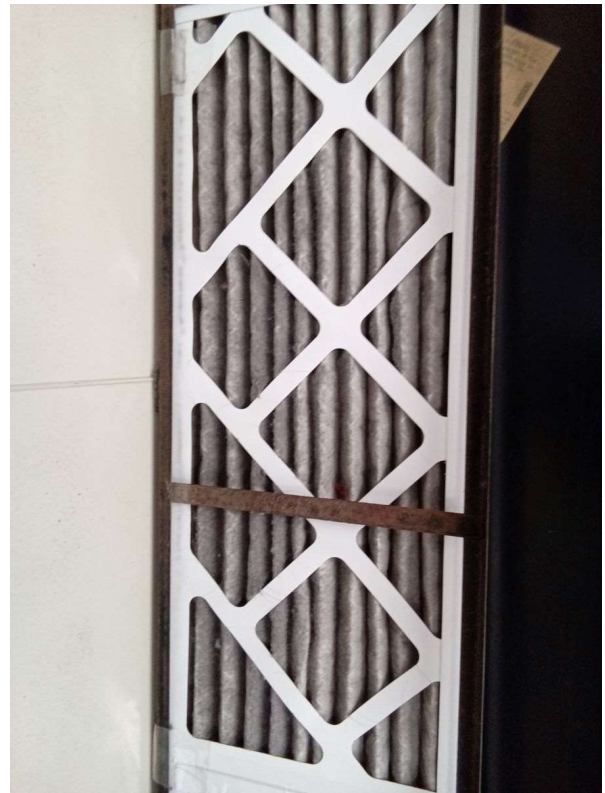
Unit Designation:	UV-2209	
Location of Unit:	2209	
Areas Served:	2209	
System Enhancements:	None	
Supply System	Outdoor Air	Cleanliness and Observations
Type <ul style="list-style-type: none"> • Supply System - VAV • Heating - Steam • Cooling - None • Energy Recovery Unit (ERU) - None 	Outdoor air intake is inaccessible Outdoor air intake is located on an exterior wall. No nearby pollution sources were found.	Outdoor air filters are not present. Return air filters are not present. Mixed air pre-filters are not present. Mixed air main filters are somewhat dirty and on the border of needing replacement (scoring 4 out of 5) and fit well. Mixed air main filters are installed correctly. Drain pans are not applicable or not present. Drain pan condition is not known. Heating coils are clean. Heat wheels are not present. Exterior ducting is not visible. Exterior ducting insulation is in an unknown condition. Interior ducting is not visible. Interior ducting insulation is in an unknown condition. Interior ducting is of unknown cleanliness. Air handling room is free of trash/chemicals. Outside damper is open, and its condition is good. Return damper is open, and its condition is good. The general condition of the unit is good.

Mixed Main Filter Cleanliness
