## 2023 - 2024 Ventilation Assessment

## Saint Paul Public Schools Wellstone Elementary School

Assessment Date:  
Thursday, April 13, 2023

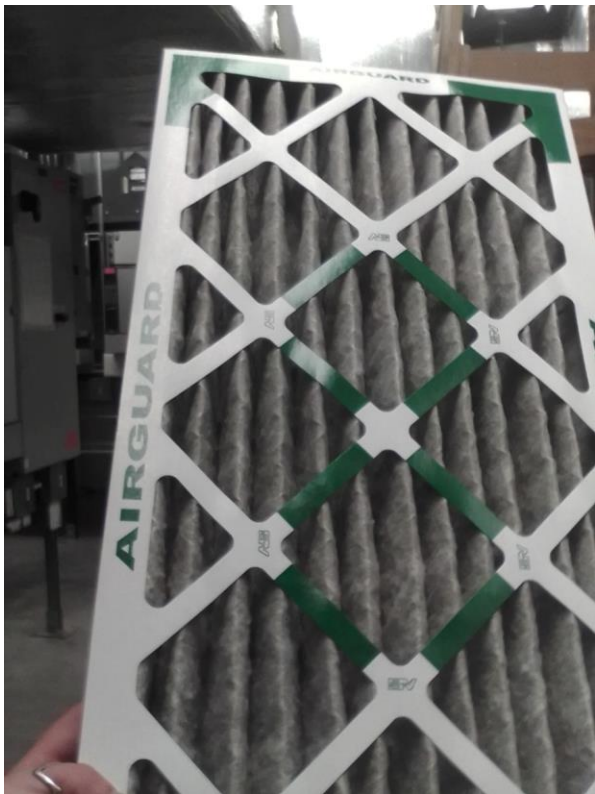
AHU-3

| <b>Filter Type - Mixed</b> <ul style="list-style-type: none"> <li>Pre-filter: None</li> <li>Main filter: Pleated, MERV 11</li> </ul> | Outdoor air intake is in good condition. | |

Mixed Main Filter Cleanliness

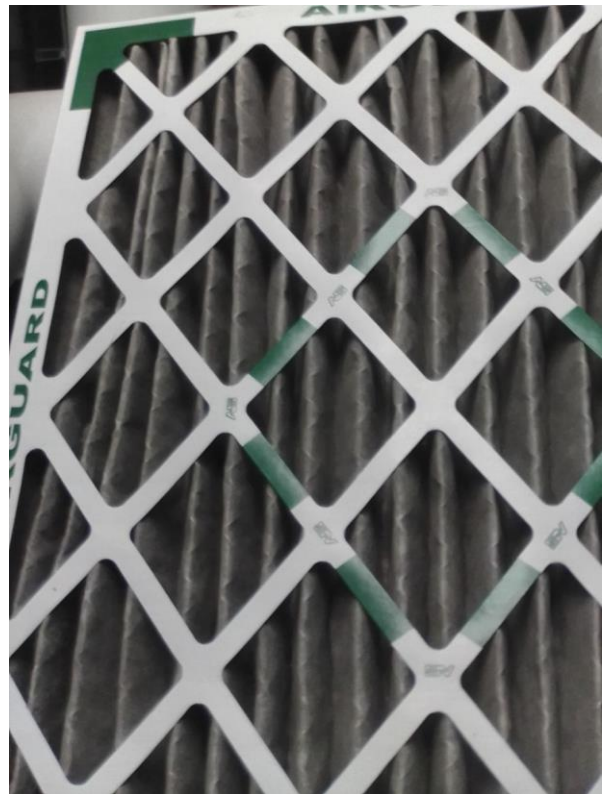
AHU-04

Dirty or poorly fitting filters were observed in units AHU-04, AHU-13 and AHU-14 during the ventilation inspection.

Mixed Main Filter Cleanliness

**Recommendation:** The operations and maintenance program for filter changes should be reviewed and revised to ensure proper filter changes to optimize filtration capacity.

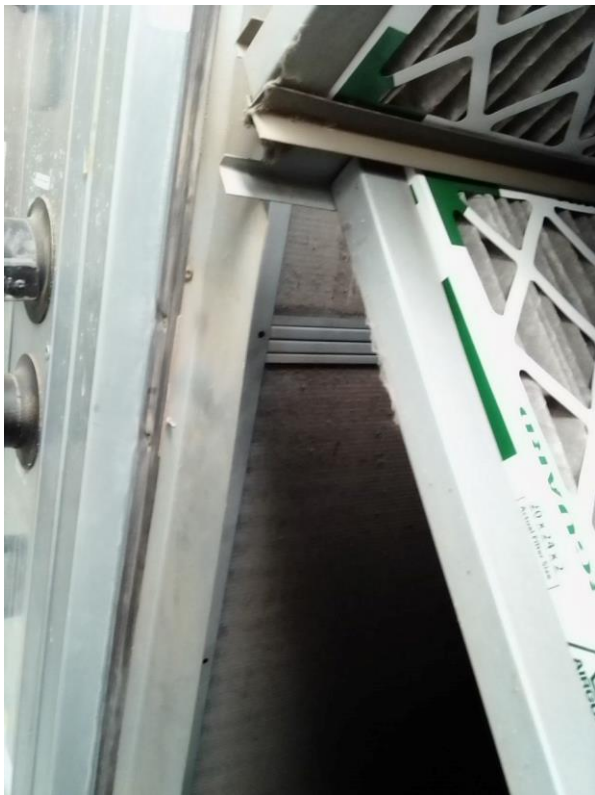
AHU-04

Mixed Main Filter Fit

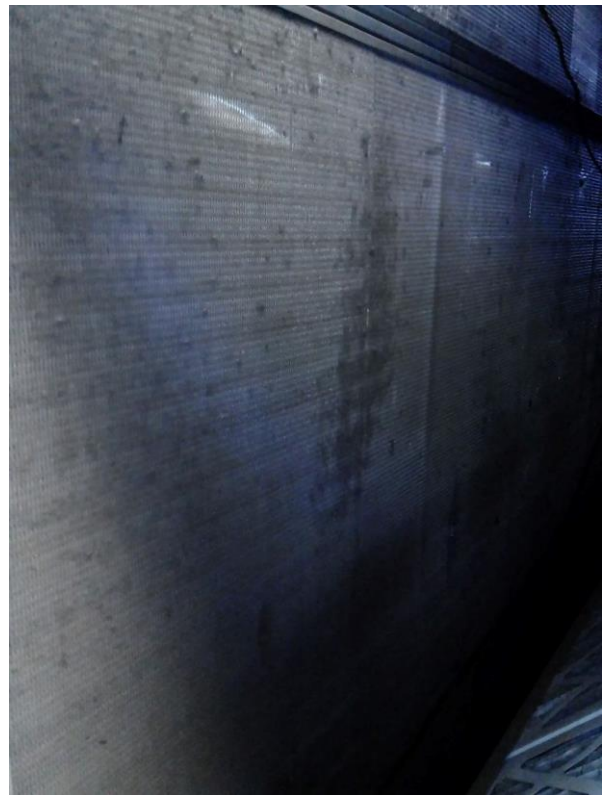
AHU-04

| <b>Filter Type - Mixed</b> <ul style="list-style-type: none"> <li>Pre-filter: None</li> <li>Main filter: Pleated, MERV 11</li> </ul> | <p>Outdoor air intake is in good condition.</p> | <p>Heating coils are dirty.</p> <p>Heat wheels are not present.</p> <p>Exterior ducting is visible. Exterior ducting insulation is in good condition.</p> <p>Interior ducting is not visible. Interior ducting insulation is in an unknown condition. Interior ducting is of unknown cleanliness.</p> <p>Air handling room is free of trash/chemicals.</p> <p>Outside damper is open, and its condition is good.</p> <p>Return damper is inaccessible, and its condition is not known.</p> <p>The general condition of the unit is good.</p> |

Dirty Coils were observed on units AHU-04, AHU-05, AHU-06, AHU-08, AHU-09, AHU-14, AHU-15 and RTU-01 during the ventilation inspection.

Heating Coils

**Recommendation:** Impacted/dirty coils can result in poor ventilation air supply as well as be a source for mold and bacterial growth on the coils. Coils should be cleaned annually, or as needed, as identified in the operations and maintenance program.

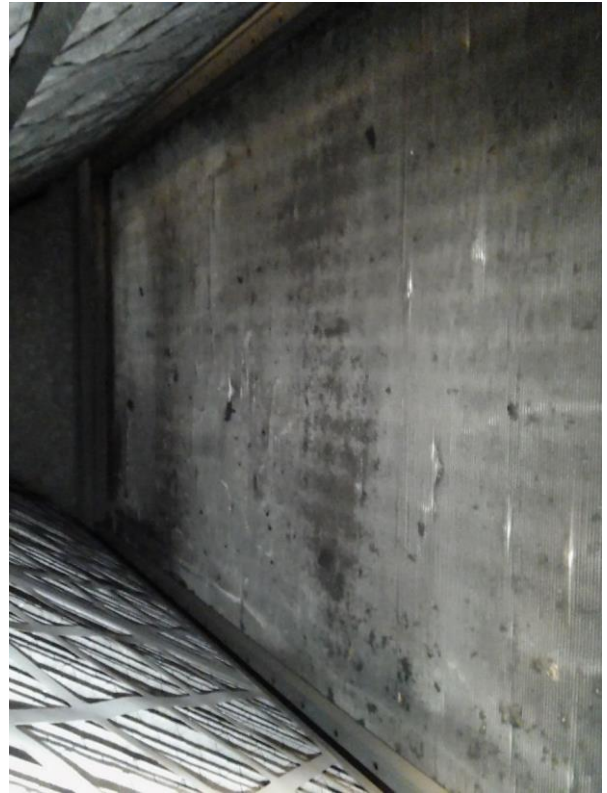
| <b>Type</b> <ul style="list-style-type: none"> <li>Supply System - Constant Volume</li> <li>Heating - Hot Water</li> <li>Cooling - None</li> <li>Energy Recovery Unit (ERU) - None</li> </ul> | Outdoor air intake is accessible<br><br>Outdoor air intake is located on the roof.<br><br>No nearby pollution sources were found. | Outdoor air filters are not present.<br><br>Return air filters are not present.<br><br>Mixed air pre-filters are not present. Mixed air main filters are clean and not in need of replacement (scoring 2 out of 5) and fit well. Mixed air main filters are installed correctly.<br><br>Drain pans are not plugged. Drain pan condition is good.<br><br>Heating coils are dirty. |

AHU-06  
Heating Coils

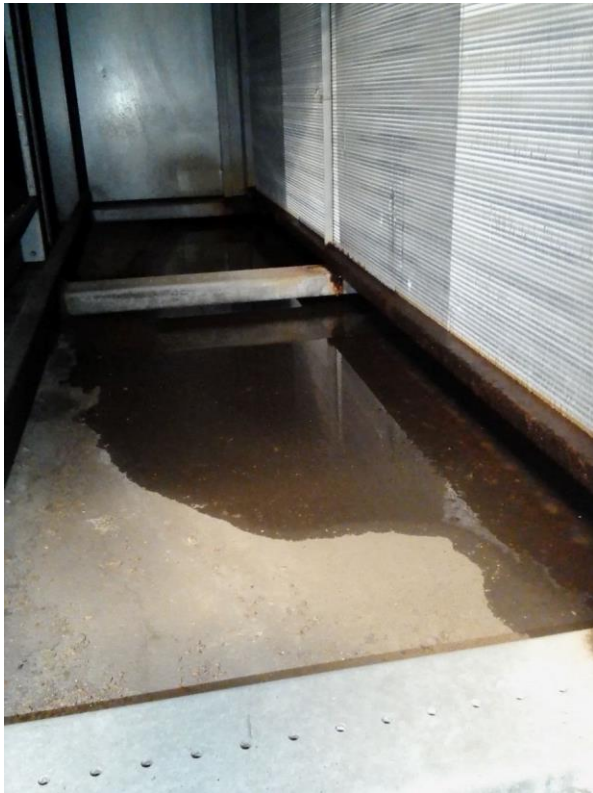
The drain pan for unit AHU-08 was plugged or damaged at the time of the site inspection.

AHU-08  
Drain Pans

**Recommendation:** Damage to the drain pan should be repaired, or the drain pan should be inspected more frequently to ensure that it does not become plugged.

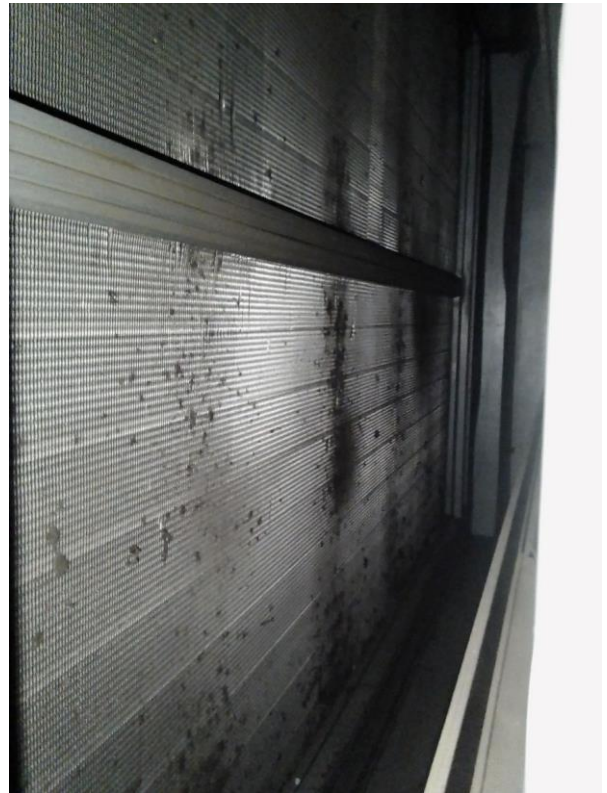
| <b>Type</b> <ul style="list-style-type: none"> <li>Supply System - VAV</li> <li>Heating - Hot Water</li> <li>Cooling - Dx</li> <li>Energy Recovery Unit (ERU) - None</li> </ul> | Outdoor air intake is accessible<br><br>Outdoor air intake is located on the roof.<br><br>No nearby pollution sources were found. | Outdoor air filters are not present.<br><br>Return air filters are not present.<br><br>Mixed air pre-filters are not present. Mixed air main filters are clean and not in need of replacement (scoring 2 out of 5) and fit well. Mixed air main filters are installed correctly.<br><br>Drain pans are plugged. Drain pan condition is good.<br><br>Heating coils are dirty and cooling coils are clean. |

AHU-08  
Heating Coils

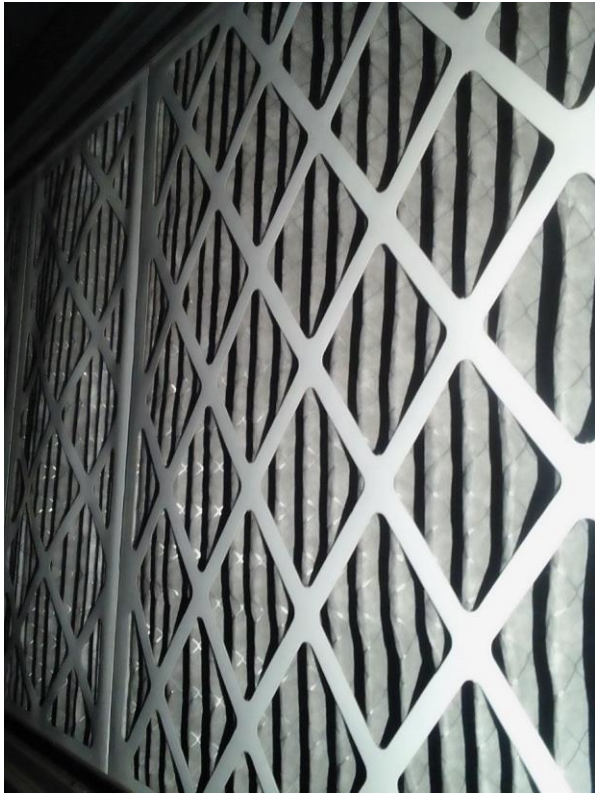
AHU-09

Mixed Main Filter Cleanliness

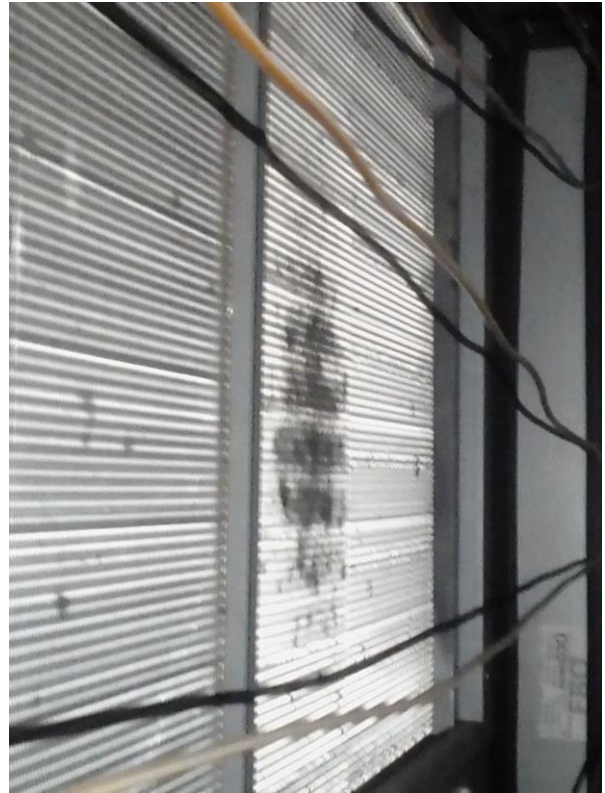
AHU-09

| <b>Filter Type - Mixed</b> <ul style="list-style-type: none"> <li>Pre-filter: None</li> <li>Main filter: Pleated, MERV 11</li> </ul> | Outdoor air intake is in good condition. | Heating coils are dirty.<br><br>Heat wheels are not present.<br><br>Exterior ducting is visible. Exterior ducting insulation is in good condition.<br><br>Interior ducting is not visible. Interior ducting insulation is in an unknown condition. Interior ducting is of unknown cleanliness.<br><br>Air handling room is free of trash/chemicals.<br><br>Outside damper is open, and its condition is good.<br><br>Return damper is inaccessible, and its condition is not known.<br><br>The general condition of the unit is good. |

Heating Coils

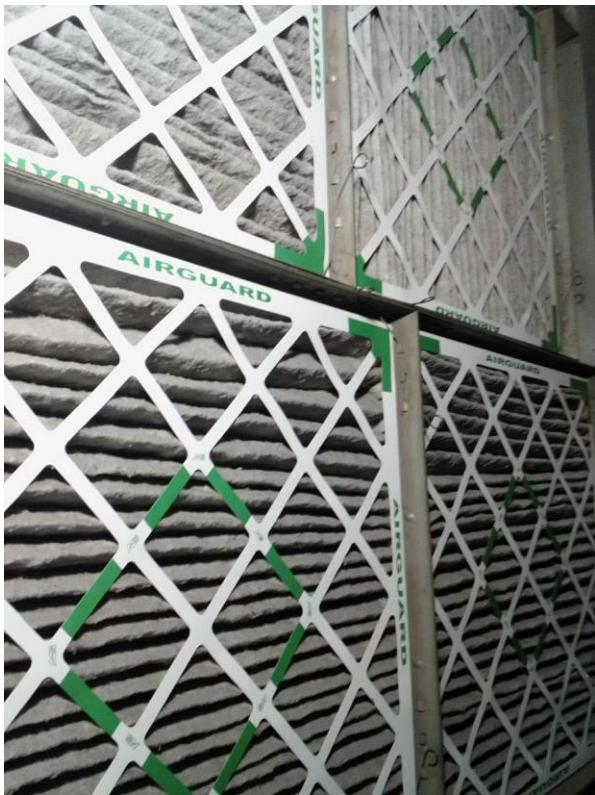
AHU-10

| | Outdoor air intake is located on the roof. | Mixed air pre-filters are not present. Mixed air main filters are somewhat dirty and on the border of needing replacement (scoring 3 out of 5) and fit well. Mixed air main filters are installed correctly. |

Mixed Main Filter Cleanliness

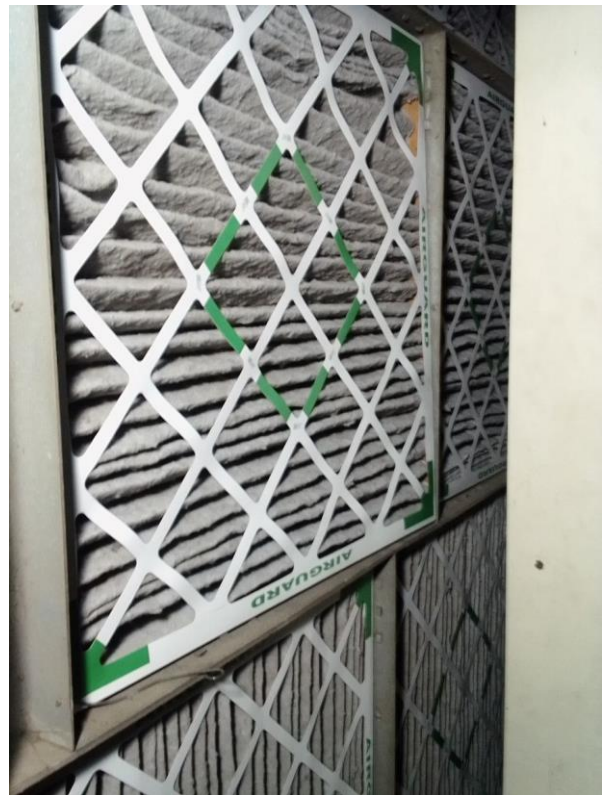
AHU-11

Mixed Main Filter Cleanliness

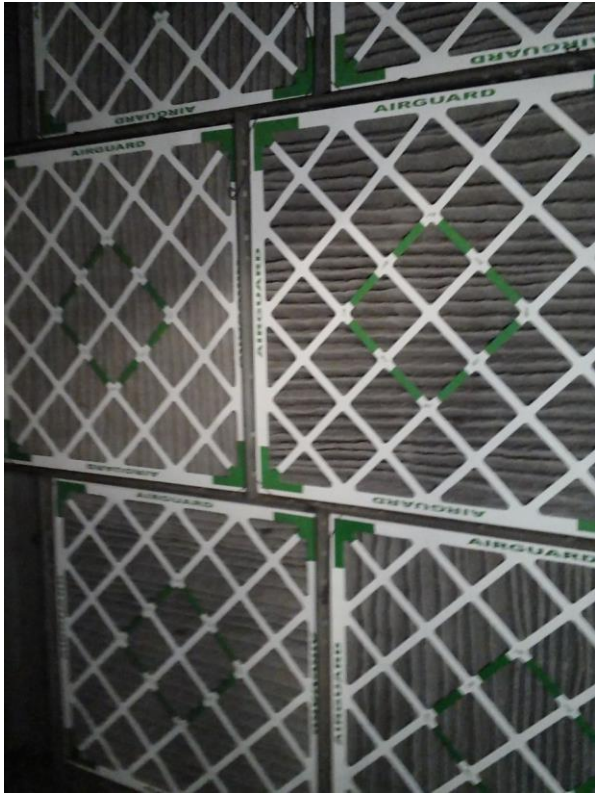
AHU-12

Mixed Main Filter Cleanliness

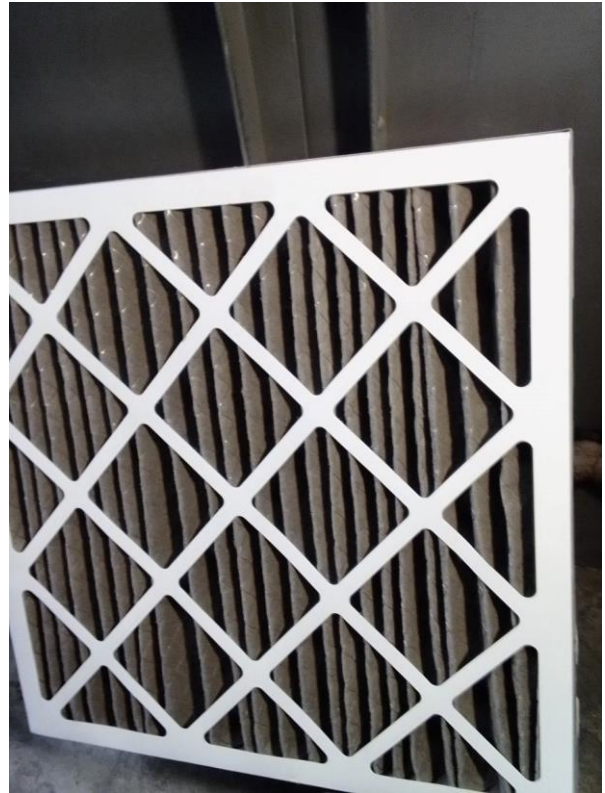
AHU-13

| | Outdoor air intake is located on the roof. | Mixed air pre-filters are not present. Mixed air main filters are somewhat dirty and on the border of needing replacement (scoring 4 out of 5) and fit well. Mixed air main filters are installed incorrectly. |

Mixed Main Filter Cleanliness

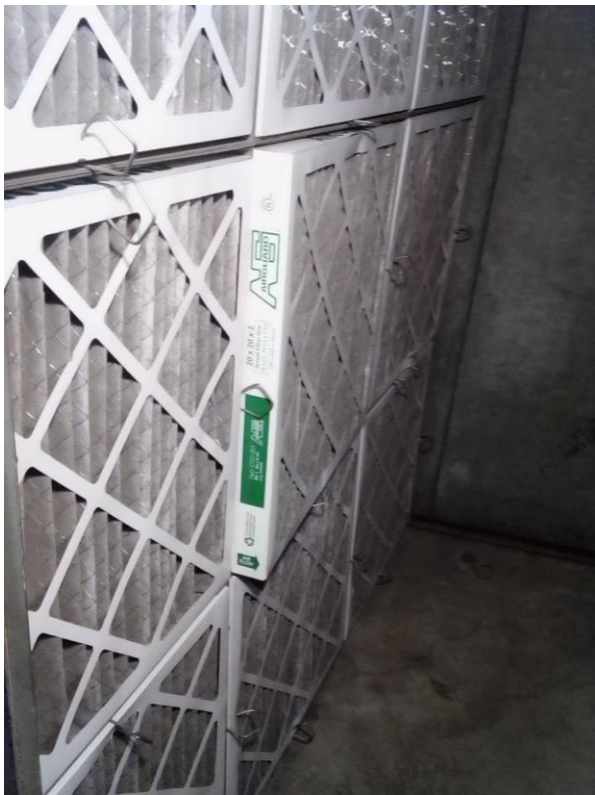
AHU-13

Mixed Main Filter Installation

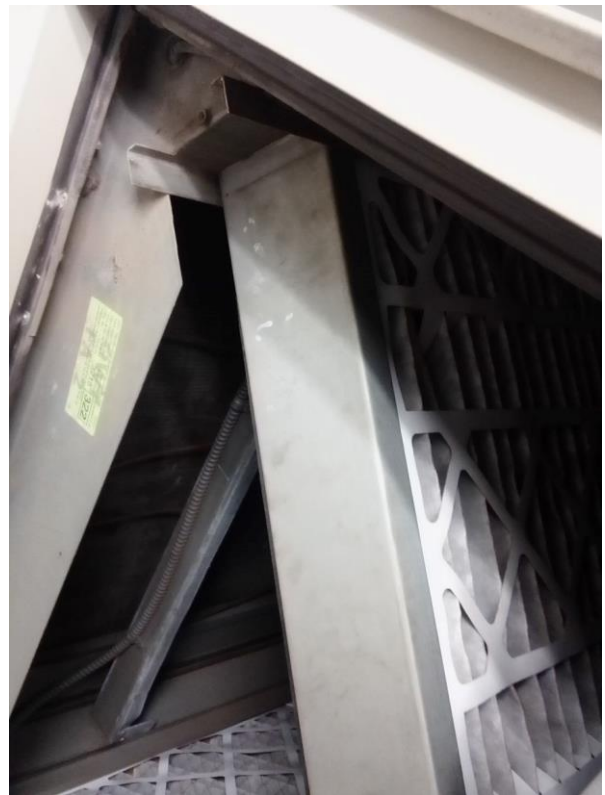
AHU-14

Mixed Main Filter Fit

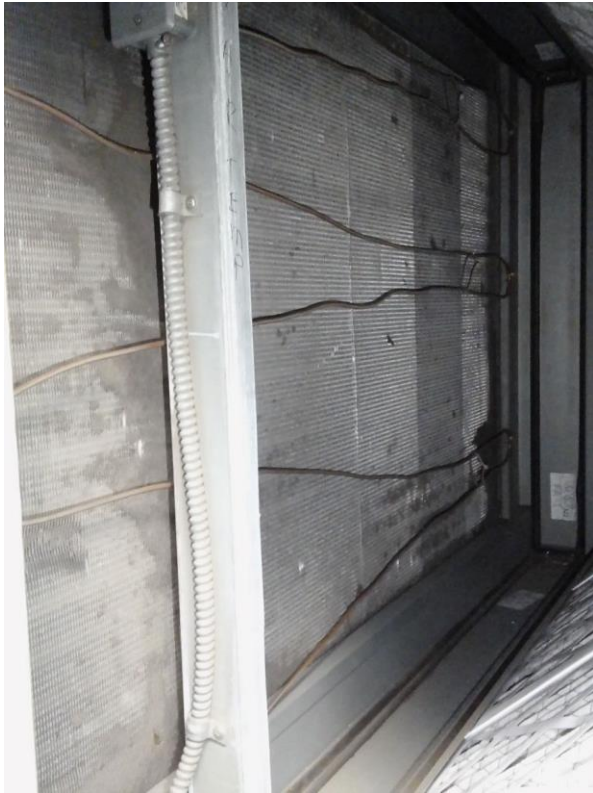
AHU-14  
Heating Coils

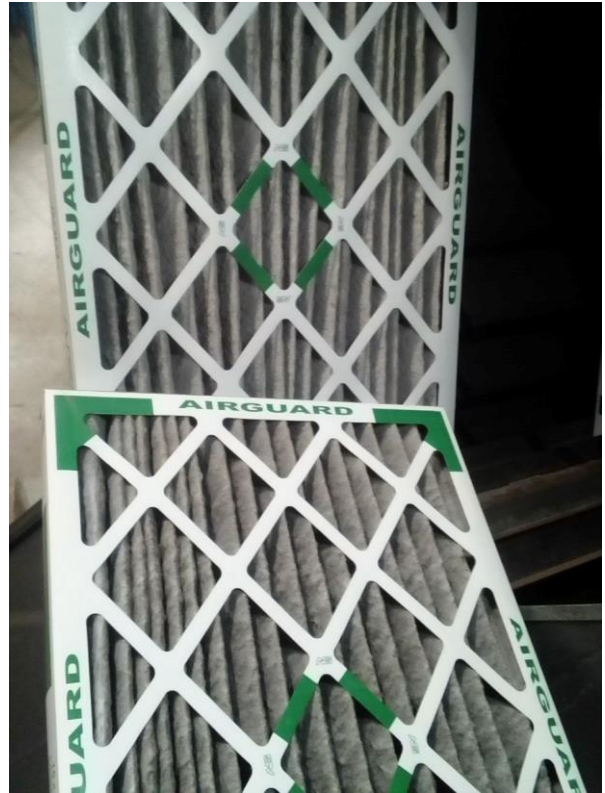
AHU-15  
Mixed Main Filter Cleanliness

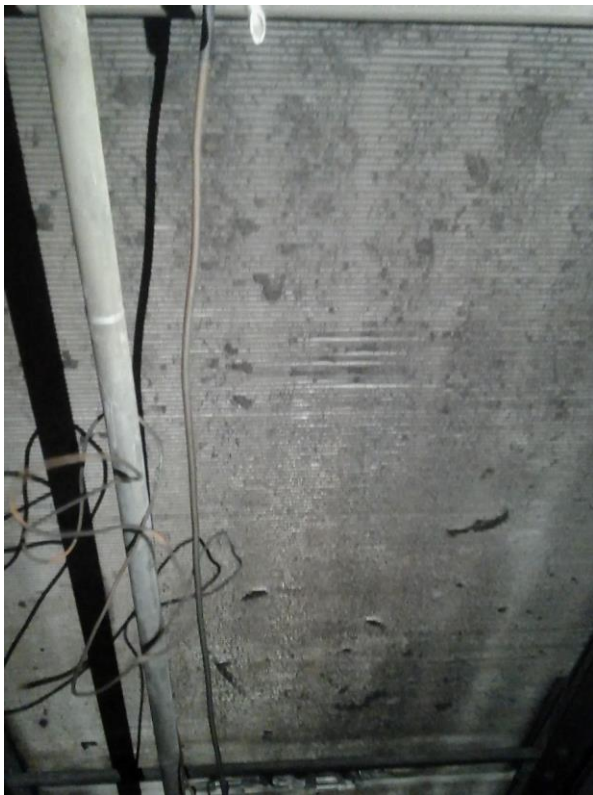
| <b>Filter Type - Mixed</b> <ul style="list-style-type: none"> <li>Pre-filter: None</li> <li>Main filter: Pleated, MERV 11</li> </ul> | <p>Outdoor air intake is in good condition.</p> | <p>Heating coils are dirty.</p> <p>Heat wheels are not present.</p> <p>Exterior ducting is visible. Exterior ducting insulation is not present.</p> <p>Interior ducting is not visible. Interior ducting insulation is in an unknown condition. Interior ducting is of unknown cleanliness.</p> <p>Air handling room is free of trash/chemicals.</p> <p>Outside damper is open, and its condition is good.</p> <p>Return damper is open, and its condition is good.</p> <p>The general condition of the unit is good.</p> |

AHU-15  
Heating Coils

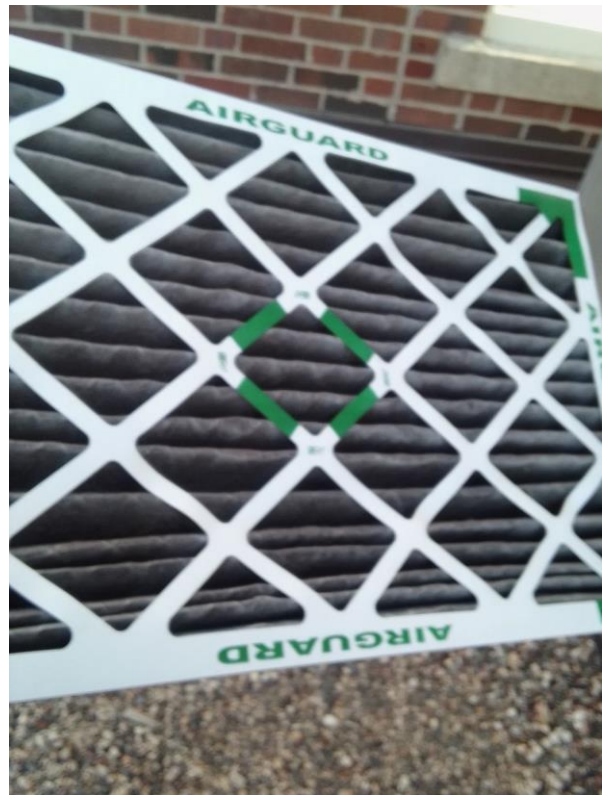
RTU-01  
Mixed Main Filter Cleanliness

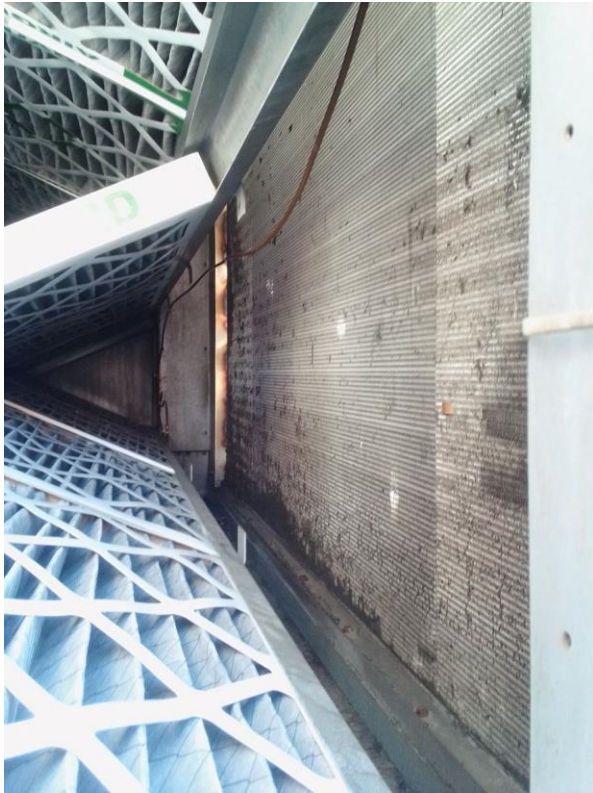
RTU-01  
Heating Coils
