Facility Condition Assessments & Master Planning "Critical Systems"

McKinstry and North Santiam School District Partnership

North Santiam School District - Visualization (VIZ) Tool Example (30 years)

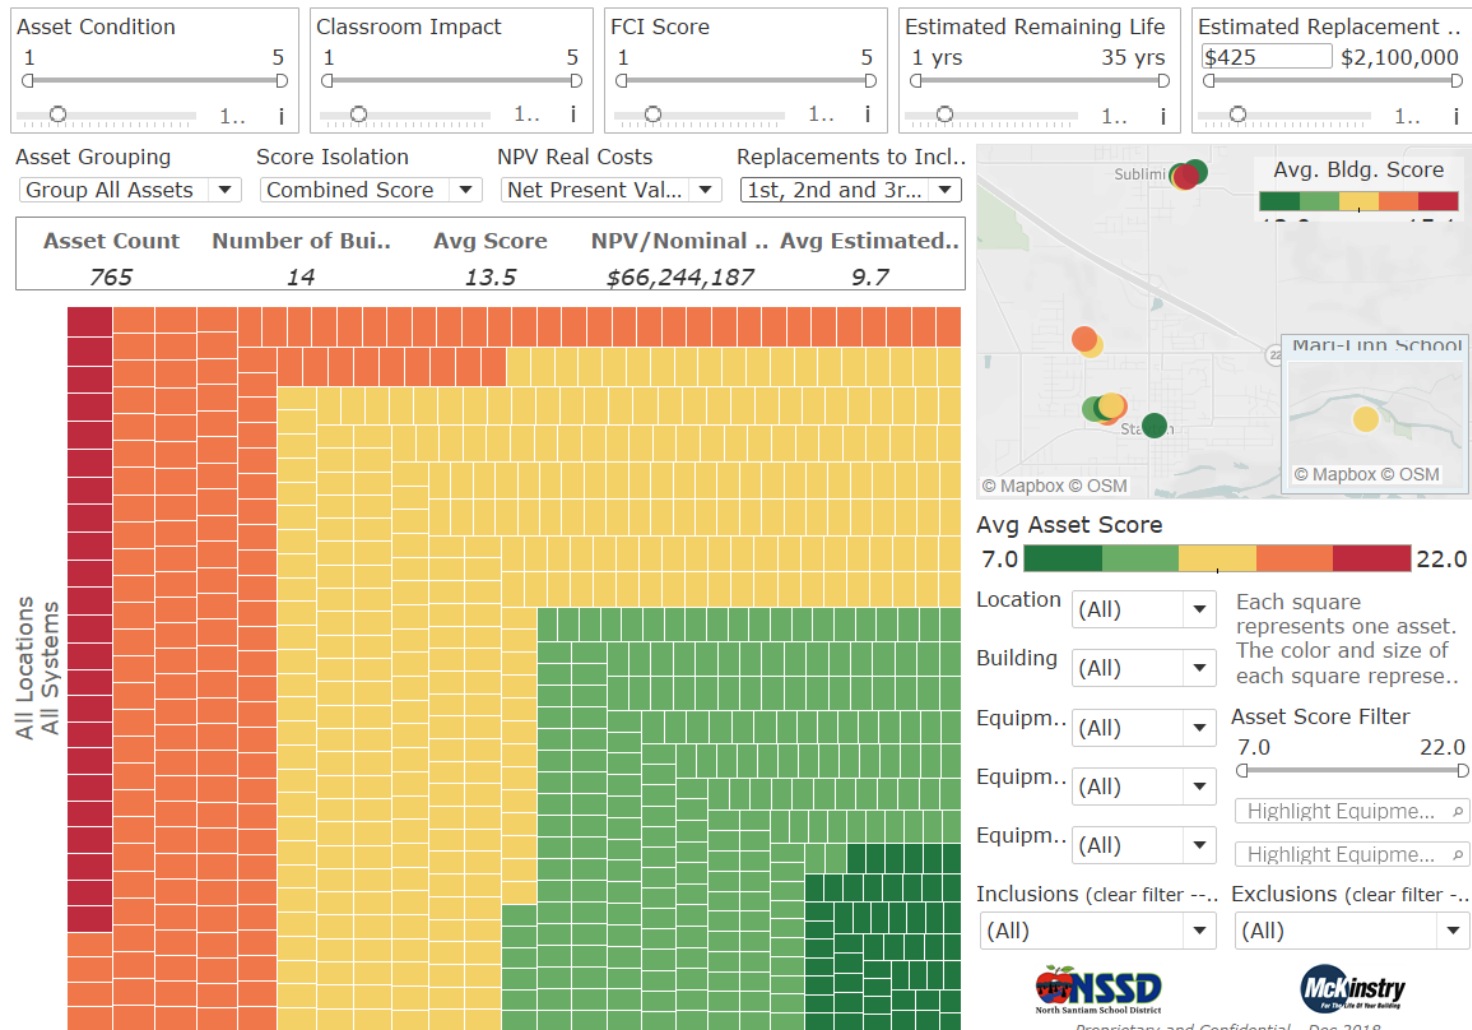
N. Santiam SD Facility portfolio value (owned) **\$66.2 Million** worth of assets

Conservative escalation for 2019 at conservative 6%: **\$70 Million**

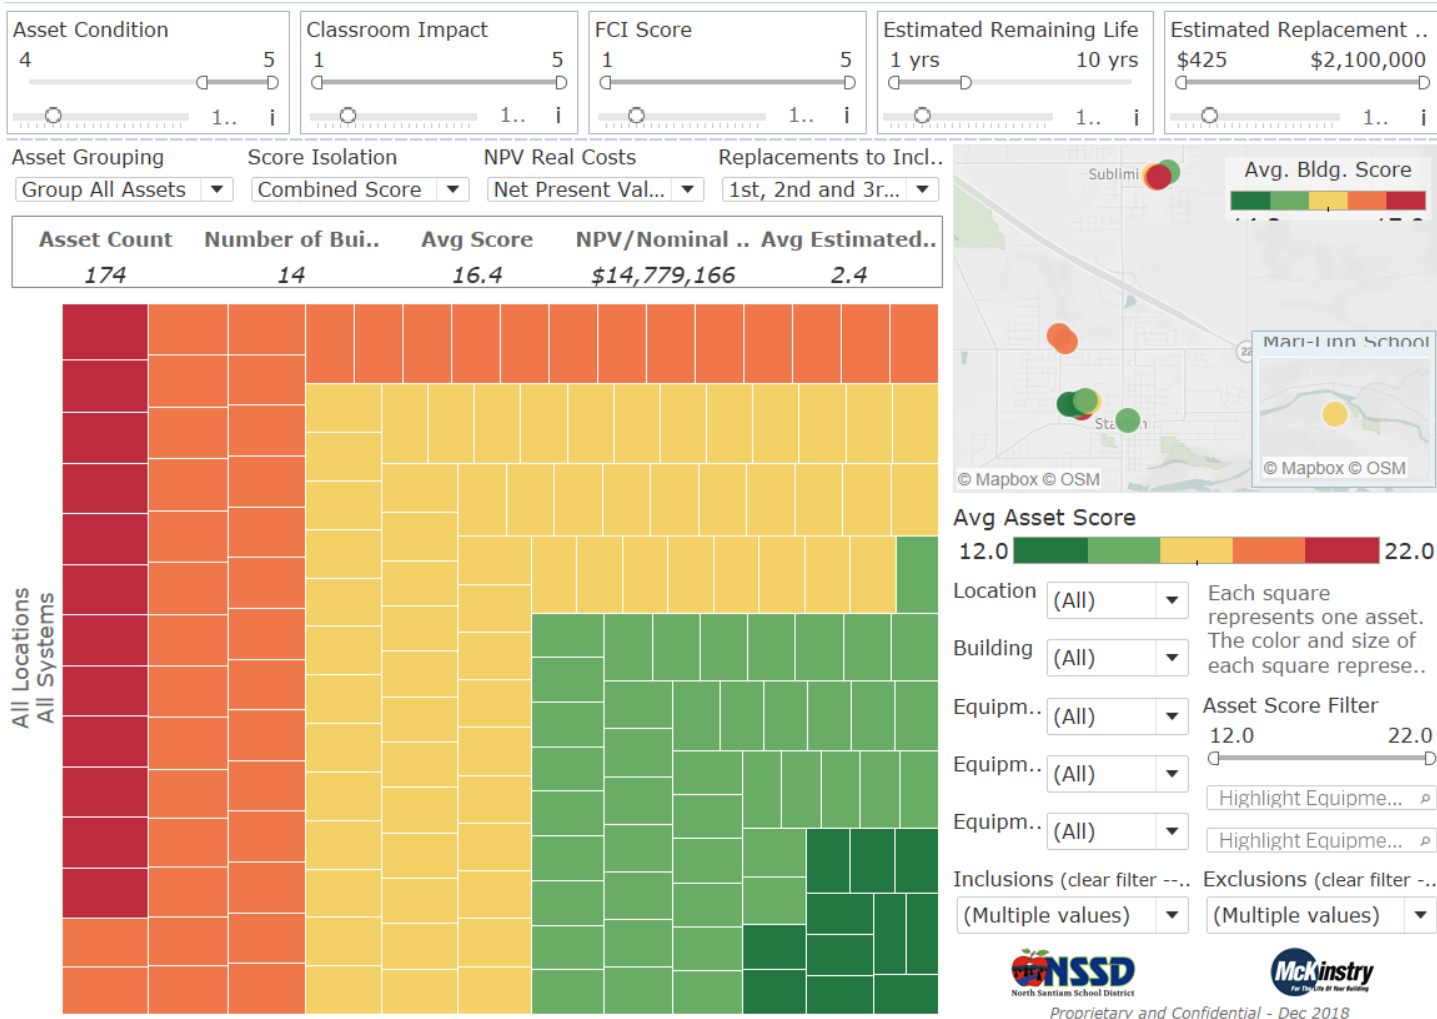
North Santiam School District - Visualization (VIZ) Tool Example (10 years)

District wide life cycle replacement needs (FCA Ratings: 4 and 5):

\$15.0 Million (All Assets)

- equipment which will reach end of life or considered unsatisfactory in next 10 years

Project Examples:

- HVAC Systems Upgrades*
- Roof Replacements*
- Lighting Upgrades*
- Plumbing

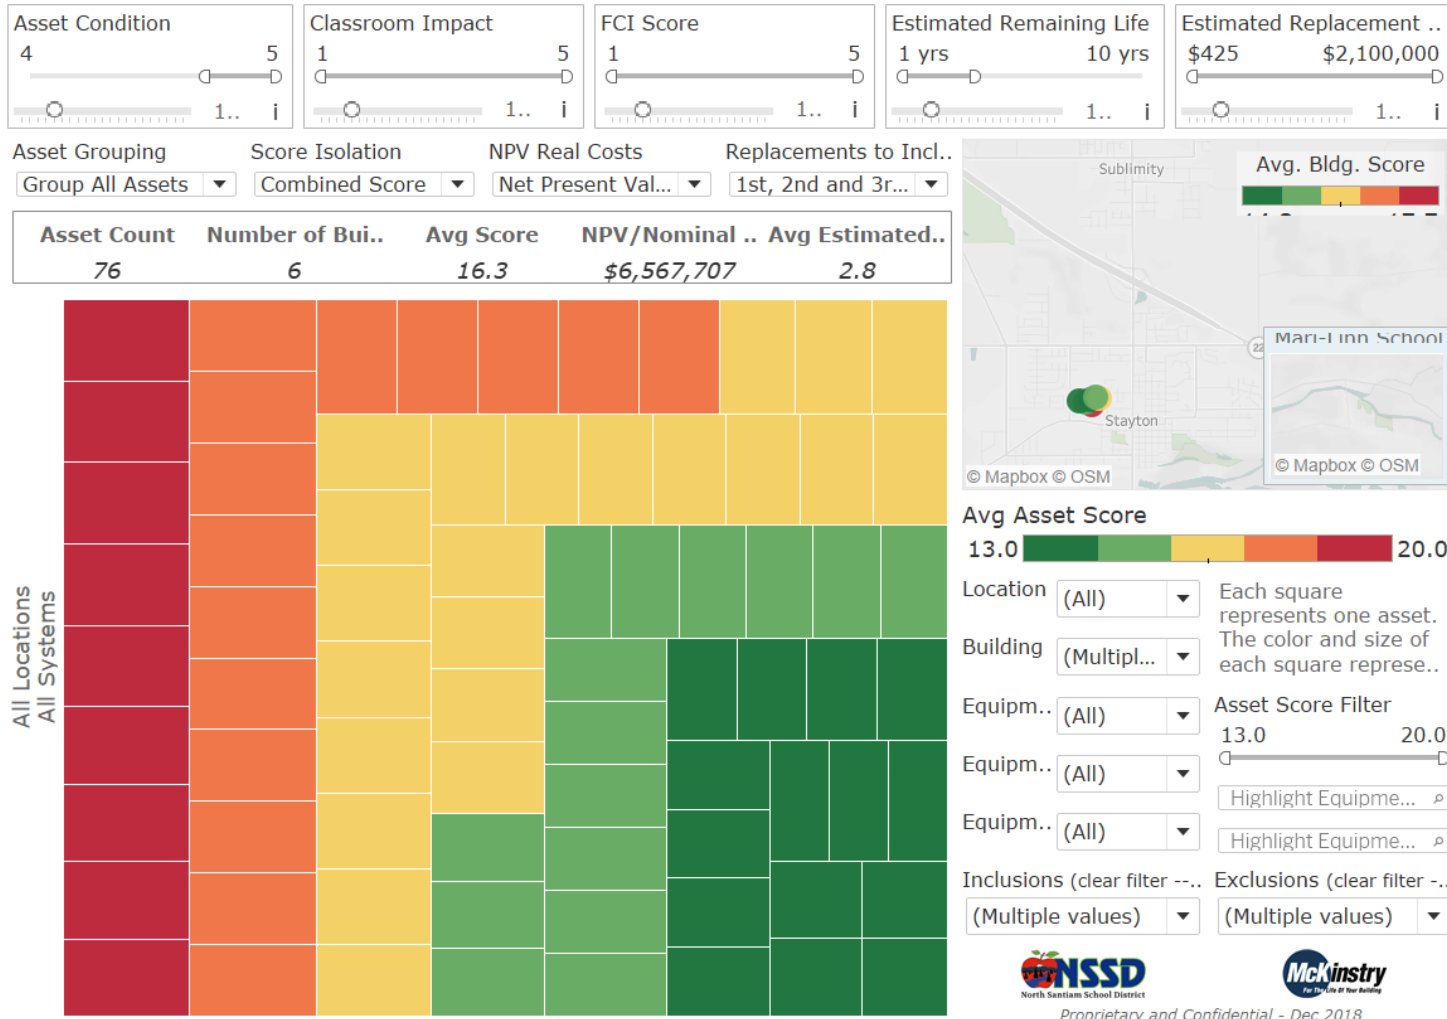
Stayton High School - Visualization (VIZ) Tool Example (10 years)

Life cycle replacement needs (FCA Ratings: 4 and 5):

\$6.5 Million (All Assets)

- equipment which will reach end of life or considered unsatisfactory in next 10 years

Project Examples:

- HVAC System Upgrade*
- Partial Roof Replacement*
- Lighting Upgrade*
- Plumbing

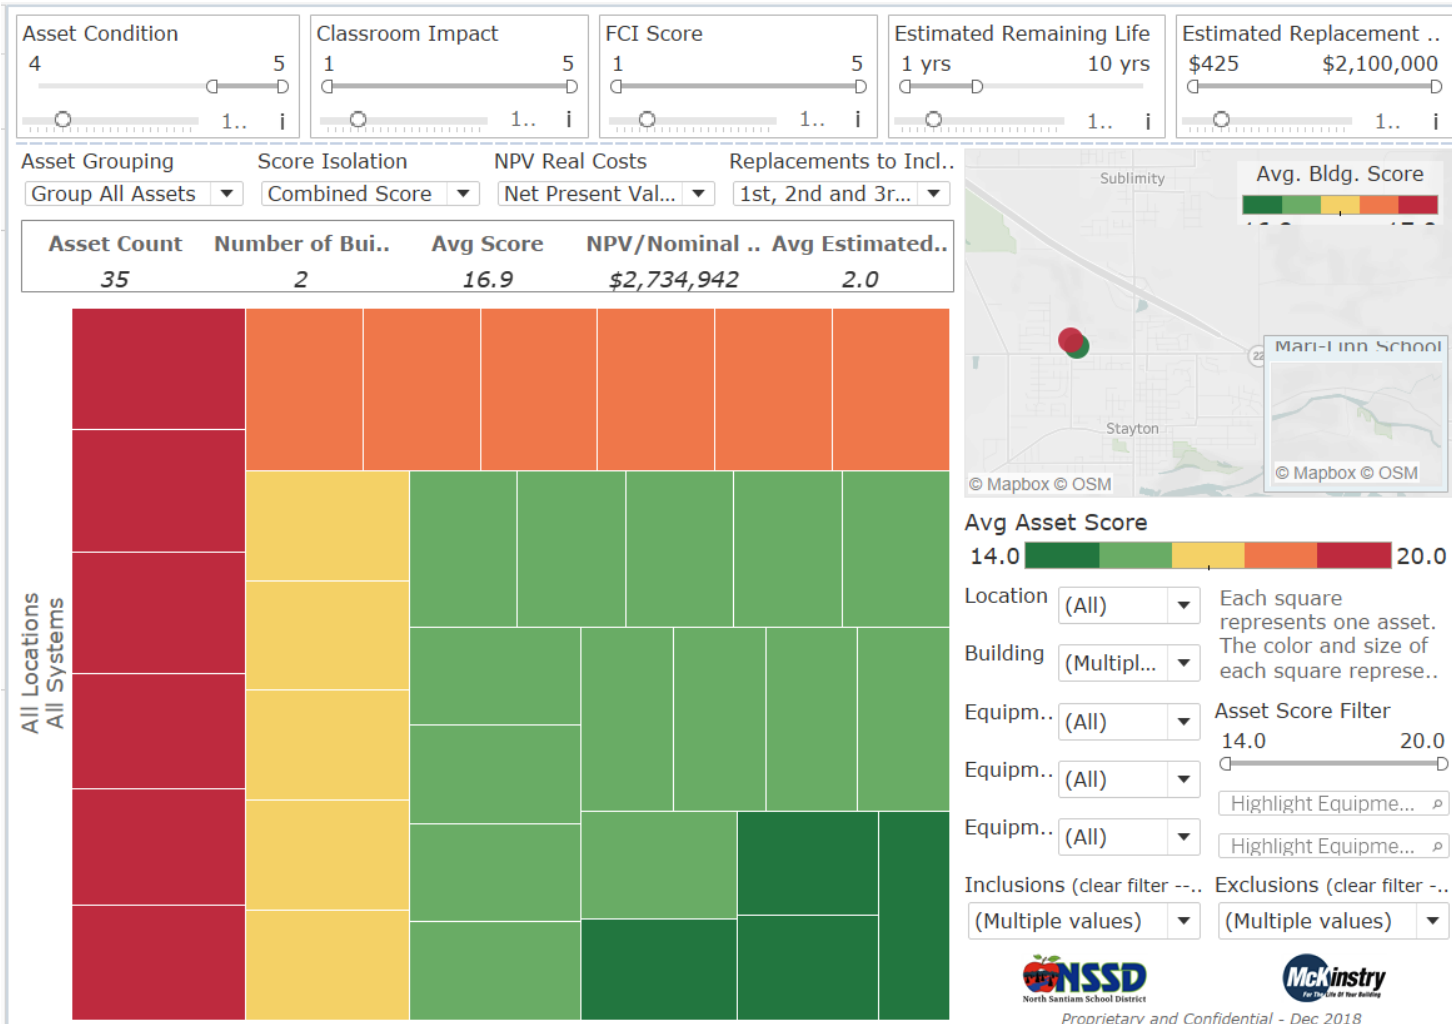
Stayton MS/Intermediate School - Visualization (VIZ) Tool Example (10 years)

Life cycle replacement needs (FCA Ratings: 4 and 5):

\$3 Million (All Assets)

- equipment which will reach end of life or considered unsatisfactory in next 10 years

Project Examples:

- HVAC System Upgrade*
- Lighting Upgrade*
- Plumbing

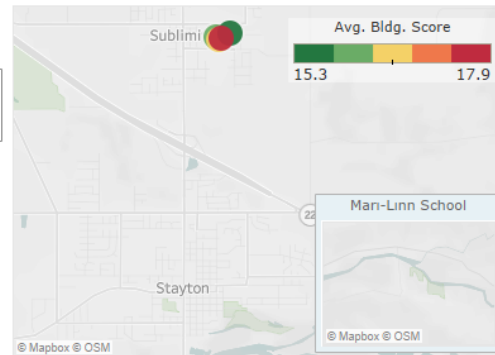
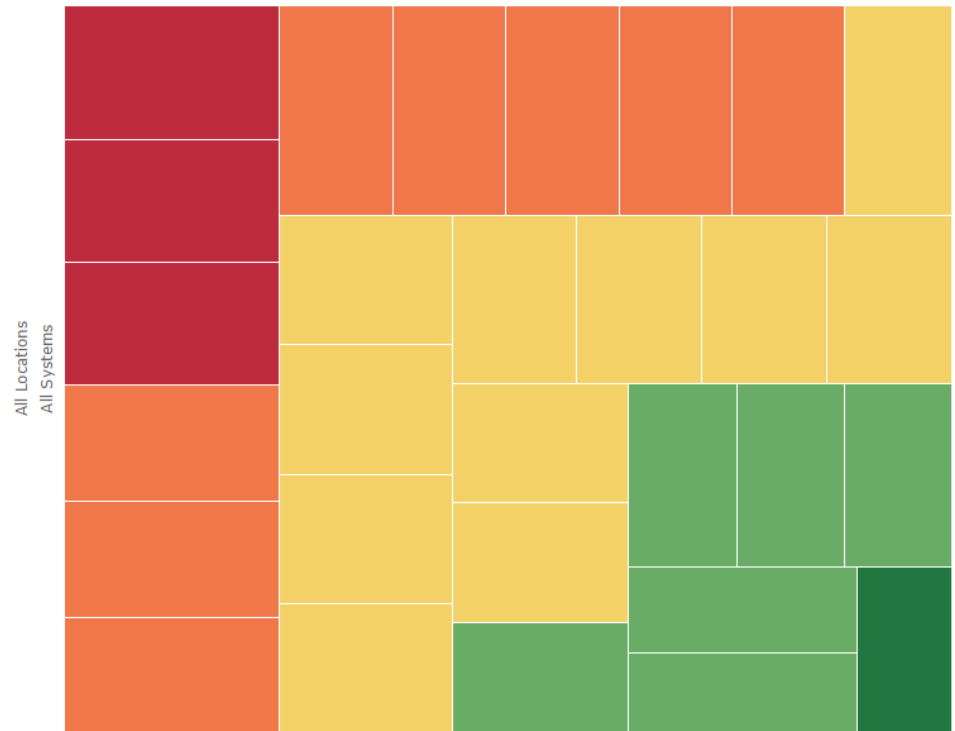
Sublimity - Visualization (VIZ) Tool Example (10 years)

Asset Count	Number of Buildings	Avg Score	NPV/Nominal Cost	Avg Estimated Remaining Life
29	4	16.9	\$3,756,827	1.7

Life cycle replacement needs (FCA Ratings: 4 and 5):

\$3.8 Million (All Assets)

- equipment which will reach end of life or considered unsatisfactory in next 10 years

Project Examples:

- HVAC System Upgrade*
- Roofing*
- Lighting Upgrade*
- Plumbing

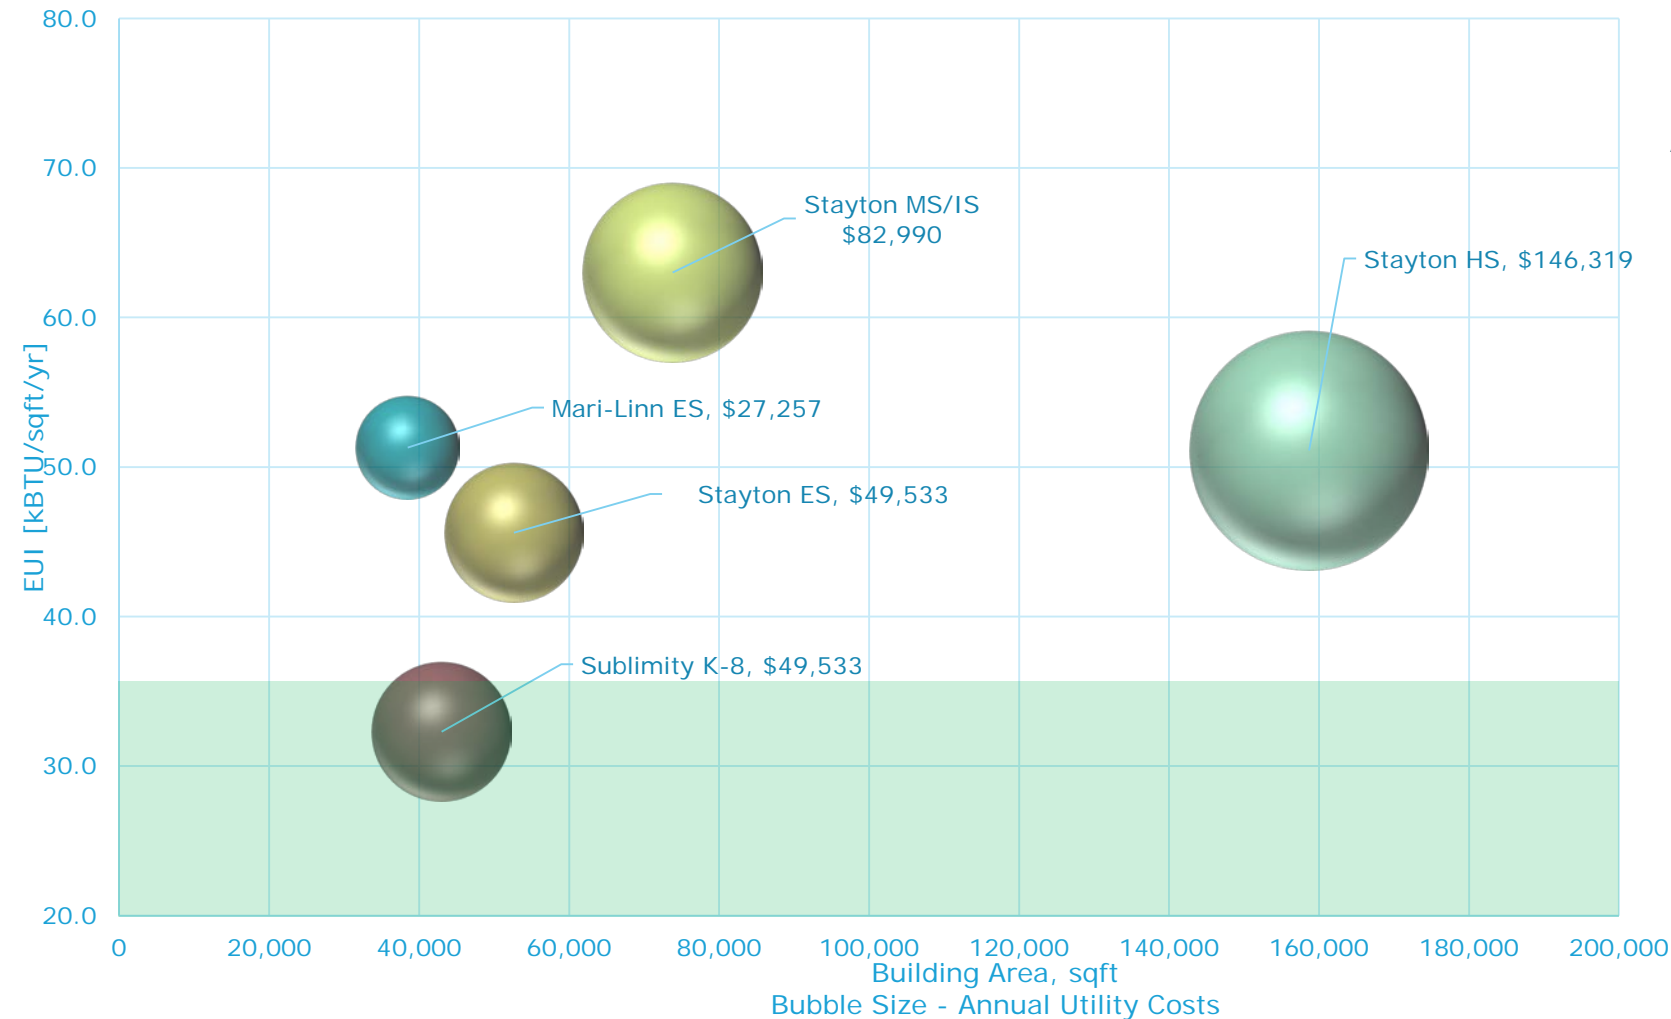
North Santiam School District EUI vs. Square Footage

Annual energy spend in 2017:
Stayton MS/IS and HS \$230,000

If these two schools alone reduced energy usage by 15-25% that would equal an annual savings of
\$35,000-\$58,000

***Green Bar represents Oregon Department of Energy Goals for K-12
