FACILITY CONDITION ASSESSMENT

JCTC | November 2020

JCTC, located at 12425 Hwy 57 in Vancleave, Mississippi, oldest building is 37 years old (at time of 2020 assessment). It comprises 36,100 gross square feet.

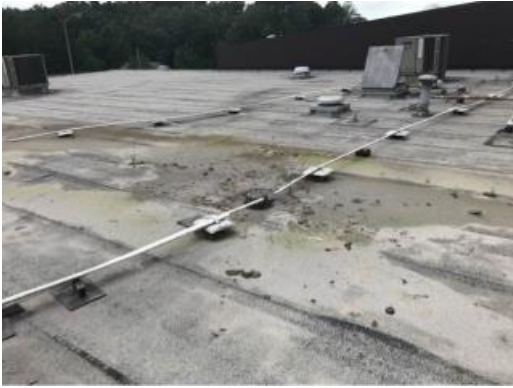
Failing modified bitumen roofing

Deficiency	Category	Qty	UoM	Priority	Repair Cost	ID
Modified Roof Covering Replacement Note: Roof is aged, delaminated, and leaks	Capital Renewal	10,000	SF	2	\$307,542	30
Sub Total for System		1	items		\$307,542

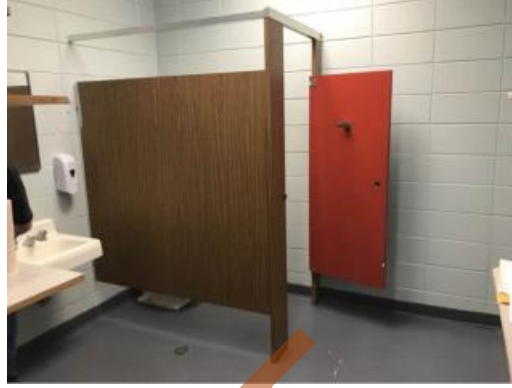
Restroom partition HVAC shop area

Deficiency	Category	Qty	UoM	Priority	Repair Cost	ID
Entry Door Does Not Have Power Assist Device Location: Main entrance	ADA Compliance	1	Ea.	3	\$14,134	28
Interior Door Hardware Replacement Note: Hardware is not ADA compliant	Capital Renewal	60	Door	3	\$79,484	25
Toilet Partition Replacement Location: Multiple locations, no restroom numbers	Capital Renewal	8	Stall	4	\$14,395	24
Sub Total for System		3	items		\$108,013

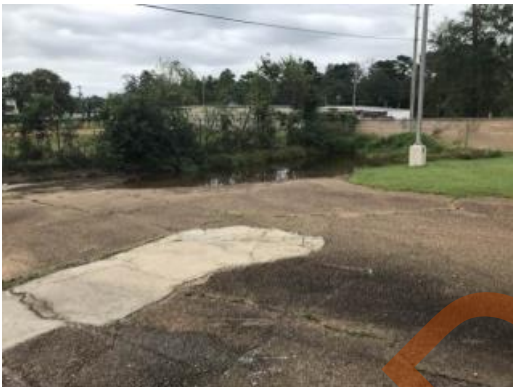
Northeast site drainage problem

Deficiency	Category	Qty	UoM	Priority	Repair Cost	ID
Asphalt Driveway Replacement Note: Driveway is damaged	Capital Renewal	22,000	SF	3	\$126,235	33
Site Requires Civil/Drainage Study Note: Water pools and the site does not drain properly. Location: Northeast corner of the property	Deferred Maintenance	1	LS	3	\$4,032	34
Asphalt Paving Replacement Note: Paving is damaged and old	Capital Renewal	85	CAR	4	\$110,038	32
Fencing Replacement (8' - 10' high Chain Link Fence)	Capital Renewal	1,700	LF	4	\$118,843	31
Sub Total for System		4	items		\$359,148	
Sub Total for School and Site Level		4	items		\$359,148

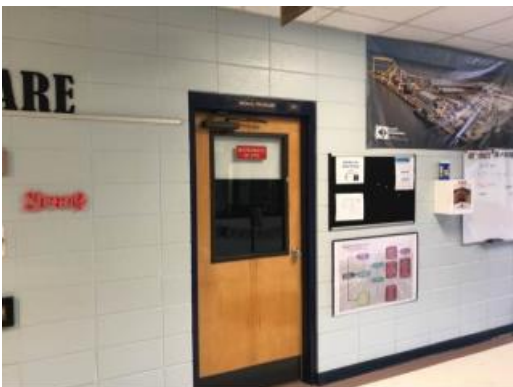
Door hardware not ADA compliant

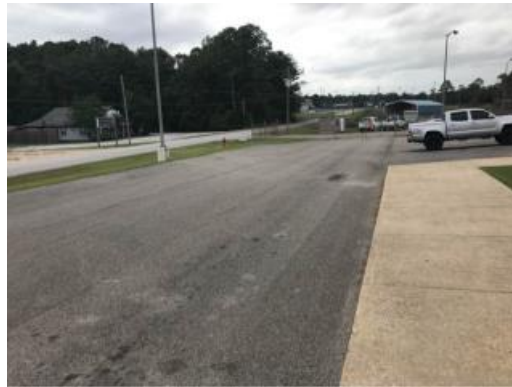
Site driveway
