FACILITY CONDITION ASSESSMENT

Central Office | November 2020

Central Office, located at 4700 Col. Vickrey in Vancleave, Mississippi, oldest building is 28 years old (at time of 2020 assessment). It comprises 10,200 gross square feet.

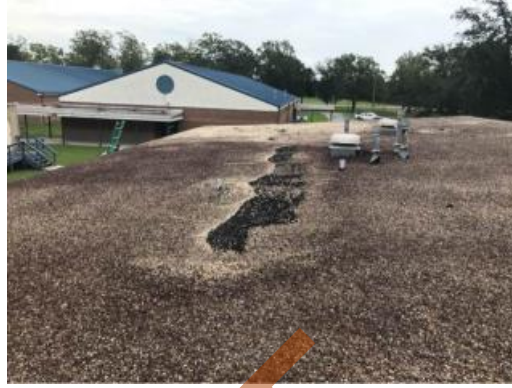
Ponding on roof

Deficiency	Category	Qty	UoM	Priority	Repair Cost	ID
Built-up Roofing Replacement	Capital Renewal	11,730	SF	2	\$370,644	13
Note: Roof is damaged, aged, and leaking						
Sub Total for System		1	items		\$370,644

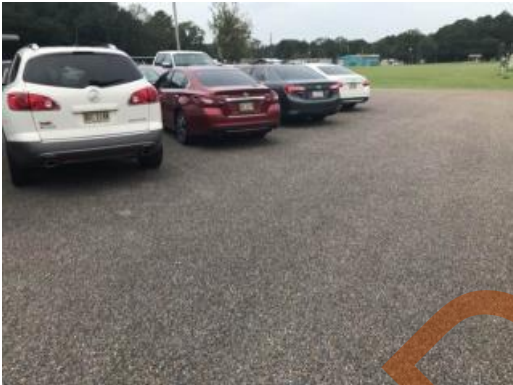
Faded parking lot striping

Deficiency	Category	Qty	UoM	Priority	Repair Cost	ID
Existing Sidewalk Is Cracked And Poses A Hazard To Accessibility	Deferred Maintenance	50	LF	2	\$3,965	10
Note: Sidewalk is cracked and not level with elevation						
Location: Main entry from front parking lot						
Car Accessible Parking Spaces Restriping	ADA Compliance	1	Ea.	3	\$101	9
Paving Restriping	Deferred Maintenance	41	CAR	5	\$1,217	14
Sub Total for System		3	items		\$5,283	
Sub Total for School and Site Level		3	items		\$5,283

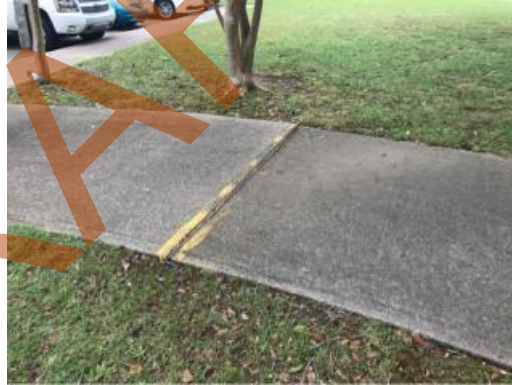
Sidewalk trip hazard

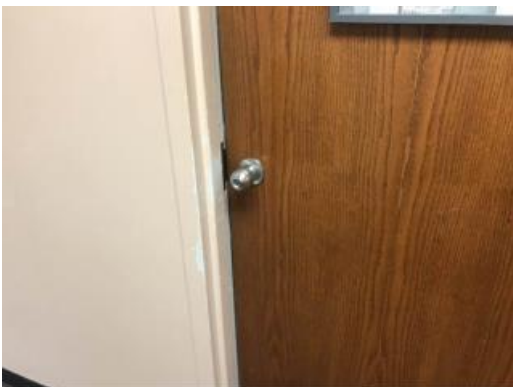
Doors lacking ADA hardware throughout

Deficiency	Category	Qty	UoM	Priority	Repair Cost	ID
Entry Door Does Not Have Power Assist Device	ADA Compliance	1	Ea.	3	\$14,134	11
Location: Main Entry						
Interior Door Hardware Replacement	Capital Renewal	48	Door	3	\$63,587	12
Note: No ADA compliant door hardware and knobs						
Sub Total for System		2	items		\$77,721

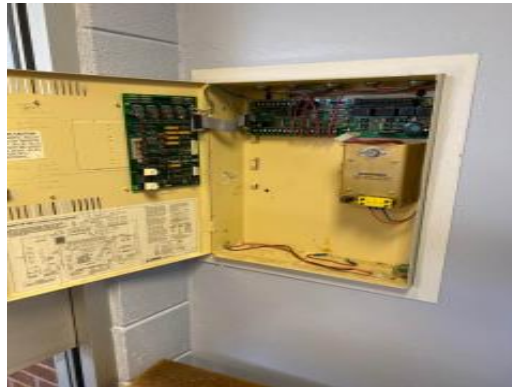
Non-functional fire panel

Deficiency	Category	Qty	UoM	Priority	Repair Cost	ID
Fire Alarm Replacement	Capital Renewal	10,200	SF	1	\$14,452	7
Note: System does not work						
Location: Building wide						
Sub Total for System		1	items		\$14,452	
Sub Total for Building 01 - School Board Ofc		10	items		\$629,629	
Total for Campus		13	items		\$634,912
