FACILITY CONDITION ASSESSMENT

Child Nutrition Office | November 2020

Child Nutrition Office, located at 13724 Hwy 57 in Vancleave, Mississippi, oldest building is 22 years old (at time of 2020 assessment). It comprises 4,000 gross square feet.

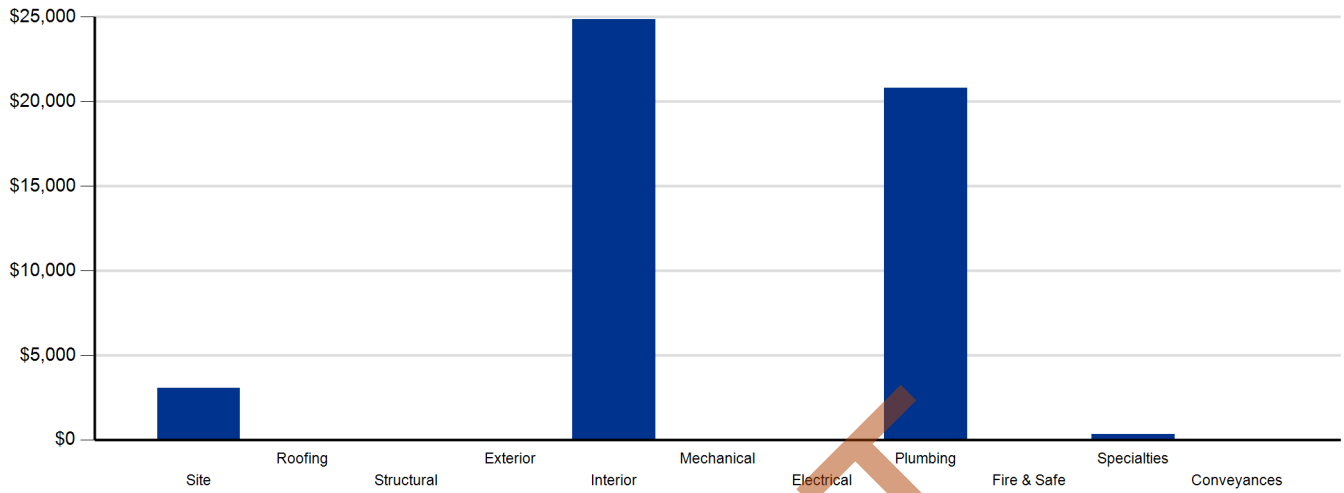
Figure 1: System Deficiencies

Mechanical	-	\$22,928
Interior	-	\$22,520
Plumbing	-	\$18,839

The chart below represents the building systems and associated deficiency costs.

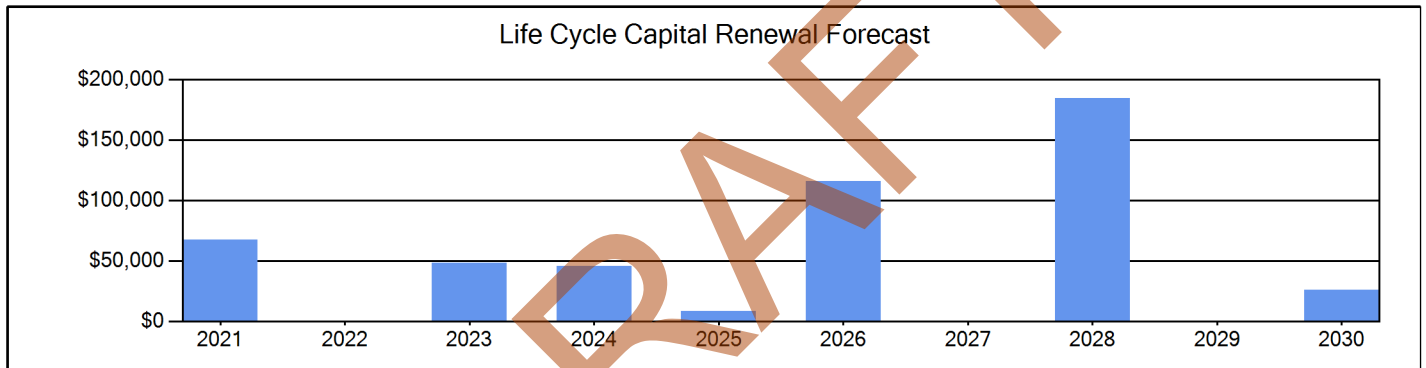
Figure 2: Ten Year Capital Renewal Forecast

The following tables show current deficiencies and the subsequent ten-year life cycle capital renewal projections. The projections outline costs for major building systems in which a component is expected to reach the end of its useful life and require capital funding for replacement.

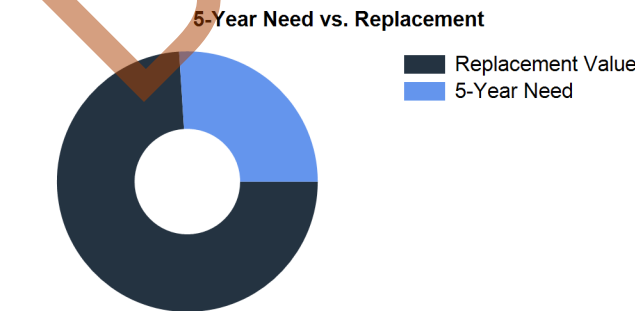
Figure 3: 5-Year FCI

The replacement value represents the estimated cost of replacing the current building with another building of like size, based on today’s estimated cost of construction in the Jackson, MS area. The estimated replacement cost for this facility is \$797,200. For planning purposes, the total 5-year need at the Child Nutrition Office is \$238,350 (Life Cycle Years 1-5 plus the FCI deficiency cost). The Child Nutrition Office facility has a 5-year FCI of 29.90%.

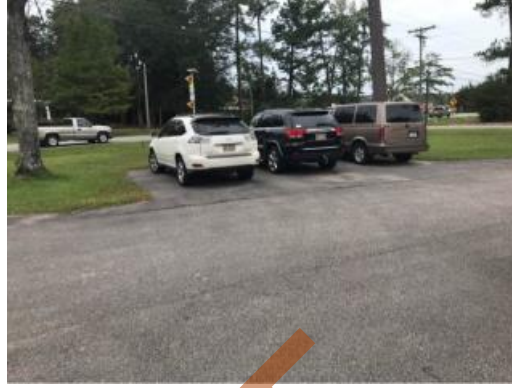
No ADA parking identified, no parking lot striping

Deficiency	Category	Qty	UoM	Priority	Repair Cost	ID
Car Accessible Parking Spaces Do Not Meet ADA Requirements	ADA Compliance	1	Ea.	3	\$697	16
Car Accessible Parking Spaces Restriping	ADA Compliance	10	Ea.	3	\$1,014	15
The Van Accessible Parking Spaces Do Not Meet ADA Requirements	ADA Compliance	1	Ea.	3	\$697	17
Paving Restriping	Deferred Maintenance	12	CAR	5	\$356	426

Location: striping needed throughout

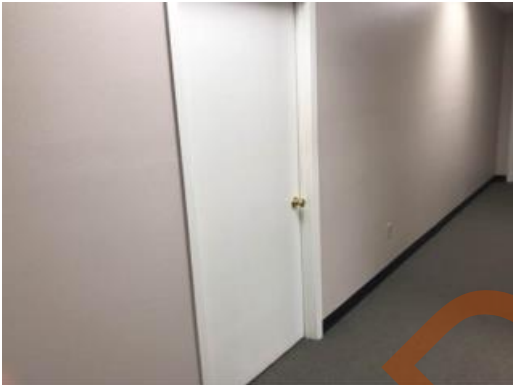
No ADA compliant door hardware

Deficiency	Category	Qty	UoM	Priority	Repair Cost	ID
Interior Door Hardware Replacement	Capital Renewal	17	Door	3	\$22,520	20

Note: Door hardware is not ADA compliant

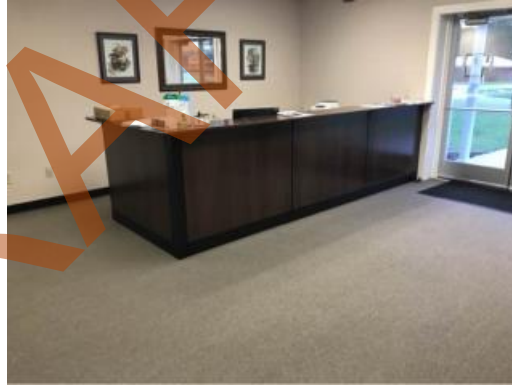
Lobby counter height not ADA compliant

Deficiency	Category	Qty	UoM	Priority	Repair Cost	ID
Counter Heights Exceed Maximum ADA Height Requirements (Modify Full)	ADA Compliance	5	LF	3	\$288	18
