FACILITY CONDITION ASSESSMENT

East Central Upper Elementary | November 2020

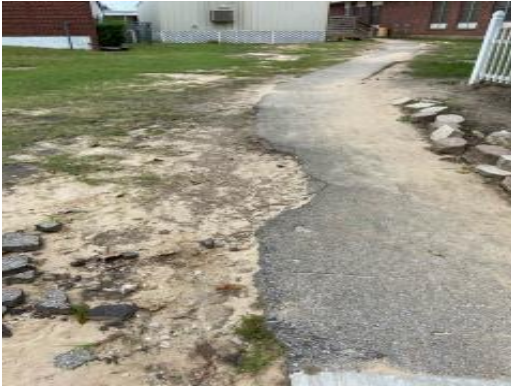
Failed asphalt walkway between Bldg F and H

Deficiency	Category	Qty	UoM	Priority	Repair Cost	ID
Asphalt Driveway Replacement	Capital Renewal	130,000	SF	3	\$745,931	400
Asphalt Walks Replacement	Capital Renewal	300	SF	3	\$1,550	405
Note: Between building F and H						
Concrete Walks Replacement	Capital Renewal	15,500	SF	3	\$156,665	406
Note: Damaged throughout sites						
Site Requires Civil/Drainage Study	Deferred Maintenance	1	LS	3	\$4,032	404
Note: Staff indicated there is an issue with standing water on sidewalks. Need to perform a study to determine if subsurface drainage could be added to alleviate the issue.						
Location: Between cafeteria and Building G, at main entrance to Building A						
Asphalt Paving Replacement	Capital Renewal	140	CAR	4	\$181,239	399
Note: Asphalt throughout damaged.						
Fencing Replacement (4' Chain Link Fence)	Capital Renewal	1,500	LF	4	\$63,172	398
Note: Fencing damaged throughout						
Site Drainage Needs Installation Of Drainage Piping	Deferred Maintenance	300	LF	4	\$16,963	402

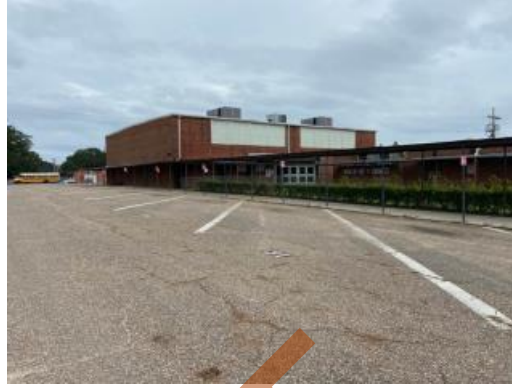
Asphalt and striping north of Bldg A

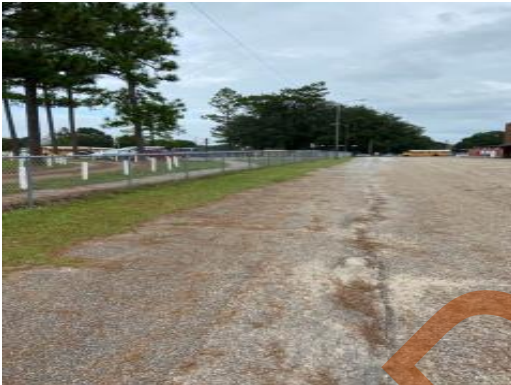
Asphalt to be replaced north of Bldg A

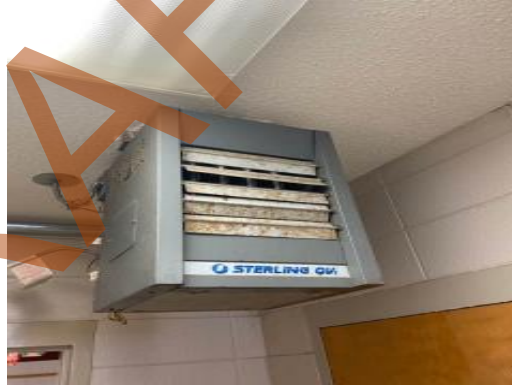
Unit heater in boys bathroom

Deficiency	Category	Qty	UoM	Priority	Repair Cost	ID
Remove Abandoned Equipment	Deferred Maintenance	1	Ea.	5	\$1,106	224
Note: Gas unit heater in boy's bathroom.						
Sub Total for System		1 items		\$1,106

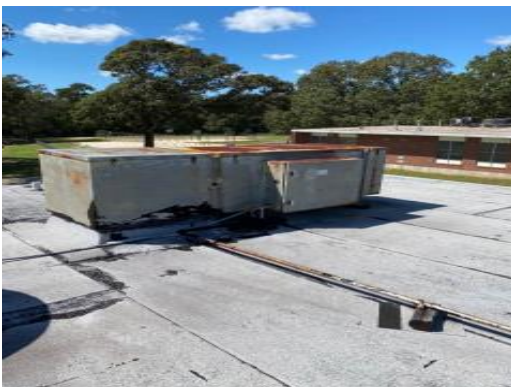
Abandoned make up air unit

Deficiency	Category	Qty	UoM	Priority	Repair Cost	ID
Remove Abandoned Equipment	Deferred Maintenance	2	Ea.	5	\$2,212	228
Note: Remove make up air units on roof. They are abandoned in place.						
	Sub Total for System	1	items		\$2,212
