# FACILITY CONDITION ASSESSMENT

Vancleave Middle School | November 2020

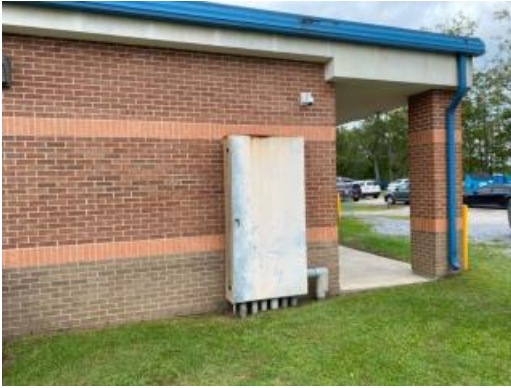
Corroded electrical panel

Deficiency	Category	Qty	UoM	Priority	Repair Cost	ID
Distribution Panel Repair <b>Note:</b> Main distribution panelboard enclosure (4'x7') is damaged; causing rust and water infiltration.	Deferred Maintenance	1	Ea.	2	\$205	514
Remove Abandoned Equipment <b>Note:</b> 1 fire alarm and 1 security alarm	Deferred Maintenance	2	Ea.	4	\$7,776	453
<b>Sub Total for System</b>		<b>2</b>	<b>items</b>		<b>\$7,981</b>	
<b>Sub Total for Building 01 - Cafeteria</b>		<b>3</b>	<b>items</b>		<b>\$45,361</b>

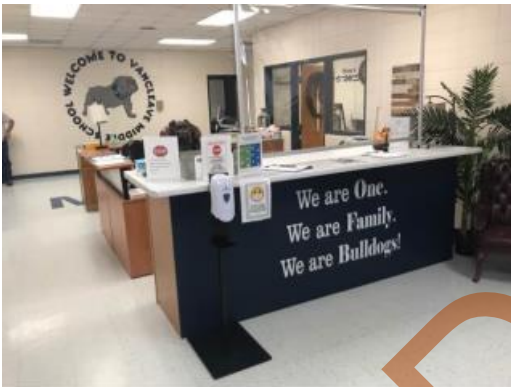
Office counter not ADA compliant

Deficiency	Category	Qty	UoM	Priority	Repair Cost	ID
Counter Heights Exceed Maximum ADA Height Requirements (Modify Full) <b>Location:</b> Classroom/main office building	ADA Compliance	5	LF	3	\$288	466
<b>Sub Total for System</b>		<b>1 items</b>			<b>\$288</b>	
<b>Sub Total for Building 02 - Class,main ofc</b>		<b>15 items</b>			<b>\$452,452</b>

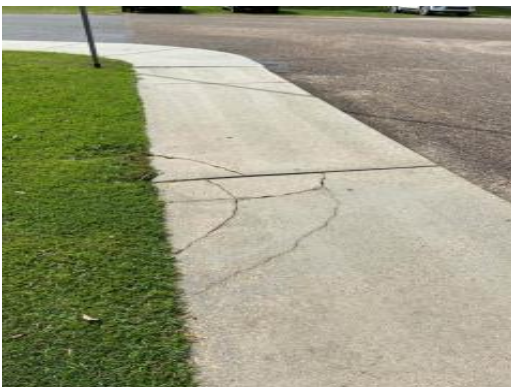
Cracked sidewalk by the main entrance

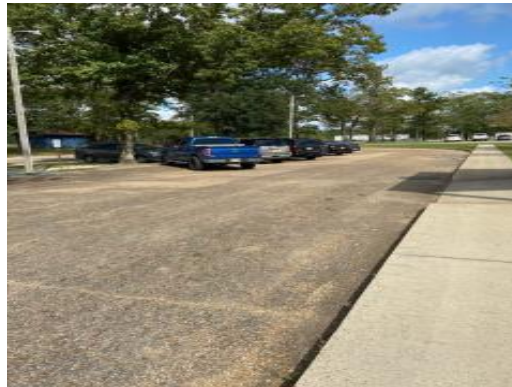
Damaged asphalt north of main entry

Deficiency	Category	Qty	UoM	Priority	Repair Cost	ID
Asphalt Driveway Replacement <b>Note:</b> Asphalt is cracked and worn north of the main entry and along the east side of the buildings.	Capital Renewal	30,000	SF	3	\$172,138	352
Car Accessible Parking Spaces Restriping <b>Location:</b> Parking lot for classroom/main office building	ADA Compliance	2	Ea.	3	\$203	462
Concrete Walks Replacement <b>Note:</b> Concrete sidewalks are cracked and uneven at northeast corner of site, near the main entrance, and at the southwest corner of the gym.	Capital Renewal	2,500	SF	3	\$25,269	355
Exterior Entry Signage At The Building Entry Does Not Meet ADA Requirements <b>Location:</b> Main entry for classroom/main office building	ADA Compliance	1	Ea.	3	\$120	465
The Van Accessible Parking Spaces Do Not Meet ADA Requirements <b>Location:</b> Parking lot for classroom/main office building	ADA Compliance	2	Ea.	3	\$1,393	464

Asphalt Paving Replacement <b>Note:</b> North of the main entry	Capital Renewal	15	CAR	4	\$19,418	350
Fencing Replacement (4' Chain Link Fence) <b>Note:</b> Between the Northeast wings	Capital Renewal	50	LF	4	\$2,106	349
Gravel Paving Replacement <b>Location:</b> East of the buildings	Capital Renewal	50	CAR	4	\$9,657	351
Site Drainage Regrading <b>Location:</b> East of gym	Deferred Maintenance	35,000	SF	4	\$44,907	354
Paving Restriping <b>Note:</b> All striping gone	Deferred Maintenance	15	CAR	5	\$445	353
Small Bench Replacement <b>Note:</b> Replace wood benches west of the cafeteria.	Deferred Maintenance	16	Ea.	5	\$29,508	356
<b>Sub Total for System</b>		<b>11</b>	<b>items</b>		<b>\$305,164</b>	
<b>Sub Total for School and Site Level</b>		<b>11</b>	<b>items</b>		<b>\$305,164</b>
