FACILITY CONDITION ASSESSMENT

Vancleave Lower Elementary | November 2020

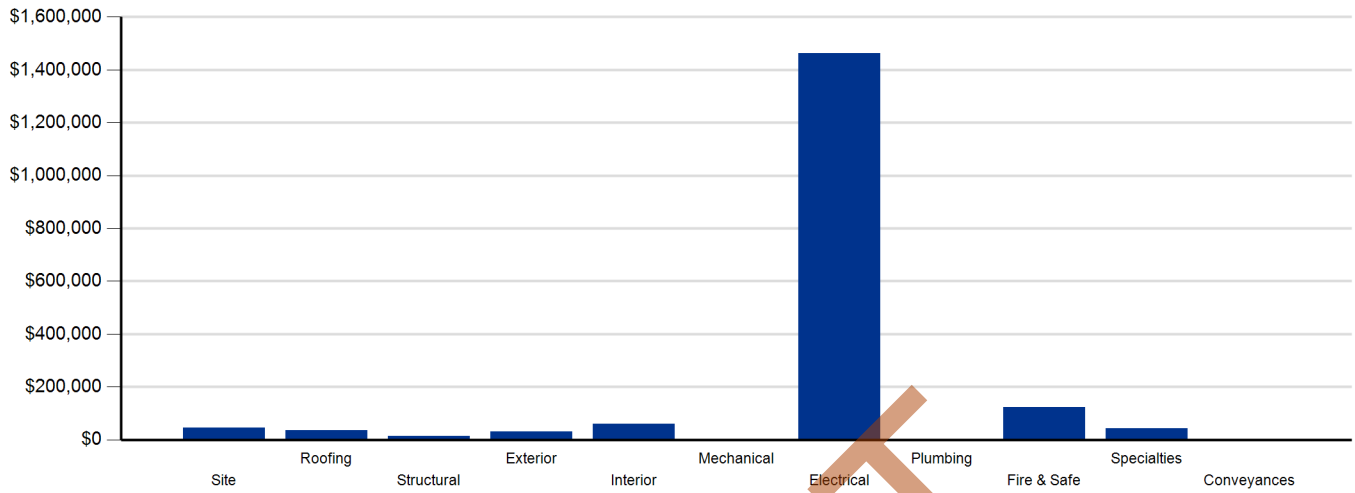
Figure 1: System Deficiencies

The chart below represents the building systems and associated deficiency costs.

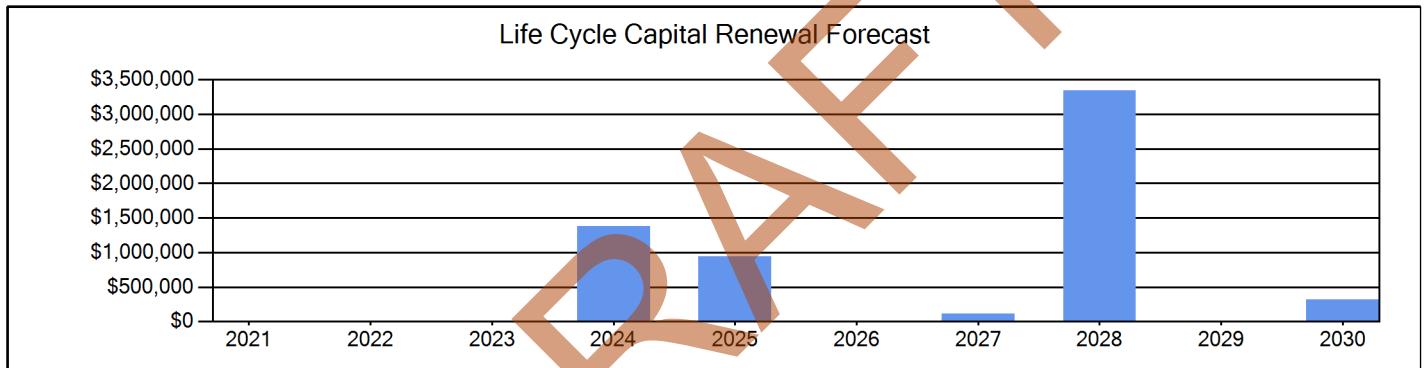
Figure 2: Ten Year Capital Renewal Forecast

The following tables show current deficiencies and the subsequent ten-year life cycle capital renewal projections. The projections outline costs for major building systems in which a component is expected to reach the end of its useful life and require capital funding for replacement.

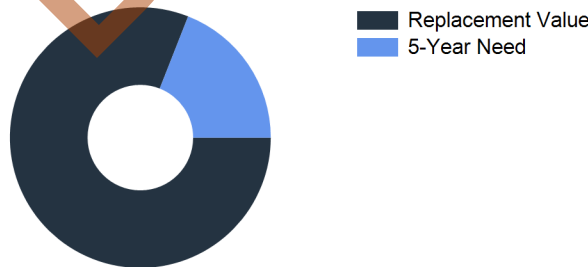
Figure 3: 5-Year FCI

The replacement value represents the estimated cost of replacing the current building with another building of like size, based on today’s estimated cost of construction in the Jackson, MS area. The estimated replacement cost for this facility is \$20,525,596. For planning purposes, the total 5-year need at the Vancleave Lower Elementary is \$4,083,204 (Life Cycle Years 1-5 plus the FCI deficiency cost). The Vancleave Lower Elementary facility has a 5-year FCI of 19.89%.

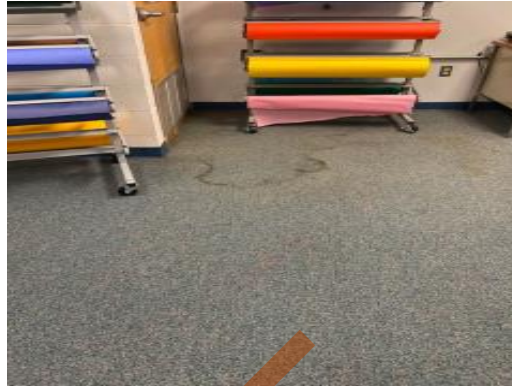
Water damaged carpet

Deficiency	Category	Qty	UoM	Priority	Repair Cost	ID
Entry Door Does Not Have Power Assist Device	ADA Compliance	1	Ea.	3	\$14,134	51
Location: Main entry						
Expansion Joints Missing or Deteriorated	Deferred Maintenance	4,200	SF	3	\$2,597	53
Note: Cracks in expansion joints. 84LF						
Location: Multiple locations: West, east, and interior of mechanical yard						
Carpet Flooring Replacement	Capital Renewal	2,247	SF	4	\$25,384	55
Note: Carpets have water damage, worn, and faded						
Location: Media and computer room

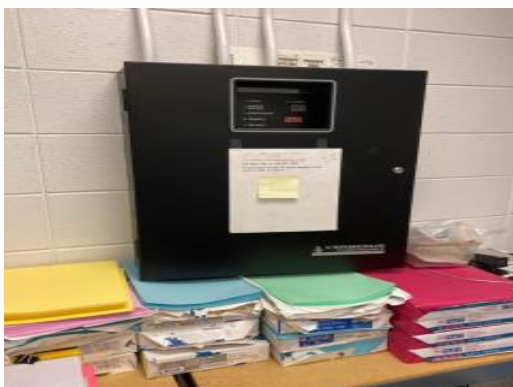
Obsolete fire alarm system

Deficiency	Category	Qty	UoM	Priority	Repair Cost	ID
Fire Alarm Actuator Replacement Note: Fire door magnetic release not working. Location: All doors located by the expansion joints	Capital Renewal	8	Ea.	1	\$4,285	45
Fire Alarm Replacement Note: Original system, battery backup doesn't work, has a blown fuse, and trouble lights are illuminated	Capital Renewal	74,900	SF	1	\$106,120	44
Sub Total for System		2 items			\$110,405

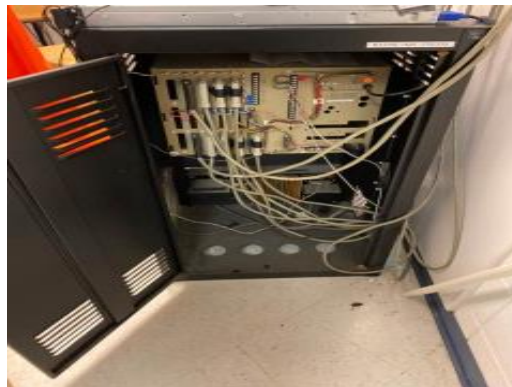
Obsolete PA system

Deficiency	Category	Qty	UoM	Priority	Repair Cost	ID
Public Address System Head-End Requires Replacement	Functional Deficiency	1	Ea.	3	\$6,520	952
Sub Total for System		1 items			\$6,520
