Caledonia-Mumford

CAL-MUM CENTRAL SCHOOL DISTRICT

HUNT ENGINEERS | ARCHITECTS | SURVEYORS

MAY 22, 2018

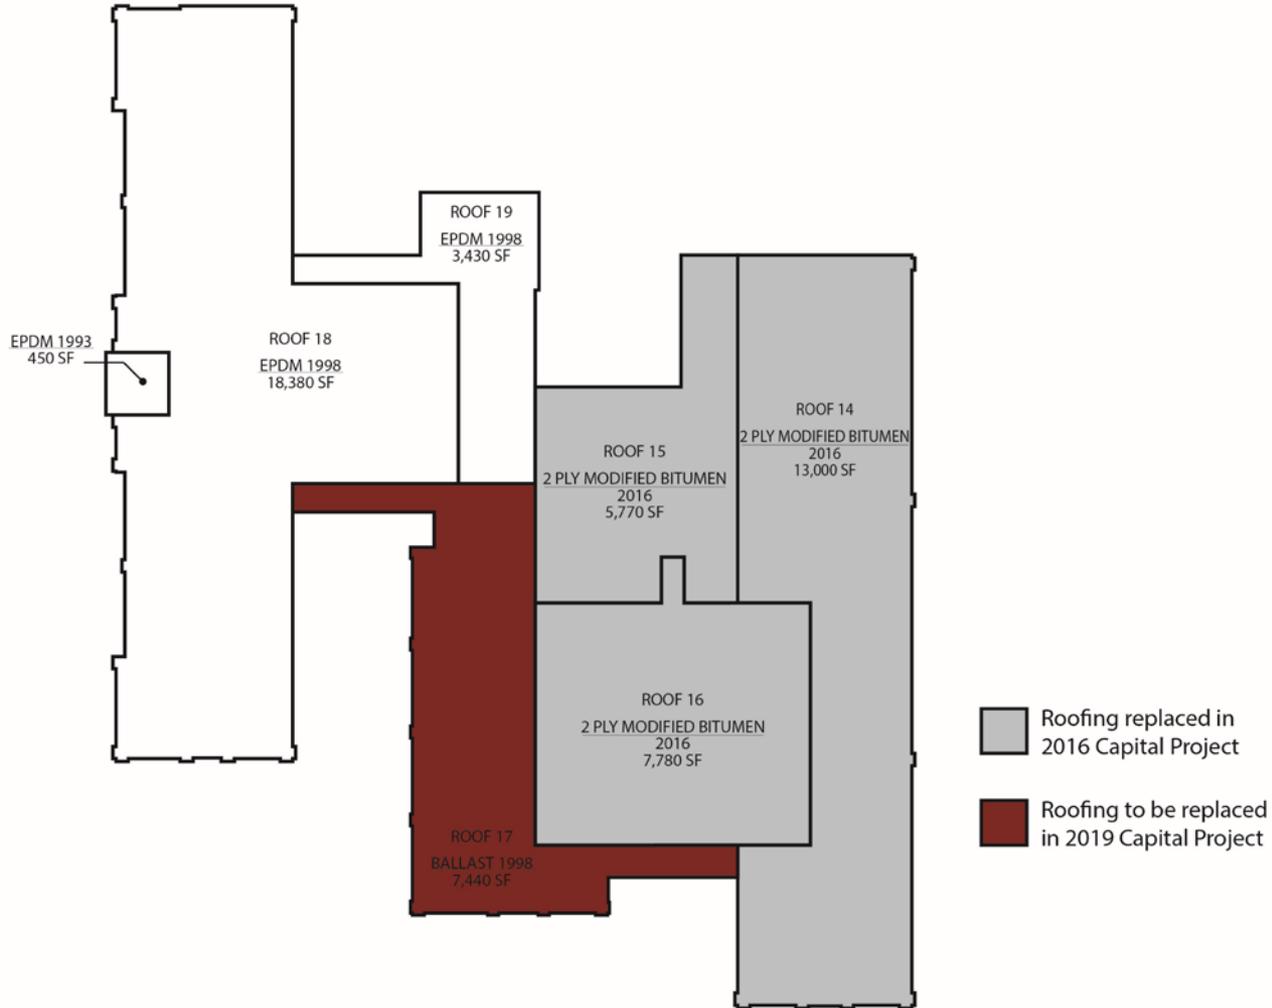
ES Roof Replacement

- Roof replacement of nearly 7500 SQ/Ft
- Replacement of PA system
- Renovation of the Elementary School Gymnasium including bleacher replacement, gym floor painting and refinishing.

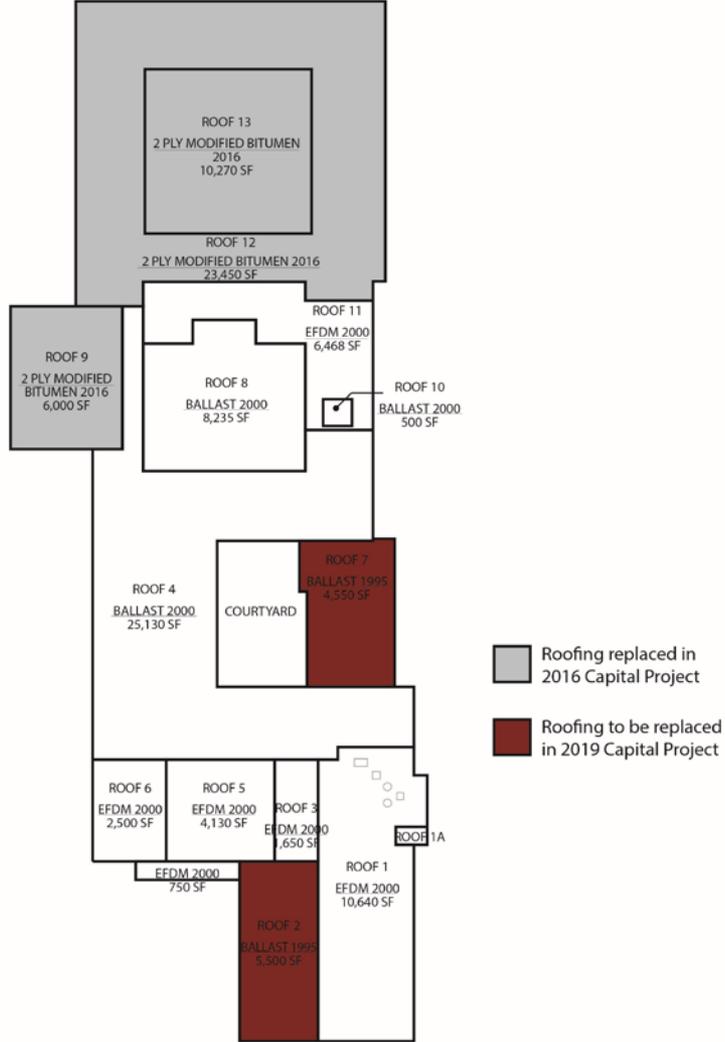
MS/HS Roof Replacement

- Renovation to MS/HS Auditorium—Sound, lighting and rigging systems
- Roof replacement of nearly 10,000 SQ/Ft
- Install in-wall flashing down the music corridor
- Replacement of septic system pumps, controls and wiring
- Enhance high school parking lot (72 spaces)

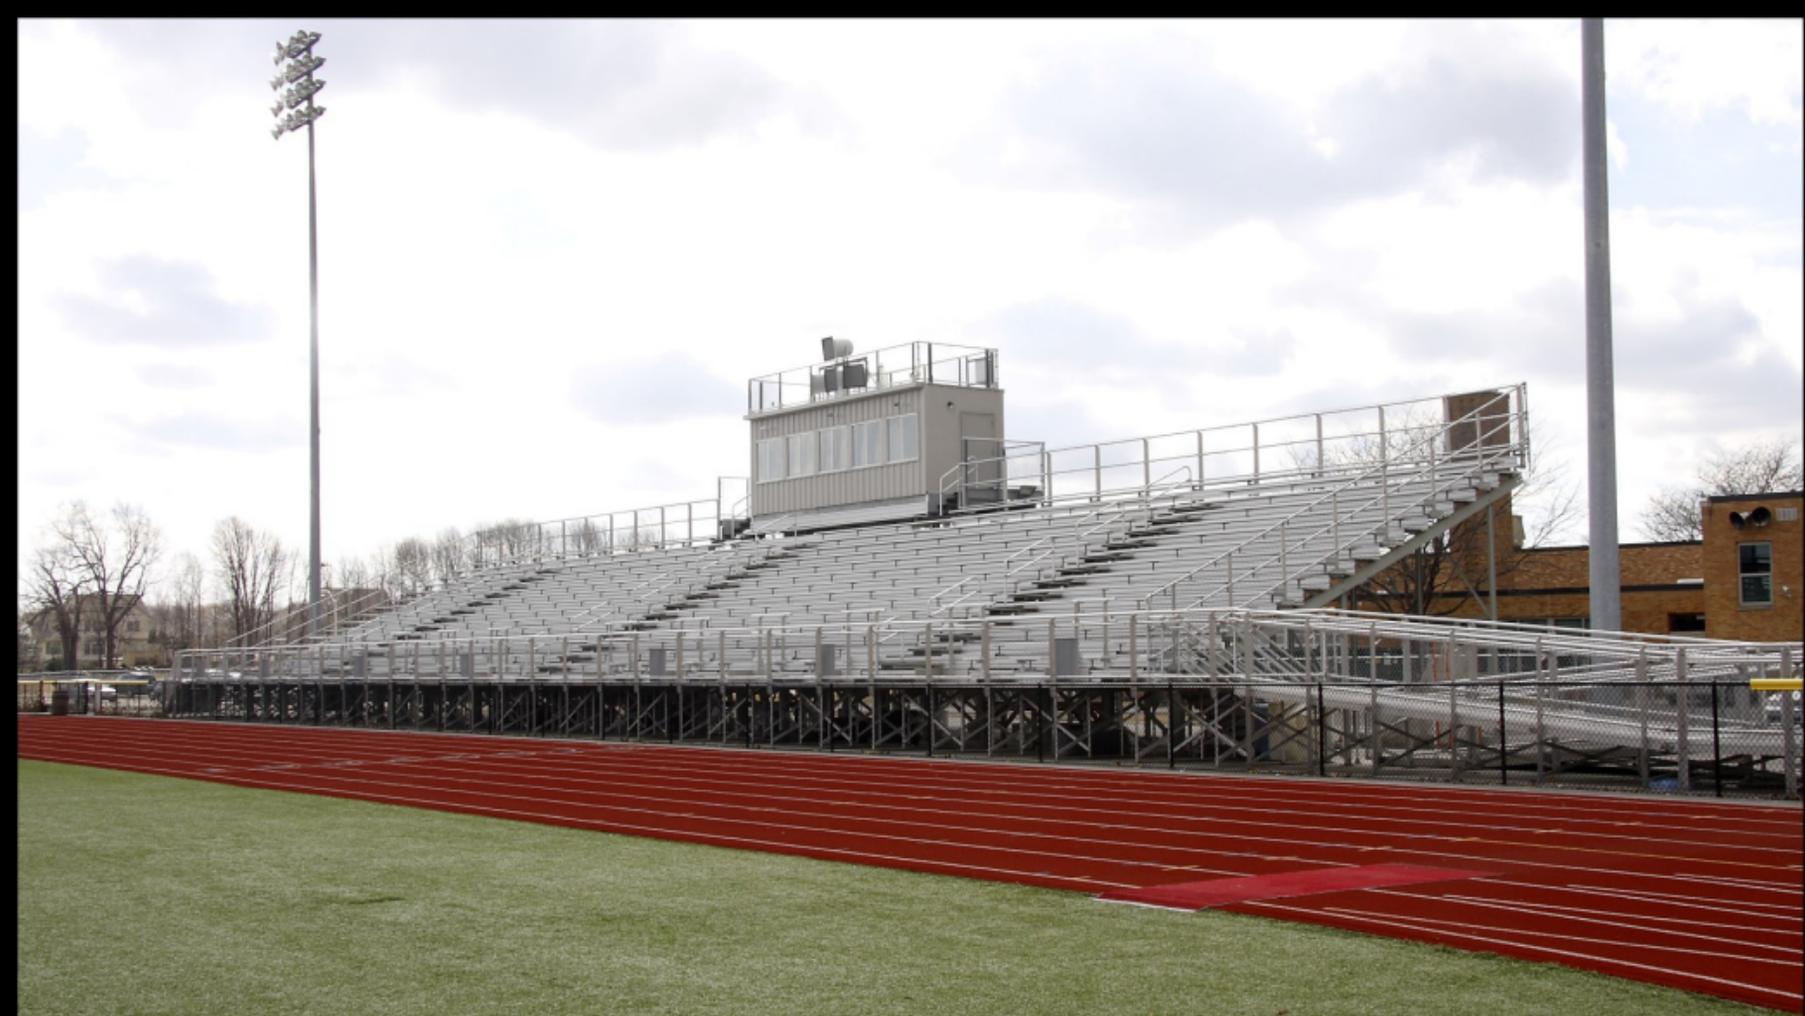
Hamilton Field Student/Athlete Sports Complex

- Replace track surface
- Replace turf fabric
- Install new shock pad
- Increase positive drainage
- Install new soccer safety netting
- Install pole vault concrete pads
- Replacement of windows in press box

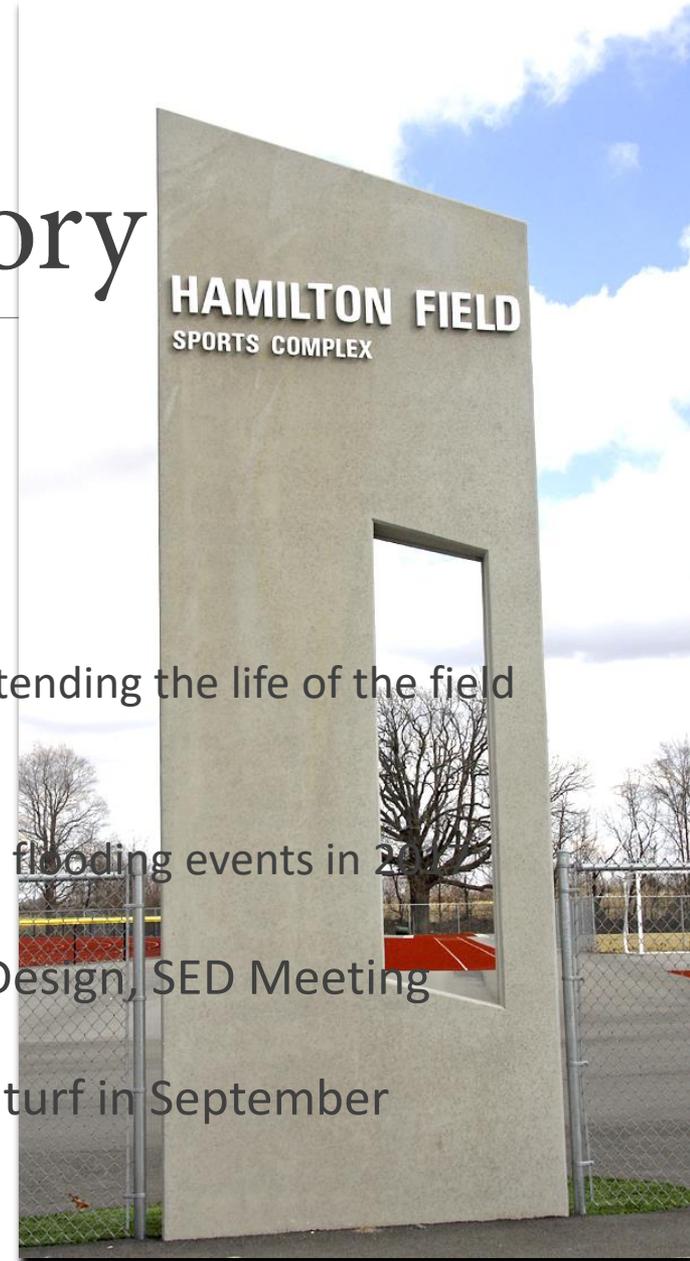
Gmax Data Report

Introduction: An analysis of the synthetic playing surface, relative to Gmax, was requested by the client. The particulars of this on-site analysis are described below.

Test Protocol: Method A - ASTM F 355, Test Methods for Synthetic Turf Systems and Materials.

ASTM F 1936-10, Standard Specification for Impact Attenuation of Turf - Playing Systems as Measured in the Field, (Gmax).

Date: 7/13/2016
Time: 1:30 PM
Weather: Sunny
Air Temp: 84 °F
Turf Avg Temp: 122 °F

Test Results: See attached map whose numbers correspond to the ten Gmax testing locations.

Conclusion: As referenced in ASTM F 1936-10, the field at the above described facility

Does

Meet the requirements for play with an overall Gmax rating of:

161

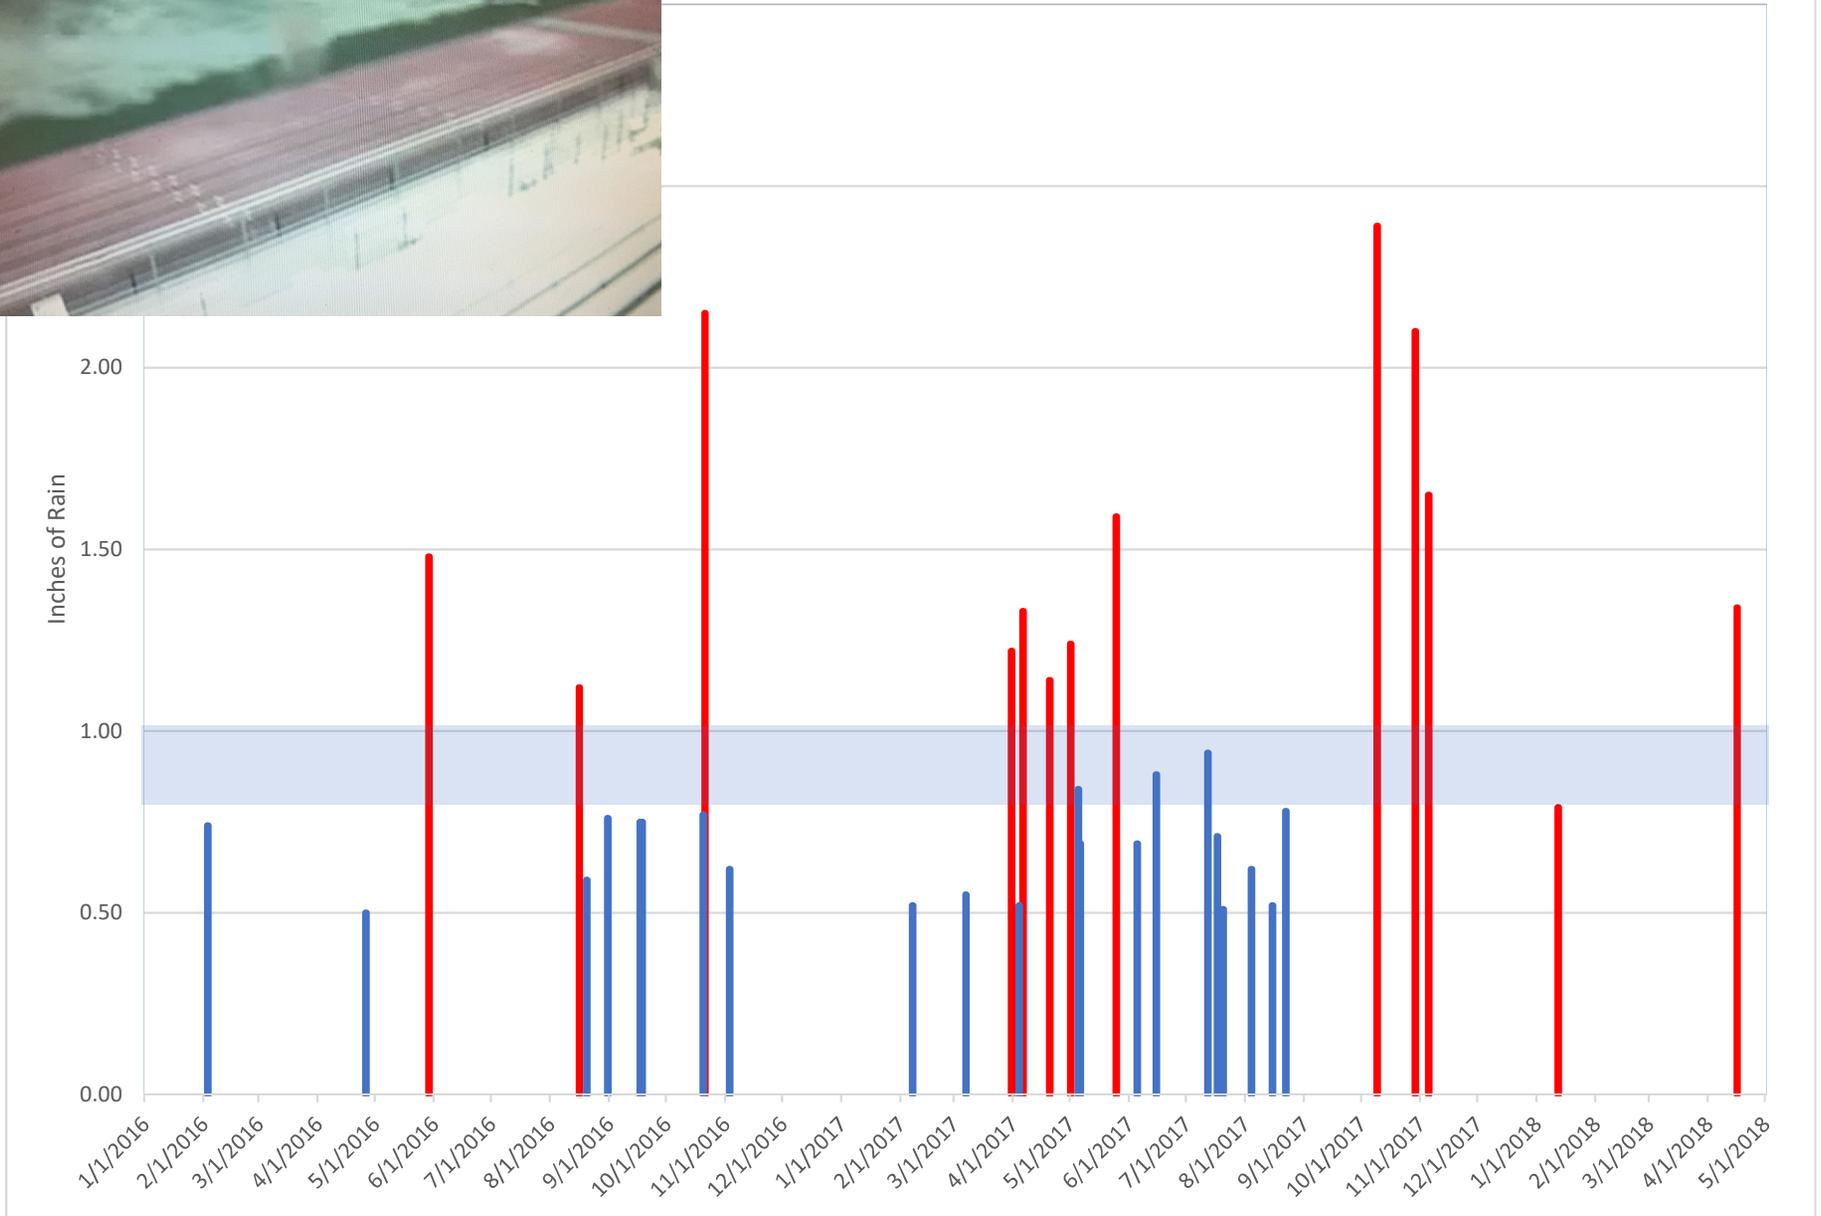
Rainfall Events 2016-2018

- 2006: Design and Installation
- 2006-2018:
 - Ongoing maintenance operations – testing & extending the life of the field
 - Utilization exceeds expectations
 - Drainage issues persist throughout the years – 8 flooding events in 2017
- 2017/18: Re-investigate drainage, Schematic Design, SED Meeting
- 2019: Re-construction with first game on new turf in September

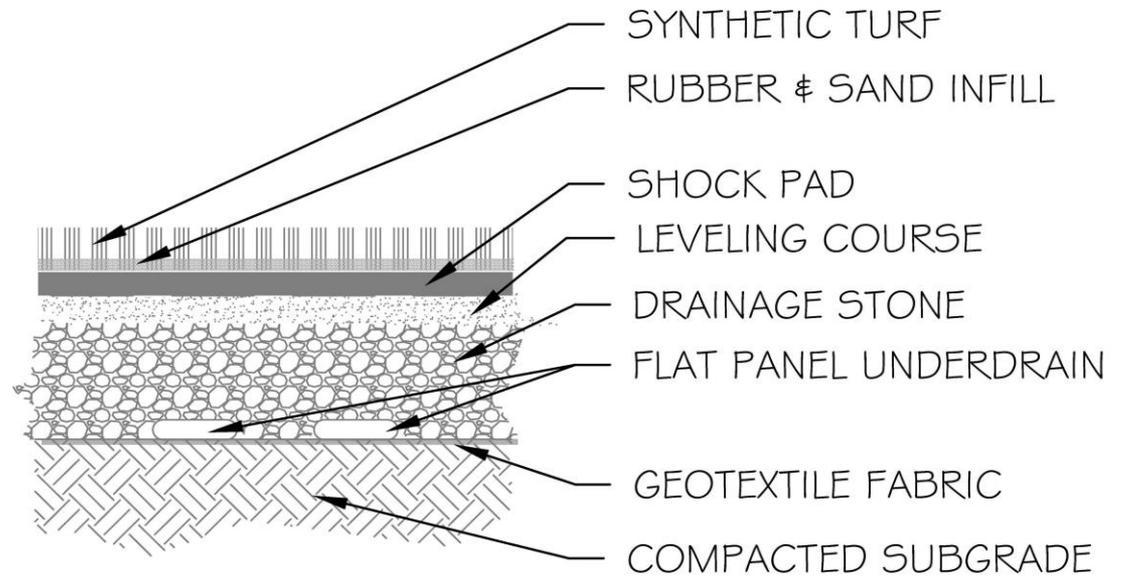
SYSTEM COMPONENTS

- 95% Compacted Subgrade
- Non-Woven Geosynthetic Fabric
- J-Drains
- ~ $\frac{3}{4}$ " Drainage Stone
- ~ $\frac{1}{4}$ " Leveling Stone
- Shock Pad (Optional)
- Turf Carpet
- Infill – Rubber & Sand

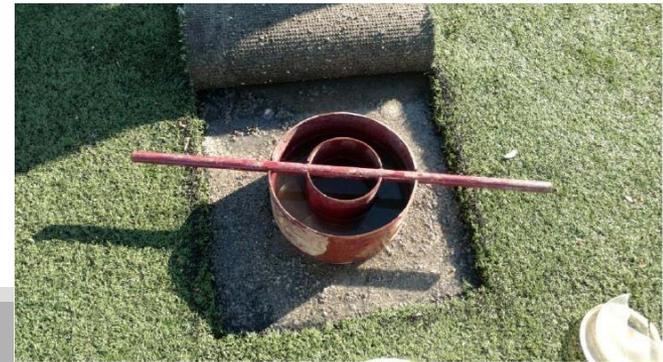
Existing Field Layout

- Synthetic Turf directly on stone (1.5" finishing & 4.5" base)
- 0.5% cross slope
- Flat Panel Underdrain in Herringbone Pattern
- Perimeter Drainage discharge to Drywells

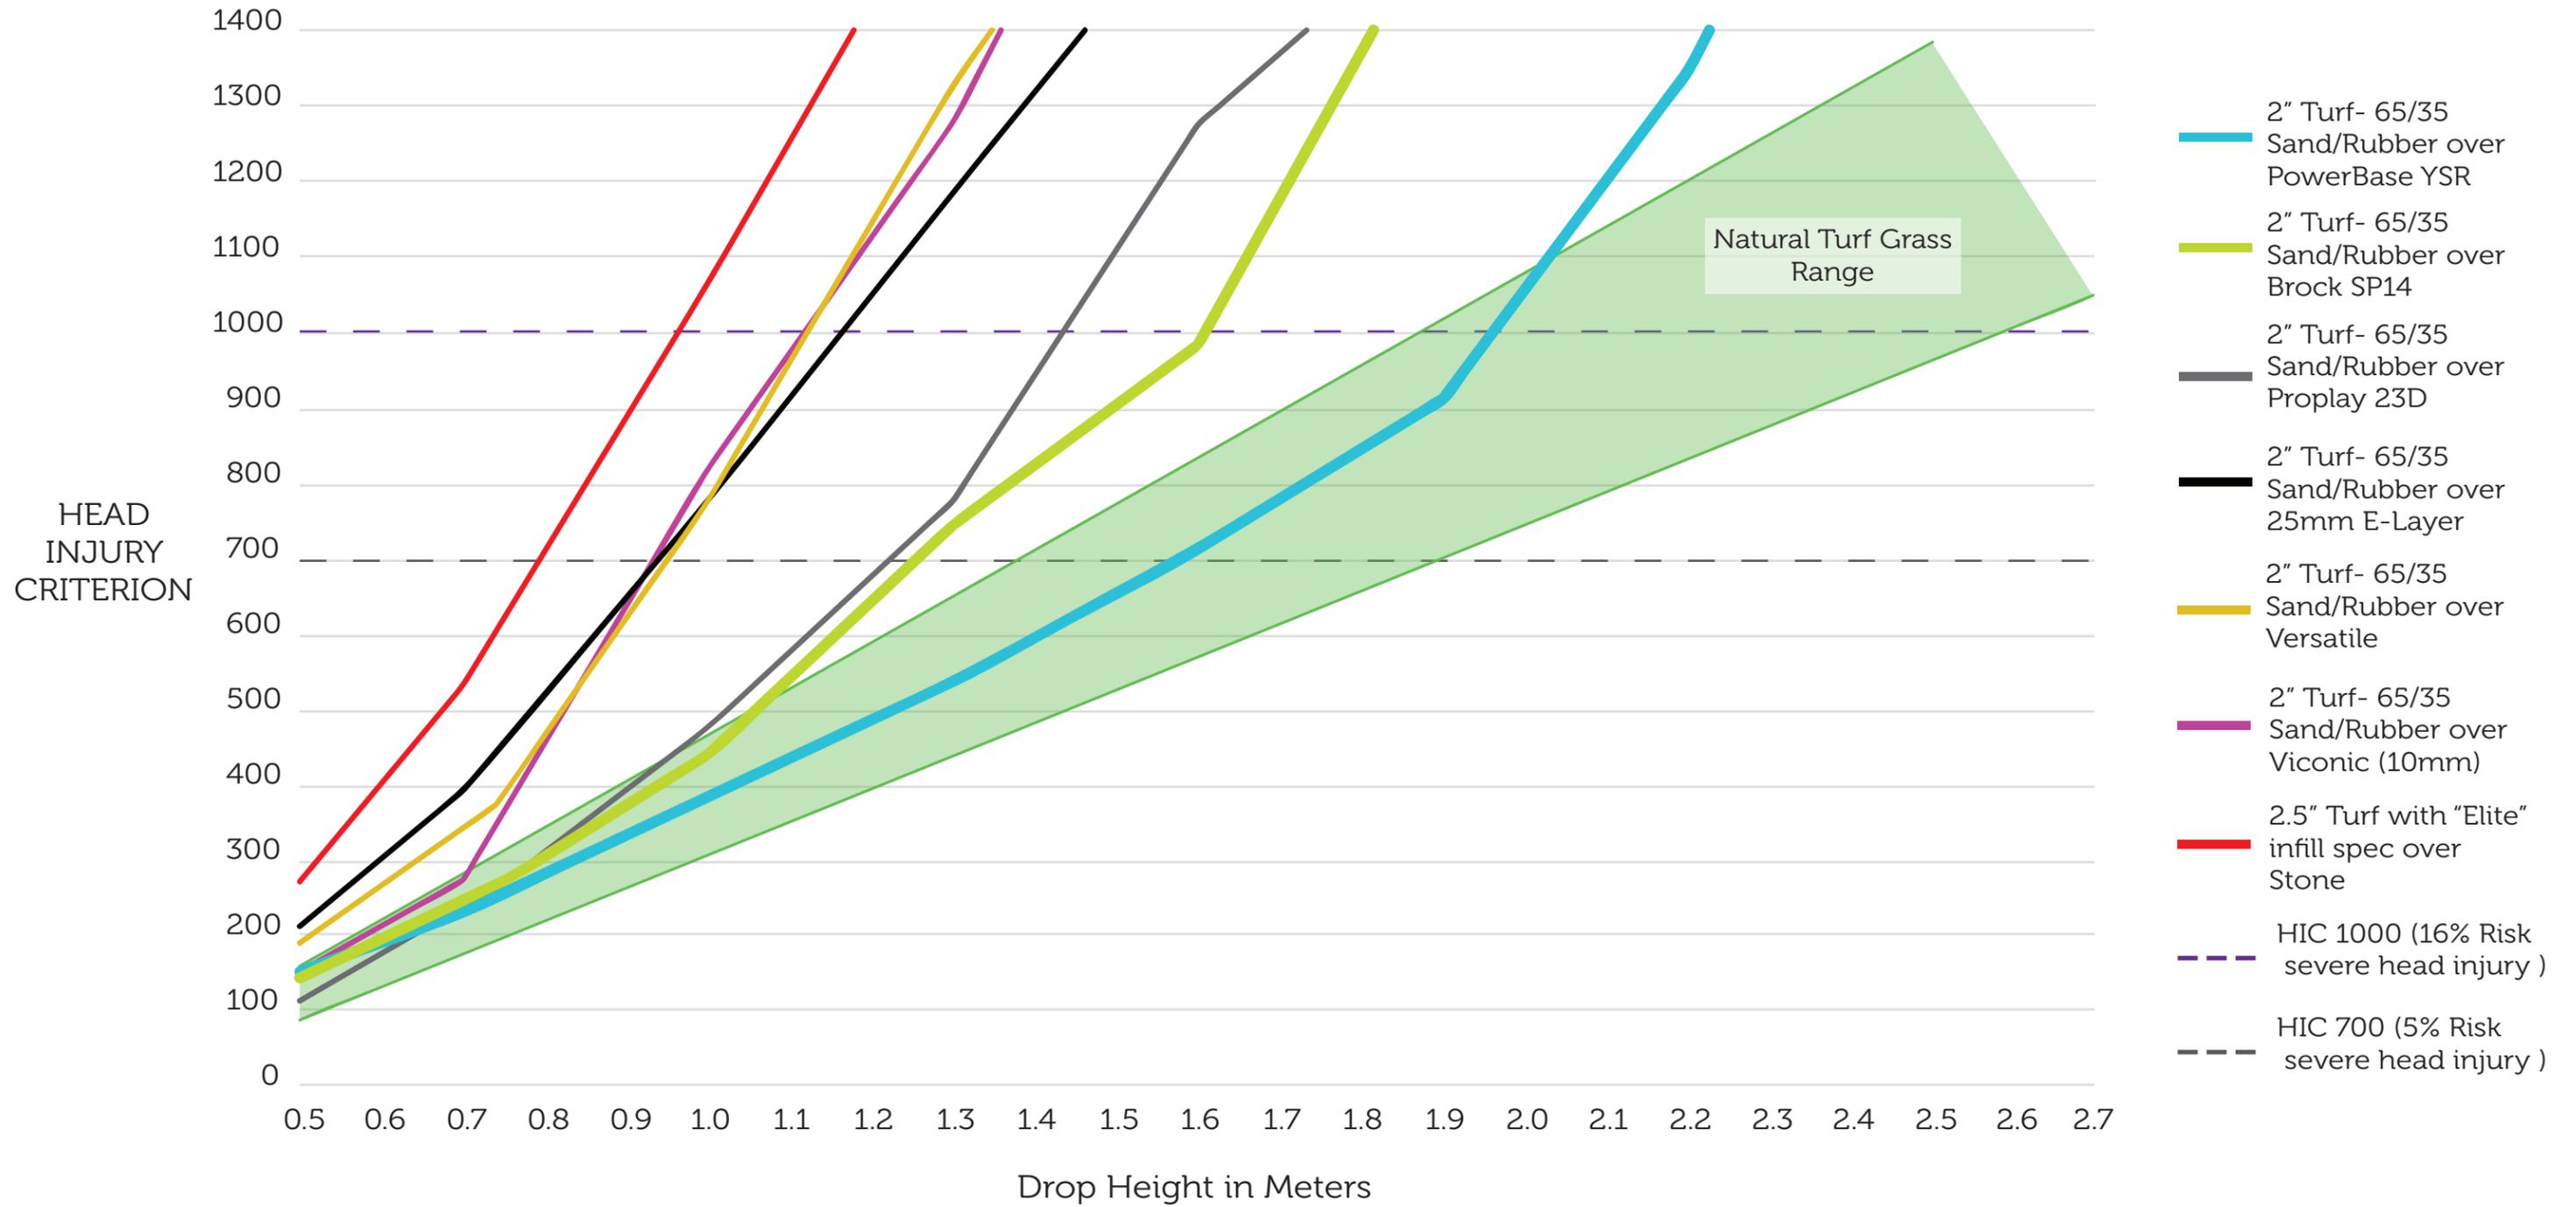
University of Tennessee Center for Athletic Field Safety - Natural Turf Grass Test Results
 ASTM F 355-2016 MISSILE E
 COMPARISON TO ARTIFICIAL TURF SYSTEMS

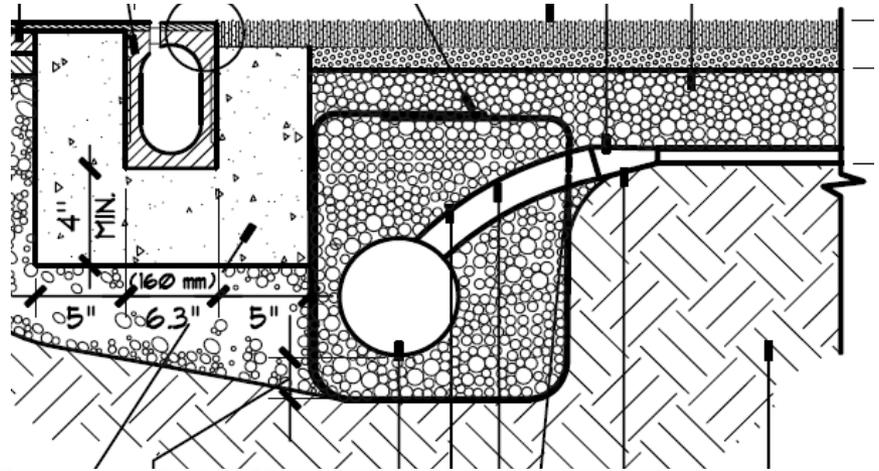
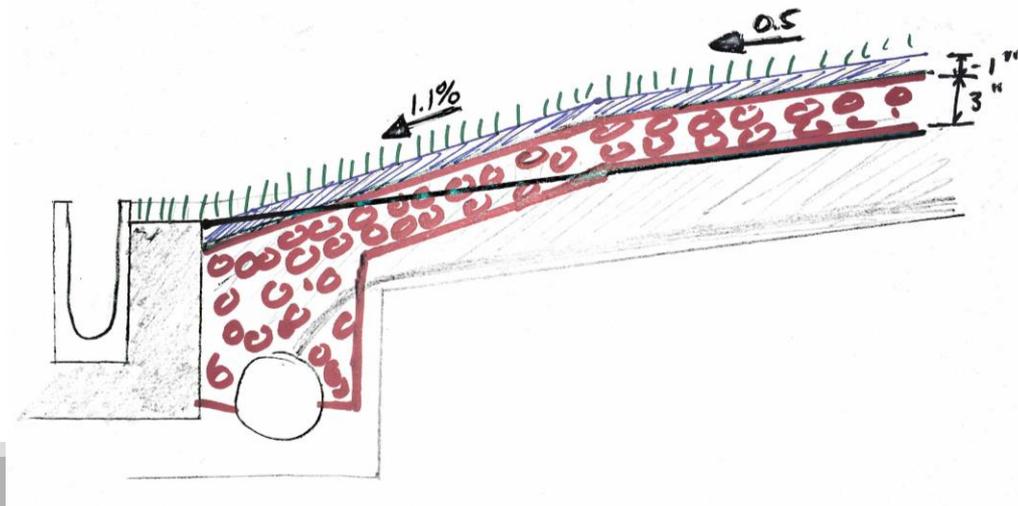
Goal #4 – Drainage

- Lateral Drainage Improvements
 - Specially Design Shockpads with Drainage Slots – similar capabilities as flat panel drains
 - Regrade Field to increase slope
 - Additional 3" of free-draining stone
- Perimeter Drainage Improvements
 - New Stone trench drain down to perimeter pipe or
 - Parallel flat drain with direct connections

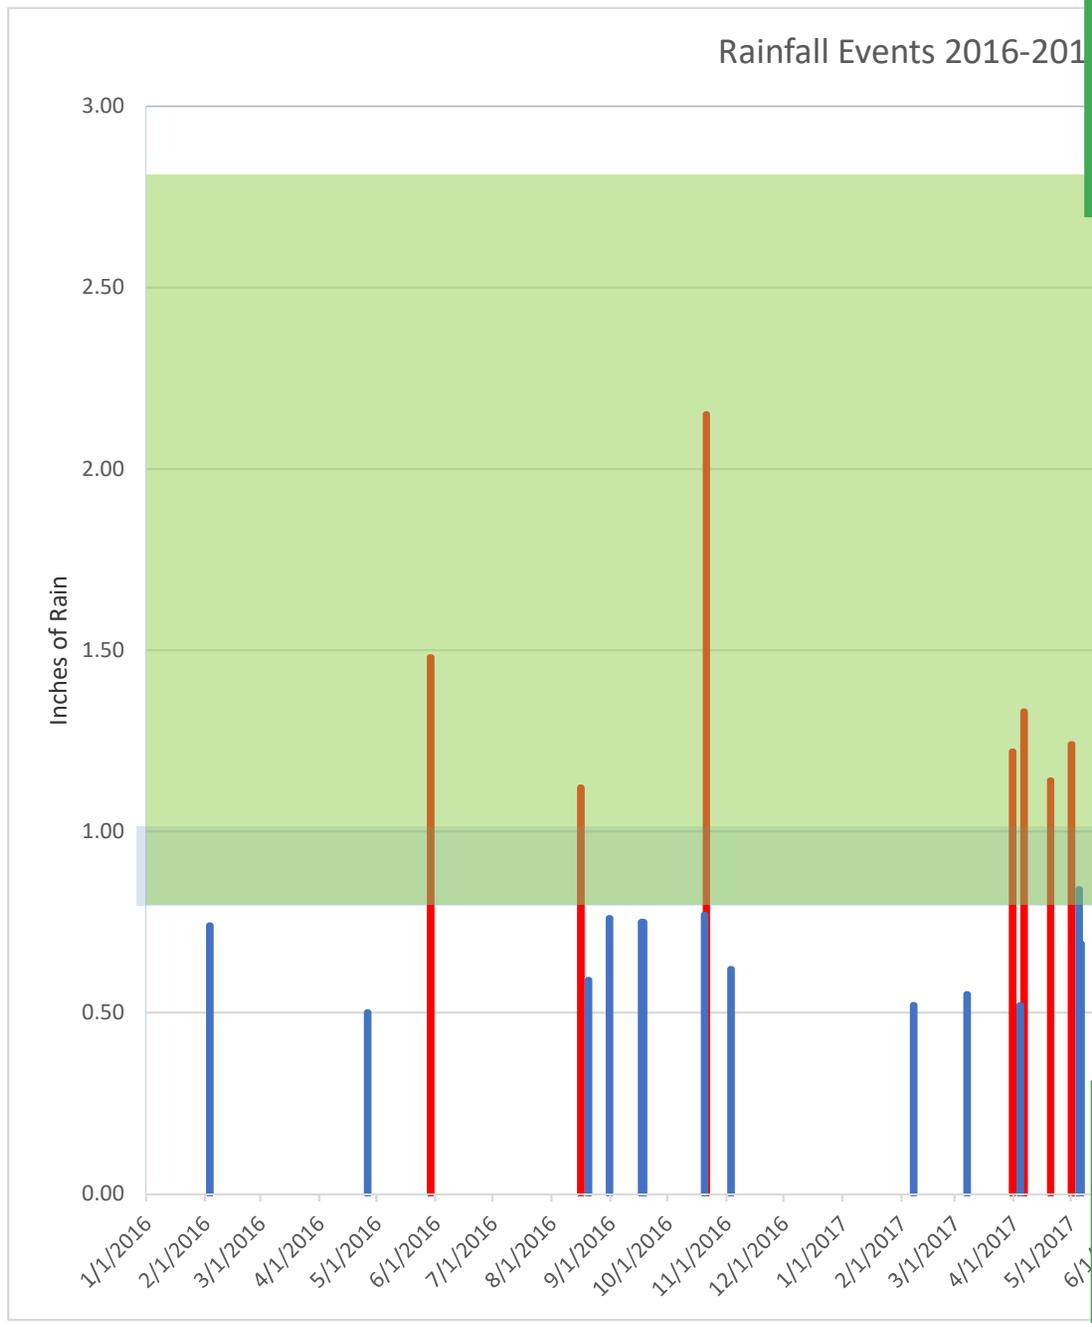
Additional Capacity For Each Side of Field

- Shockpad adds 600 GPM
- Drainage Stone adds 1400 GPM
- Total Additional Capacity: 2000 GPM
- Current Capacity estimated as 770 GPM
