FACILITY CONDITION ASSESSMENT

NORTH MIDDLESEX REGIONAL SCHOOL DISTRICT

Ashby Elementary School

July 7, 2020
H&A JN 1919.01

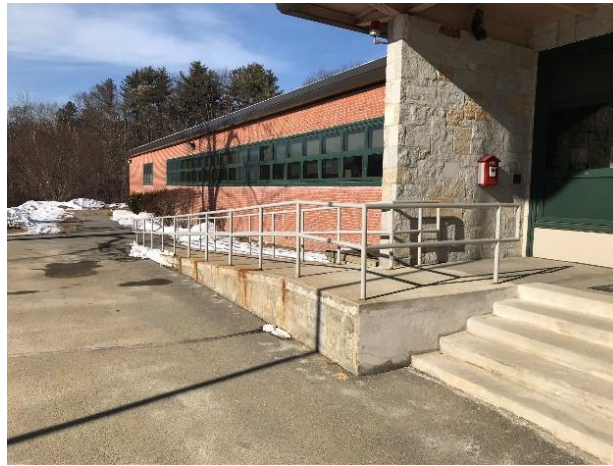
1.5 Non-Compliant handrails

1.4 Site Lighting: Install site lighting at the new paved parking lot.	10	EA	5,000.00	50,000	65,000			65,000	65,000
1.5 Non-compliant Galvanized Painted Steel Handrails: Exterior galvanized painted steel handrails are missing extensions or not continuous. Modify/Replace/Add new galvanized painted steel handrails and guardrails.	1	LS	5,000.00	5,000	6,500			6,500	6,500

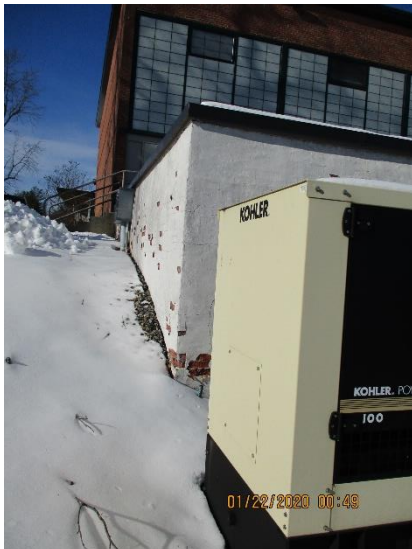
1.7 Water Infiltration at Foundation Walls: It is reported that water is penetrating building below grade foundation at the cafeteria, the main electrical room, and the boiler room. Excavate and install water proofing.	150	LF	235.00	35,250	45,825	45,825			45,825

1.7 Exterior wall at electrical room

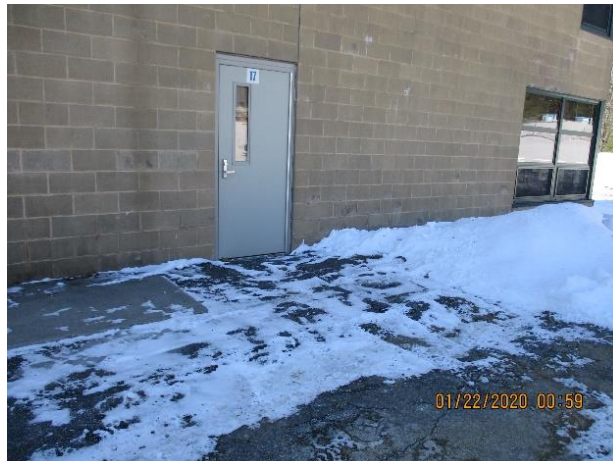
Work Item Description	Qty	Unit	Unit Cost	Total	¹ Total w/ Soft Costs	Scope 1	Scope 2	Scope 3	Totals
1. SITE					ASHBY ELEMENTARY SCHOOL				
1.8 Replace Bituminous Concrete Pads: Existing bituminous concrete pads at end wall of the 1989 addition are heaving and preventing door from opening. Remove and replace.	14	SY	30.00	420	546	546			546

1.8 Bituminous concrete pad at exit door

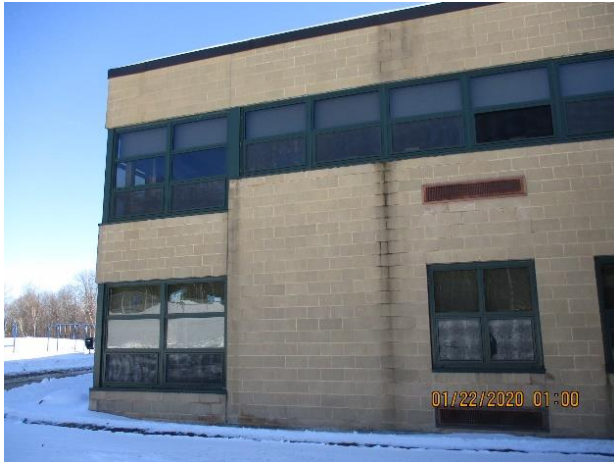
2.1 Staining and efflorescence on masonry wall

Work Item Description	Qty	Unit	Unit Cost	Total	¹ Total w/ Soft Costs	Scope 1	Scope 2	Scope 3	Totals
2. BUILDING ENVELOPE					ASHBY ELEMENTARY SCHOOL				
2.1 Staining and efflorescence on masonry walls - 1989 addition: Power wash and clean.	500	SF	5.00	2,500	3,250		3,250		3,250
2.2 Paint Rusted Boiler Flue: Existing steel boiler flue is heavily rusted. Prepare, prime and paint existing steel boiler flue.	400	SF	15.00	6,000	7,800	7,800			7,800
2.3 Snow Guard at Canopies: Install snow guard at canopies over egress doors	1	LS	750.00	750	975	975			975
2.4 Demolish 1960 addition: The 1960 addition has not been used and has been abandoned for over 15 years.	1	LS	230,000	230,000	299,000	299,000			299,000
Total						307,775	3,250	0	311,025
Total Inflated @ 4% Compounded Annually						332,889	3,954	0	336,844

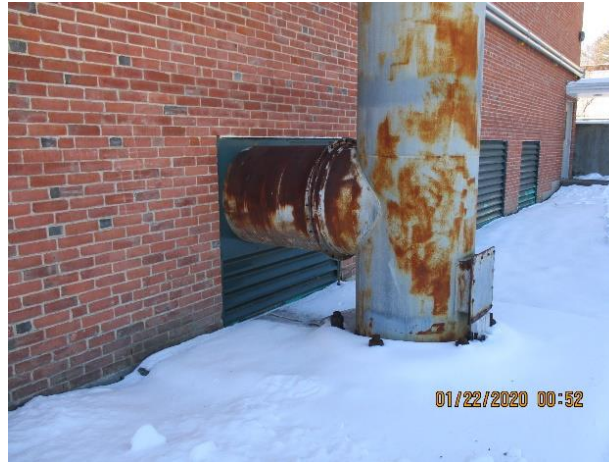
2.2 Rusted boiler flue

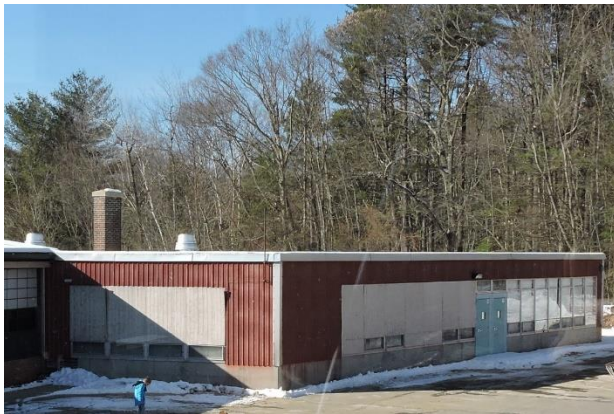
2.4 The abandoned 1960 addition

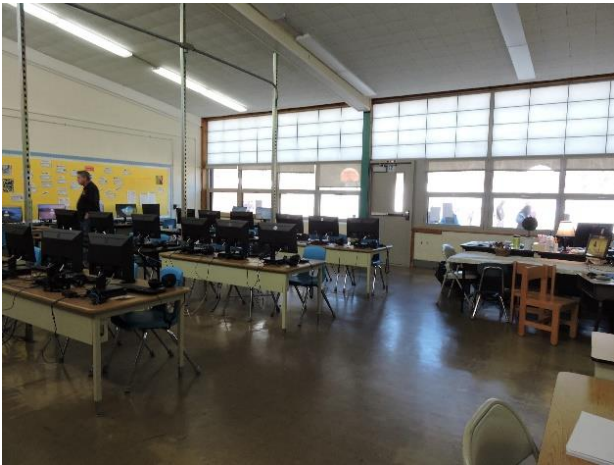
3.1 Replace Asbestos Containing Floor Tiles, and Linoleum: The AHERA report dated 7/18/17 indicates that 9"x9" floor tiles, linoleum, and mastic contain ACM. Abate ACM tile, linoleum and mastic and provide new VCT tile flooring and vinyl base. (Note, 378 SF of asbestos floor tiles were removed in July 2019).	5,838	SF	15.00	87,570	113,841	113,841			113,841

3.1 9"x9" asbestos floor tiles

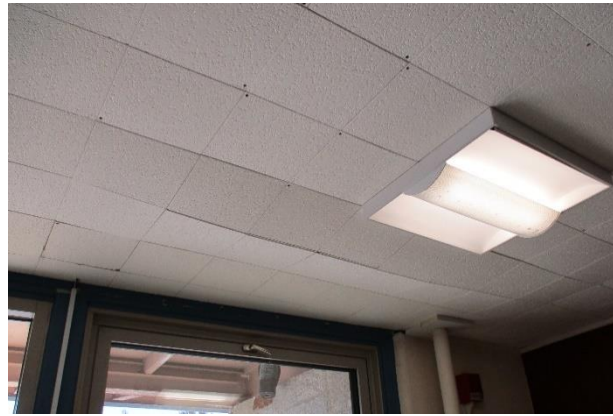
3.6 Replace 1x1 Ceiling Tiles: Existing 1x1 acoustical ceiling tiles are sagging at the front lobby. Remove and replace with 2x4 ACT tile with new suspension grid.	560	SF	8.00	4,480	5,824		5,824		5,824

3.6 Sagging acoustical ceiling tiles

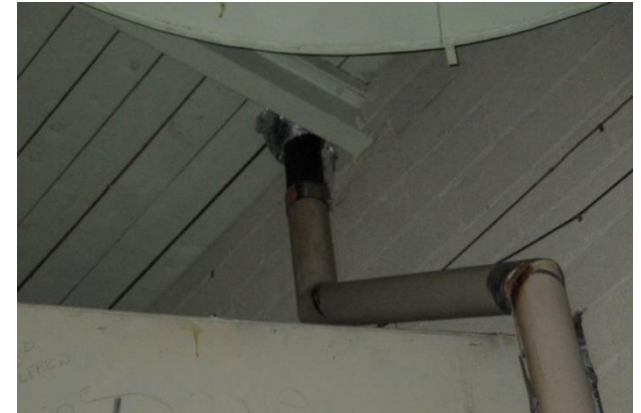
3.7 Leaking interior roof drain leader

3.7 Leaking Roof Drain Leader: Remove and replace roof drain leader behind the proscenium wall at the gymnasium.	1	LS	2,500.00	2,500	3,250	3,250			3,250

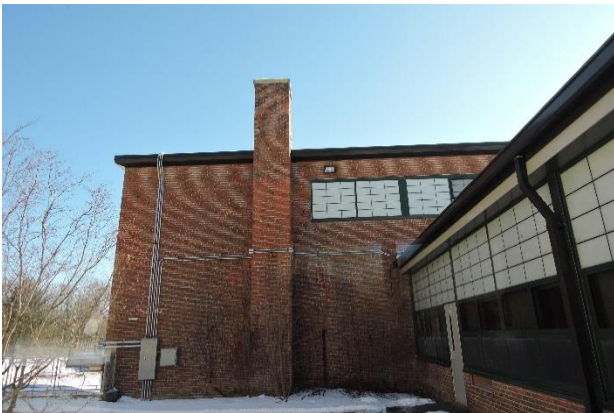
3.8 Roof leak through chimney

3.8 Roof Leak through Chimney: Remove existing chimney flashing and install new flashing.	1	LS	1,000.00	1,000	1,300	1,300			1,300

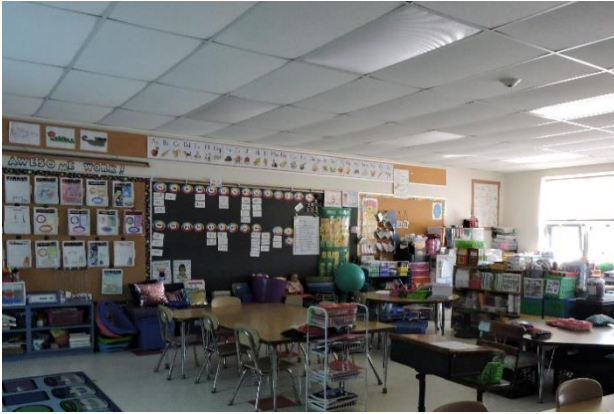
3.11 2x4 Mineral Fiber ACT in 1989 Addition: Existing 2x4 ACT tiles in the 1989 addition are warped and sagging. Replace existing ceiling tiles with new moisture resistant mineral fiber acoustic ceiling tiles in existing suspension grid.	19,900	SF	8.00	159,200	206,960		206,960		206,960

3.11 2x4 ACT tiles in the 1989 addition are warped and sagging

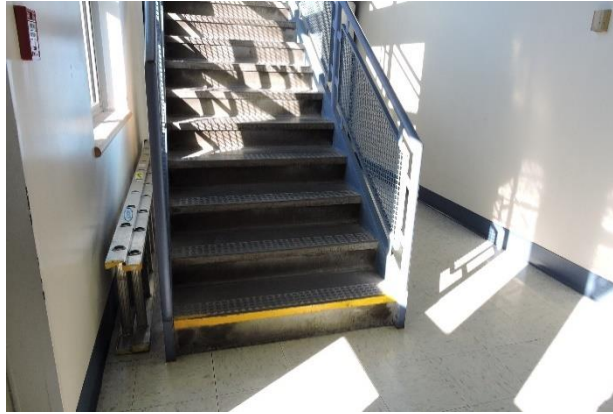
3.12 Non-compliant Handrails/Guardrails on Stairs in 1989 Addition: Existing handrails are not continuous and not at the right height and missing the extensions. Guarding is only on one side of stair. Modify and/or add to the existing handrails/guardrails.	150	LF	45.00	6,750	8,775			8,775	8,775

3.12 Non-compliant Handrails/Guardrails on Stairs in 1989 Addition

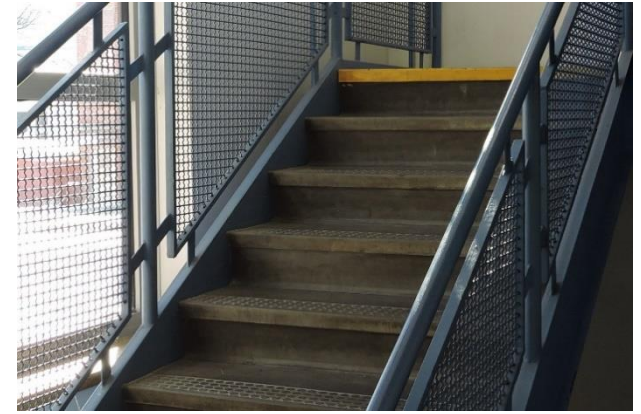
3.13 Rubber Stair Treads and Risers - 1989 Addition: Existing rubber stair treads and risers are discolored. Replace in kind.	160	LF	50.00	8,000	10,400		10,400		10,400

3.13 Rubber stair treads and risers are discolored

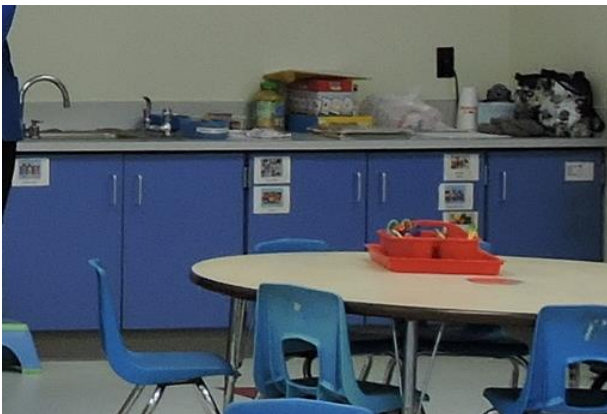
3.14 Classroom sinks are not wheelchair accessible

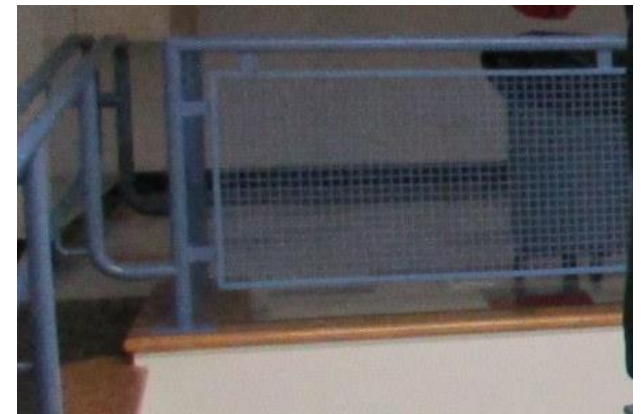
3.17 Handrail on Mezzanine Ramp in Cafeteria: Existing handrail on ramp is missing top extensions. Modify or add new handrail with extensions.	32	LF	45.00	1,440	1,872			1,872	1,872

3.17 Handrail on ramp is missing top extension

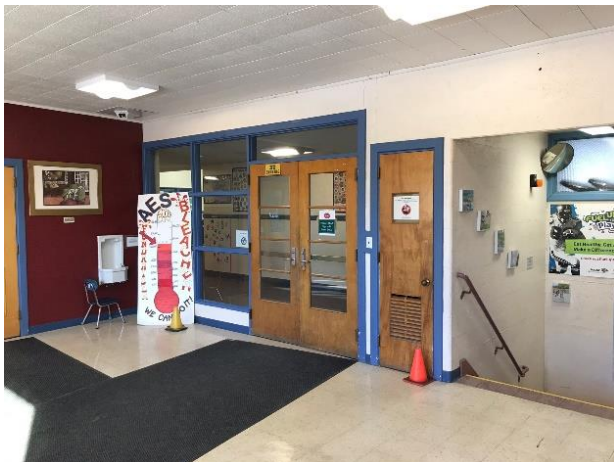
3.23 Gymnasium Stage: Existing gymnasium stage is not wheelchair accessible. Install new chair lift.	1	LS	15,000.00	15,000	19,500			19,500	19,500
3.24 Lobby Double Doors: The lobby double wood doors are not compliant, single door does meet minimum clear width. Remove and replace with new uneven leaf doors.	1	LS	2,500.00	2,500	3,250			3,250	3,250

3.24 Lobby double doors

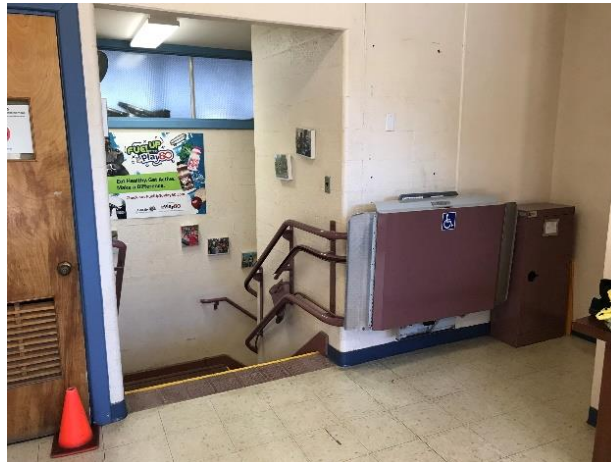
3.25 Handrail on Lobby Stair to Cafeteria: Handrails on stair to cafeteria are missing top extensions. Modify/add new handrails.	20	LF	45.00	900	1,170			1,170	1,170

3.25 Handrail on lobby stair to cafeteria

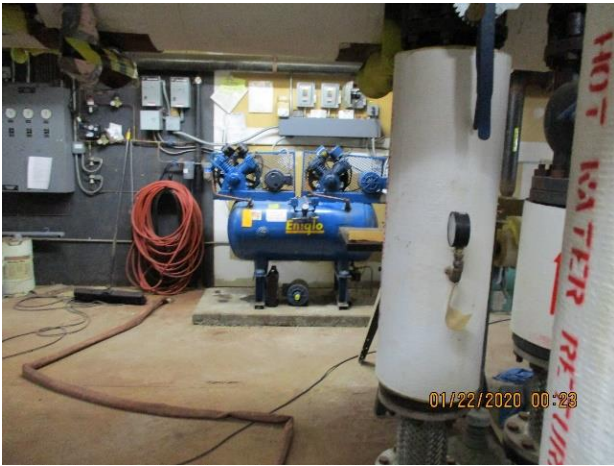
4.2 Air compressor tank for pneumatic control

4.2 Replace Pneumatic Control: Replace the existing pneumatic control of the 1989 unit ventilators.	19,900	SF	5.00	99,500	129,350	129,350			129,350
4.3 Remove Window Unit Air Conditioner: Remove three window unit air conditioners in the office area. Install new split system.	3	EA	12,000.00	36,000	46,800		46,800		46,800

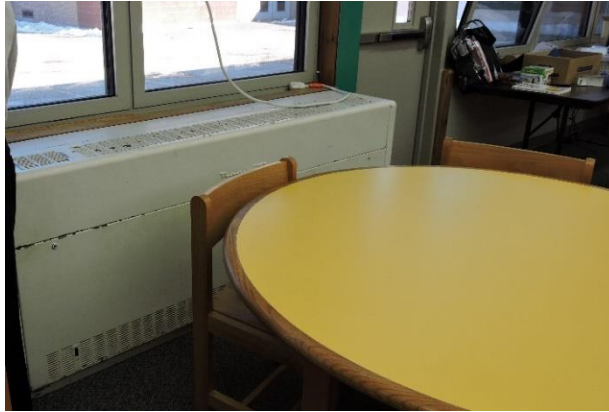
4.6 Unit ventilator in 1950 building

4.6 Replace the Heating and Ventilation System in the Original 1950 Building: Remove the entire steam heating system. Replace with high efficiency condensing boilers.	22,500	SF	22.00	495,000	643,500		643,500		643,500

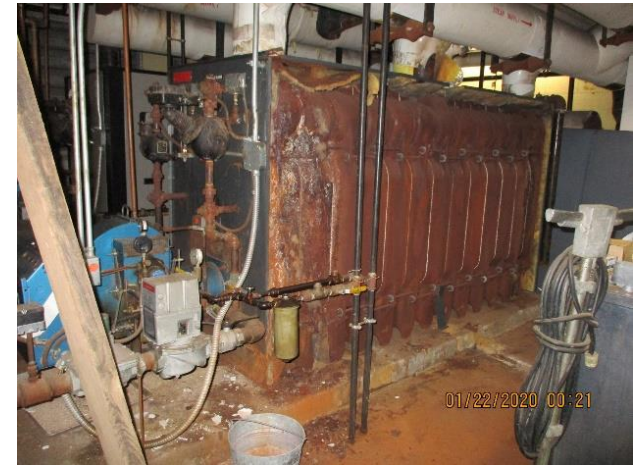
4.7 Replace non-functioning boiler: Only one boiler is working which was replaced about two years ago. The other one is not functioning and used for parts salvaging.	1	LS	150,000	150,000	195,000		195,000		195,000
Total						129,350	1,083,420	234,000	1,446,770
Total Inflated @ 4% Compounded Annually						139,905	1,318,146	284,697	1,742,748

4.7 Non-functioning boiler
