Limited Indoor Air Quality And Microbial Assessment Report

Pembroke Public Schools

Hobomock Elementary School 81 Learning Lanes Pembroke, MA 02359

September 22, 2023

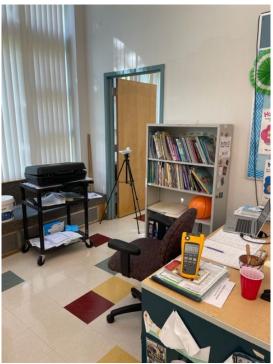
- 3. <u>Classroom 245/250:</u> The analysis results for the sample collected in the back doorway of classroom 245/250 indicate generally normal levels of mold spores. However, 10 spores of Asp/Pen species were identified. Although not excessive, their presence is noted and is higher than the hallways and outdoor sample.

Photograph 1 - Spore trap sample collected at back door of classrooms # 245/250. IAQ measurements collected at desk.

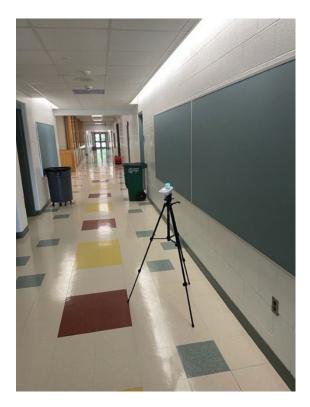
- 1. <u>Hallways</u> (Samples 02, 04, and 05): The analysis results for each of the hallway samples indicate normal levels of mold spores when compared to the outdoor sample. The indoor airborne mold spore levels in these locations sampled are considered generally low and acceptable. The airborne spore levels in the hallways sampled on the assessment date are not representative of an amplified airborne mold spore condition.

Photograph 2 - Spore trap sample collected at Art Room Hallway. Note: lower wall/cove base previously cleaned.
