# INDOOR AIR QUALITY ASSESSMENT

**Hobomock Elementary School  
81 Learning Lane  
Pembroke, MA**

Prepared by:  
Massachusetts Department of Public Health  
Bureau of Environmental Health  
Indoor Air Quality Program  
November 2017

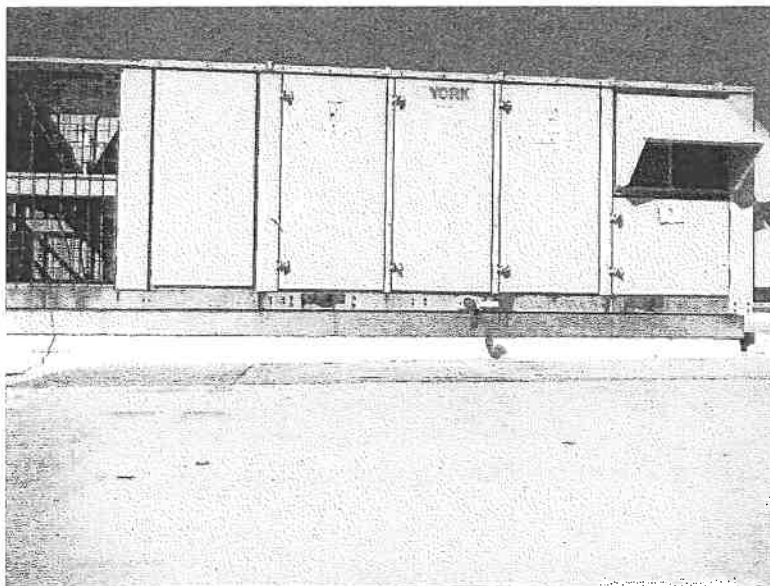
**Picture 1**

Fresh air is provided air handling units (AHUs; Picture 1), which provide fresh air and heat to all areas of the school. One AHU also provides cooling. Air from the AHUs is filtered, heated or cooled as needed, and delivered to rooms via ducted supply vents on the ceiling. Air is exhausted from ceiling-mounted exhaust vents (Picture 2). In some cases these vents are located near classroom doors such that when classroom doors are open, exhaust vents will tend to pull hallway air into the classroom instead of removing stale air/pollutants from the room and out the building. Additional heat is provided by radiators in some areas.

**Rooftop air handling unit (AHU)**

1. Operate all supply and exhaust ventilation equipment continuously during occupied periods.
2. Use openable windows to supplement fresh air during temperate weather. Ensure all windows are tightly closed at the end of the day.
3. Check exhaust vents for draw periodically and repair any non-operating vents.
4. Close classroom doors to facilitate exhaust function.

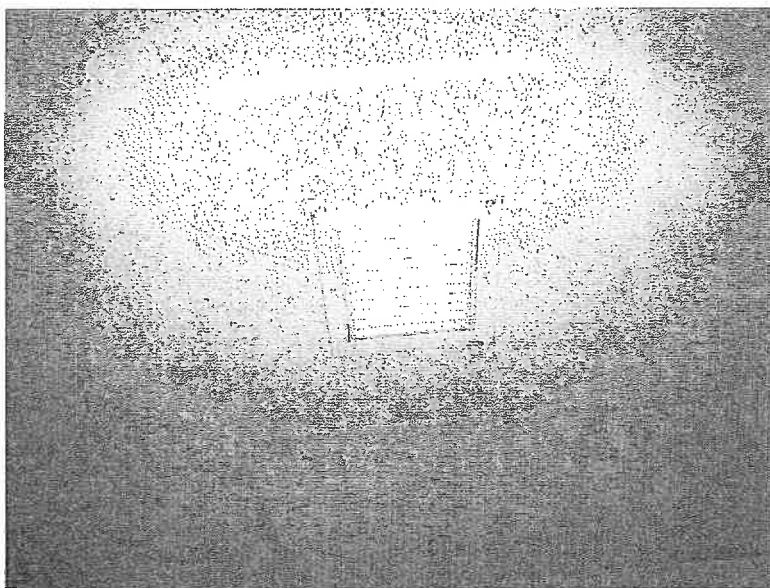
**Picture 2**

**Ceiling-mounted exhaust vent**

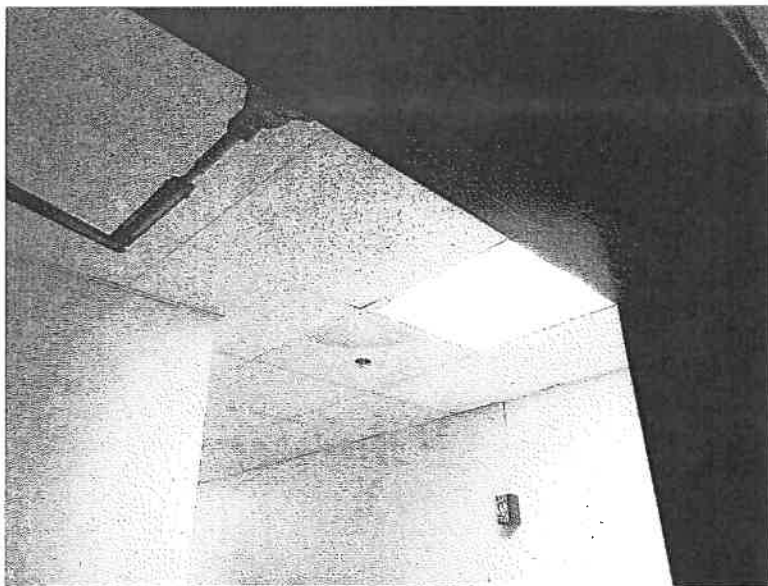
**Picture 3**

Water-damaged ceiling tiles were observed in a few areas (Picture 3; Table 1), which indicate leaks from the building envelope or plumbing system. These tiles should be replaced after the leak is found and repaired. It was reported that a new roof has been installed for the entire building, which has prevented leaks recently in most areas. A single area has still been reported to leak and an investigation to the source of this leak is ongoing.

**Water-damaged ceiling tile**

7. Ensure roof and plumbing leaks are repaired and replace water-damaged ceiling tiles.
8. Repair and maintain classroom sinks including fixing leaks and replacing gaskets to ensure they can be easily shut off. Repair sink backsplashes to seal gaps, or replace with a one-piece unit. Avoid storage of porous materials and large amounts of materials under sinks.

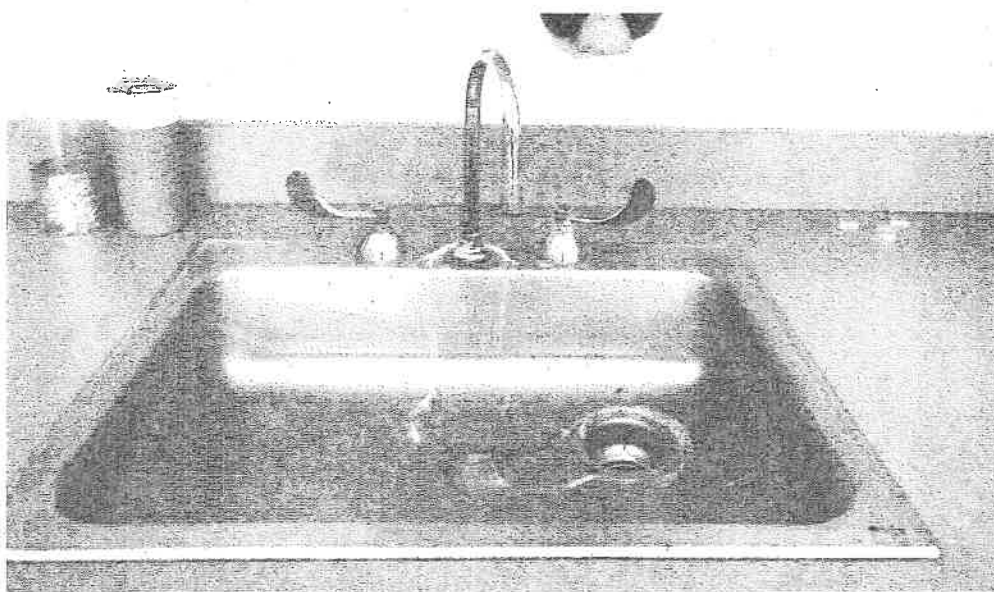
**Picture 4**

Sinks were observed in most classrooms. Many of these sinks were leaking or difficult to turn off, which can be a source of water to moisten building materials (Picture 4). The backsplashes of some of the sinks had a gap which can allow the materials of the sink countertop to become damaged or lead to microbial growth (Picture 5). Some sinks also had porous materials (e.g., paper, boxes), carpeting, or large amounts of materials stored in the cabinets underneath them. Cabinets under sinks are a moist environment and items stored there may become water-damaged or colonized with mold.

**Leaking of sink faucet where it joins the sink basin**

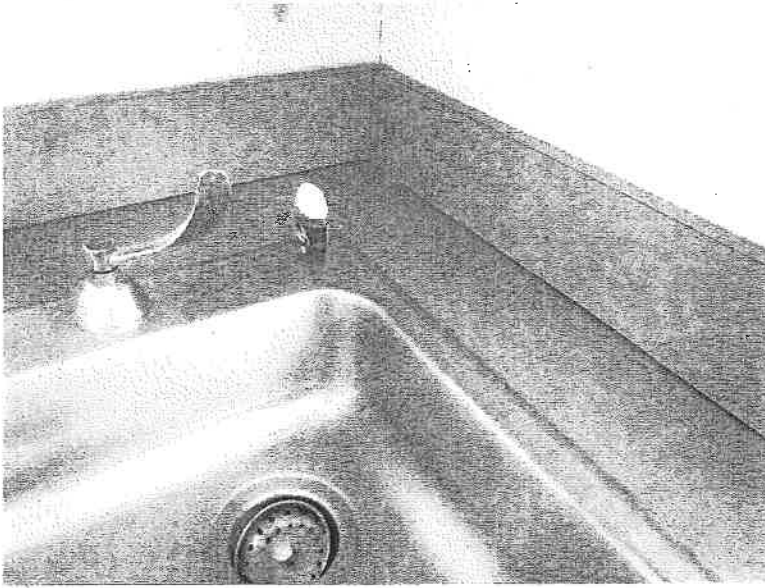
**Picture 5**

**Gap between sink cabinet top and backsplash**

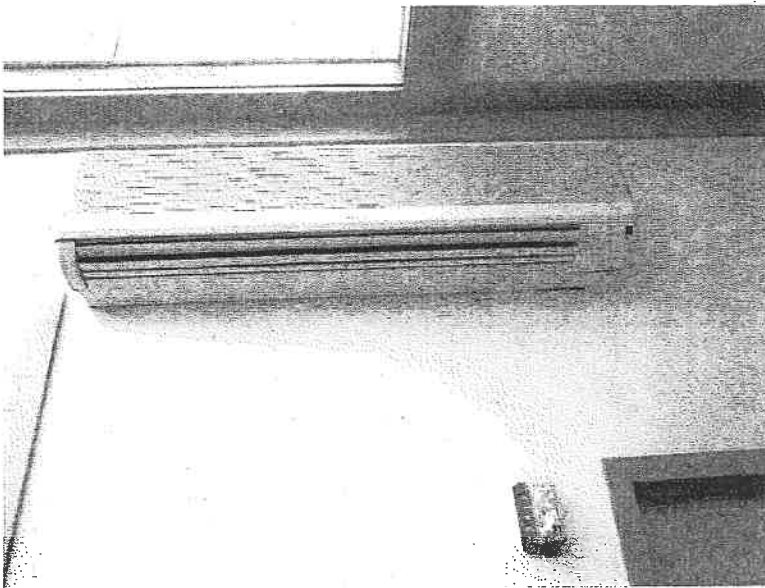
**Picture 6**

The Large Instruction Room was equipped with two ductless air conditioner (AC) units, one of which was on during the visit (Picture 6). A slight musty or sour odor was observed in this room which seemed to be associated with the AC. Ductless AC units produce condensate that needs to be drained. If condensate becomes stagnant, odors can result.

**Ductless AC in the Large Instruction Room**

9. Ensure that ductless AC condensate is draining properly and clean the units in the Large Instruction Room to prevent odors.
10. Keep logs of any chronic odors in other areas including time, weather, and classroom activities to assist in determining the cause. Consider both indoor and outdoor sources when investigating odors.

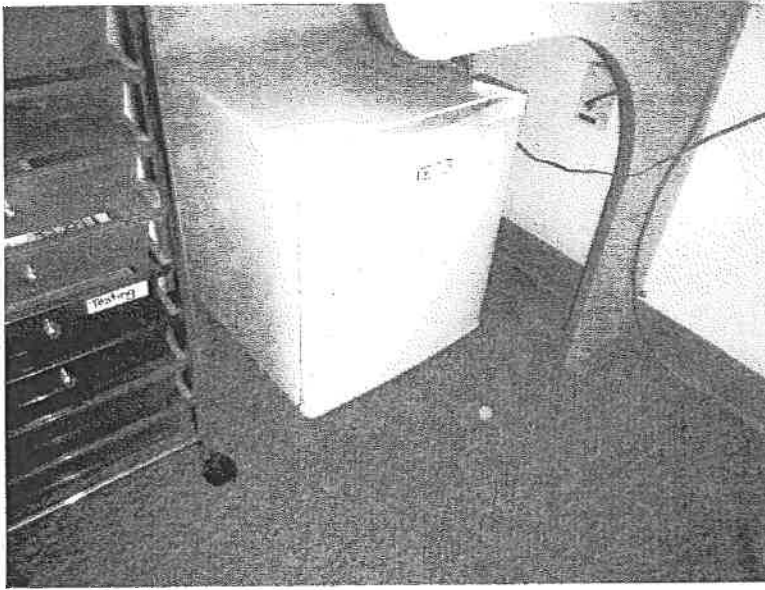
**Picture 7**

Small refrigerators were observed in carpeted areas (Picture 7). Carpeting under refrigerators and water dispensing equipment can become moistened and soiled leading to odors and microbial growth.

**Small refrigerator on carpet**

11. Avoid placing refrigerators and water dispensers on carpet; use a waterproof mat or place the appliances in tiled areas.
12. Properly maintain plants, including drip pans, to prevent water damage to porous materials. Plants should also be located away from air diffusers to prevent the aerosolization of dirt, pollen, and mold.

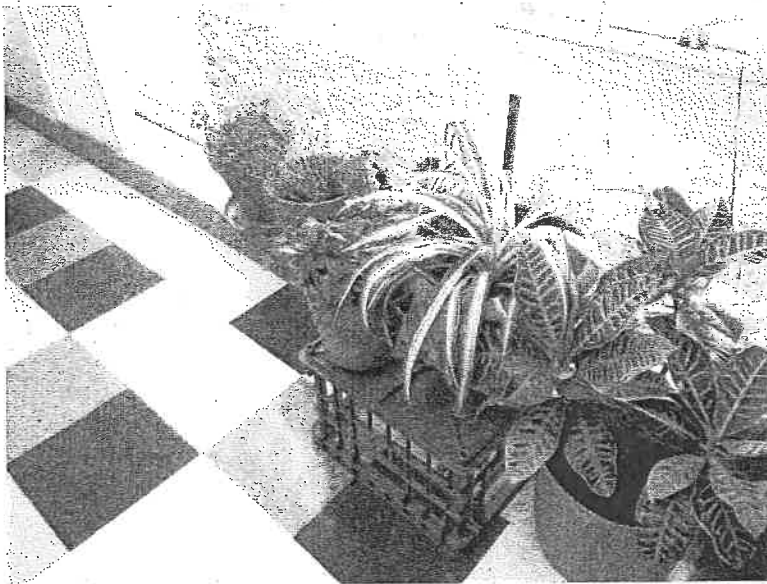
**Picture 8**

Indoor plants were observed in a few areas (Picture 8; Table 1). Plants can be a source of pollen and mold, which can be respiratory irritants to some individuals. Plants should be properly maintained and equipped with drip pans and should be located away from air diffusers to prevent the aerosolization of dirt, pollen and mold.

**Plants**

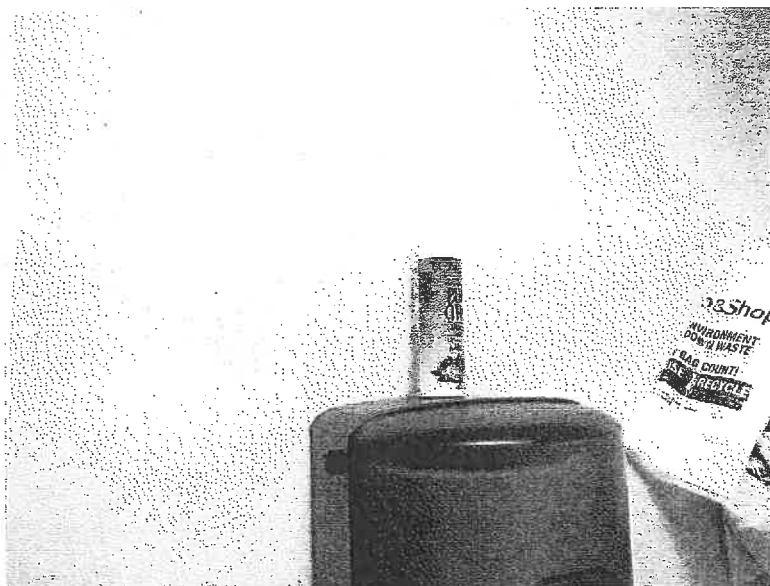
Picture 9

Exposure to low levels of total VOCs (TVOCs) may produce eye, nose, throat, and/or respiratory irritation in some sensitive individuals. To determine if VOCs were present, BEH/IAQ staff examined rooms for products containing VOCs. BEH/IAQ staff noted hand sanitizers, cleaners/spray bottles, air fresheners, and dry erase materials in use within the building (Picture 9 -11; Table 1). All of these products have the potential to be irritants to the eyes, nose, throat, and respiratory system of sensitive individuals. Cleaners were observed to be of different types/manufacturers which may lead to product interactions with irritating or toxic byproducts. Cleaners used in classrooms should be supplied by the school or compatible. Cleaning products should also be clearly labeled and kept out of reach of children.

Air freshener spray

13. Reduce use of products and equipment that create VOCs and only use in well-ventilated areas. Minimize the use of air fresheners, deodorizers and scented products.

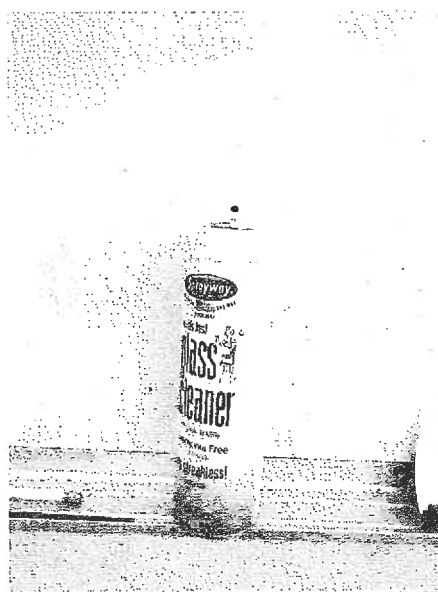
Picture 10

Glass cleaner in a classroom

14. Keep spray bottles/cleaning products out of the reach of children (e.g., in cabinets over sinks). Ensure that products are compatible with one another. It is suggested that only school-supplied products be used to avoid product interactions.

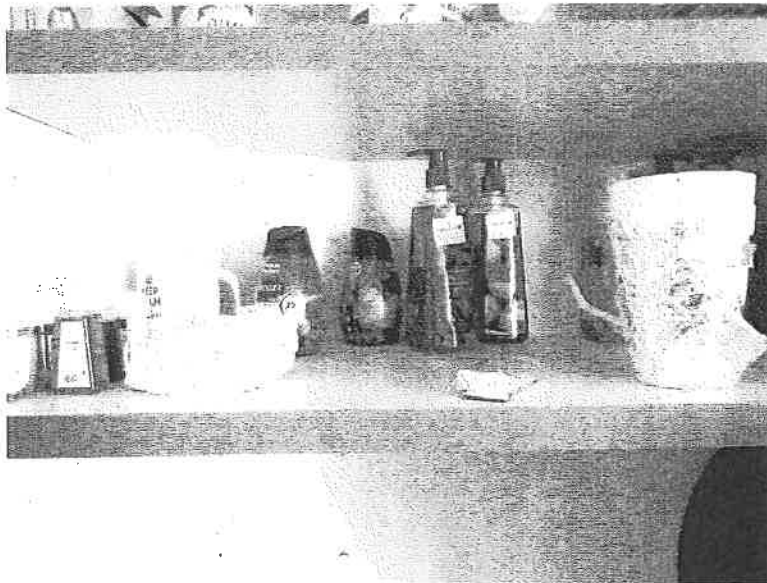
**Picture 11**

**Air fresheners and scented hand sanitizers in classroom**

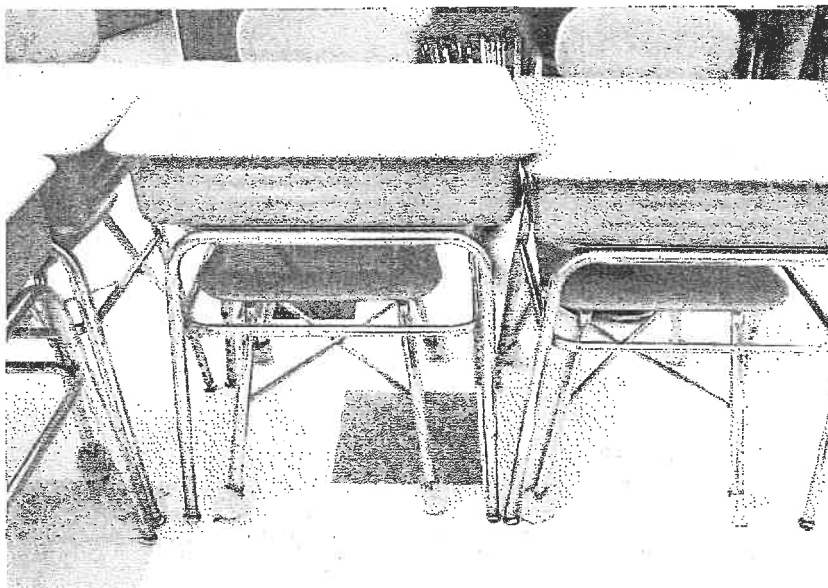
**Picture 12**

In a few areas, tennis balls had been sliced open and placed on chair footings to reduce noise (Picture 12). Tennis balls are made of a number of materials that are a source of respiratory irritants. Constant wearing of tennis balls can produce fibers and lead to off-gassing of VOCs. Tennis balls are made with a natural rubber latex bladder, which becomes abraded when used as a chair leg pad. Use of tennis balls in this manner may introduce latex dust into the school environment. Some individuals are highly allergic to latex (e.g., spina bifida patients) (SBAA, 2001). It is recommended that the use of materials containing latex be limited in buildings to reduce the likelihood of symptoms in sensitive individuals (NIOSH, 1997; NIOSH, 1998).

**Tennis balls as chair glides**

15. Replace tennis balls on chair footings with latex-free glides.
16. Continue to change filters for HVAC equipment 2-4 times a year. The MDPH recommends using pleated filters of Minimum Efficiency Reporting Value (MERV) of 8, which are

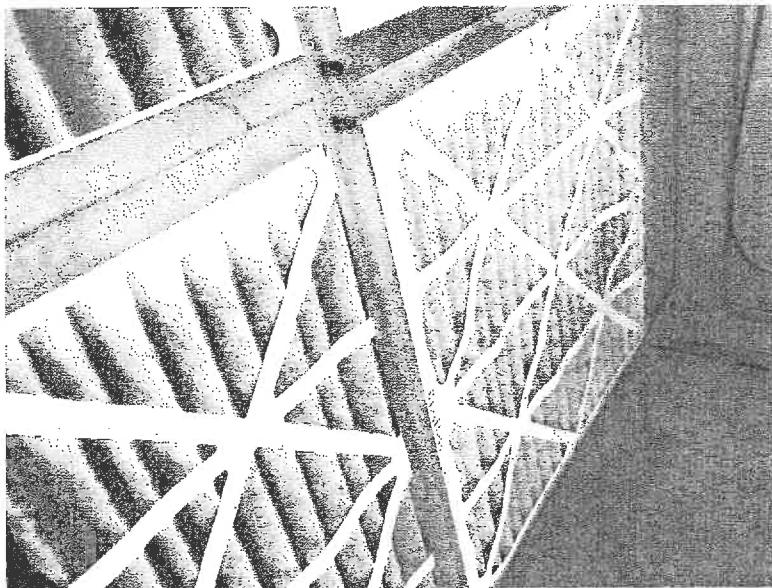
**Picture 13**

The AHUs are equipped with filters, one set of which were examined and found to be of the recommended pleated type and well-fitted into the AHU filter rack (Picture 13). It is recommended that AHUs be outfitted with pleated filters of a Minimum Efficiency Reporting Value (MERV) of 8 or higher, which are adequate in filtering out pollen and mold spores (ASHRAE, 2012). In addition, filters should be changed 2-4 times a year or in accordance with the manufacture's recommendations. It is reported that filters are changed at least twice a year in these units.

**Filters in a rooftop AHU**

adequate in filtering out pollen and mold spores (ASHRAE, 2012), if these can be used with current equipment.

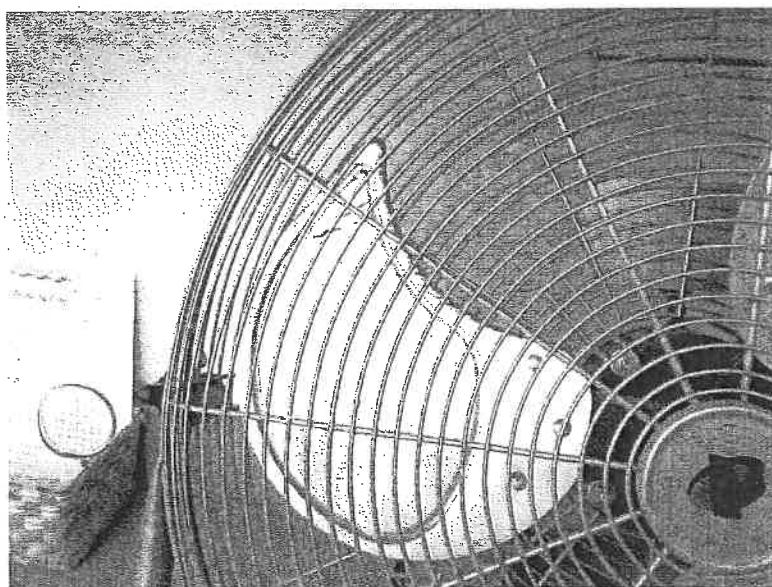
**Picture 14**

Many classrooms had personal fans. Some of these had dusty blades (Picture 14; Table 1). Some supply diffusers, exhaust vents, and window AC units (Picture 15) were also observed to be dusty. This dust can be reaerosolized when the equipment is activated. Note that window AC units also have filters which need to be cleaned periodically in accordance with manufacturers' instructions.

**Dusty fan blade**

17. Regularly clean/vacuum supply/return vents and fans to avoid aerosolizing accumulated particulate matter.
18. Clean window-mounted ACs including filters prior to the start of the cooling season and according to the manufacturer's instructions.

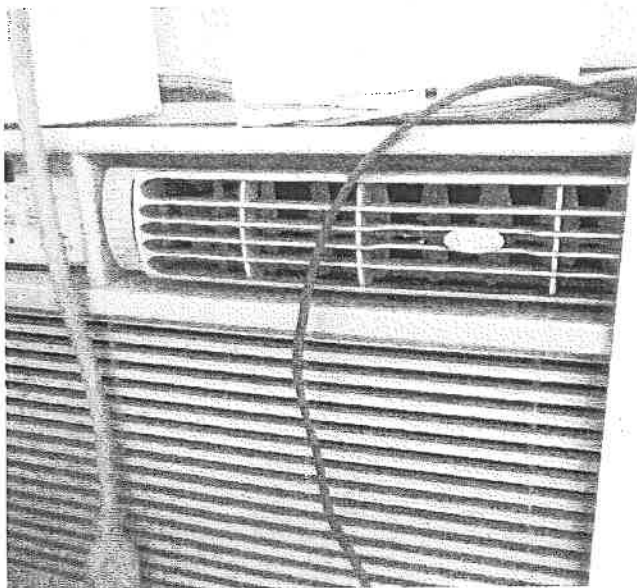
**Picture 15**

**Dusty window air conditioner in classroom**

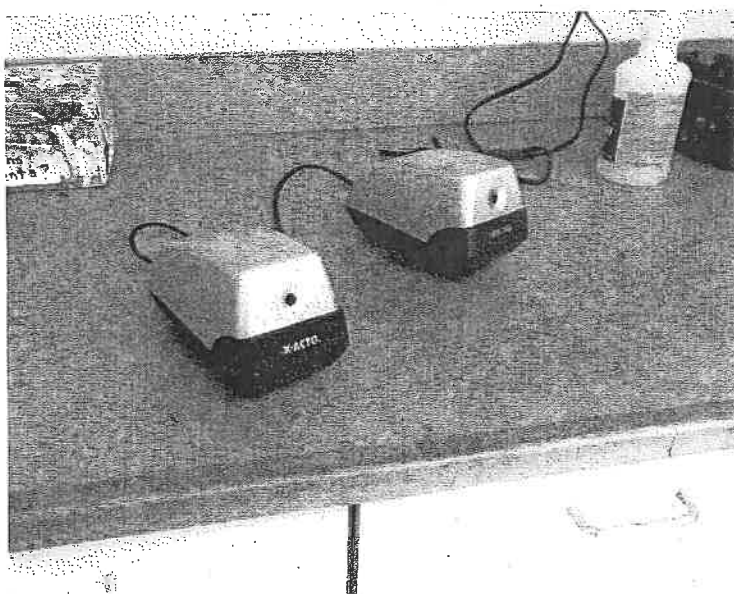
**Picture 16**

Some classrooms have a nook area in the back with an overhang and in many cases the ceiling and walls in this area were dusty. In some areas, items, including books, papers, toys and decorative items were observed on floors, windowsills, tabletops, counters, bookcases, and desks (Table 1), which can make it more difficult for custodial staff to clean. Pencil shavings/markings were observed on some counters (Picture 16); this debris can be a source of irritating dusts.

**Pencil shavings/markings on table**

20. Clean pencil sharpener debris regularly.
21. Clean carpeting annually (or semi-annually in soiled high traffic areas) as per the recommendations of the Institute of Inspection, Cleaning and Restoration Certification (IICRC) including carpeting over heaters. Discard area rugs that are too worn or soiled to be effectively cleaned.

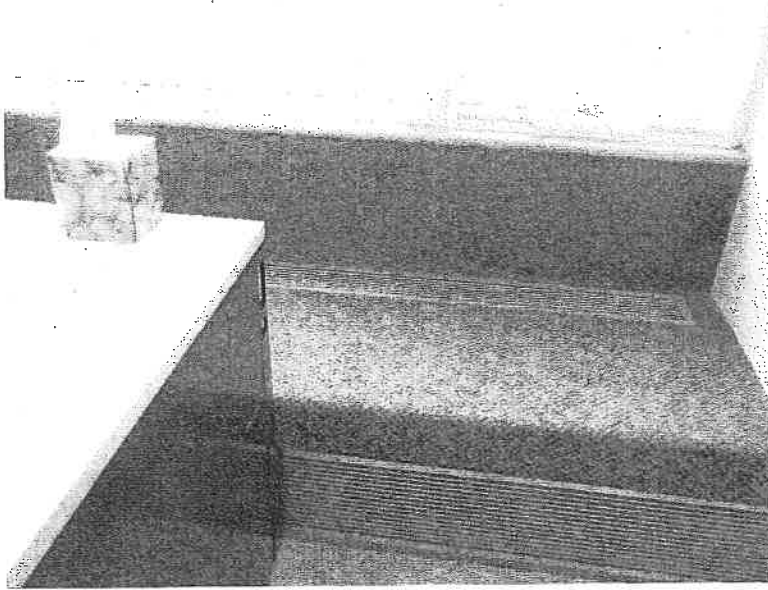
**Picture 17**

Many areas had carpeting. Carpeting should be cleaned annually or semi-annually in soiled high traffic areas as per the recommendations of the Institute of Inspection, Cleaning and Restoration Certification (IICRC, 2012). Carpeting is built in over the heaters in classrooms in some areas (Picture 17); this carpeting should be thoroughly cleaned regularly as it is both a place where students may sit and also will become heated during the winter, which may cause soil or dust in the carpet to produce odors. Many classrooms had area rugs, which should also be cleaned regularly and discarded when too worn out or soiled to be cleaned. Some of the area rugs were found to be frayed (Picture 18) and should be replaced to avoid both a tripping hazard and a source of irritating particles.

**Carpeting/seat over heater**

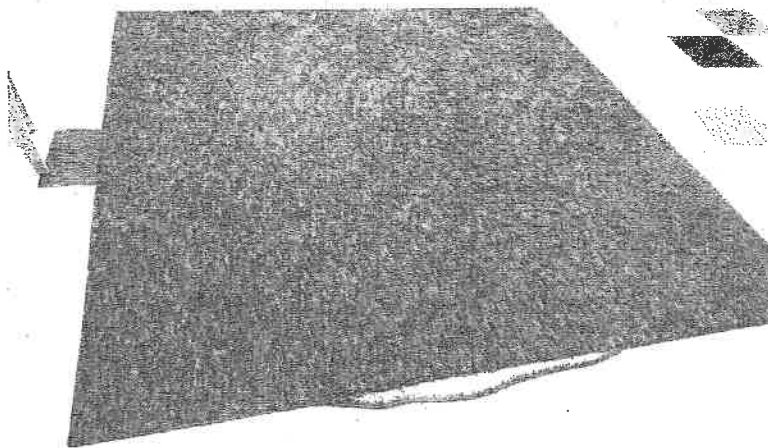
**Picture 18**

**Frayed area rug**
