Microbial Assessment Report

Hobomock Elementary School
81 Learning Lanes
Pembroke, MA 02359

March 19, 2024

RE: Microbial (Mold) Sampling Report for
Hobomock Elementary School
81 Learning Lanes, Pembroke, MA
PMEC Project #24-117

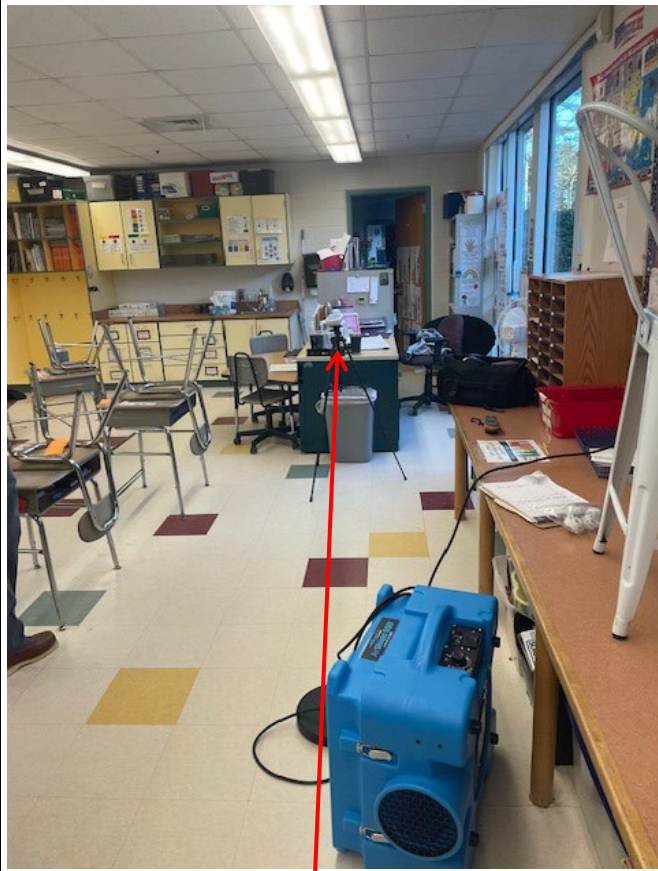
Photo 1: View of typical classroom spore trap air sampling. HEPA filtered fan unit present operated off-hours.

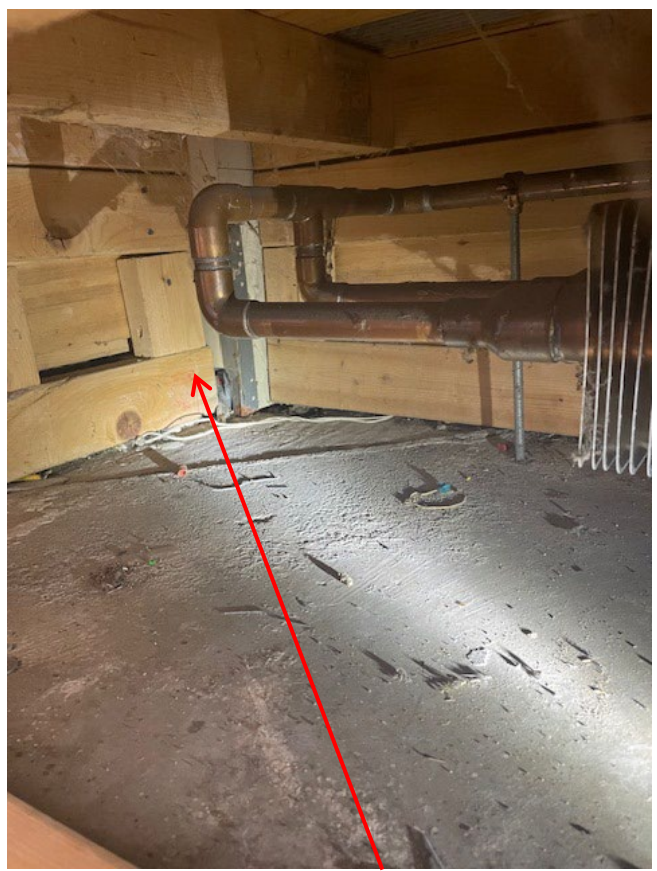
- C. PMEC inspected surfaces within the classroom 240 back left perimeter bench unit. The bare concrete floor slab and wood joist supports were generally dry with no evidence of visible mold and previous water leaks. However, the benchtop wood underside contained suspect mold growth (whitish surface staining). Surface tape lift sampling confirmed the presence of microbial growth (*Aspergillus/penicillium* and *stachybotrys* species).

- Classroom 240 – under bench top – Bare concrete floor measured at 16-20% (slightly damp). Wood supports under the benches were dry at 10-12%. Note: the operating heating system assist in keeping surfaces warm and dry. During the summer and early fall season with the heating system off, surfaces under the benches may contain higher moisture levels resulting in potential condensation and microbial growth.

- Classroom 240 – concrete floor within perimeter wood bench – no microbial growth found.
 - Classroom 240 - Active mold growth present on the underside of the wood bench.

Photo 2: View of Classroom 240 under perimeter bench top at heat piping/radiation unit with bare concrete floor. Wood support joists dry with no visible mold. Suspect mold growth on underside of bench top (not pictured).

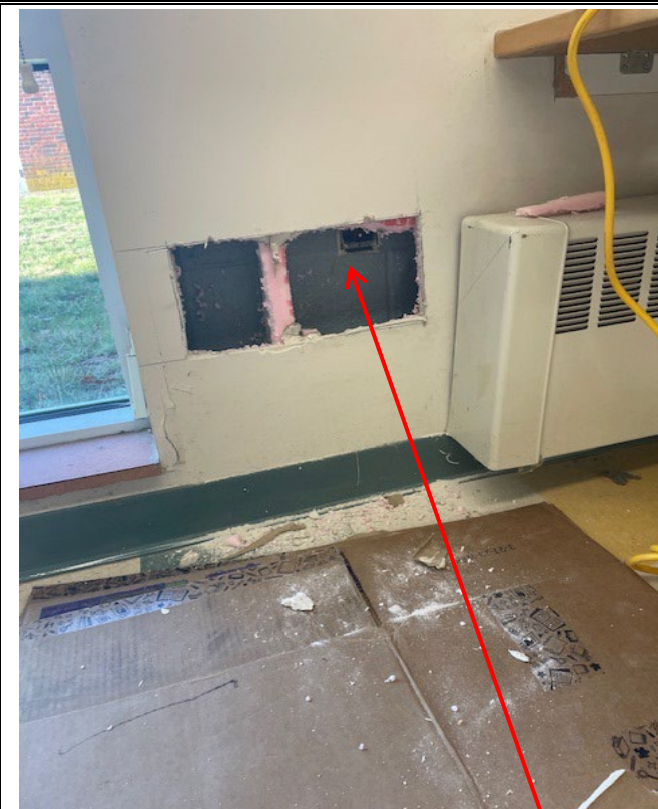
- D. PMEC also inspected representative surfaces within classroom 140. The ceiling plenum spaces were dry with no suspect mold growth. A perimeter wallboard section was opened for interior wall cavity inspection. No suspect mold growth or water damage was identified within the wall cavity. PMEC noted that air infiltrates the wall cavity at air gaps around an electrical outlet at the foundation block wall. Air from the brick veneer passes through the foundation wall into the wall cavity behind the newer sheetrock wallboard. This condition is assumed to be present where wall outlets and other air gaps (prior to the 1999 renovation) exist in the original block walls. Accumulated settled dust within the back left ceiling supply diffuser vent was identified. The settled dust was sampled and found to contain mold (*Cladosporium*).

- Classroom 140 – Inside perimeter wall on interior lower sheetrock wallboard.
 - Classroom 140 – Surface mold found inside metal duct ceiling supply vent.

Photo 3: View of classroom 140 at perimeter wall. No suspect mold growth within wall cavity. Original block wall outlet allows outside air leakage to enter wall cavity.

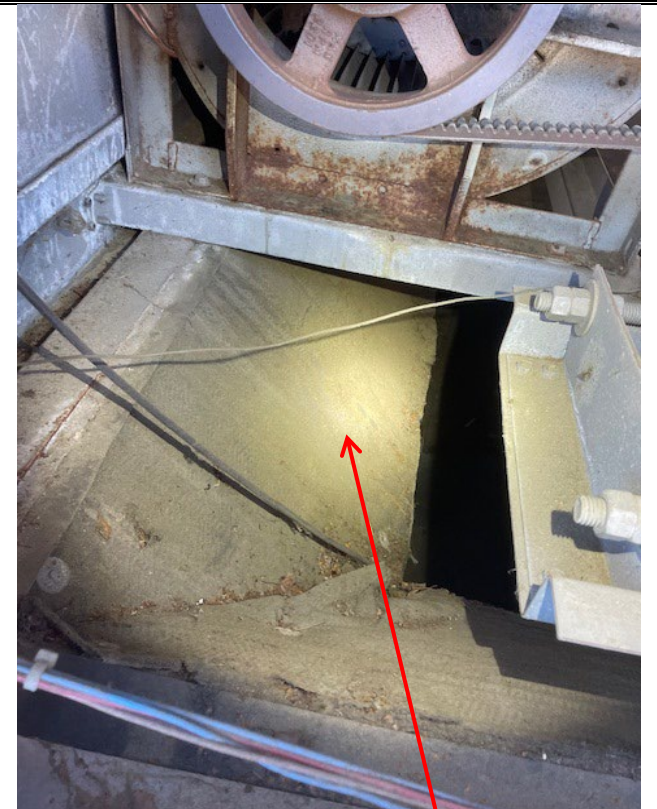
- E. Select roof top units, RTU #7, RTU#1, ACU#1, and RTU#2, were inspected for the presence of mold growth. RTU#2 interior surfaces were cleaned last October and is generally clean with no debris build up. RTU#7, RTU#1 and ACU #1 each contained loose debris, grease/grime buildup, blocked screens, etc. Additionally, duct liners (interior insulation) on supply duct work leading down into the building contained frayed edges, damaged insulation, miscellaneous debris, and suspect mold growth. This condition was present on RTU #1, ACU#1, and a limited quantity on RTU#2. A surface tape list sample in ACU #1 confirmed the presence of mold growth (*Cladosporium*).

| Table 4 - continued Tape Lift (Bio-Tape) Surface Sampling Analysis Results | | | | |
|--|---|---|---|---|
| 07T (#16) | Roof top unit (ACU) #1 Over library – inside on duct insulation liner leading down supply duct | Cladosporium – heavy (yellow discoloration and damaged liner present) | few | Surface mold present on duct liner |

- ACU #1 (roof above library) – Surface mold found on interior supply duct insulation.
(duct liner Insulation worn, frayed, and visibly contaminated)

Photo 4: View of ACU1 servicing library. Accumulated dirt and suspect mold growth on damaged/frayed interior duct liner at vertical supply duct.
