Subject: Remodeling of Horizons K-8 Charter School
Boulder, Colorado
Eidos Project No. 24006

On Wednesday, 04/03/2024, we held a DAT meeting for Horizons K-8 Charter School.

LEVEL 1 FLOOR PLAN

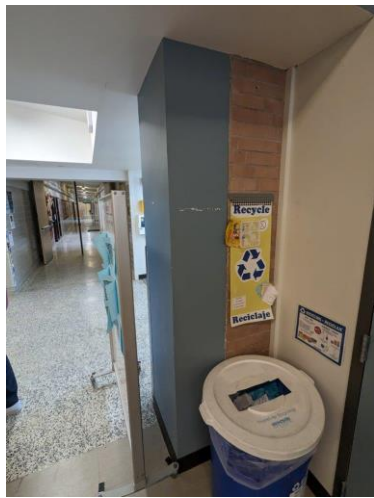
Photo 01 – Carry allowance for misc. paint touch up.

The design team will specify an allowance in the specifications to cover misc. touch ups throughout the building that will be identified in the field with the painter.

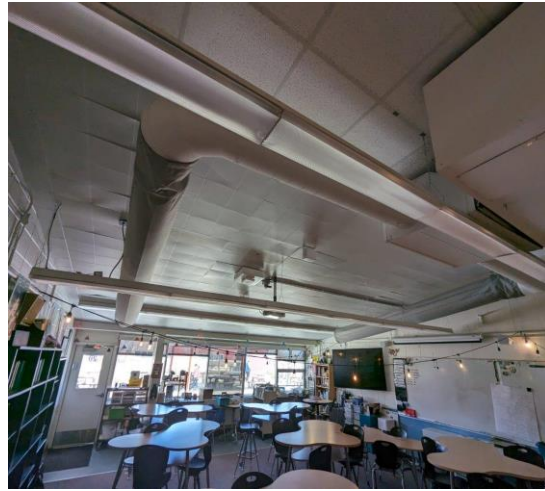
Photo 02 – Classroom Lighting Replacement.

- **Lighting Fixtures:** The team identified the areas of the building in the greatest need for lighting upgrades. There was also some discussion about upgrading lighting in special needs areas that is more appropriate for the spaces.

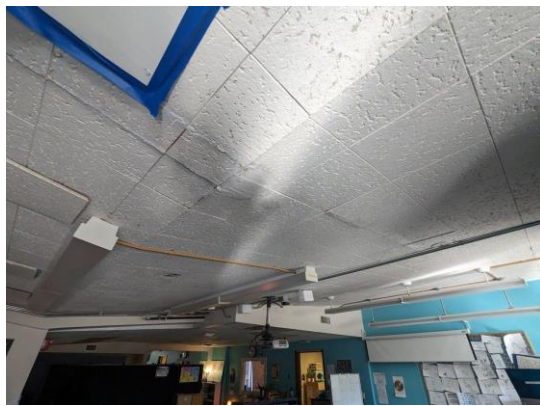
Photo 03 – Damaged Ceiling Tile Replacement.

- **ACT System:** The team discussed the renewal of ceiling systems. It was noted that the main North South corridor has some stained and delaminating tiles. The school will talk internally to establish any additional areas that would be prioritized. There were several stained tiles outside of the gymnasium that may be replaced with attic stock once any required roof repairs have been completed.

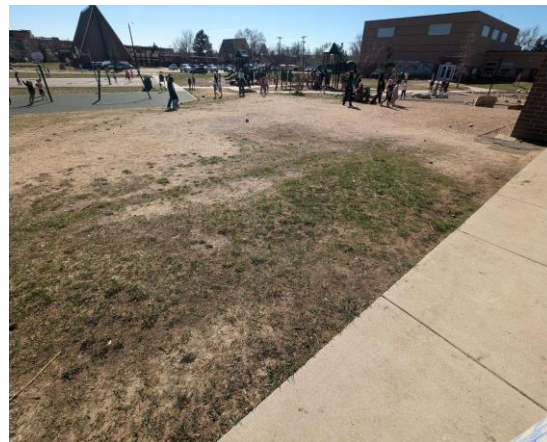
Photo 04 – Install sidewalk from classrooms to play area.

- **Parking Lot-Asphalt Deterioration:** The team discussed the area outside of the main entrance to target for repairs. There was also a discussion/request to add a sidewalk out in the play area to connect the north wing to the other sidewalks (see attachment).

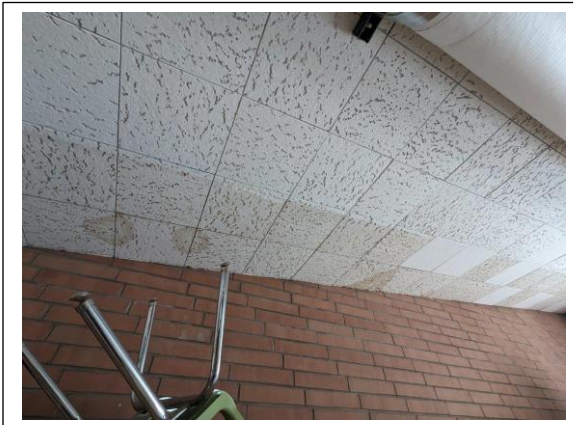
Photo 07 – Stained ceiling tile replacement.

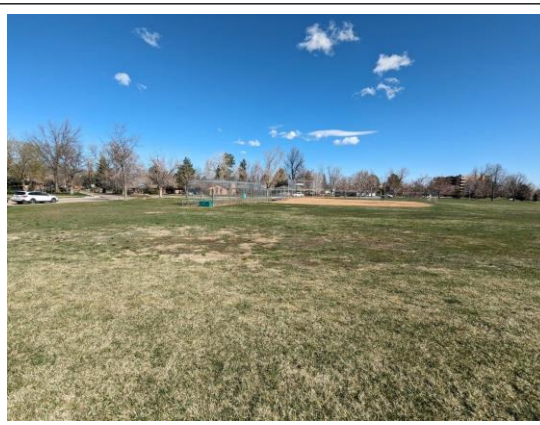
Photo 08 – Turf repair.

- **Playing Field:** The scope will be limited to aerate, top dress, and overseed of the existing field. The remaining funds in the budget will be allocated to other scopes (painting).

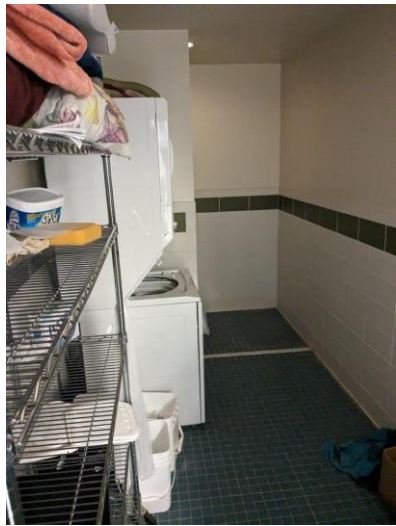
Photo 09 – Upgrade to gender neutral toilet room.

- **Gender Neutral Bathroom:** The team discussed converting the existing shower/laundry space into a gender neutral toilet facility while maintaining the shower and laundry. We discussed potentially moving the washer/dryer to the mechanical room in order to provide the floorspace for the toilet and lavatory fixtures (if required to meet clearance requirements)
- **Mouse Infestation:** The 1961 (west classroom wing) building has an mouse infestation (approximately 40 caught this winter). Design will investigate potential points of entry and try to close them.

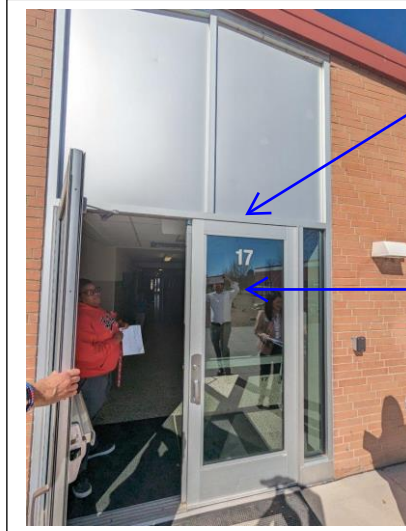
Note for Facilities: Right door was missing weatherstripping and several holes in door may be allowing water entry (some from above).

Photo 10 – Water infiltration at exterior doors.

- **Misc. Roof Leaks:** Gene is going to hire a 3rd party consultant to do an evaluation of the existing roof to allocate the dollars to the highest priority needs. The team did discuss water infiltration at a door in the main North-South corridor that occurred during the recent storm.

Note for Facilities: Recommend installing sealant at the base of the transite panel as it appears water is infiltrating into the frame and leaking in.

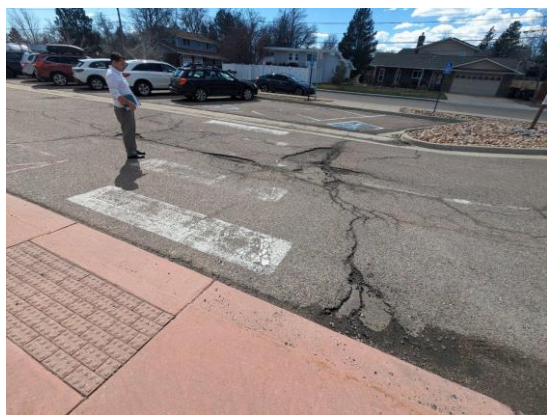
Photo 11 – Repair asphalt by main entry

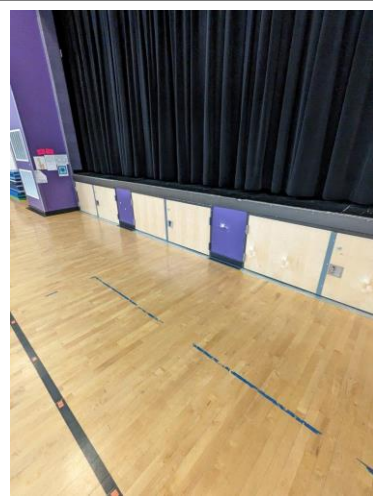
Photo 12 – Patch and paint accents below the stage.

- **Security:** Gener will review/investigate this with HSS directly outside of the Bond scope/budget.
- **Painting:** The team discussed re-painting the existing facility. It was decided to prioritize the scopes as follows and to complete as much as the budget will allow:
 - **Priority 1:** Corridors and public areas. Note: Design will identify cracks for repair and install of control joints at gyp bd., caulk/seal and paint at transite panels. Will focus on paint above the glazed block and include exposed pipes at part of the scope.
 - **Priority 2:** Main office. Focus on student/public facing areas.
 - **Priority 3:** Gymnasium: We discussed painting the bottom 10' of the light field color as well as below the stage.
