# Solano K-8 School

## Solano K-8 School - Background information

## Solano K-8 School - Existing Conditions Summary

# Solano K-8 School - Facilities Needs Spreadsheet

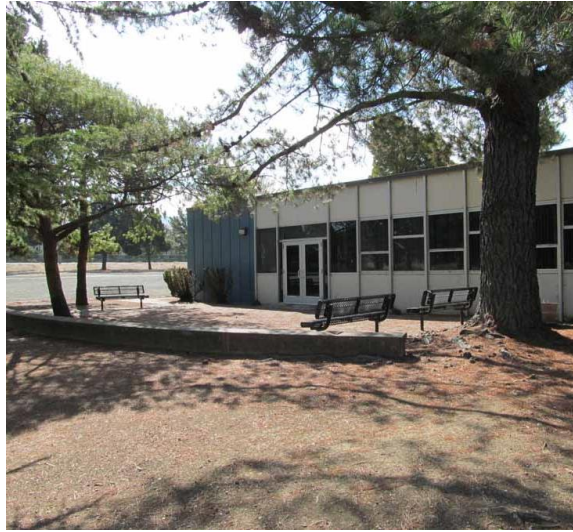
CODE	DISCIPLINE	LOCATION		DESCRIPTION	SITE PLAN KEY	PHOTO	ESTIMATED TAKE OFF		COST/ UNIT	TOTAL COST
							Qty.	Unit		
SITE ISSUES										
CFN	Site Utilities	Site	Deficiency	Site utilities are nearing the end of their useful life			1	ls	\$ 950,000.00	\$ 950,000.00
			Remedy	Replace underground utility lines						
CFN	Fencing	Site	Deficiency	Fencing			Completed 2016			\$ -
			Remedy							
CFN	Structural	Campus-wide	Deficiency	Structural Upgrades			1	ls	\$ 4,500,000.00	\$ 4,500,000.00
			Remedy							
CFN	Electrical	Campus-wide	Deficiency	Electrical/Security Systems			1	ls	\$ 1,980,231.00	\$ 1,980,231.00
			Remedy							
CFN	Accessibility Issue	Site	Deficiency	Landing at Door/Ramp exceeds 2% Slope at 4 locations throughout site.	1		200	sf	\$ 40.00	\$ 8,000.00
			Remedy	Saw cut, remove and replace Landings. Estimated 50 sf ea landing						
CFN	Accessibility Issue	Site	Deficiency	Non-compliant Door threshold at 25 locations throughout site.	2		625	sf	\$ 40.00	\$ 25,000.00

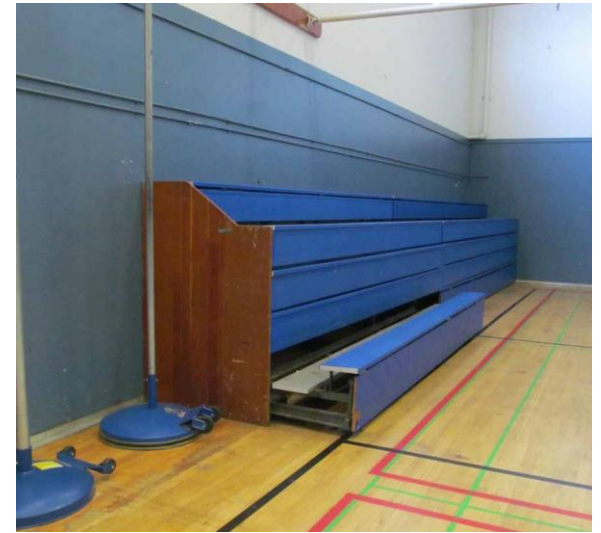
9

Remedy	Corridor will need to be widened						
EPN	Site	Gym	Deficiency	Needs new bleachers.		09	1	ls	\$ 200,000.00	\$ 200,000.00
			Remedy	Provide new bleachers.						
EPN	Walls & Finishes	Gym	Deficiency	Acoustical treatment lacking.		11	Cost included in Acoustical Treatment cost		\$	-
			Remedy	Provide acoustical treatment at walls from ± 8'-0" AFF to structure at ± 11'-0". Provide acoustical treatment below roof deck.						
EPN	Ceiling	Gym	Deficiency	Spray on fireproofing at structure is extremely unattractive.		11	1	ls	\$ 46,500.00	\$ 46,500.00
			Remedy	Hide via ceiling element at underside of beams.						
EPN	Flooring	Gym	Deficiency	Wood flooring has some damaged areas.			1	ls	\$ 18,000.00	\$ 18,000.00
			Remedy	Repair damage, refinish and stripe existing wood flooring.						
EPN	Flooring, Wall Finish	Weight Room	Deficiency	Flooring and wall finishes are damaged.			Cost included in Flooring cost		\$	-

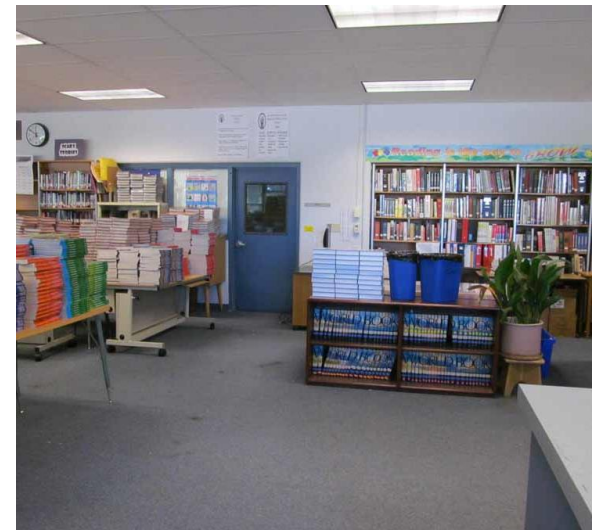
CODE	DISCIPLINE	LOCATION	DESCRIPTION		SITE PLAN KEY	PHOTO	ESTIMATED TAKE OFF		COST/ UNIT	TOTAL COST
							Qty.	Unit		
EPN	Flooring	Library	Deficiency	Flooring (carpet) old/worn.		12	2000	sf	\$ 7.50	\$ 15,000.00
			Remedy	Replace						
EPN	Flooring	Snack Bar	Deficiency	Epoxy flooring damaged where bollards were removed.			1	ls	\$ 1,500.00	\$ 1,500.00
			Remedy	Patch						
ADMINISTRATION/SNACK BAR										
EPN	Ceiling	Admin/Snack Bar/ Music Room	Deficiency	Admin corridor ceiling: adhesive applied acoustical tile - dark.			4200	sf	\$ 3.40	\$ 14,280.00
			Remedy	Remove adhesive applied tile - paint fire rated gyp board ceiling. Provide acoustical treatment at walls.						
GYMNASIUM										
CFN	Window Coverings	Gym	Deficiency	Window coverings lacking.		11	86097	sf	\$ 0.88	\$ 75,765.36
			Remedy	Provide window coverings and controls for high windows.						
CFN	Accessibility	Corridor	Deficiency	Passage way and door to weight room is not accessible.			1	ea	\$ 2,500.00	\$ 2,500.00

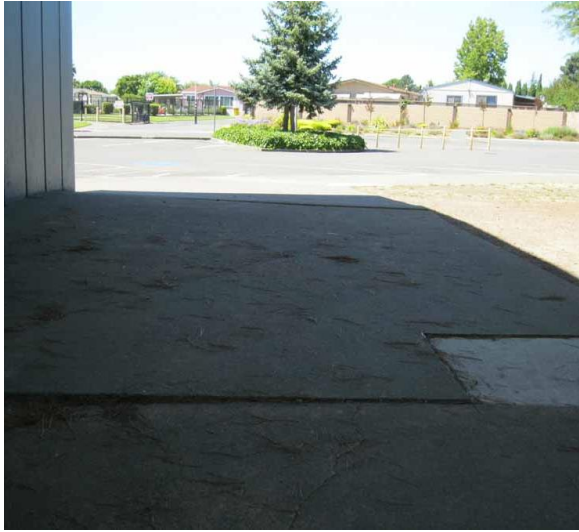
CODE	DISCIPLINE	LOCATION	DESCRIPTION		SITE PLAN KEY	PHOTO	ESTIMATED TAKE OFF		COST/ UNIT	TOTAL COST
							Qty.	Unit		
CFN	Accessibility Issue	Site	Deficiency	Pavement markings faded.	14	17	2	ea	\$ 450.00	\$ 900.00
			Remedy	Restripe as part of pavement slurry item						
CFN	Accessibility Issue	Site	Deficiency	No Accessible route of travel.	16		1	ea	\$ 2,500.00	\$ 2,500.00
			Remedy	Provide code compliant accessible route as required to this area.						
CFN	Accessibility Issue	Site	Deficiency	Accessible drinking fountain not provided	17		86097	sf	\$ 0.30	\$ 25,829.10
			Remedy	Provide code compliant approved drinking fountain.						
CFN	Accessibility Issue	Site	Deficiency	Non compliant storm drain grate	18		1	ea	\$ 85.00	\$ 85.00
			Remedy	Provide lock down storm drain grates with 1/2" maximum openings.						
CFN	Accessibility Issue	Site	Deficiency	No Accessible route to public right of way	19		1	ea	\$ 2,500.00	\$ 2,500.00

Remedy	Provide code compliant accessible route to public right of way.						
CFN	Accessibility Issue	Site	Deficiency	No Accessible drop off area provided	20		1	ea	\$ 75,000.00	\$ 75,000.00
			Remedy							
CFN	Accessibility Issue	Site	Deficiency	Non compliant/missing accessible signage at parking lot entry	21		Cost included in Signage cost			\$ -
			Remedy	Provide code compliant signage						
CFN	Fire & Life Safety	Site	Deficiency	Inadequate fire protection	25		Cost included in Site Utilities			\$ -
			Remedy	Provide additional fire hydrants on site.						
CFN	Accessibility Issue	Site	Deficiency	Non-compliant ramp to portable building.	28		1	ea	\$ 2,500.00	\$ 2,500.00
			Remedy	Reconstruct ramp per code requirements						
CFN	Accessibility Issue	Site	Deficiency	Non-compliant ramp to portable building - railings failing.	30		1	ea	\$ 2,500.00	\$ 2,500.00
			Remedy	Reconstruct ramp per code requirements
