Vallejo High School

Vallejo High School Main Campus - Existing Conditions Summary

Vallejo High School - Master Plan Summary

Vallejo High School - Facilities Needs Spreadsheet

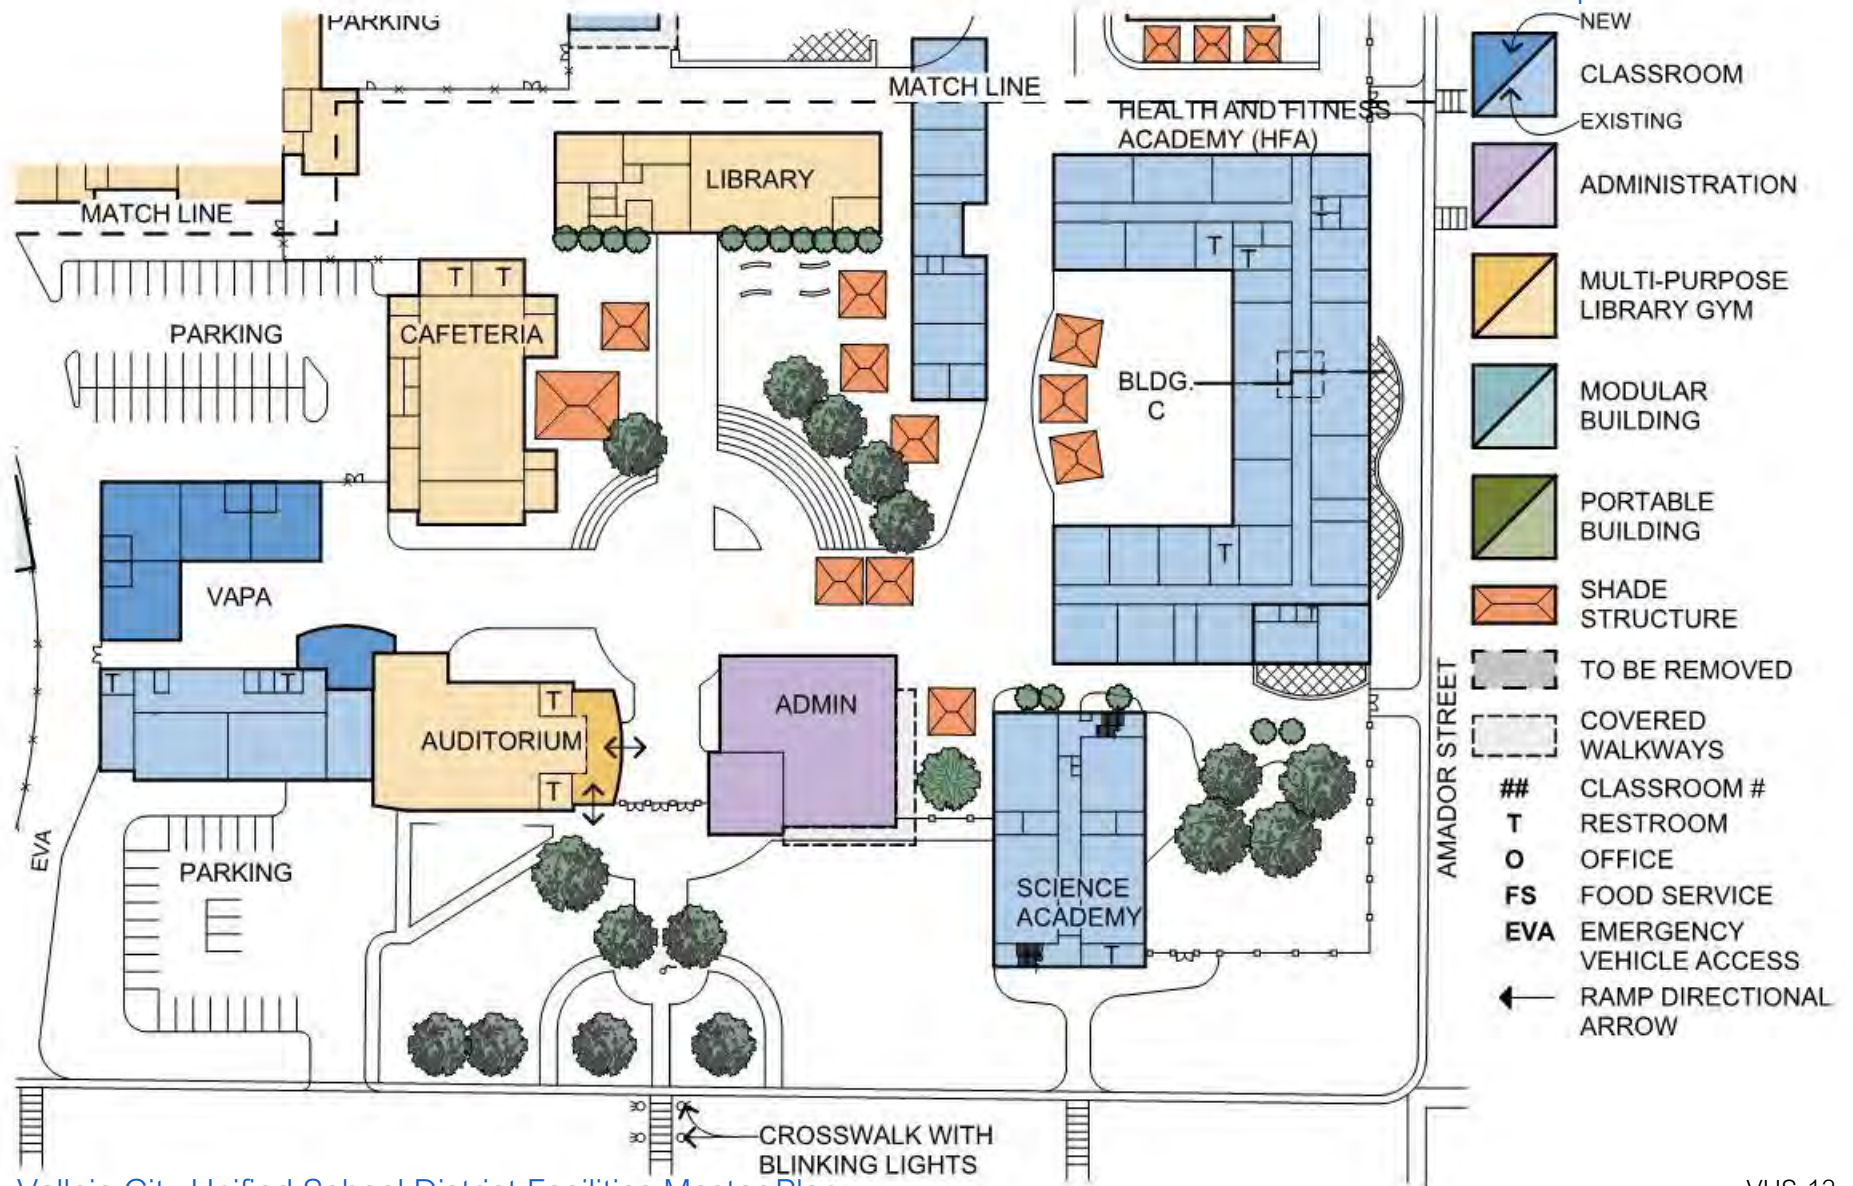
Main Campus Conceptual Plan South

- Create independent spaces for the 5 Academies: Visual and Performing Arts, Hospitality, Engineering, Biotechnology and 9th Grade
- Improvements to campus safety and access control
- Remove portable classrooms and replace with permanent classrooms as necessary
- Construct new Administration building and campus entry

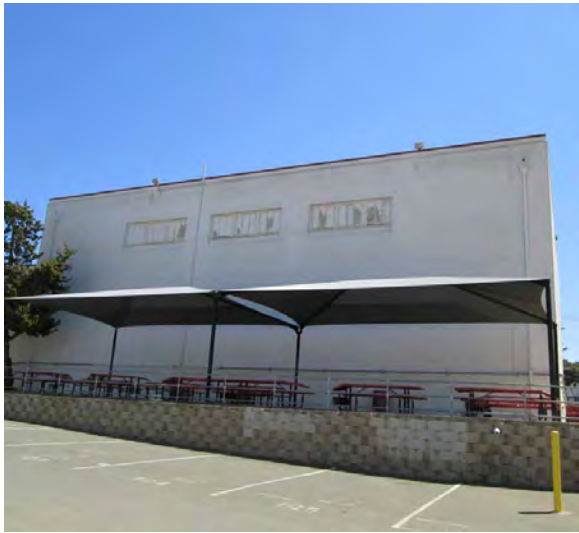
CODE	DISCIPLINE	LOCATION		DESCRIPTION	SITE PLAN KEY	PHOTO	ESTIMATED TAKE OFF		COST/ UNIT	TOTAL COST
							Qty.	Unit		
SITE ISSUES										
CFN	Site Utilities	Site	Deficiency	Site utilities are nearing the end of their useful life			1	ls	\$ 950,000.00	\$ 617,500.00
			Remedy	Replace underground utility lines						
CFN	Electrical	Campus-wide	Deficiency	Electrical System/Security			1	ls	\$ 5,593,853.00	\$ 3,636,004.45
			Remedy							
EPN	Structural	Campus-wide	Deficiency	Structural Upgrades			1	ls	\$ 4,500,000.00	\$ 4,500,000.00
			Remedy							
EPN	Paving & Grading	Site	Deficiency	Roadway Reconfiguration			1	ls	\$ 1,200,000.00	\$ 780,000.00
			Remedy							
EPN	Site	Campus-wide	Deficiency	Parking Lots			1	ls	\$ 2,250,000.00	\$ 1,462,500.00
			Remedy							
SITE ISSUES MAIN CAMPUS										
CFN	Accessibility Issue	Site	Deficiency	Landing at Door/Ramp exceeds 2% Slope at 25 locations throughout site.	1	27 30	625	sf	\$ 40.00	\$ 25,000.00

Remedy	Saw cut, remove and replace Landings. Estimated 25 sf ea landing						
CFN	Accessibility Issue	Site	Deficiency	Non-compliant Door threshold at 13 locations throughout site.	2		650	sf	\$ 40.00	\$ 26,000.00
			Remedy	Remove and replace with compliant threshold.						
CFN	Accessibility Issue	Site	Deficiency	Cross slope on path of travel exceeds 2% at 13 locations throughout site.	4	28	1300	sf	\$ 40.00	\$ 52,000.00
			Remedy	Remove and replace section of walkway that is non compliant. Estimate of 100 sf ea occurrence.						
CFN	Accessibility Issue	Site	Deficiency	Slopes on path of travel > 5% without handrails at 5 locations.	5		450	sf	\$ 40.00	\$ 18,000.00
			Remedy	Remove and replace ramp with slopes < 5% or provide handrails for ramp as required path of travel.						
CFN	Accessibility Issue	Site	Deficiency	Slopes on path of travel > 8.33% at 12 locations.	6	30	600	sf	\$ 40.00	\$ 24,000.00
