Hogan Middle School - Background information

Hogan Middle School - Existing Conditions Summary

Vallejo City Unified School District Facilities Master Plan

Hogan Middle School - Photographs

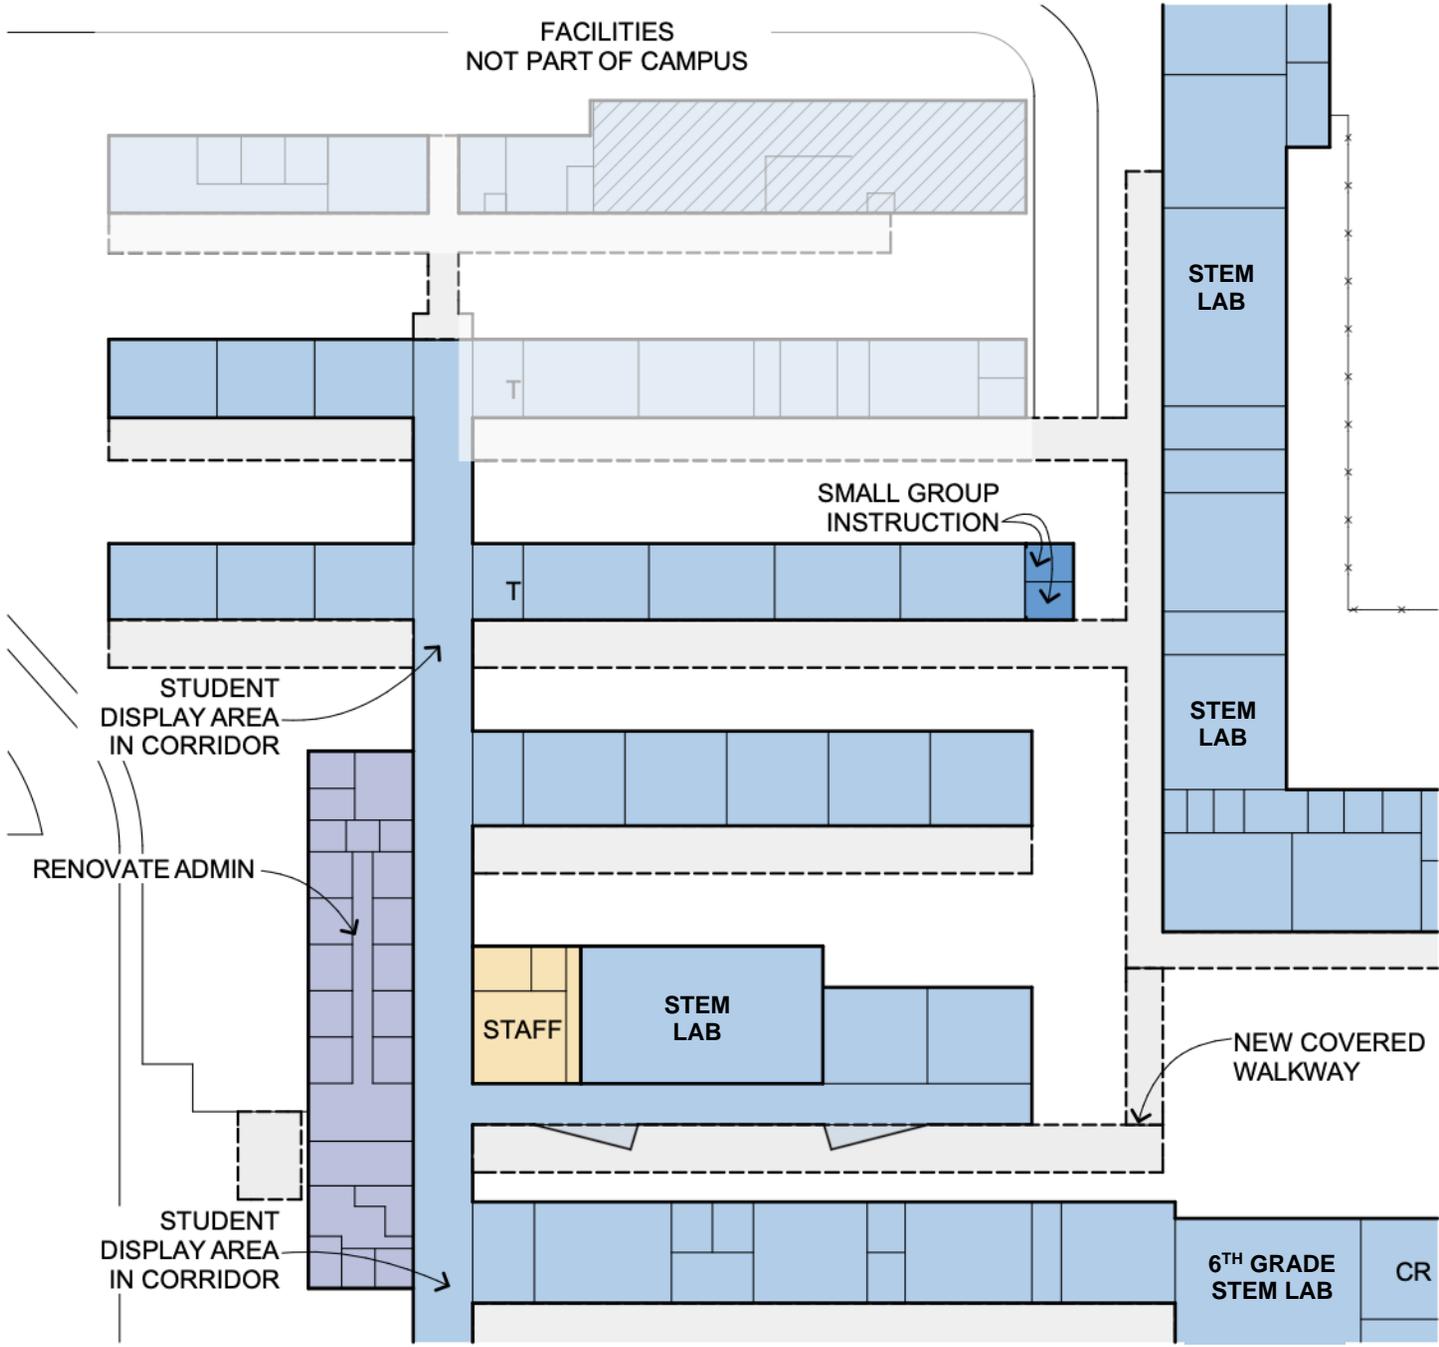
Conceptual Plan - Central Campus

- Create separate area of campus for 6th Grade students to ease transition to Middle School
- Replace Portable Classrooms with new 6th Grade Classroom Building
- Renovate existing small Gym into new Library and Classrooms
- Create outdoor learning environments

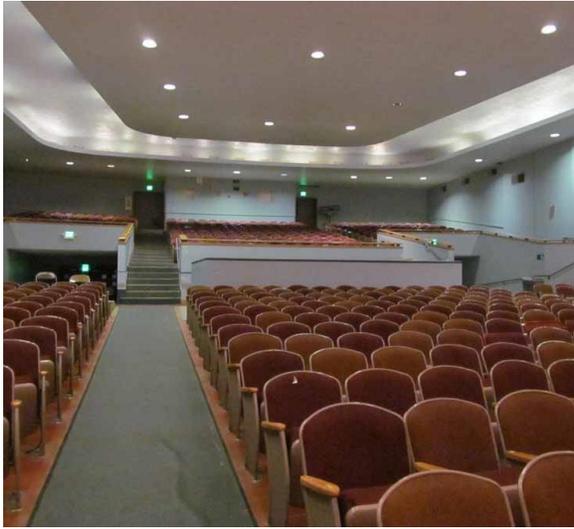
CFN	Accessibility Issue	Site	Deficiency No Accessible route to this area. Remedy Provide code compliant accessible route as required.	16	18	2	ea	\$ 2,500.00	\$ 5,000.00
