Vallejo Charter School
2833 Tennessee

Vallejo Charter School - Background information

Vallejo Charter School - Existing Conditions Summary

Vallejo City Unified School District Facilities Master Plan

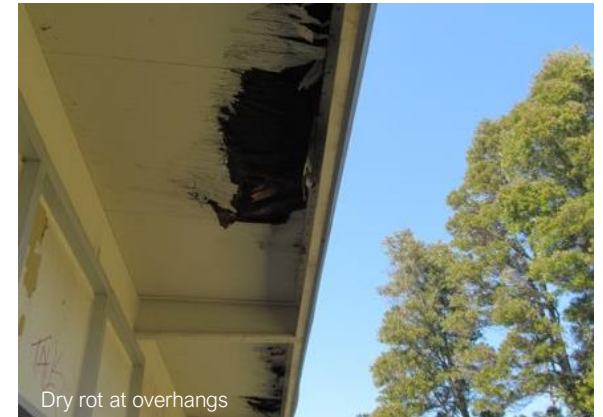
- Address accessibility issues throughout campus including ramps in corridors and classrooms doors in two story building
- Corridor walls damaged and need repair and painting
- Most classrooms lack adequate sun control
- Metal lockers in corridor are damaged
- Exterior is dirty and marred
- Athletic areas, locker rooms, offices and support areas need complete modernization.
- Kitchen requires complete modernization
- Provide code compliant signage throughout campus
- Band room fabric wall surface dirty and damaged and needs replacing
- Exterior needs painting
- Modular classrooms have damaged stucco and dry rot in overhangs

Dry rot at overhangs

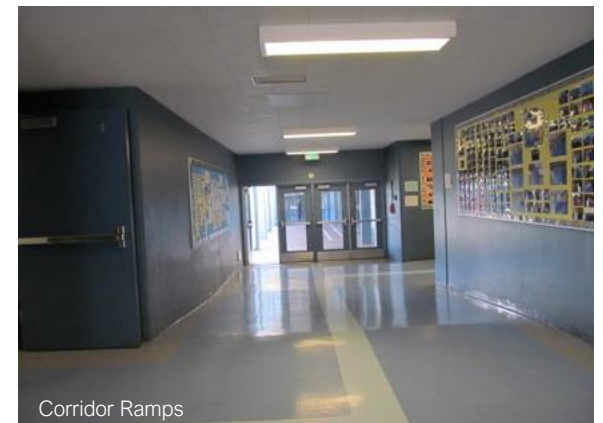
Corridor Ramps

- Address accessibility issues throughout campus
- Ramps in corridors are not accessible
- Classrooms doors in two story building set in alcoves, not accessible
- Provide code compliant signage throughout campus
- Modular classrooms have damaged stucco and dry rot in overhangs (Modulars are not currently used by school)
- Separate play field from street with trees
- Provide lighting at parking
- Stoplight/crosswalk with flashing lights on Tennessee
- Full modernization of kitchen
- Kindergarten restrooms
- Small presentation areas
- Shaded areas at P.F. and playground

Accessibility	Provide code compliant interior and exterior ramps. Upgrade drinking fountains, restrooms and other features to meet accessibility code requirements. Provide accessible identification signage. Relocate lockers to create compliant landings and side clearance at classroom doors.

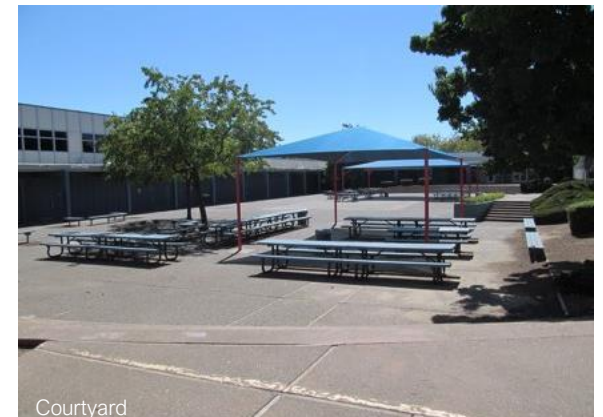
- Courtyard can be developed into a more usable and inviting space

Courtyard

FFN	Additional Needs	Courtyards	Deficiency	Courtyard area under used. Requires minor renovation and accessible ramp.			1	ls	\$ 250,000.00	\$ 250,000.00
FFN	Additional Needs	Courtyards	Remedy	Construct ramp to presentation area.						
									CFN Total	\$ 2,372,520.00
									EPN Total	\$ 3,628,554.96
									FFN Total	\$ 414,028.00
									TOTAL COSTS (not including	\$ 6,415,102.96

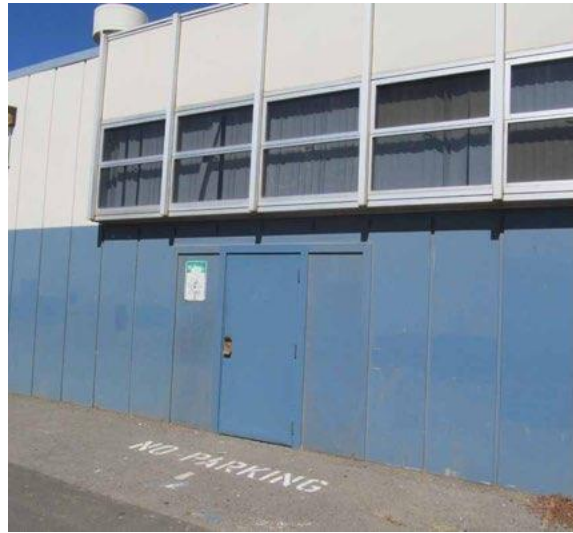
8
11

Remedy	Provide exterior sun shades						
FFN	Exterior Envelope	Campus-wide	Deficiency	Exterior of buildings are dirty, marred and have peeling paint.		08	41264	sf	\$ 1.00	\$ 41,264.00
			Remedy	Prep and paint all buildings.						
FFN	Walls & Finishes	Campus-wide	Deficiency	Interior walls are marred and show some damage.		01	41264	sf	\$ 1.00	\$ 41,264.00
			Remedy	Repair minor damage and paint.		02 03				
FFN	Flooring	Library	Deficiency	Carpet in library at end of useful life.			2000	sf	\$ 7.50	\$ 15,000.00
			Remedy	Replace carpet.						
FFN	Walls & Finishes	Bandroom/ Clsm26	Deficiency	Bandroom, classroom 26, acoustical wall panels are dirty and damaged.		06 07	1	ls	\$ 6,500.00	\$ 6,500.00
			Remedy	Replace all acoustical wall panels.

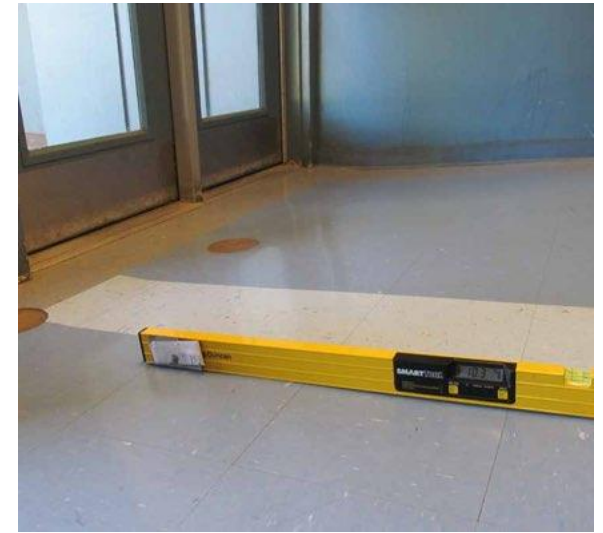
9

GENERAL & CAMPUS-WIDE ISSUES										
CFN	Accessibility Issue	Child Care	Deficiency	Scope of ramps in child care corridor exceeds max allowance scope per code.		09	1	ls	\$ 12,500.00	\$ 12,500.00
			Remedy	Demo concrete ramps and slab and construct ramps per code						
CFN	Accessibility Issue	Main Corridor	Deficiency	Ramps at doors in main corridor do not provide required landing at doors.		04 09	100	sf	\$ 40.00	\$ 4,000.00
			Remedy	Demolish ramps and slab and construct ramps per code (two locations).						
CFN	Accessibility Issue	Classrooms	Deficiency	Doors to classrooms are in alcove and do not have required landing.		03	1	ls	\$ 10,850.00	\$ 10,850.00
			Remedy	Relocate lockers and demolish wing walls.						
CFN	Accessibility Issue	Campus-wide	Deficiency	Campus lacks code compliant signage.			82070	sf	\$ 0.50	\$ 41,035.00
			Remedy	Provide code compliant signature.						
CFN	Mechanical	Campus-wide	Deficiency	Mechanical units at end of useful life.			1	ls	\$ 495,168.00	\$ 495,168.00
