Jesse Bethel High School

1800 Ascot Parkway

Jesse Bethel High School - Existing Conditions Summary

Jesse Bethel High School - Facilities Needs Spreadsheet

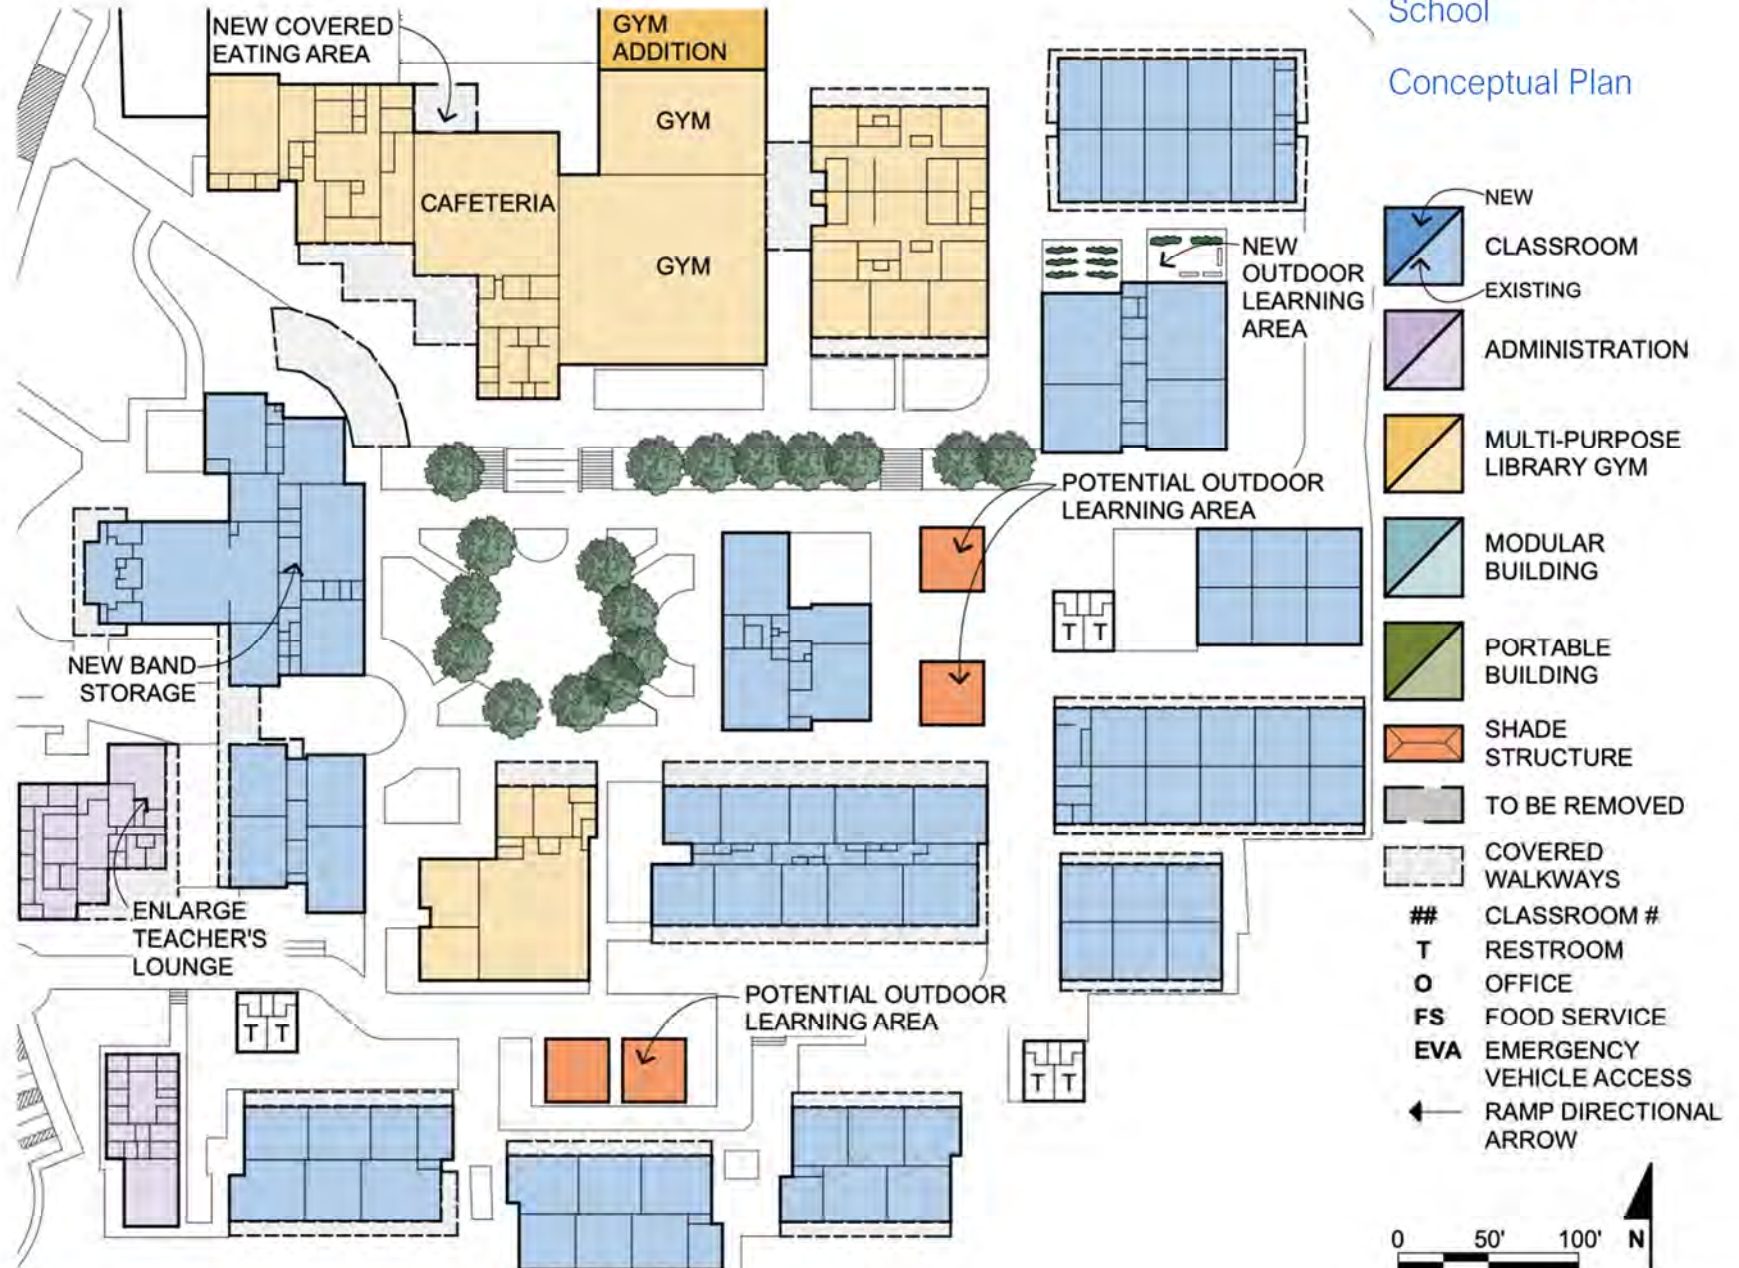
Conceptual Plan

- Provide infrastructure for multi-media presentations in classrooms, student union and theater
- Provide athletic stadium
- Remodel and construct addition at gym - Develop outdoor learning areas
- Renovate interior and exterior finishes

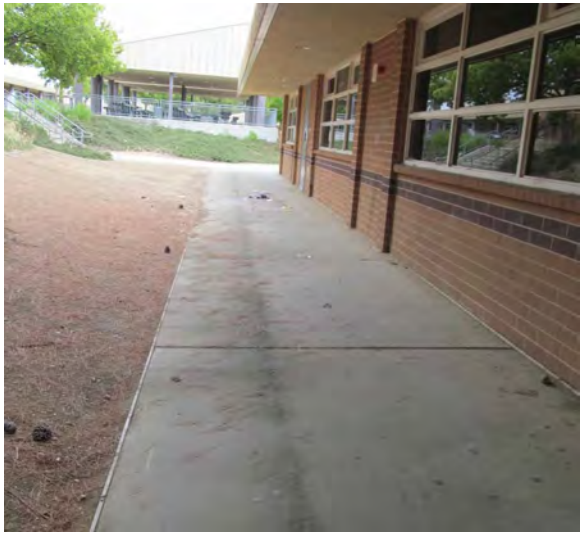
1	2	3
4	5	6

CODE	DISCIPLINE	LOCATION	DESCRIPTION		SITE PLAN KEY	PHOTO	ESTIMATED TAKE OFF		COST/ UNIT	TOTAL COST
							Qty.	Unit		
SITE ISSUES										
CFN	Site Utilities	Site	Deficiency	Site utilities are nearing the end of their useful life			1	ls	\$ 950,000.00	\$ 950,000.00
			Remedy	Replace underground utility lines						
CFN	Accessibility Issue	Site	Deficiency	Landing at Door/Ramp exceeds 2% Slope at 59 locations throughout site .	1	2062	1475	sf	\$ 40.00	\$ 59,000.00
			Remedy	Saw cut, remove and replace Landings. Estimated 25 sf ea landing						
CFN	Accessibility Issue	Site	Deficiency	Cross slope on path of travel exceeds 2% at 46 locations throughout site.	4	2063	6900	sf	\$ 40.00	\$ 276,000.00
			Remedy	Remove and replace section of walkway that is non compliant. Estimate of 150 sf ea occurrence.						
CFN	Accessibility Issue	Site	Deficiency	Slopes on path of travel > 5% without handrails at 8 locations.	5	2061	1200	sf	\$ 40.00	\$ 48,000.00

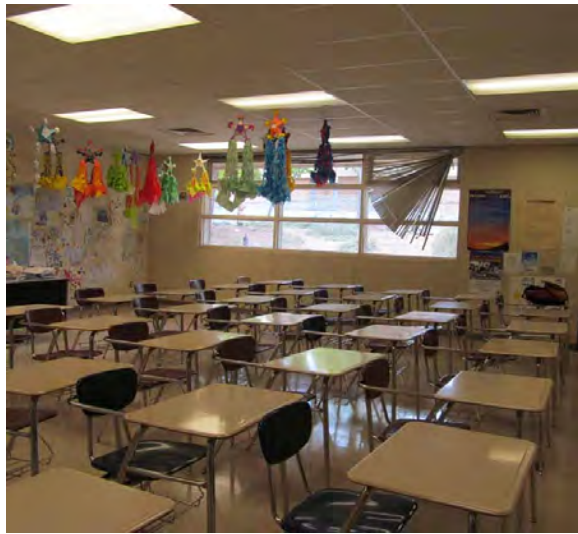
7

EPN	Windows	Classrooms	Deficiency	Window blinds damaged or missing.		07	174934	sf	\$ 0.88	\$ 153,941.92
			Remedy	Replace window coverings throughout campus						
EPN	Flooring	Classrooms	Deficiency	VCT flooring worn out and damaged.			Cost included in Flooring cost		\$	-
			Remedy	Replace all VCT flooring throughout campus with linoleum/sheet vinyl						
STUDENT RESTROOMS										
	Restrooms	Campuswide		Full upgrade to all campus restrooms			5984	sf	\$ 575.00	\$ 3,440,800.00
CFN	Accessibility	Student Restrooms	Deficiency	44" clear pathway obstructed by Lav.			Cost Included in Restroom Cost		\$	-
			Remedy	Remove lav. To create 44" wide pathway.

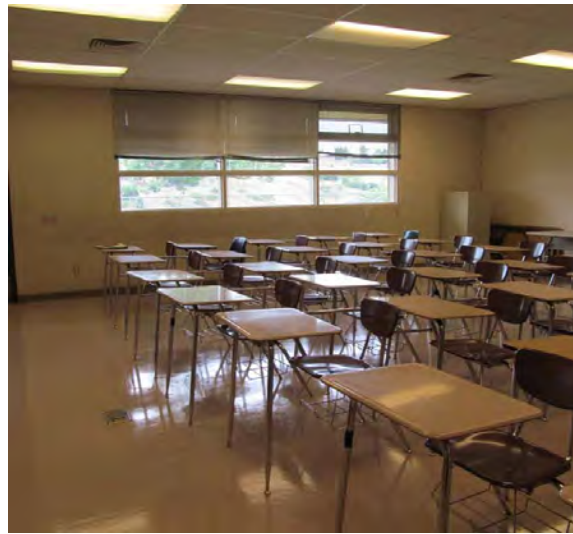
8

EPN	Flooring	Campus-wide	Deficiency	Flooring materials throughout campus worn and at end of useful life.			174934	sf	\$ 6.00	\$ 1,049,604.00
			Remedy	Replace all VCT and carpet with linoleum/sheet vinyl or carpet						
EPN	Plumbing	Campus-wide	Deficiency	Exterior drinking fountains damaged.			174934	sf	\$ 0.88	\$ 153,941.92
			Remedy	Replace with stainless.						
CLASSROOMS										
EPN	Walls	Classrooms	Deficiency	Vinyl wall covering dirty and damaged.		04 05 06	174934	sf	\$ 1.00	\$ 174,934.00
			Remedy	Remove all vinyl wall covering and repair gypboard and paint or provide wall covering						
EPN	Ceiling	Classrooms	Deficiency	Suspended ceiling panels old, dirty and sagging.			174934	sf	\$ 3.50	\$ 612,269.00
			Remedy	Replace all ceiling panels and re-tension grid						
EPN	Lighting	Classrooms	Deficiency	Light fixtures are old and inefficient.		08	Cost included in Electrical cost		\$	-
			Remedy	Replace fixtures with more efficient up/down fixtures
