& COHASSET PUBLIC SCHOOLS: EXISTING CONDITIONS STUDY

2022

Presentation of Draft Report
March 22, 2022

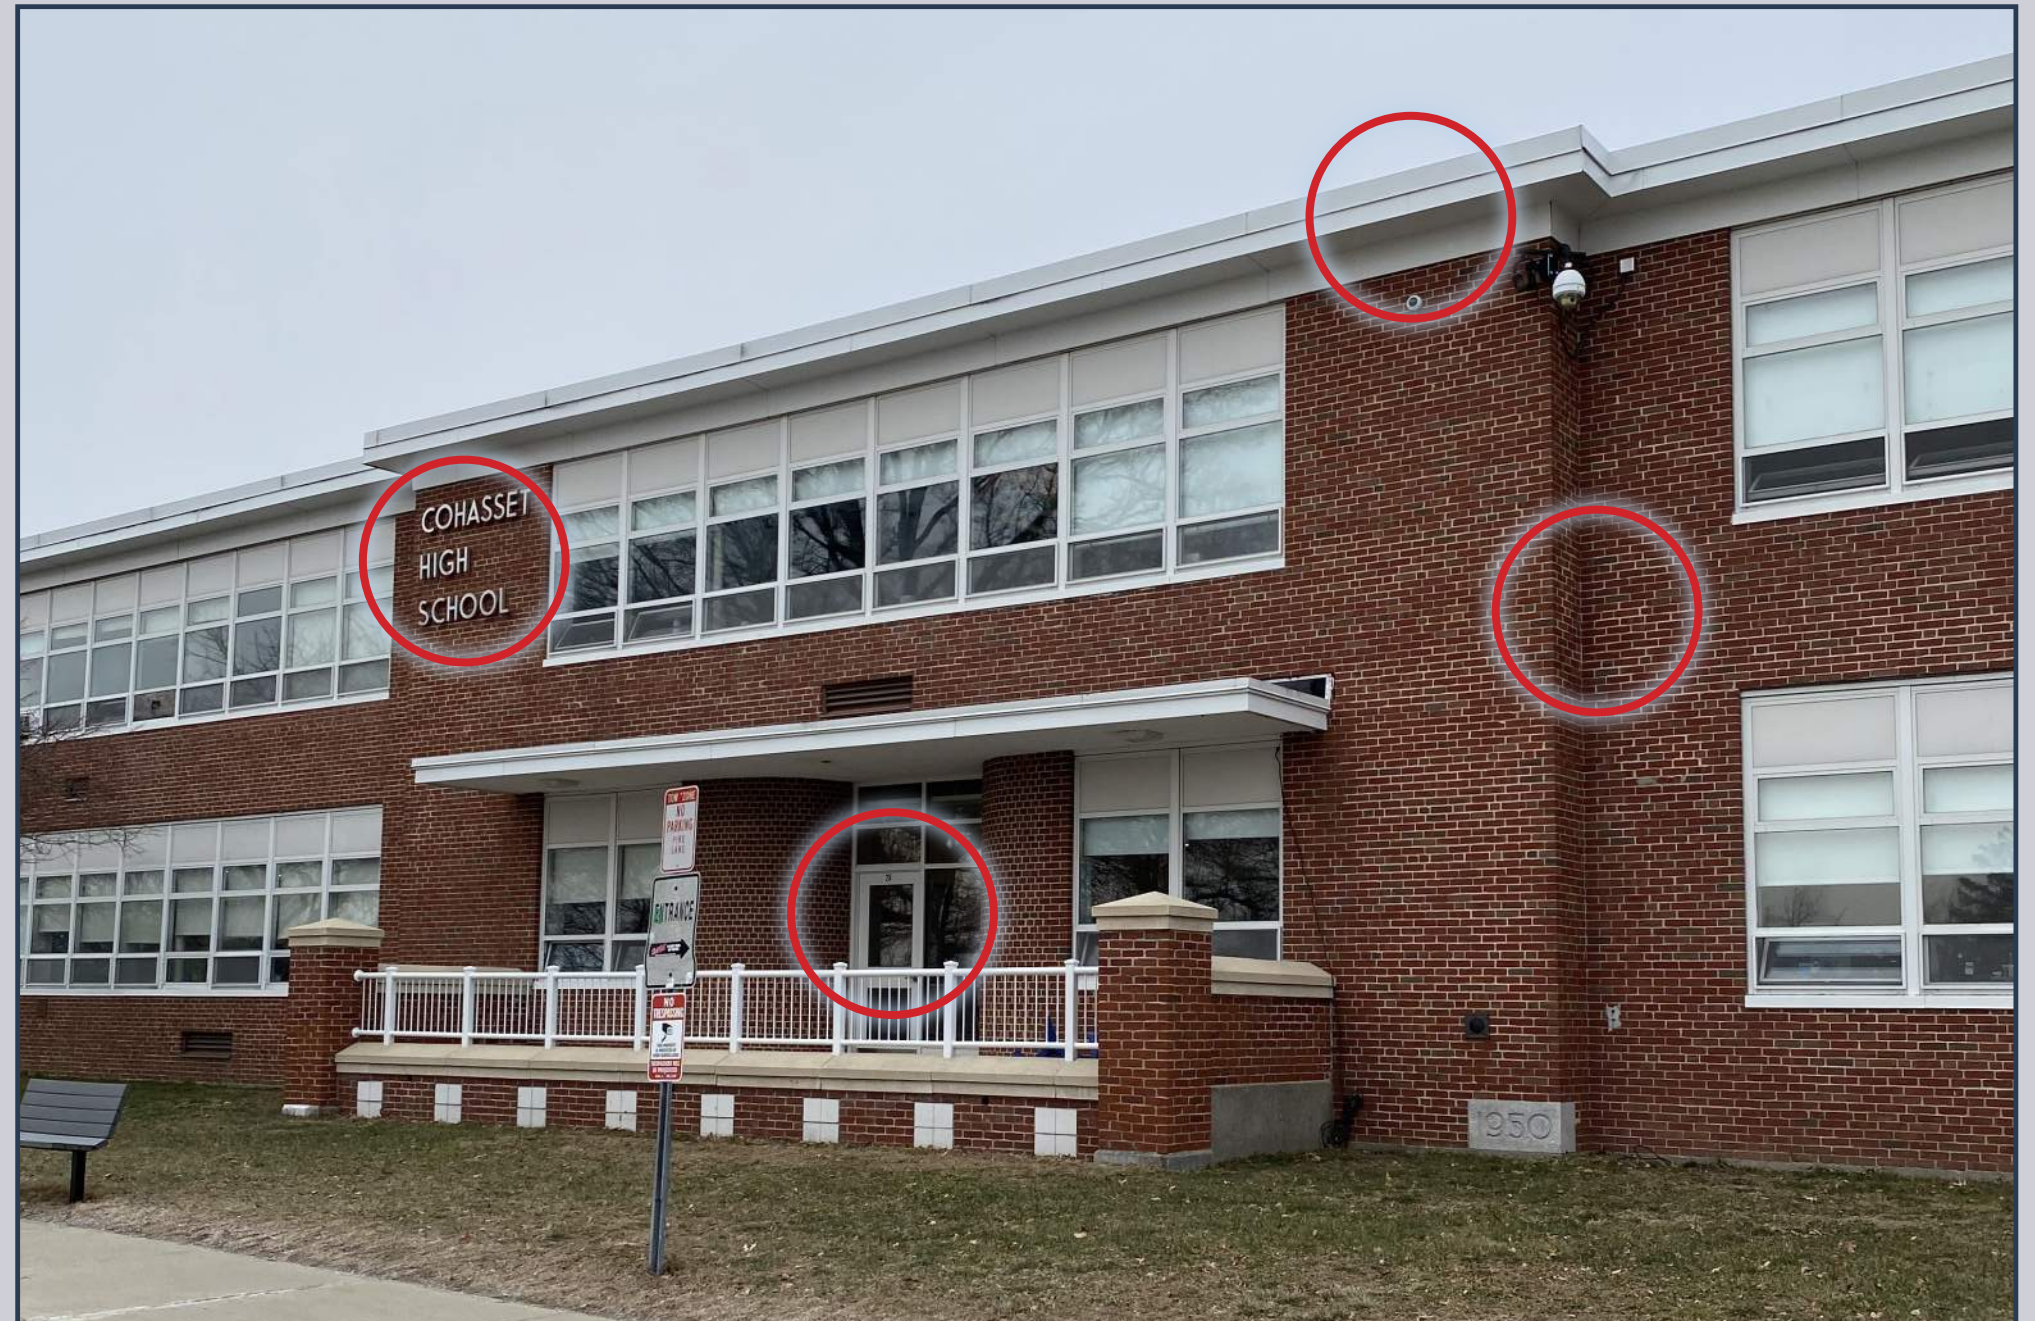
- Broken gutters
- Finish grade above foundations
- Poor seals and gaskets + cracked sealant
- Holes in masonry
- Deteriorating finishes
- Lack of flashing (may be contributing to the air quality/moisture issues felt on the interior)
- Failing finishes/bricks are safety hazards
- Unaddressed tears in roof membrane
- Major water ponding on roof
- Insulation thickness at walls and roof doesn't meet energy code standards
- Entrances not easily identifiable
- Old signage still reads High School only

2-3	Architectural Evaluation - Exterior	Walls	Broken gutters, finish grade above foundations, poor seals, holes in masonry, deteriorating finishes, and lack of flashing may be contributing to the air quality/ moisture control issues felt on the interior; Failing finishes/bricks are safety hazards
3	Site Evaluation	Landscape	Accessibility issues common throughout site, including access to school - upgrading is necessary to avoid hazardous conditions for visitors; Grading and drainage issues impact functionality of site (playfields oversaturated); Replace synthetic turf
4	Site Evaluation	Civil	Access to and from site is currently the biggest hurdle to achieve a functional site; Circulation is tight, access around building is challenging, drop-off locations are distant from main entries; Parking is a major challenge on site and wetlands inhibit expansion
4	Structural Evaluation	Structural	All of the structural components that are visible appear to be performing adequately , though exterior rusted lintels , cracks in the façade, and displaced bricks are recommended to be repaired as part of the maintenance program

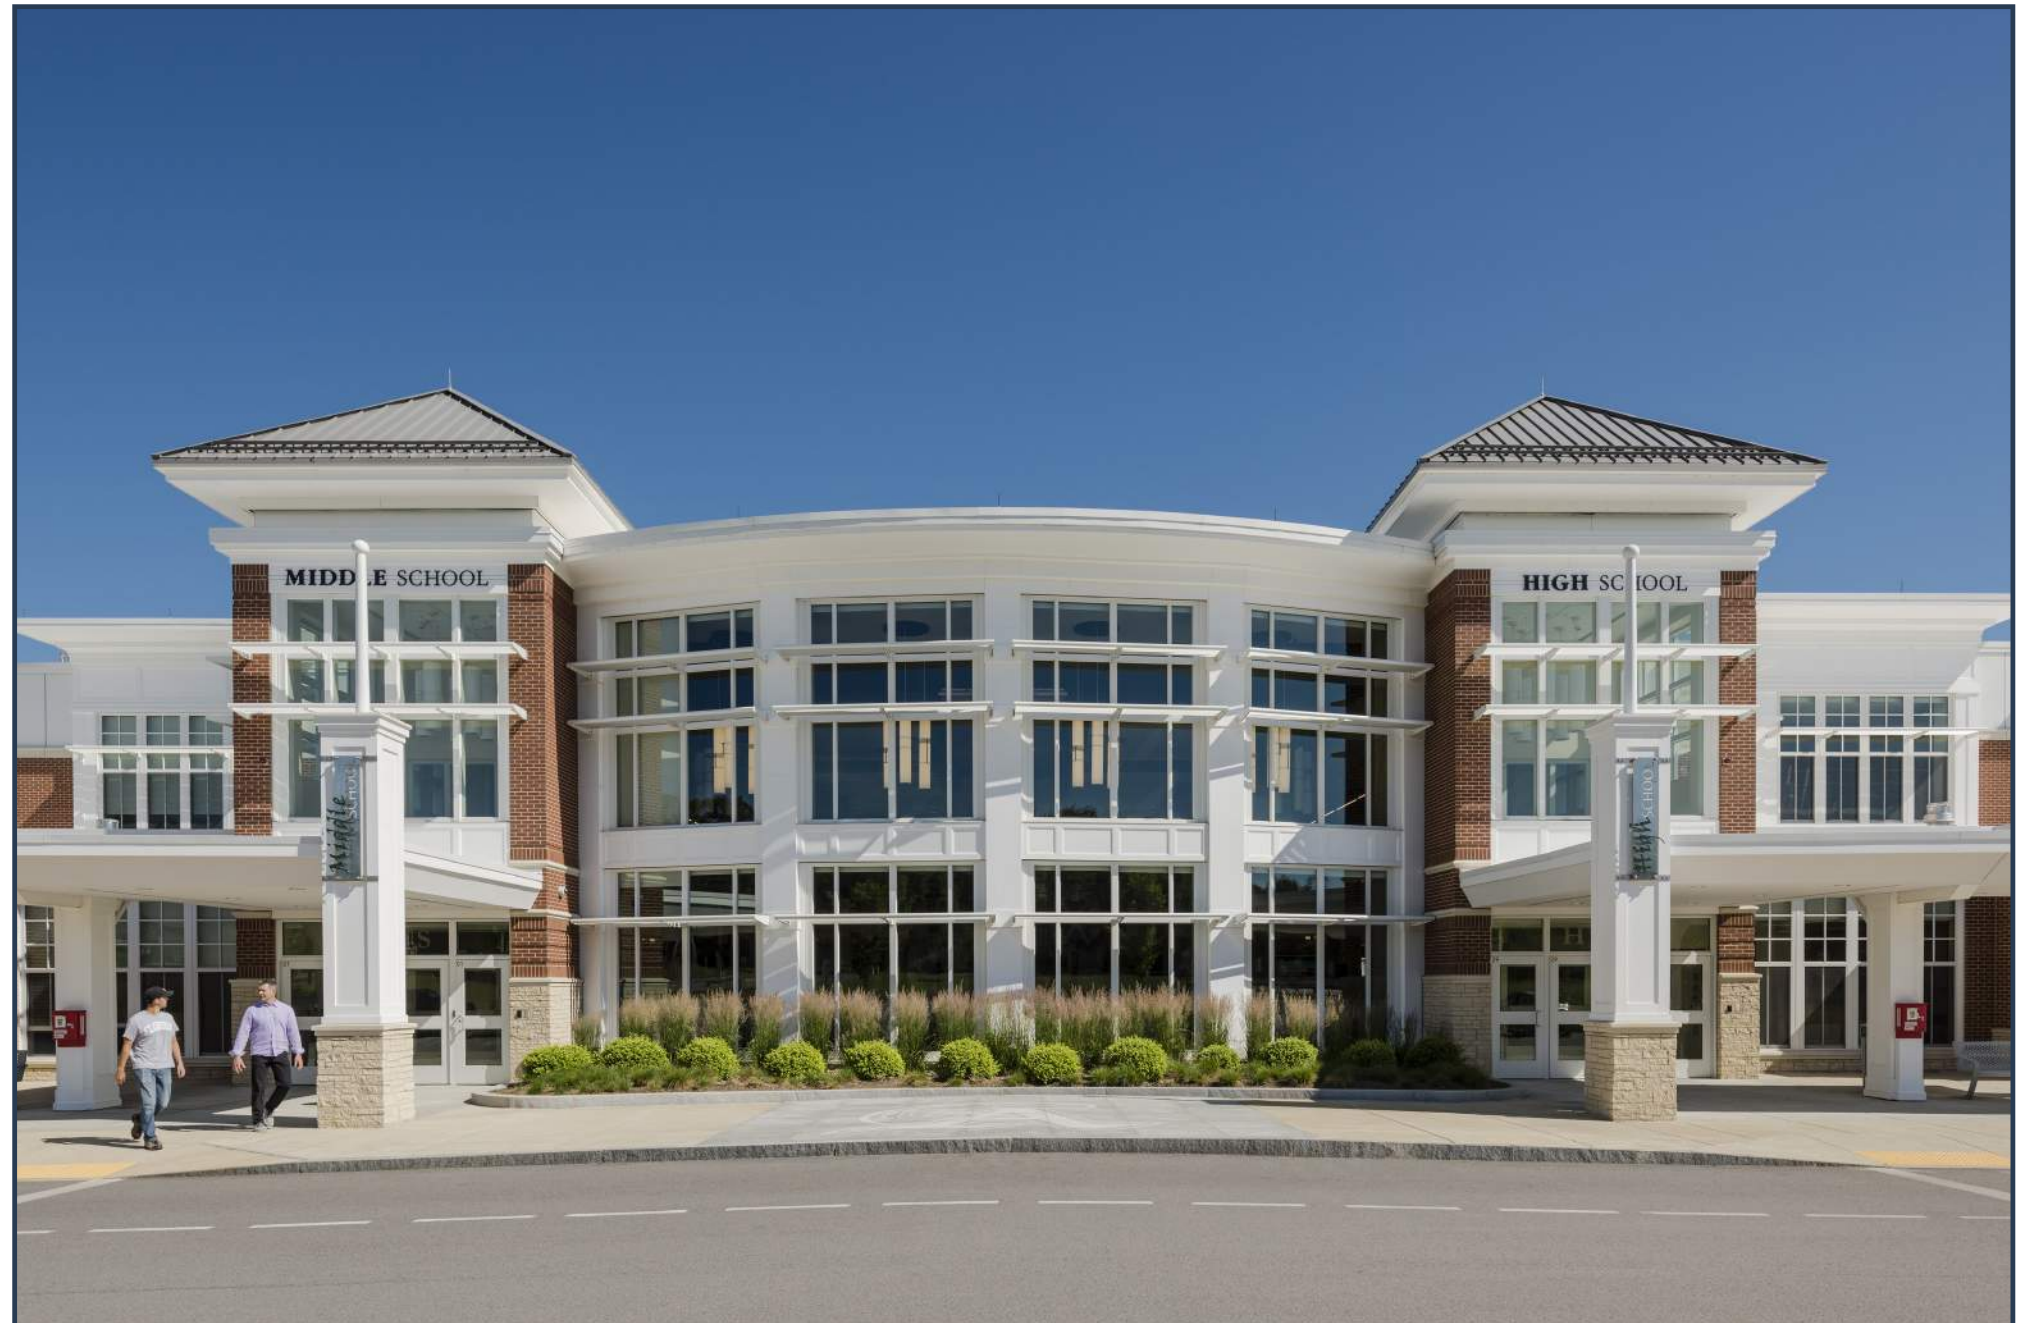
*Abington Co-Located Middle-High School
Abington, MA*

- ✓ Adequate exterior wall construction, with vapor barrier, air gap, insulation, and metal stud backup with drywall
- ✓ Energy efficient windows with sun control devices
- ✓ Clearly identifiable and accessible entries with signs
- ✓ Boulevard for bus/parent circulation surrounded by vegetated buffers
- ✓ Light-colored roof for limited heat gain

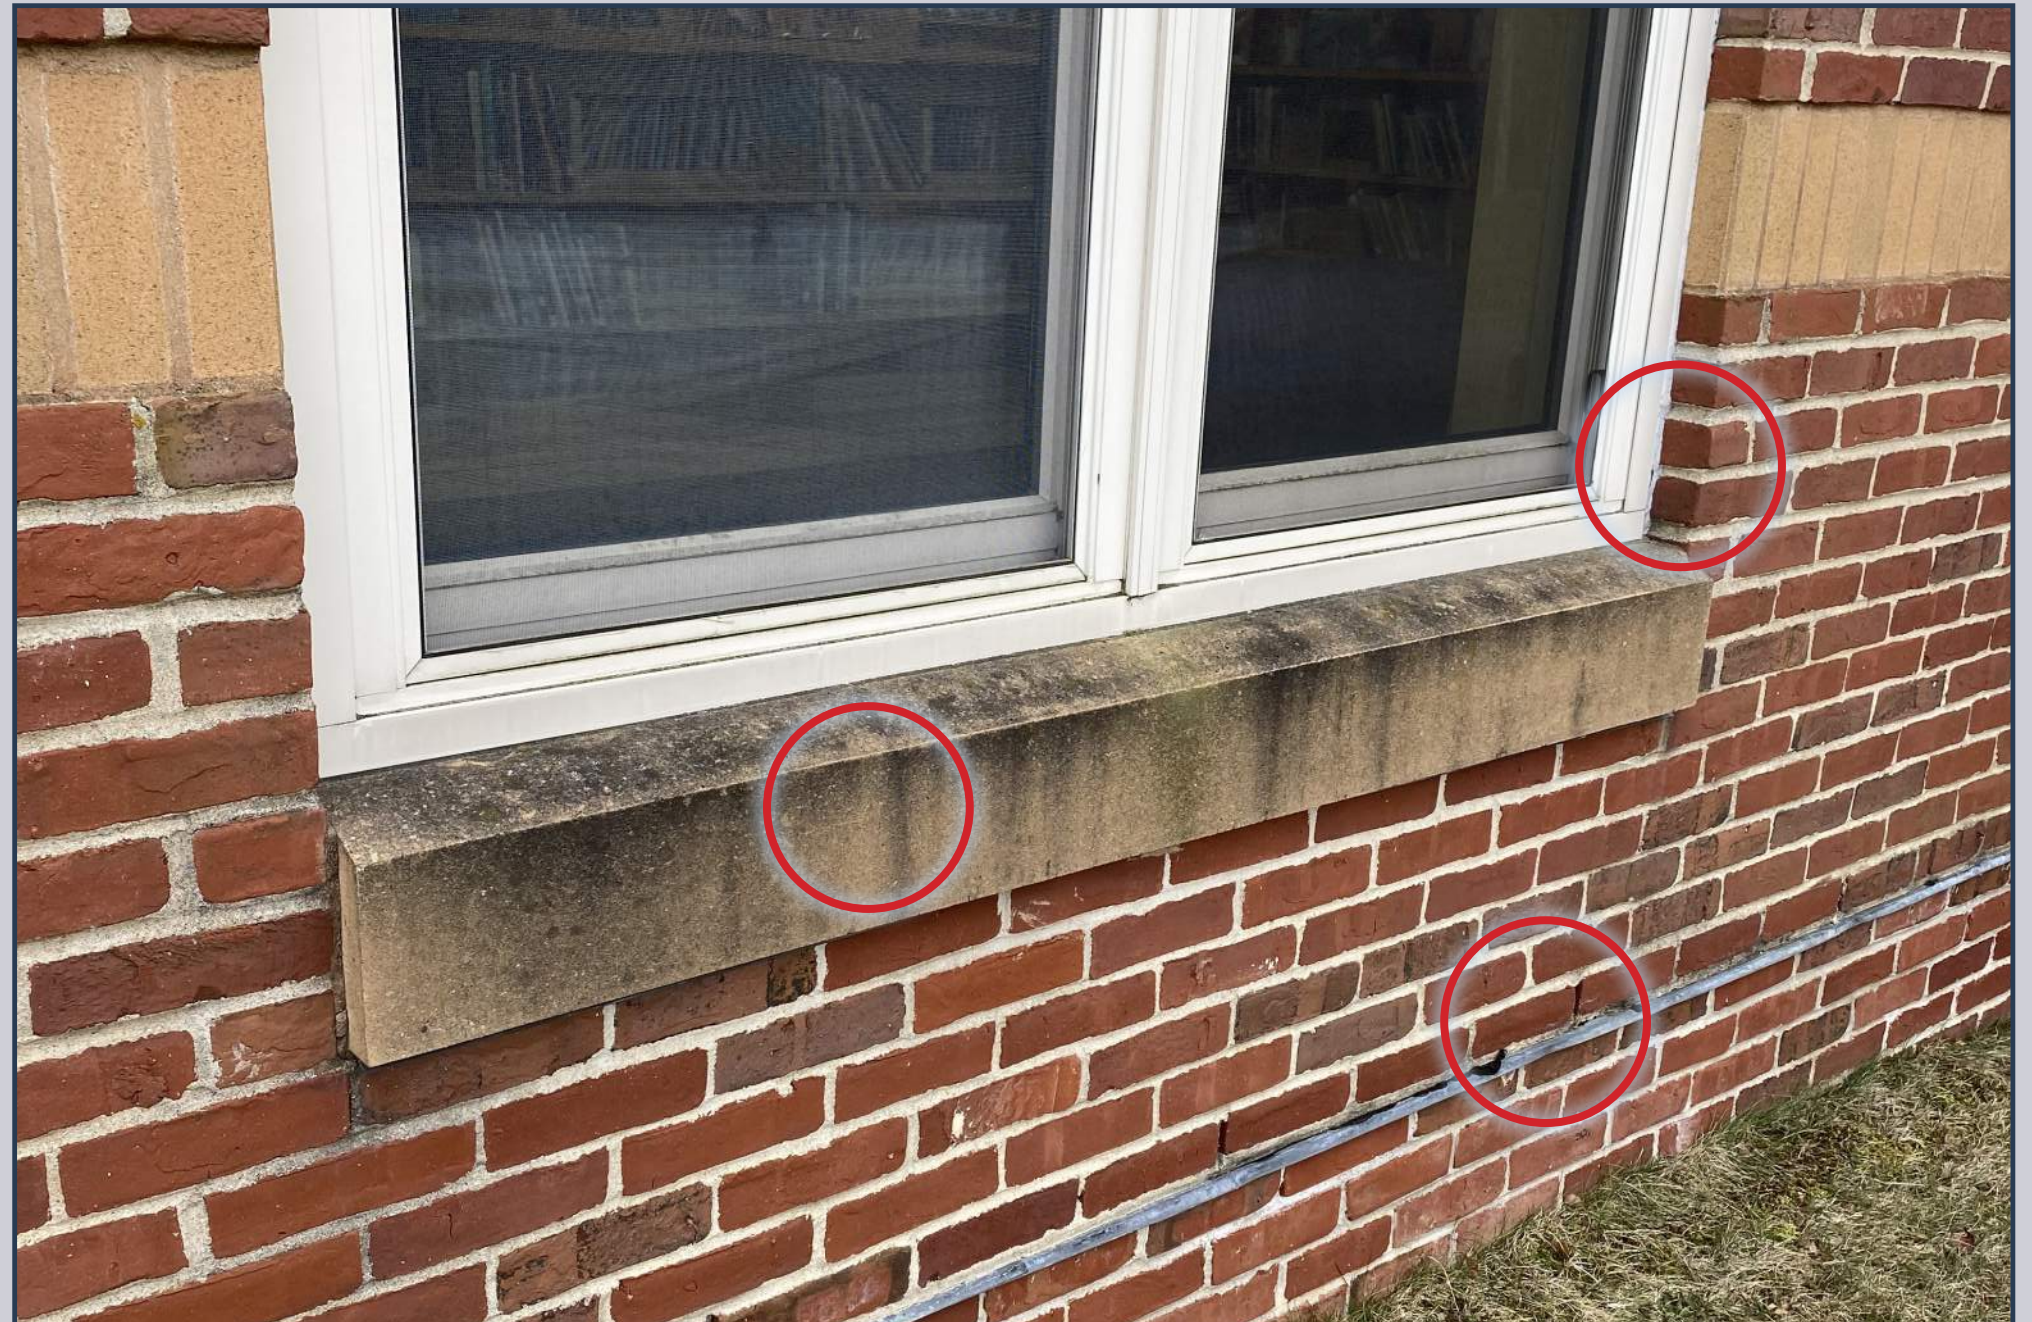
- Masonry to be cleaned of water stains and moss
- Precast concrete to be cleaned of water stains and moss
- Metal doors to be painted, as well as metal components like caps and lintels, to prevent corrosion
- FRP to be washed and sealed at joints
- Seals at windows and penetrations to be maintained
- Un-adhered roof membrane to be repaired
- Clear roof drains of debris

3	Architectural Evaluation - Exterior	Walls	The masonry is in acceptable condition and would benefit from cleaning to remove water stains and moss ; Paint metal doors, supports, caps, lintels and any other components with rust; FRP should be washed and sealed at joints; Maintain seals
4	Site Evaluation	Landscape	Inaccessible routes are not yet critical in physical condition, but upgrading is necessary to avoid hazardous conditions for visitors; Maintenance practices of the grounds, plantings, and play equipment should continue
4	Site Evaluation	Civil	Options to alleviate traffic flows during drop-off and pick-up times should be reviewed and reconsidered; Consider repaving in areas with broken/settled pavement ; Parking is a challenge on site and wetlands inhibit expansion
4	Structural Evaluation	Structural	All of the structural components that are visible appear to be performing adequately , though exterior rusted lintels are recommended to be repaired as part of the maintenance program; Monitor cracks along exterior and interior walls

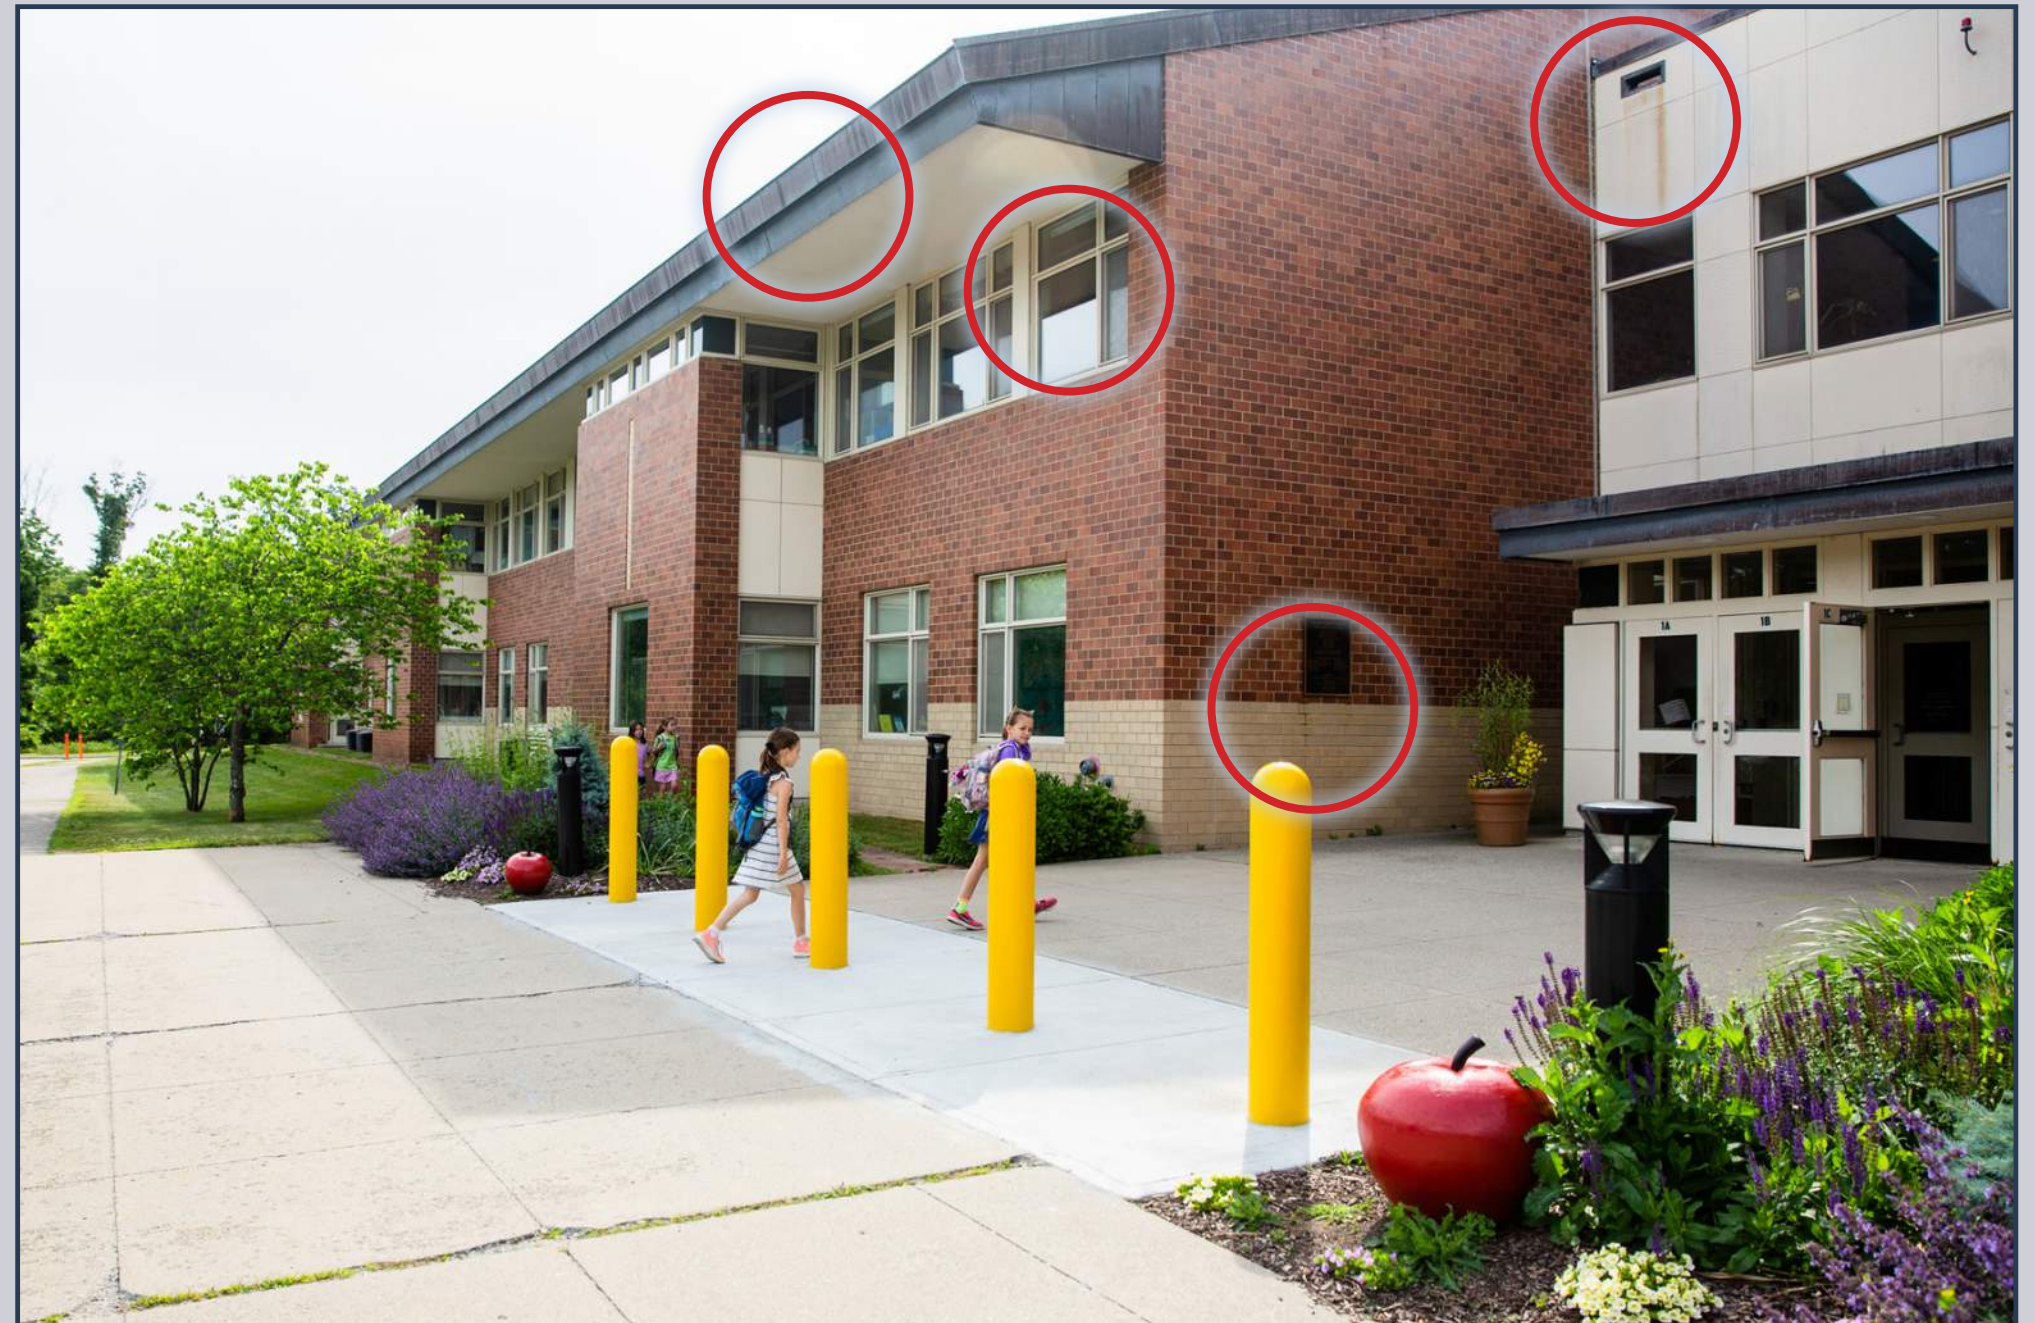
- Consider replacement of asphalt shingle roofs with standing seam instead, to alleviate consistent shingle replacement
- Continue to review and repair seams at EPDM and monitor ponding
- Replace oxidized flashing/accessories
- Consider incorporation of green roof
- Windows in poor condition due to failed seals and should be replaced
- Consider removal of the composite panels and replacement with all new, for a cohesive look, or another product, like aluminum composite or wood, for a face lift

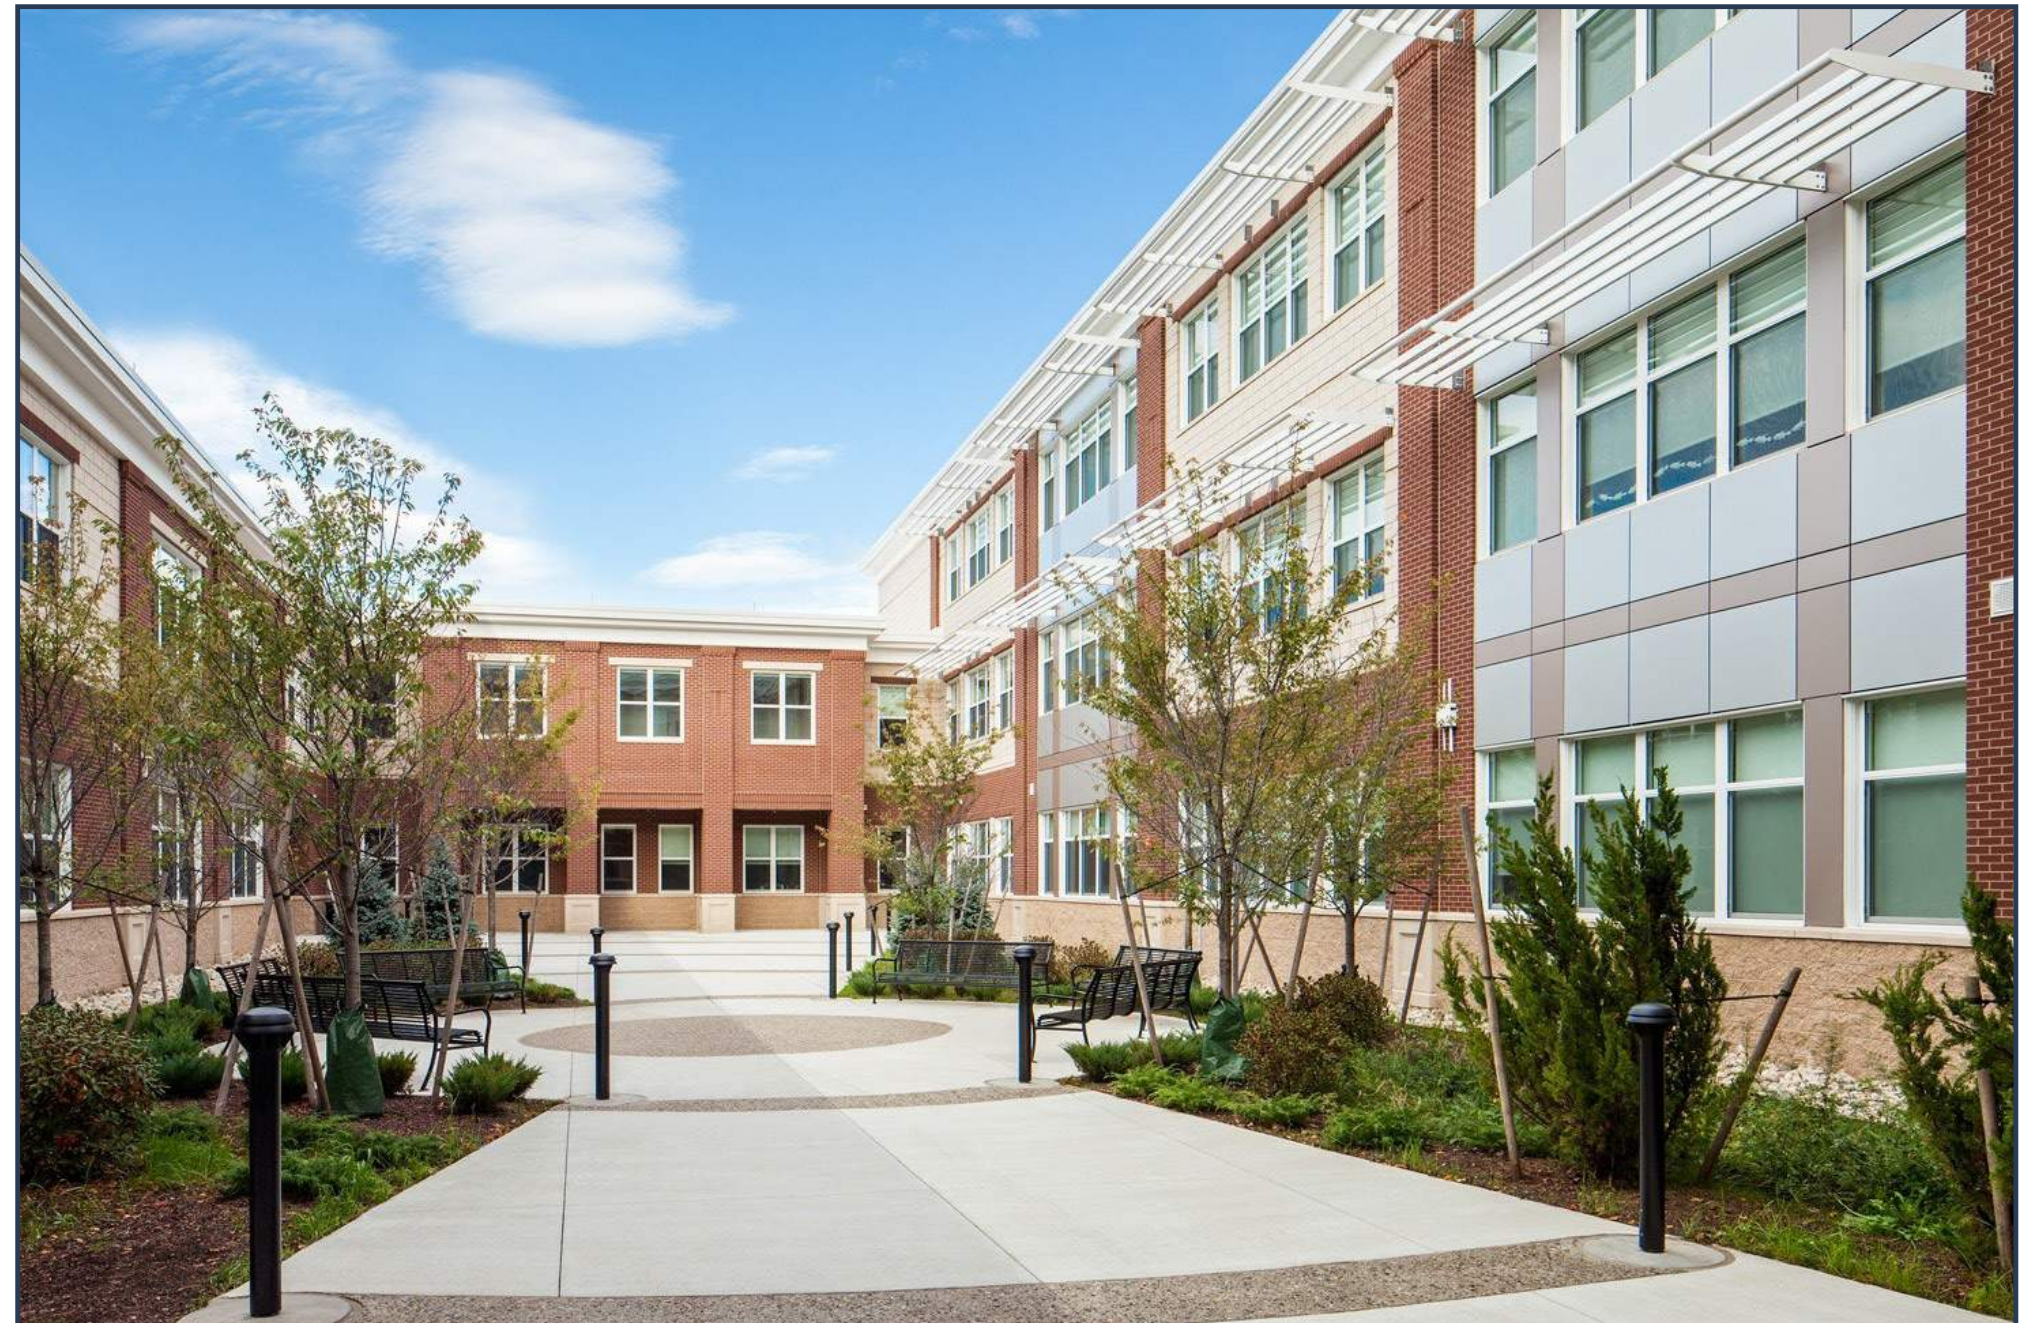
*Hingham Middle School
Hingham, MA*

- ✓ Exterior wall panels clean with no stains
- ✓ Brick includes adequate mortar and control joints
- ✓ Energy efficient windows with sun control devices
- ✓ Light-colored roof for limited heat gain

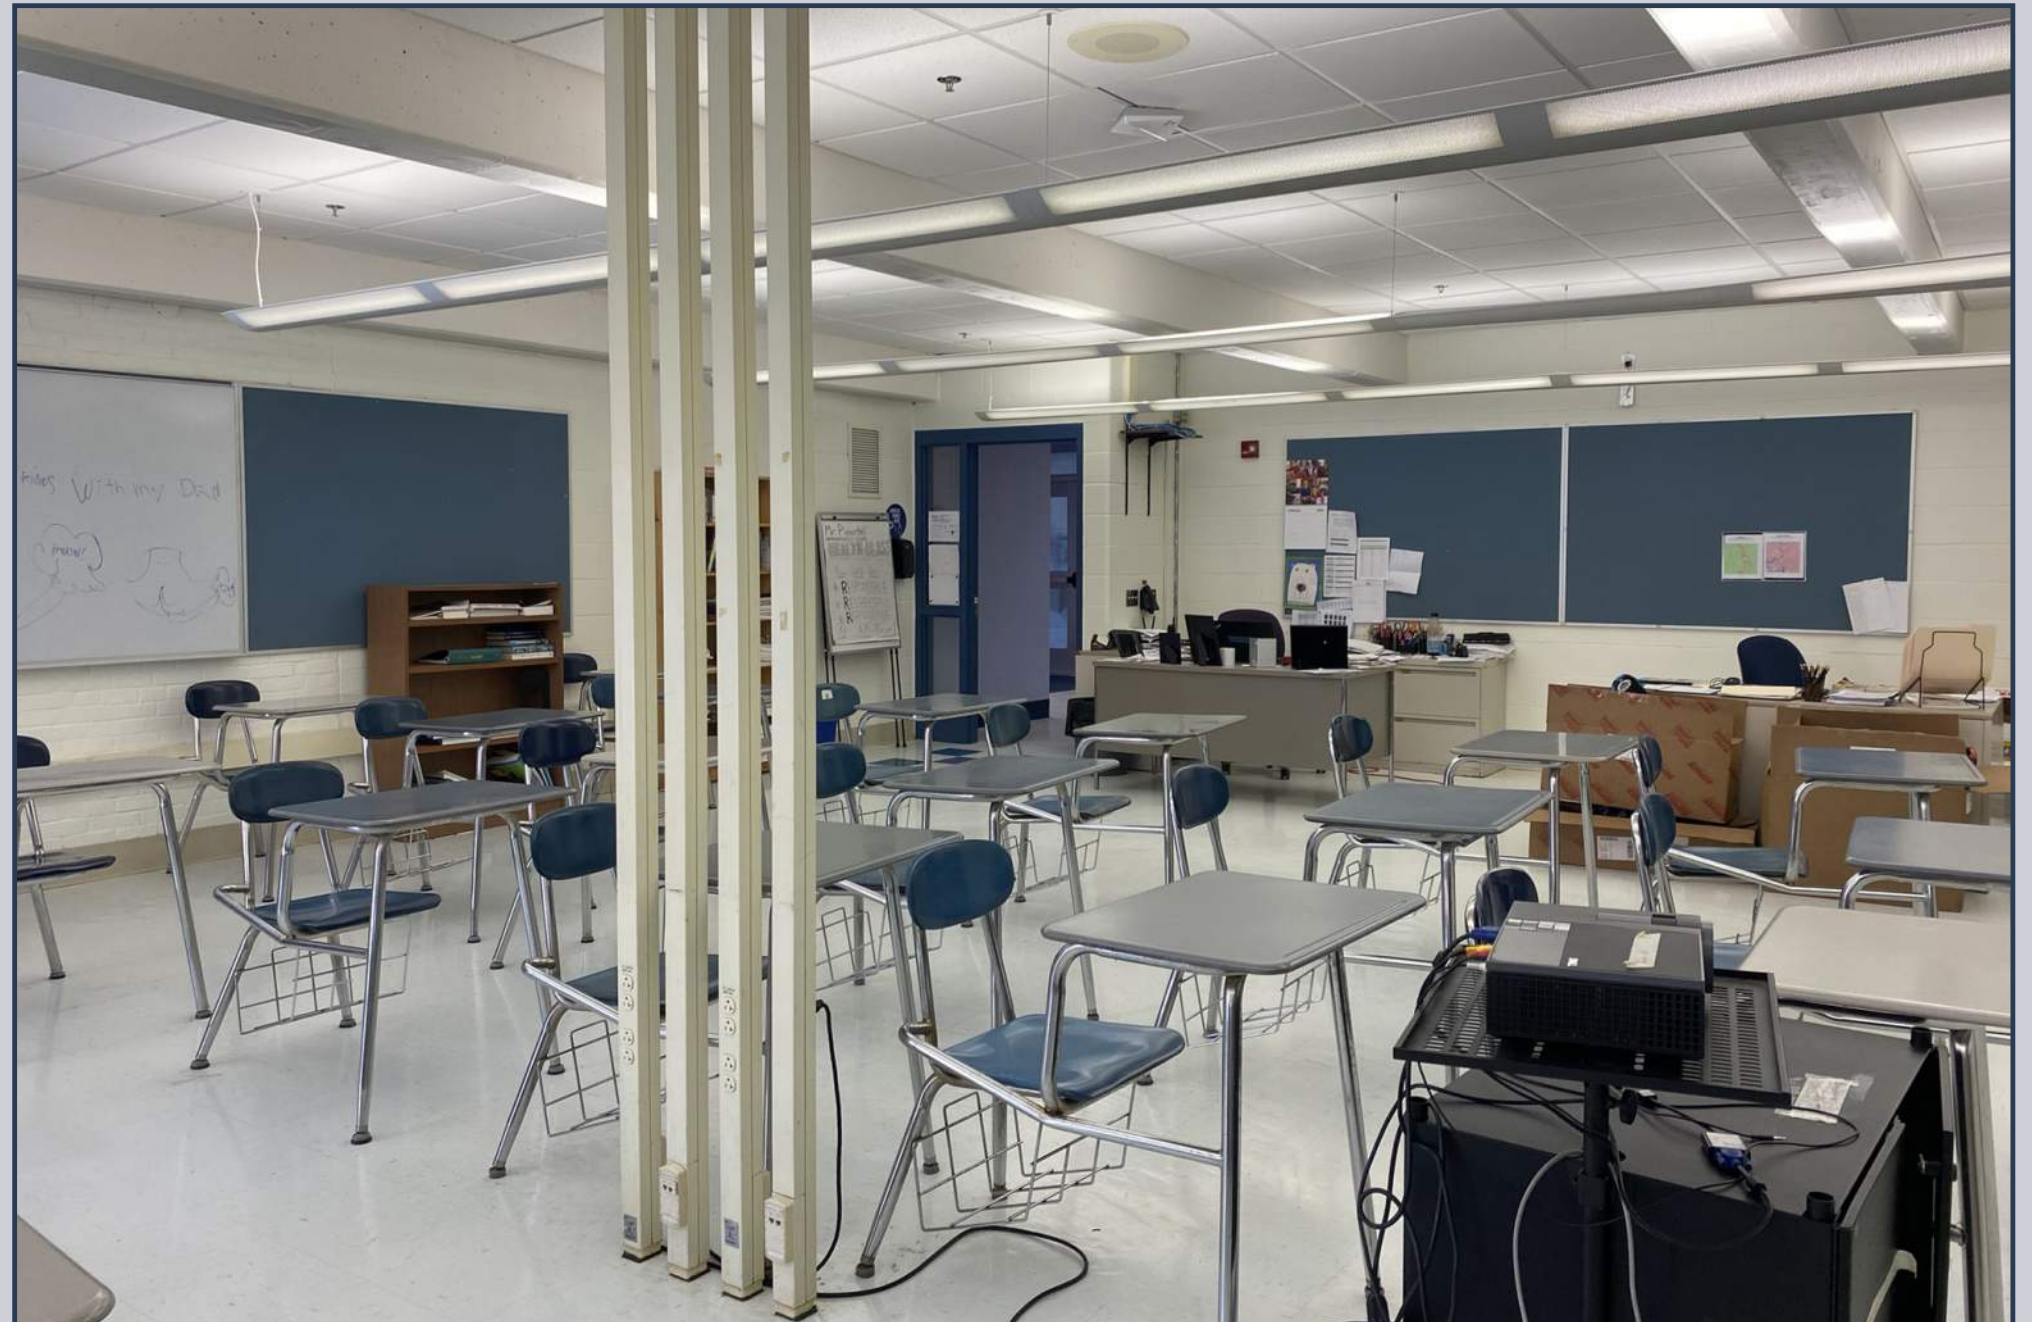
- **No** appropriately sized core classrooms or options for flexibility
- **No** sufficient storage
- **No** interaction with the outdoors
- **No** ability to logically organize classes into academic neighborhoods at MS level

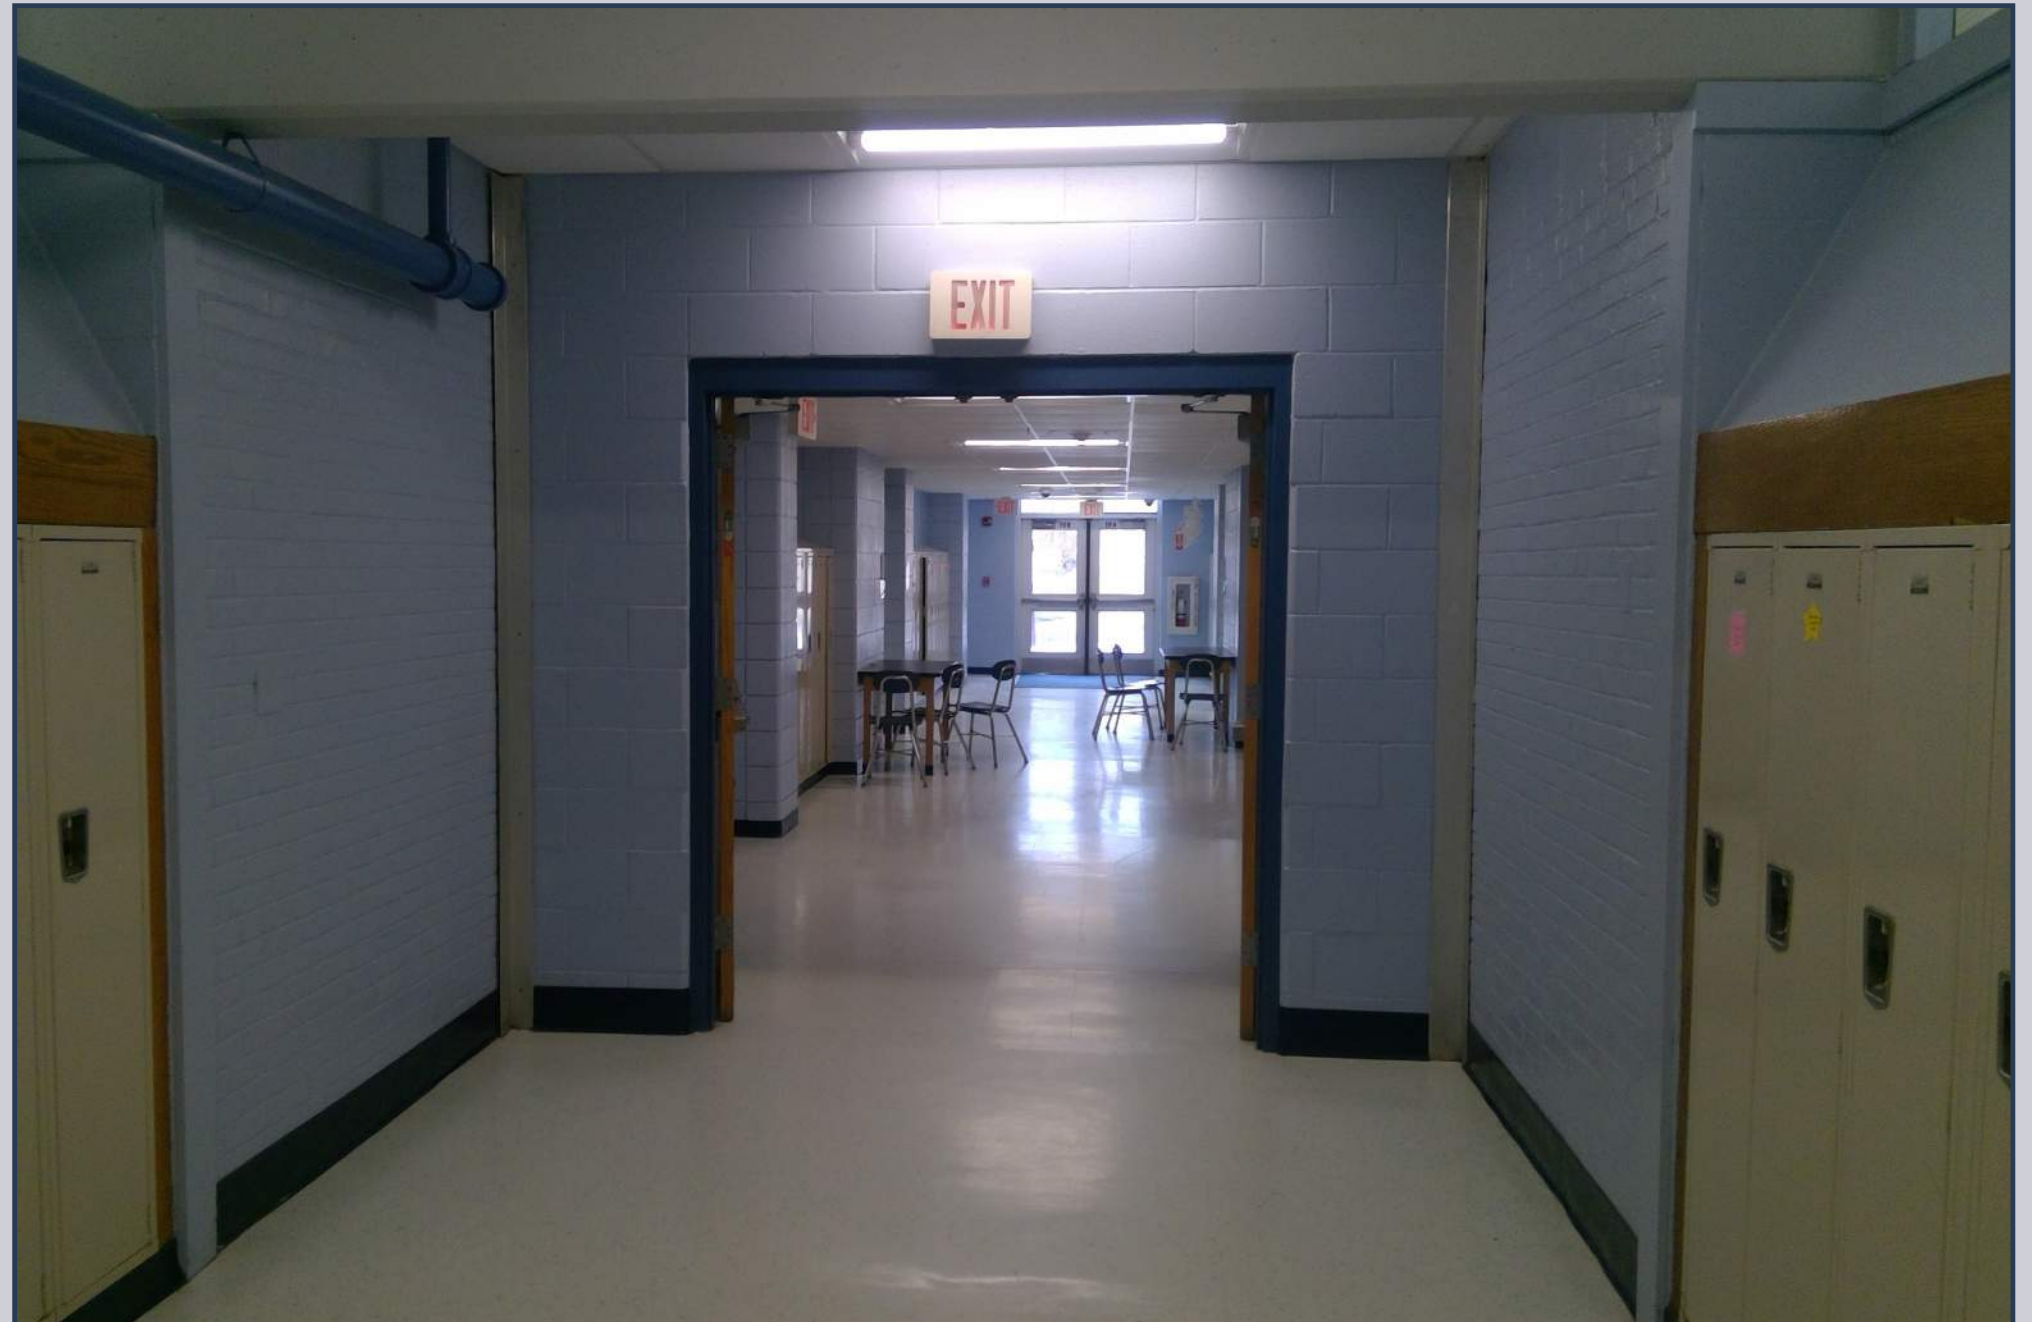
- **No** ability to logically organize classes into academic neighborhoods at MS level
- **No** signage or understanding of location within the school
- **No** resources for learning or social interaction available within the academic wing

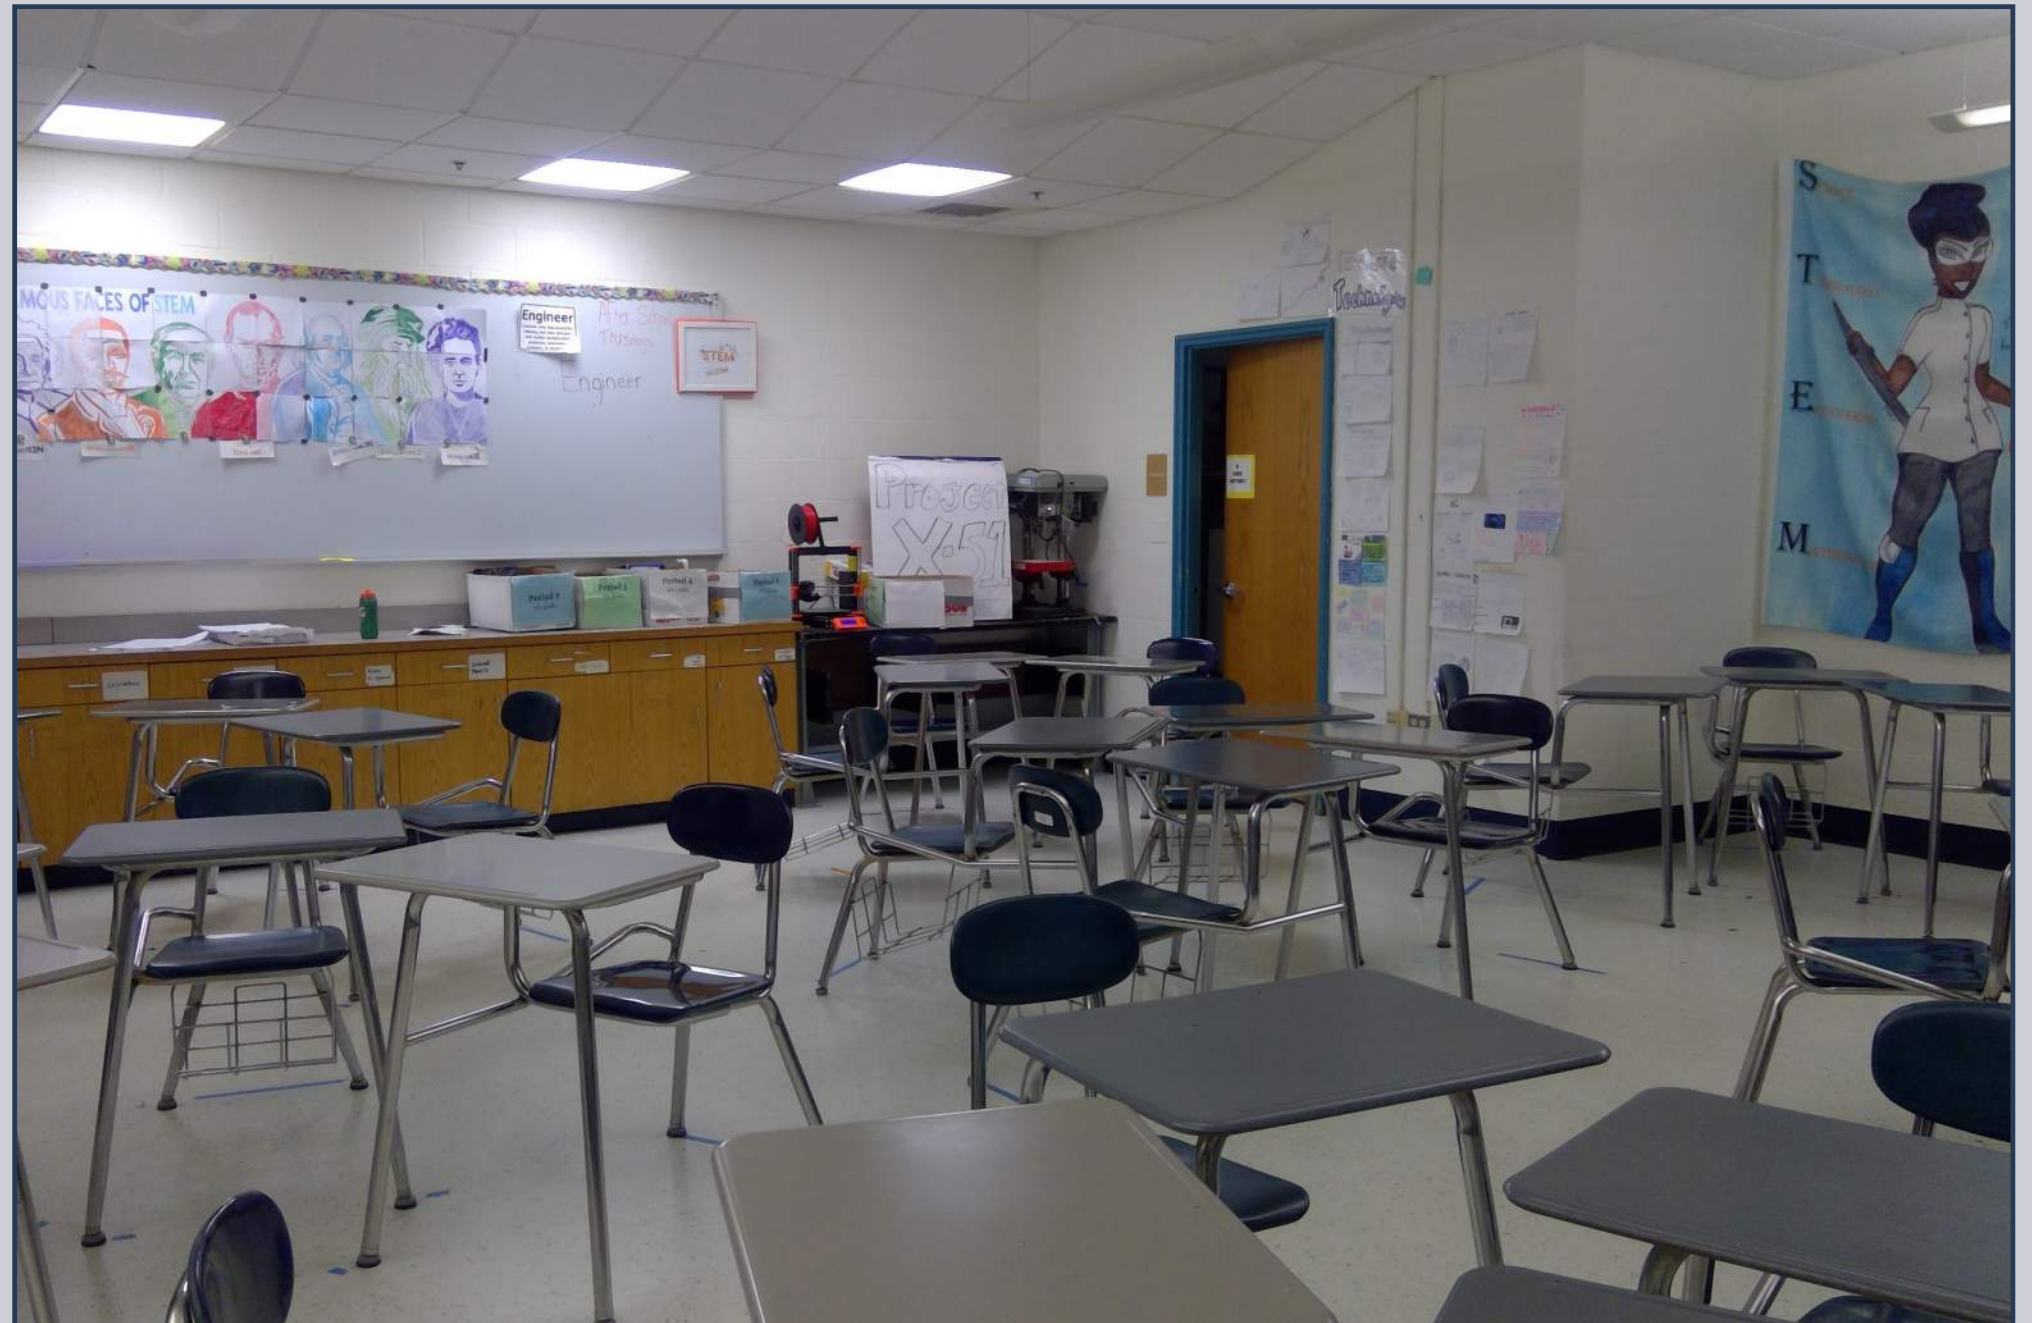
- **No** modern project labs for students to gain diverse, hands-on experiences
- **No** difference between core classroom and STEM room at MS level
- **No** vocations other than wood shop at the HS level; preference for courses related to Cohasset's marine location
