& COHASSET PUBLIC SCHOOLS: EXISTING CONDITIONS STUDY

2022

Presentation of Draft Report
March 22, 2022

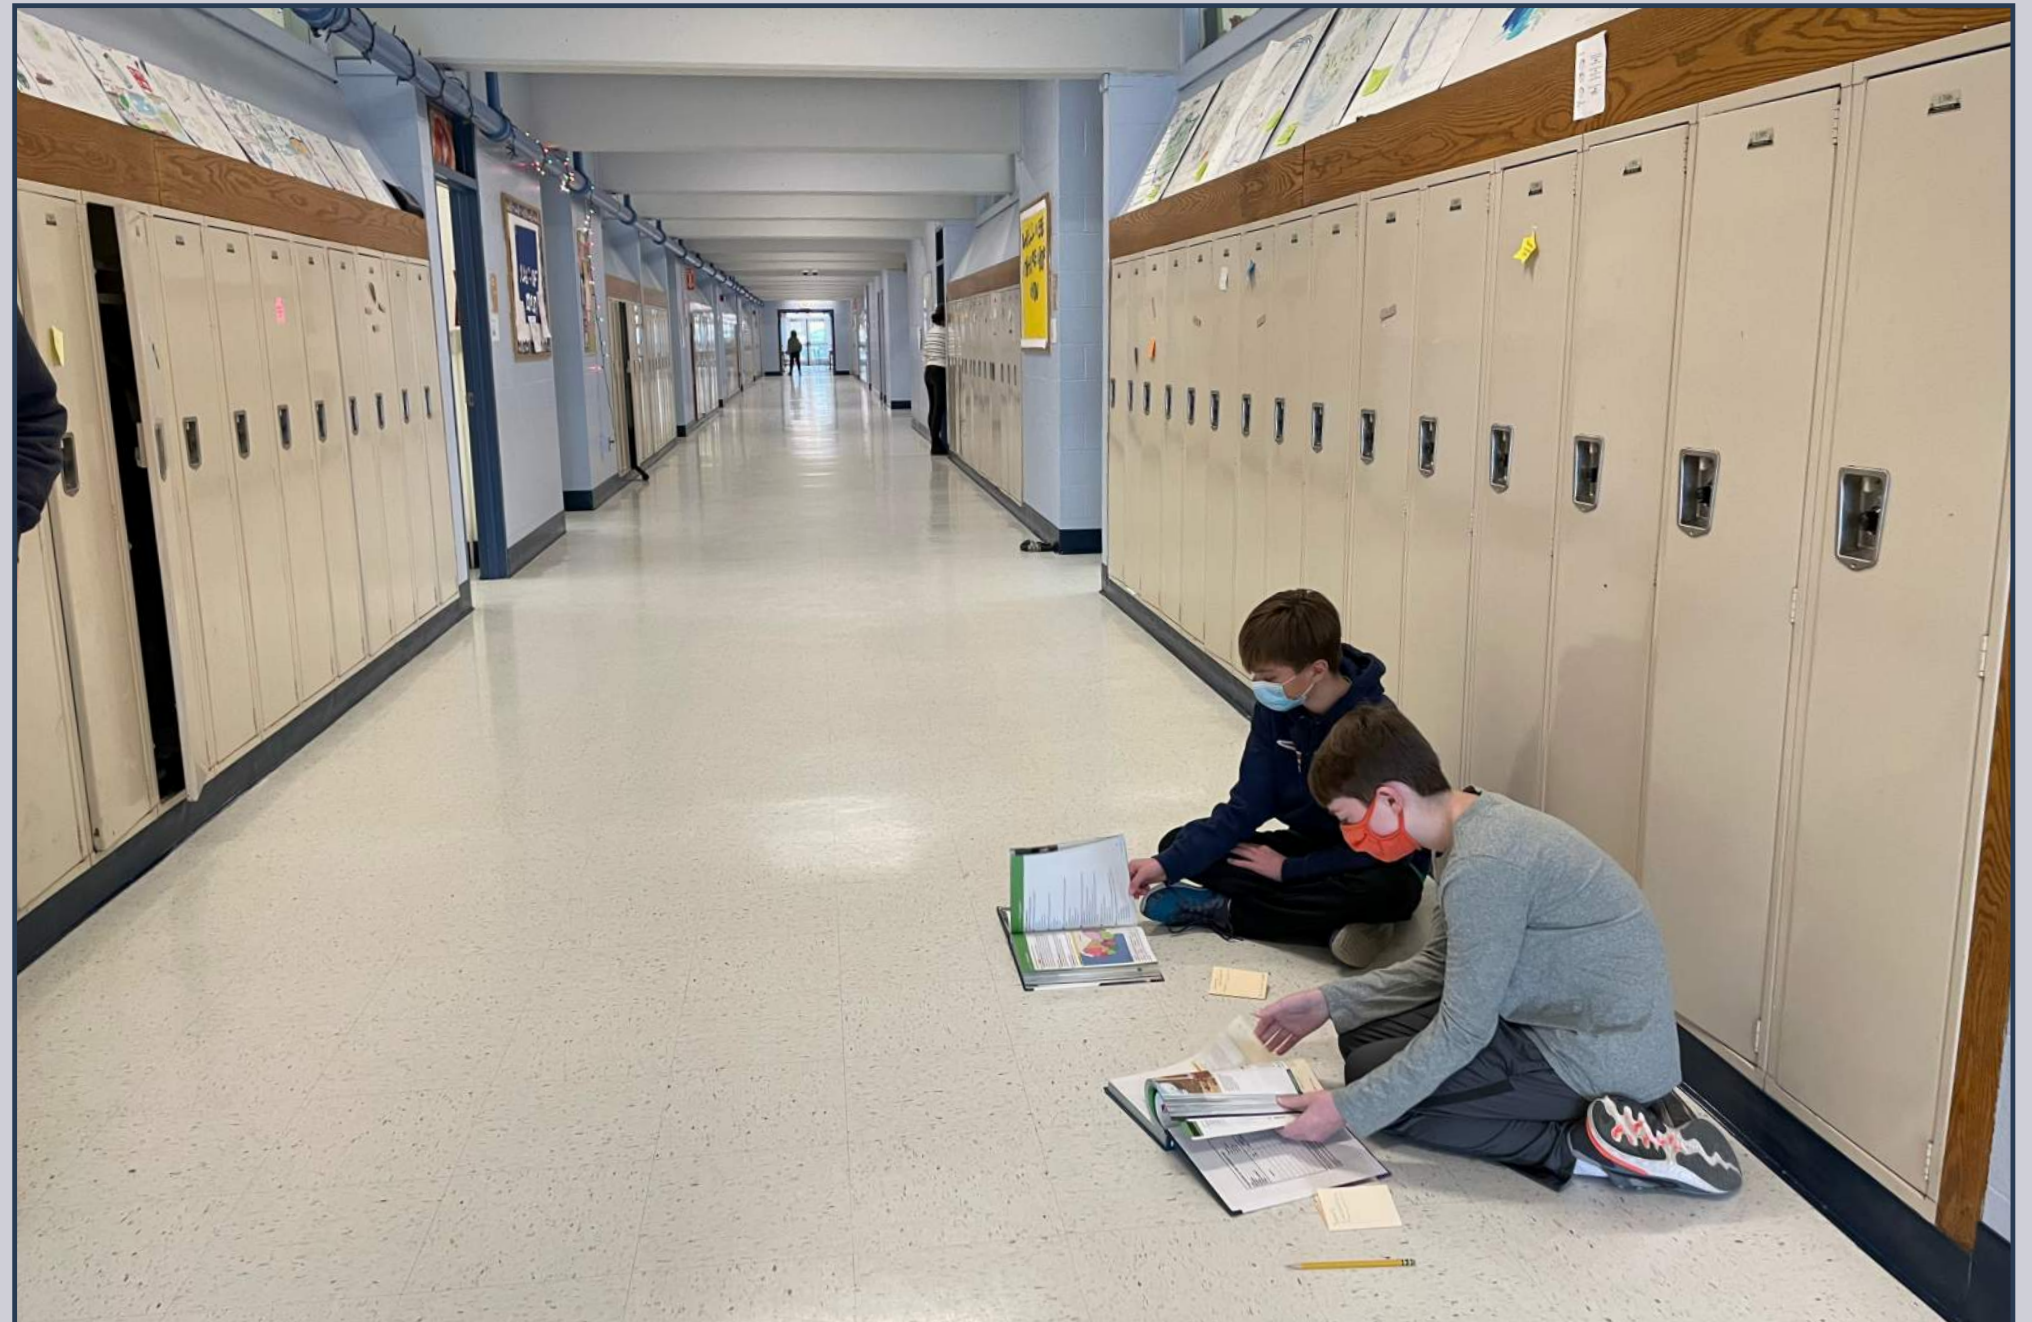
- **No** appropriately sized collaborative work spaces for either students or staff
- **No** visual relationship between the core classrooms and collaborative space
- **No** furniture to accommodate flexible group settings or varied layouts
- **No** small group rooms, resource rooms, tiered lecture spaces, or learning labs

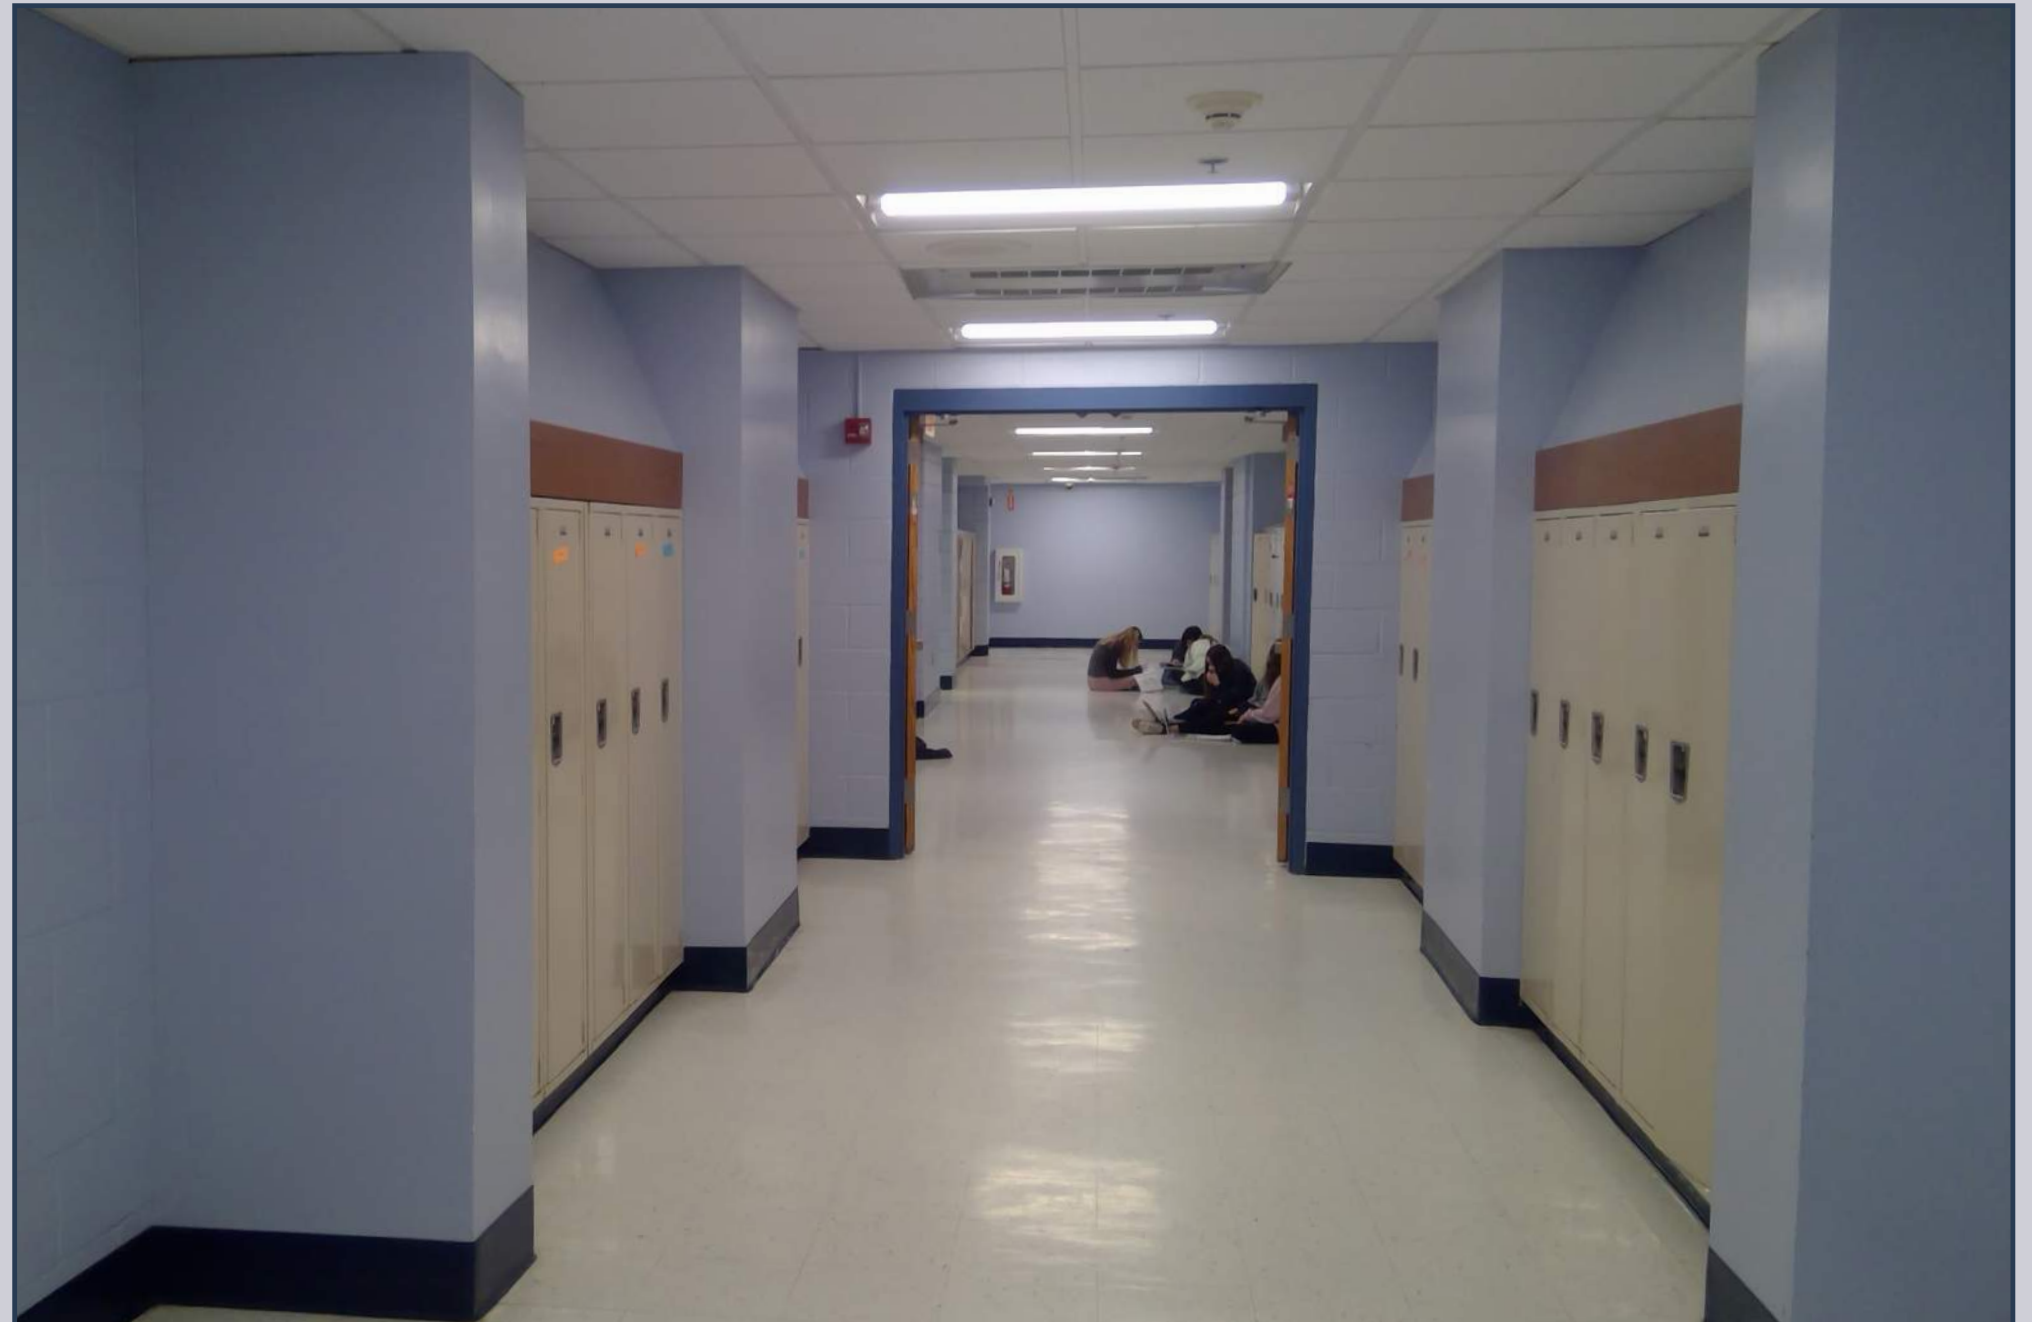
- **No** sign of connectivity, transparency, or sense of what's happening behind walls
- **No** opportunity for personalization or display; lockers dominate wall space
- **No** sense of identity or excitement for learning within the corridors
- **No** learning on display

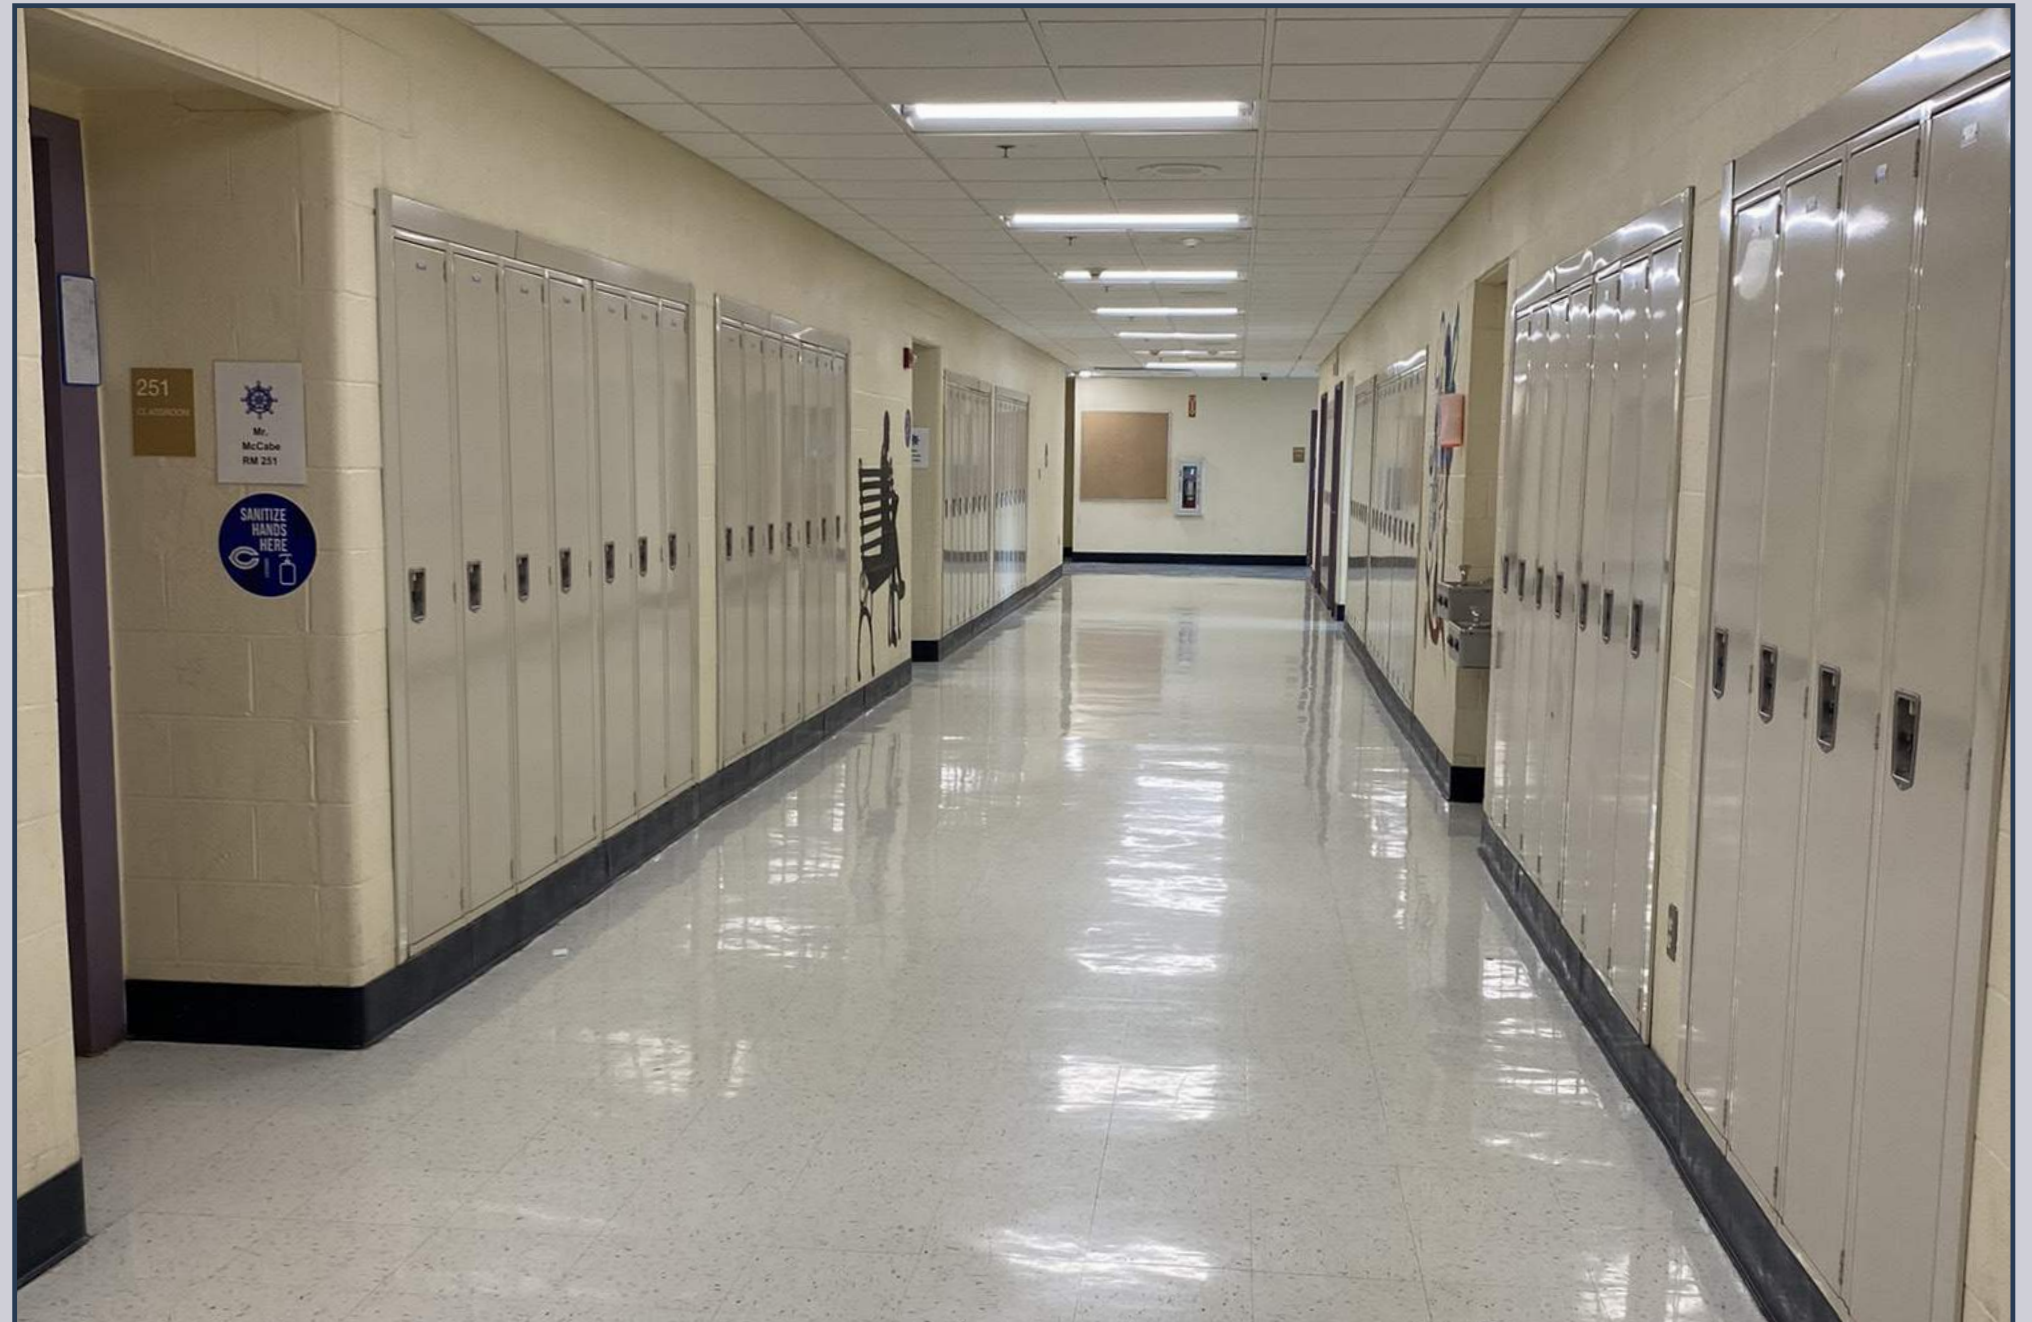
- **No** visibility to the outdoors is disorienting
- **No** spaces that engage indoor/outdoor learning connections
- **No** natural daylight

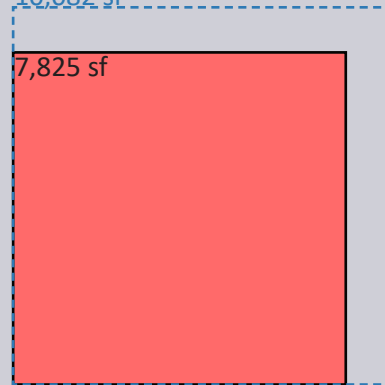
- **Not** adequately sized
- **No** differentiation (we understand the separated seating due to COVID...)
- **No** natural daylight
- Senior cafe is a good start, but only accommodates one of the six grade levels

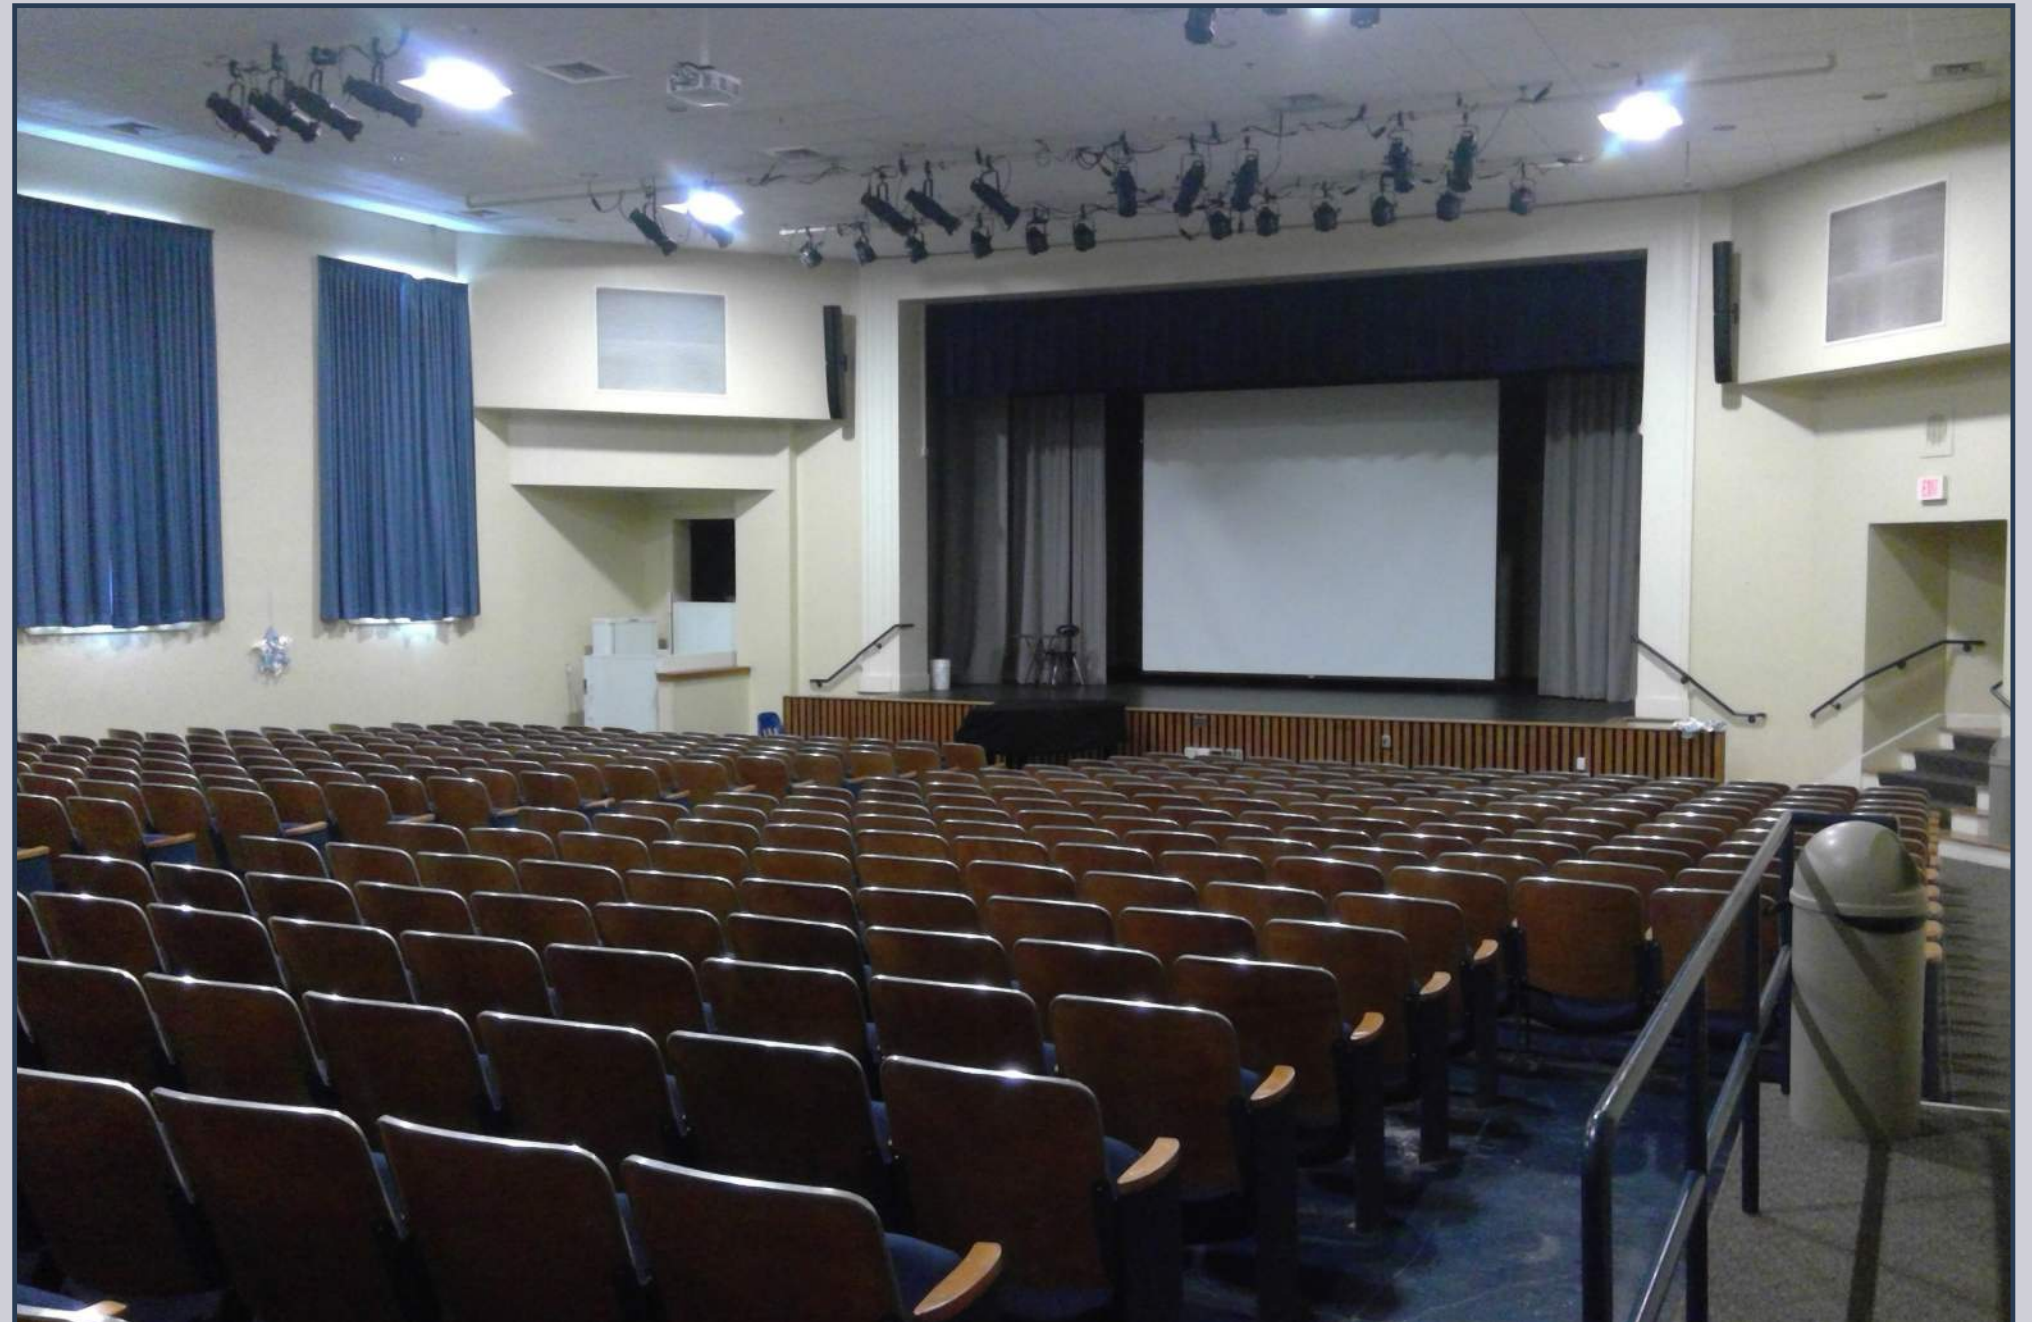
- No acoustical materials of an appropriate sound transmission class
- No flexibility of use or modern aesthetic
- Not appropriately sized for performance use or seminar use
