MINUTES OF THE MEETING
THE WOODSTOCK ACADEMY
BOARD OF TRUSTEES
BUILDING AND GROUNDS
COMMITTEE

(AST) ABOVE GROUND STORAGE TANK INSTALLATION (UST) UNDERGROUND STORAGE TANK REMOVAL AND PREPARED FOR

Corps Permit Number: NAE-2009-462

Project Name: Woodstock Academy Athletic Complex Expansion

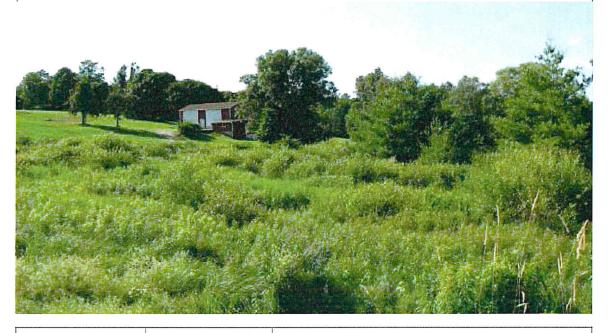
Photograph No.: 1 Date: 7-10-2009 Direction Taken: North

Description: Older photo showing WMMA before mowing started (from previous mitigation reports)

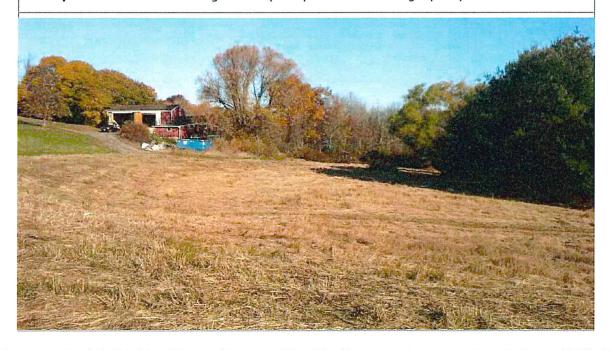
Photograph No.: 2 Date: 10-30-2015 Direction Taken: North

Description: WMMA after mowing in 2015 (from previous monitoring reports)

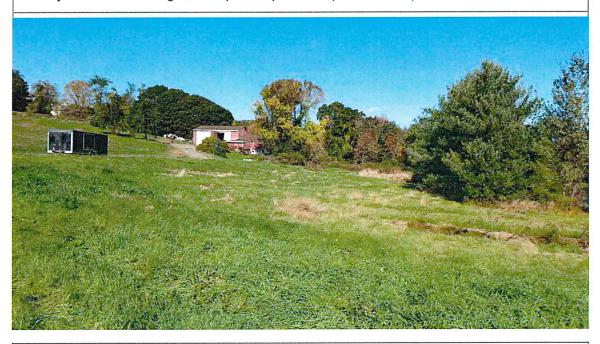
Photograph No.: 3 Date: 10-18-2018 Direction Taken: North

Description: WMMA during 2018 inspection (reference photo location)

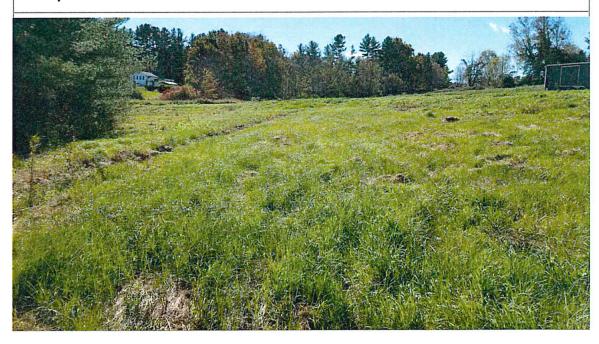
Photograph No.: 4 Date: 10-18-2018 Direction Taken: South

Description: View within WMMA.

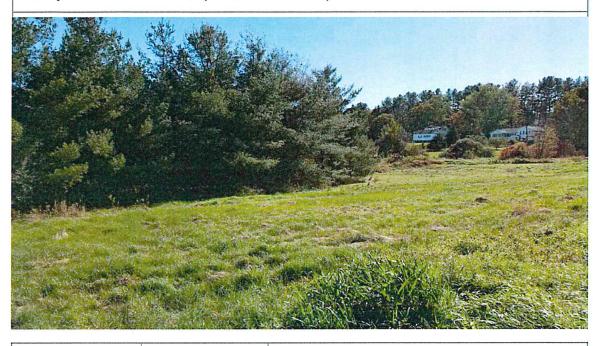
Photograph No.: 5 Date: 10-18-2018 Direction Taken: southeast

Description: WMMA view from upland buffer and cart path to the southeast.

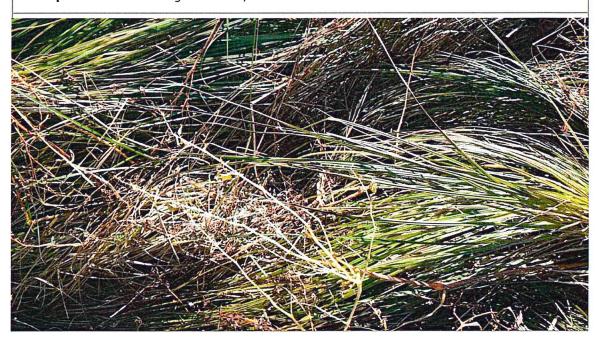
Photograph No.: 6 Date: 10-18-2018 Direction Taken: detail

The dominant vegetation observed in the WMMA remains a sedge. This sedge is thought to be tussock sedge (*Carex stricta*) growing in a non-tussock form in this area. The grass bluejoint (*Calamagrostis canadensis*) is a co-dominant in parts of the WMMA and to the north of the mowed area.

Description: Dominant sedge in WMMA, assumed to be Carex stricta variant

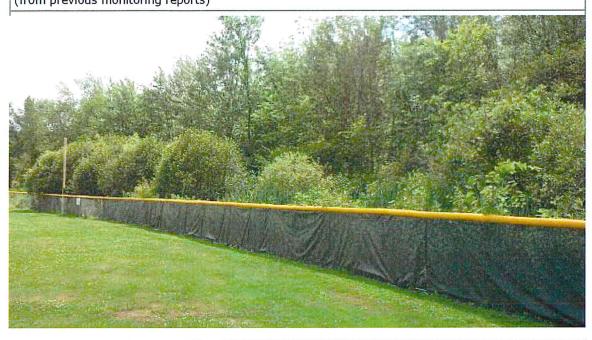
Photograph No.: 7 Date: 7-17-2014 Direction Taken: southwest

Description: SCEA mitigation area following shrub planting, note areas of existing shrub canopy (from previous monitoring reports)

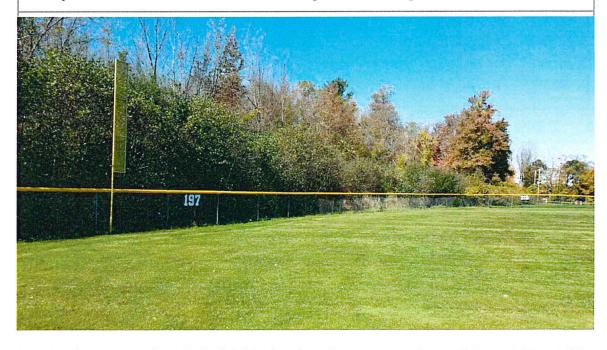
Photograph No.: 8 Date: 10-18-2018 Direction Taken: northwest

Description: View of SCEA from softball field during 2018 monitoring visit
