Oakdale Joint Unified
DRAFT School District
Facilities Needs Assessment & Master Plan
May 2024

Oakdale High School - Master Planning Evaluation

SAMPLE SITE ASSESSMENT-Oakdale High School

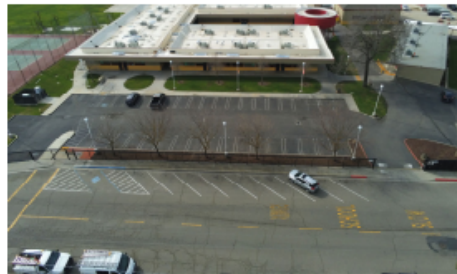
Site

1. Parking and Traffic Flow and Paving

There are three distinct parking lots with one along G street to the west used by staff and a small lot on the east for staff. There is a large student lot on the west in the center of campus accessed from

Hinckley. All parking lots are enclosed by decorative iron fencing with rolling gates electronically operated that remain closed during the day. The student lot also has a drop-off area adjacent to the gym plaza. The paving is beginning to show its age and showing a number of cracks with patchwork from years of campus upgrades. All lots are in need of repaving and restriping with some redesign of the student lot for better circulation and flow. There is no designated visitor parking on site so on street parking needs to be used. A designated warning crosswalk has been added at the front of the campus for students and visitors to use for protected ADA access to the entrance. The buses drop off from an access drive off J street at the back of campus through an electronic rolling gate to a circle drop off loop with a covered shade structure waiting area and ADA loading zone. Paving is in good condition. Various ADA spaces are provided in different locations at the various parking lots.

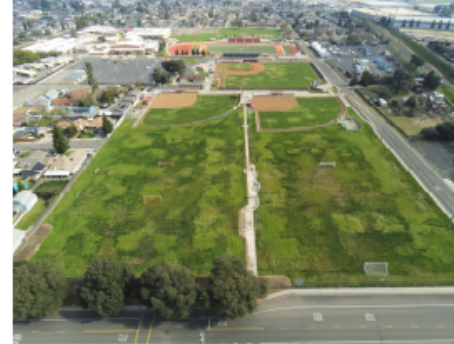
The campus provides adequate sports fields for baseball, softball, soccer and football. The fields are in generally good condition, with numerous amenities. The soccer fields have now aged to the point that they have developed some drainage concerns and need to be renovated. The baseball and softball fields, both the turf and dirt, are in good condition, complete with fences and warning tracks. Lighting is provided for soccer fields and is on good operating condition.

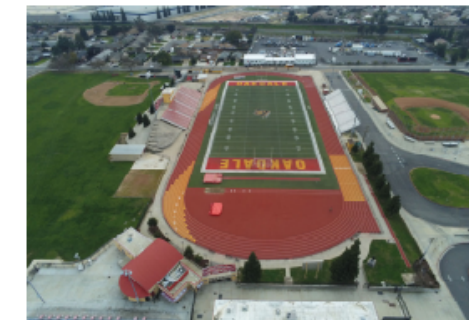
Stadium- The artificial turf was replaced about 4 years ago and the synthetic track was resurfaced about a year ago and are in excellent condition. The visitors bleachers are newer aluminum bleachers from the last ten years. The bleachers on the home side are older and have been resurfaced. They are structurally sound but have open risers and no ADA seating. The structure below is starting to show its age and plans for renovation need to be accounted for in the future. The press box is two story and has recently had the exterior wood resurfaced but the interiors are old and need to be updated. There are new restrooms as part of a building shared with the aquatic center. They are ADA compliant and in excellent condition. A smaller restroom building on the south side of the stadium is old and small and beyond its life and need to be replaced. There is one concession building that needs to be updated. The scoreboard is older and showing its age.

Baseball- One of the premiere high school baseball facilities in the area. The dugouts are CMU and there are some portable aluminum bleachers behind the backstop. The scoreboard is in good condition along with outfield fences. There are batting cages in a excellent condition and an adjacent restroom facility that is CMU but age and use is showing wear and the need to be renovated and improved.

Softball- Also one of the best softball fields in the area, there are CMU dugouts and bleachers and batting cages much like baseball. The scoreboard is excellent and the fences are also in good condition.

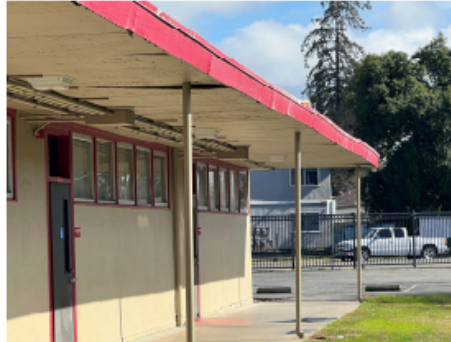
18. Exterior Building Finishes

Most all building exteriors are stucco or cement plaster with the exception of concrete exterior walls at the Main Gymnasium. A couple buildings in the athletic area are CMU painted exteriors. All of the exteriors are in good condition. The portables are all T1-11 plywood siding and older, except for one unit, and in need of upgrades in fair to poor condition.

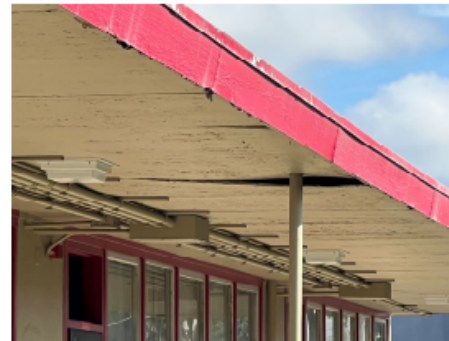
19. Roofing Facias, Gutters and Soffits

Most of the roofing is a coated built-up system with varying slopes, except for one building which has a standing seam metal. Those buildings with overhangs have wood fascia's, some showing

damage from age and exposure to the elements with plywood soffit in similar condition. The new Library and Classroom complex has stucco soffits in good condition.

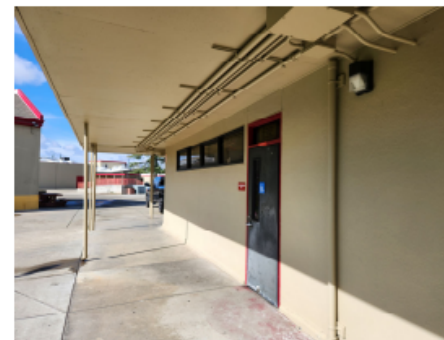
22. Exterior Doors and Hardware

There are various combinations with the older buildings comprised of wood doors and hollow metal or wood frames. Newer buildings and remodeled facilities are HM frames with HM doors and FRP doors, which are showing some fading with sun exposure. The newer doors have ADA compliant hardware in good condition. The original buildings

and the portable buildings generally do not have ADA compliant hardware and they are in aged condition.

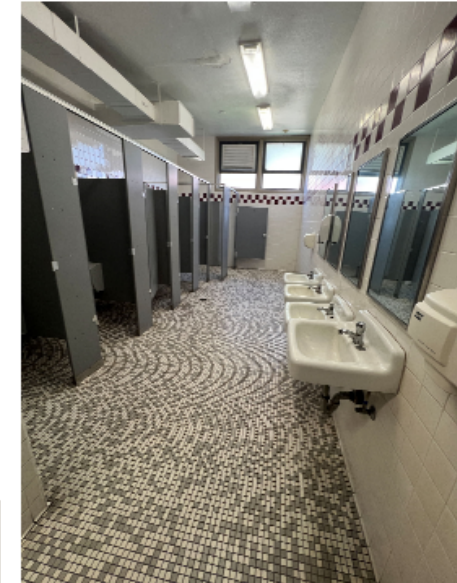
31. Student Restrooms Finishes/Accessories/ Fixtures

There are numerous sets of large student restrooms that are ADA compliant and in good condition. They have tile floors and walls with painted gyp board ceiling. The partitions are plastic urethane and fixtures are in good condition with ADA compliant hardware at doors. There is a lack of designated Gender Neutral restrooms

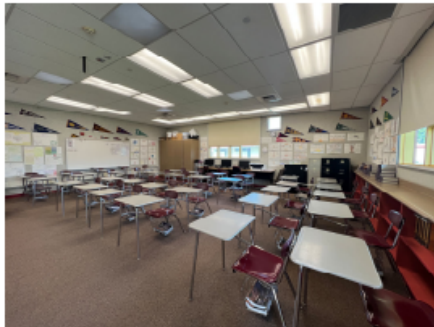
35. Interior Lighting

Lighting is good with use of drop-in 2 x 4 light fixtures in ceiling grid or 2 x 4 surface mounted fixtures..

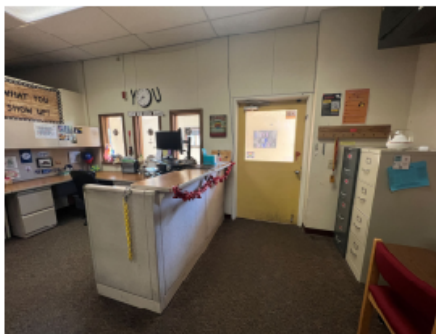
43. Interior Wall Finishes

The office areas are mainly painted gyp and concrete walls, with minimal tackboard in fair to good condition. The library has painted walls in good condition while the cafeteria has painted gyp board and plastic laminate wall panels. concrete and gyp board walls with bright murals and is in good condition. The gyms have painted concrete and

painted plywood wall finishes in fair to good condition. The locker rooms have painted gyp board walls that are showing wear from their use.

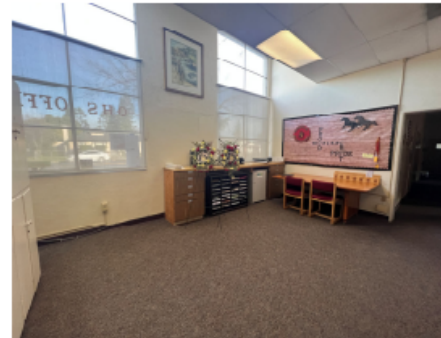
44. Flooring

The office has mostly carpet with VCT in selected high use locations that are older and in wearing. There is still some VAT present in older rooms that needs to be abated or encapsulated. The library and computer room have carpet flooring in good condition. The gymnasium has VCT in the lobby, concrete in the locker rooms and an athletic wood floor in the main gym and all are in fair to good condition. The wood floor is original and has been refinished for the last time a few years ago and will need to be replaced. The small gym has a synthetic floor in good condition. The cafeteria has VCT flooring in a checkerboard pattern in good condition.

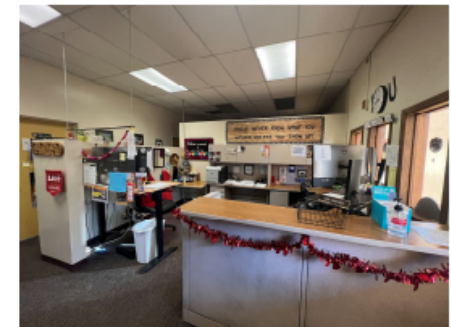
48. Casework

Library has a large plastic laminate circulation desk with laminate counters and shelving in good condition. There is older wood and laminate casework in the office that is aged and wearing while there are numerous display cases in the gym lobby.

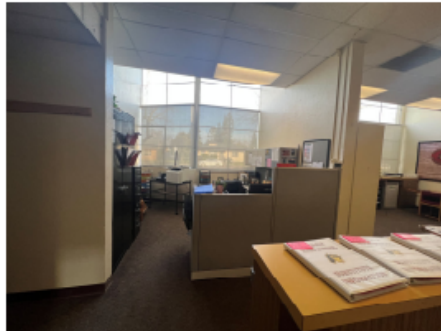
57. Administration Office

Based on the age and construction, the administrative office has rooms that are small and laid out in maze-like manner. Offices are spread out and disconnected and they have tight clearances and lack ADA compliance. The size and function of the space works well but lacks the newer specialty support staff spaces required at schools today, with some of those offices located remotely in other buildings. A complete renovation to accommodate functionality and refresh interiors and ADA would be desirable.

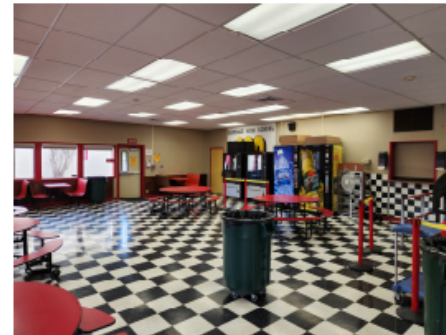
59. Cafeteria and Kitchen

The campus has a very small cafeteria for the current student population with serving kitchen. The interior of the space is inviting with a black and white checkerboard floor, but it is not adequate for a campus of this size. Additionally, it does not function as a multi-purpose building because it has no stage or other functions to contribute to a multiple use situation. It is centrally located and there is an outside cooler/freezer unit for the kitchen which also would need expansion.

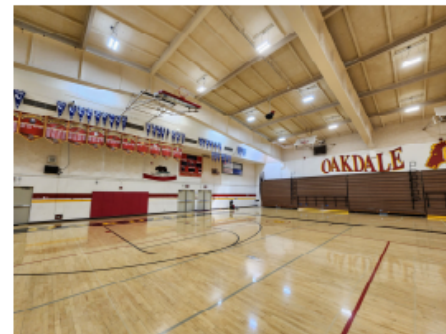
60. Gymnasium

There are two gymnasiums. One is the older original small gymnasium used for PE and practice and was recently updated. The other gym is the Main Gym which is used for practice, competition, events and PE. It is well sized for the campus and has a large lobby, concession, storage and restrooms with upgraded boys locker room and a new plaza space for the public. There is a main court with two cross courts and 12 rows of operable bleacher seats on each side of the court but they lack full ADA compliance.

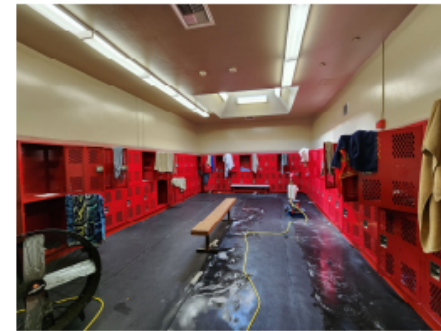
61. Locker Rooms

The Boys locker room is adjacent to the main gym and contains a large Team Room with a smaller team room in addition to lockers, showers, storage and raised coaches office with restrooms and shower. Adjacent to the Main Gym is a separate building that is the girls locker room which has a team room, lockers, showers, storage and raised coaches office with restrooms and shower. Both are adequately sized but need updates and enlarged team rooms

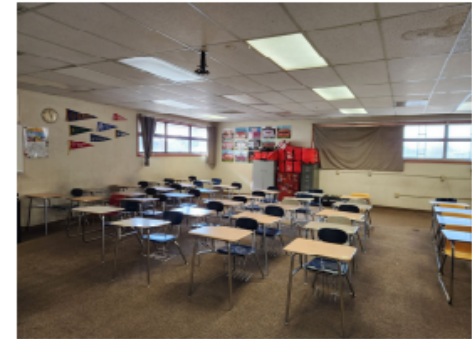
63. General Classrooms

There appears to be an adequate amount of classrooms that are properly sized. A majority are newer or recently renovated and appear to need minimal improvements. There are classrooms in the Main Building complex that are connected by interior corridors. Those classrooms are in old and have been renovated numerous times in a patchwork manner and in need of major renovation.

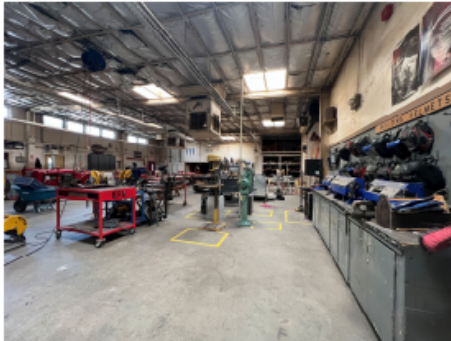
66. CTE and Specialty Rooms

There is a CTE complex that is comprised of an Ag Building that has classrooms and a multi-function shop and a CTE facility with classrooms, wood and auto shop. The Ag Building has numerous greenhouses and outdoor growing areas while both buildings have exterior covered areas with roll-up doors. The buildings are older, have had mechanical added on the roof and have had limited renovations. They need to be completely refreshed or replaced using a layout more consistent with current CTE space design.

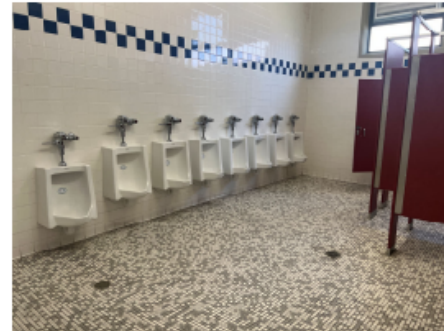
69. Student Restrooms

There are an adequate number of restrooms and fixtures disbursed through the campus. Most are accessible and in good condition.
