STATE COLLEGE AREA SCHOOL DISTRICT

District-Wide
Facility Master Plan Update
SCHOOL BOARD MEETING

FACILITY ASSESSMENT REPORT NARRATIVES (DWFMP)

6 | Park Forest Middle School

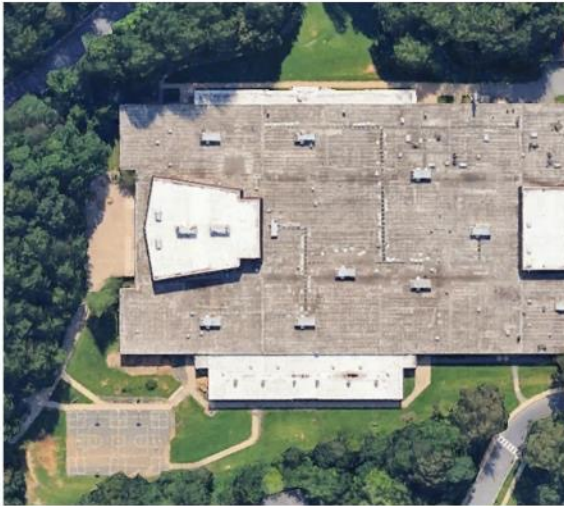
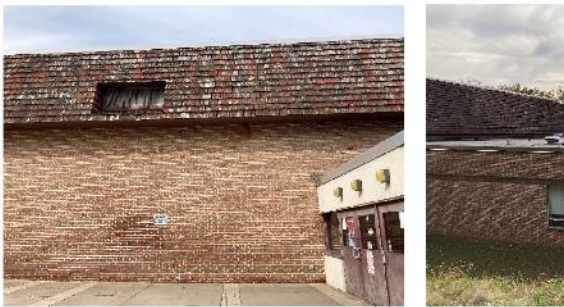
The roofs that are lighter in color on the plan below were roofs replaced membrane roofing system. The remainder of the flat roofs are built-up roofs. One of the higher roofs has a mansard style roof with wood shingles and one of the roofs replaced in 2015. The wood shingles appear to be in fair collected via roof drains and the internal roof water conductors run vertically. From there they run horizontally and tie into exterior underground storm
