RYE NECK UNION FREE SCHOOL DISTRICT

SEPTEMBER 20, 2023

Building Condition Survey

Observations, Findings & Opinions

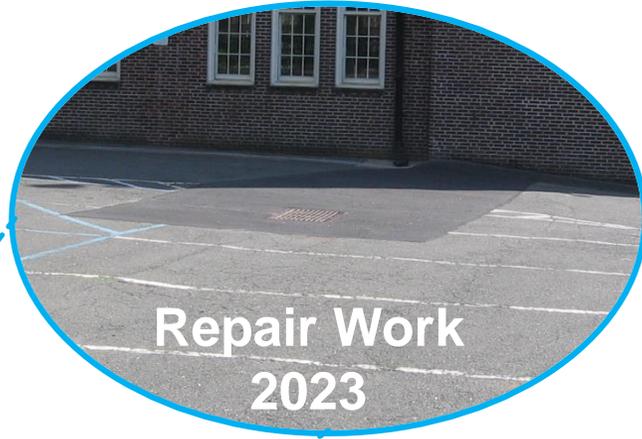
Sitework Improvements

- Pavement Replacement
 - Some Repairs Made Spring 2023
- Re-Striping
- Curb Replacement
- Fencing Repair
- Dumpster Enclosures

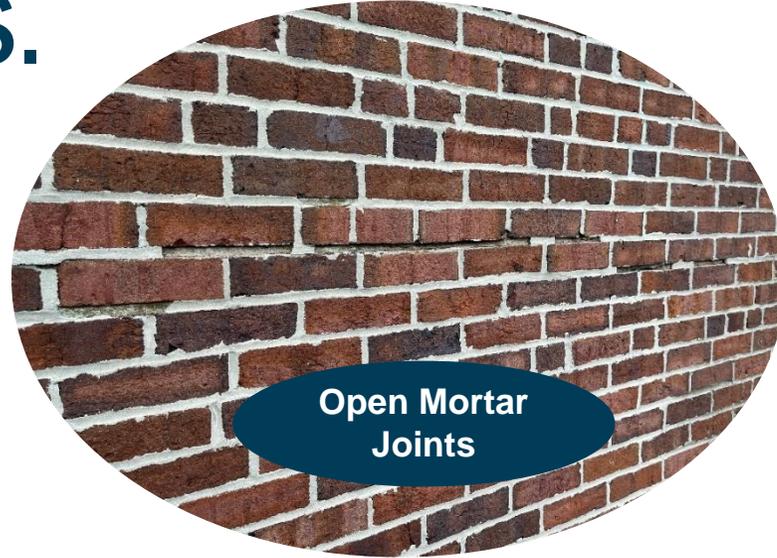
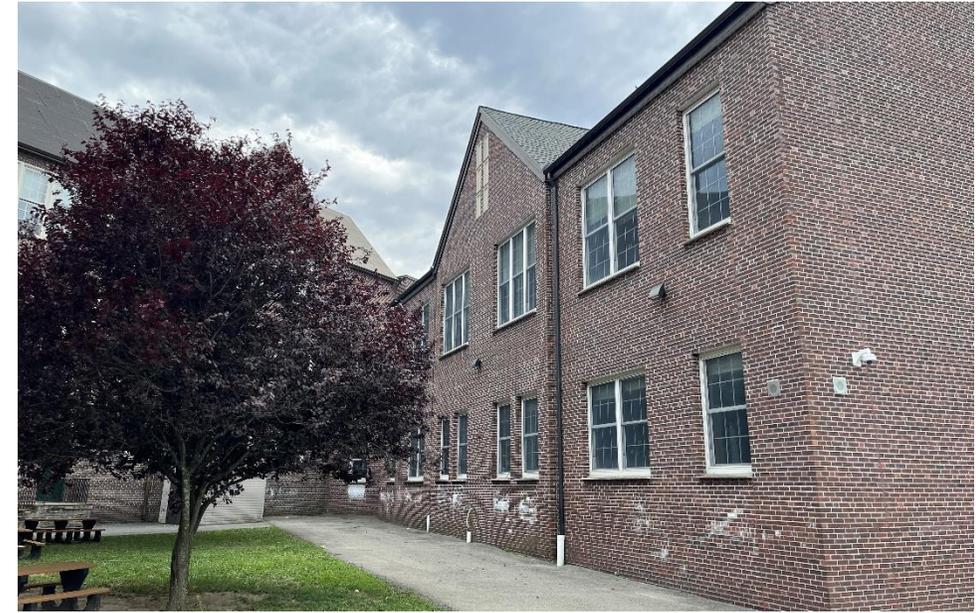
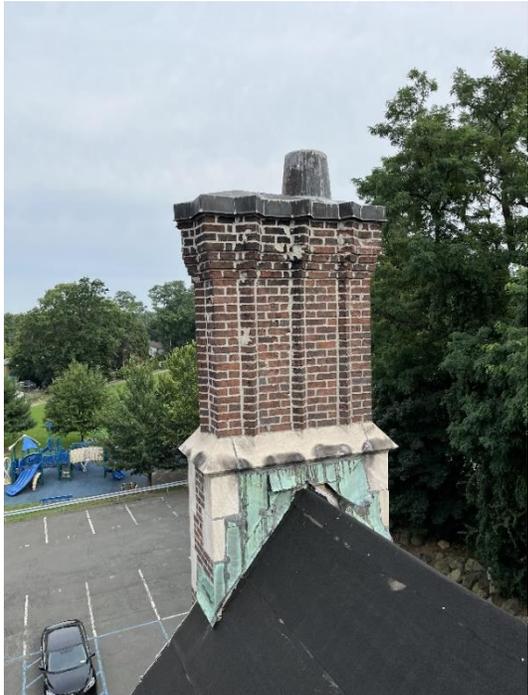
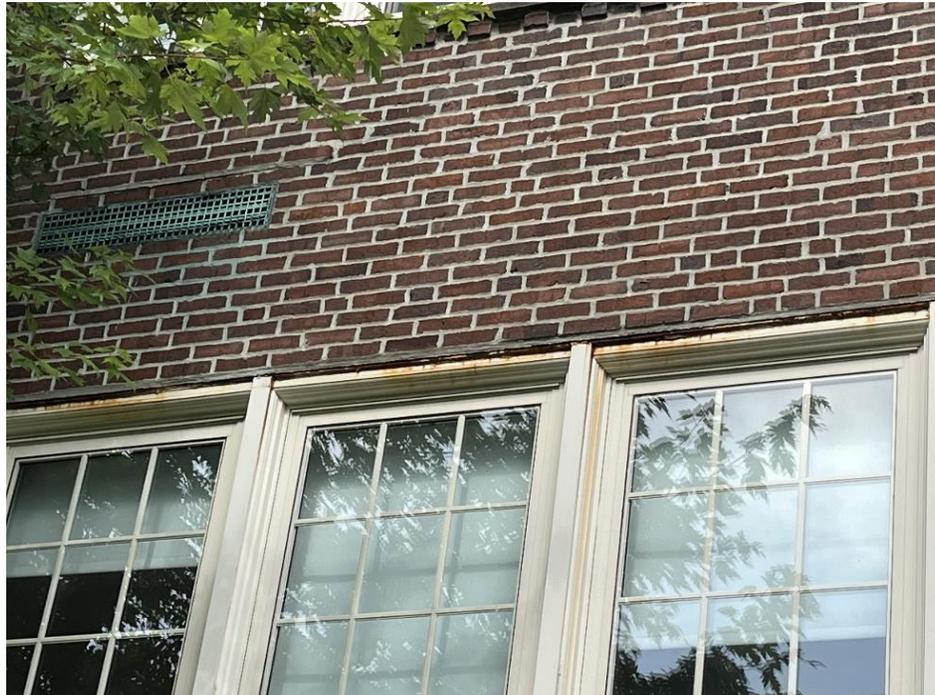
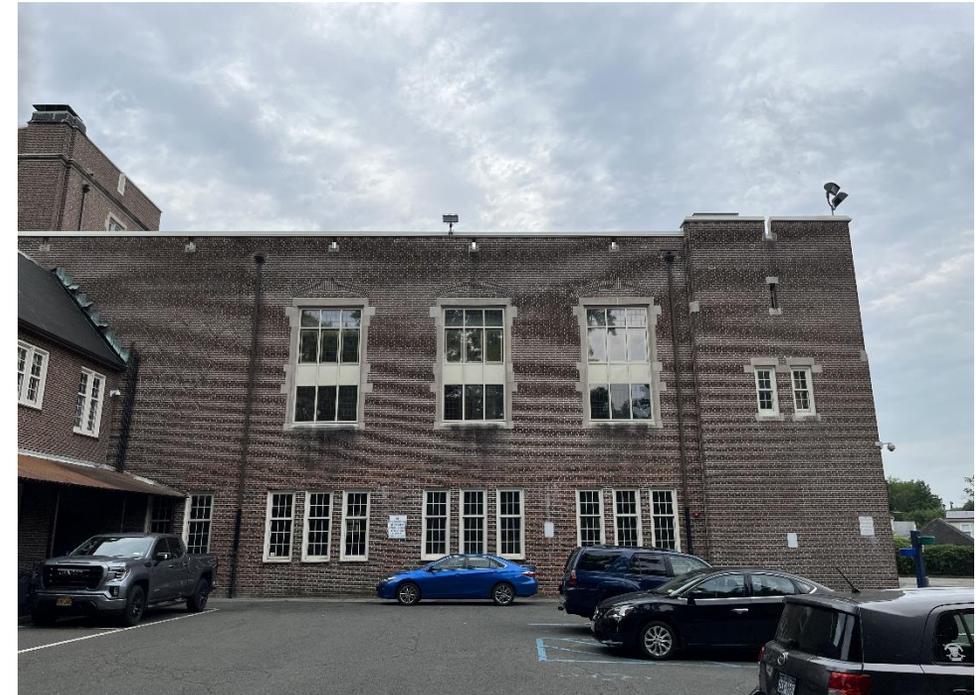
Envelope Improvements

- Masonry Repair and Repointing
- Masonry Cleaning
- Paint Window Lintels

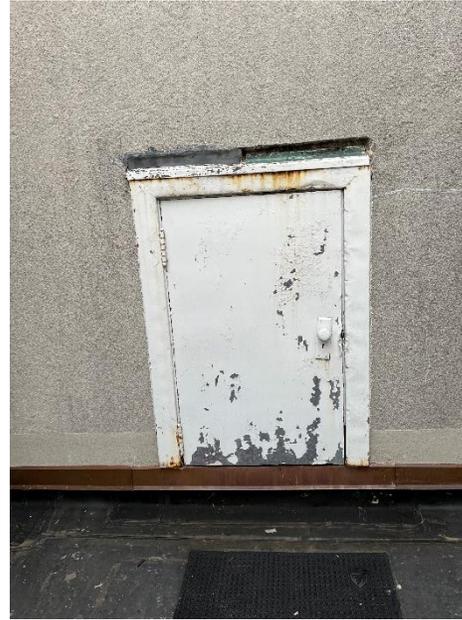
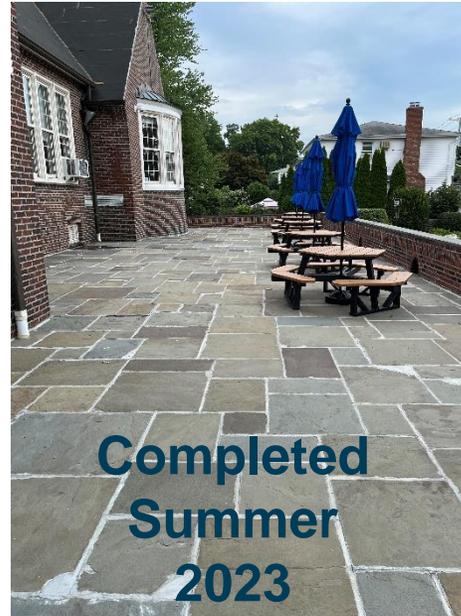
Envelope Improvements

- Window Replacement
- Attic Access Door Replacement
- Exterior Stair Improvements
- Reset Main Entrance Patio Stones
 - Partially reset in Summer 2023

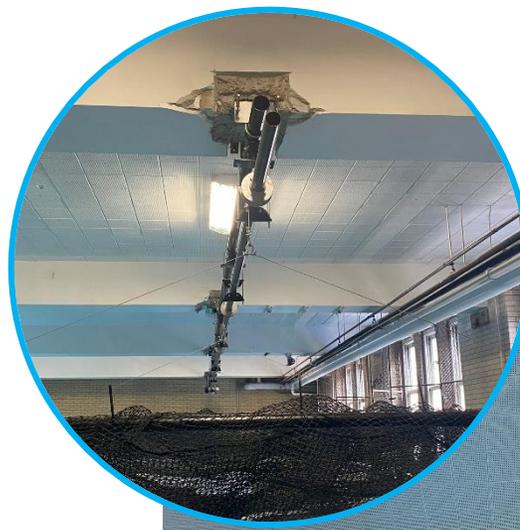
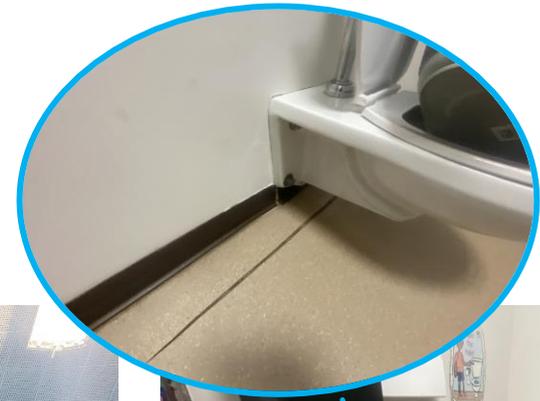
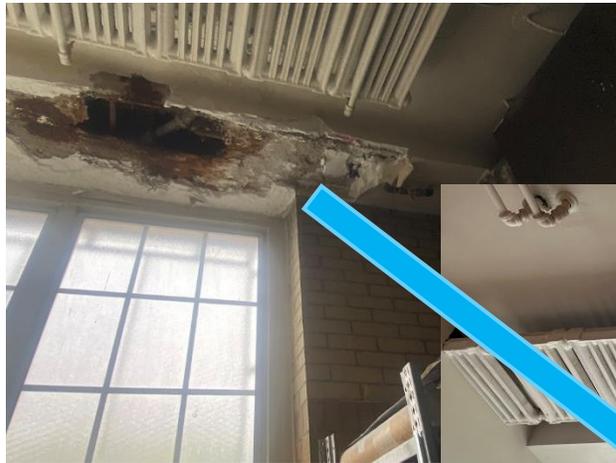
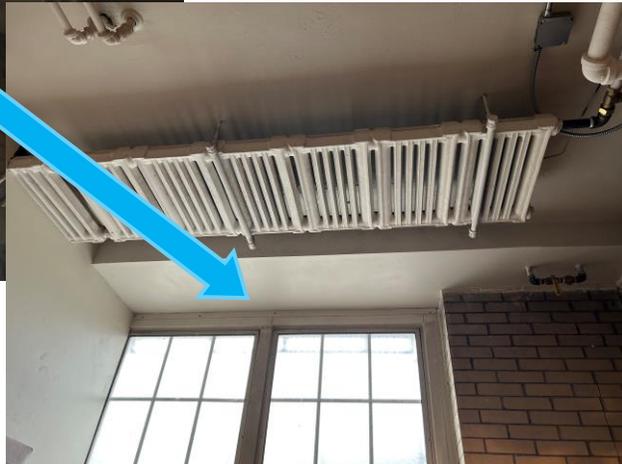
Interior Improvements

- Storage Room Fire Separation
- Ceiling Replacement
- Beam Repair
- ADA Signage
- Bathroom Flooring Repairs
- Nurse's Bathroom Renovation
 - Completed

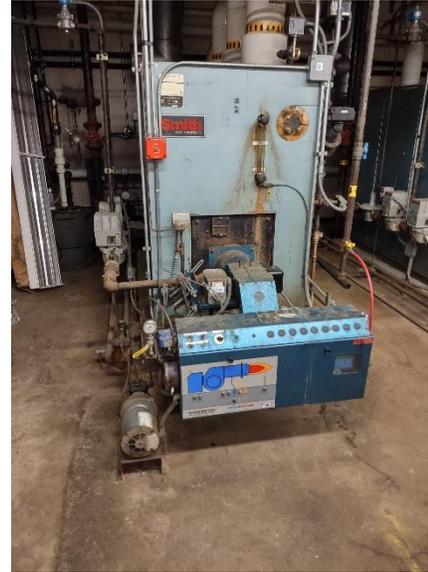
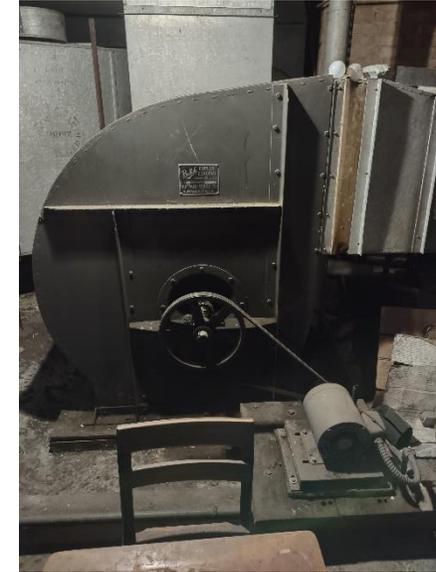
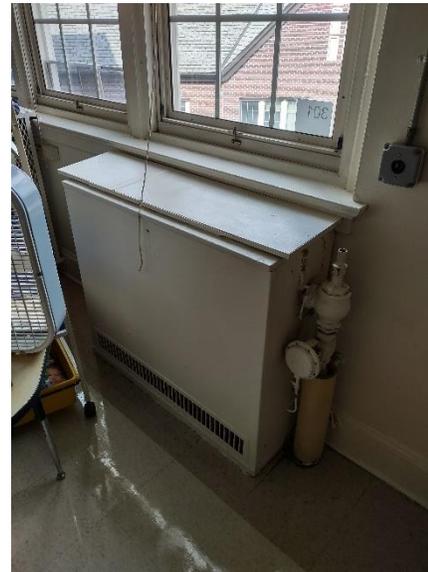
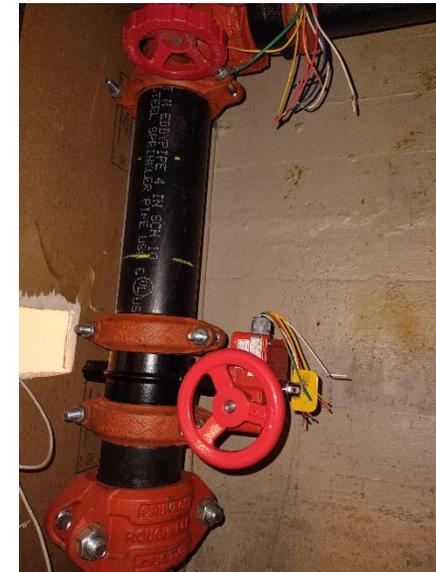
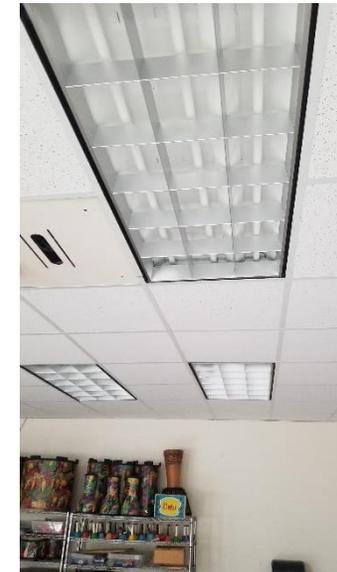
Electrical

- Replace outdated Federal Pacific Electrical Panels
- Upgrade existing fluorescent fixtures with LED
- Install energy efficient lighting control system
- Install fire alarm notification devices in classrooms

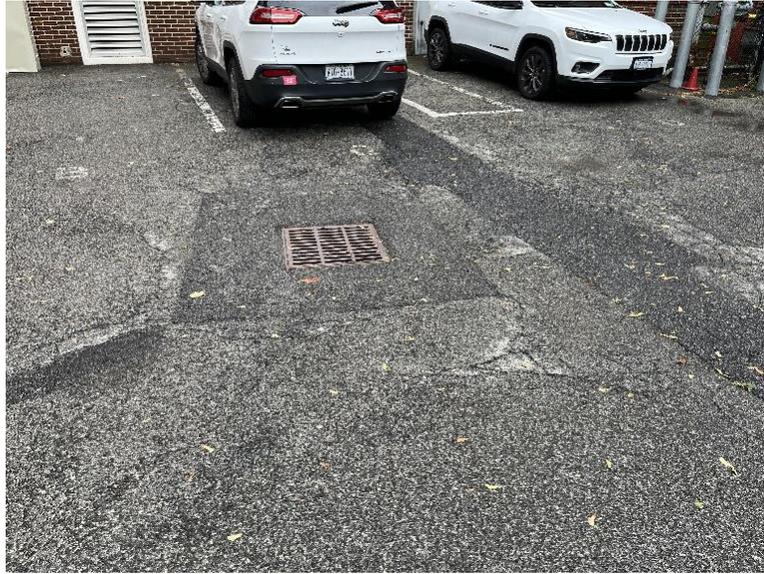
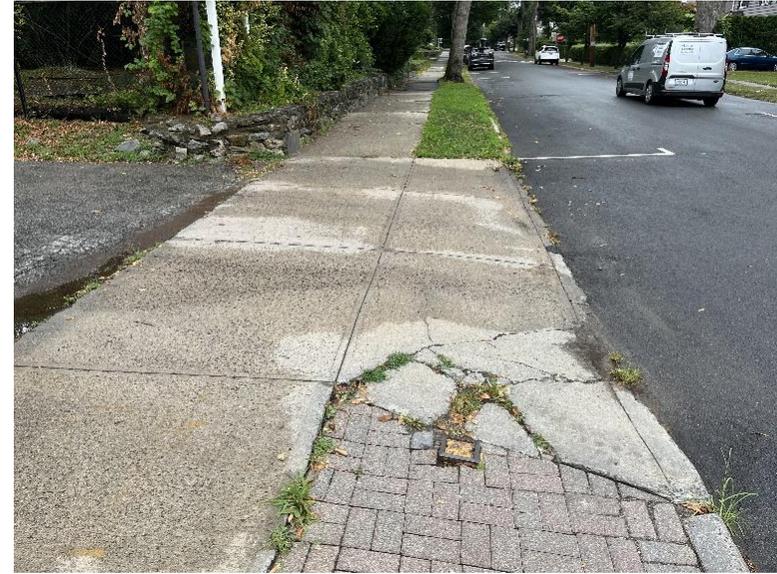
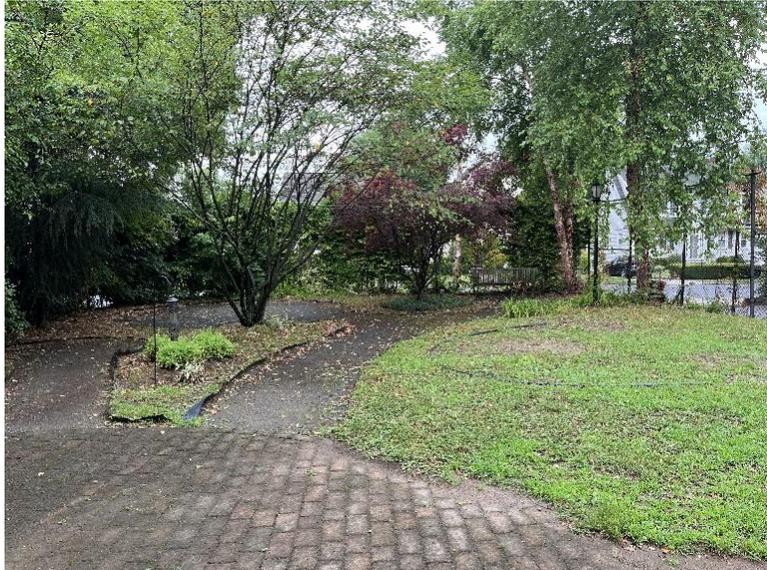
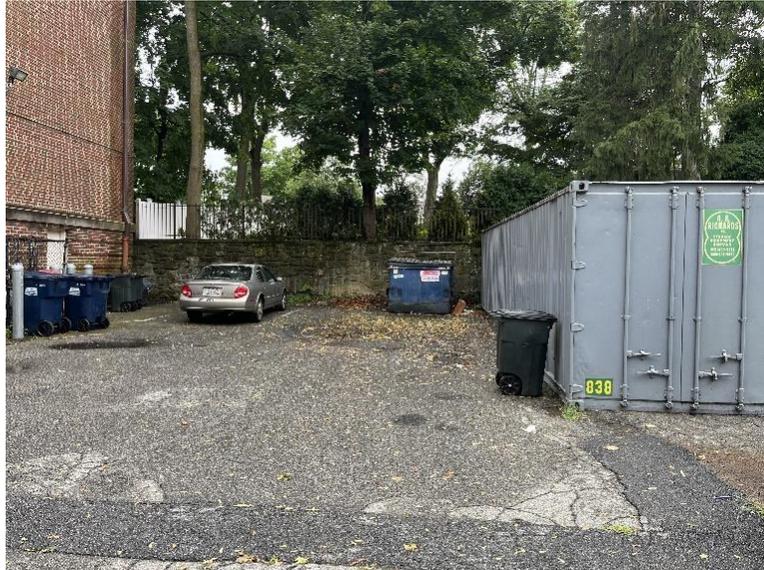
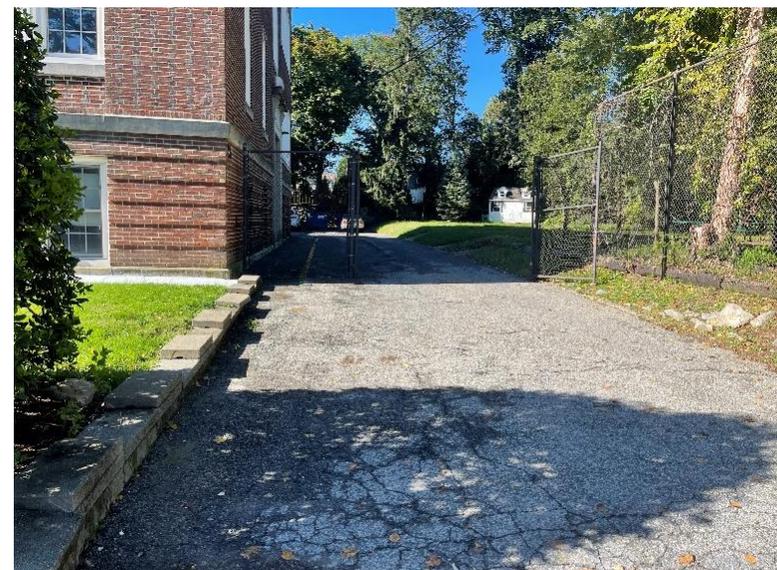
Sitework Improvements

- Paver/Walkway Repair (North Yard)
- Asphalt Repair/Replacement
- Catch Basin Repair
- Sidewalk Repair

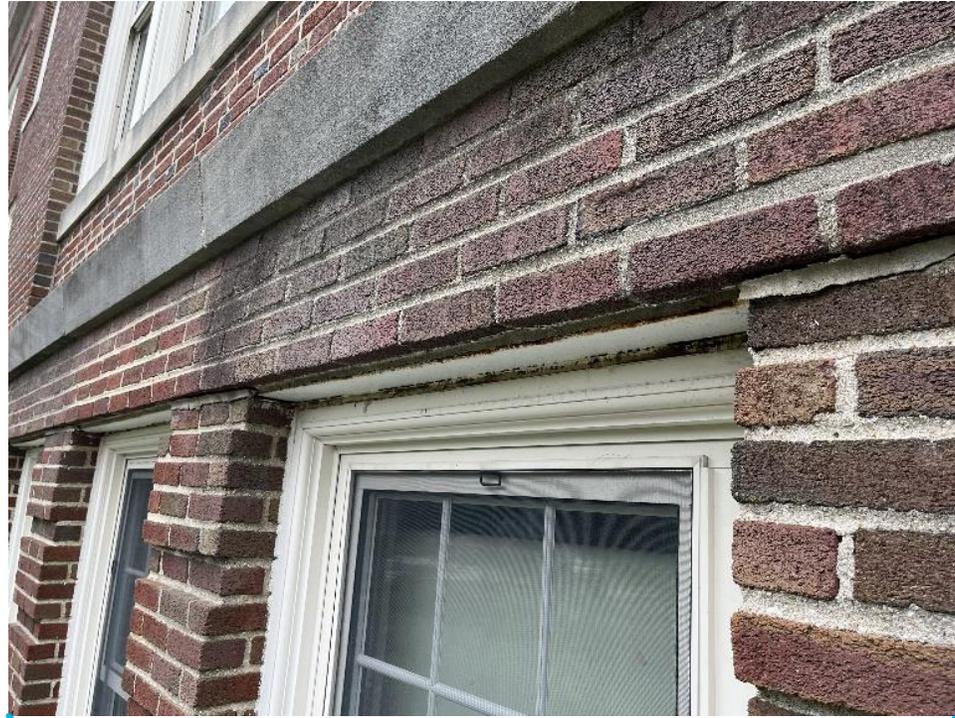
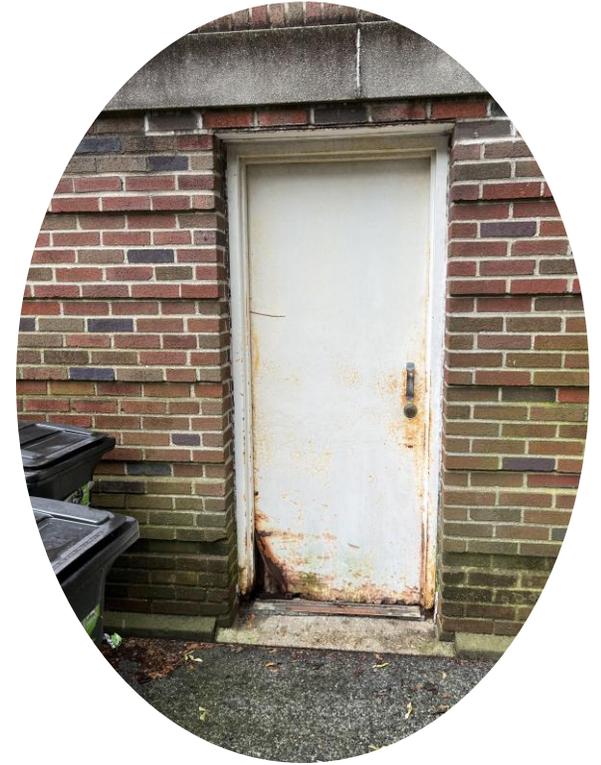
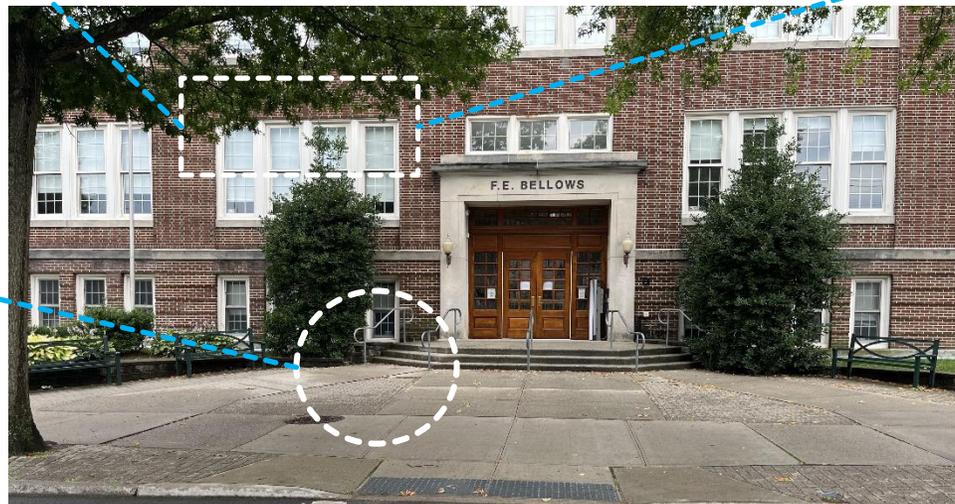
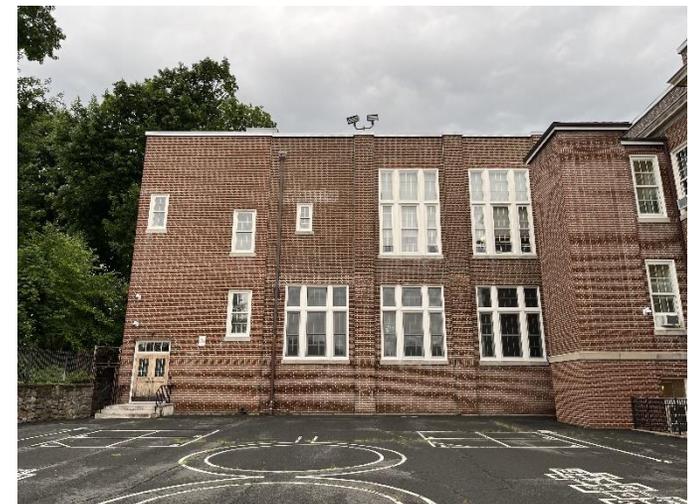
Envelope Improvements

- Masonry Repair and Repointing
- Masonry Cleaning
- Paint Window Lintels
- Exterior Door Replacement

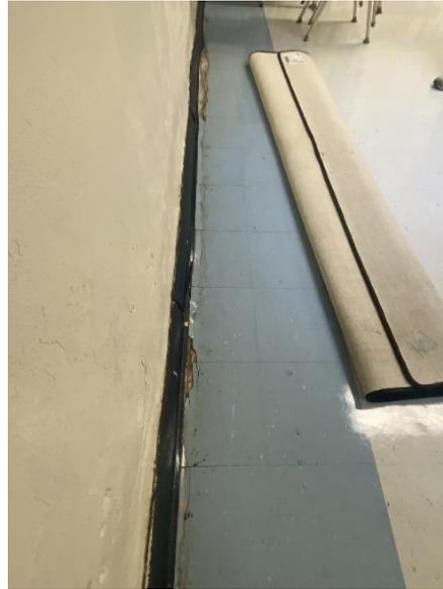
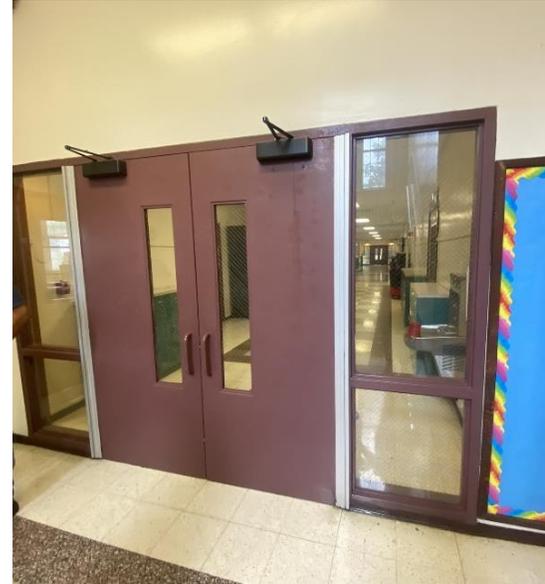
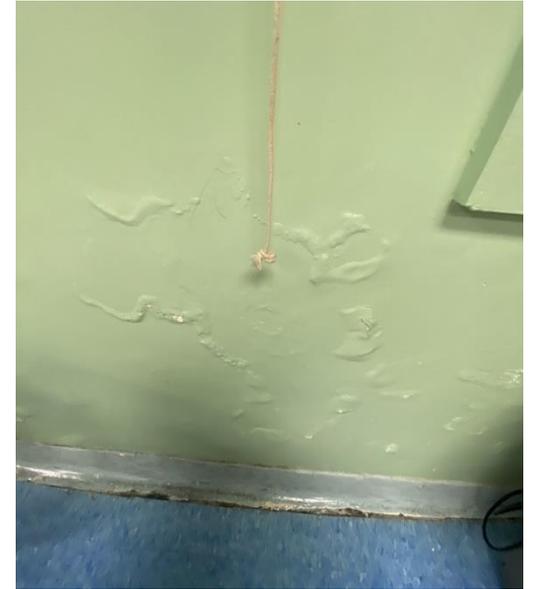
Interior Improvements

- Ceiling Replacement
 - Gym ceiling repainted Summer of 2023
- Plaster Wall Repair/Repaint
- Stair Door Replacement
- Flooring Replacement
 - Gymnasium
 - Classrooms
 - Replaced with LVT Summer of 2023

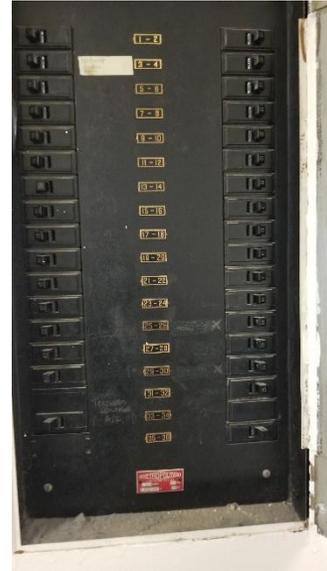
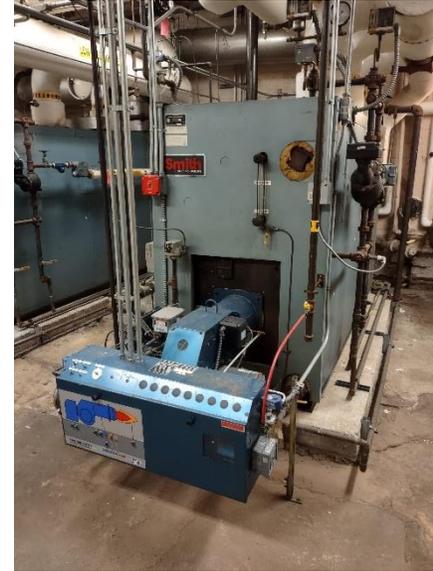
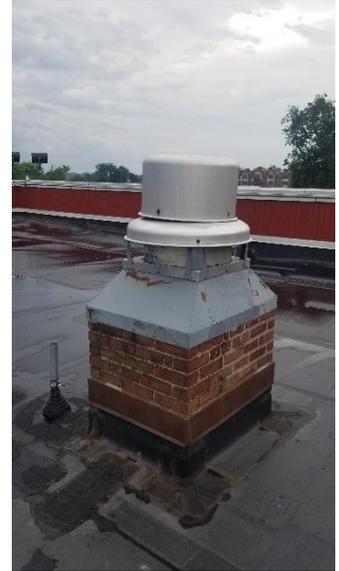
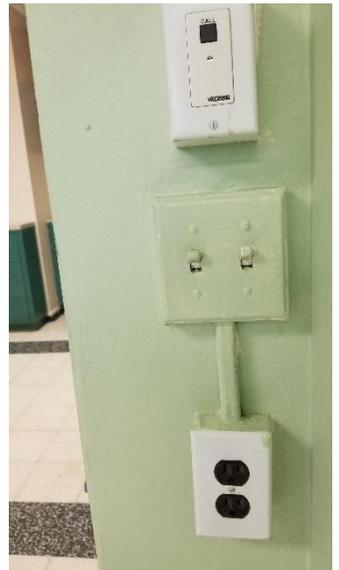
- Replace boilers if classroom unit ventilators and fan coil units are added for mechanical ventilation
- Replace (2) main general exhaust fans
- Install classroom unit ventilators and fan coil units throughout building, add air conditioning

Electrical

- Upsize Service for future expansion
- Replace outdated electrical panels
- Upgrade lighting throughout building with LED fixtures
- Upgrade lighting controls throughout building
- Upgrade classroom communication system

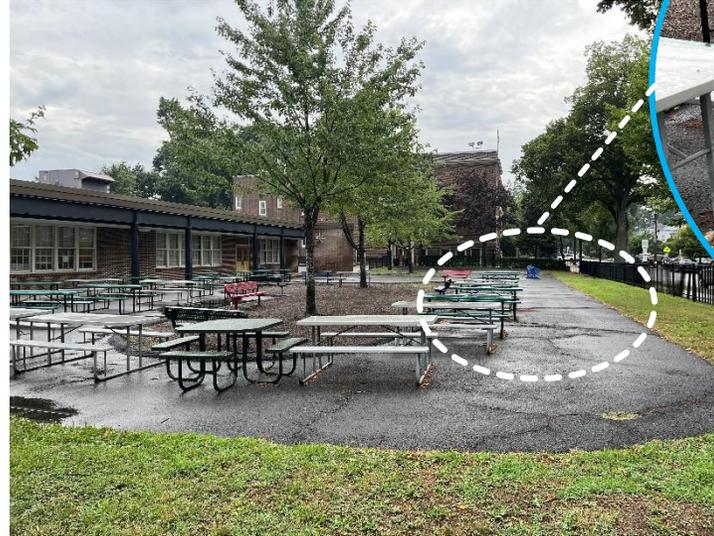
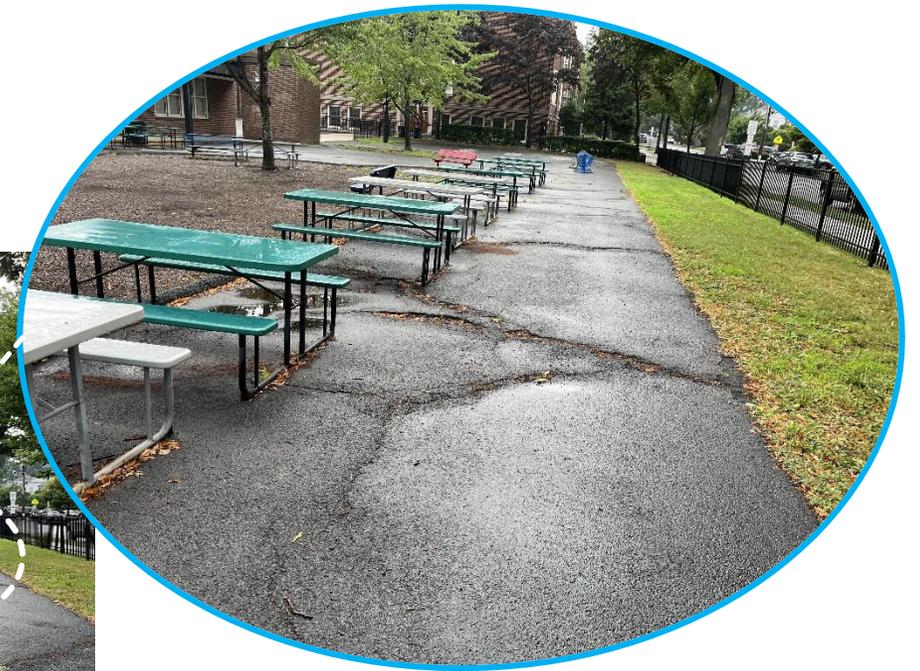
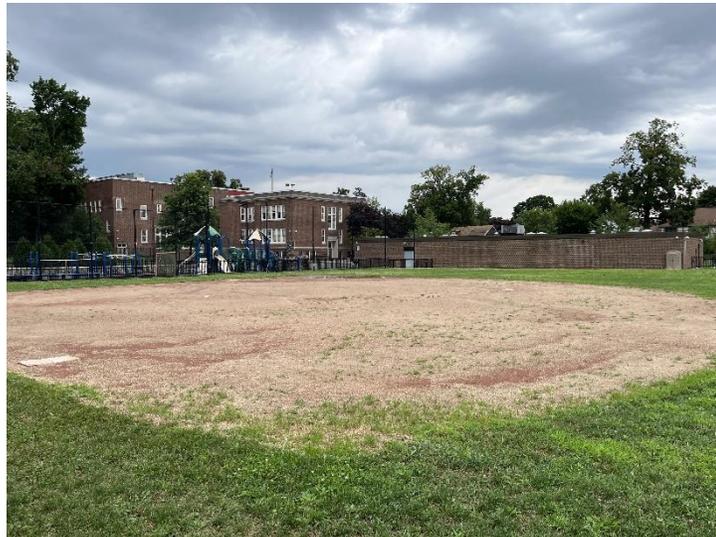
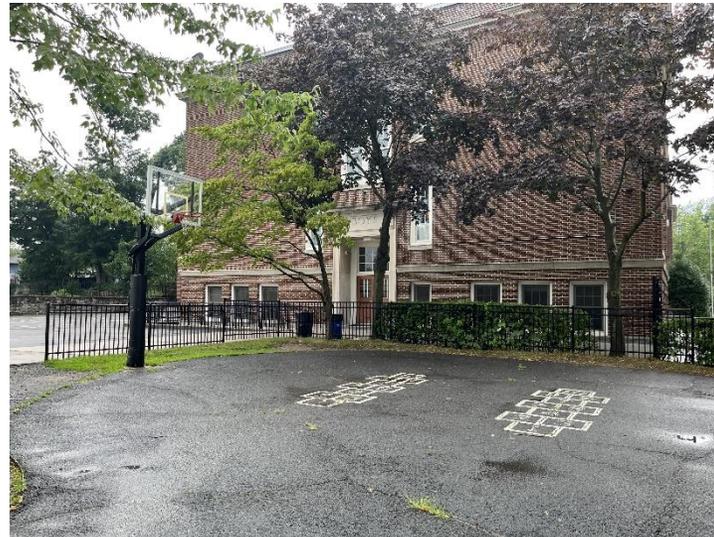
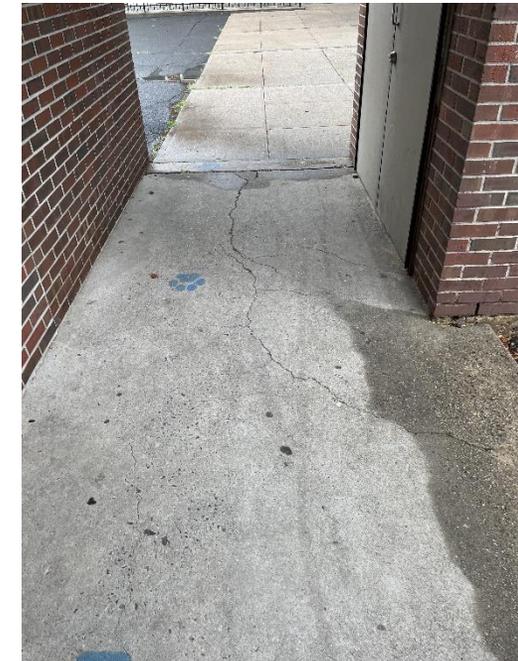
Sitework Improvements

- Repave Play Areas
- Restripe Surface Games
- Concrete Sidewalk Repair
- Resurface Baseball Diamond Infield

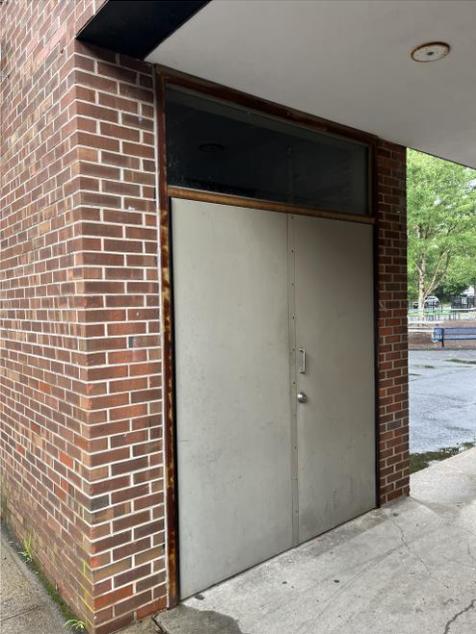
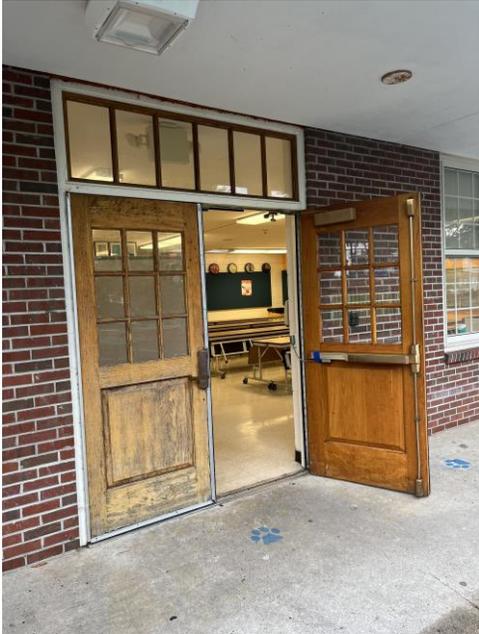
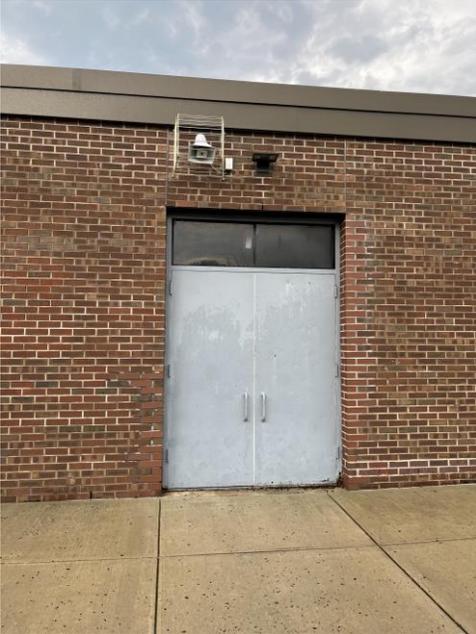
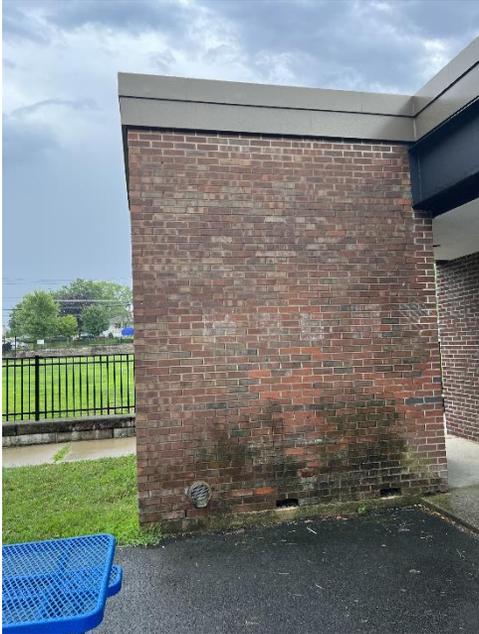
Envelope Improvements

- Masonry Repair and Repointing
- Masonry Cleaning
- Door Replacement

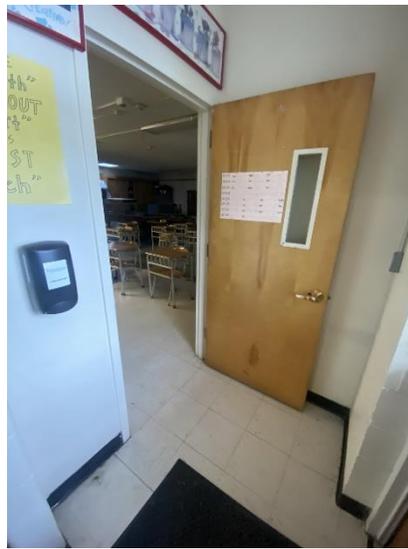
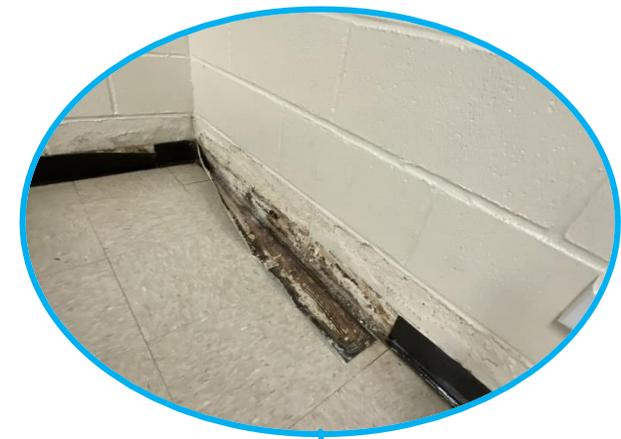
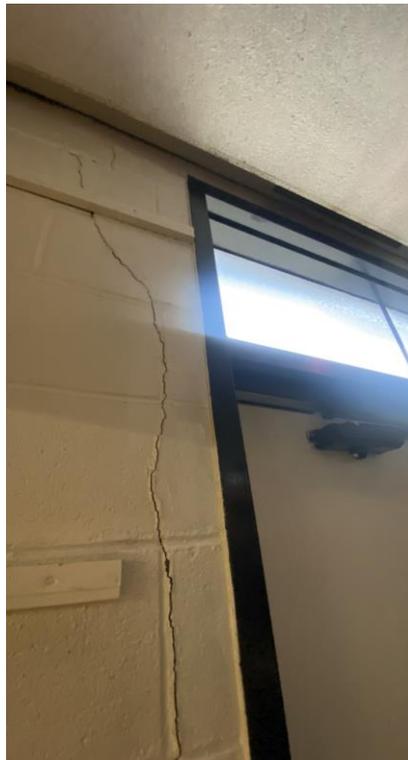
Interior Improvements

- Flooring Replacement
- CMU Wall Water Damage Repair
- Door Replacement
- Bathroom Renovations

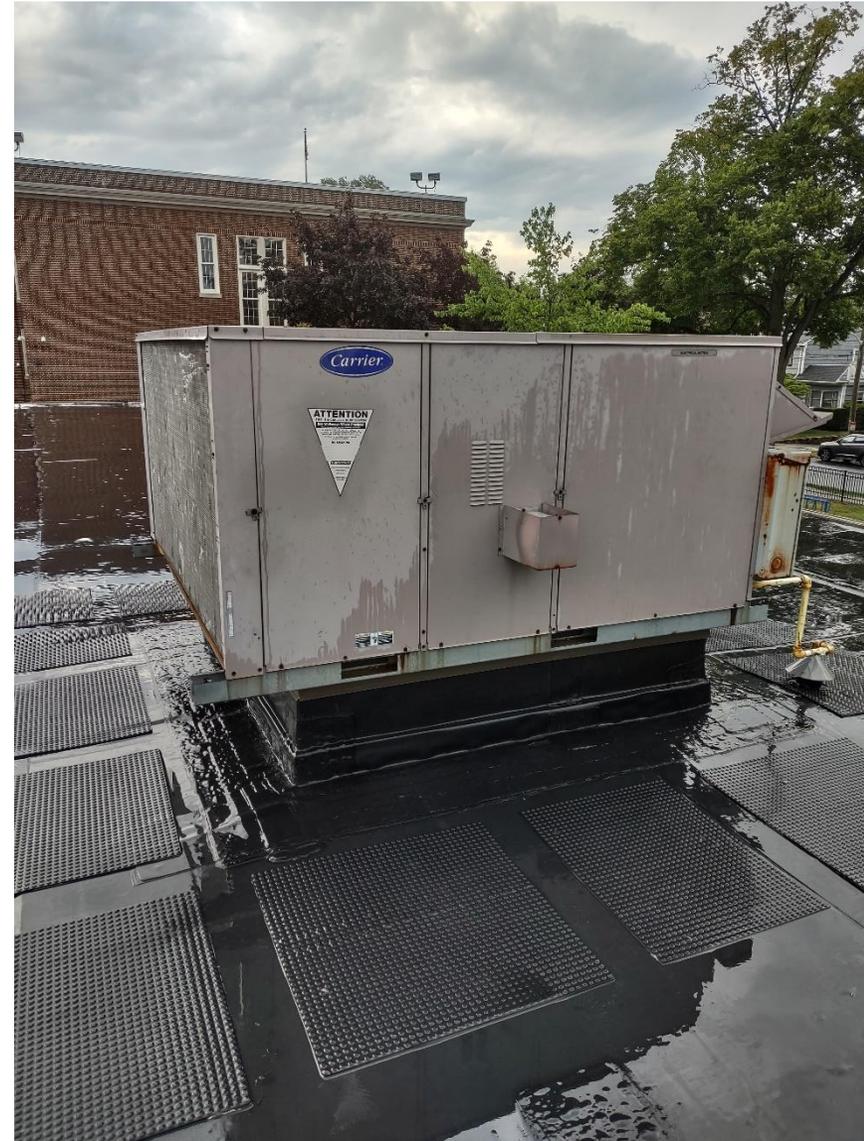
Mechanical, Plumbing & Electrical Improvements

- Replace 15-ton gas fired packaged rooftop unit
- Add variable air volume boxes (VAV)
- Update controls system to add VAV boxes and replacement rooftop unit

- Upgrade electrical service for future expansion
- Replace outdated electrical panels
- Upgrade light fixtures throughout building and building exterior with LED type

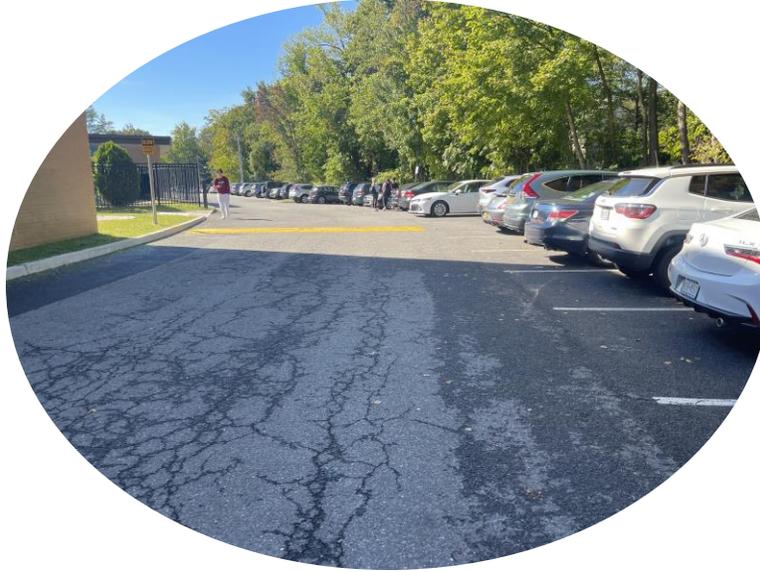
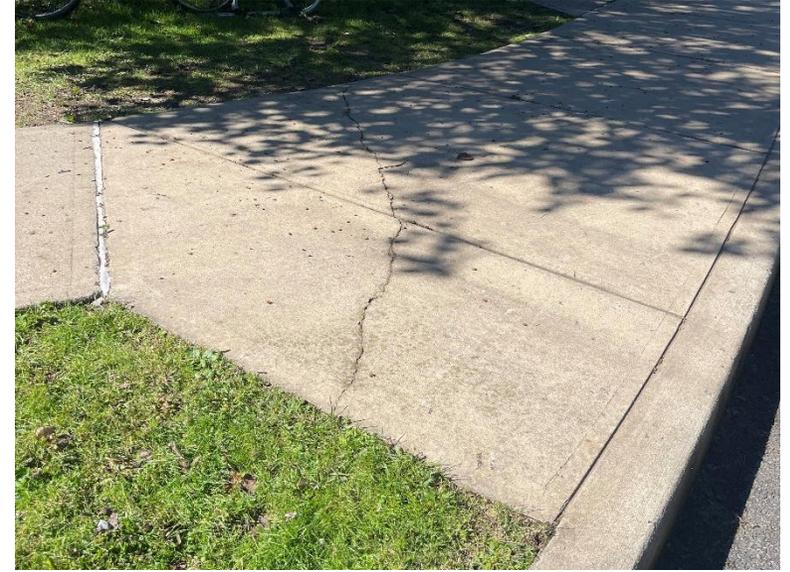
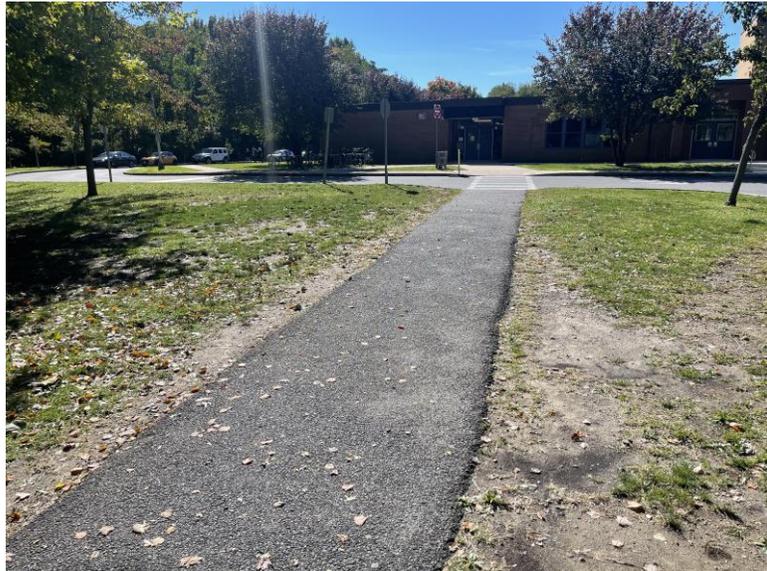
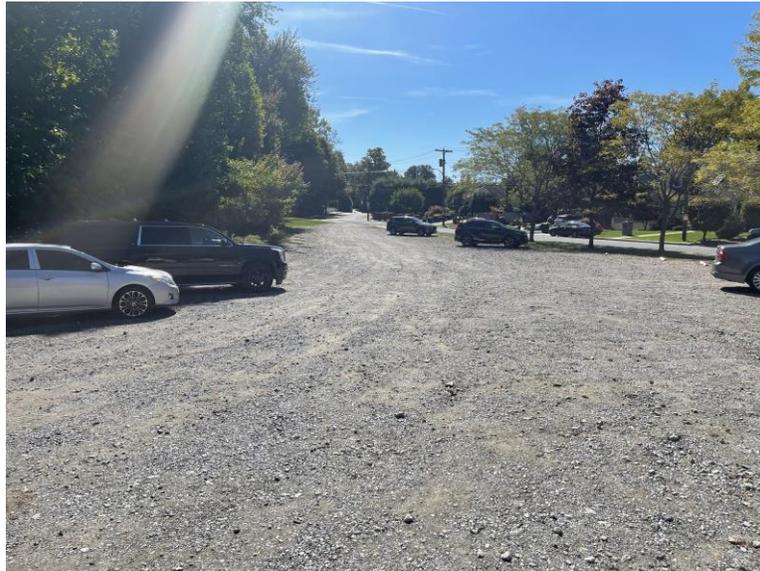
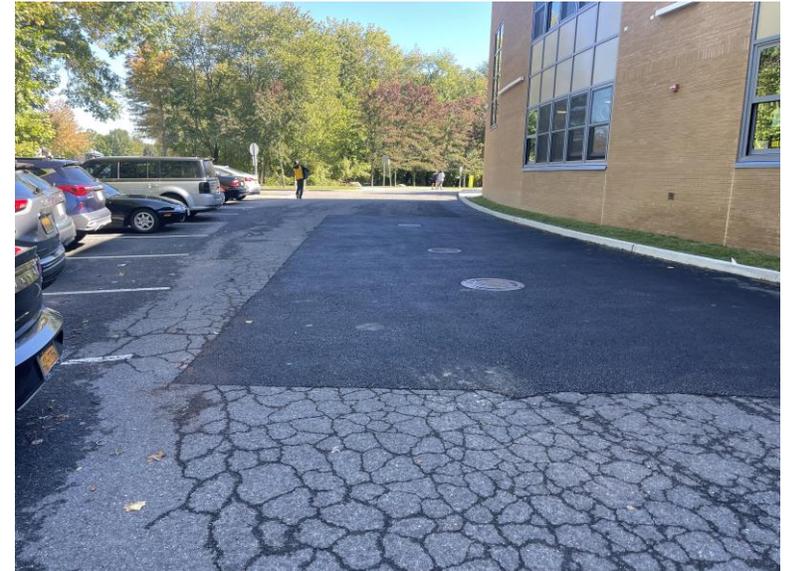
Sitework Improvements

- Asphalt Repair/Replacement
- Temporary Parking lot to Permanent
 - Project in Design
- Sidewalk Repair

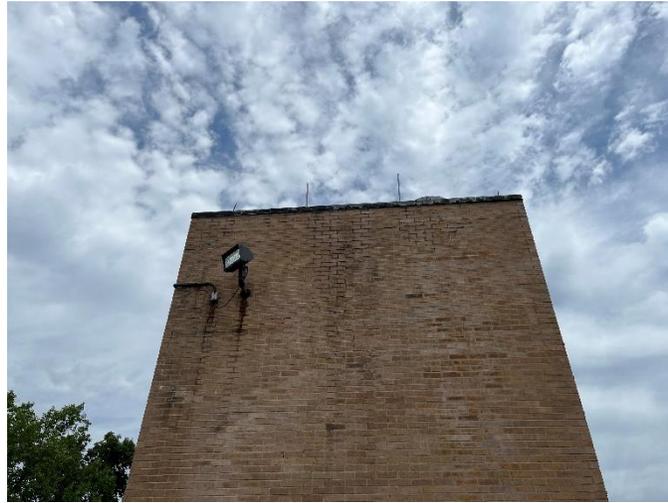
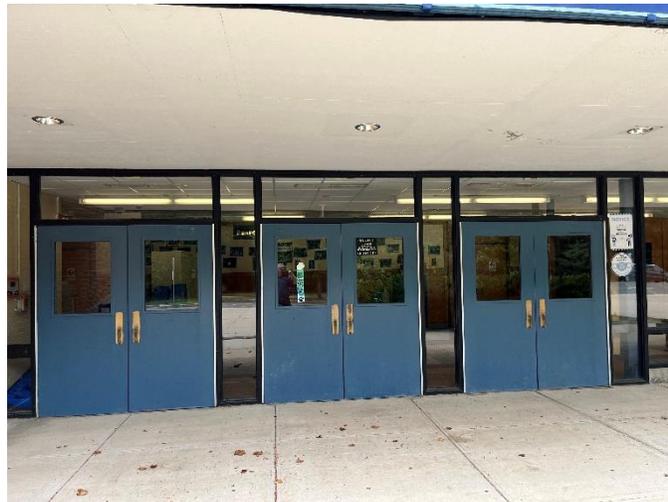
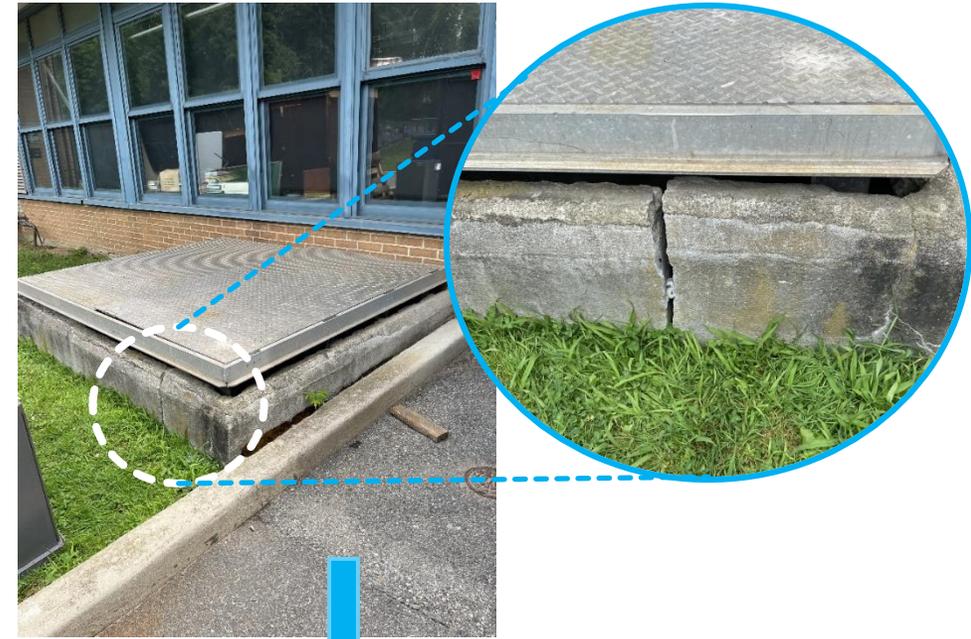
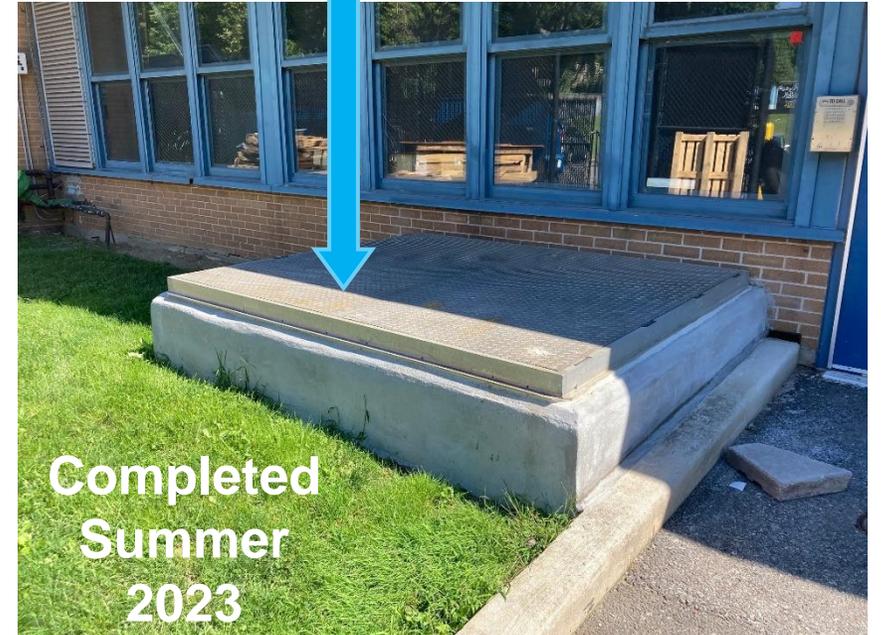
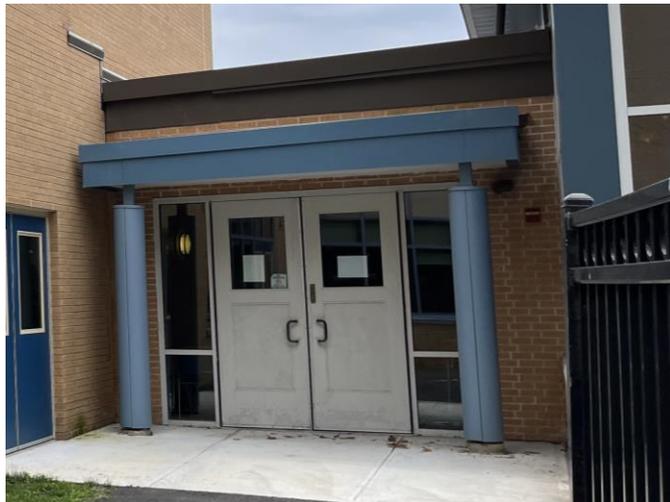
Envelope Improvements

- Masonry Repair and Repointing
- Masonry Cleaning
- Door Replacement
- Basement Bilco Door Repair
 - Completed Summer 2023
