RYE NECK UNION FREE SCHOOL DISTRICT

SEPTEMBER 20, 2023

Building Condition Survey

Observations, Findings & Opinions

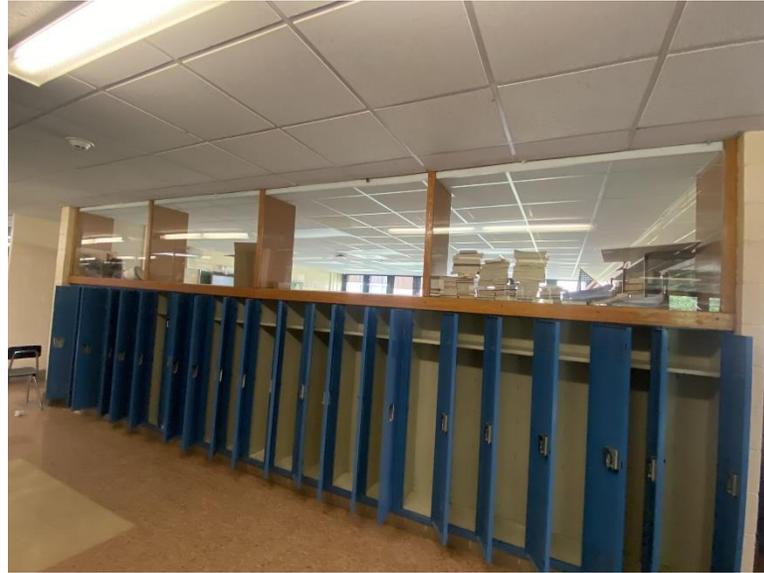
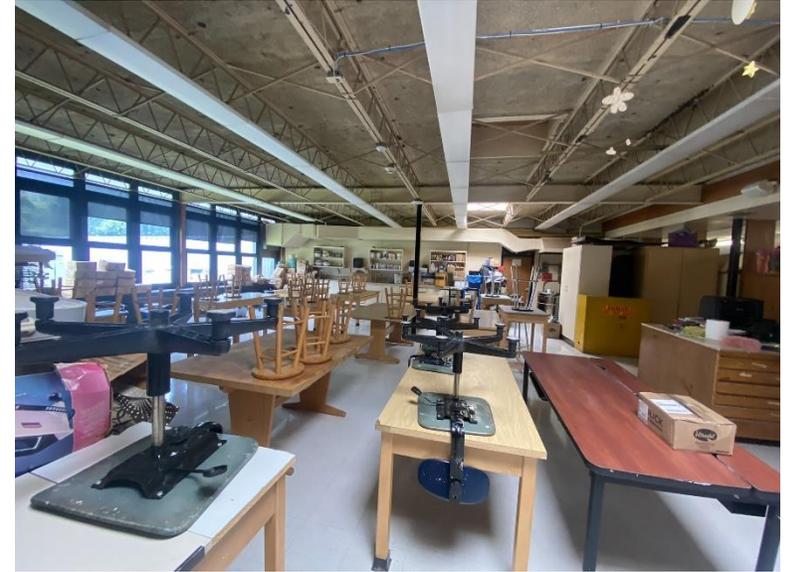
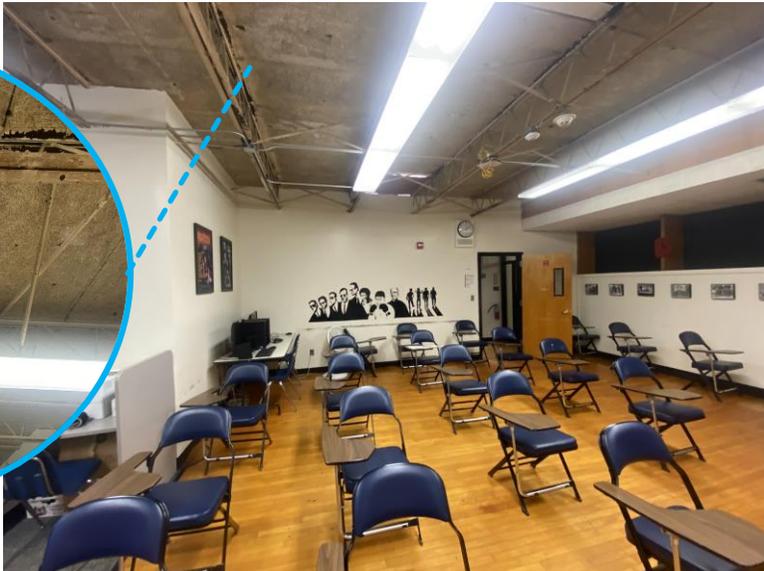
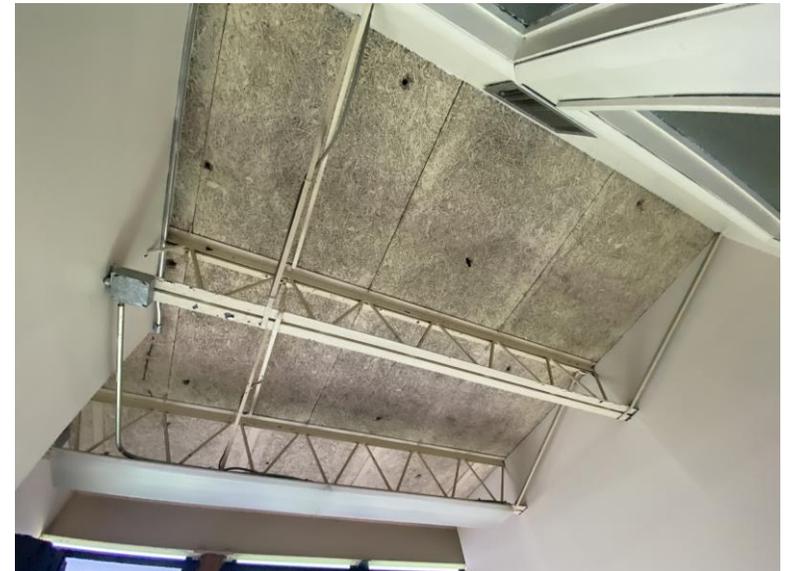
Interior Improvements

- Corridor "E" Slab Stabilization and Flooring Replacement
 - Completed Summer 2023
- Ceiling Replacement
- Wood Floor Replacement
- Art Room Upgrades

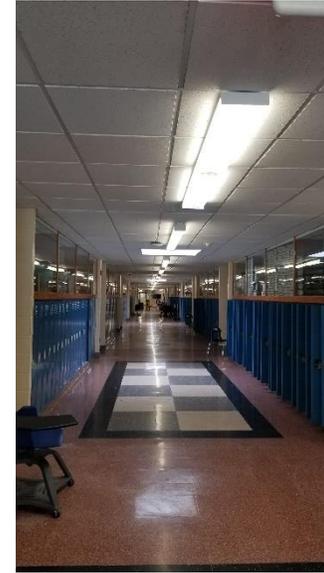
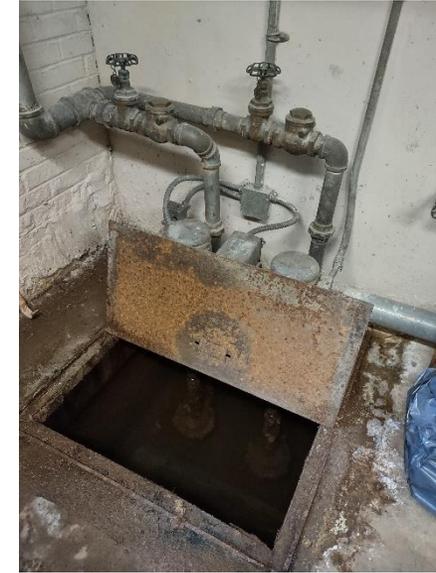
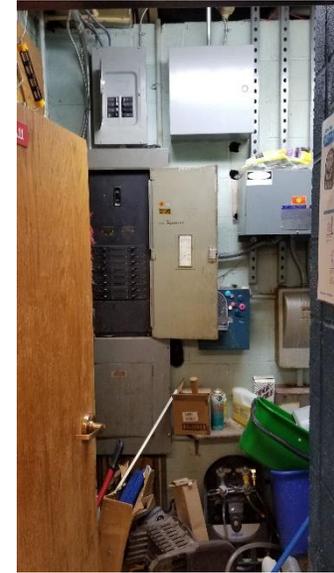
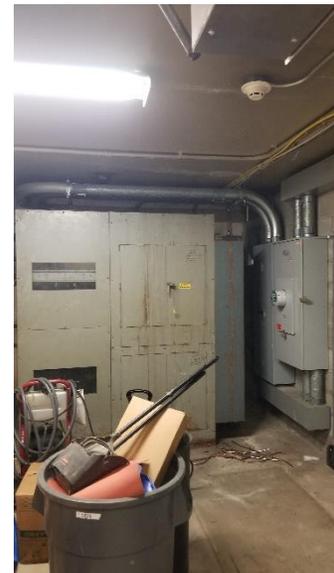
- Install classroom unit ventilators and fan coil units throughout building, add air conditioning
- Replace (15) packaged rooftop units and split systems that have surpassed useful service life
- Replace (10) exhaust fans that have surpassed useful service life

- Replace sump pump system in Boiler Room
 - Completed

- Relocate / Replace utility switch. Provide proper working space clearance and condition
- Replace outdated electrical panels
- Upgrade lighting and lighting controls in older section

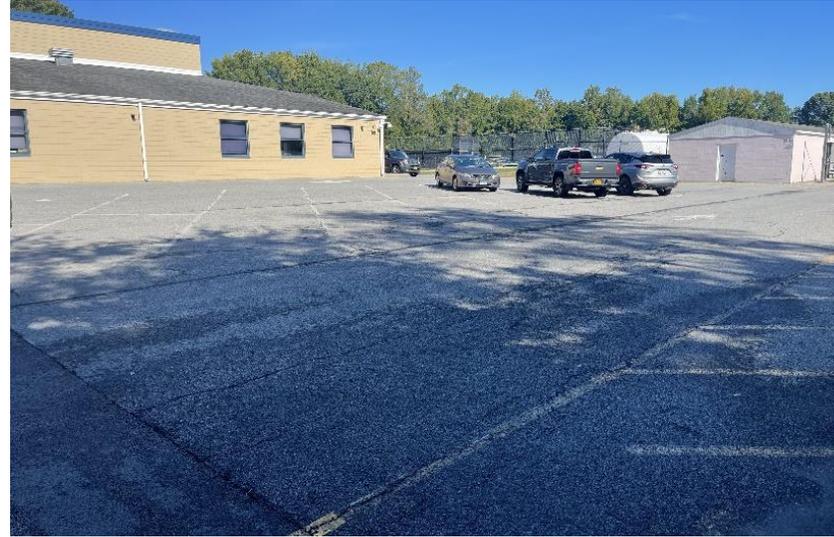
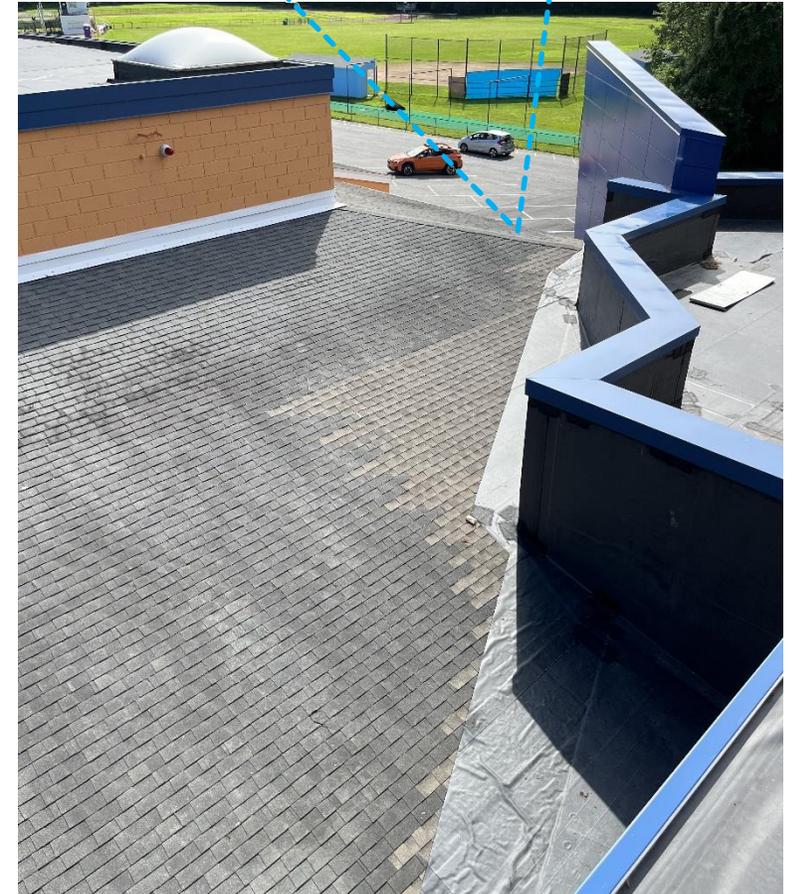
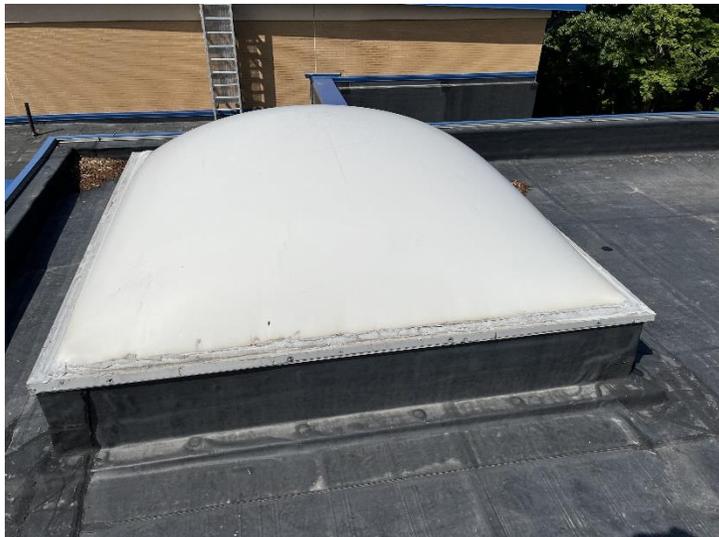
Sitework and Envelope Improvements

- Parking Lot Repaving
- Asphalt Shingle Replacement
 - Repair Completed
- Skylight Replacement
- Door Replacement
 - Replacement Doors Ordered

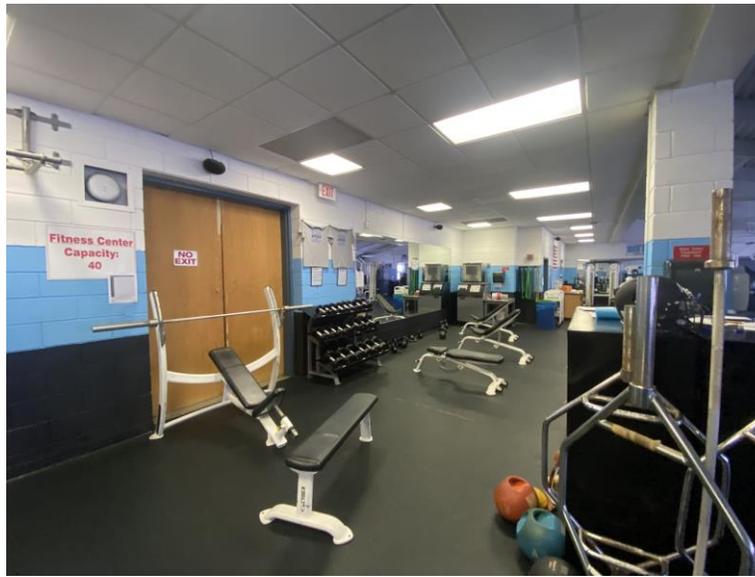
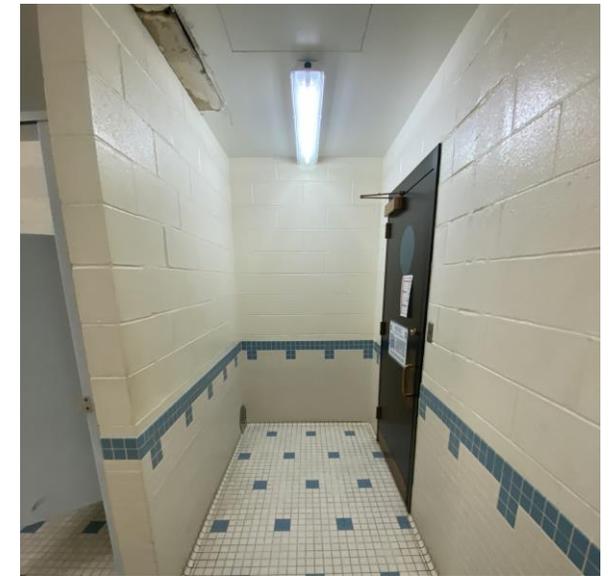
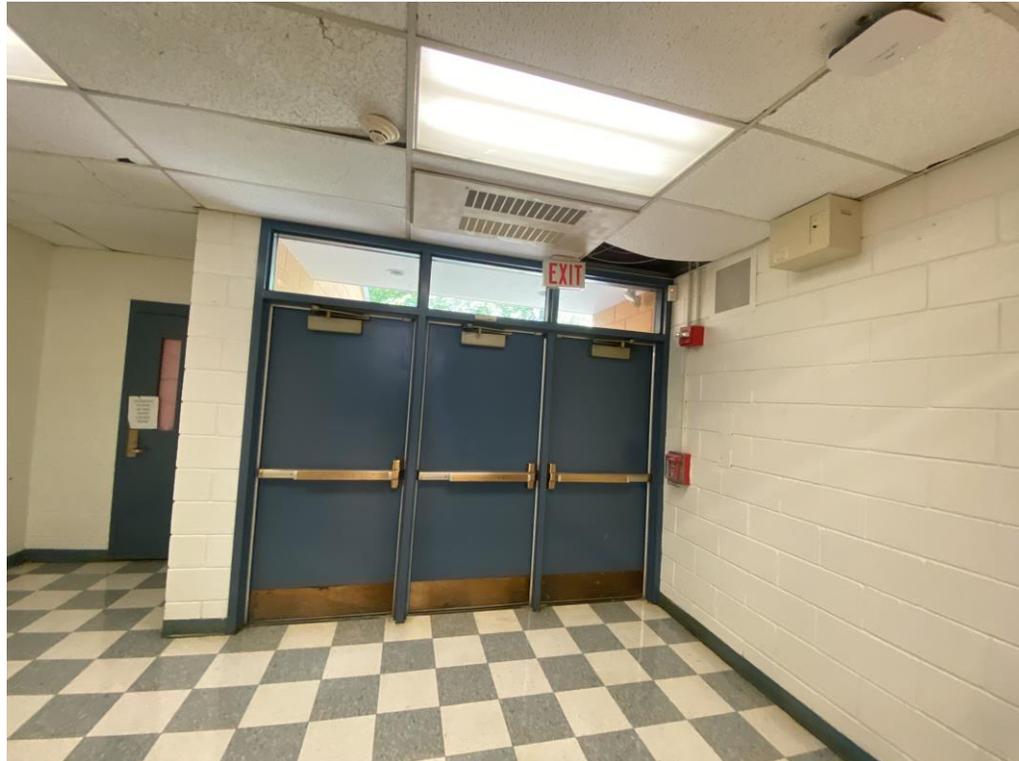
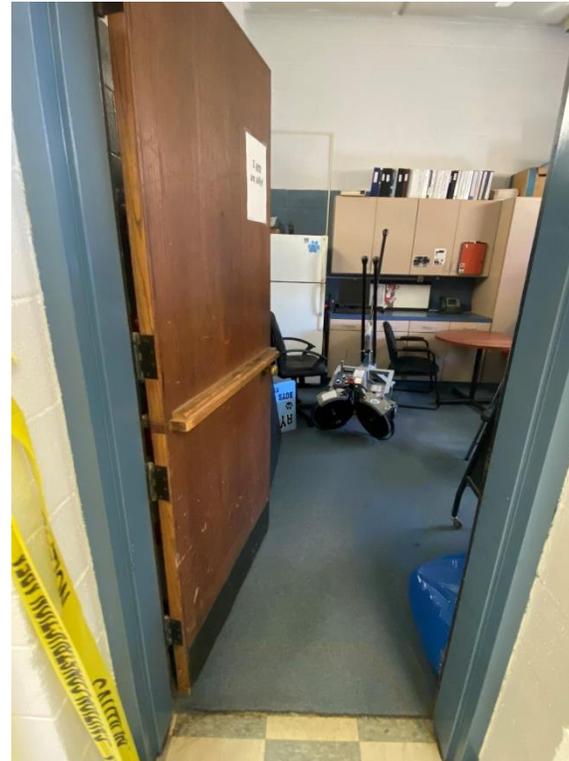
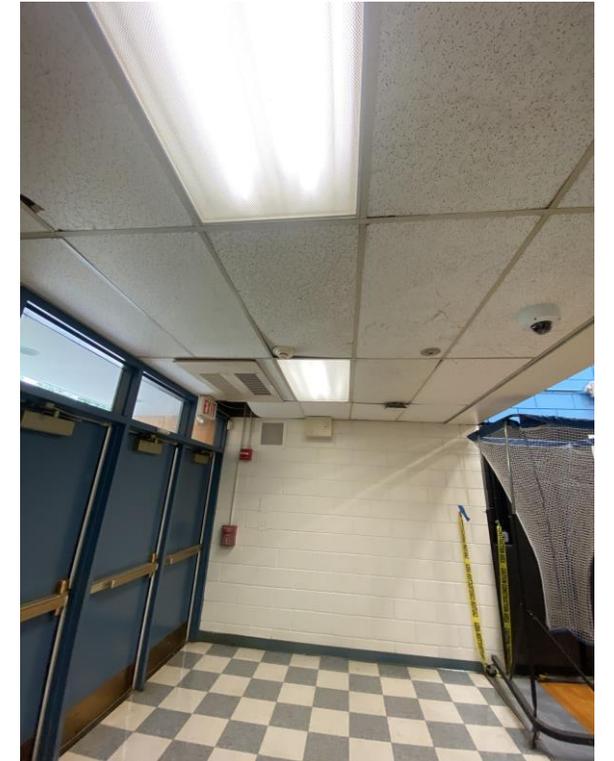
Interior Improvements

- Ceiling Replacement
- Door Replacement
 - Replacement Doors Ordered
- Carpet Replacement

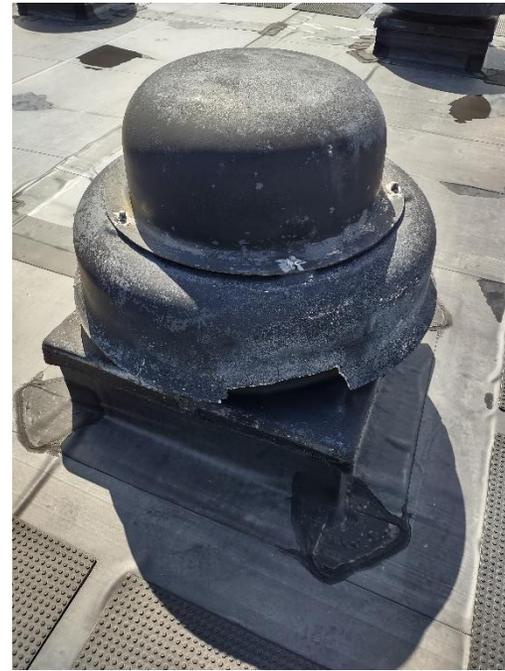
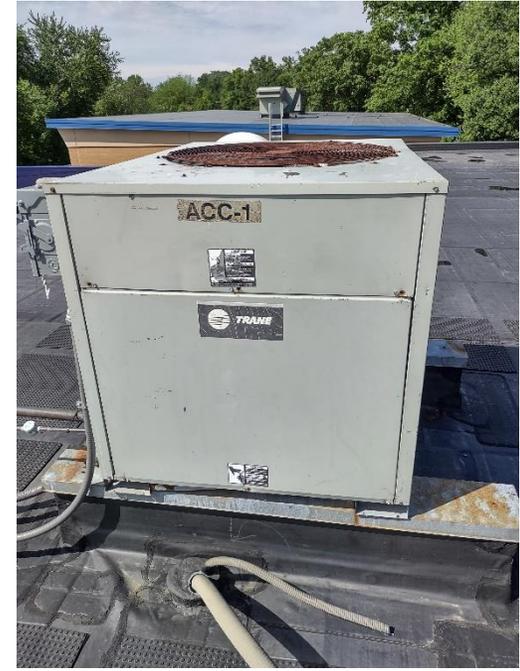
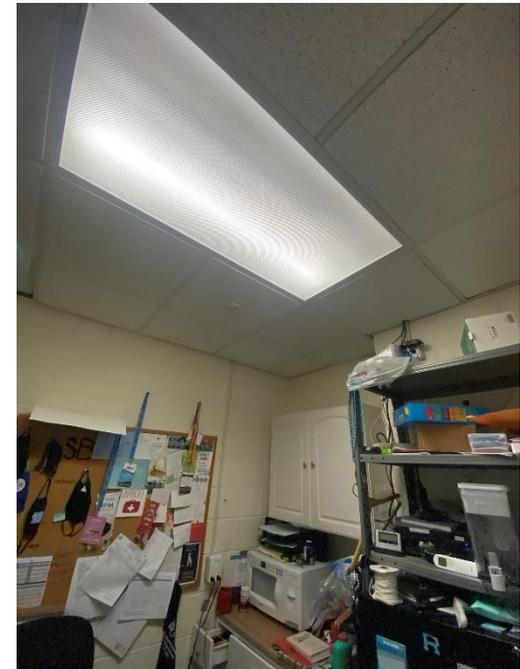
HS/MS Gymnasium

- Replace (4) exhaust fans on original gymnasium roof
- Replace 10-ton split system serving the Exercise Room
 - Completed Summer 2023

- Upgrade light fixtures in the old section to LED type

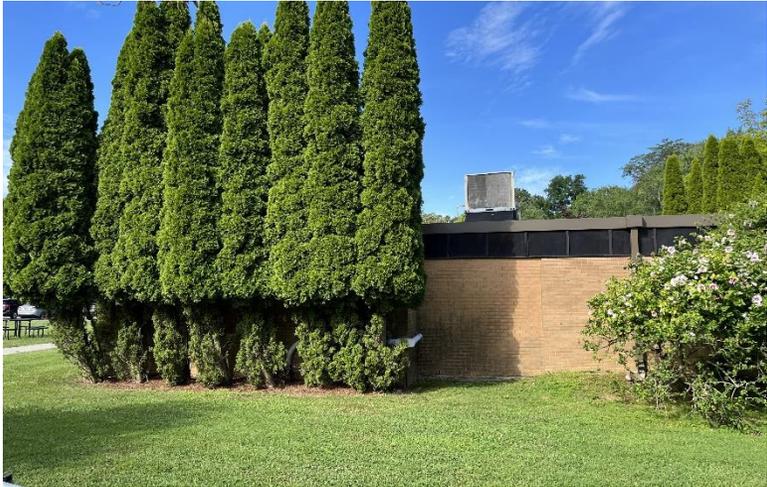
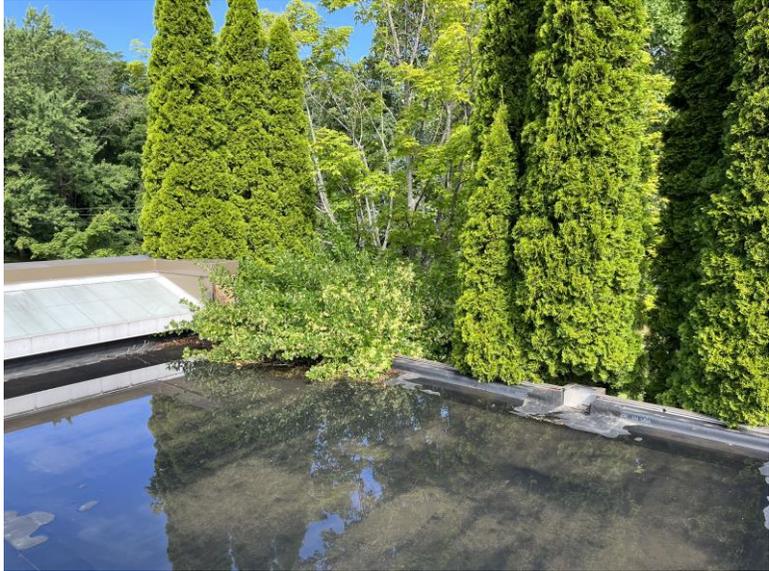
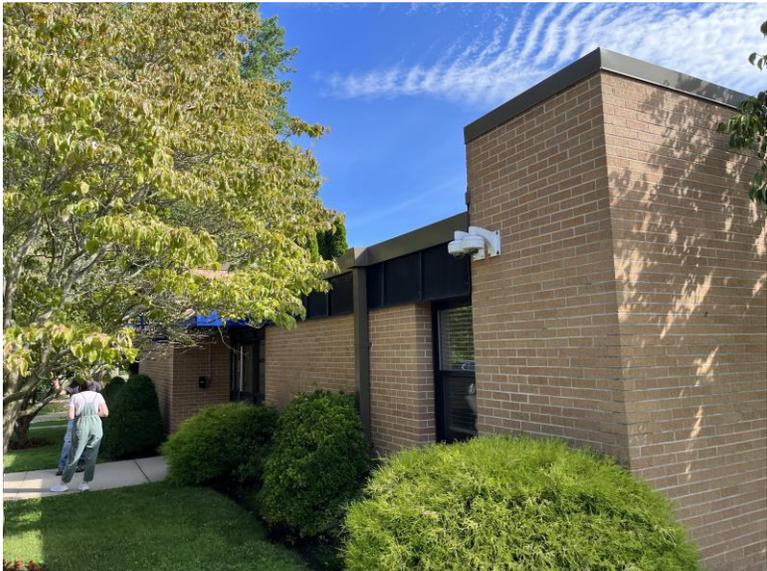
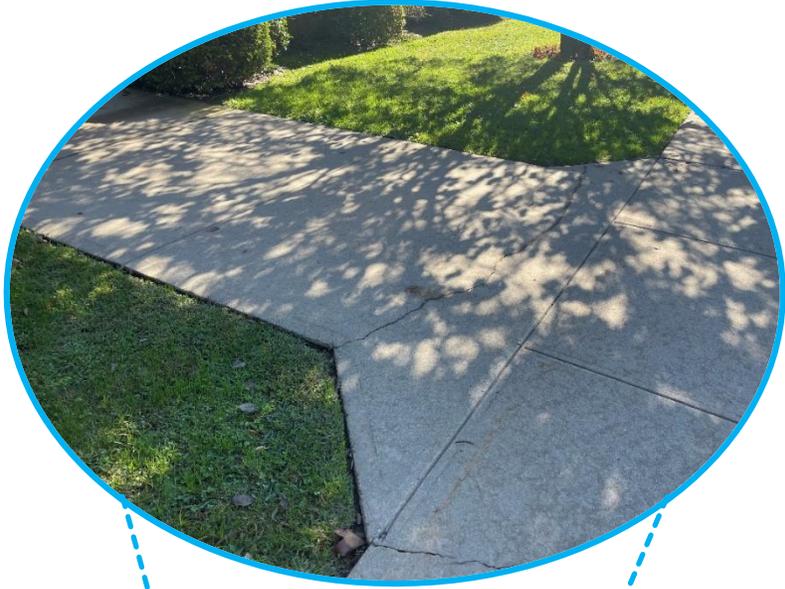
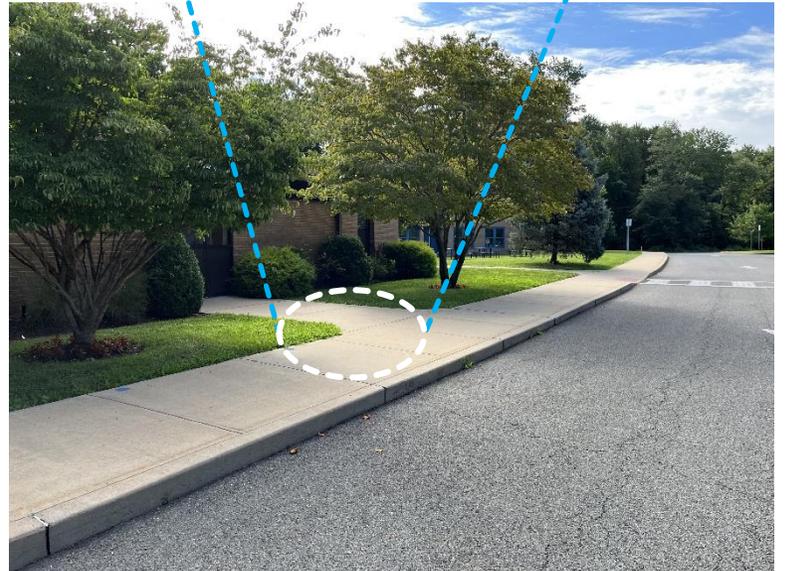
Admin. Building

- Sidewalk Pair
- Masonry Cleaning
- Prune Trees Touching Building and Roof
 - Completed
- Remove Foam From Weep Holes
 - Completed

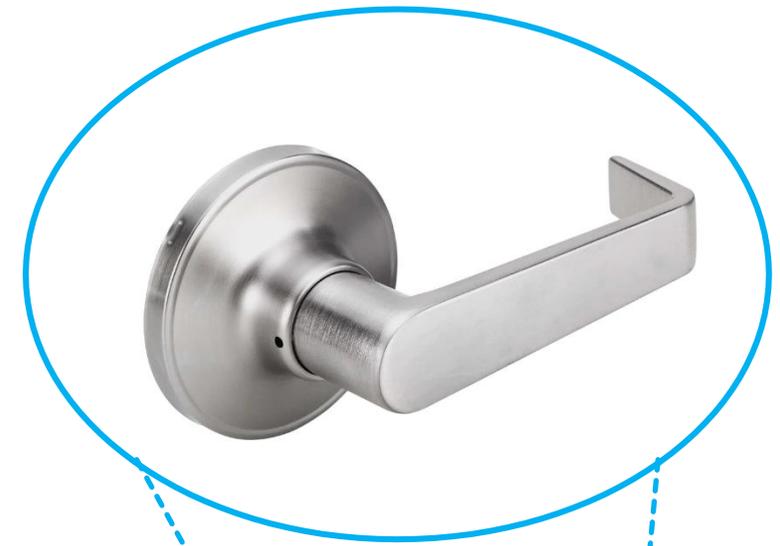
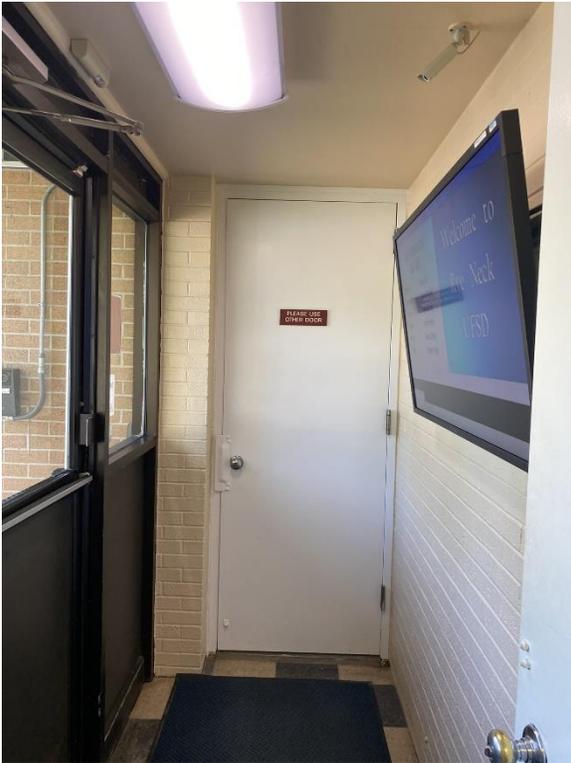
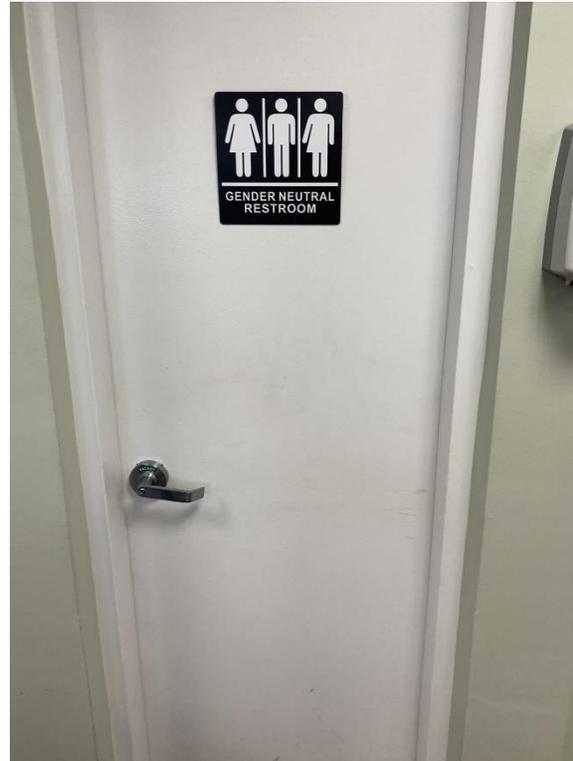
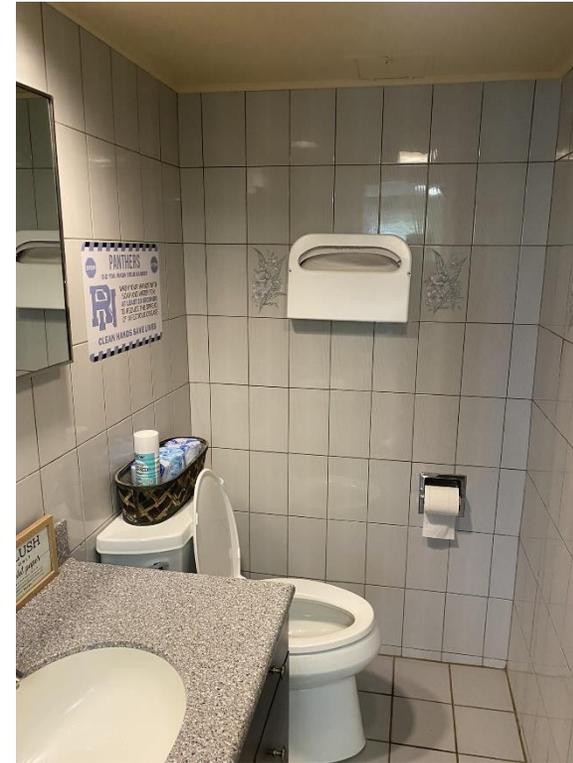
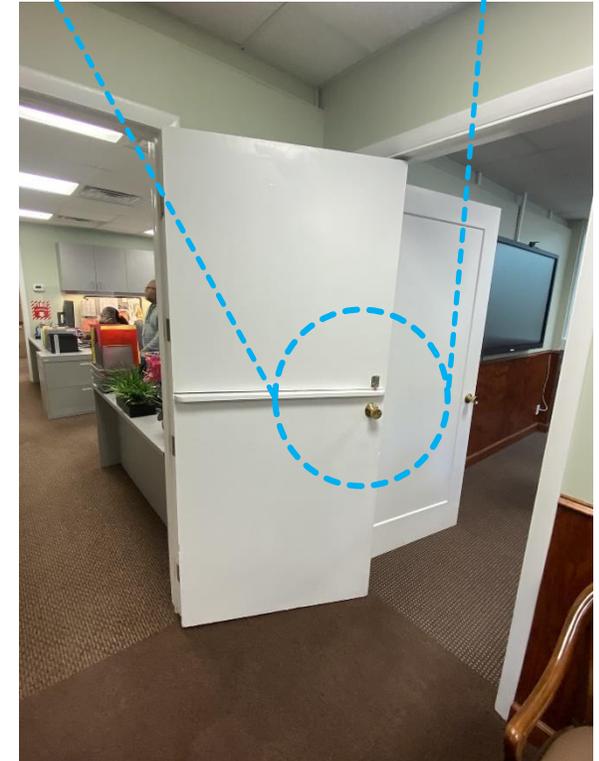
Interior Improvements

- Enlarge Entrance Vestibule to Meet ADA
- Renovate Bathroom to Meet ADA
- Replace Door Hardware to Meet ADA

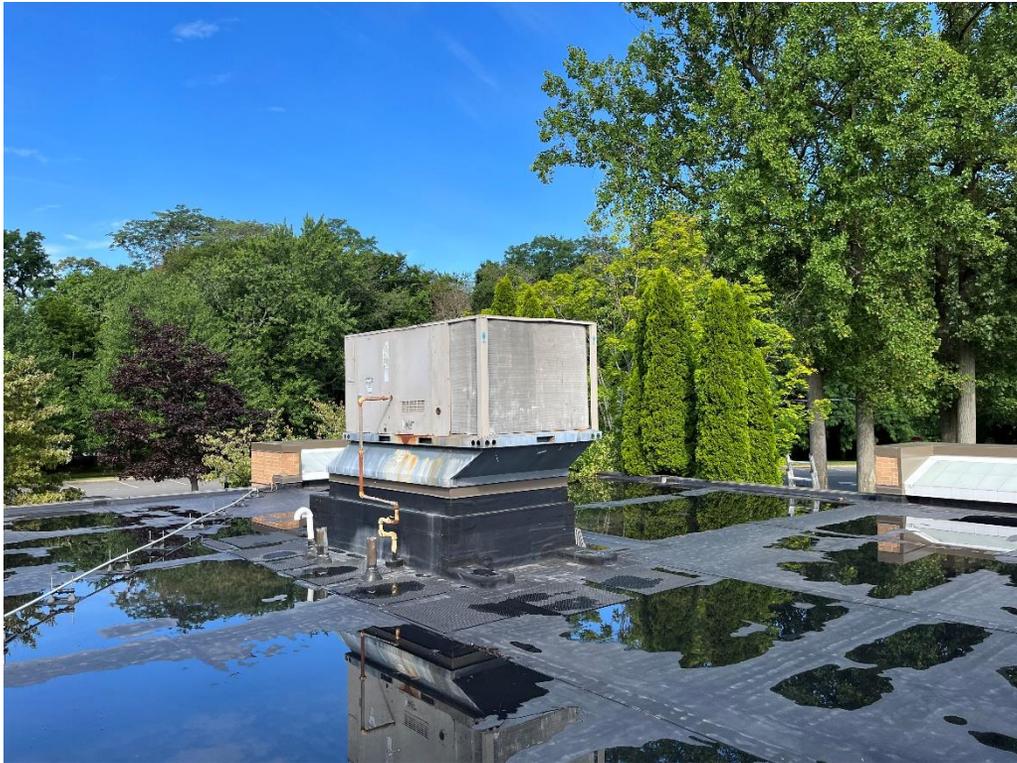
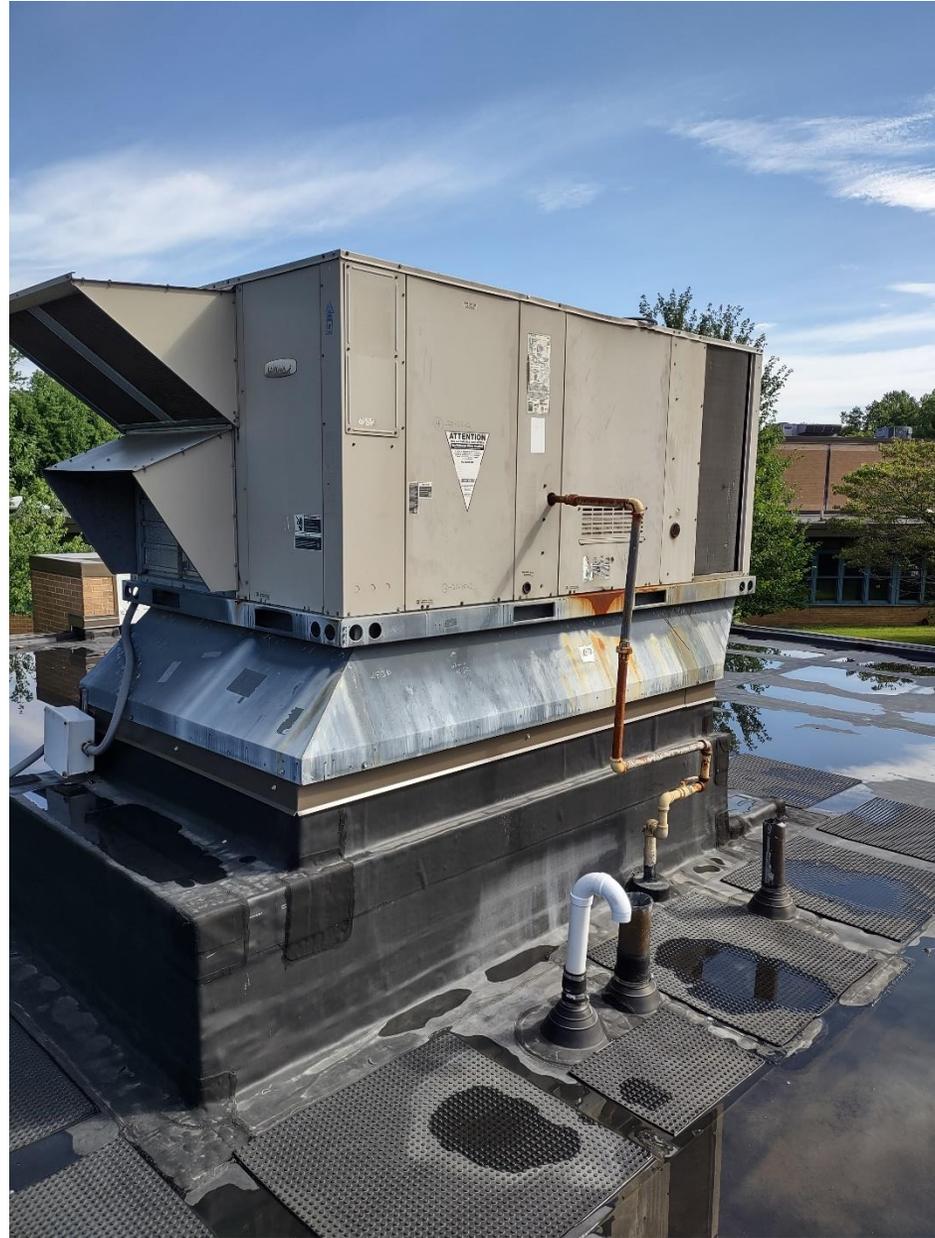
Mechanical, Plumbing & Electrical Improvements

- Replace 10-ton gas fired packaged rooftop unit
 - Completed Summer 2023
