# Building Condition Survey

Sweet Home CSD

Presentation by  
**Young + Wright Architectural**  
May 10, 2022

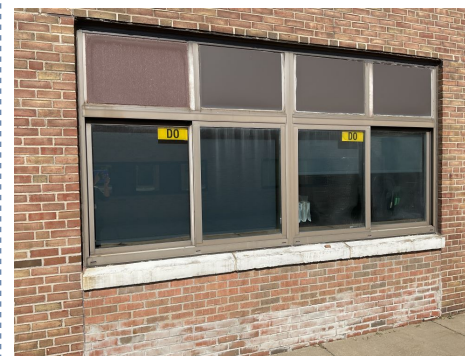
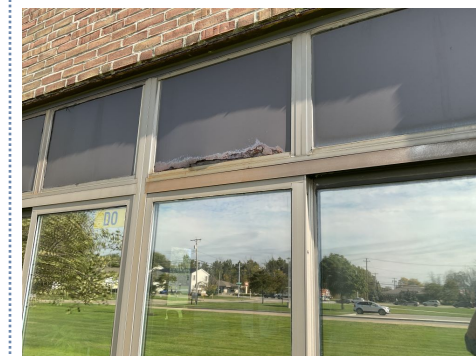
Condition **Unsatisfactory** | v Remaining Useful Life 1 year +/- | v

Windows are in poor condition. Frames are rusting and weathered. Sills are damaged and cracking in many areas. Some screens are showing signs of damage. Windows have roll down shades.

| | Quantity | Units | Cost Per Unit | Totals |
|---|---|---|---|---|
| Remove existing window. Abatement and sills not included. Provide new aluminum window with insulated glazing. | 3,100 | S.F. | \$100 | = \$310,000 |
| Provide new blackout window shades and mechanism. Removal and disposal of existing included | 3,100 | S.F. | \$18 | = \$55,800 |

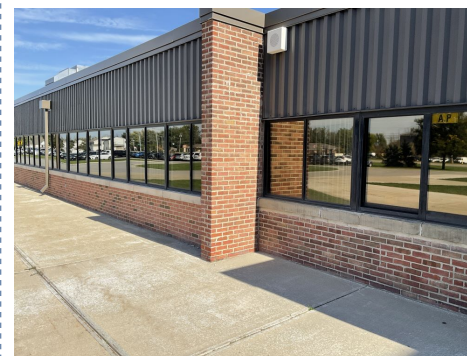
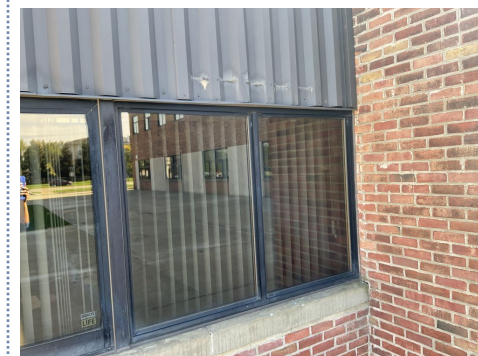
Condition Satisfactory | v Remaining Useful Life 5 years +/- | v

Aluminum band Windows are weathered. window sills are damaged and cracking in many areas. some screens are showing signs of damage. Windows have roll down shades or vertical blinds.

| | Quantity | Units | Cost Per Unit | Totals |
|---|---|---|---|---|
| Remove existing window. Abatement and sills not included. Provide new aluminum window with insulated glazing. | 5,000 | S.F. | \$100 | = \$500,000 |
| Provide new blackout shades and mechanism. Removal and disposal of existing included. | 5,000 | S.F. | \$18 | = \$90,000 |

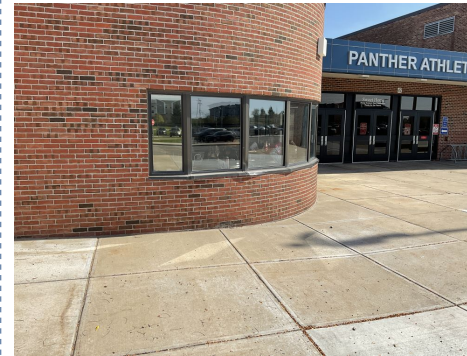
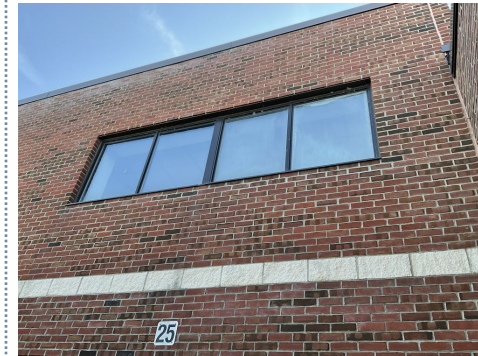
Condition Satisfactory | v Remaining Useful Life 7 years +/- | v

Windows are in pool area and have condensation within the glazing. Other Windows are in satisfactory condition

| | Quantity | Units | Cost Per Unit | Totals |
|---|---|---|---|---|
| Remove existing window. Abatement and sills not included. Provide new aluminum window with insulated glazing and roller shades | 200 | S.F. | \$100 | = \$20,000 |

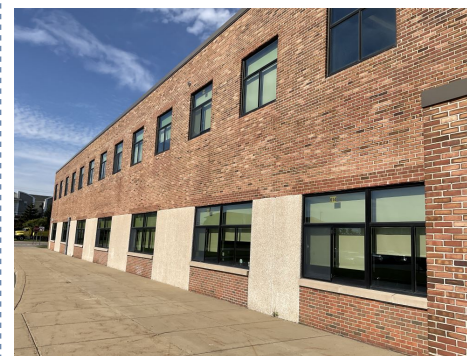
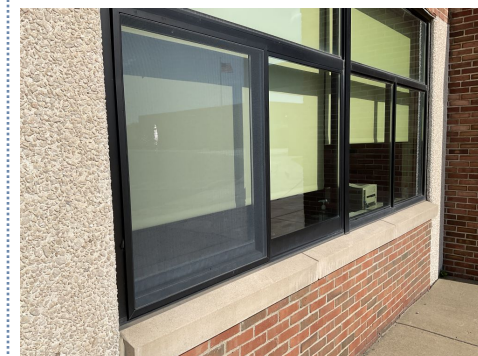
Condition Satisfactory | v Remaining Useful Life 10 years +/- | v

Windows are in satisfactory condition. Windows are tinted with solar glazing. Lintels, flashing, and sills were replaced. Windows have roller shades

No necessary replacement at time of review.  
Recommend to review again in 7 years.

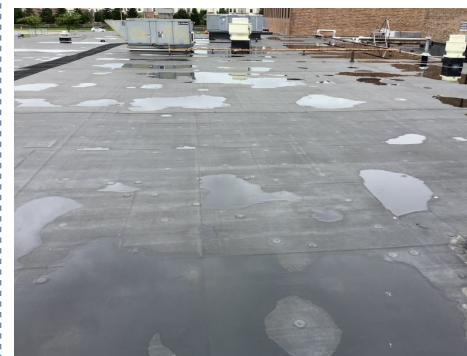
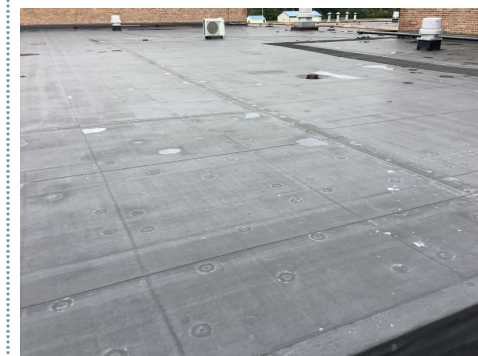
Condition Satisfactory | v Remaining Useful Life 5 years +/- | v

Type: Fully adhered single-ply EPDM over polyisocyanurate insulation over existing various deck types; gypsum, metal deck.

- 20 year warranty.
- many areas of ponding due to inadequate slope.
- wood steps and corroding steel ladders.
- drains require general maintenance cleaning.

| | Quantity | Units | Cost Per Unit | Totals |
|---|---|---|---|---|
| Replace; all wood steps and ladders. Add fall protection at roof hatches. | 1 | L.S. | \$50,000 | \$50,000 |

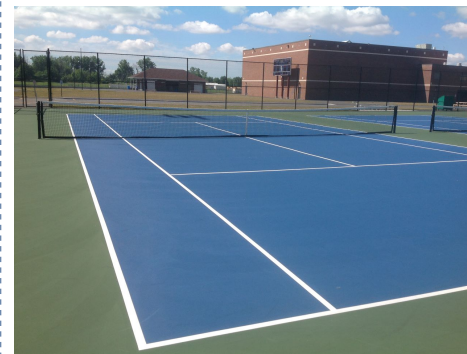
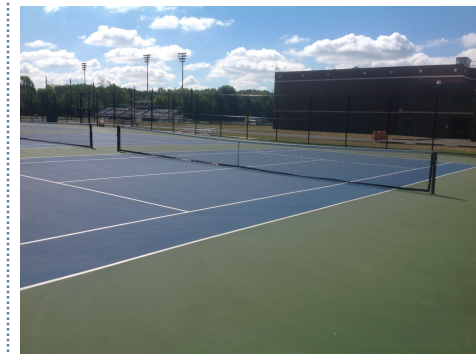
Condition Satisfactory | v Remaining Useful Life 15 years +/- | v

6 courts. All new fencing in good condition.  
Surface is pitched and crowned in the middle.  
Nets and posts in good condition.  
Spectator seating areas with concrete pads and portable aluminum bleachers.  
No ponding water present.

No necessary replacement at time of review.  
Recommend to review again in 7 years.

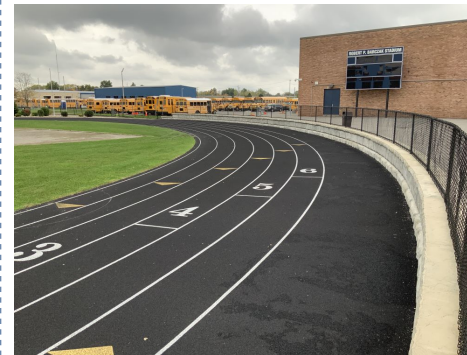
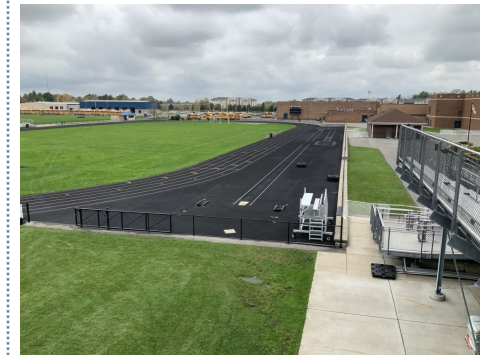
Condition Satisfactory | v Remaining Useful Life 7 years +/- | v

The synthetic rubber track surface is in satisfactory condition, this system was installed in 2015. The surface is beginning to fade, also beginning to have some structural issues. There is a small amount of heaving and breaking away of material

| | Quantity | Units | Cost Per Unit | Totals |
|---|---|---|---|---|
| No necessary replacement at time of review. Recommend to review again in 7 years.. replace track surface in next 7-10 years with synthetic system that best fits the location | 6,670 | S.Y. | \$64 | = \$426,880 |
