# 2016 FACILITIES MASTER PLAN

# Buckeye Union School District

## 2016 Facility Master Plan

Prepared: March 2016

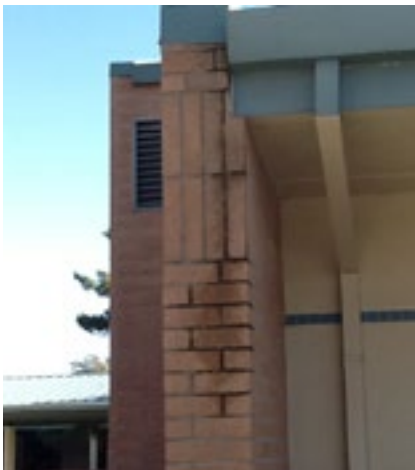
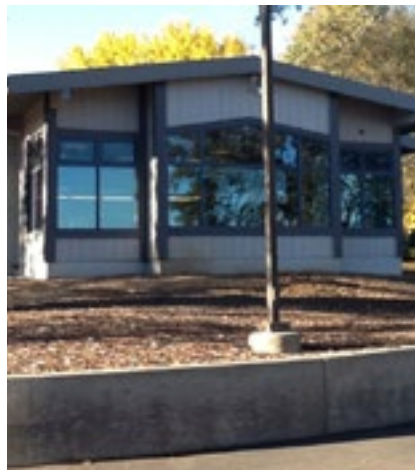
## Building Shells

**Finishes.** Exterior wall finishes of stucco, brick and wood are in excellent condition with minimal wear issues present. A couple areas in need of attention were observed, as shown in photos below. *Regular painting and sealing will continue to protect the finishes.*

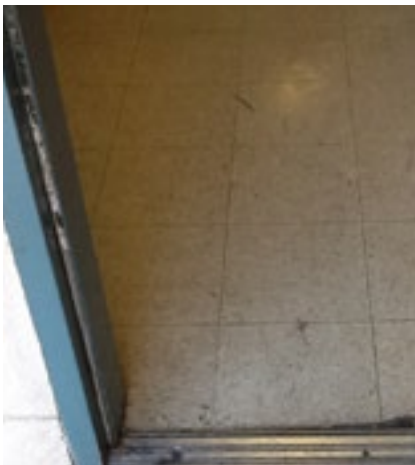
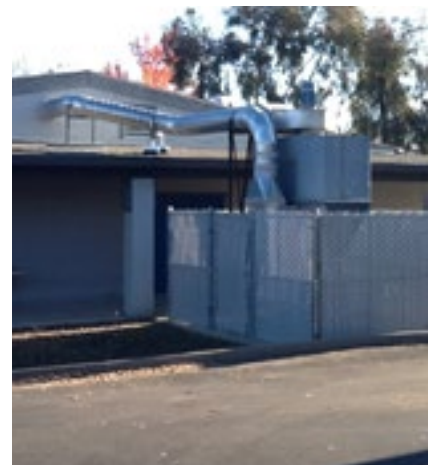
**HVAC systems.** Systems are newer and working well at school sites. *Due to age and useful life, the assessment identifies a number of buildings in the future which will require system replacement.* In some selected locations, server rooms, restrooms, locker rooms and kitchens - air conditioning needs to be added.

**Lighting.** Lighting is adequate and operating well throughout the district. Lighting control systems are in place and operating well. *A conversion to LED fixtures over time is recommended.*

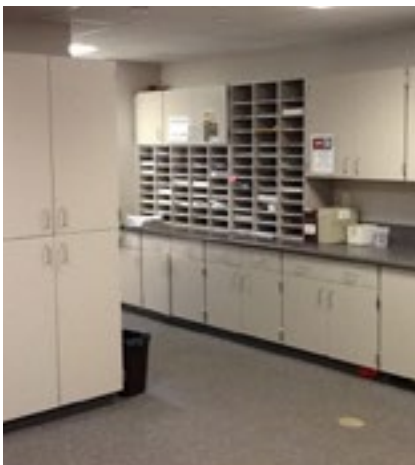
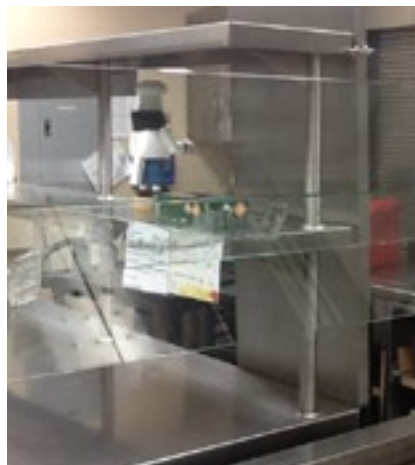
# Equipment & Furnishings

**Casework.** Casework is in good condition at sites, although it is a bit worn and dated at a couple older sites and will need updating. *There is a desire through the District to move away from fixed casework for more flexible furniture components.* Numerous portables have less built-in casework than permanent classroom spaces.

**Window Coverings.** These are in overall good condition; however, *some windows lack coverings and need to have them added.*

**Kitchen Equipment.** The equipment is in good condition and functioning well. *Kitchens at some school sites are small and need expansion.* As the district grows and a couple more schools are opened in the El Dorado Hills area, a second central kitchen should be considered to serve the area.

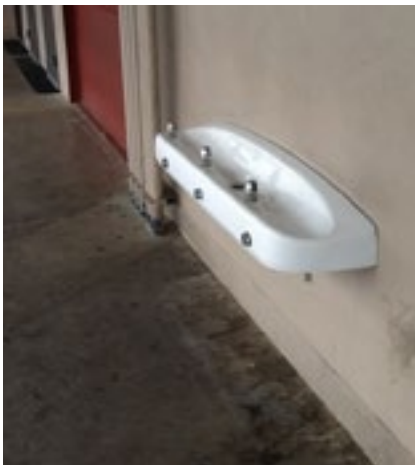
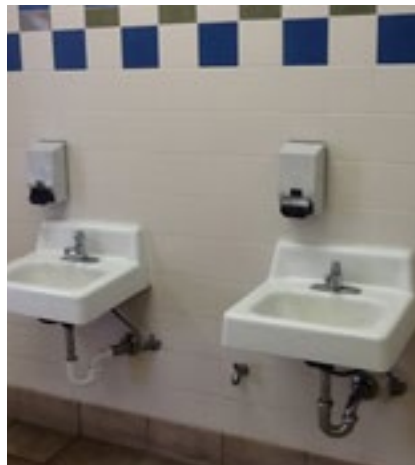
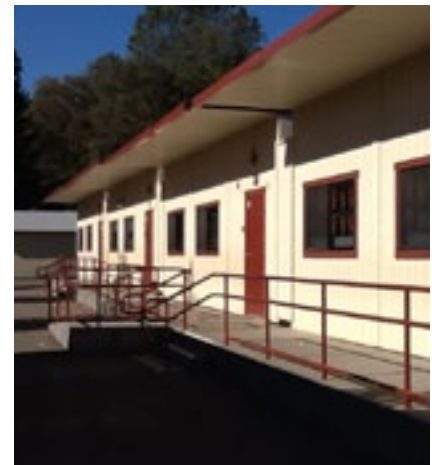
**Restrooms.** Older restrooms have been modernized and brought to accessible standards. Overall, restrooms are in good condition and in general accessible compliance. Although older modernized restrooms have some minor ADA issues to upgrade. *A few issues exist with ceramic tile at some restrooms and some sites lack enough fixtures as required by code due to expansion.*

**Portables.** Each campus has portables, from one to a dozen. They have been kept new, updated and modernized as needed, and are in very good overall condition. *A couple issues exist with wood foundations that need repair. On campuses with numerous portables, it is recommended that, as the units age, they be replaced with a permanent classroom building.*

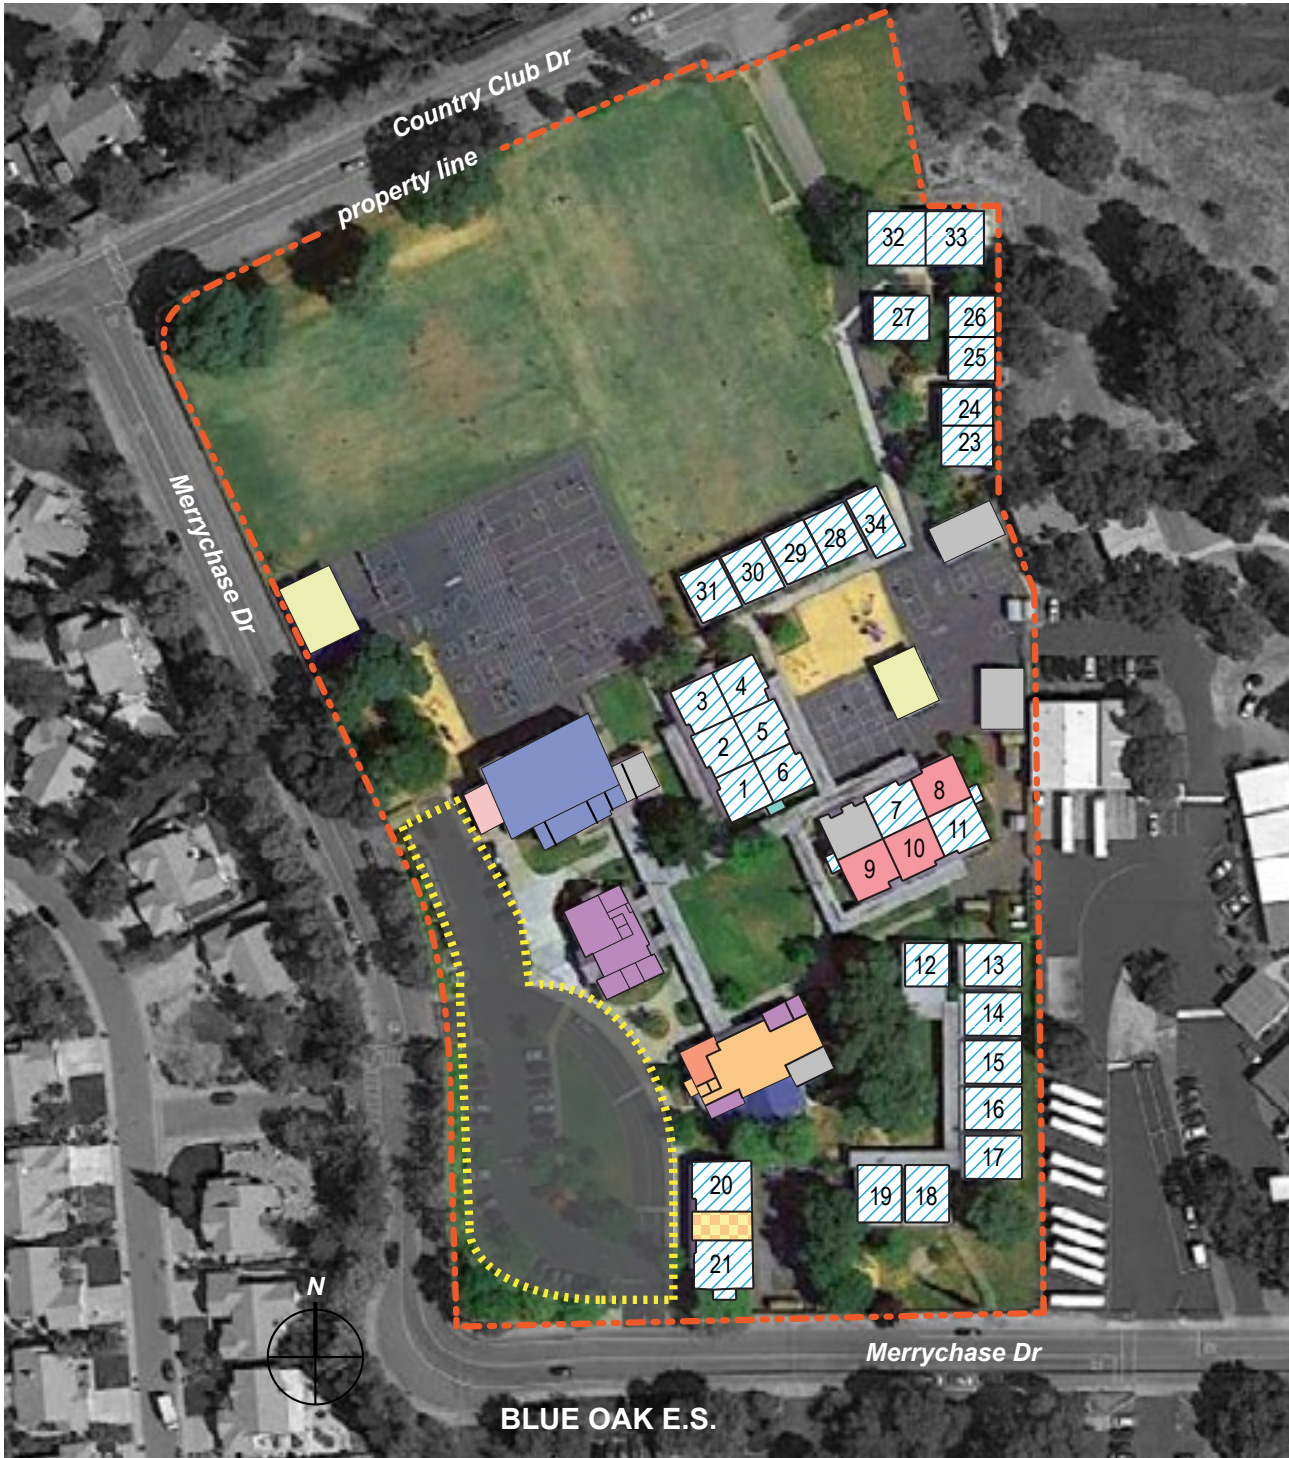
EXISTING SITE PLAN

The following concerns with suggested improvements were noted during the site observation of Blue Oak Elementary School.

2. Site has an inadequate amount of parking. Expansion of parking lot along Merrychase Drive is recommended.

4. Ramp to portables on south side is not ADA compliant and should be replaced.

5. Central lawn area is underutilized. Recommend creating a quad or amphitheatre area using concrete and seat walls.

6. School is wide open to public. Fencing and gates for a secured perimeter is recommended.

10. The site has 17 portables. It is recommended that as the northern 10 units near 20 years of age, that they be replaced with a permanent new classroom building.

13. Kitchen is small and needs to be expanded.

14. Portable classrooms have minimal casework in comparison to existing classrooms. Additional casework or portable storage should be considered being added.

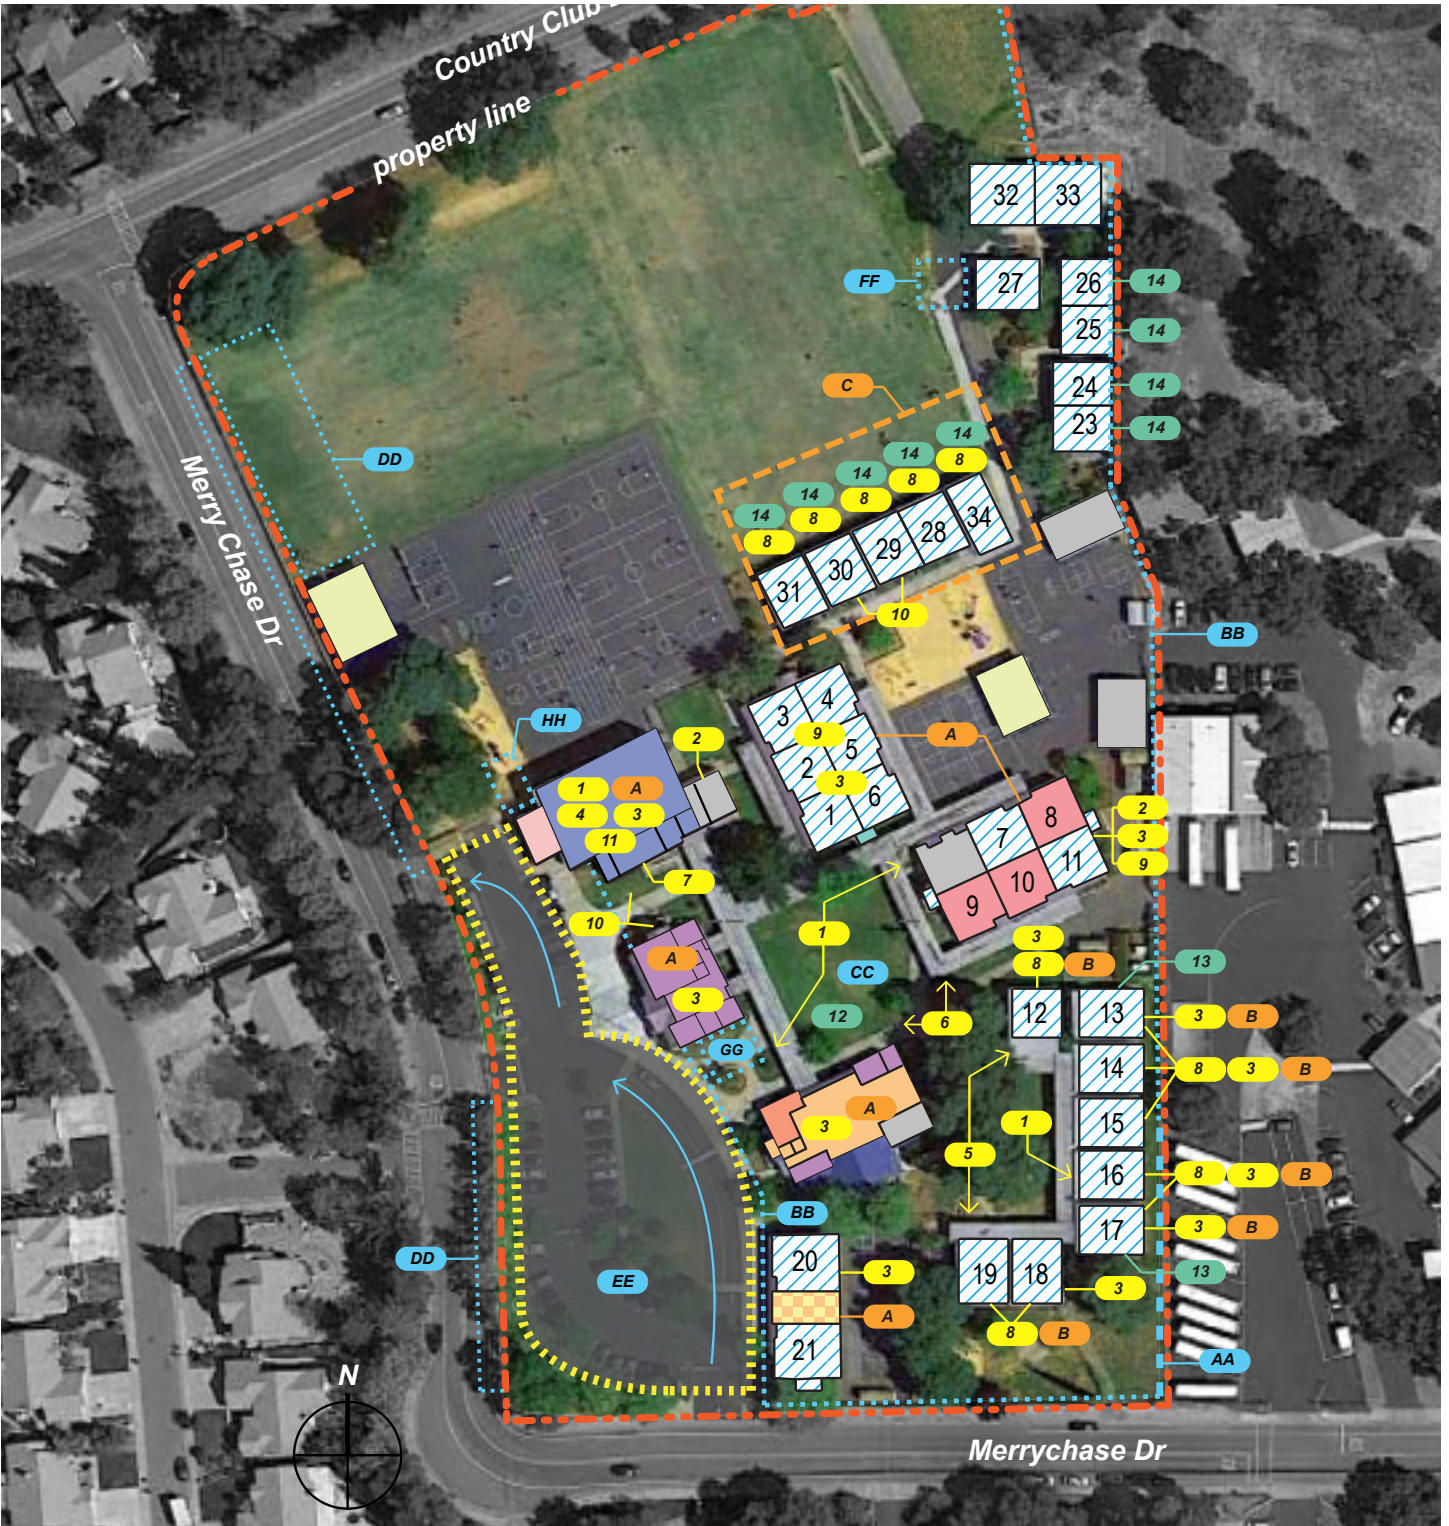
# Blue Oak Elementary School

## LEGEND

**CATEGORY 3**

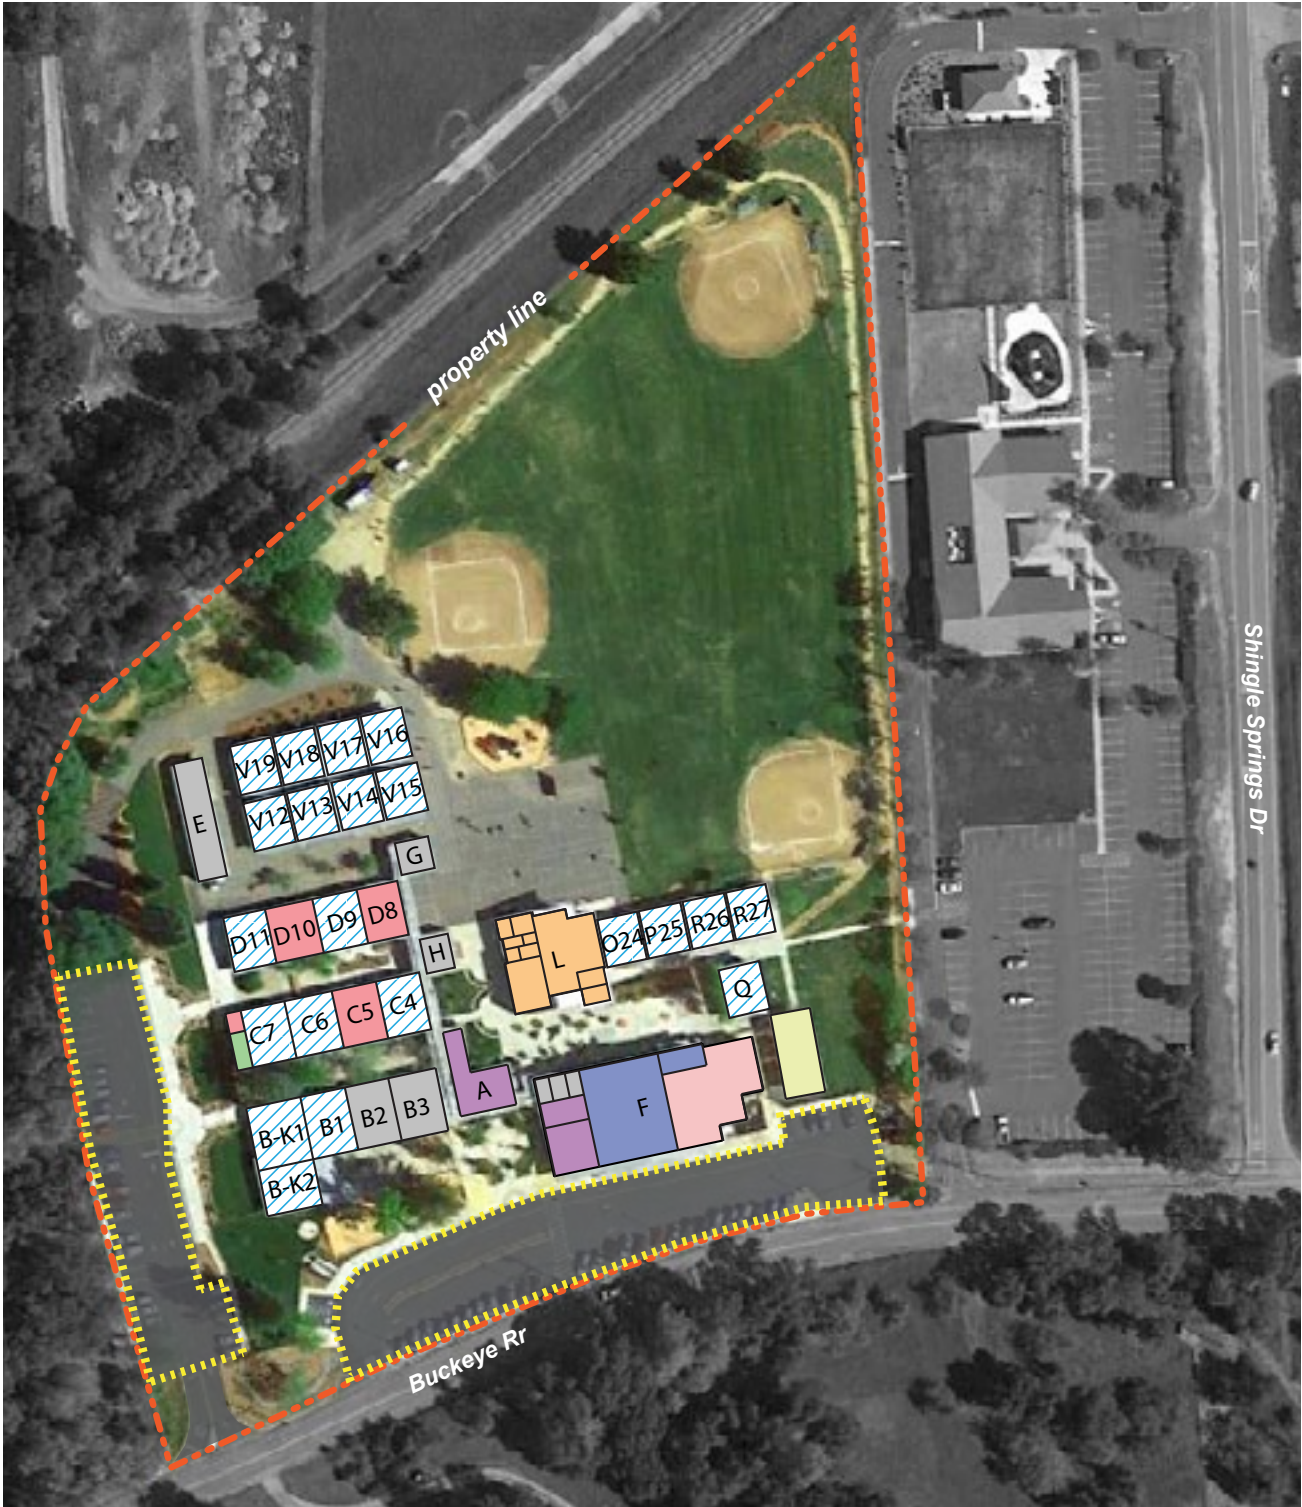
The following concerns with suggested improvements were noted during the site observation of Buckeye Elementary School.

1. There is no ramp to connect auto drop-off to campus buildings below even though a project was recently DSA approved. A ramp should be added.
2. Auto drop-off is located with no separation to parking or designated turn around. A divider and turn-around should be added.
3. Central kitchen has no dedicated loading zone. Service area should be reconfigured to add a loading area.
4. Office is small and lacks meeting space and should be expanded.
5. School is open to public access. Fencing and gates for secured perimeter is recommended.
6. Site has well developed outdoor learning areas. Consideration for a second exit door from classrooms direct to courts would be desirable.

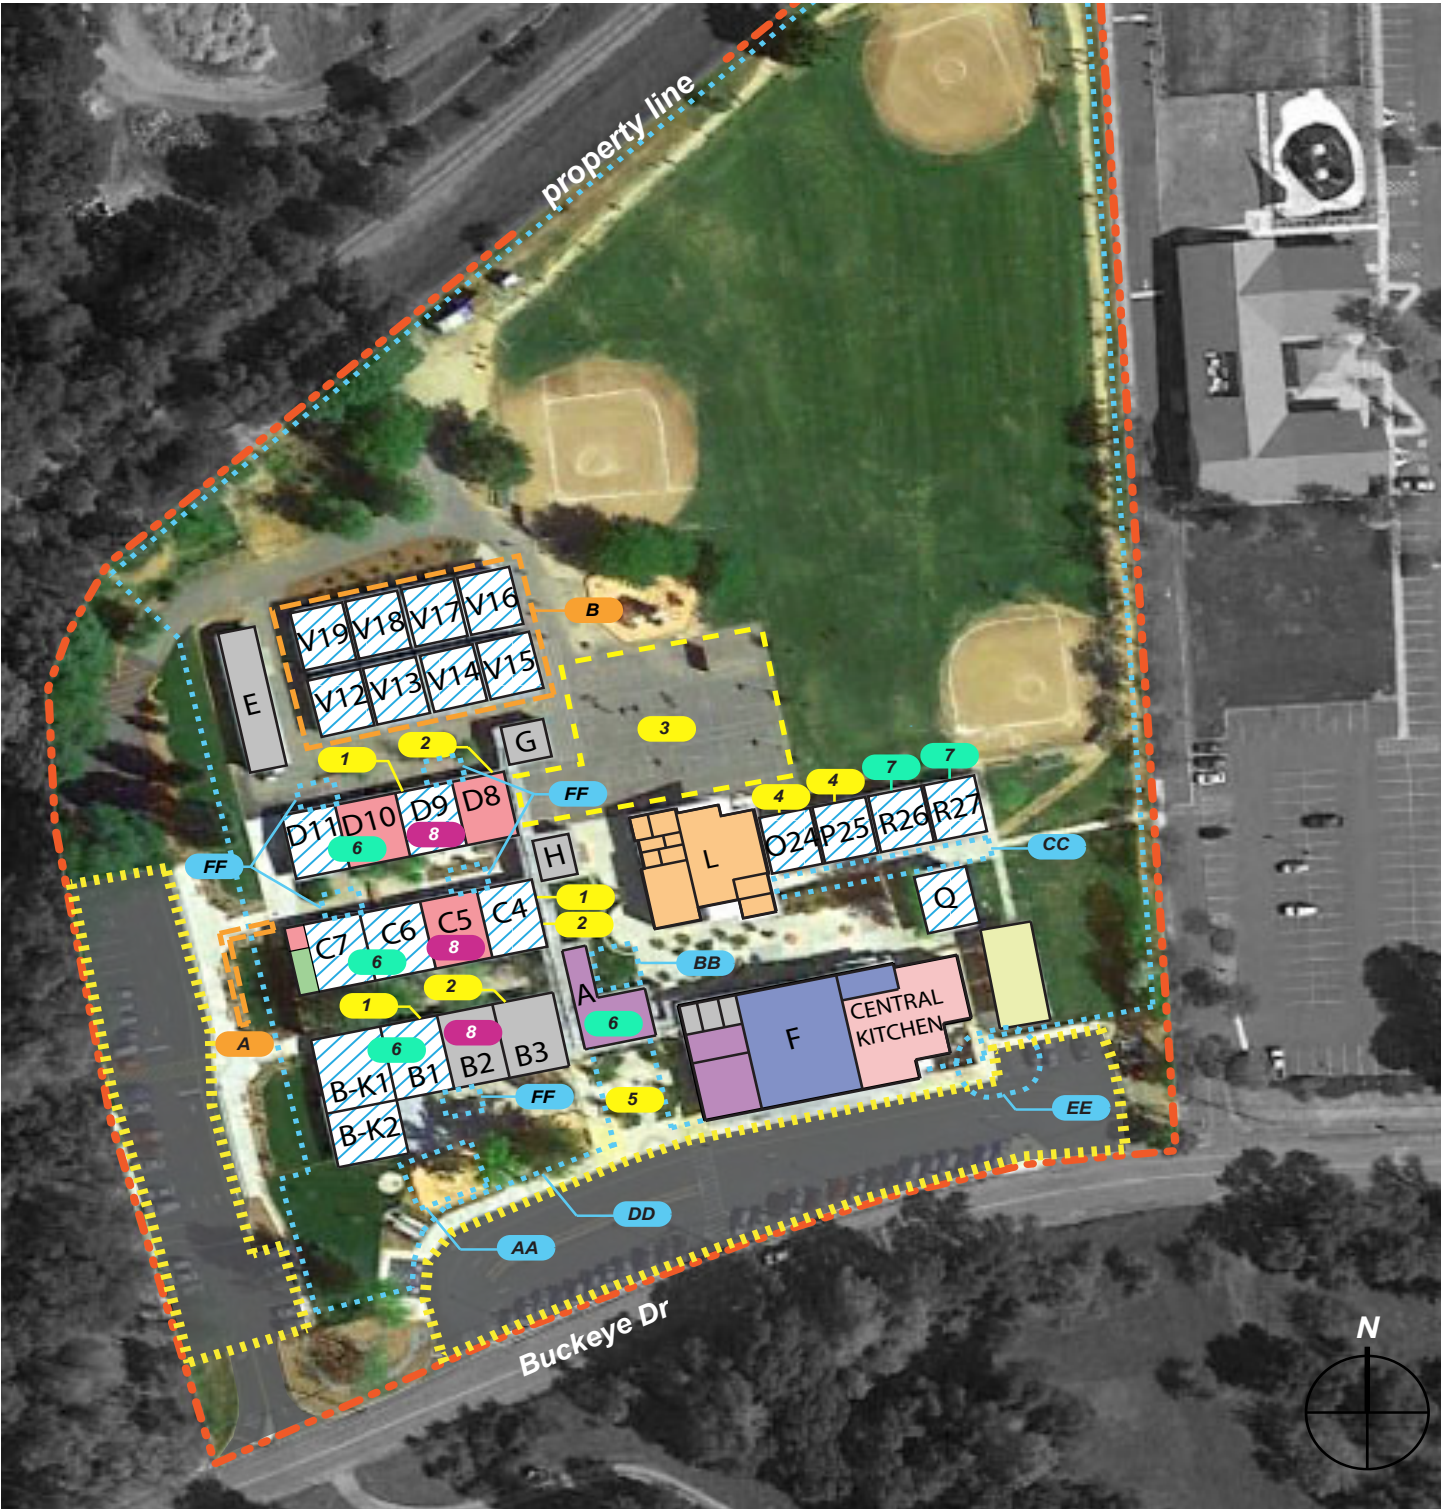
# PROPOSED MASTER SITE PLAN

LEGEND		
CATEGORY 1	CATEGORY 2	CATEGORY 3
1 0 - 1 YEAR	A	AA
1 2 - 5 YEARS		
1 6 - 10 YEARS		
1 11 - 15 YEARS

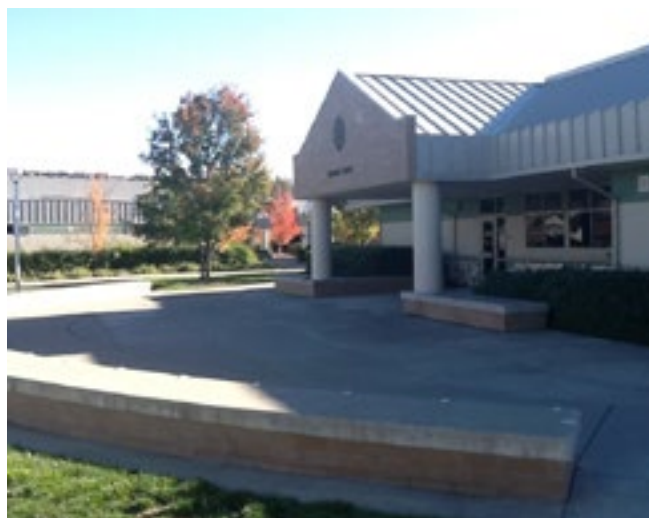
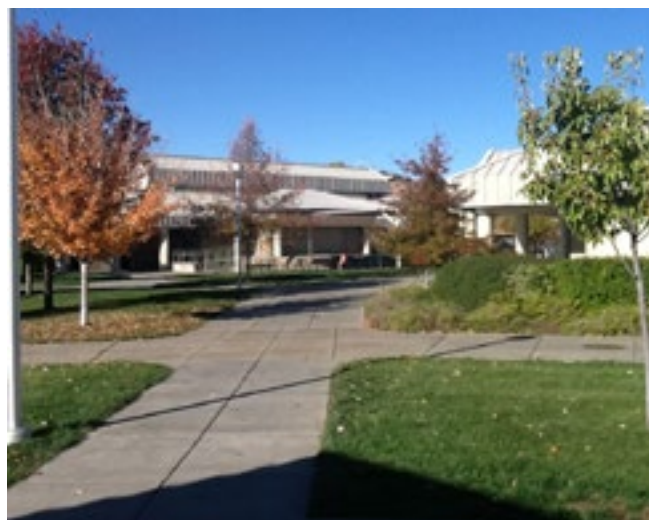
Site landscaping within the building campus is quite lush with a large amount of grass, shrubs, and trees. The maintenance required for it is labor intensive. The District may want to consider a turf and shrub reduction program to realize labor and water savings.

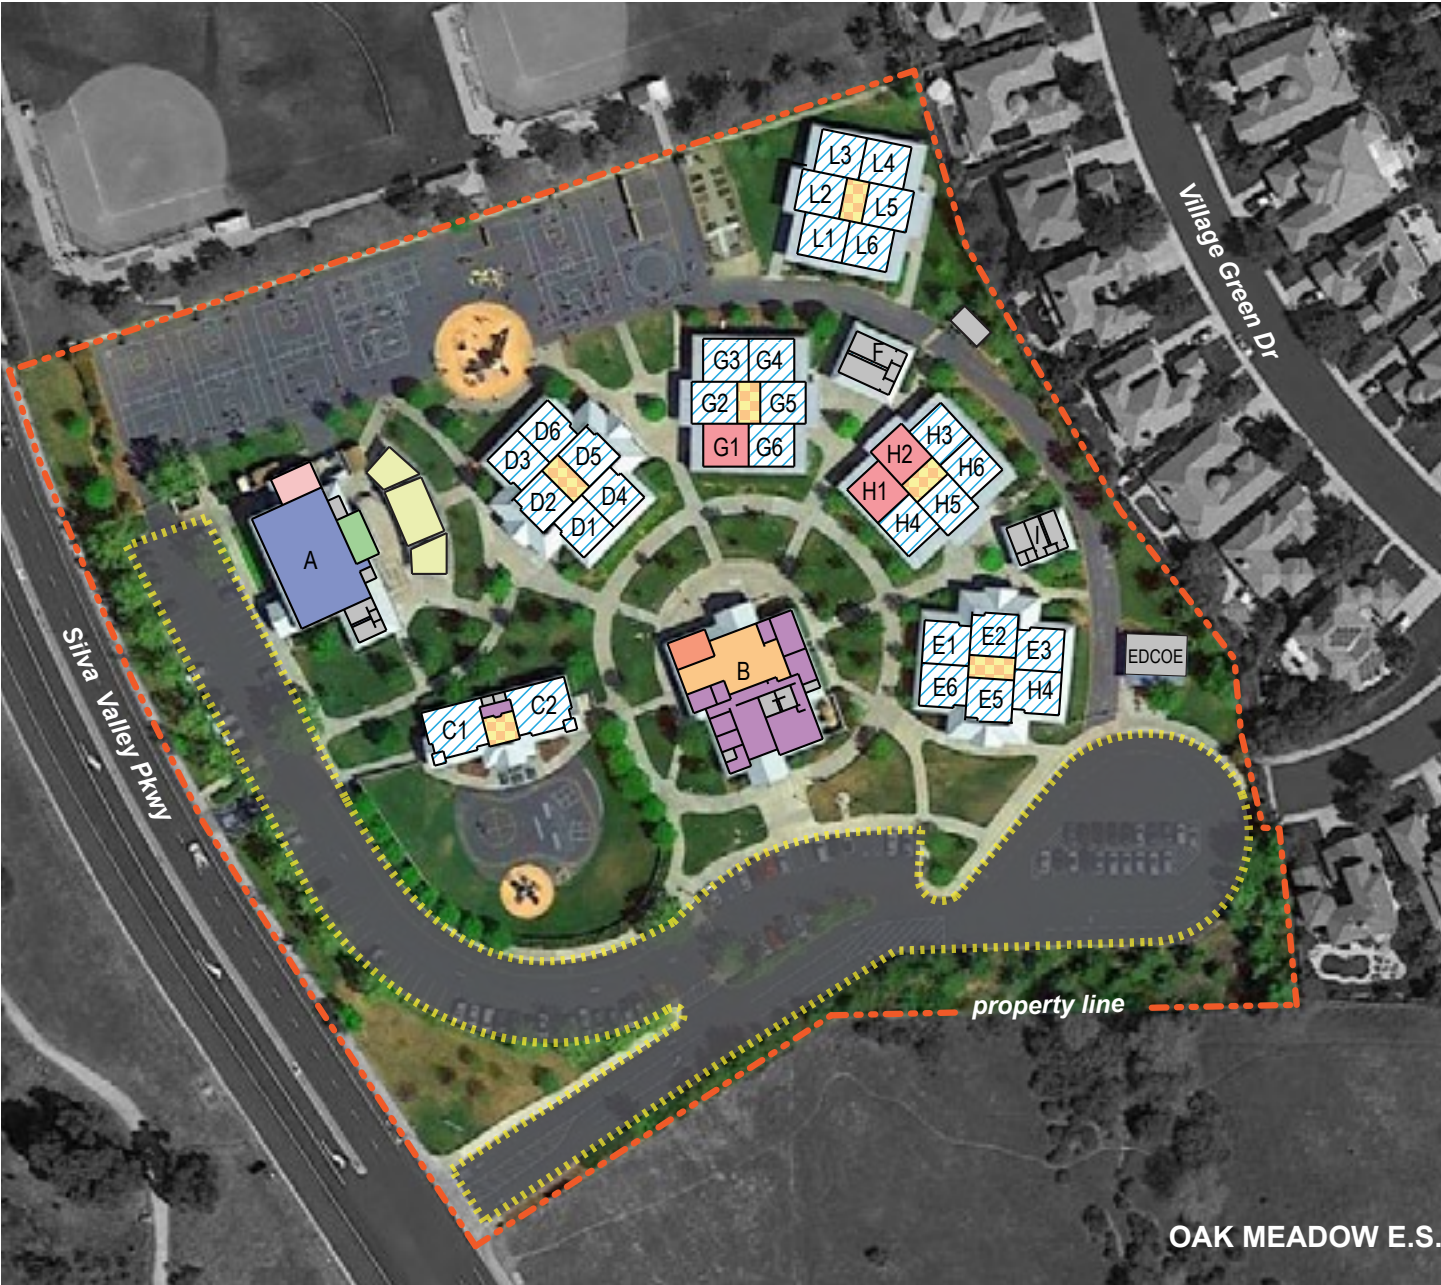
EXISTING PROGRAMMING

13. Building L needs a better connection back to central campus.

14. Courtyard spaces are nice but not used for outdoor learning or connected to classrooms.

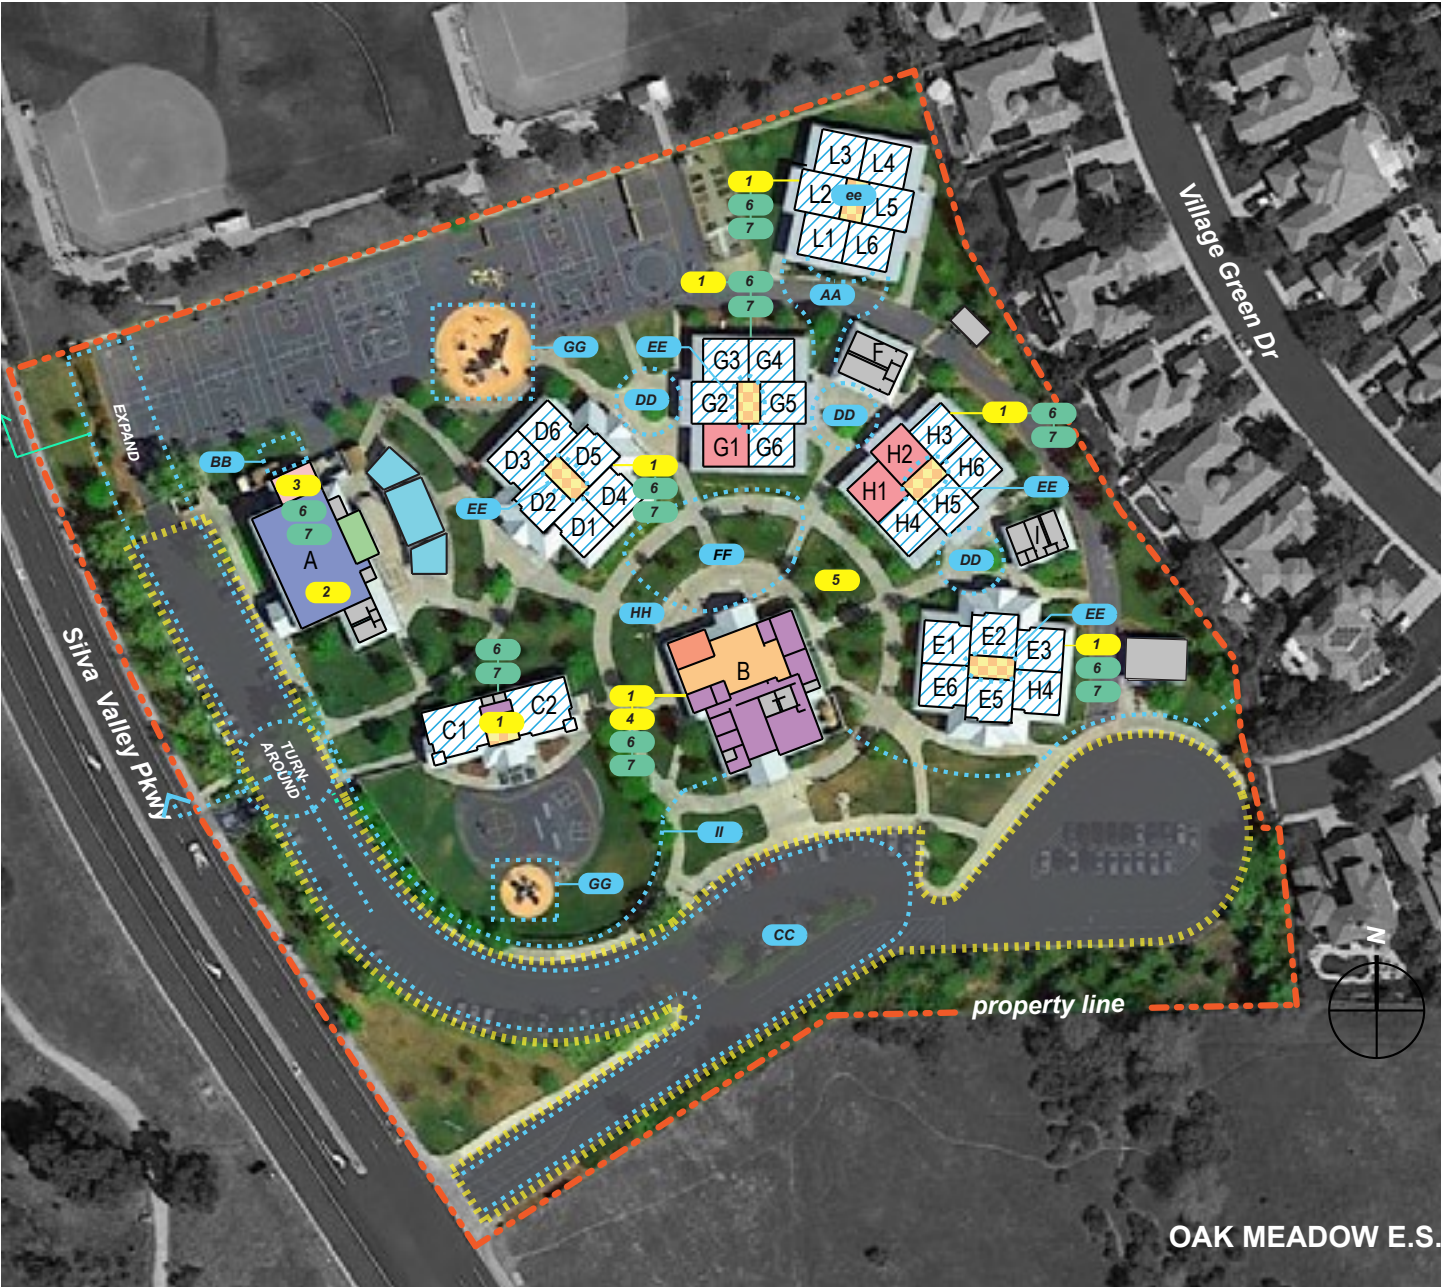
# PROPOSED MASTER SITE PLAN

LEGEND		
CATEGORY 1	CATEGORY 2	CATEGORY 3
1 0 - 1 YEAR	A	AA
1 2 - 5 YEARS		
1 6 - 10 YEARS		
1 11 - 15 YEARS

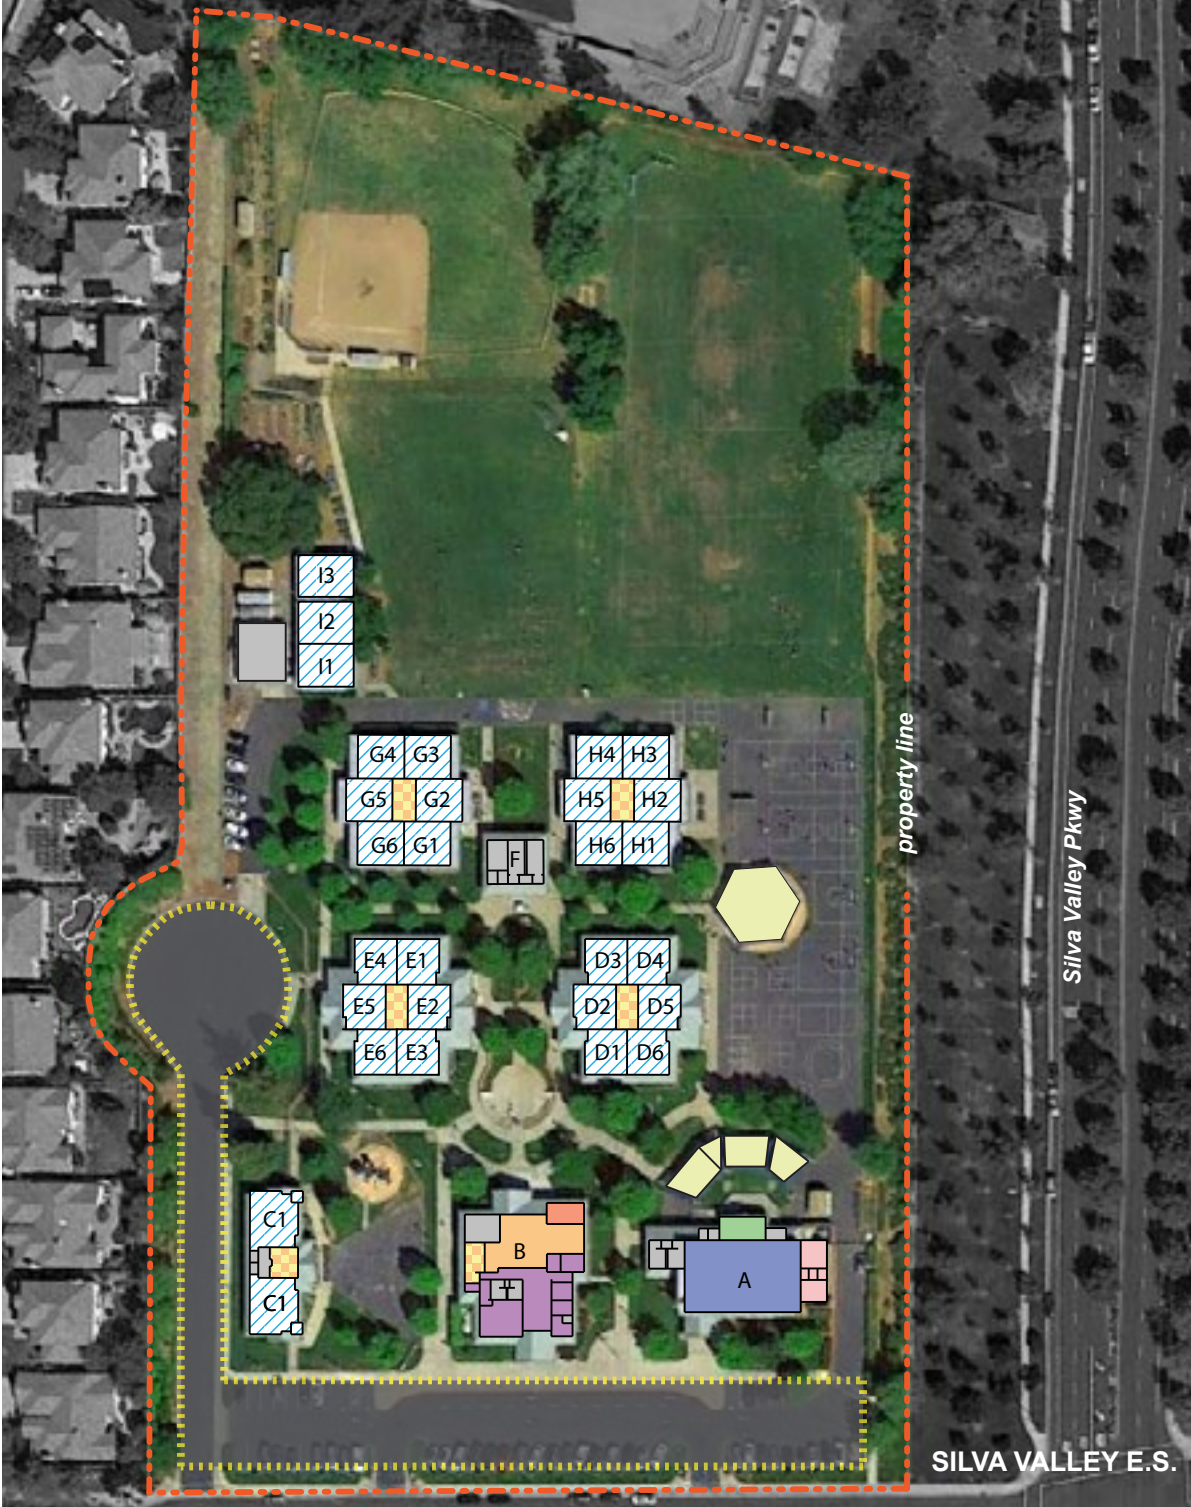
EXISTING PROGRAMMING

Classroom		Media Center	
Science Classroom		Computer Lab	
Collaboration Room		Food Service	
Administration		Special Education	
Multi-purpose		PE/Athletics	
Misc. Building Support		Shade Structure	
Shop/ Music / Art

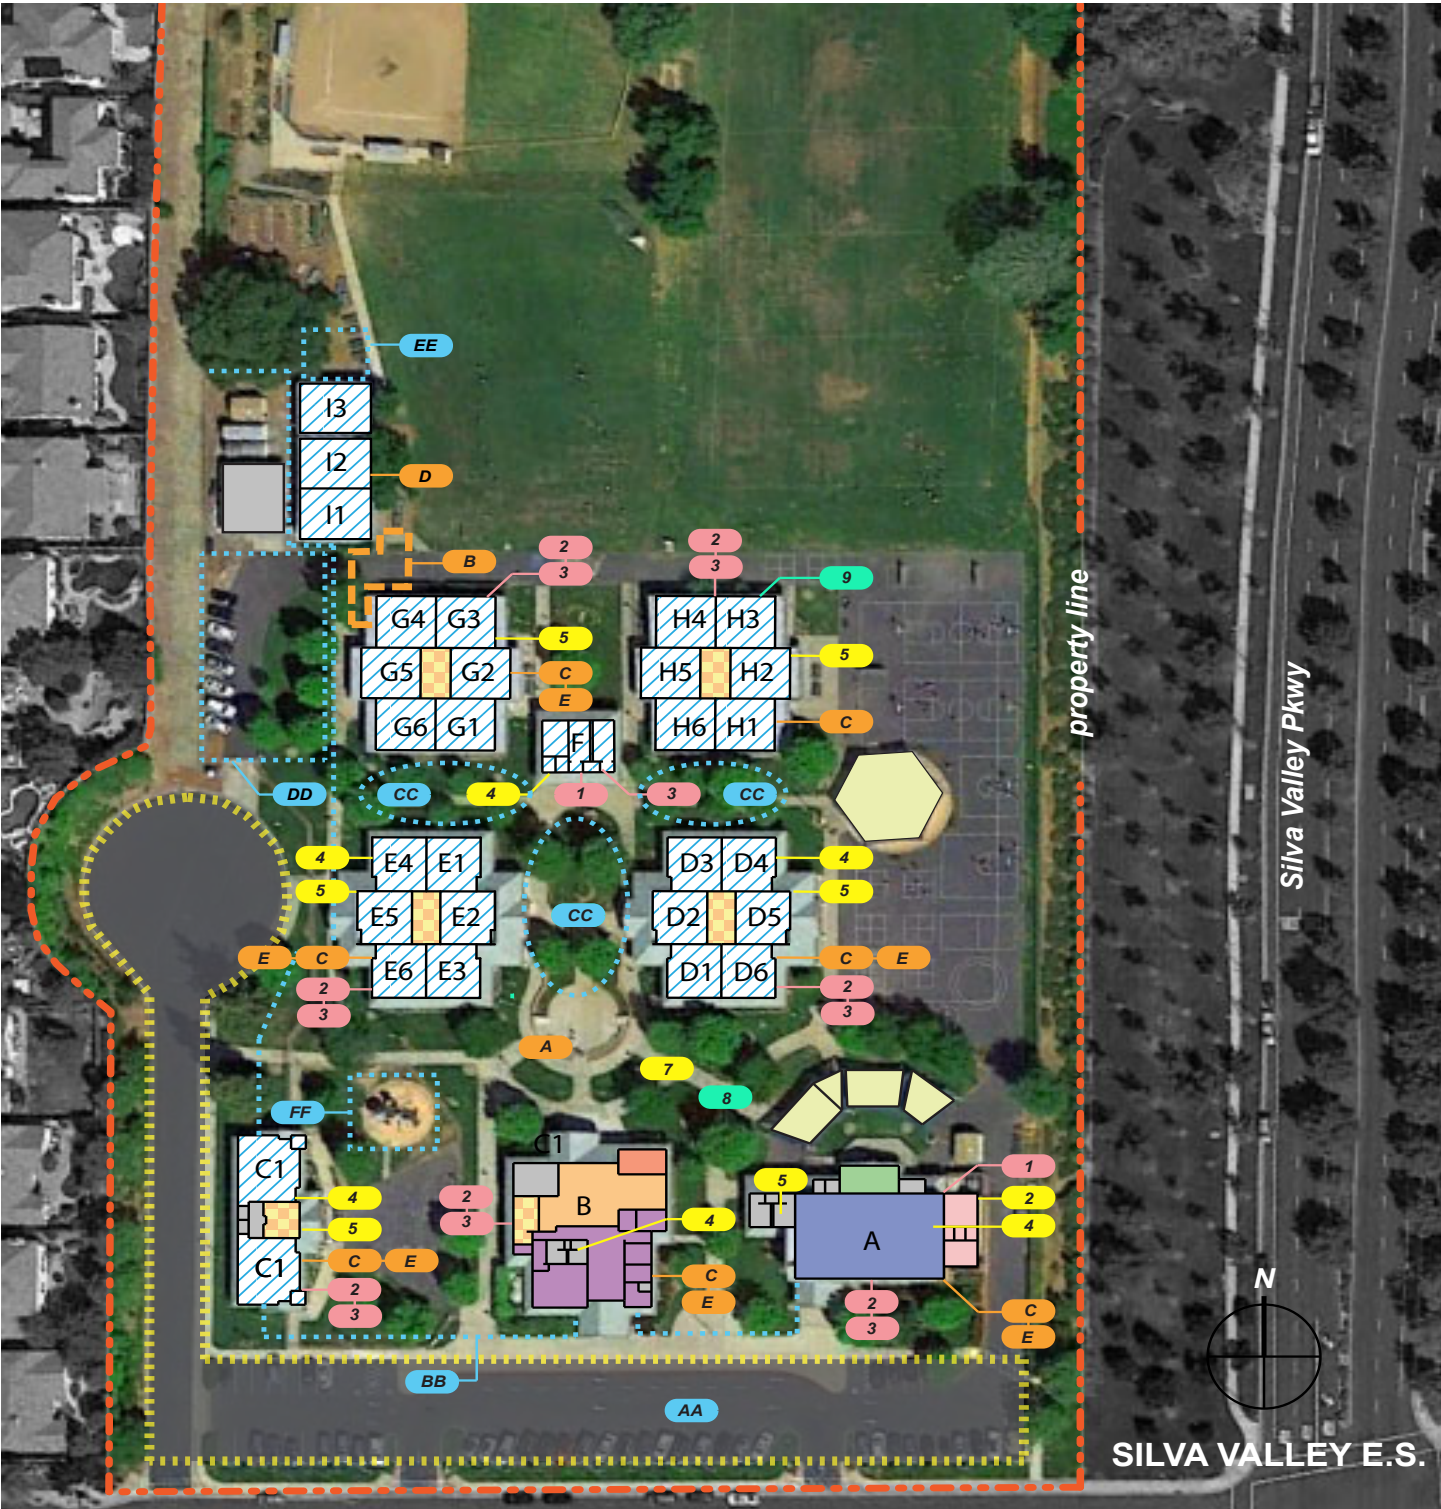
PROPOSED MASTER SITE PLAN

Silva Valley  
Elementary  
School

3001 Golden Eagle Lane  
El Dorado Hills, CA 95762

ITEM	DESCRIPTION	COSTS(\$)
0 - 1 YEAR PROJECT		
1	Install wheelchair lift	66,049
2	Replace built-up roofing	359,792
3	Replace HVAC system on original campus buildings	1,299,005
	Sub-Total	1,724,846
2- 5 YEARS PROJECT		
4	Repair tile floor/base in problem areas at restrooms	22,128
5	Replace vinyl flooring	59,007
6	Replace foldout tables in MP room	286,775
7	Replace landscape with drought tolerant ground cover & shrubs	59,007
	Sub-Total	426,918
6 - 10 YEARS PROJECT		
8	Drainage system improvements	34,887
9	Replace HVAC on Building H	290,895
	Sub-Total	325,782
11 - 15 YEARS PROJECT		
	None identified	
	Sub-Total	
Category 1 Total		2,477,545

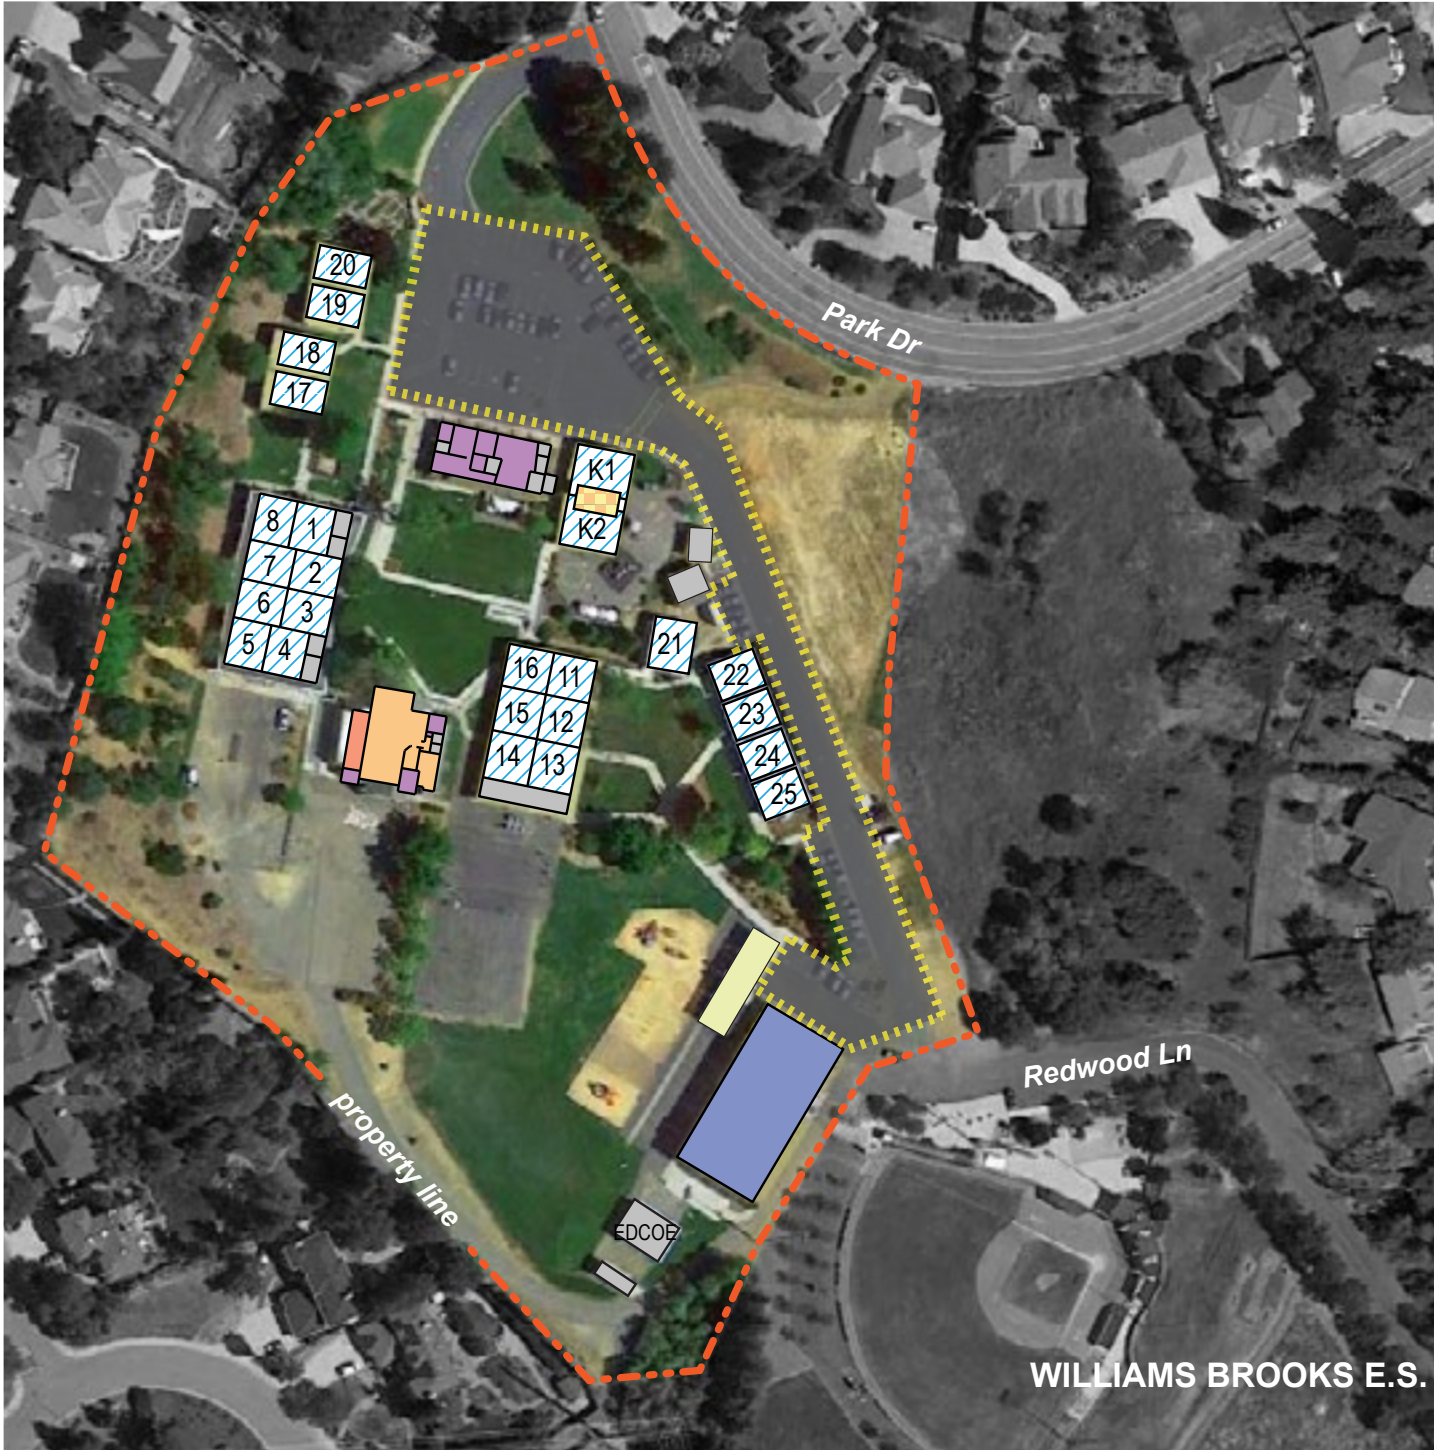
EXISTING PROGRAMMING

Classroom		Media Center	
Science Classroom		Computer Lab	
Collaboration Room		Food Service	
Administration		Special Education	
Multi-purpose		PE/Athletics	
Misc. Building Support		Shade Structure	
Shop/ Music / Art
