# 2016 FACILITIES MASTER PLAN

# Buckeye Union School District

## 2016 Facility Master Plan

Prepared: March 2016

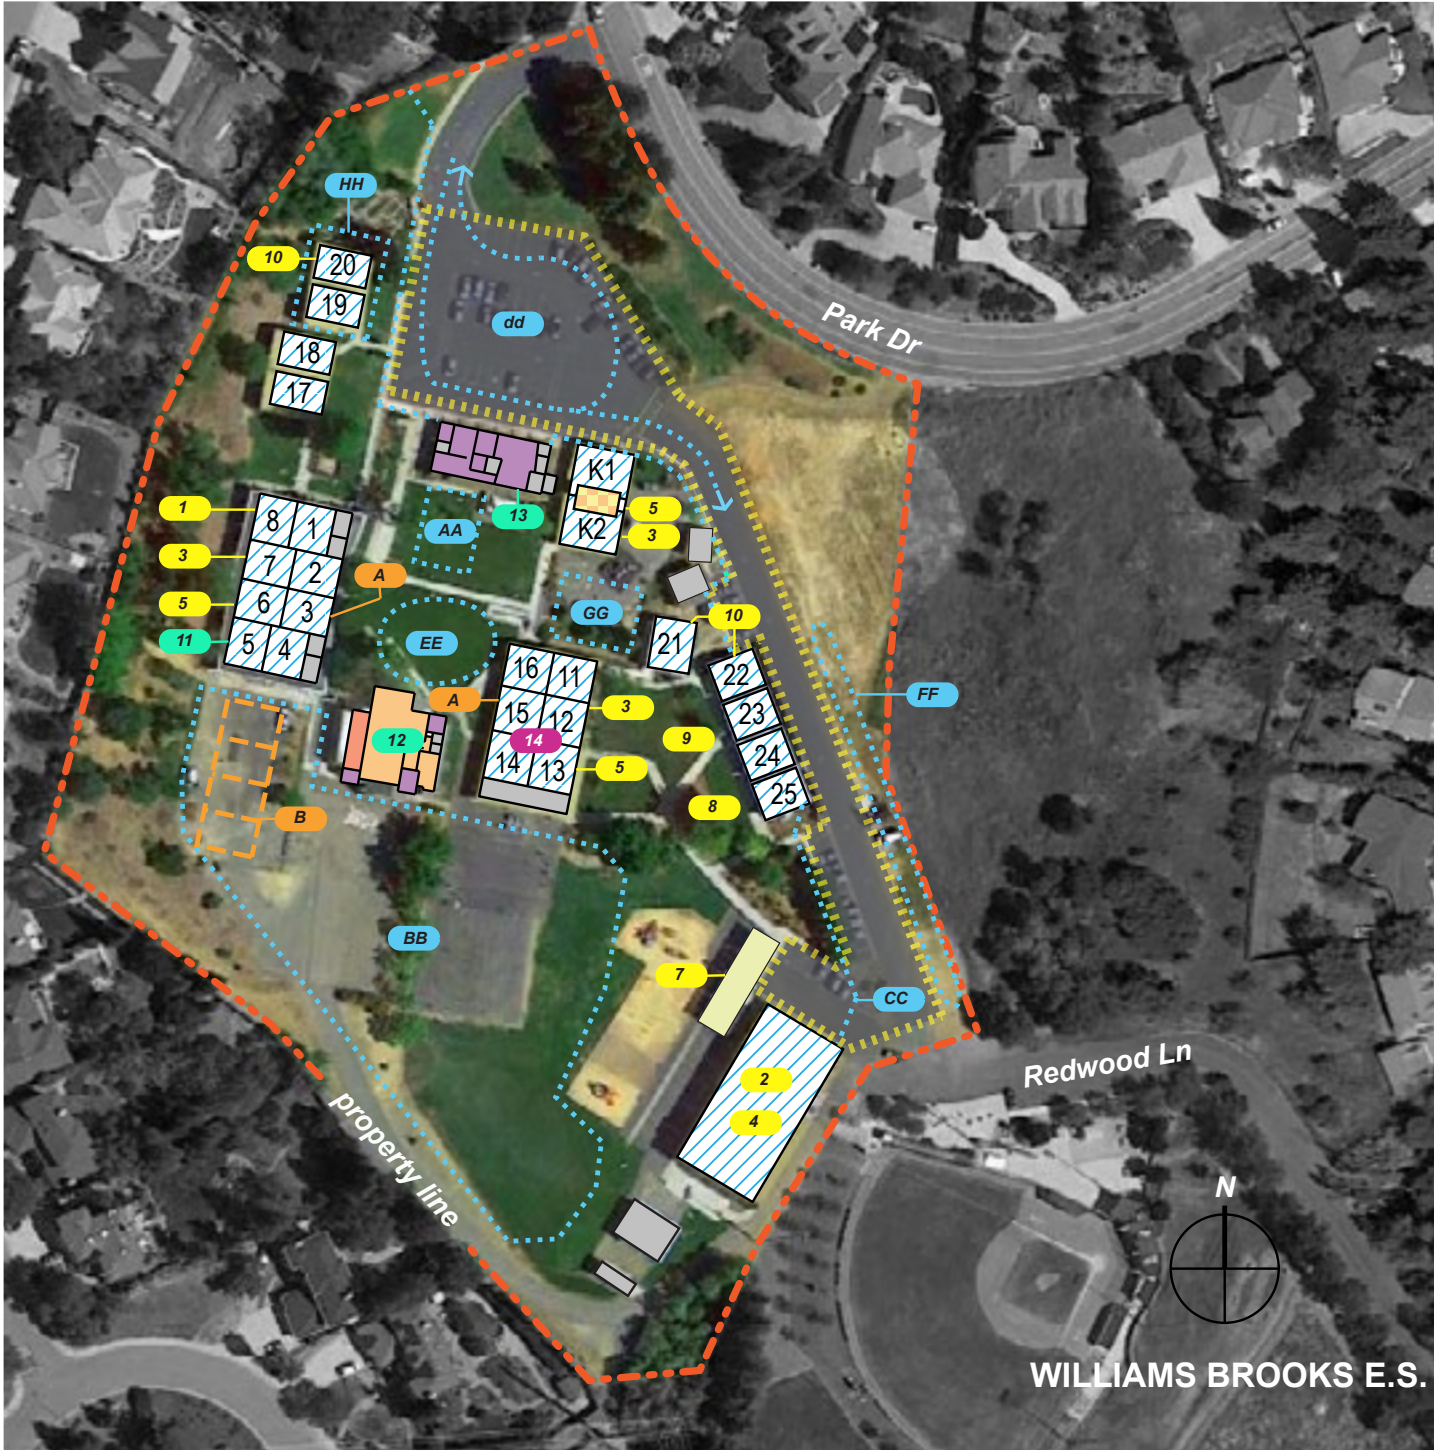
# PROPOSED MASTER SITE PLAN

## William Brooks Elementary School

3610 Park Dr.  
El Dorado Hills, CA 95762

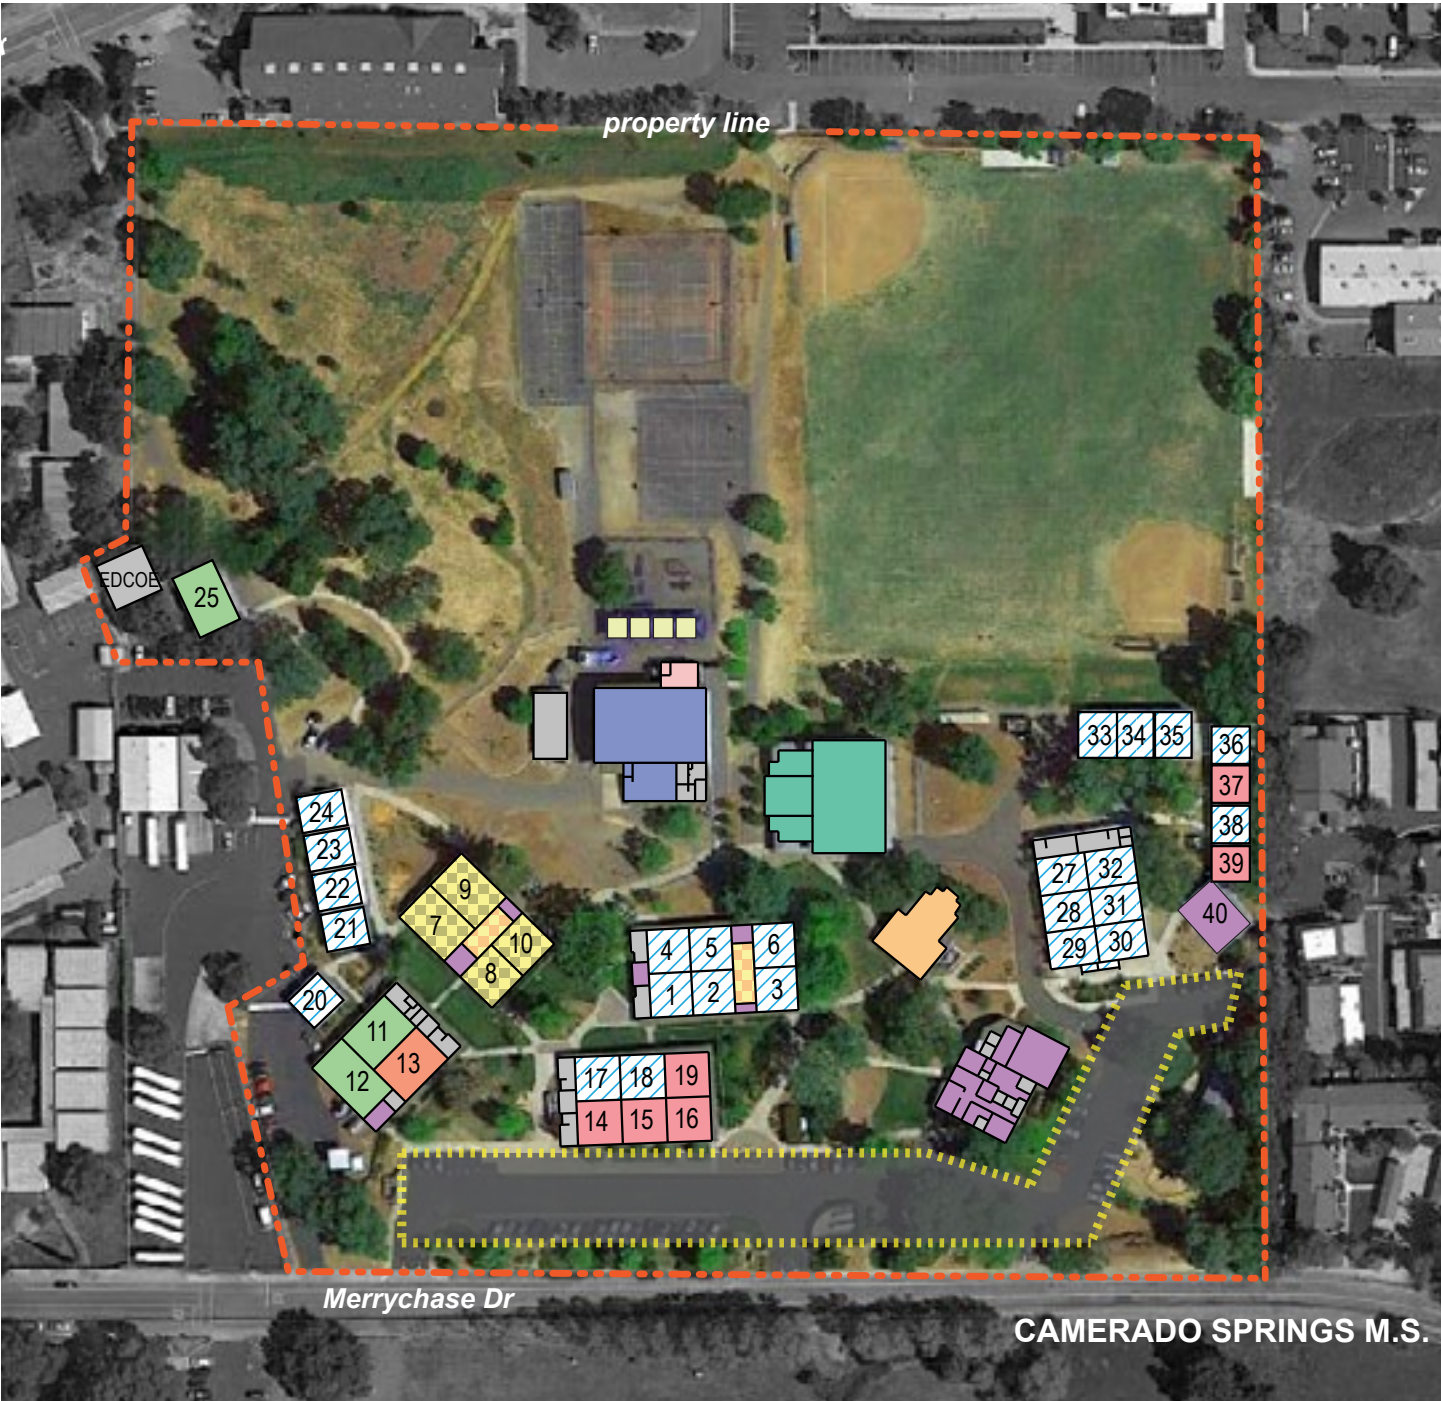
# FUNCTIONAL SITE OBSERVATIONS

The following concerns with suggested improvements were noted during the site observation of Camerado Springs Middle School.

1. Library is small and lacks a computer area and collaboration space.
2. Auto drop-off is located with no separation to parking. A divider should be added.
3. Office is small and lacks meeting space and should be expanded.
4. School is wide open to public access. Fencing and gates for secured perimeter is recommended.
5. School lacks adequate separation to bus maintenance facility and Blue Oak E.S.
6. Site has great nature areas but they are not developed. Creating outdoor classrooms and gathering areas is desirable.
7. Access to portable classrooms 33 to 40 needs an upgraded path for improved student flow.

10. There is an outdoor stage but no gathering space adjacent so the development of an amphitheatre is recommended.

11. Units 25 and 26 are remotely located and should be moved closer to the campus core.

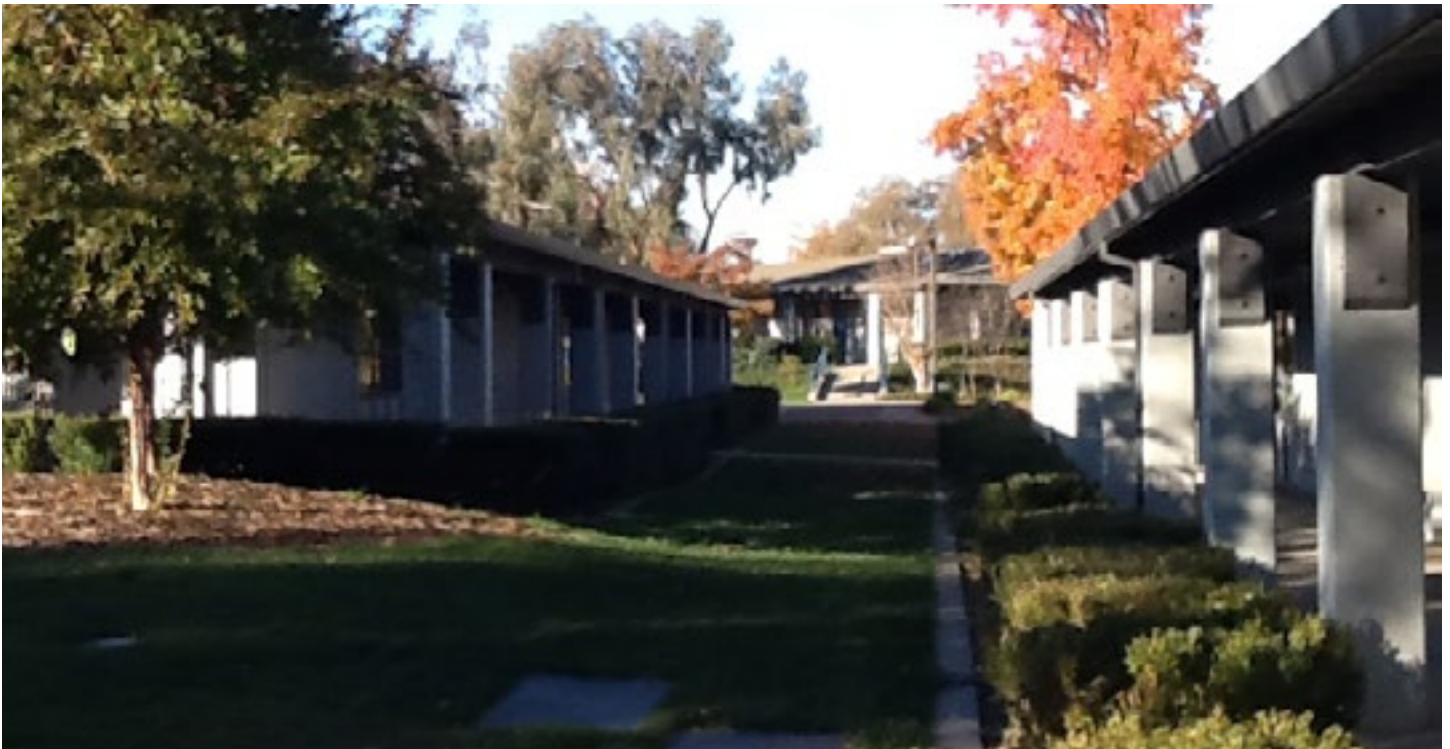
## Camerado Springs Middle School

# PROPOSED MASTER SITE PLAN

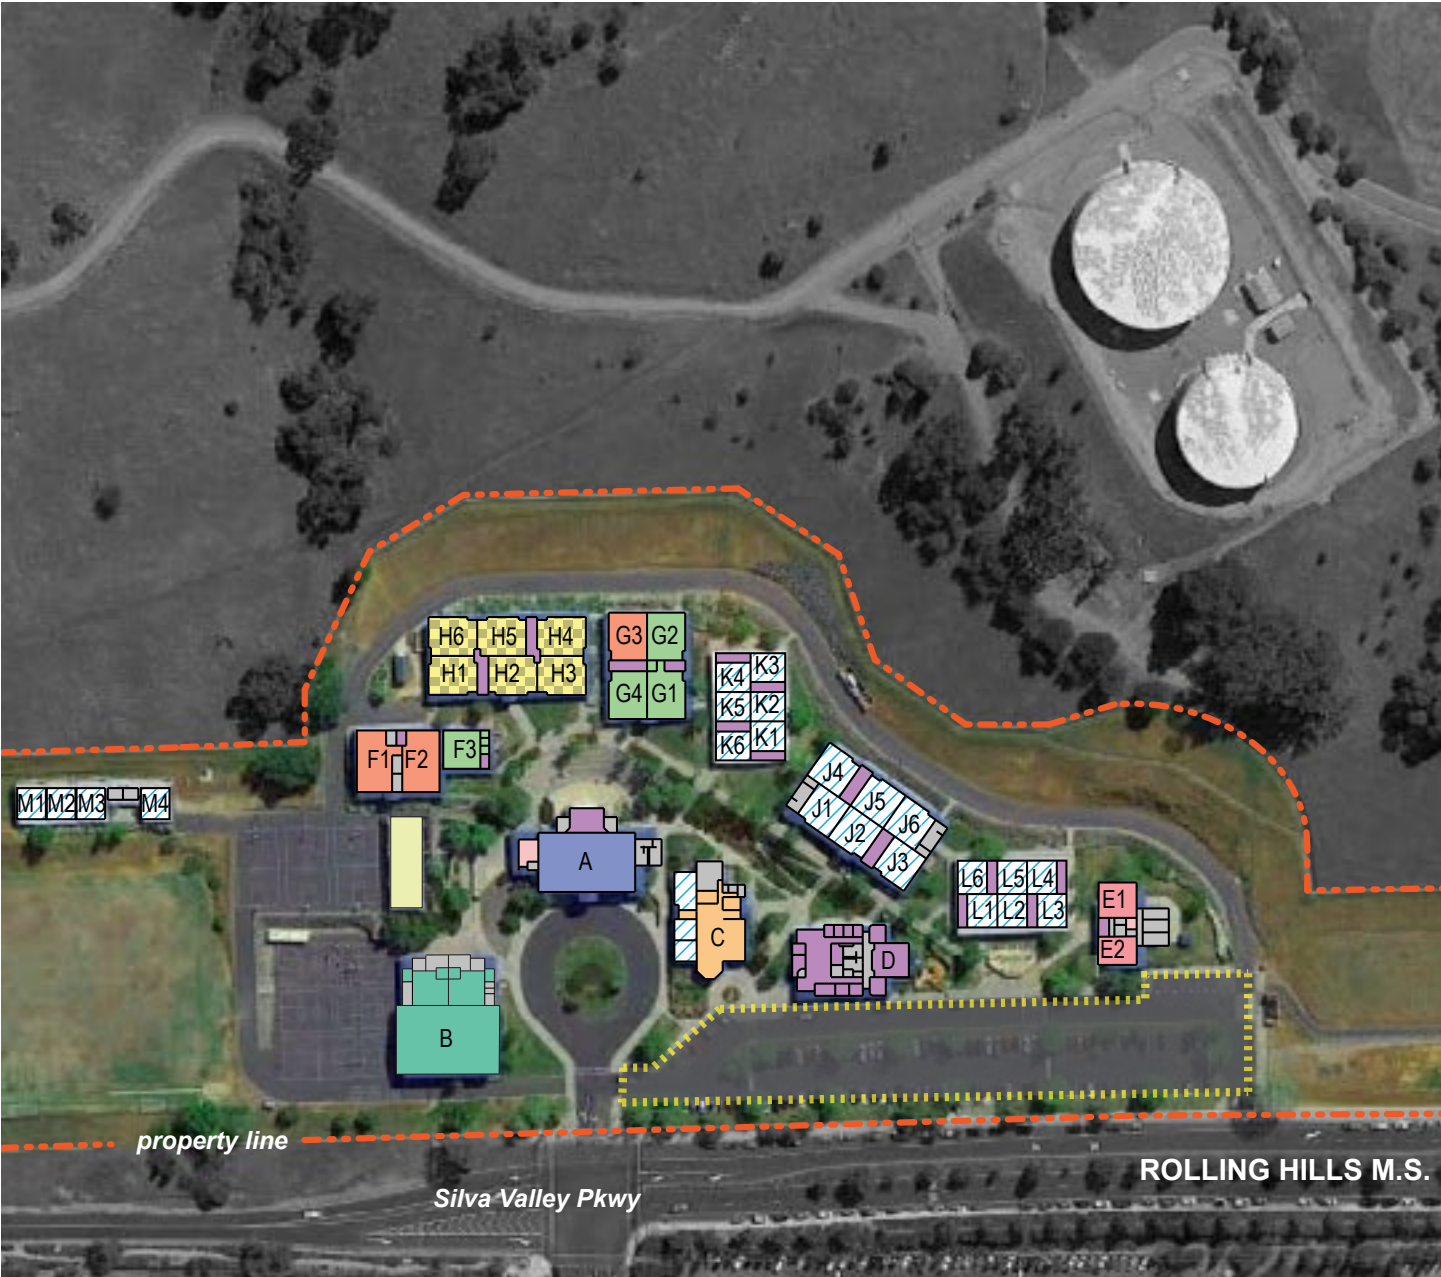
# FUNCTIONAL SITE OBSERVATIONS

The following concerns with suggested improvements were noted during the site observation of Rolling Hills Middle School.

12. Existing outdoor eating and hard courts are very crowded at lunch. Area needs expansion.

13. The long linear site has field and court spaces far from the athletic facilities.

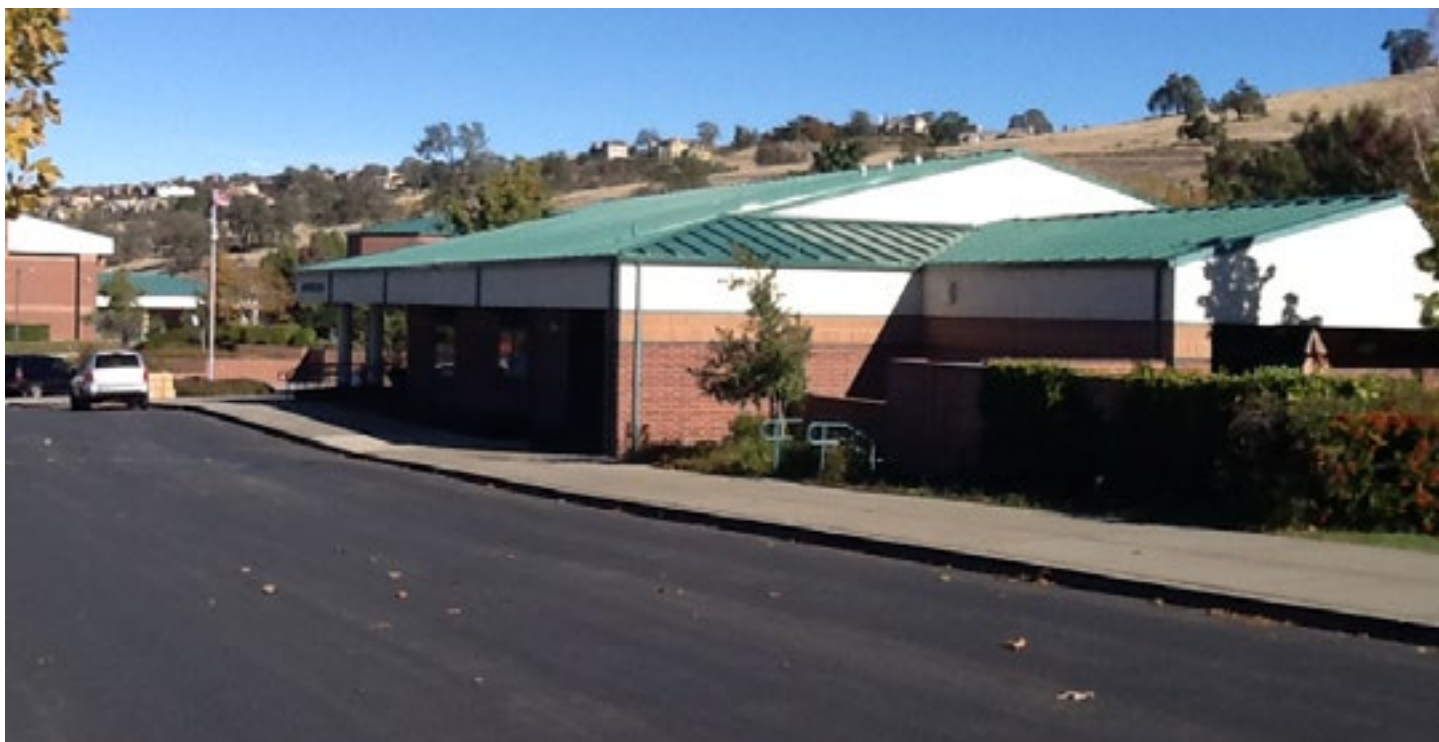
## Rolling Hills Middle School

# PROPOSED MASTER SITE PLAN
