Conceptual Alternatives Report
Phase 1 - Design Services for the Repair or
Replacement of the Retaining Wall
Montford North Star Academy Retaining Wall
Asheville, North Carolina
S&ME Project No. 1541-20-010

Reference: **Conceptual Alternatives Report**
Phase 1 - Design Services for Wall Repair or Replacement
Montford North Star Academy Retaining Wall
Asheville, North Carolina
S&ME Project No. 1541-20-010

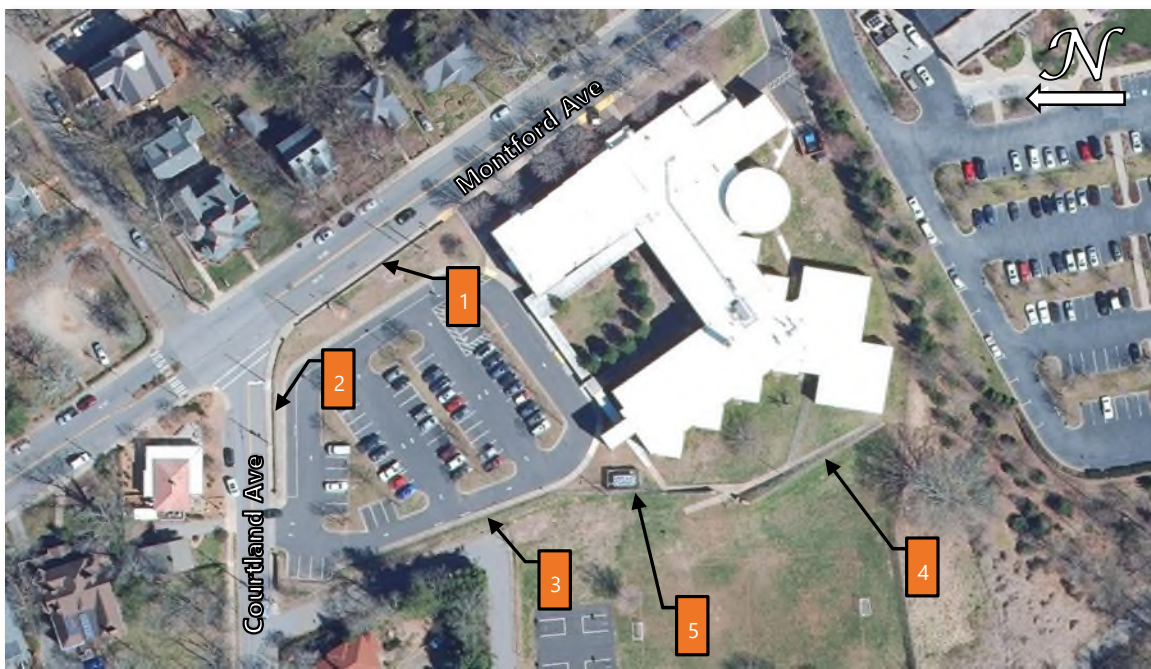
Figure 1-2: Site Aerial View

For the purpose of identification and discussion throughout this report, the stone walls on the property have been divided into 5 sections as numbered and described below, with corresponding number annotation on the aerial photo presented as Figure 1-2.

1. Montford Avenue Wall: short freestanding wall along Montford Avenue. This wall was originally a low height retaining wall constructed in front of the 1890s school building.
2. Courtland Avenue Wall: short freestanding wall located between the sidewalk along the south side of Courtland Avenue and the school parking lot;
3. North Wall: Retaining wall along Gudger Street and extending to the vertex point in the recreation area;
4. South Wall: Retaining wall section south of the opening into the recreation area; and
5. Middle Wall: Retaining wall section between the North and South sections.

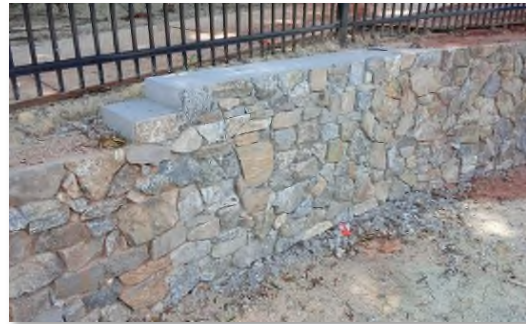
Figure 6-1: Natural Stone Veneer Example Photo

Natural thin stone veneer could be used as a likely cost saving alternative to re-using the existing stone. Natural stone, quarried, processed and sawn is routinely used for veneer applications on foundations, retaining walls, and other structures. The sawn side of the stone provides a good surface for a mortared connection to anchor ties, steel lath or other structural connection. There are numerous aesthetic options for this type of veneer. Figure 6-1 shows a natural stone veneer placed over a Mechanically Stabilized Earth (MSE) segmental block retaining wall.

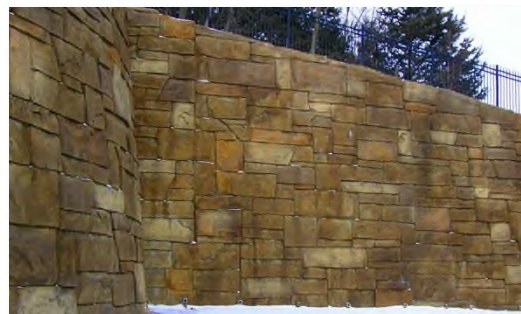
Figure 6-2: Shotcrete Sculpted Facing Example Photo

Shotcrete is a sprayed concrete application, typically used on vertical surfaces. Shotcrete can be sculpted and stained to mimic the look of stone or natural rock face as shown in Figure 6-2.

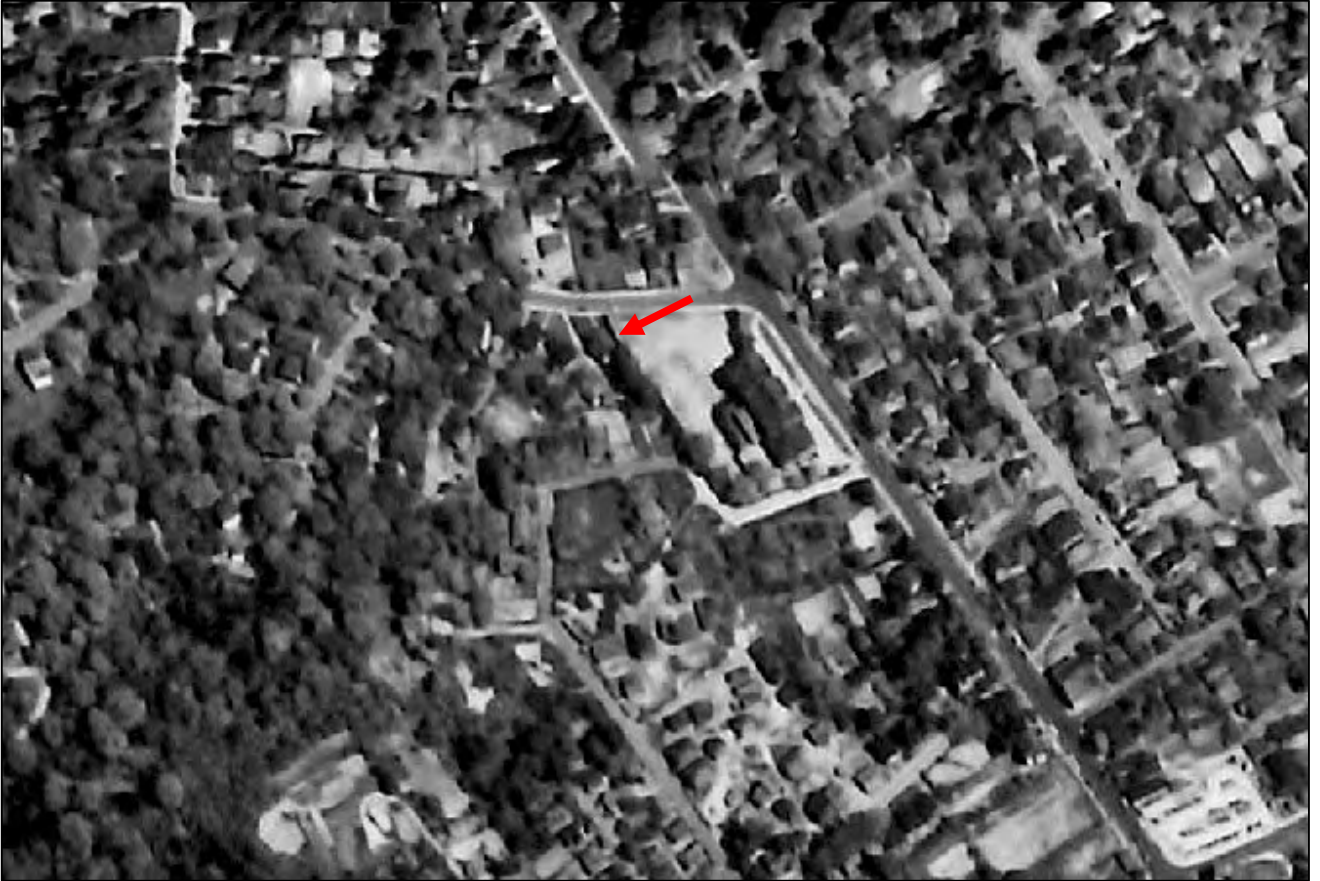
Figure 13. Aerial photograph (1951), showing wall feature on west property edge (NRCS via Buncombe County GIS).

1951 Aerial Photo (Appendix A, Figure 13): A retaining wall feature is visible along the west side of the property, in a north-south orientation and generally located between Courtland Avenue and the old intersection of Gudger Street and Gudger Place. Measurements in the Buncombe County GIS program suggest this wall feature was located along the school property's west boundary, approximately 25 feet east of the existing North Wall section. Gudger Street had not been realigned to connect to Courtland Avenue by this date.

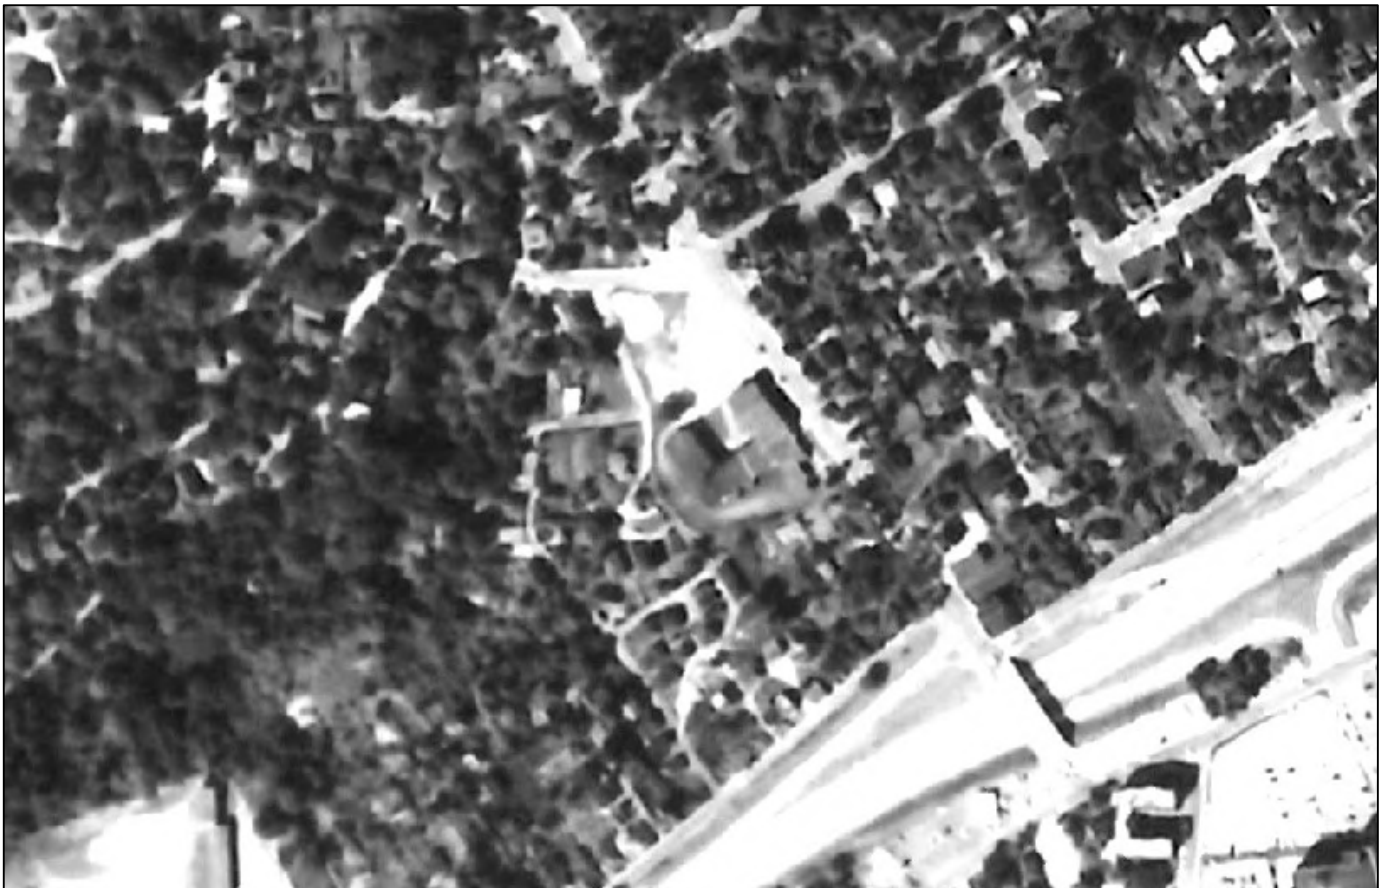
Figure 14 Aerial photograph (1963), showing wall location (Buncombe County GIS).

1963 Aerial Photo (Appendix A, Figure 14): A retaining wall feature matching the alignment of the North and Middle Walls is visible. The South Wall is not evident on this photo. Gudger Street is shown as connecting to Courtland Avenue, but the east-west section of Gudger Street is not on its current alignment.

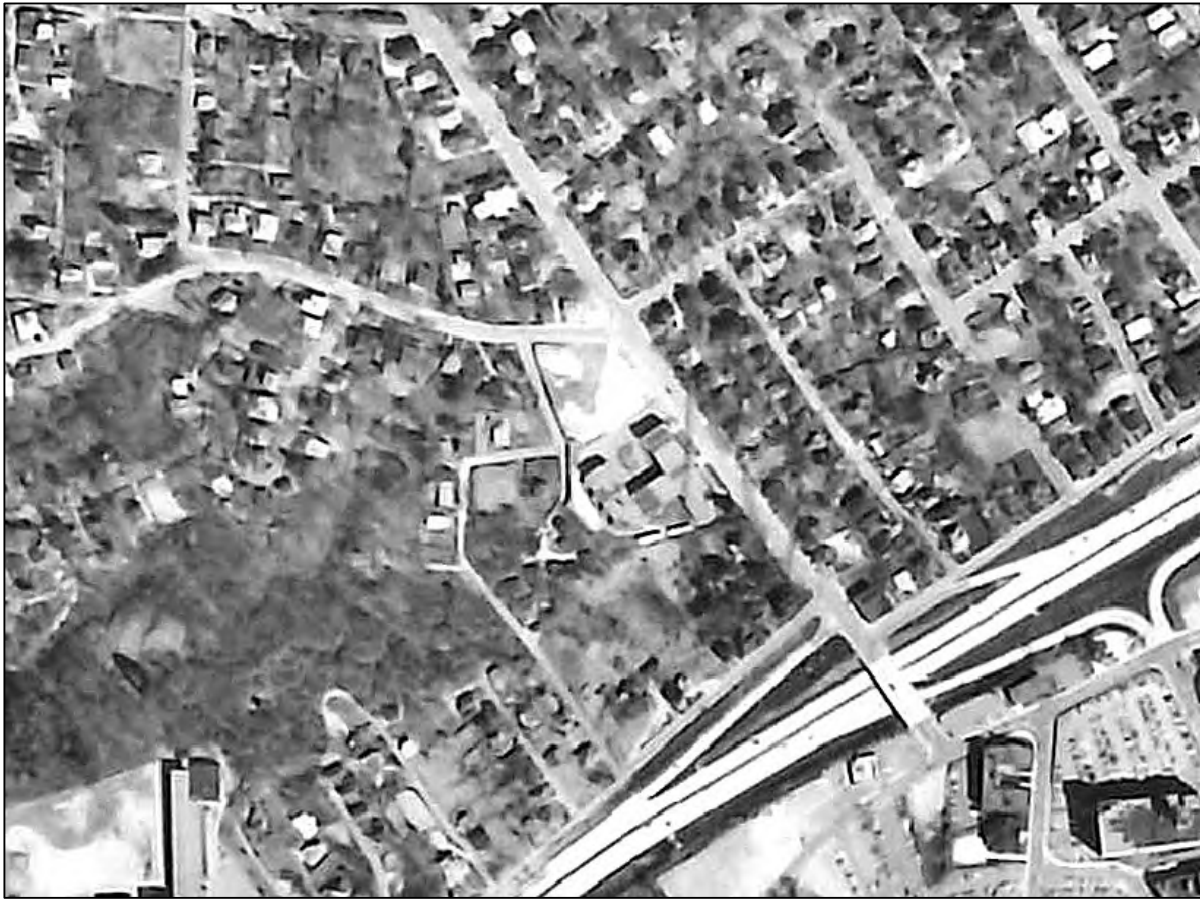
Figure 15. Aerial photograph (1975), showing wall location (Buncombe County GIS).

1975 Aerial Photo (Appendix A, Figure 15): The North and Middle wall sections are clearly visible on this photograph. Although inconclusive, the south wall does not appear to be present in this photo. The east-west section of Gudger Street is not on its current alignment.

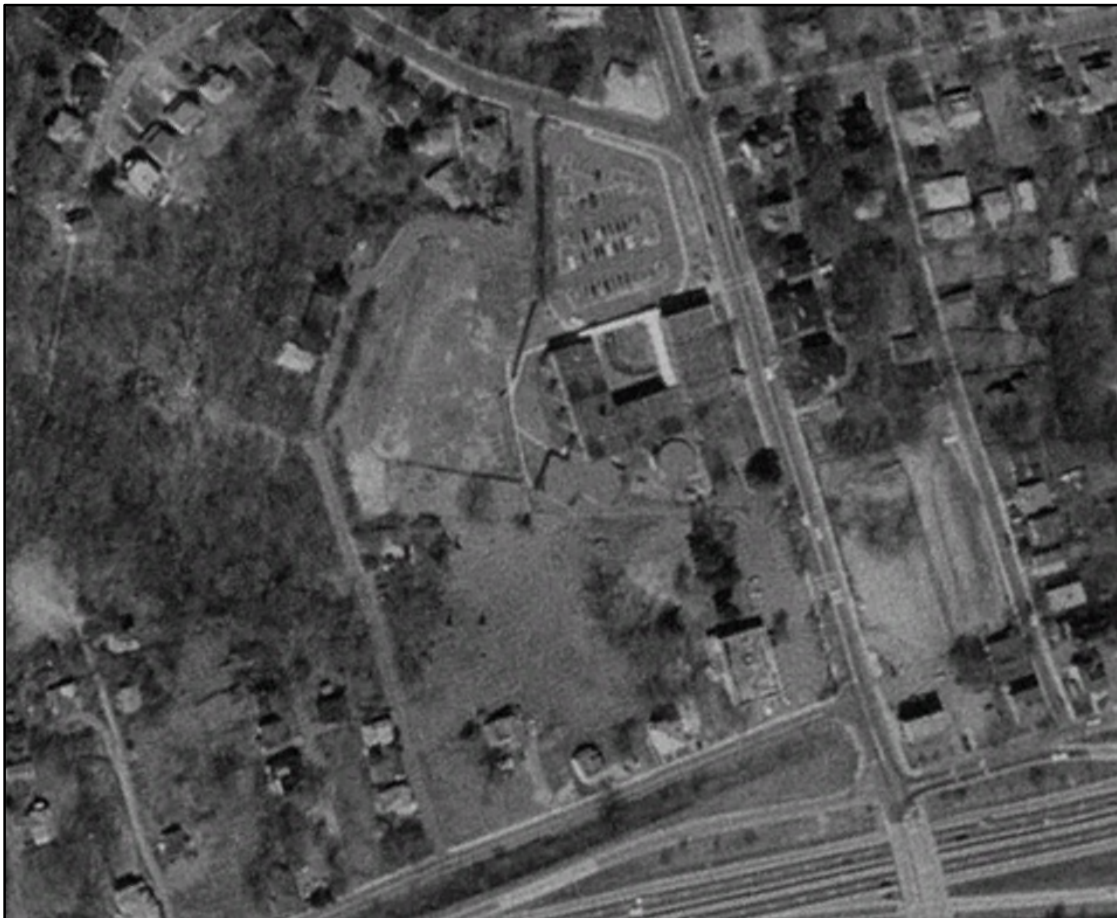
Figure 16. Aerial photograph (1994), showing wall location (Buncombe County GIS).

1994 Aerial Photo (Appendix A, Figure 16): This photo shows most of the present-day features on the school property, the current alignment of Gudger Street, and all 3 sections (North, Middle, South) of the retaining wall.

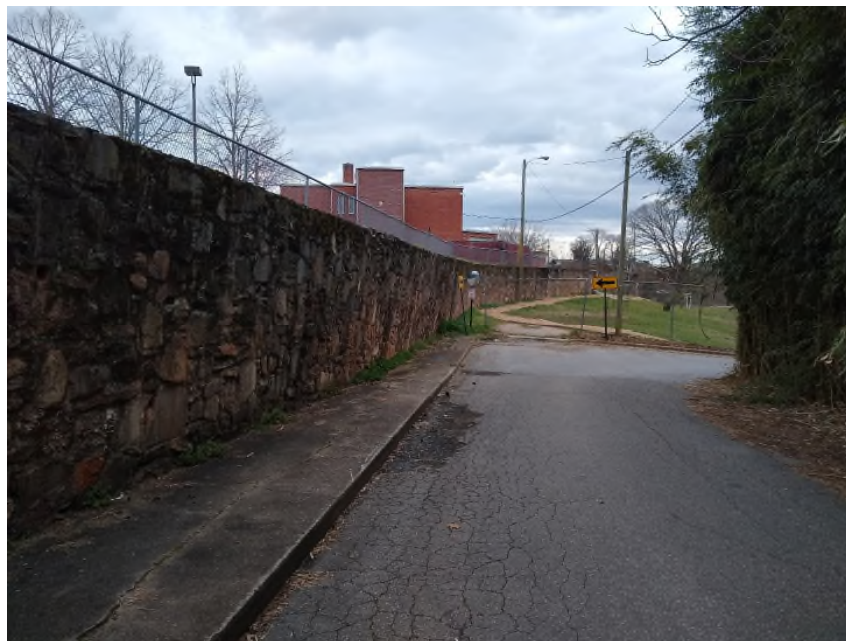
1	Location / Orientation	View from Gudger Street looking south	Photographer: S&ME	Date: Varies
	Remarks	General View. North Wall in foreground

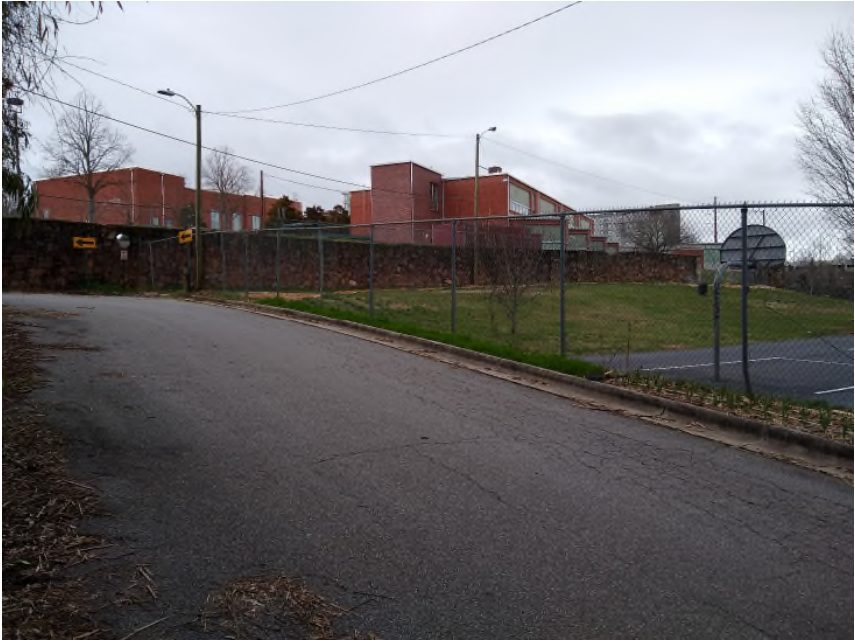
3	Location / Orientation	North and Middle Wall Sections / View looking SE
	Remarks	General View

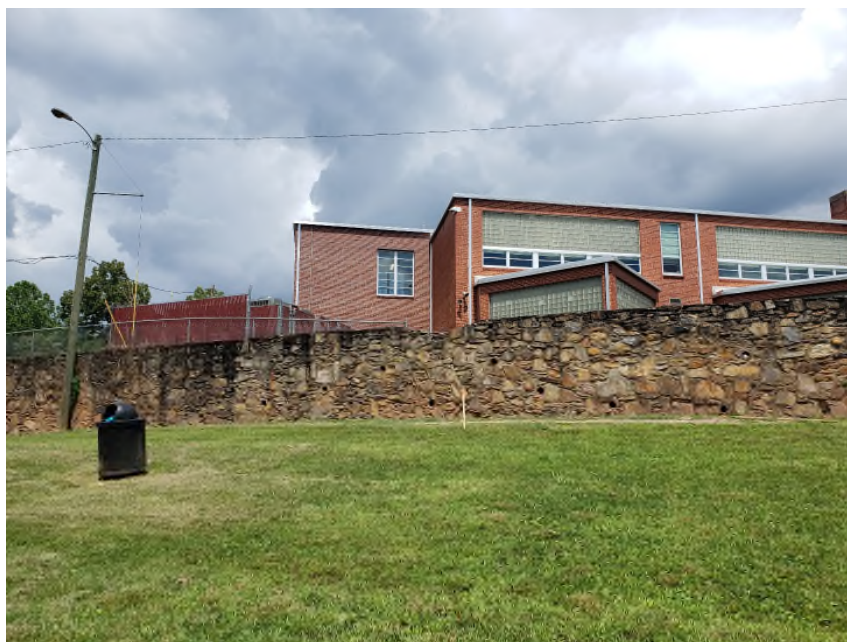
6	Location / Orientation	Middle Wall Section / View looking East	Photographer: S&ME	Date: Varies
	Remarks	General view. Note varied weep hole locations

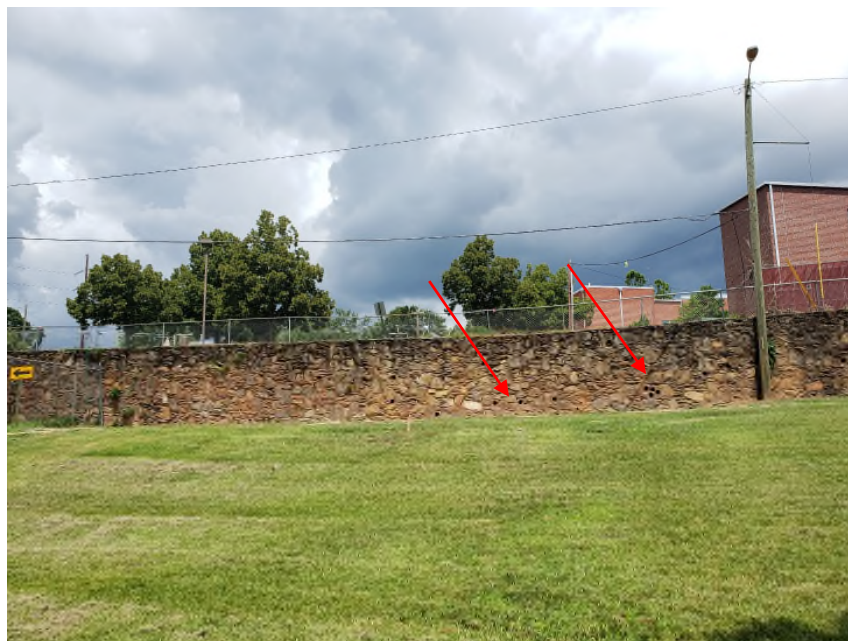
7	Location / Orientation	North Wall Section	Photographer: S&ME	Date: Varies
	Remarks	Brick structure locations visible through weepholes

- Approximately 12 feet north of the HVAC pad, a brick wall structure was observed through a cluster of 4 weep holes. The face of the brick wall is approximately 4 ½ feet behind the face of the stone wall.

- Approximately 27 feet north of the HVAC pad, a semicircular open brick structure was observed through 2 weep holes spaced 30 inches apart. The brick matched that as noted in the previous observation; and

No other indications were made as to the origin of the brick structure located underground behind the wall. It is possible that the structure is the remains of the outbuilding foundation noted on the property in the Historic Review section. The semi-circular brick structure may be a brick cistern or old catch basin drainage structure.

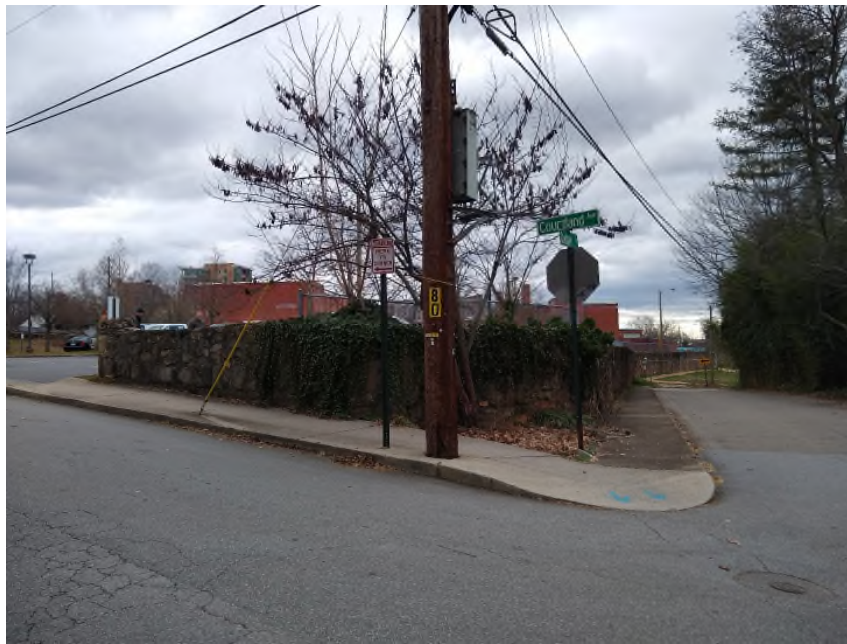
9	Location / Orientation	North Wall at Courtland Ave/Gudger St Intersection	Photographer: S&ME	Date: Varies
	Remarks	Radius transition of wall to Courtland Ave

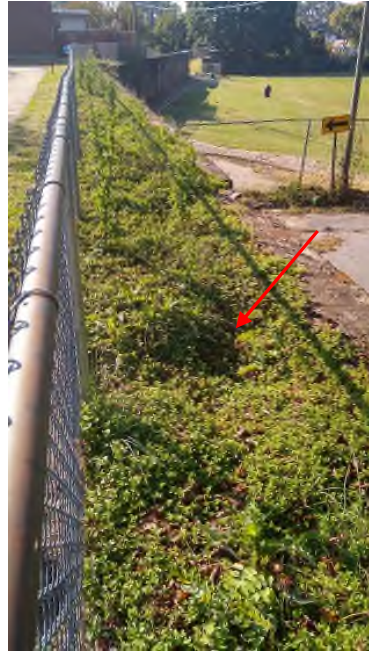
11	Location / Orientation	Top of North Wall / View looking south	Date: Varies
	Remarks	Depression behind rotated section of wall

Based on our evaluation and observations, S&ME recommends the majority of the North Wall be stabilized or reconstructed. The affected length generally extends between the vertex point at the transition to the Middle Wall, to slightly north of the halfway point along Gudger Street. This length totals approximately 160 feet. Given the age and uncertainty regarding the "structural" composition of the existing wall, consideration should be given to stabilizing or reconstructing most of the wall for long term stability. S&ME evaluated several concepts for stabilization or reconstruction with consideration of a wall facing aesthetically similar to the existing stone, or in some cases re-using the existing stone. Keep in mind that some reconstruction options require significant disturbance to the existing parking lot and the reconstructed wall section may need to include additional length.

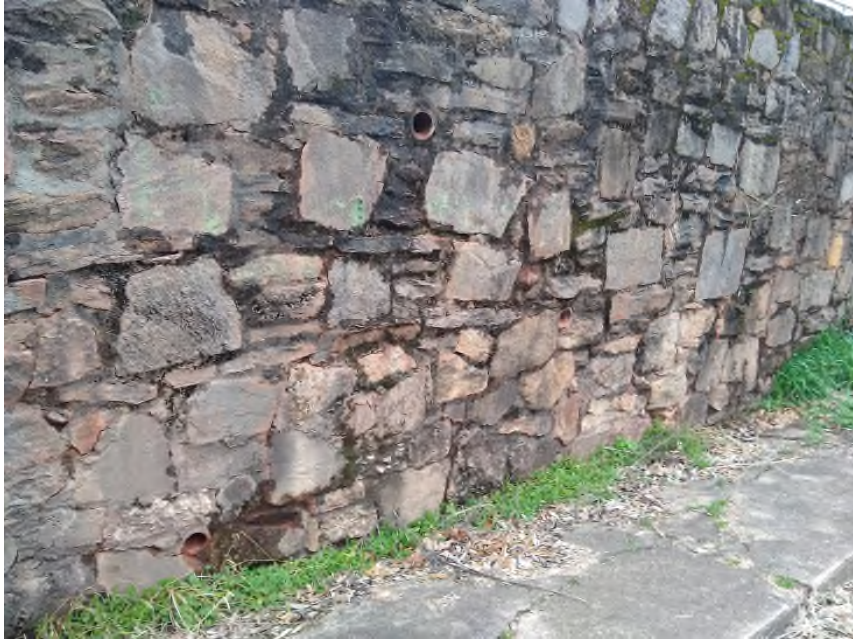
Date: Varies
		Photographer: S&ME
14	Location / Orientation	North Wall
	Remarks	Close-up of stone masonry wall construction. Note clay pipes through wall.

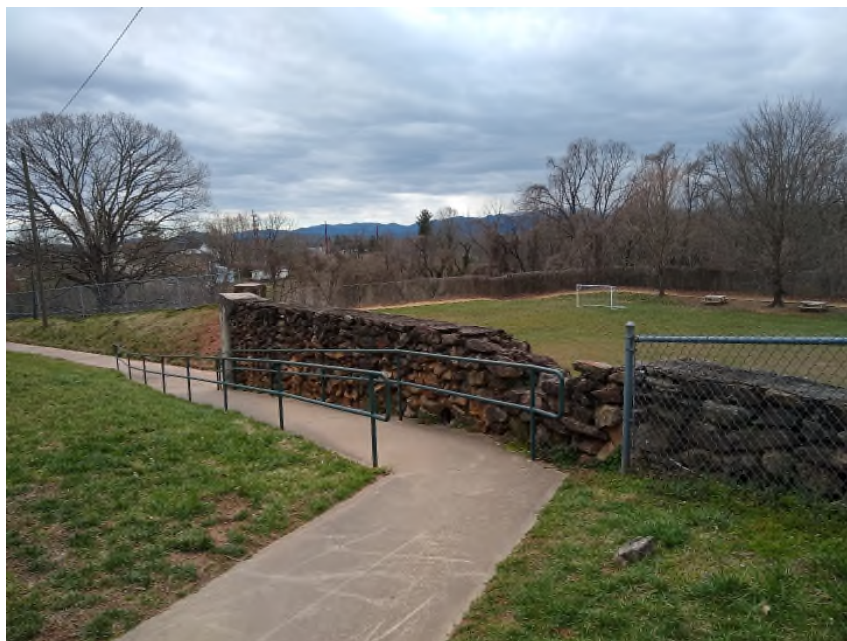
15	Location / Orientation	Backside of Middle Wall at south end	Photographer: S&ME	Date: Varies
	Remarks	Freestanding wall section along sidewalk. Large section of displaced stone. Note difference in stone texture.

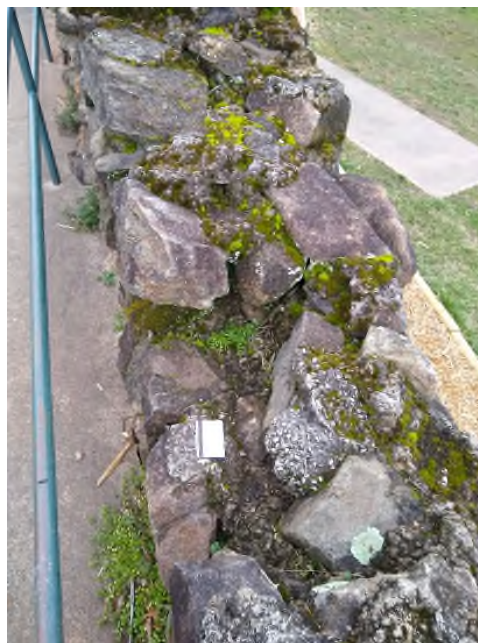
16	Location / Orientation	North Wall	Photographer: S&ME	Date: Varies
	Remarks	Top view of displaced stone area from photo 15

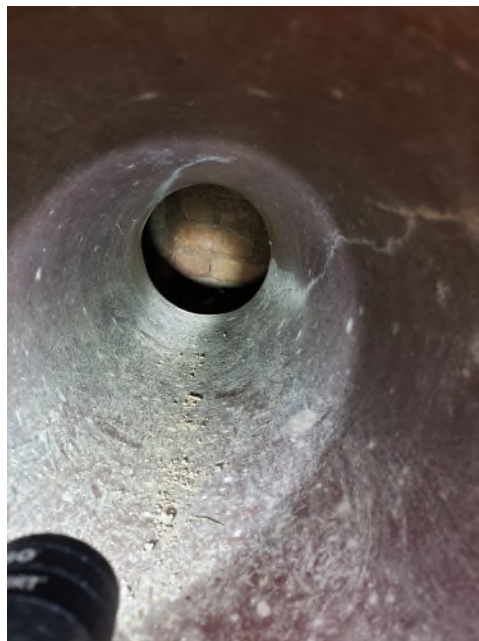
17	Location / Orientation	Middle Wall	Photographer: S&ME	Date: Varies
	Remarks	Brick structure visible through clay pipe

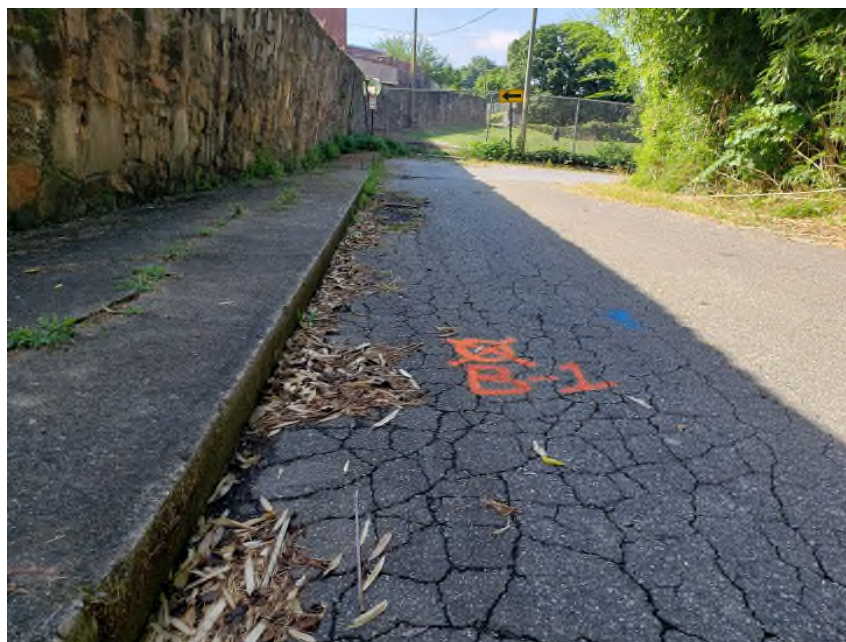
18	Location / Orientation	North Wall along Gudger St	Photographer: S&ME	Date: Varies
	Remarks	Cracking in sidewalk

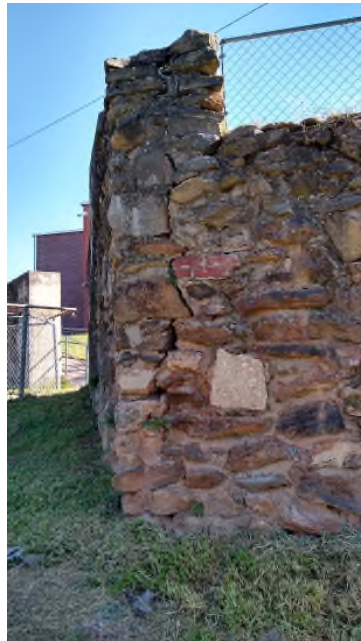
19	Location / Orientation	Corner at north end of South Wall	Date: Varies
	Remarks	Vertical crack along mortar joints. Patching with brick and concrete

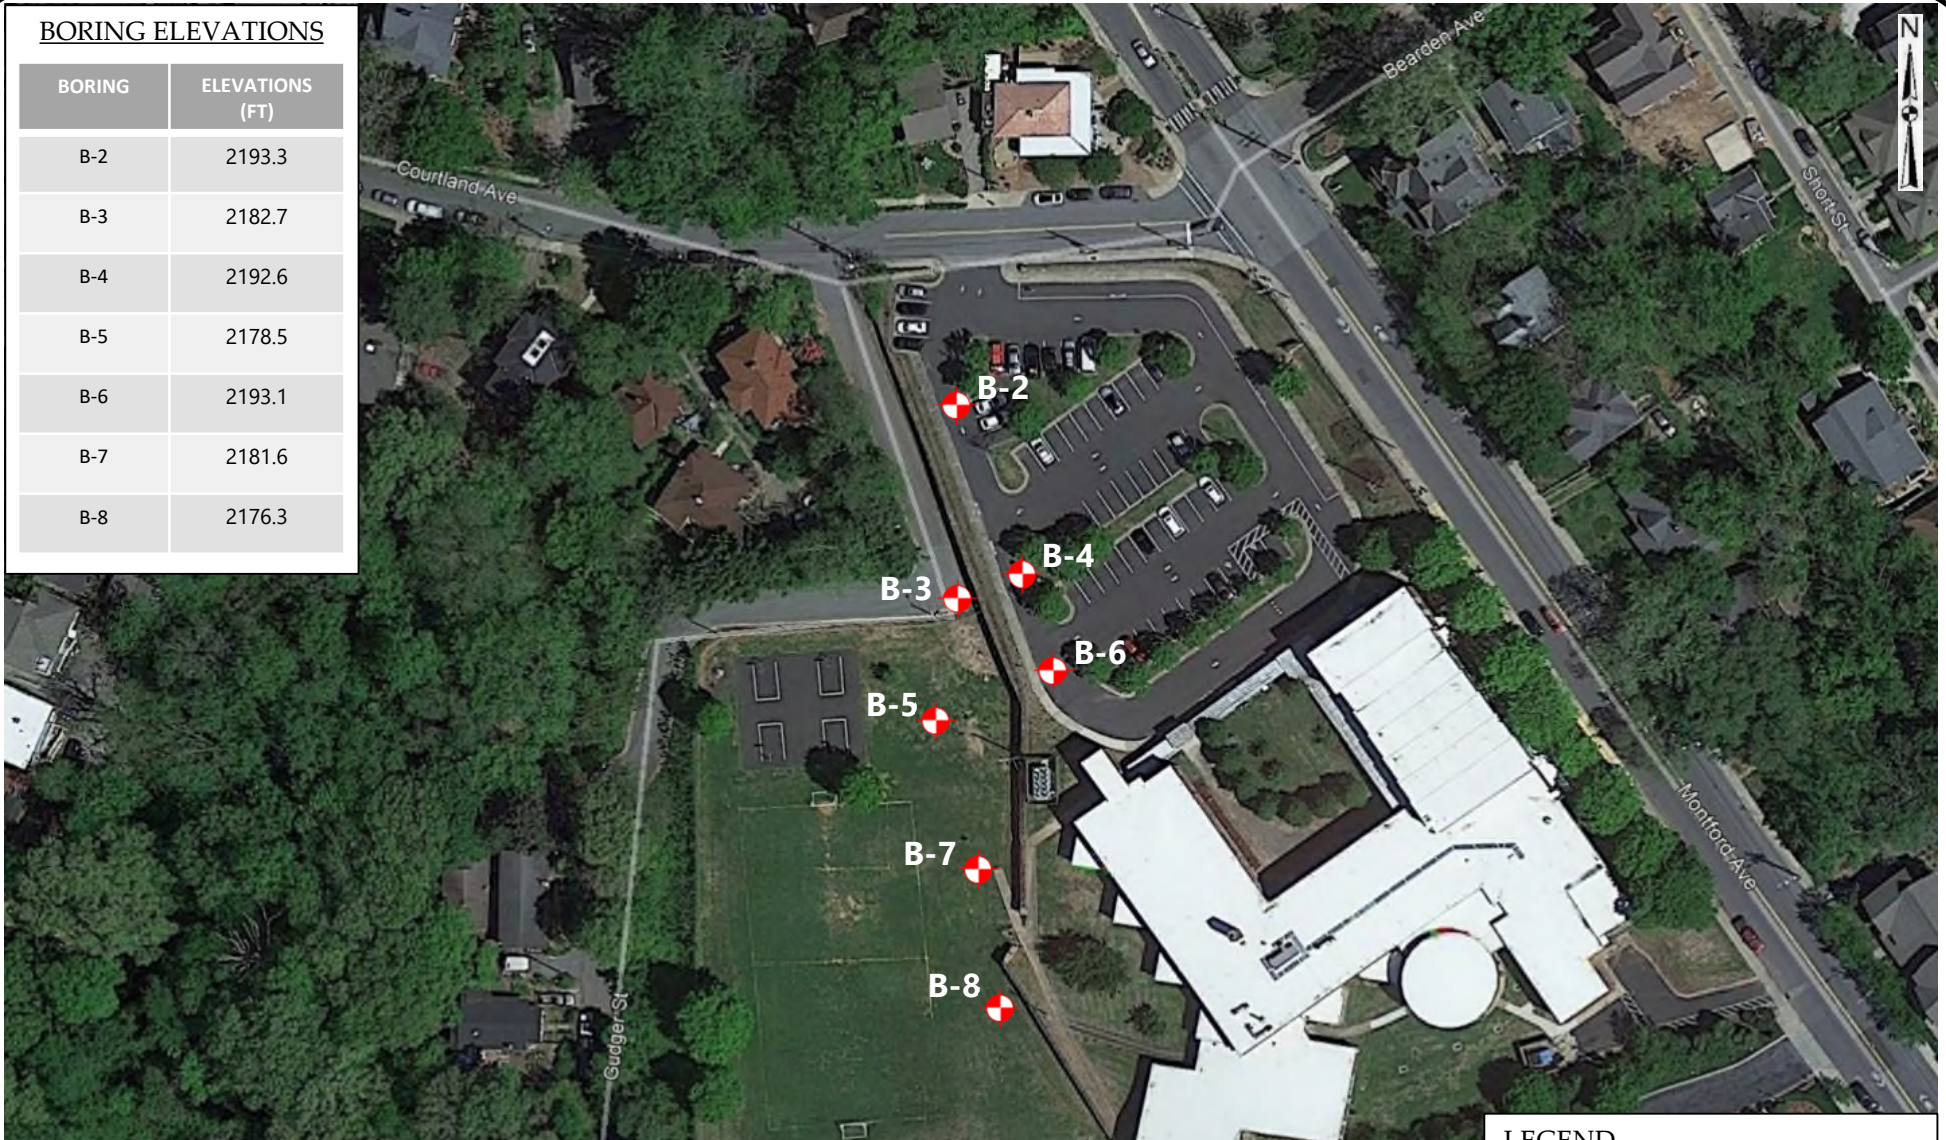
BORING	ELEVATIONS (FT)
B-2	2193.3
B-3	2182.7
B-4	2192.6
B-5	2178.5
B-6	2193.1
B-7	2181.6
B-8	2176.3

On the dates of July 29, 2020 and August 12, 2020, 7 soil test borings, designated as Borings B-2 through B-8, were advanced at the project site to depths ranging between 15 and 25 feet below the existing ground surface. Borings were performed from the school parking lot, along Gudger Street, and in the recreation area. Details of the field exploration, a general description of the subsurface conditions, and results of laboratory testing are presented in Appendix C – Subsurface Investigation. Logs of the borings and a Boring Location Plan are presented in Attachments I of Appendix C. The laboratory test results are presented in Attachment II of Appendix C.

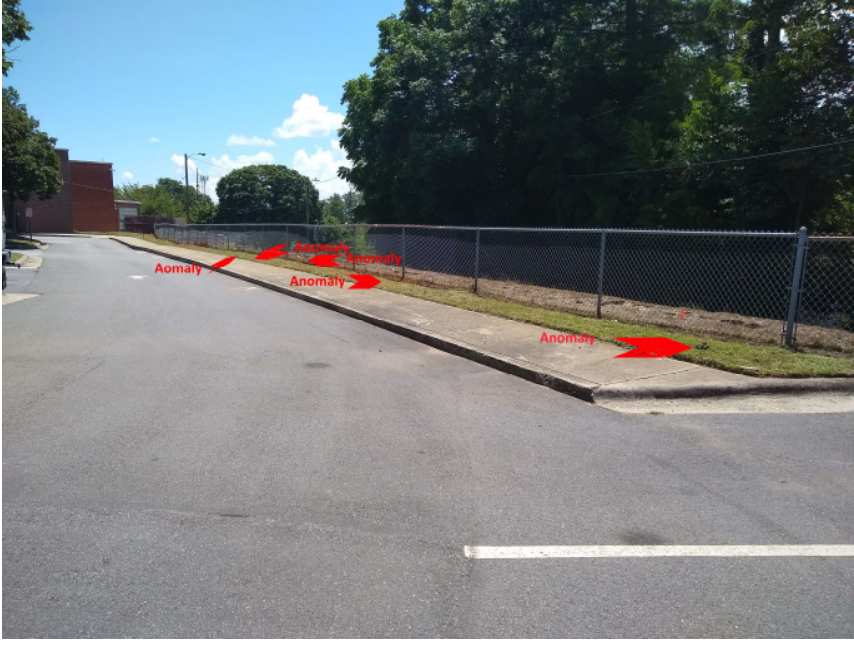
1	Location / Orientation	North Wall Section
	Remarks	Observed anomalies from GPR survey

- Rubble or debris is present within the backfill of the wall;
- The soil about 2.5 feet below the surface seems to be very soft through the entire area of the back of wall;
- There appears to be old tree stumps along the back of the north segment of the wall; and
- Several anomalies were noted along the back of the south segment of the wall.

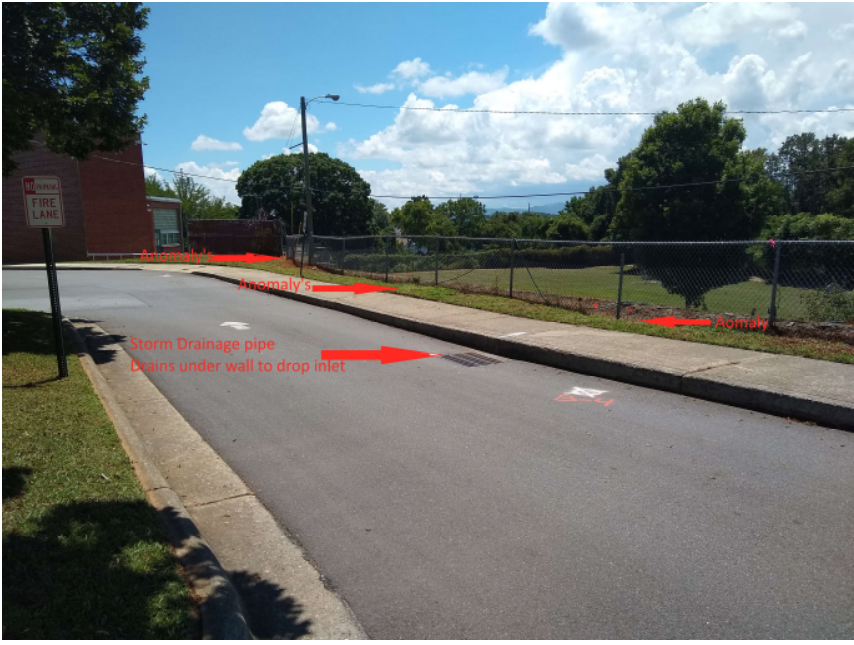
2	Location / Orientation	North Wall Section
	Remarks	Observed anomalies from GPR survey

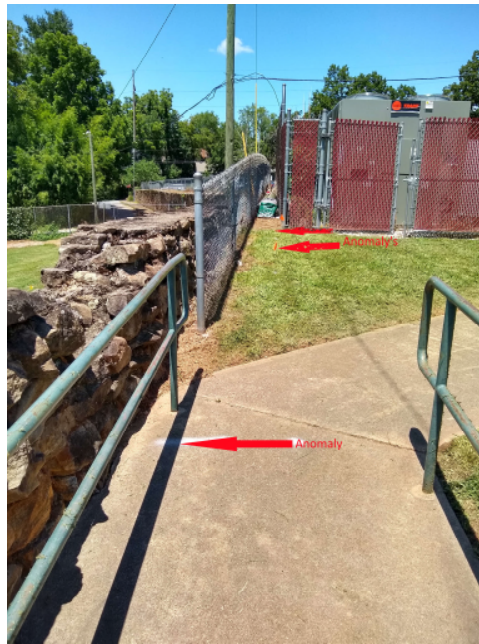
3	Location / Orientation	Middle Wall Section	Date: 7/27/2020
	Remarks	Observed anomalies from GPR survey

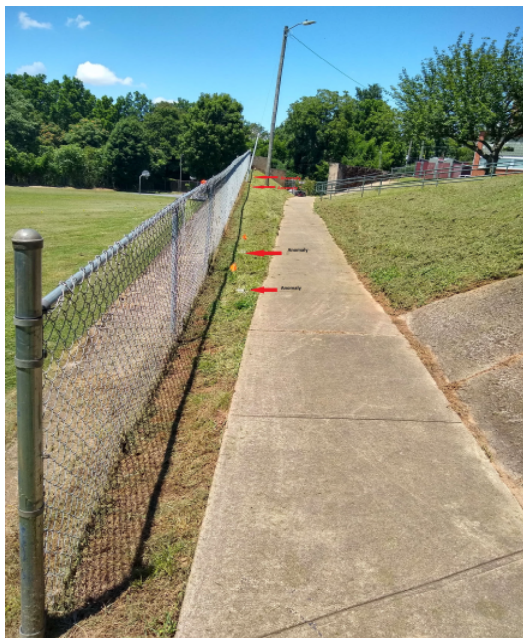
4	Location / Orientation	South Wall Section	Date: 7/27/2020
	Remarks	Observed anomalies from GPR survey

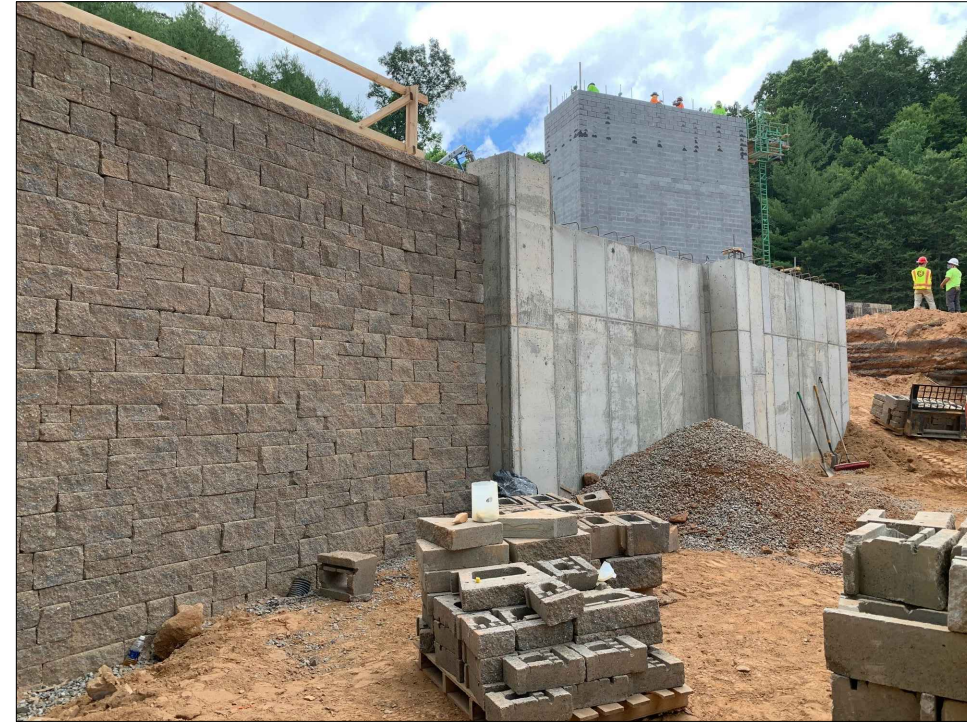
PHOTOGRAPH OF AESTHETIC FACING

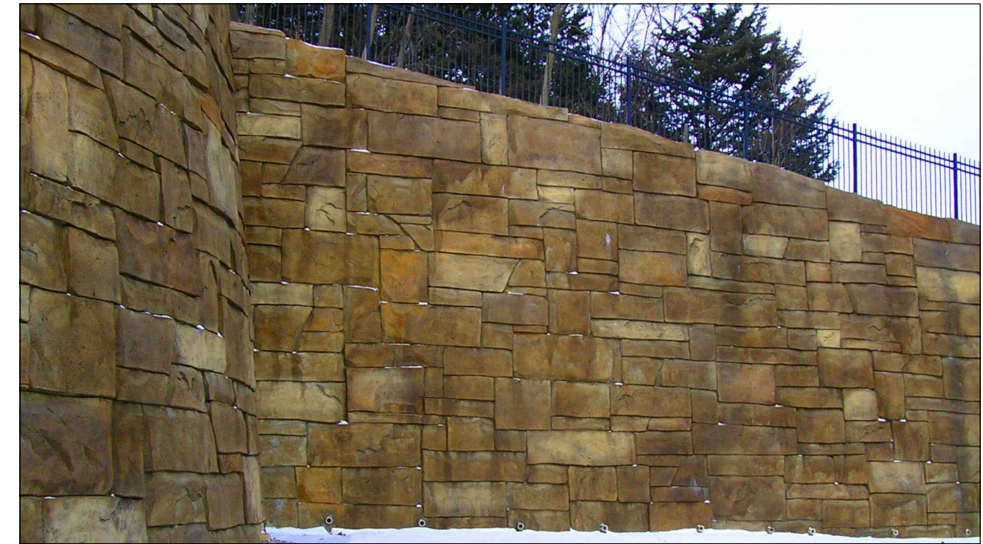
PHOTOGRAPH OF SCULPTED BOULDER FACE

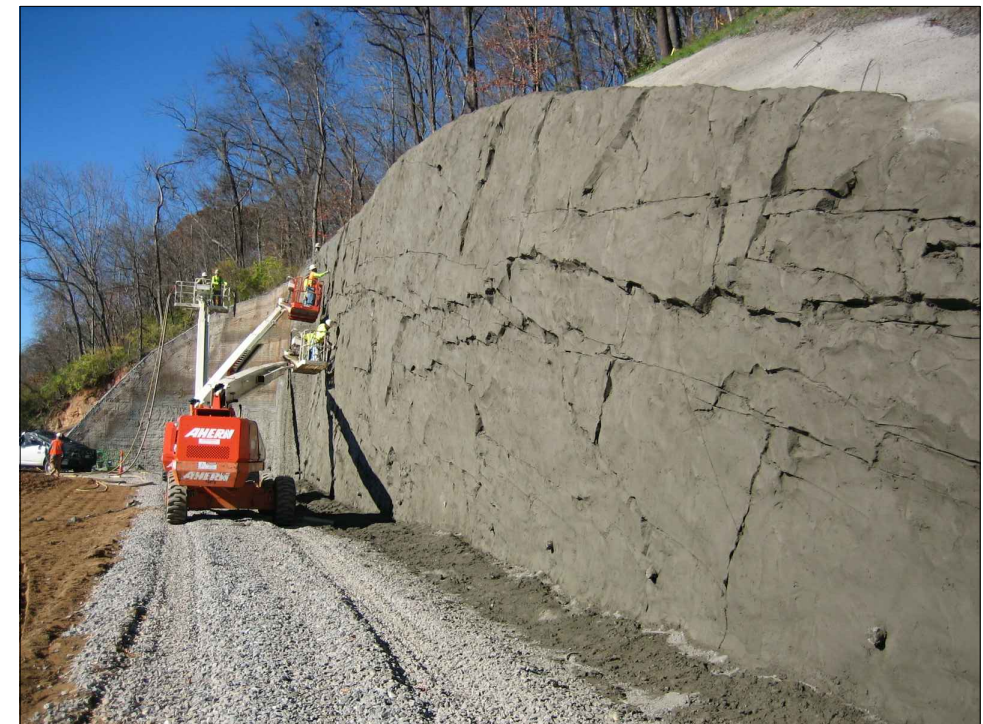
PHOTOGRAPH OF SCULPTED ROCK FACE

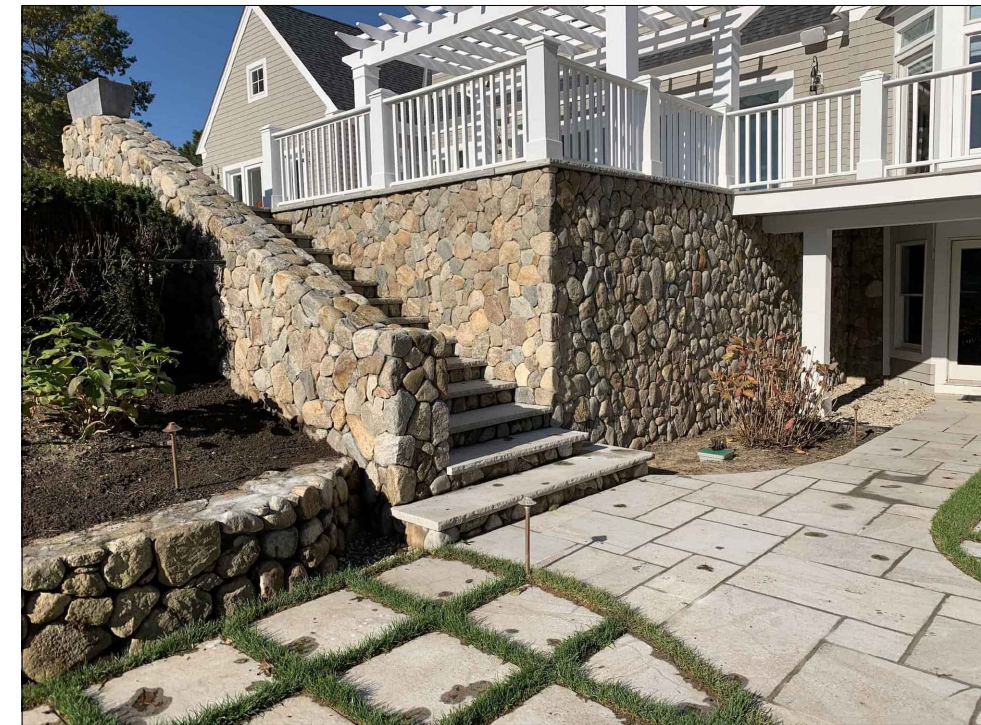
PHOTOGRAPH OF STONE VENEER
