FACILITY CONDITION ASSESSMENT & NETZERO ENERGY AUDIT

Bernice A. Ray School
26 Reservoir Road
Hanover, New Hampshire 03755

158531.22R000-001.379

January 27, 2023

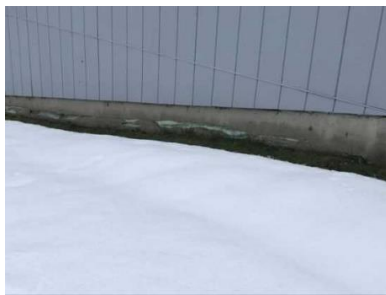
Concrete or CMU Walls w/out Footings
 Bernice A. Ray School Building exterior

Foundation System in Poor condition.

Cracking on concrete foundation. Repair is recommended. - AssetCALC ID: 4714434

Recommendation: **Concrete or CMU Walls w/out Footings in 2024**

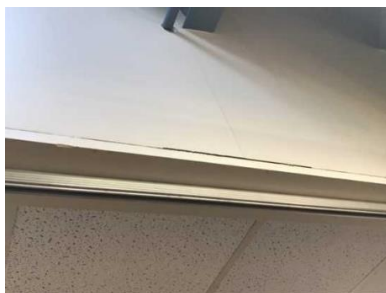
Gypsum Board/Plaster
 Bernice A. Ray School Special Ed Area

Interior Wall in Poor condition.

Special Ed area cracking on interior walls. - AssetCALC ID: 4714361

Recommendation: **Repair in 2022**

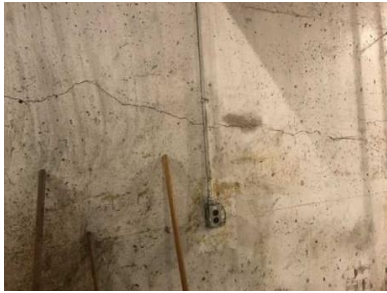
Concrete
Bernice A. Ray School Mechanical room

Interior Wall in Poor condition.

Concrete cracking in mechanical room. Repair is recommended. - AssetCALC ID: 4714410

Uniformat Code: C1010
Recommendation: **Repair in 2022**

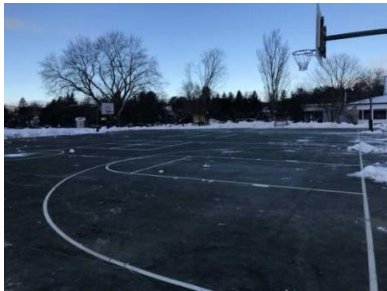
Basketball/General, Asphalt Pavement
Bernice A. Ray School Site

Athletic Surfaces & Courts in Poor condition.

Isolated cracking on basketball court - AssetCALC ID: 4714357

Uniformat Code: G2050
Recommendation: **Seal & Stripe in 2024**

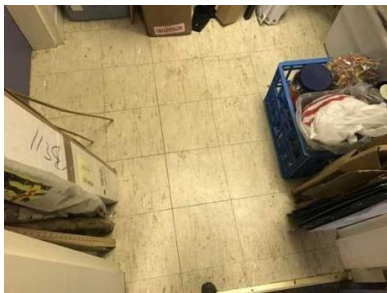
Vinyl Tile (VCT), w/ Asbestos Abatement
Bernice A. Ray School Classroom Supply Closets

The interior finishes are replaced on an as needed basis. The hallway and kitchen flooring was replaced in 2014-2015. The point of contact noted that the flooring in the supply closets between classrooms is original to the 1970's and contains signs of asbestos. Asbestos abatement has been implemented annually with the most recent work occurring in April 2022. A few isolated areas of interior wall cracking were observed that will require repair during the reserve term. Typical lifecycle replacements for exterior and interior finish replacements are budgeted and anticipated.

Flooring in Poor condition.

Uniformat Code: C2030
Recommendation: **Replace in 2024**

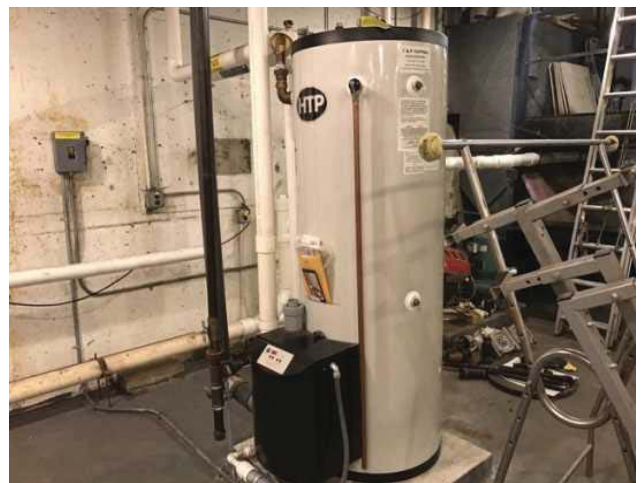
24 - WATER HEATER

Hot water is supplied by a central gas water heater and a supplemental smaller electric water heater near the gym. The central water heater was replaced in 2019. Typical commercial plumbing fixtures are utilized in the restrooms. Plumbing blockages have occurred three times in the past year but have since been repaired. The piping is reportedly original.
