INDOOR AIR QUALITY ASSESSMENT

**Greater Lowell Technical High School
250 Pawtucket Boulevard
Tyngsborough, Massachusetts**

Prepared by:
Massachusetts Department of Public Health
Bureau of Environmental Health
Indoor Air Quality Program
November 2014

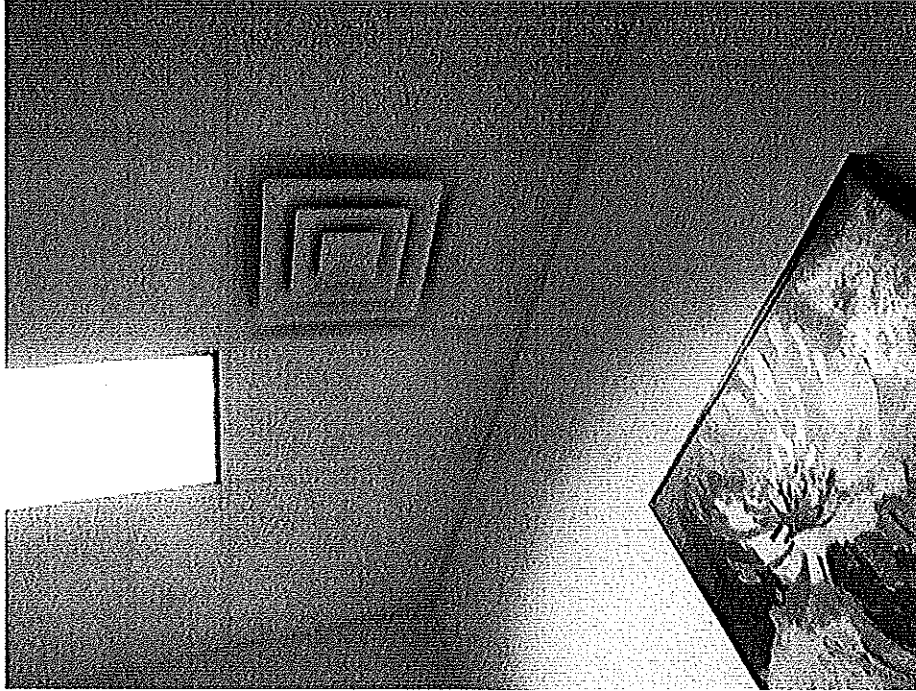
Picture 1

Supply vent from rooftop AHU

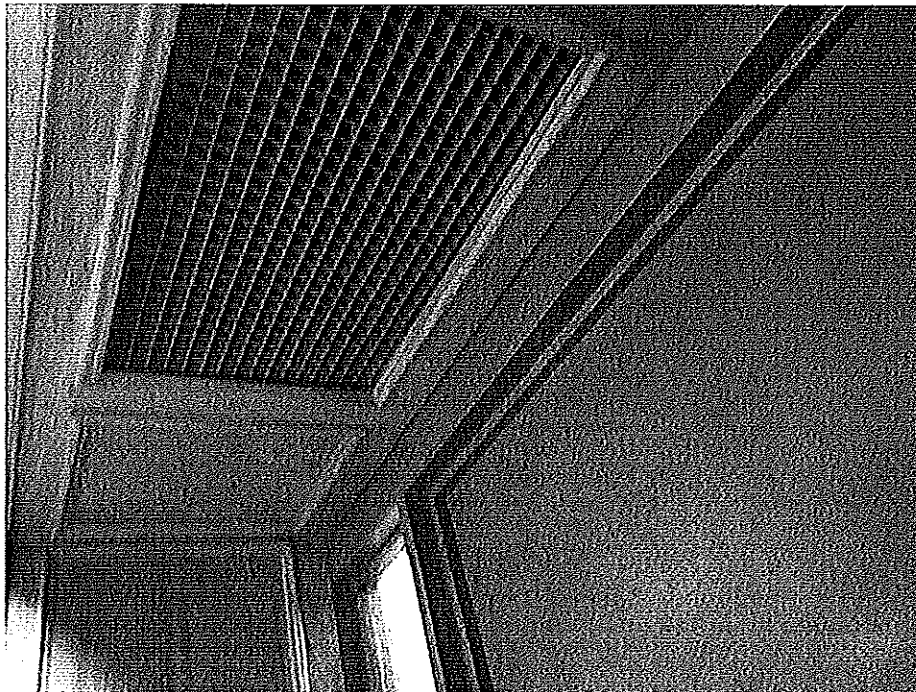
Picture 2

Return vent inside superintendent's suite

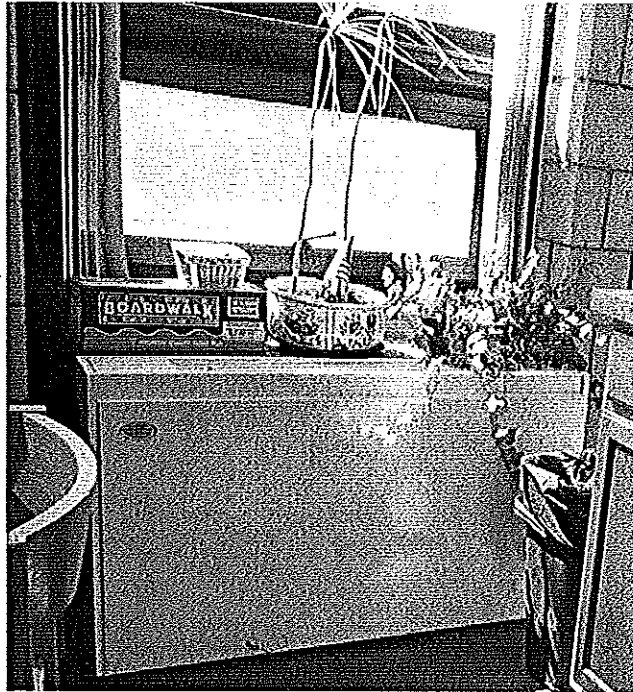
Picture 3

Plants were observed in several classrooms and offices (Tables 1 and 2; Picture 3). Plant soil, standing water and drip pans can be potential sources of mold growth. Drip pans should be

Univent blocked with items and plants

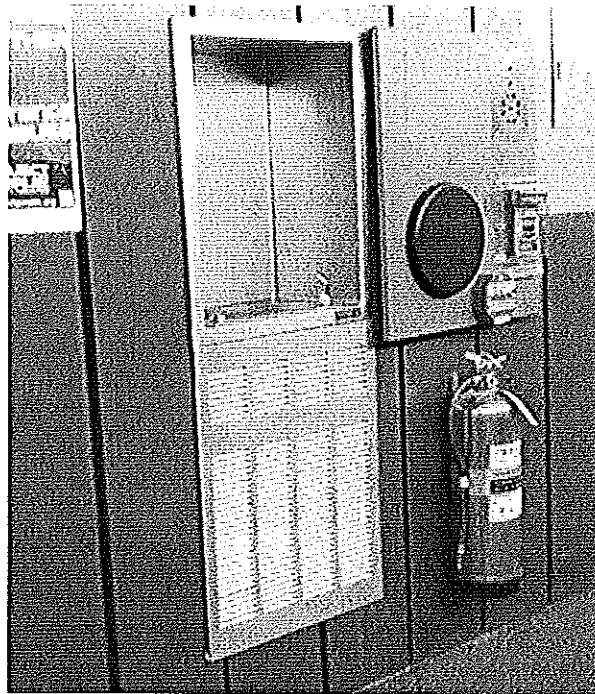
Picture 8

Water dispensers were located in several hallways over carpeting (Table 1; Picture 8). Overflow/spills from water coolers/fountains can moisten carpeting. It is recommended that these dispensers be located on non-porous flooring or a waterproof mat. It is also important that the catch basin of water coolers be cleaned regularly as stagnant water can be a source of odors.

Water dispenser over carpet

12. Consider moving water dispensing equipment to areas with tiled floors instead of carpeting, or installing waterproof mats to prevent water damage to carpeting.

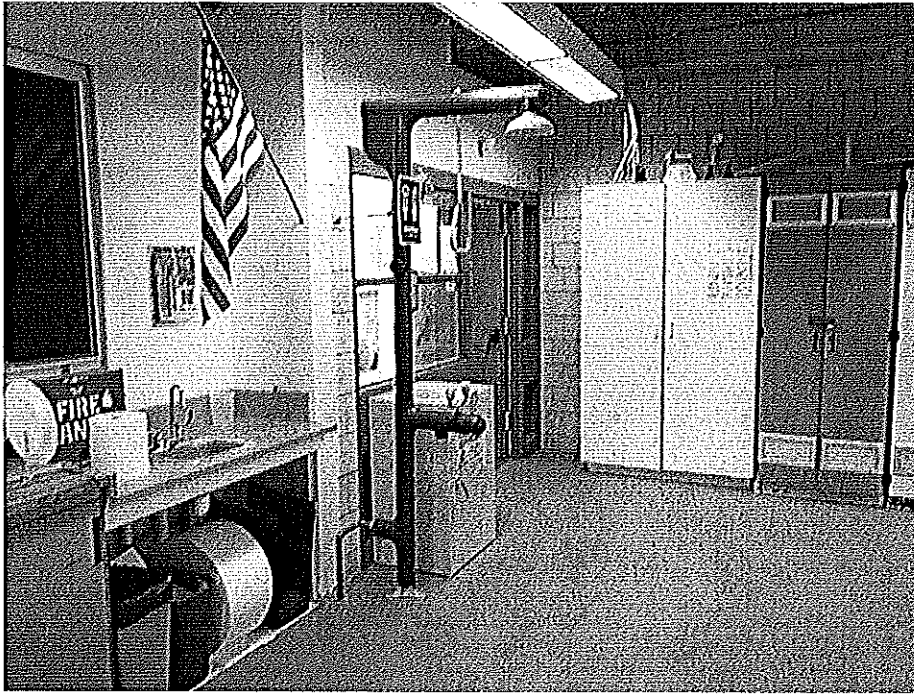
Picture 9

In several of the shops, emergency showers and eyewash stations were observed located in carpeted areas (Picture 9, Table 2). Carpeting in these areas should be removed.

Safety shower in carpeted area

14. Remove carpeting and install non-porous flooring materials in the areas where emergency showers and eyewashes are present.
15. Clean and maintain dehumidifiers in accordance with manufacturer's instructions.

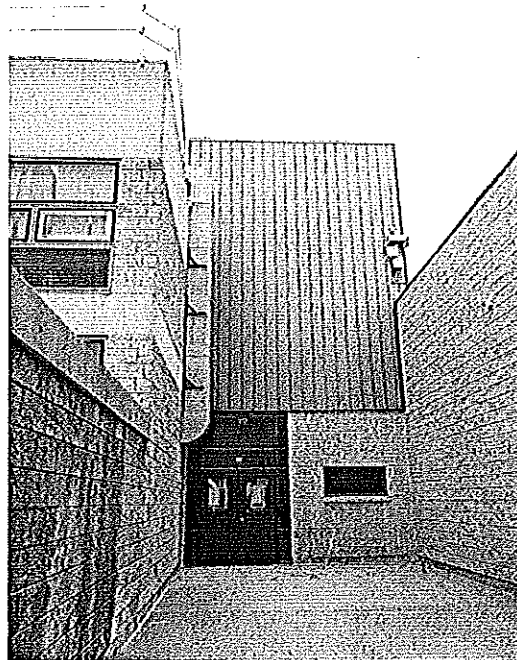
Picture 10

The outside of the building was examined for additional sources of water penetration. The building façade shows signs of water staining in some areas (Picture 10), which may indicate that roof drains or gutter systems are not functioning ideally and need cleaning and/or maintenance. It may also indicate that weep holes along the bottom of the building are clogged and should be cleaned. An exterior wall system should consist of an exterior curtain wall (Figure 2). Behind the curtain wall is an air space that allows for water to drain downward and for the exterior cladding system to dry. In order to allow for water to drain from the exterior brick system, a series of weep holes is customarily installed in the exterior wall, at or near the foundation slab/exterior wall system junction. Weep holes allow for accumulated water to drain from a wall system (Dalzell, 1955). Opposite the exterior wall and across the air space is a continuous, water-resistant material adhered to the back-up wall that forms the drainage plane. The purpose of the drainage plane is to prevent moisture that crosses the air space from penetrating the interior of the building. The plane also directs moisture downwards toward the

Signs of water staining on exterior walls

16. Examine roof drain and weephole systems to ensure that they are not clogged and are functioning efficiently to drain water from the building. Repair as necessary.

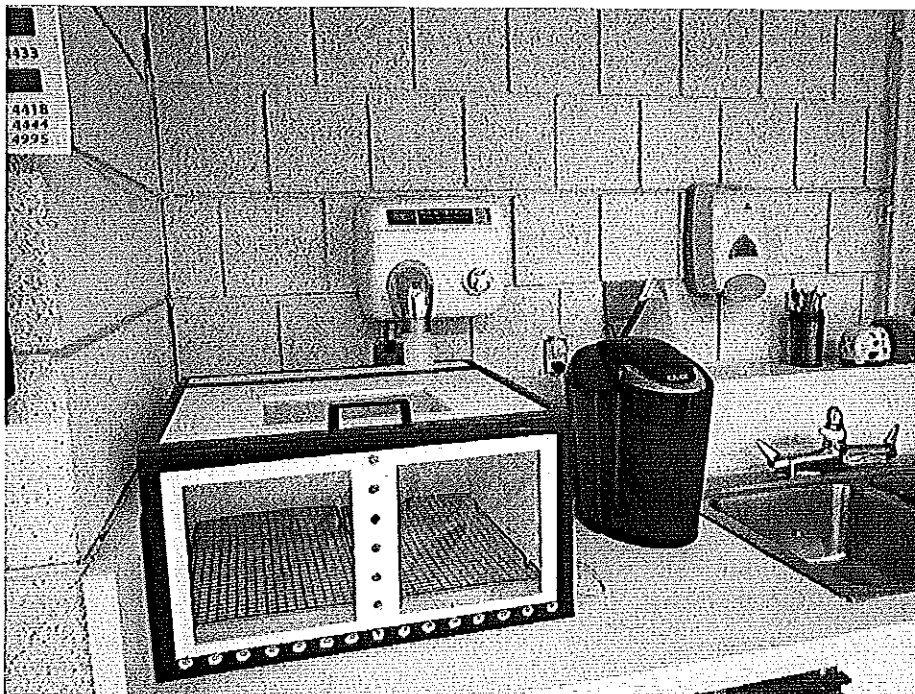
Picture 16

Homemade drying box connected to hand dryer

32. Replace missing ceiling tiles and ensure that the ceiling tile system is intact.
33. Remove the “drying box” shown in Picture 16; if this function is needed, ensure that the exhaust from the unit vents to the outside of the building.
