# SCHOOL BUS PRE-TRIP INSPECTION VISUAL GUIDE

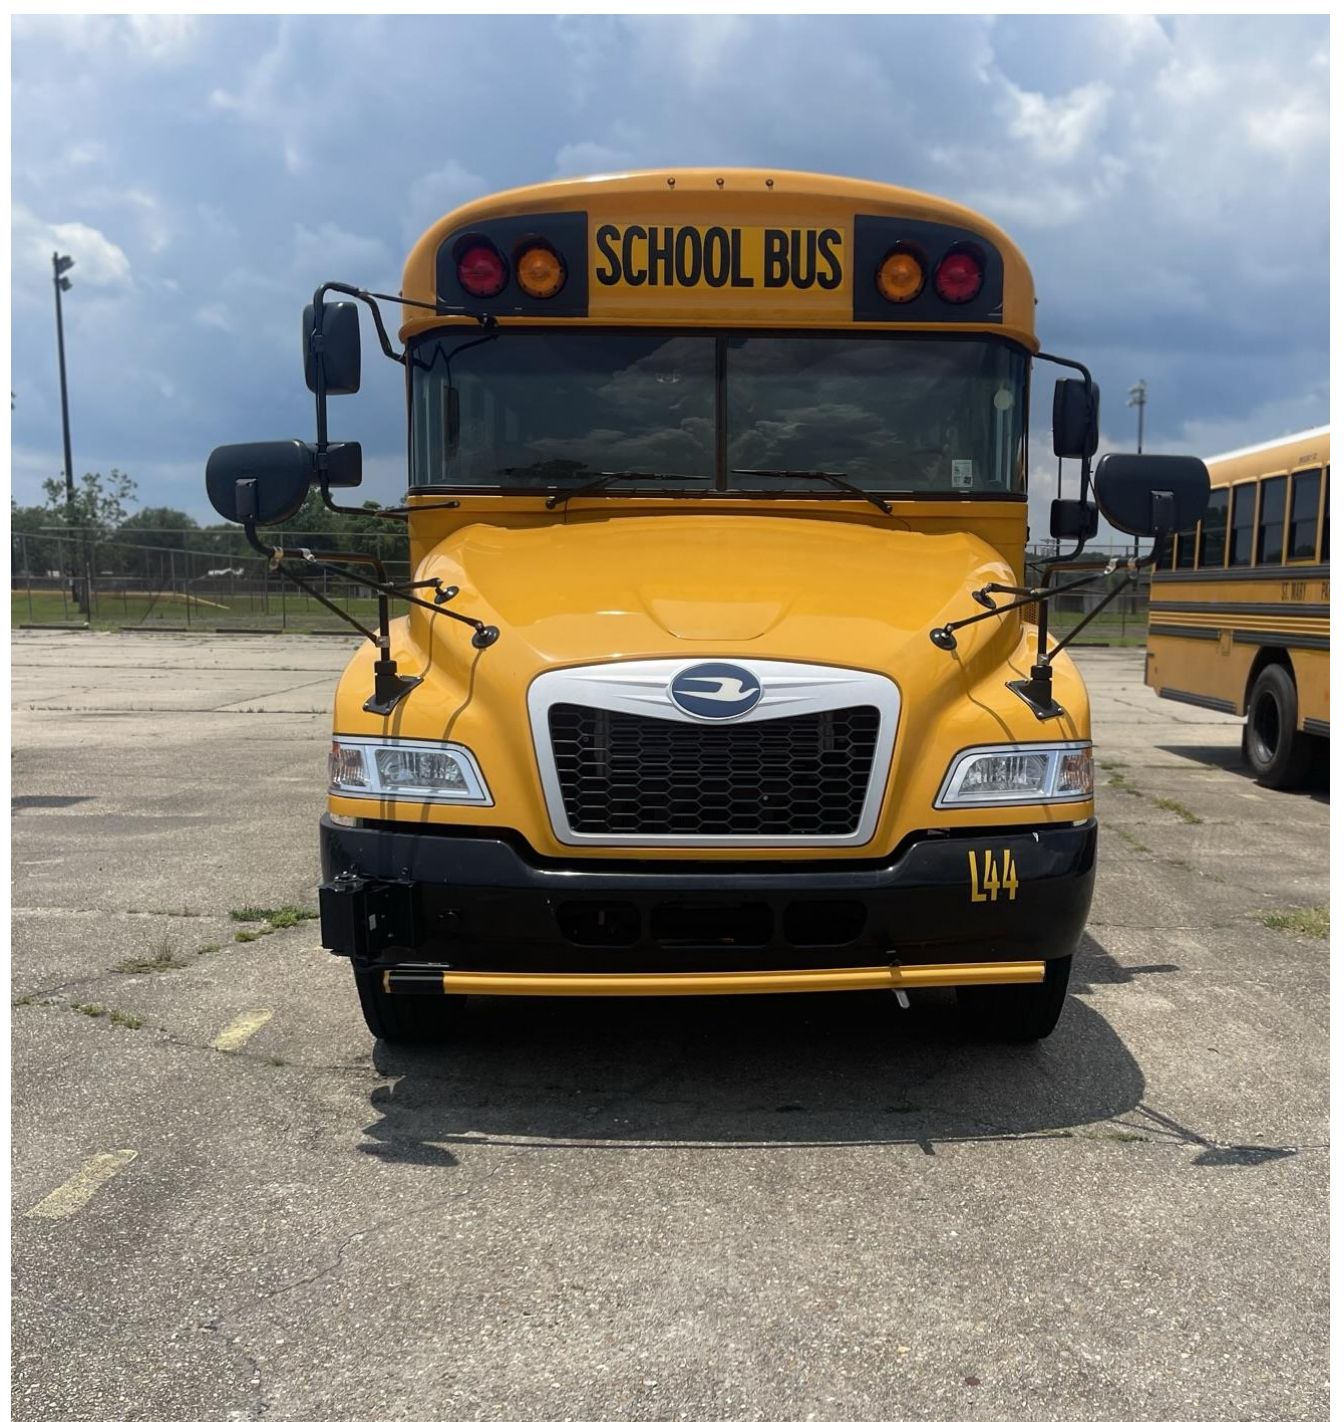
# General Appearance

- While on level ground, Bus is not leaning to the left or right.
- There is no hanging debris.

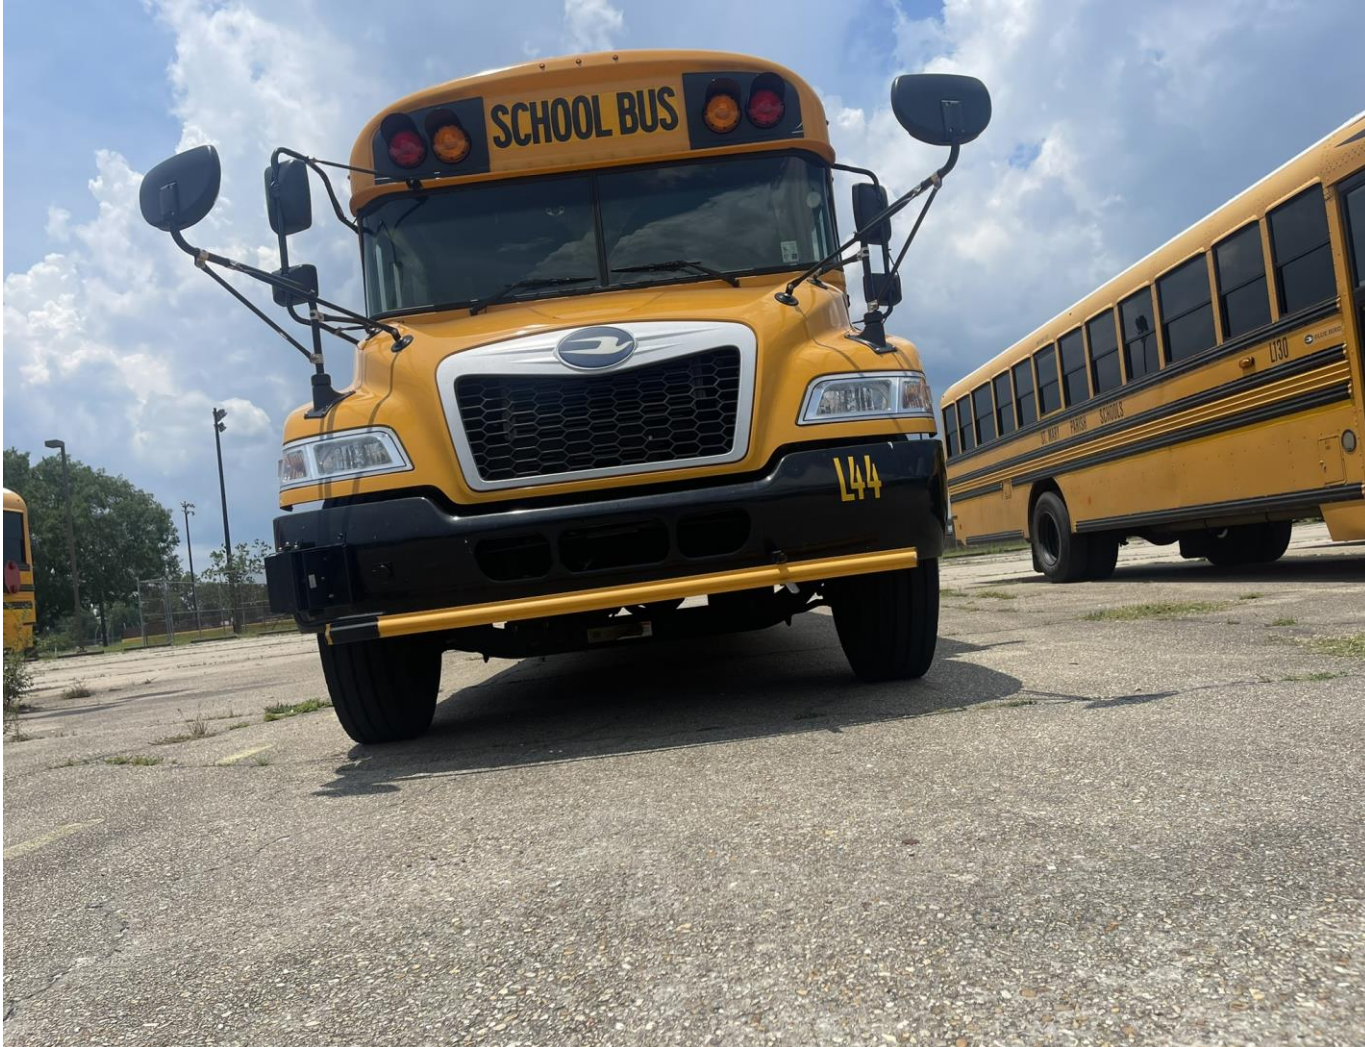
# Leaks

- There are no leaks or puddles of fluid on the ground under the engine and transmission.

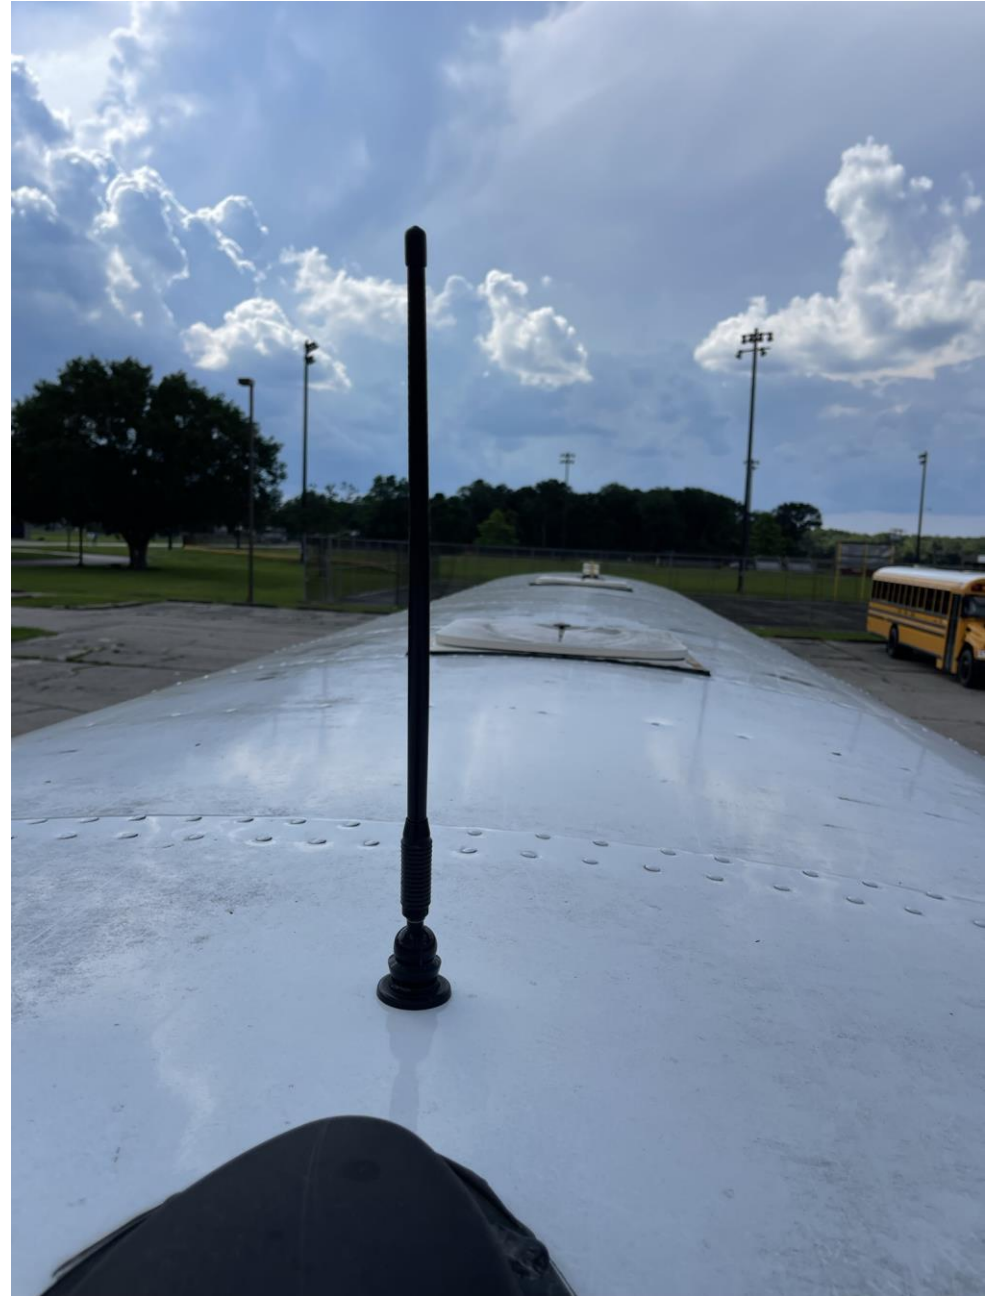
# Antenna

- Antenna is attached and properly secured to the bus.
- Not damaged.

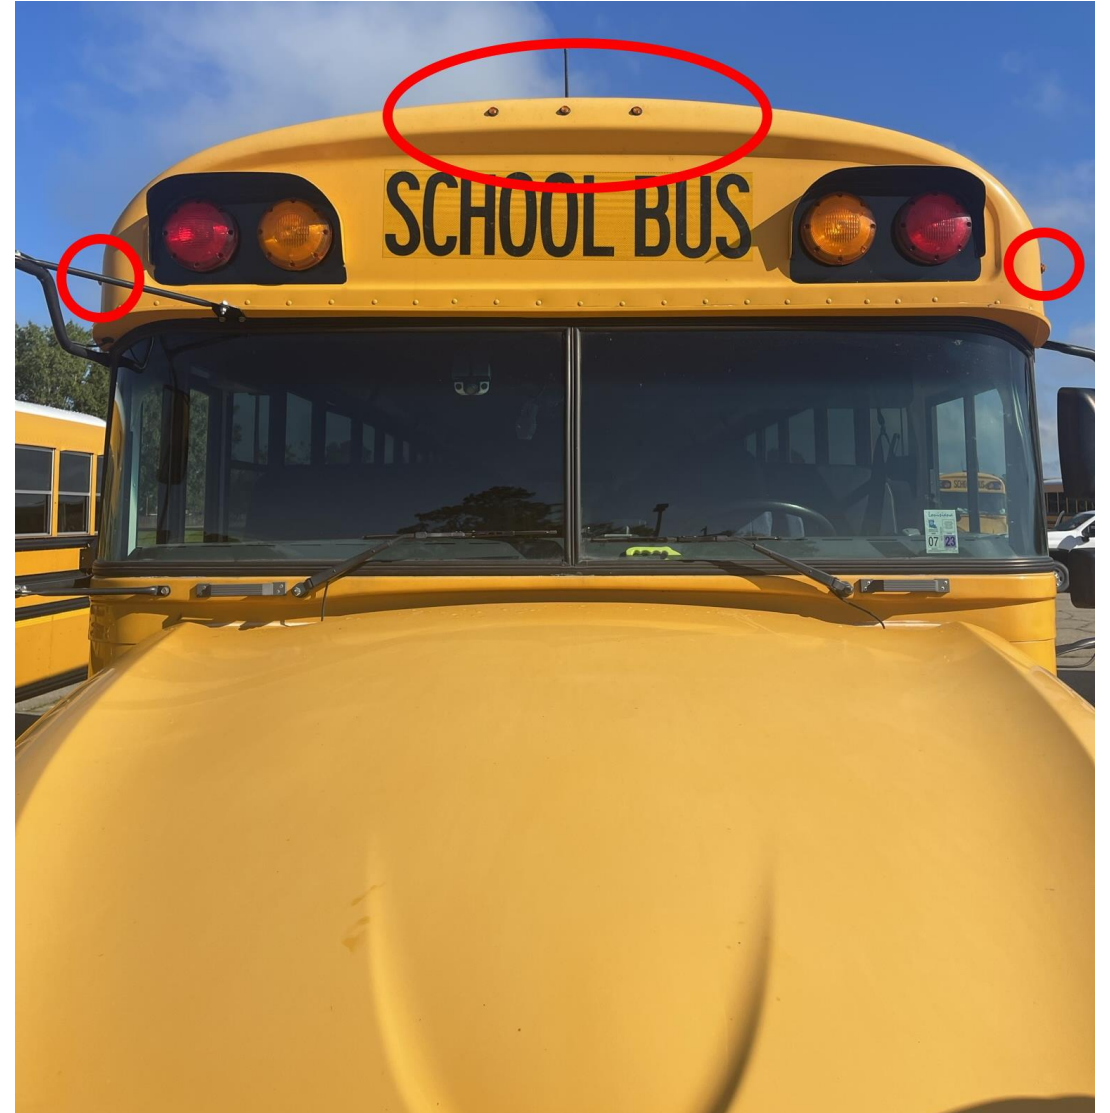
# Check Amber Clearance Lights

- Front clearance lights are amber in color and not cracked or broken.
- 3 on top center and 1 on each side.

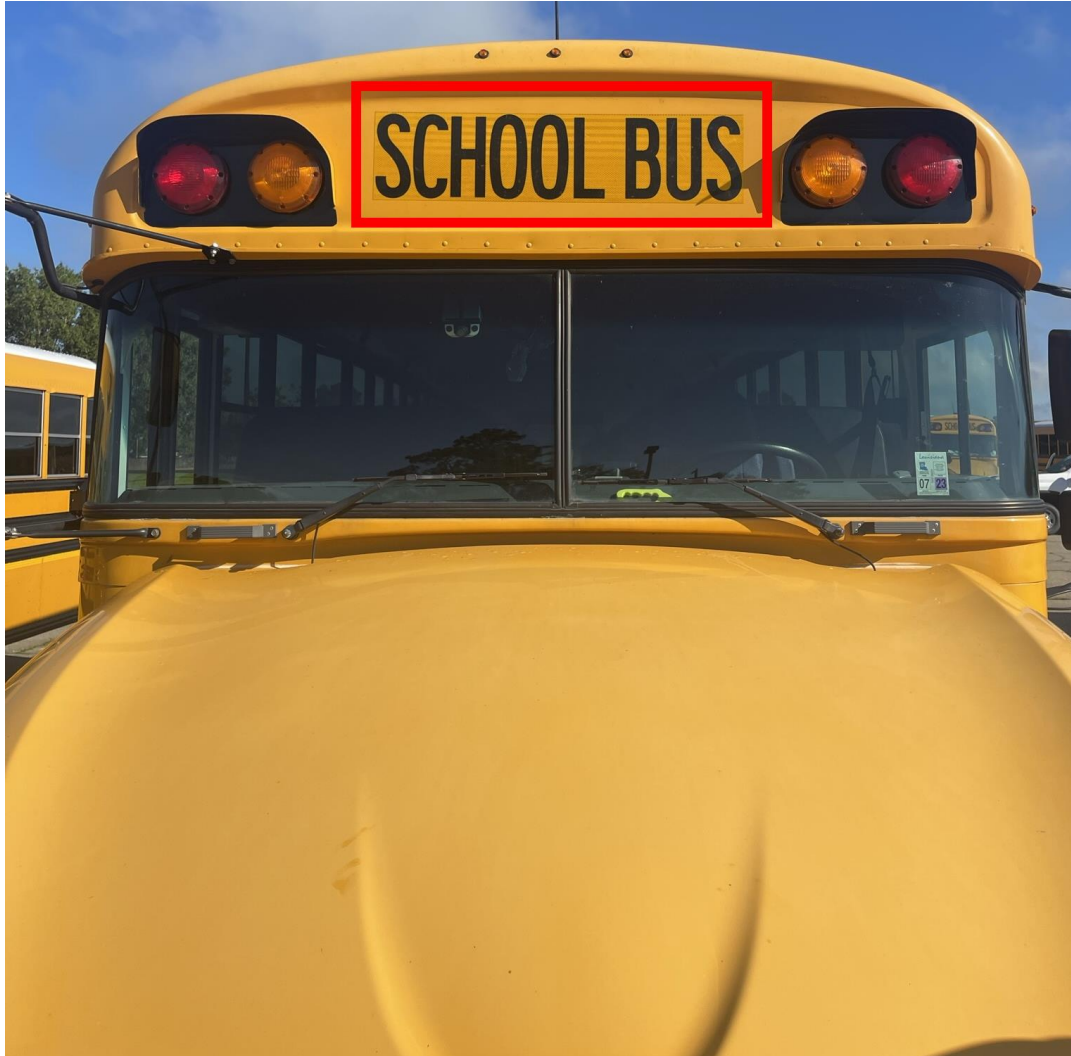
# School Bus Decal

- School bus decal is visible, good in color, and not excessively worn.
- Reflective.

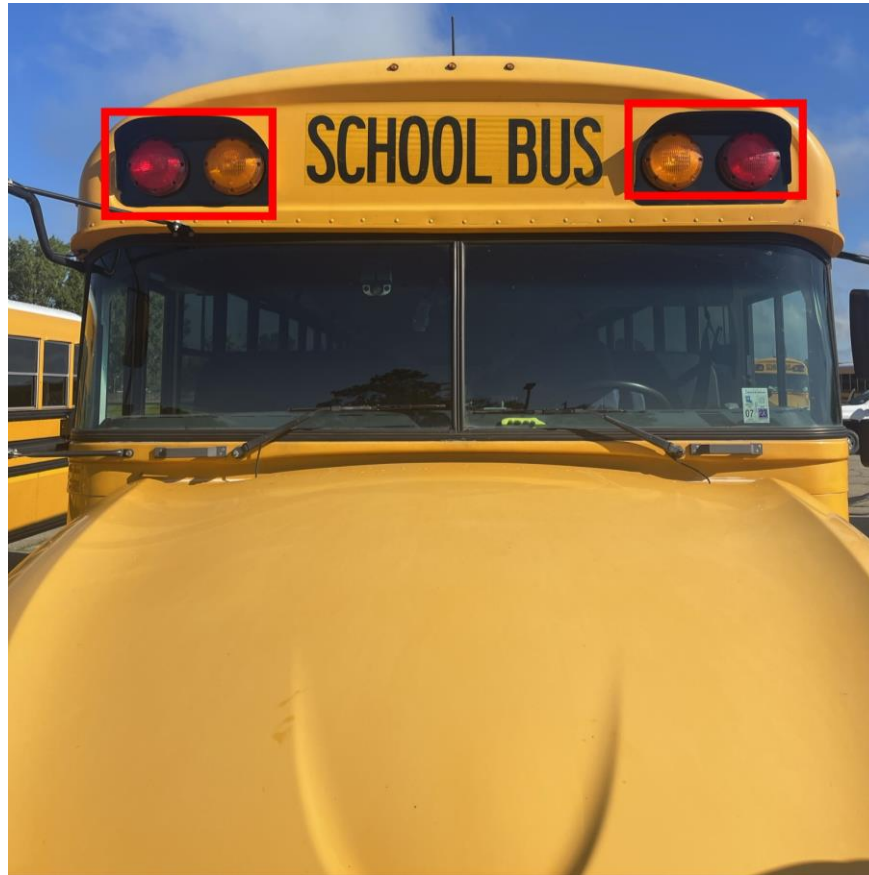
# Warning Lights

- Amber and Red Warning lights are visible in color, clean, and not cracked or broken.
- Lights are functioning properly.

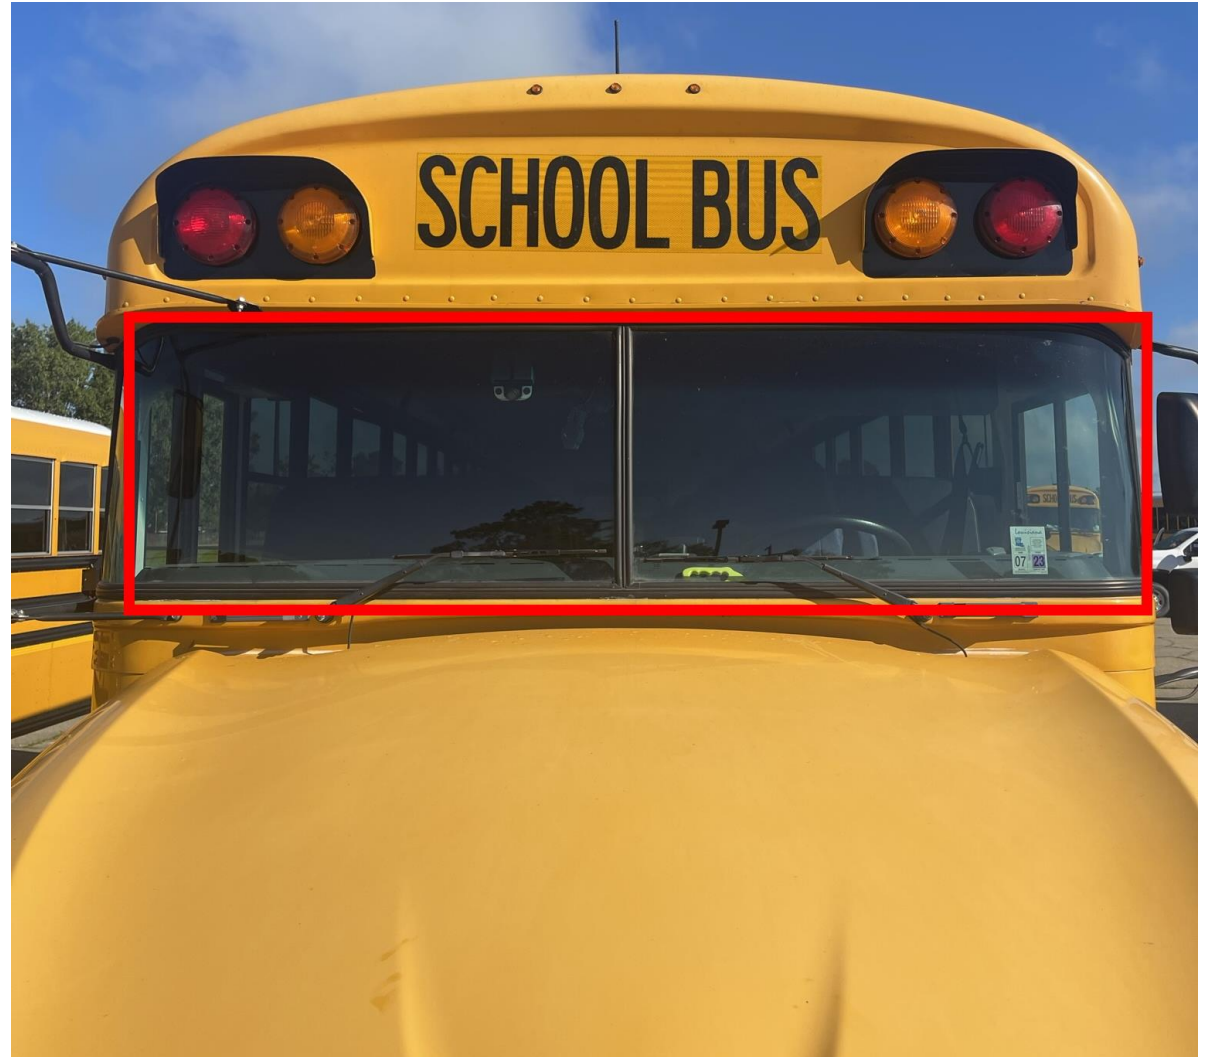
# Windshield

- Windshield is clean, visible to see through, and not cracked or broken. There is no obstruction of view.
- Seal around the windshield is not missing, not cracked, or damaged.
- NO ILLEGAL STICKERS.

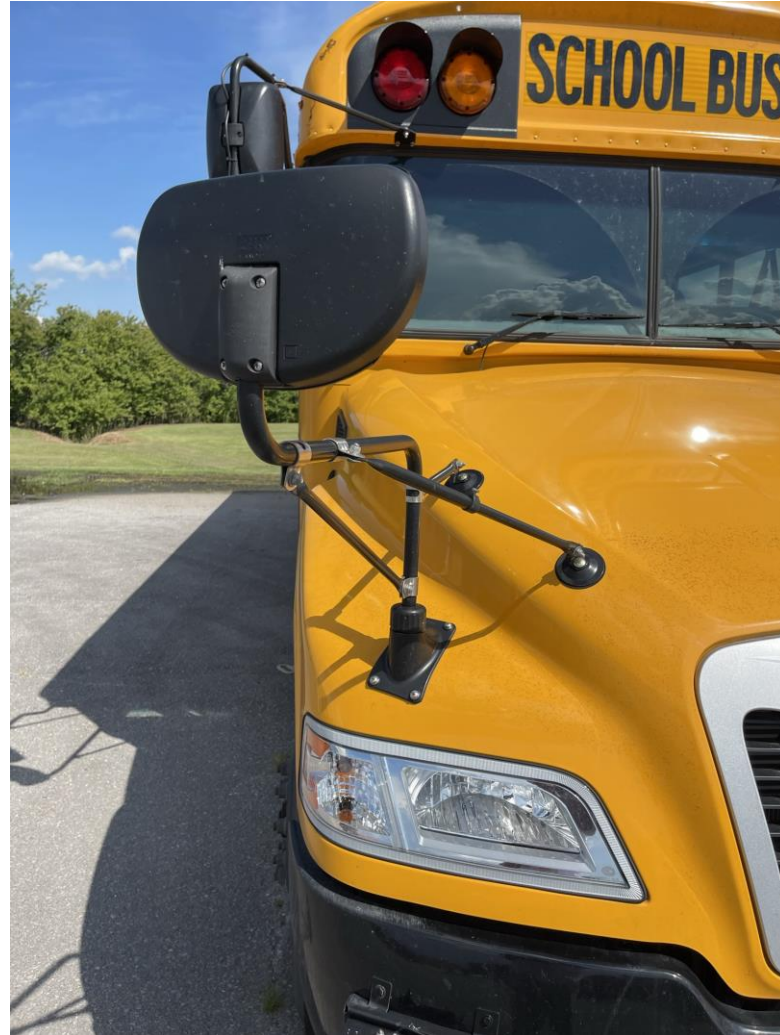
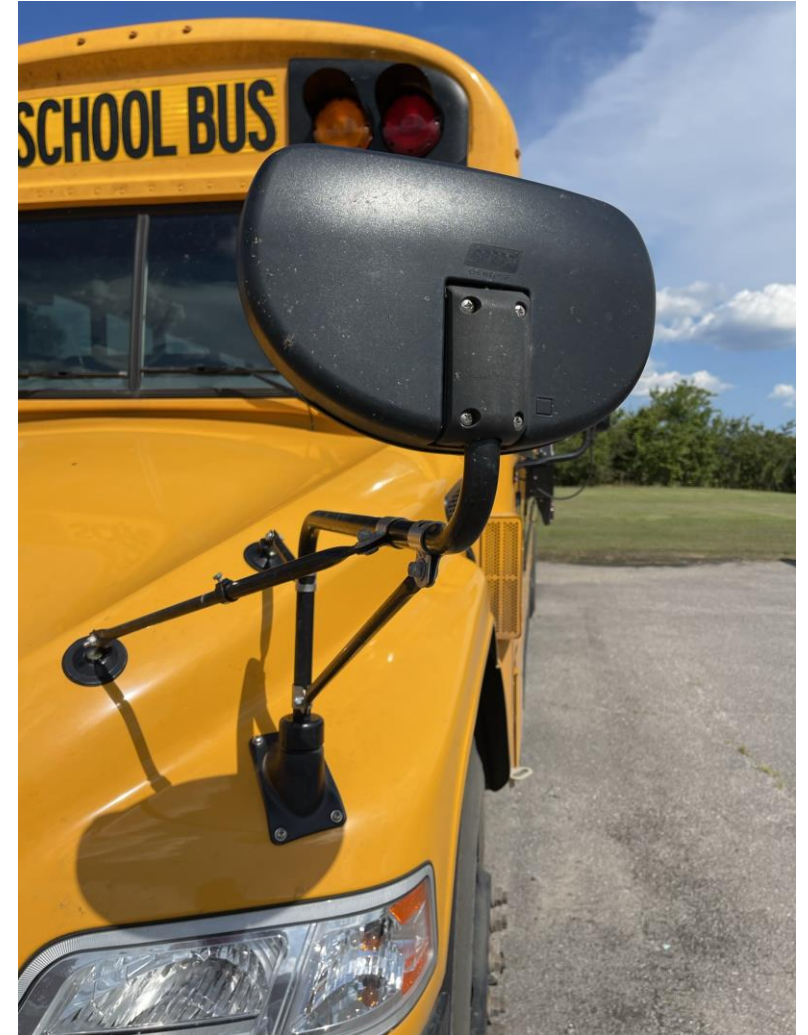
# Cross View Mirrors

- Cross-view mirror is tight, secure, and properly positioned-not cracked or broken. All brackets are mounted securely to the hood of the bus.
- Brackets are not missing any nuts or bolts.

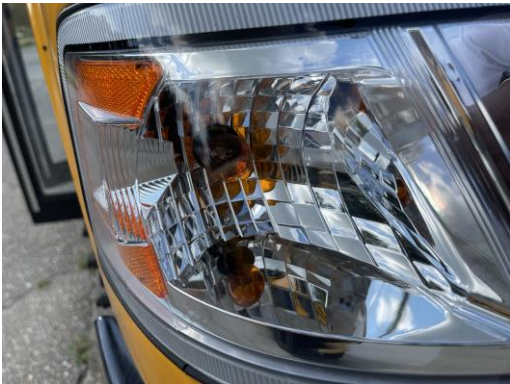
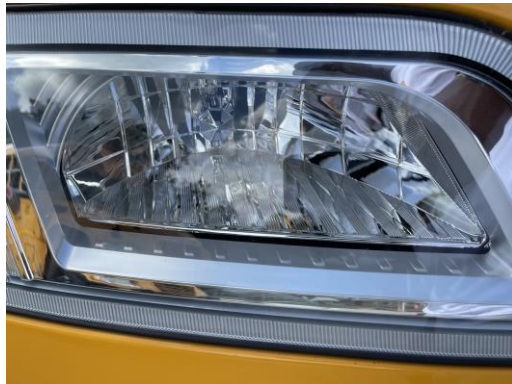
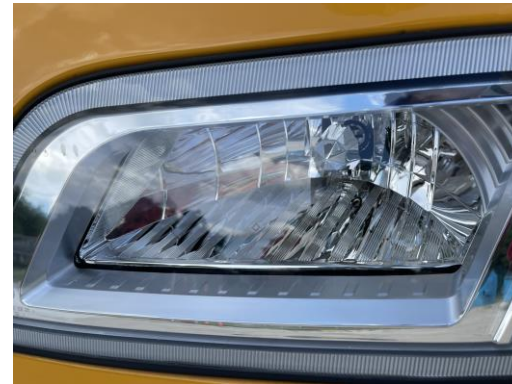
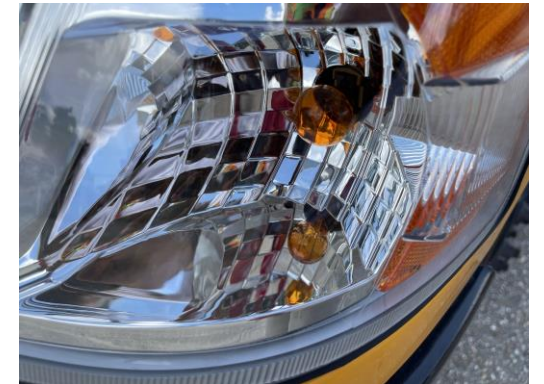
# Headlights, turn signals, 4-way flashers

- Headlamps are clean, visible to see through, and not cracked or broken.
- This should include low beam, high beam, turn signals and 4-way flashers.

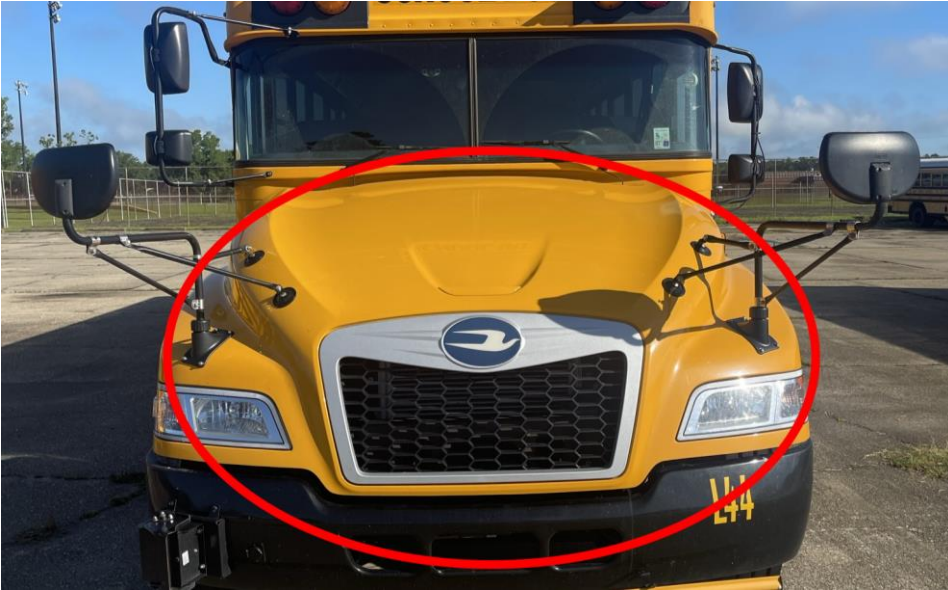
# Hood and grille

- Hood is good in color, not cracked, broken, or torn. Hood is securely mounted to the front bumper and frame of the bus.

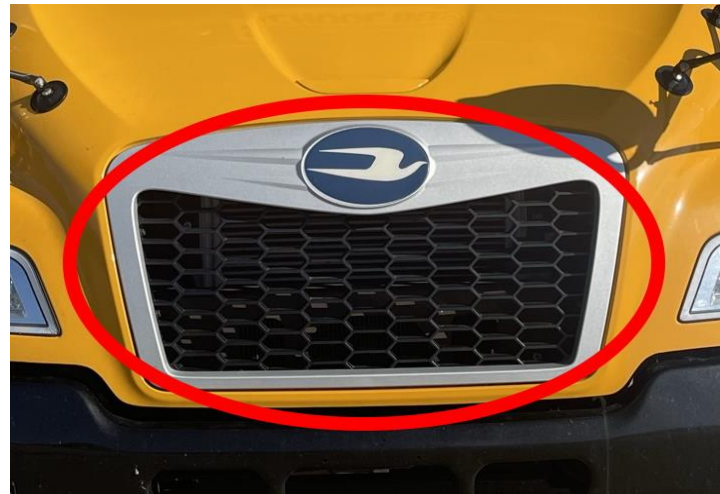
- Grille is good in color, not cracked or broken, and securely mounted to the hood of the bus.

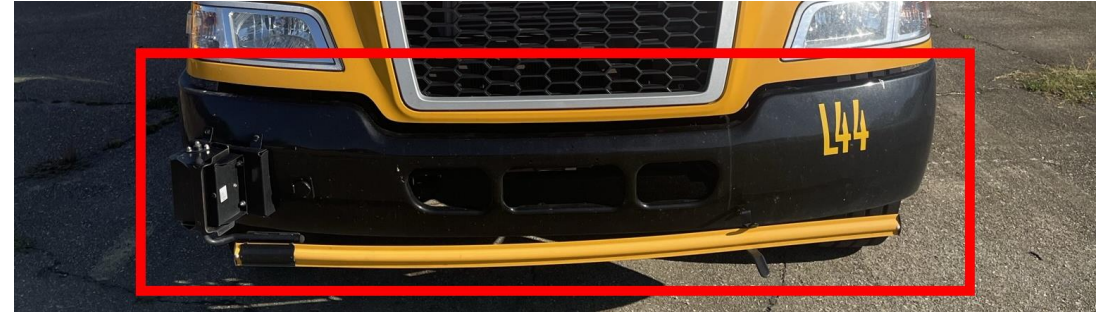
# Front Bumper and Cross Arm

- Front bumper is securely mounted to the frame of the bus and not bent or broken.

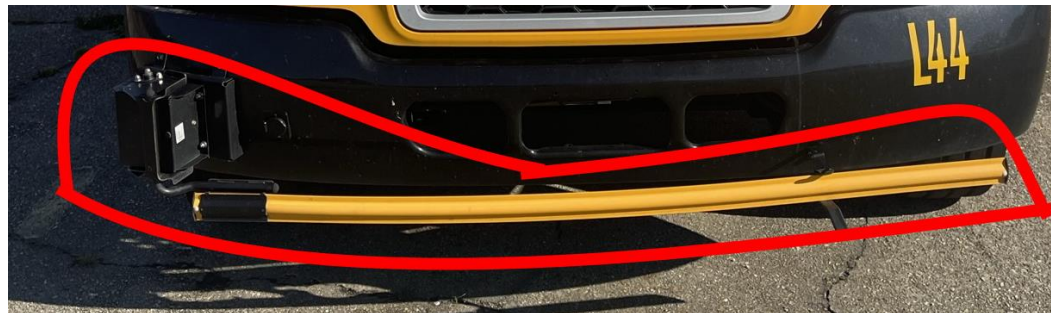
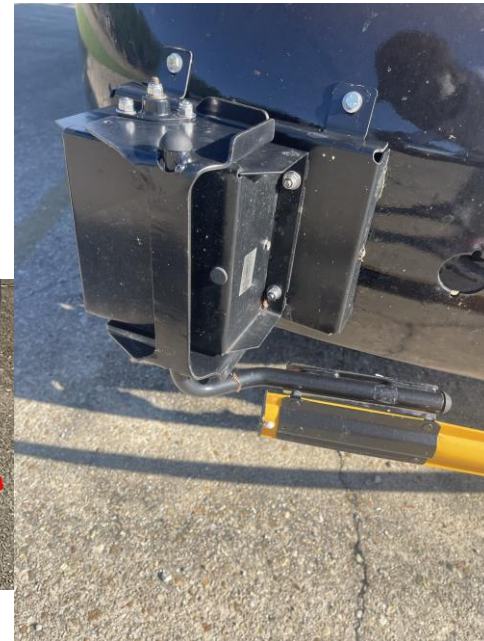
Cross Arm Device is securely mounted to the front bumper.

It is good in color and not bent or broken.

Check that it is in working condition.

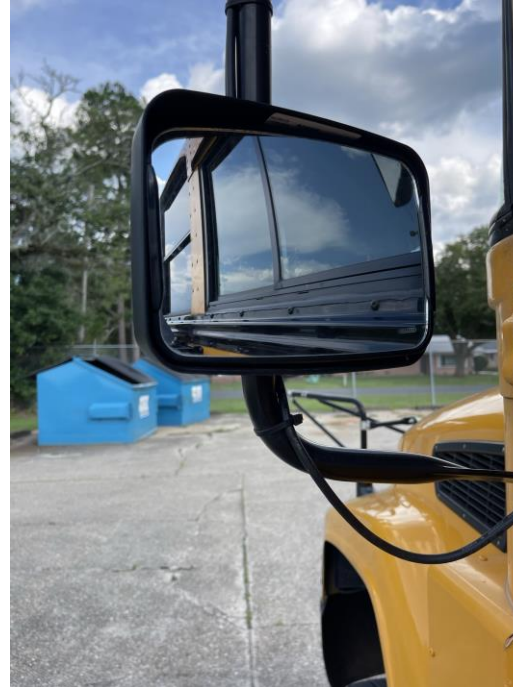
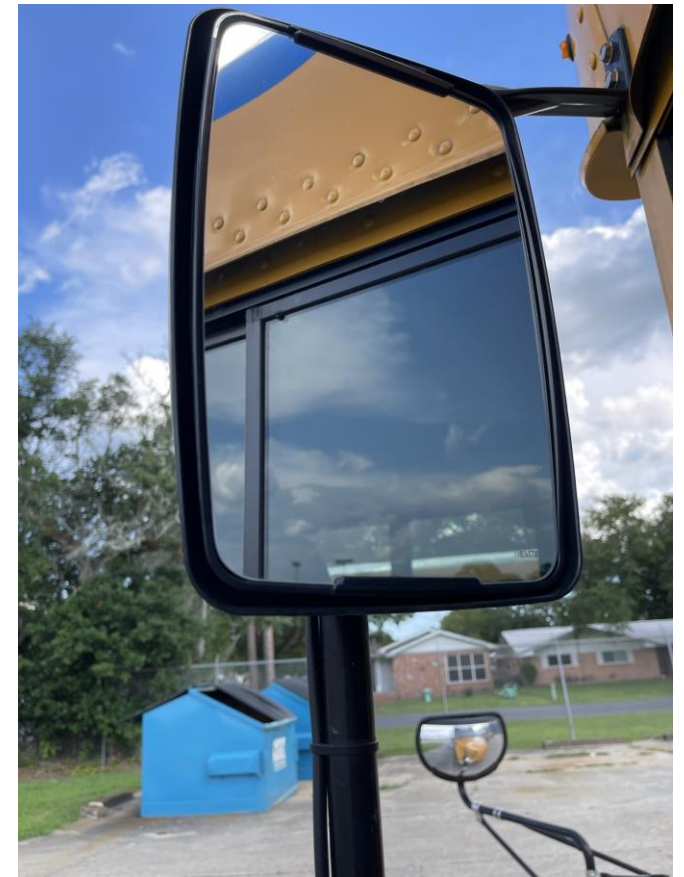
# Flat and Convex Mirrors

- Mirrors are properly mounted to the side of bus and are adjusted correctly.
- Mirrors are not cracked or broken.

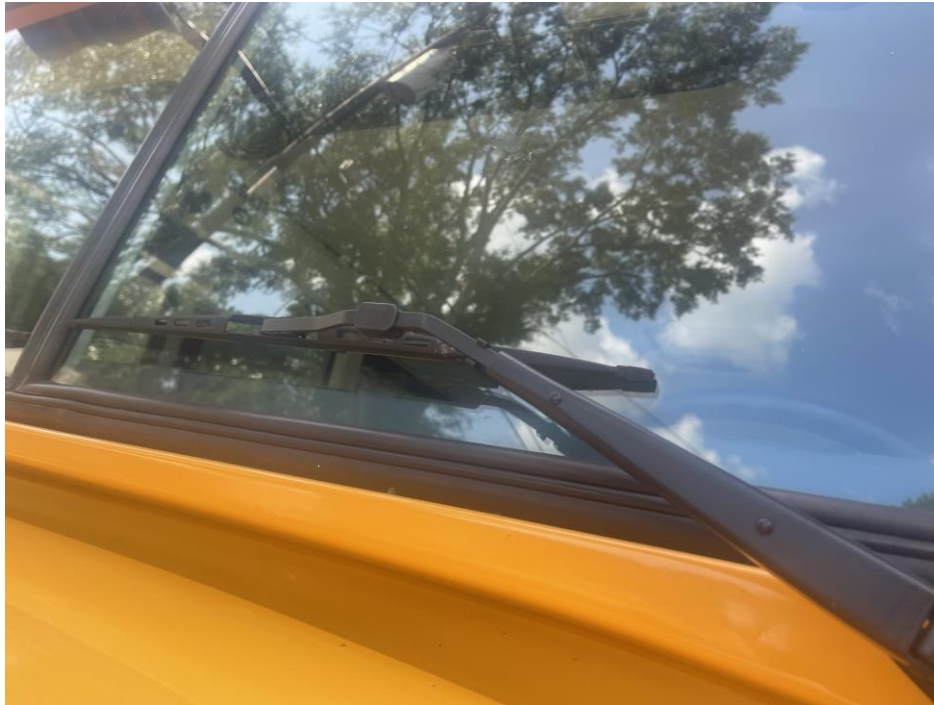
# Windshield Wiper (Driver's Side)

- Wiper is securely attached and is in working condition.
- Blades are not excessively worn and not cut or frayed.

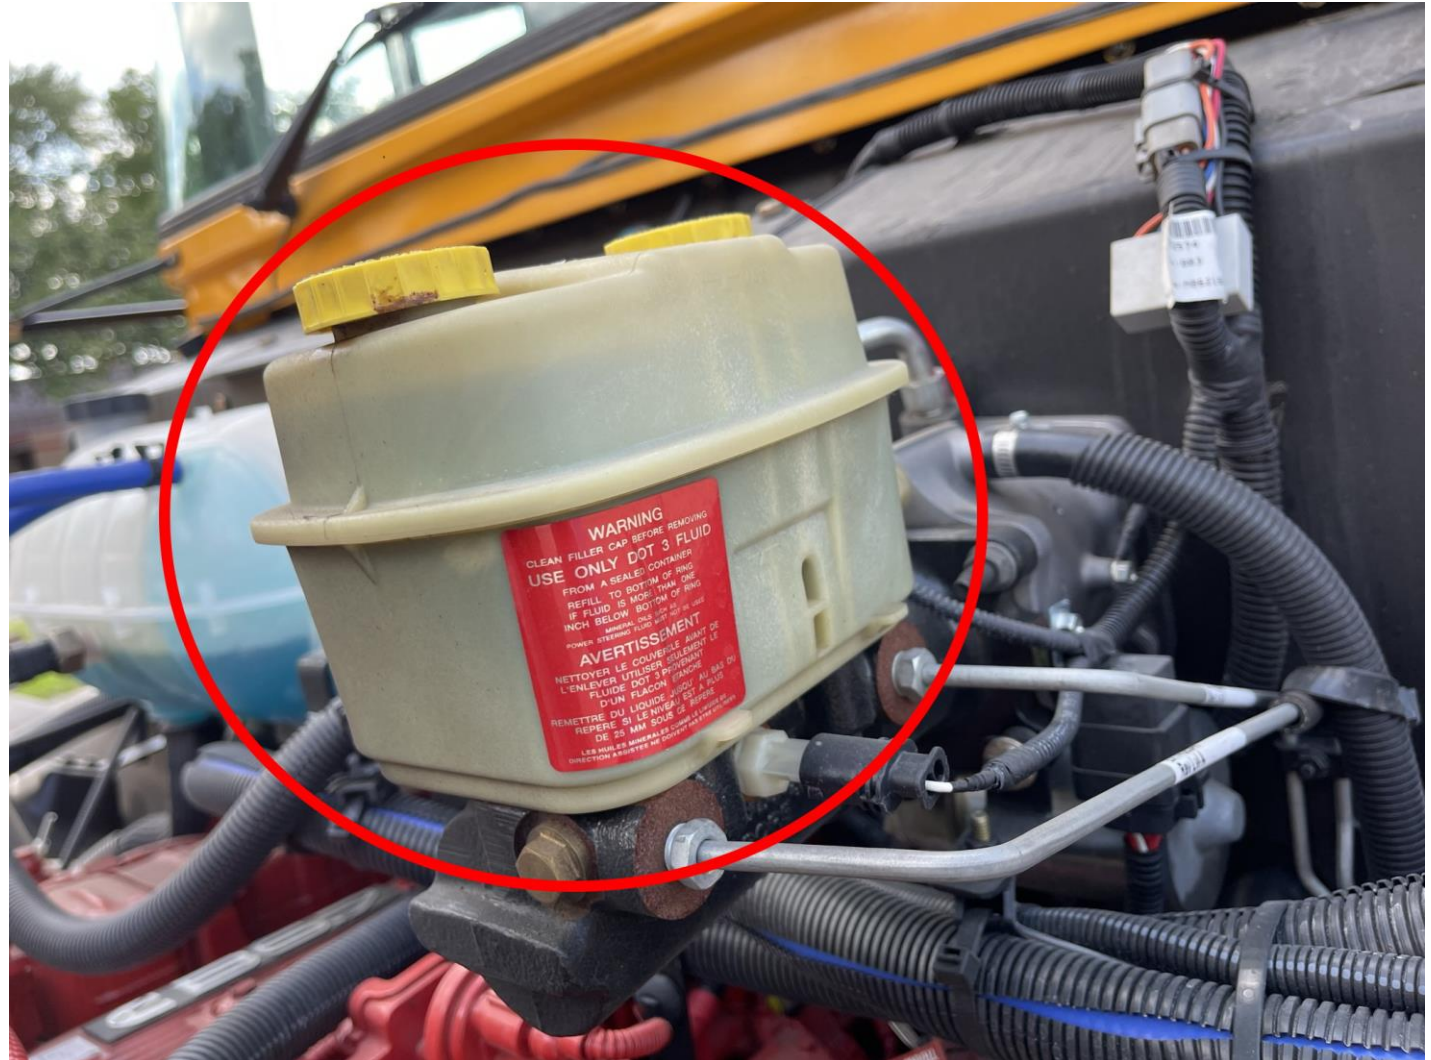
# Brake Fluid

- Brake Fluid Reservoir is properly mounted and is not cracked or broken.
- There are no missing parts.
- Has adequate Brake Fluid.

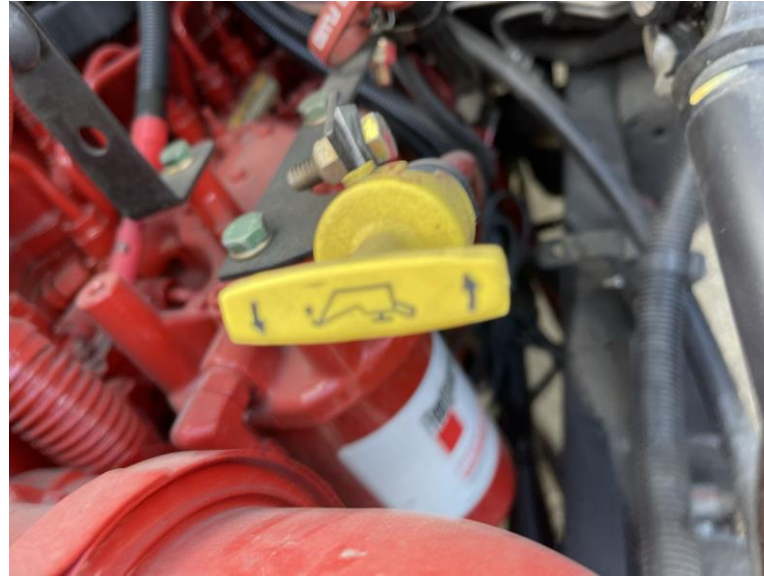
# Checking Engine Oil/Engine Oil Fill

- Check oil level when engine is off.
- Locate engine oil dip stick.
- When checking dip stick, oil level should be between “Add” and “Full”.

To add engine oil: Remove the oil filler cap located on top of the engine block as shown above. Then add appropriate oil to the engine.

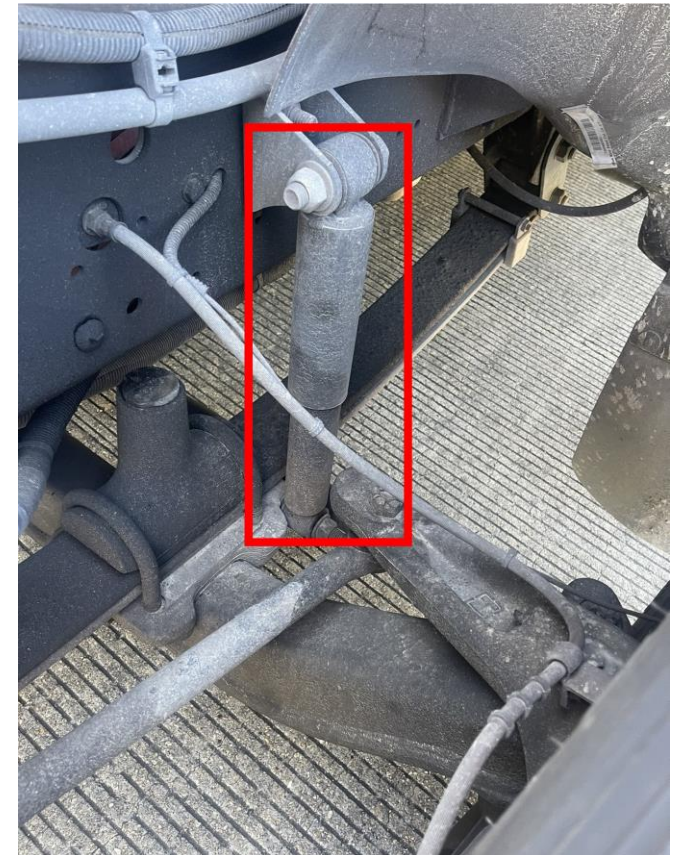
# Shock Absorber

- Shock Absorber is securely mounted to the frame of the bus and is not leaking.
- In good condition and not missing any parts.
- Absorber is not leaking.

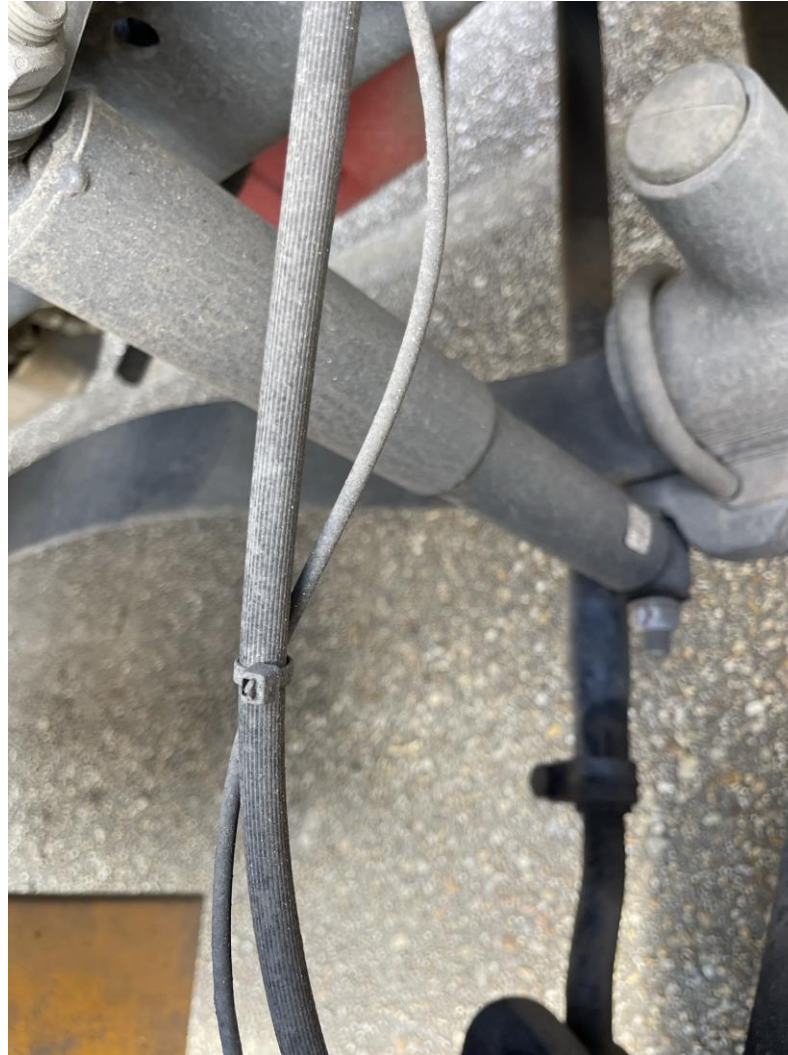
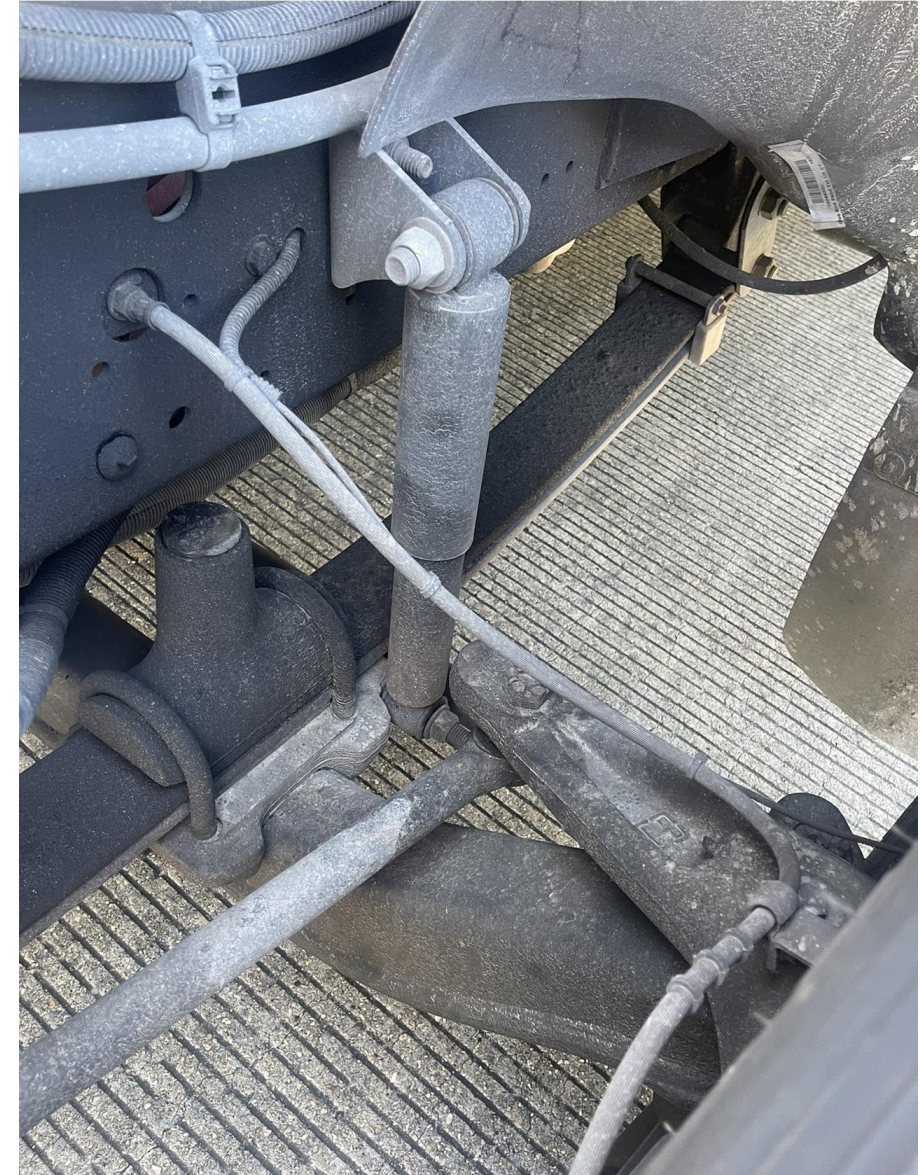
# Brake Lines and ABS

- Brake lines are secure and not cut, frayed, or torn.
- There are no leaks.
- All couplings and fittings are secure and not leaking.

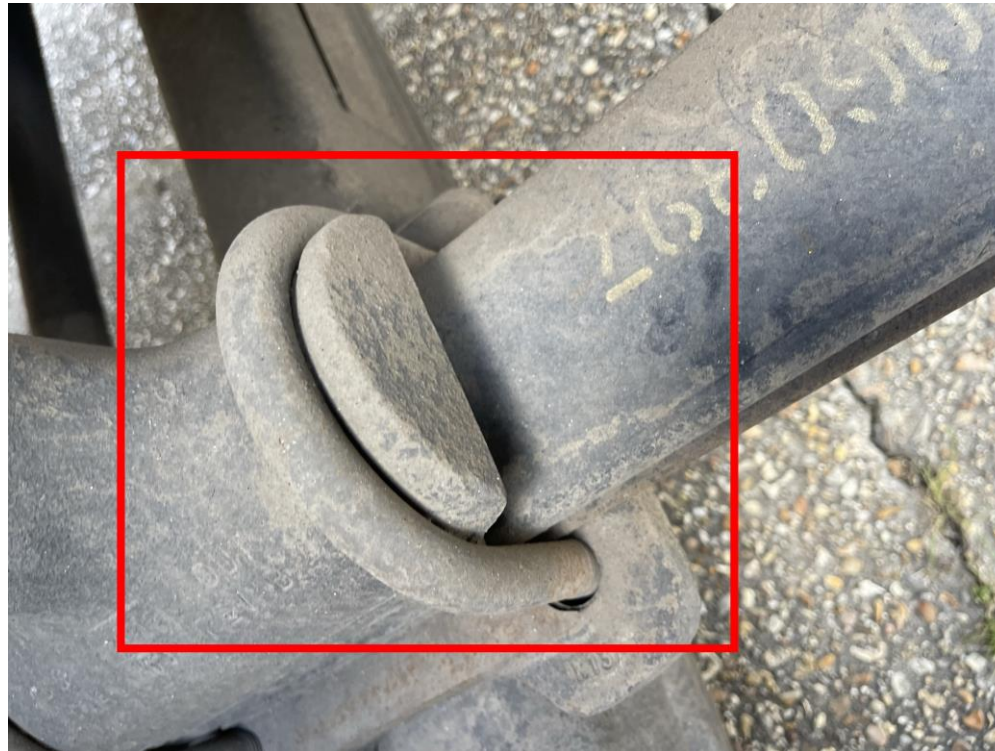
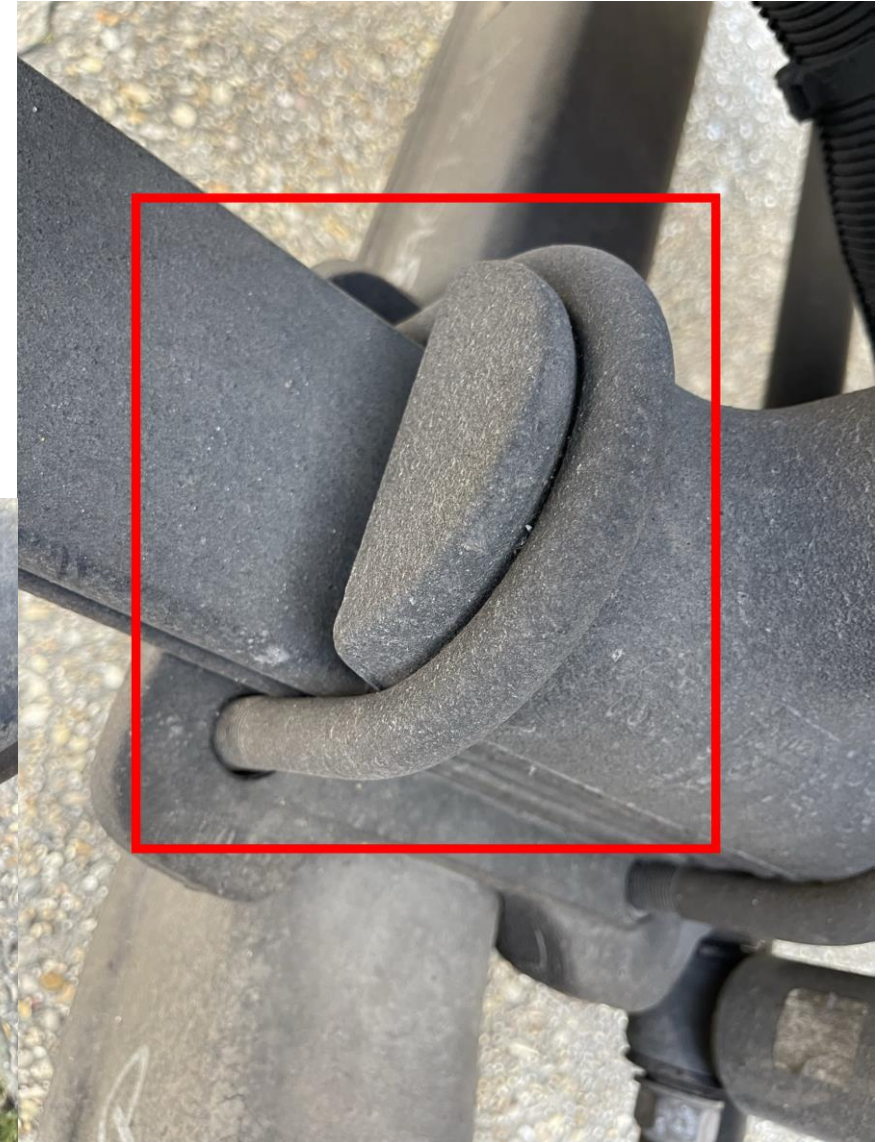
# U-Bolts

- U-Bolts are secured to the front axle of the bus.
- There are no missing, broken, or loose bolts.

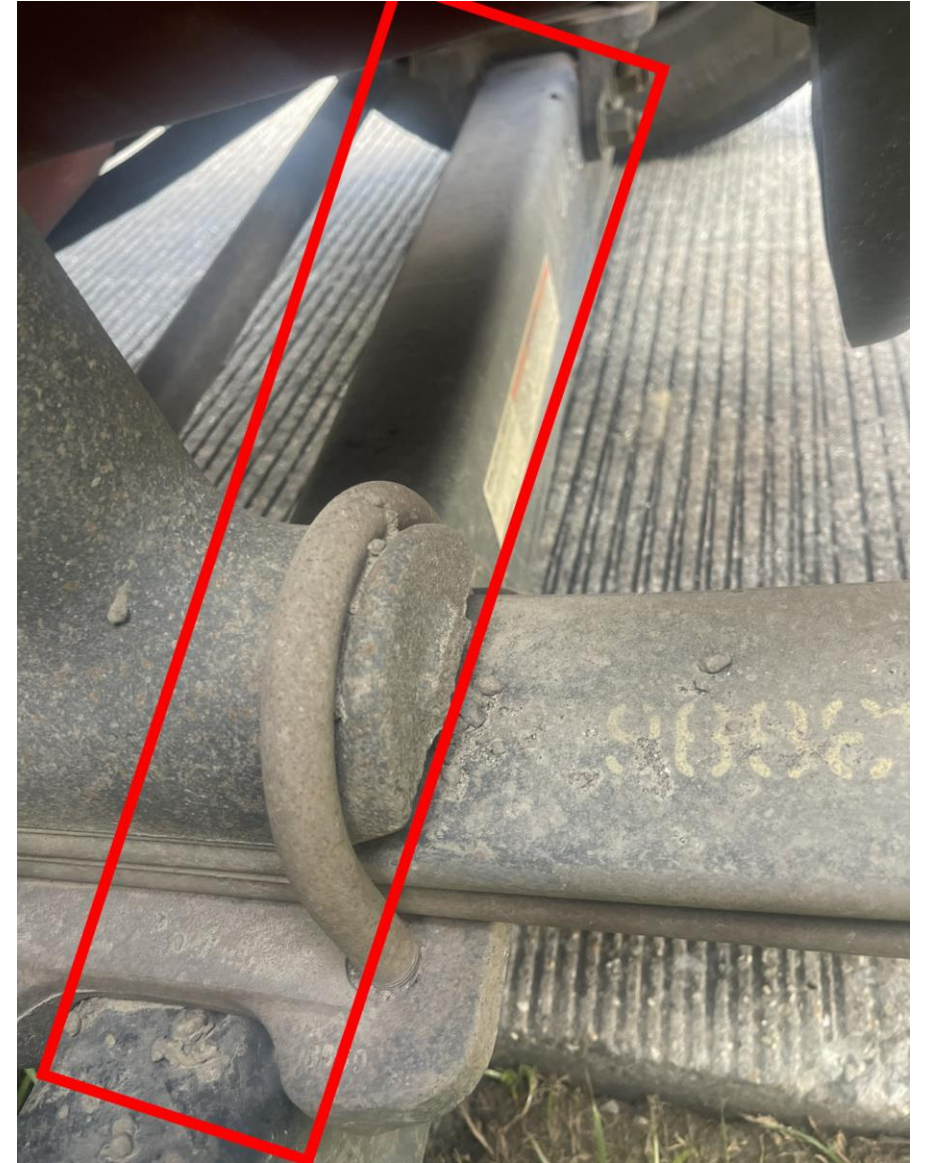
# Front Axle

- Front Axle is straight and not bent or broken.
  - There are no missing parts.
  - Not hanging or dragging.
