# SCHOOL BUS PRE-TRIP INSPECTION VISUAL GUIDE

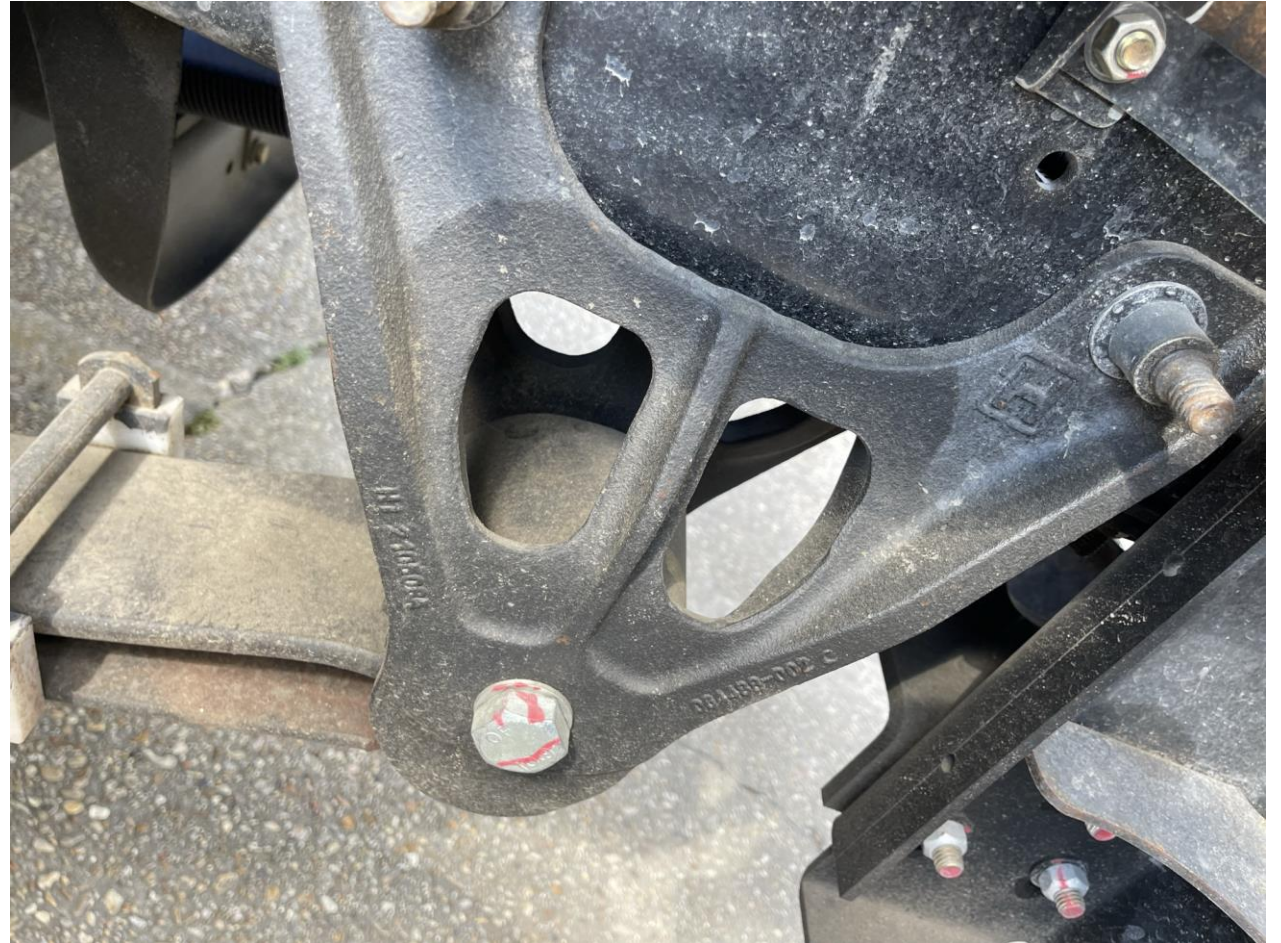
# Spring Leaf Mounts

- Spring Leaf Mounts are in place.
- They are not cracked or damaged.
- There are no missing bolts.
- Bushings are not damaged or missing.

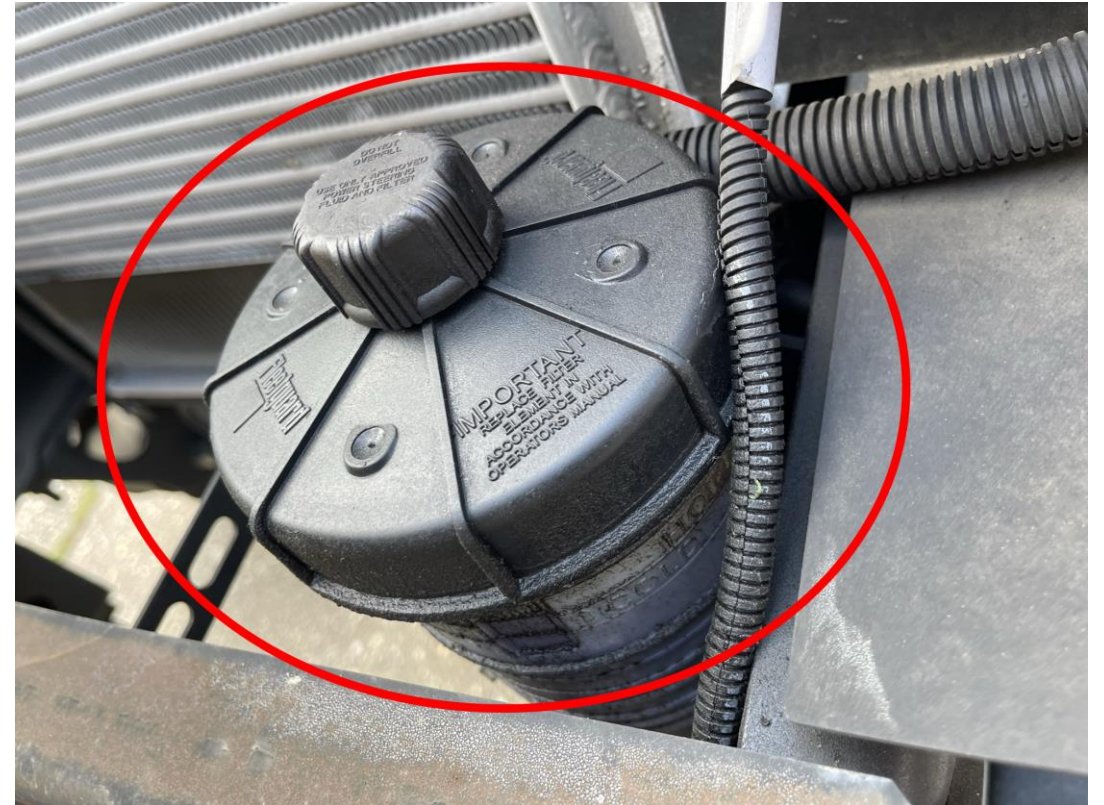
# Power Steering Reservoir

- Power Steering is gear driven is securely mounted to the frame of the bus.
- Power steering is not leaking and has adequate Power Steering Fluid.
- To check Power Steering Fluid, the engine should be off.
  - Check the dipstick to see where fluid levels are. Levels must be above the refill mark.

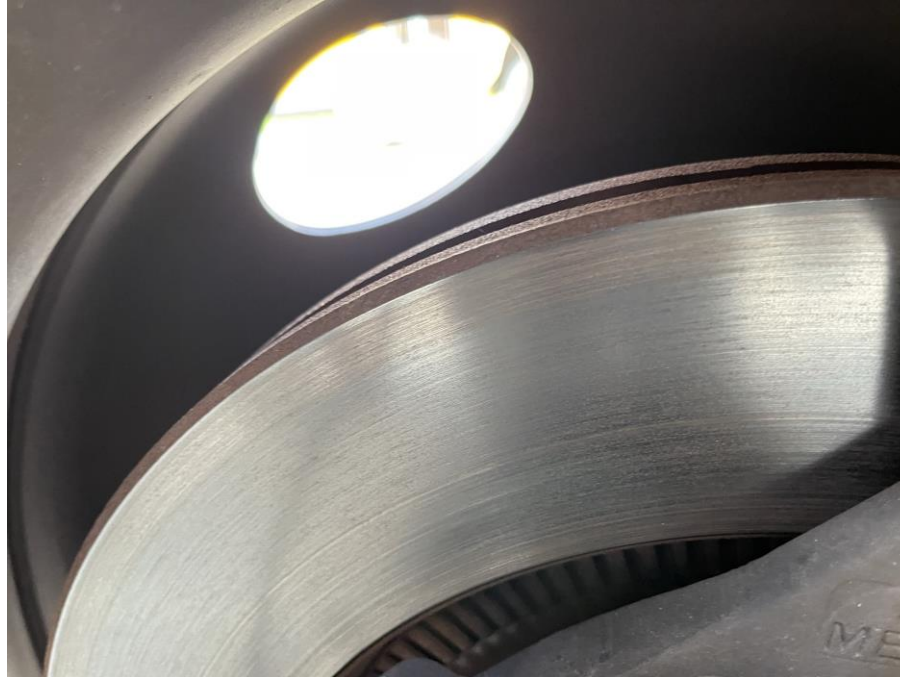
# Brake Discs & Linings

- Brake discs are not cracked, bent, or broken.
  - There are no dents or holes.
- Brake pads are in good condition and not worn dangerously thin.
- Brake caliper is securely mounted and in good condition.

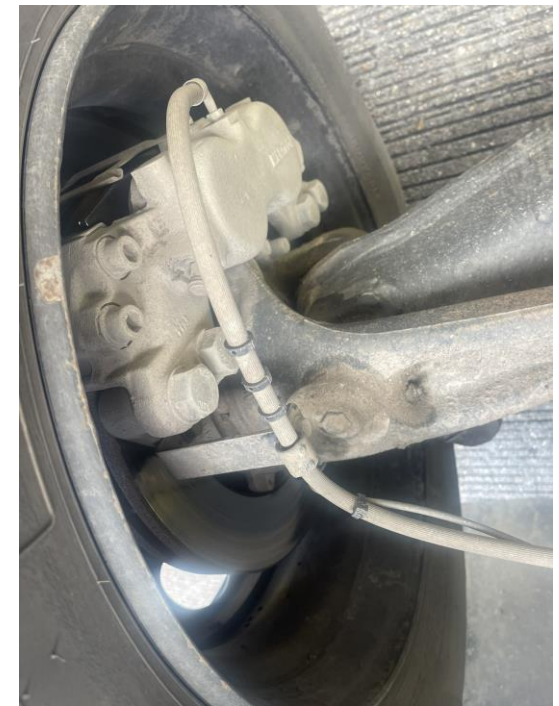
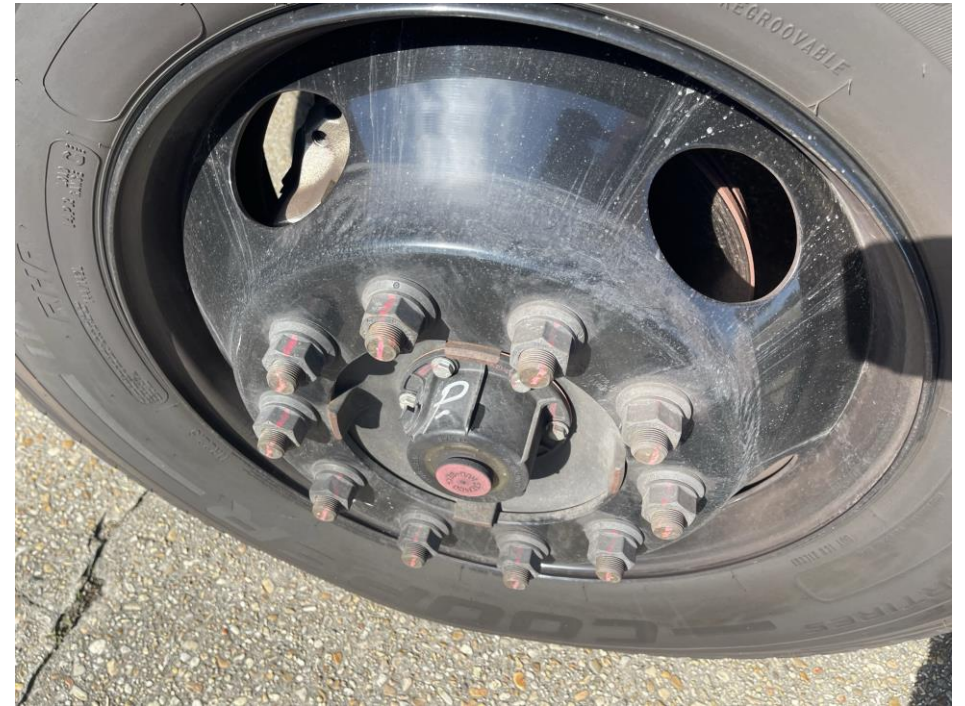
# Front Rim

- The inside of the rim is in good condition.
- There are no illegal welds
- Rims are not bent or cracked.

- The outside of the rim is in good condition.
- There are no illegal welds.
- Rim is not bent or cracked.
- There are no rust trails that may indicate the rim is loose on the wheel.

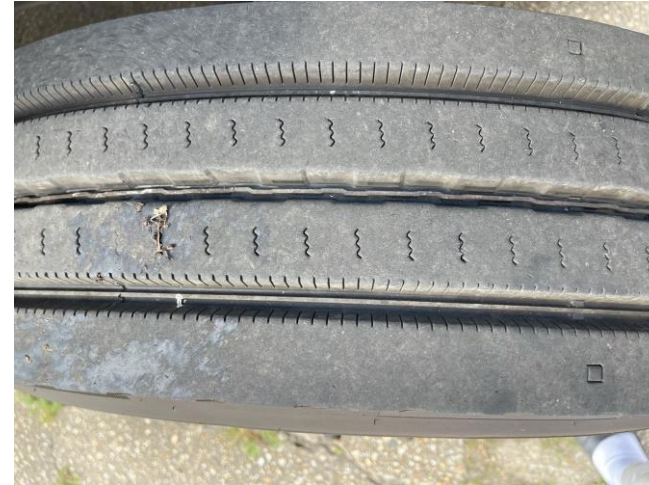
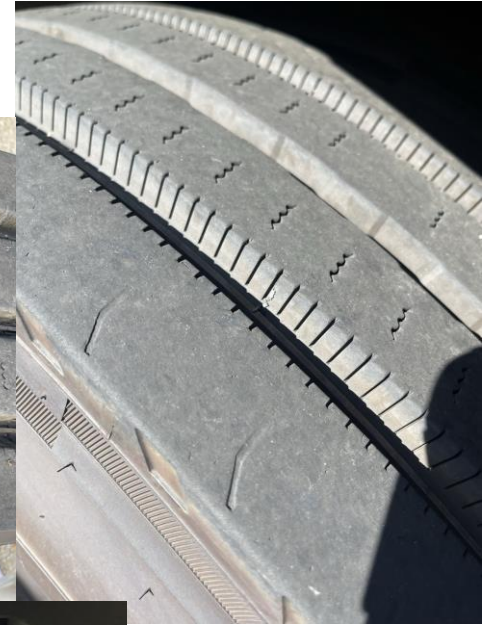
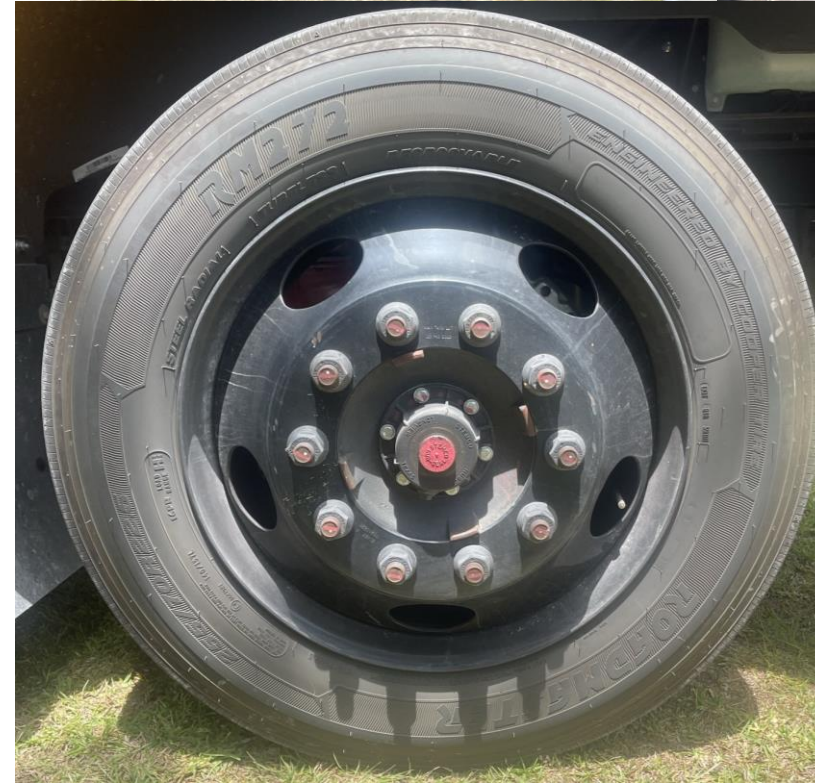
# Front Tire (ICD)

- **Inflation:** The tire is properly inflated, and you would check for proper inflation with a commercial tire gauge.
- **Condition:**
  - Outside face of the Front tire is in good condition.
  - There are no cut or tears.
  - Inside face of the tire is in good condition and there are no cuts or tears.
- **Depth:** Tire tread is evenly worn across and there is a minimum of 4/32 of tread depth.

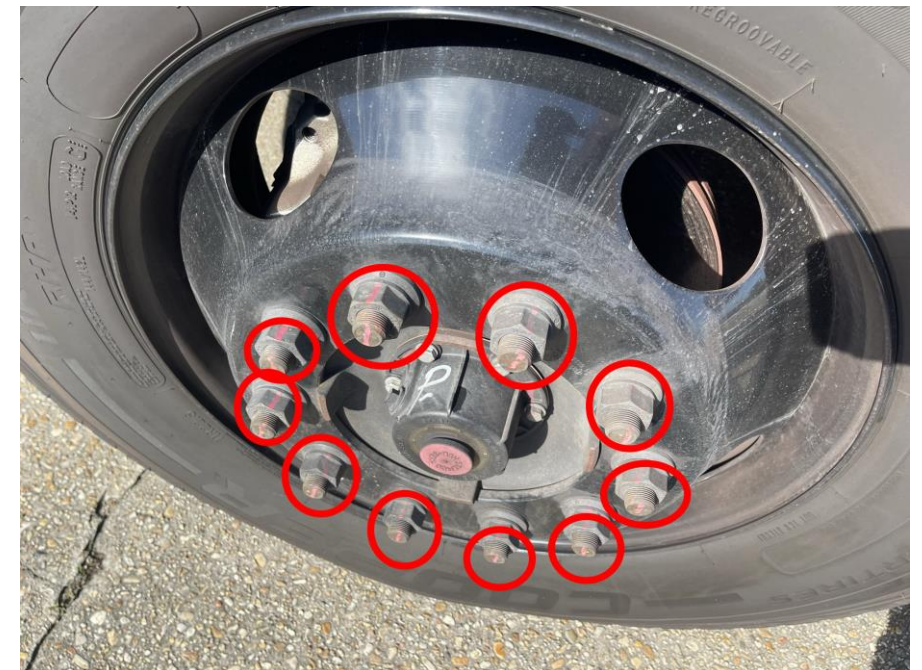
# Hub Seal and Lug Nuts

- Hub oil seal is securely mounted to the rim.
  - Seal is not leaking and has adequate fluid.
- Lug Nuts
  - All lug nuts are present.
  - Lugs are not loose.
  - There are no receding cracks around lug bolt holes.

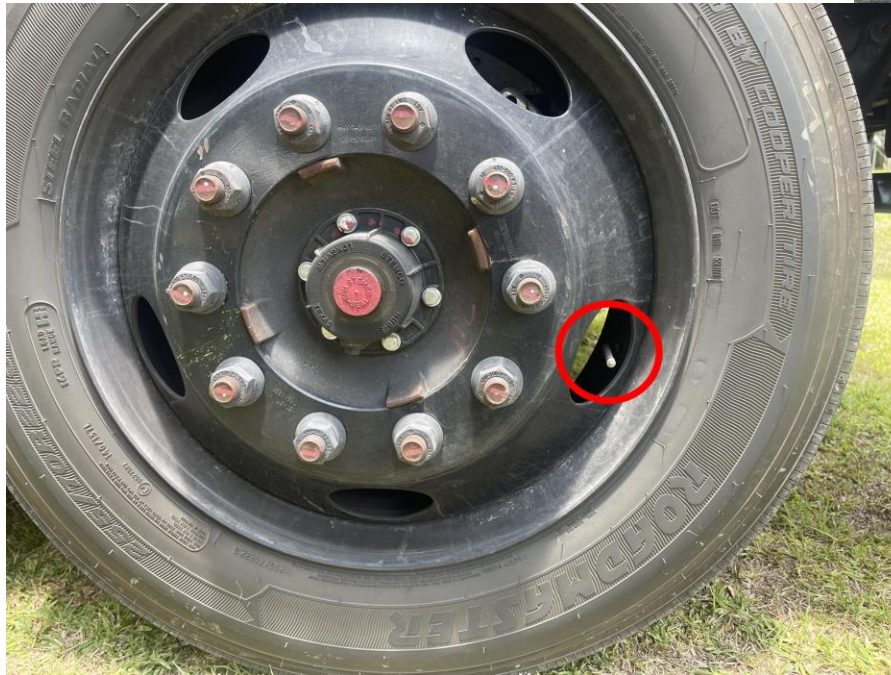
# Valve Stem

- Valve stem is straight and has cap.
- Stem is not leaking , bent or broken.

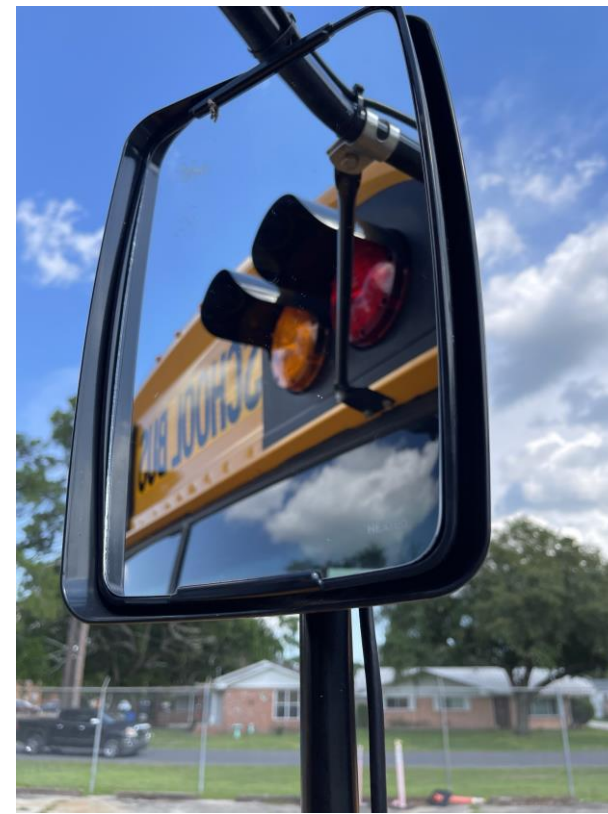
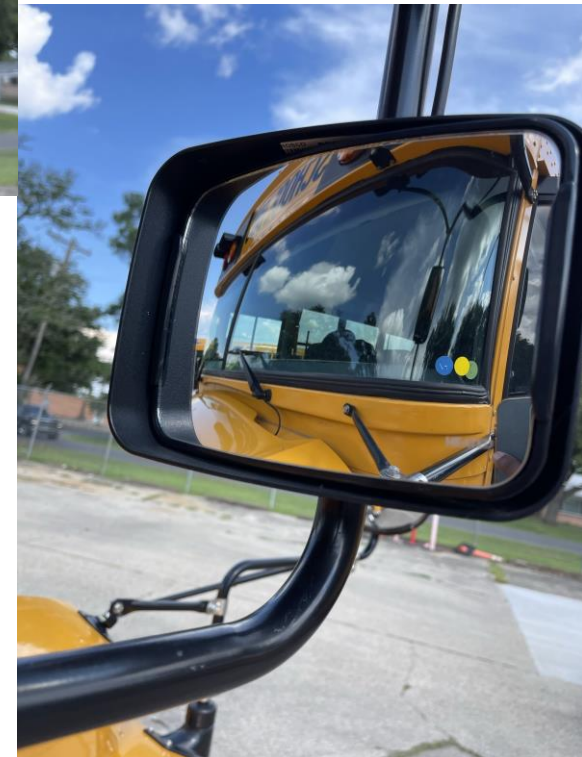
# Flat and Convex Mirrors

- Mirrors are properly mounted to the side of bus and are adjusted correctly.
- Mirrors are not cracked or broken.

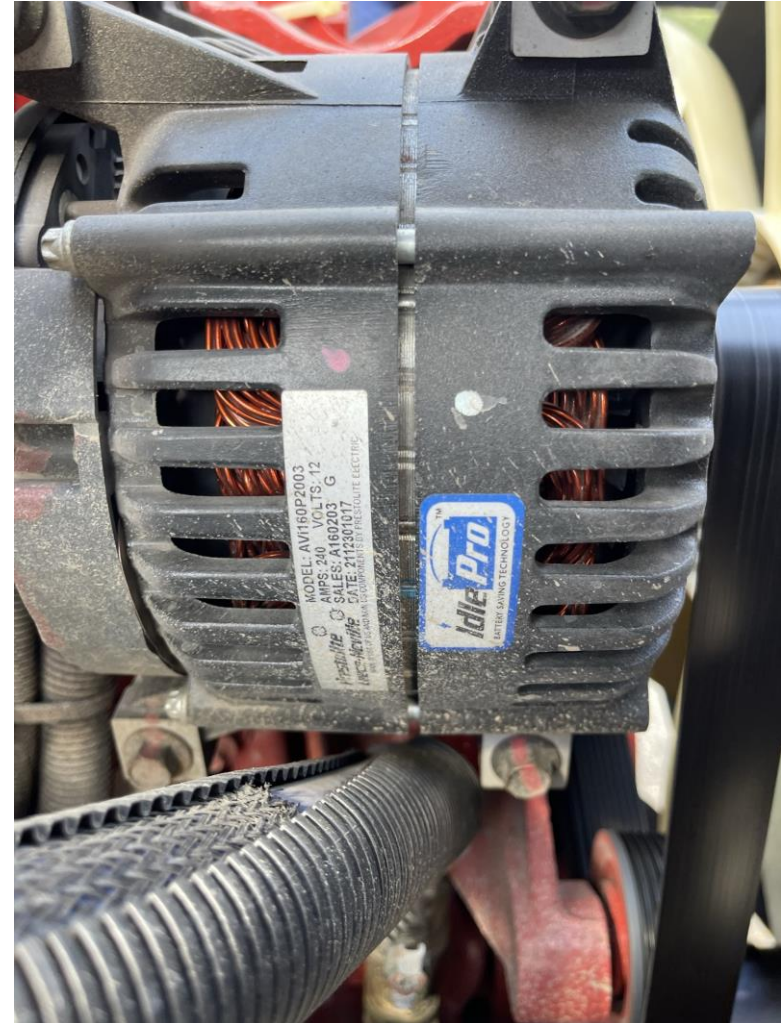
# Alternator

- Alternator is belt driven and properly mounted to the engine block.
- All alternator wires are securely fastened, and not frayed or damaged.

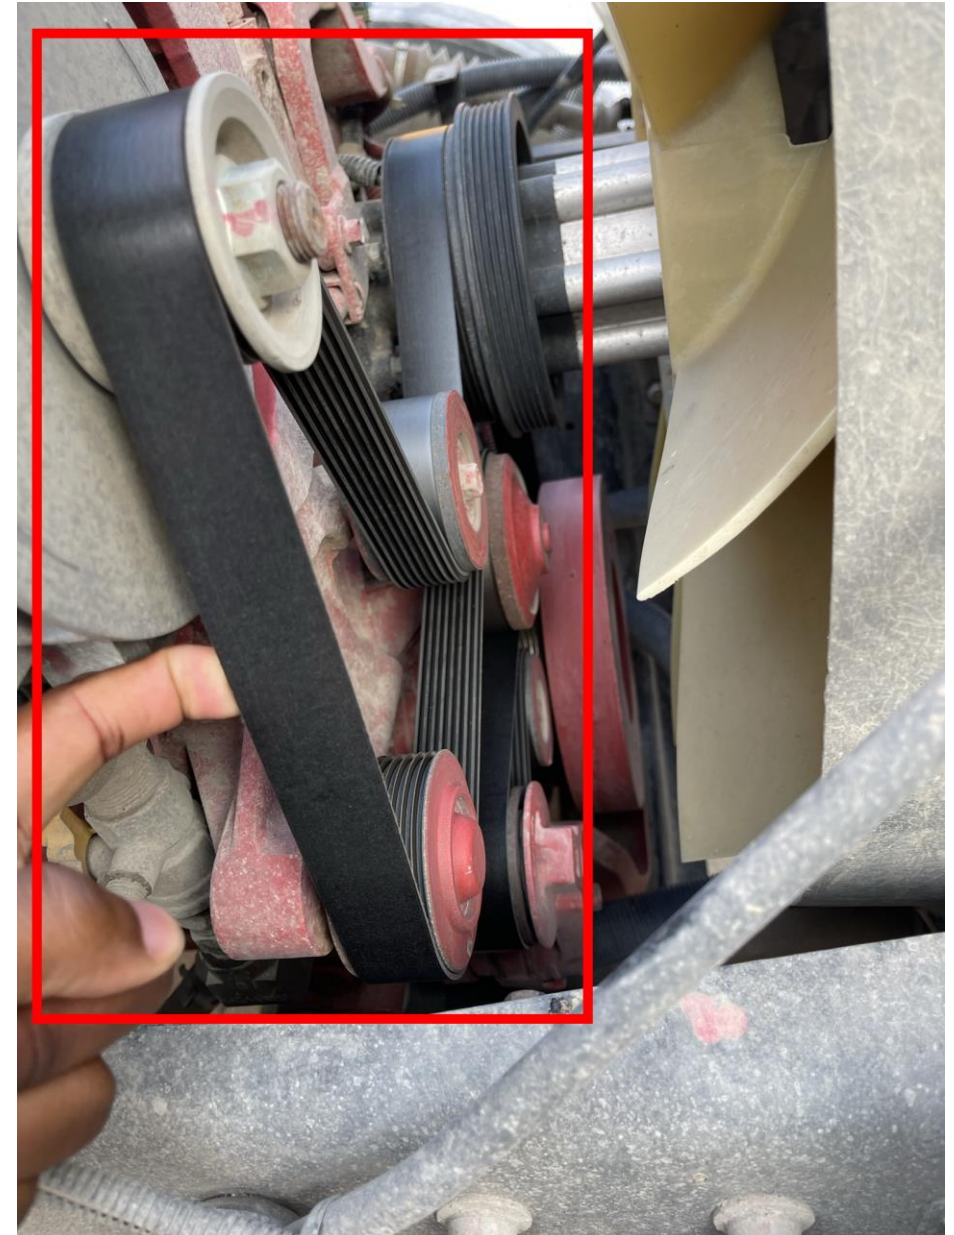
# Belts

- Belts are not frayed, or cracked and there is no sign of wear.
  - No loose fibers.
  - Belts have no more than  $\frac{3}{4}$  inch play (defect).
- **With the engine off, touch and tug on the belts to make sure there are no excessive defects.**

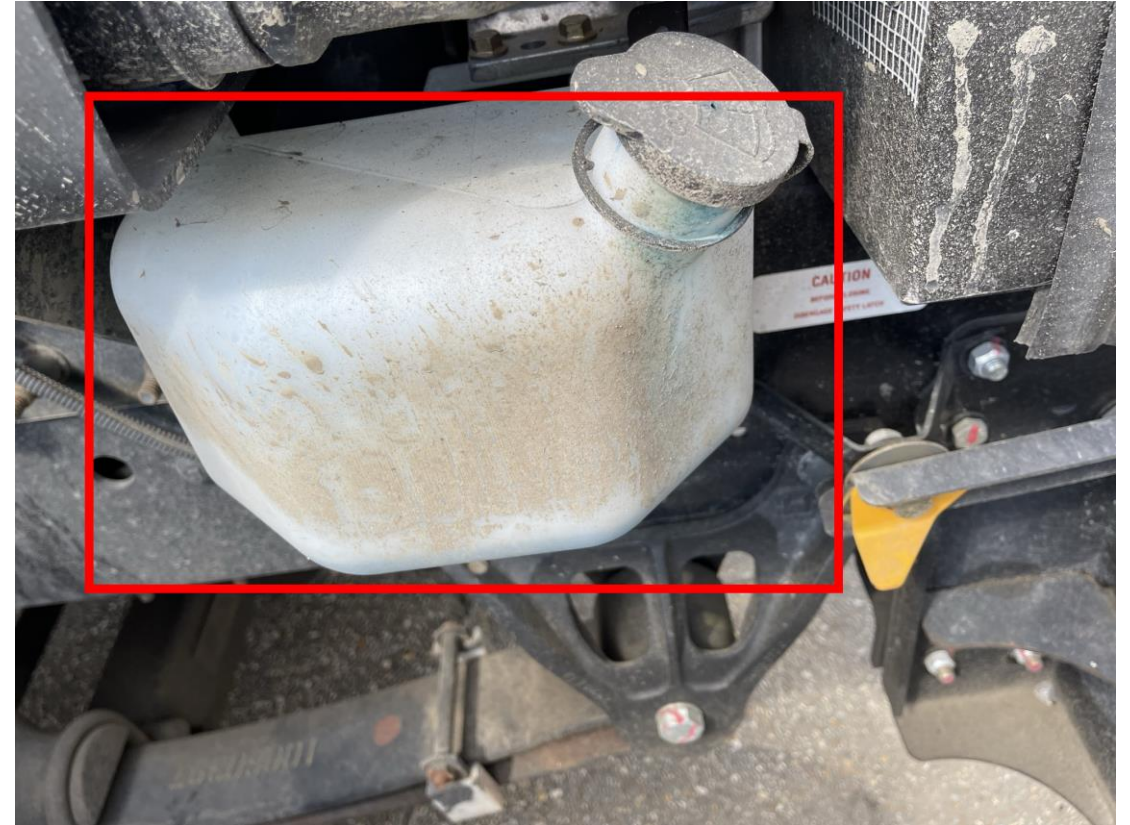
# Windshield Wiper Reservoir

- Windshield Wiper Reservoir is securely mounted to the frame of the bus.
  - There are no leaks, and it has adequate washer fluid.

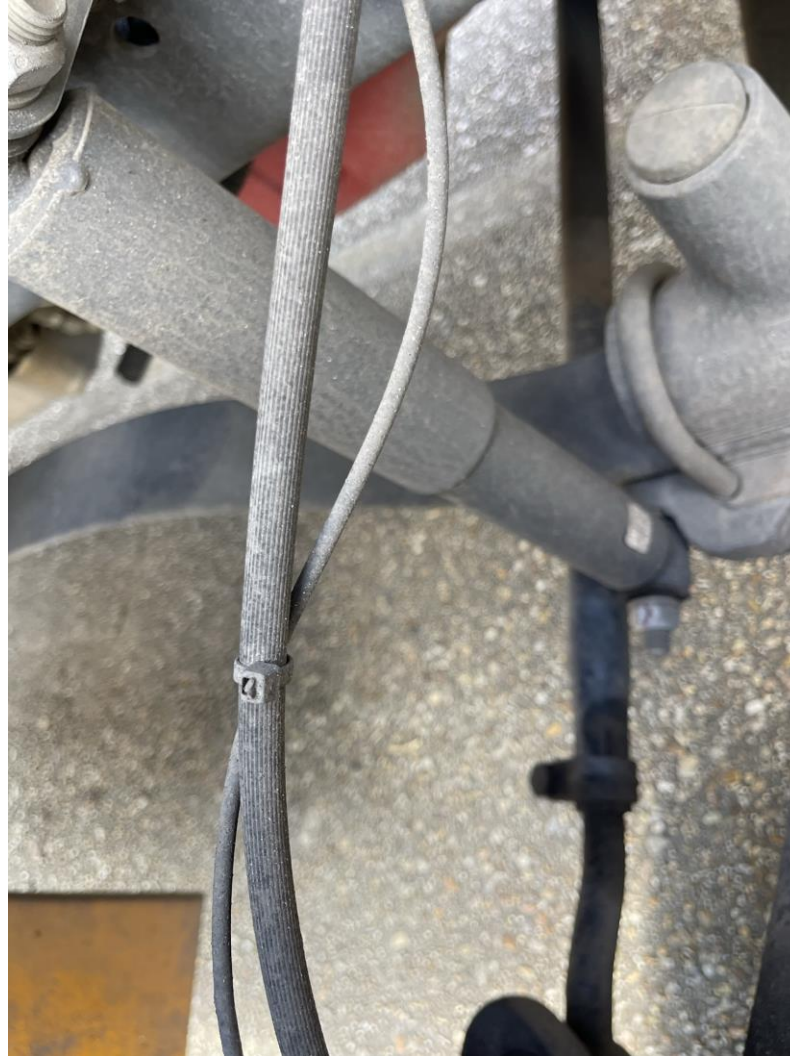
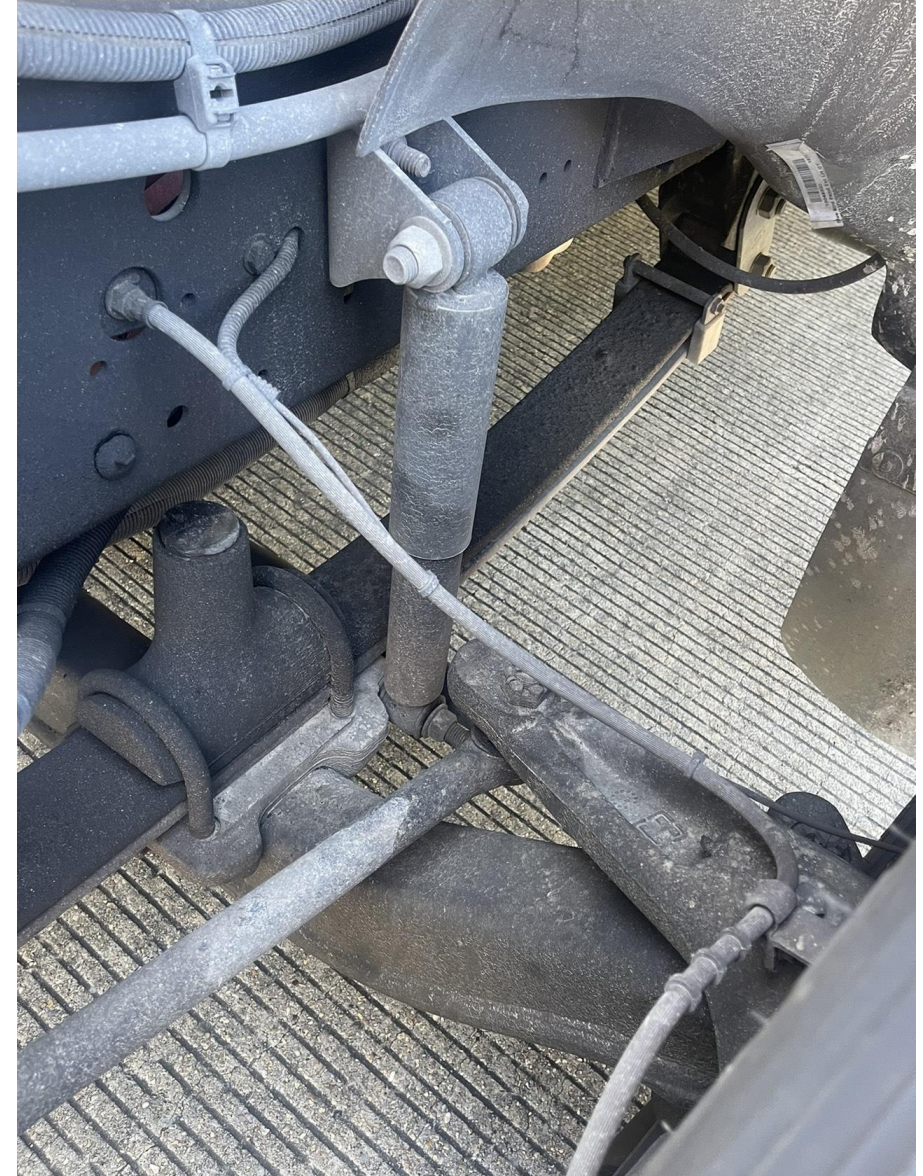
# Brake Lines and ABS

- Brake lines are secure and not cut, frayed, or torn.
- There are no leaks.
- All couplings and fittings are secure and not leaking.

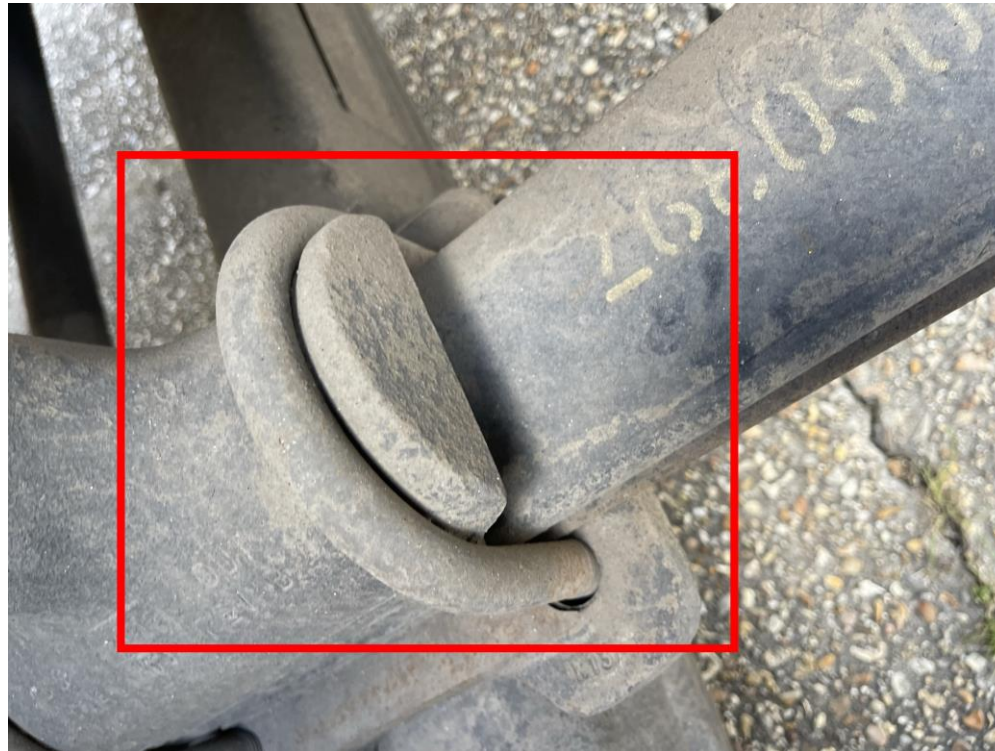
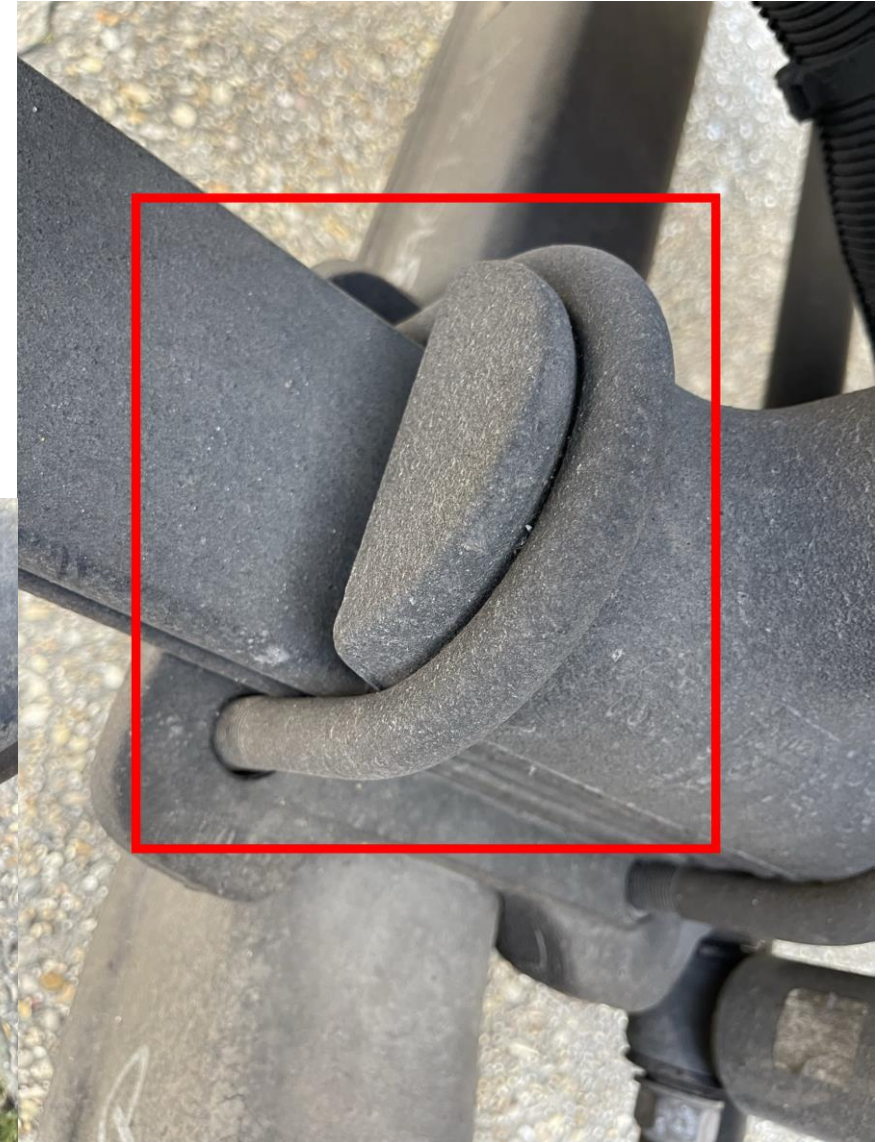
# U-Bolts

- U-Bolts are secured to the front axle of the bus.
- There are no missing, broken, or loose bolts.

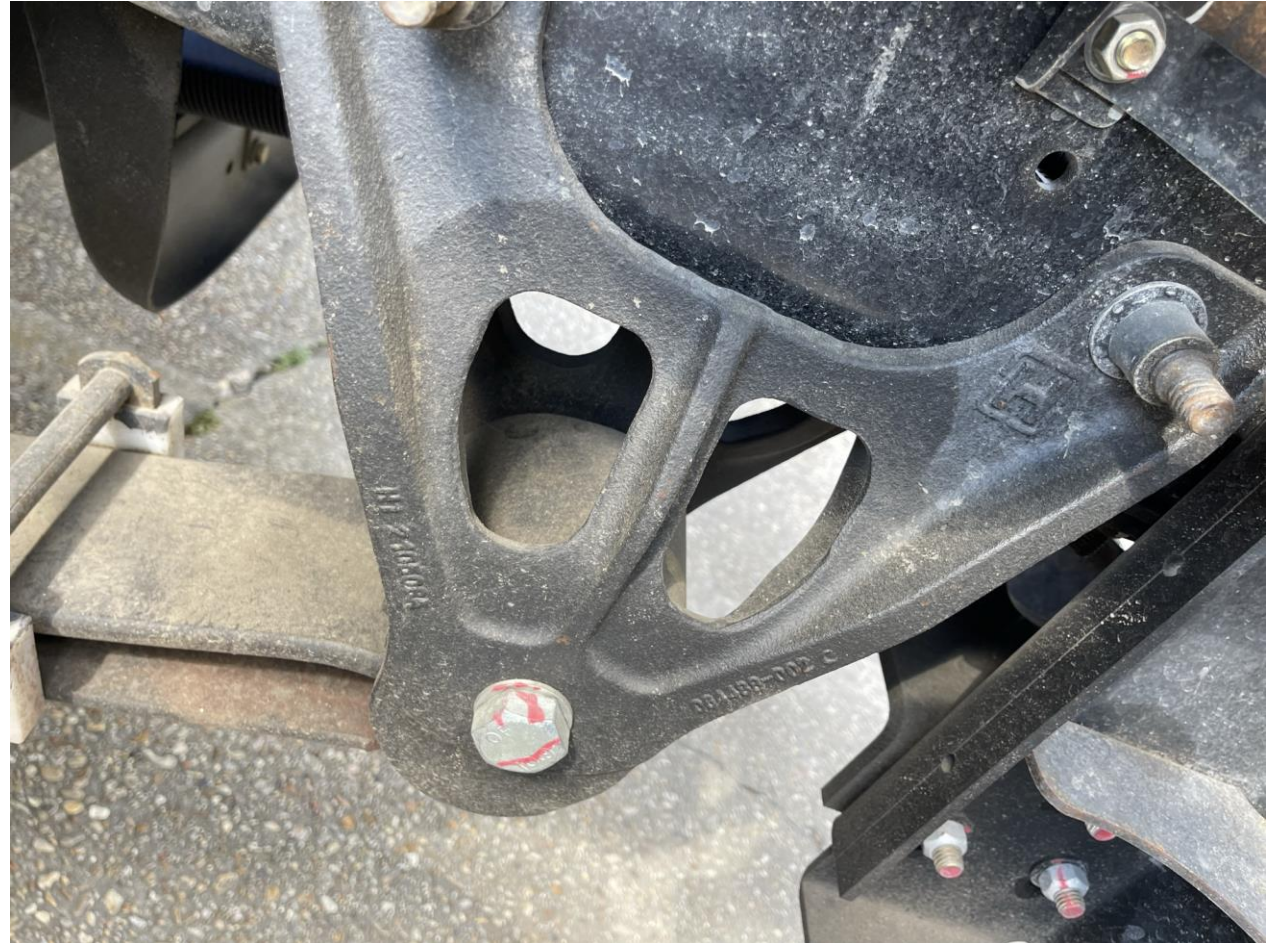
# Spring Leaf Mounts

- Spring Leaf Mounts are in place.
- They are not cracked or damaged.
- There are no missing bolts.
- Bushings are not damaged or missing.

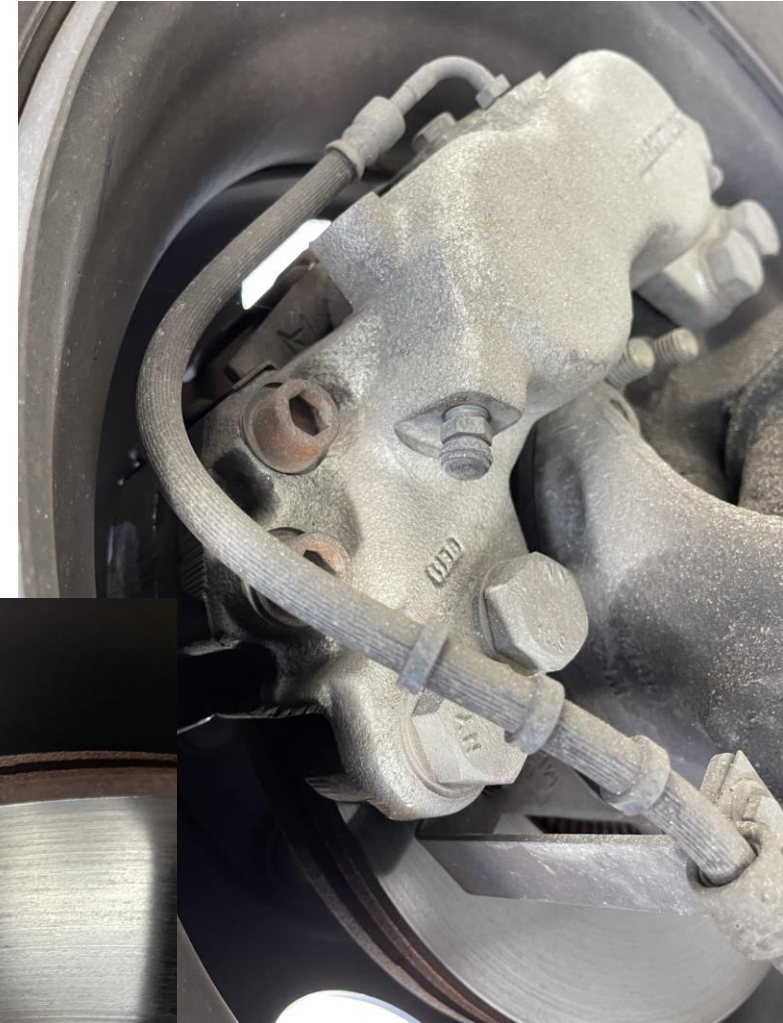
# Brake Discs & Linings

- Brake discs are not cracked, bent, or broken.
  - There are no dents or holes.
- Brake pads are in good condition and not worn dangerously thin.
- Brake caliper is securely mounted and in good condition.

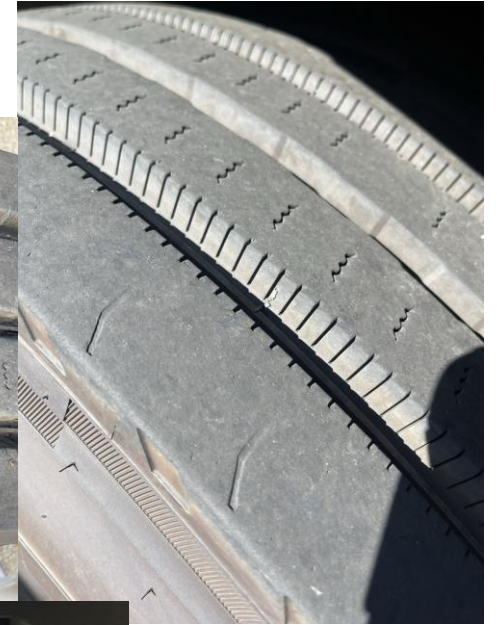
# Front Tire (ICD)

- **Inflation:** The tire is properly inflated, and you would check for proper inflation with a commercial tire gauge.
- **Tread:** Tire tread is evenly worn across and there is a minimum of 4/32 tread depth.
- **Condition:**
  - Outside face of the Front tire is in good condition.
  - There are no cut or tears.
  - Inside face of the tire is in good condition and there are no cuts or tears.

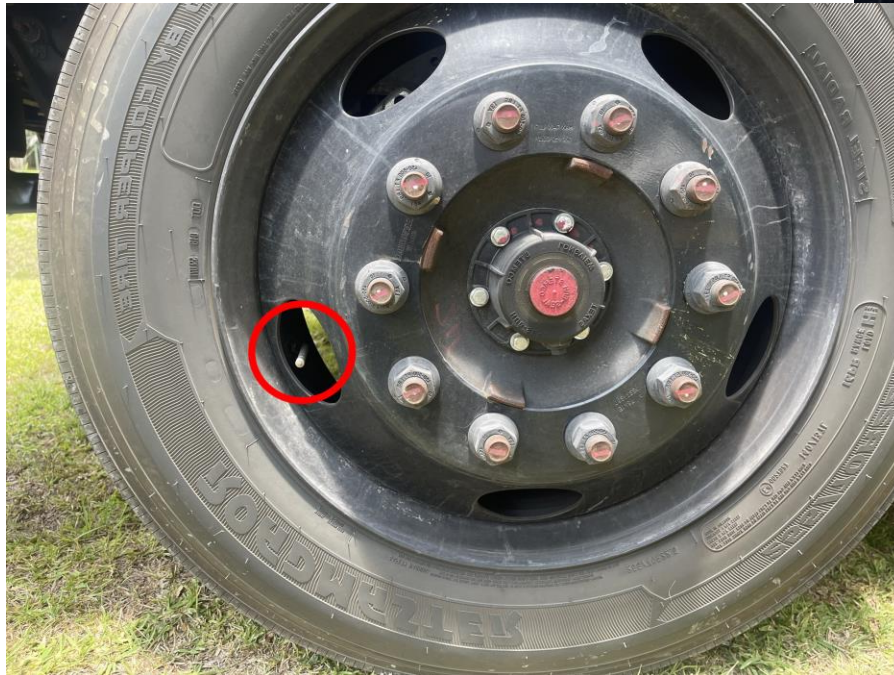
# Valve Stem

- Valve stem is straight and has cap.
- Stem is not leaking , bent or broken.

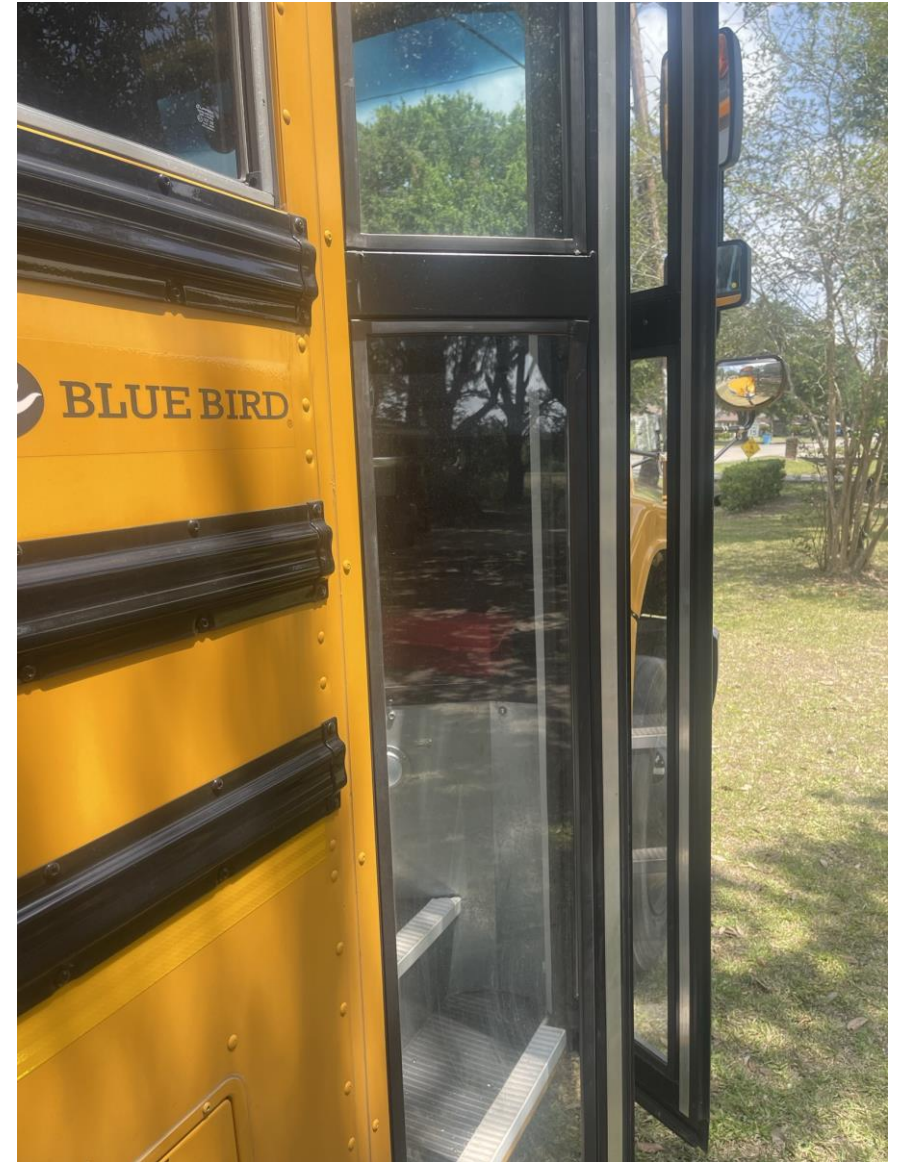
# Service Door

- Door is not damaged and opens & closes properly.
- Door window is not cracked or broken and glass is clean.
- Hinges are secure.
- Rubber gaskets and seals are intact.

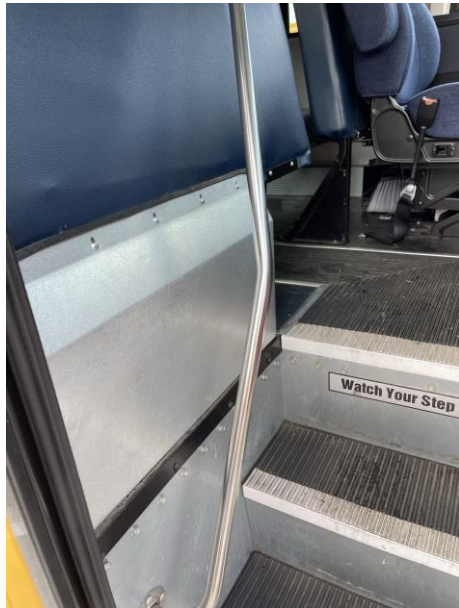
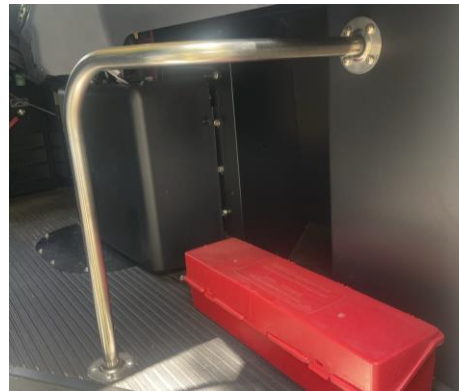
# Front Door Entry

- Handrails are secure.
- Entry steps are clear of any obstructions.
- Treads on steps are not loose or worn excessively.

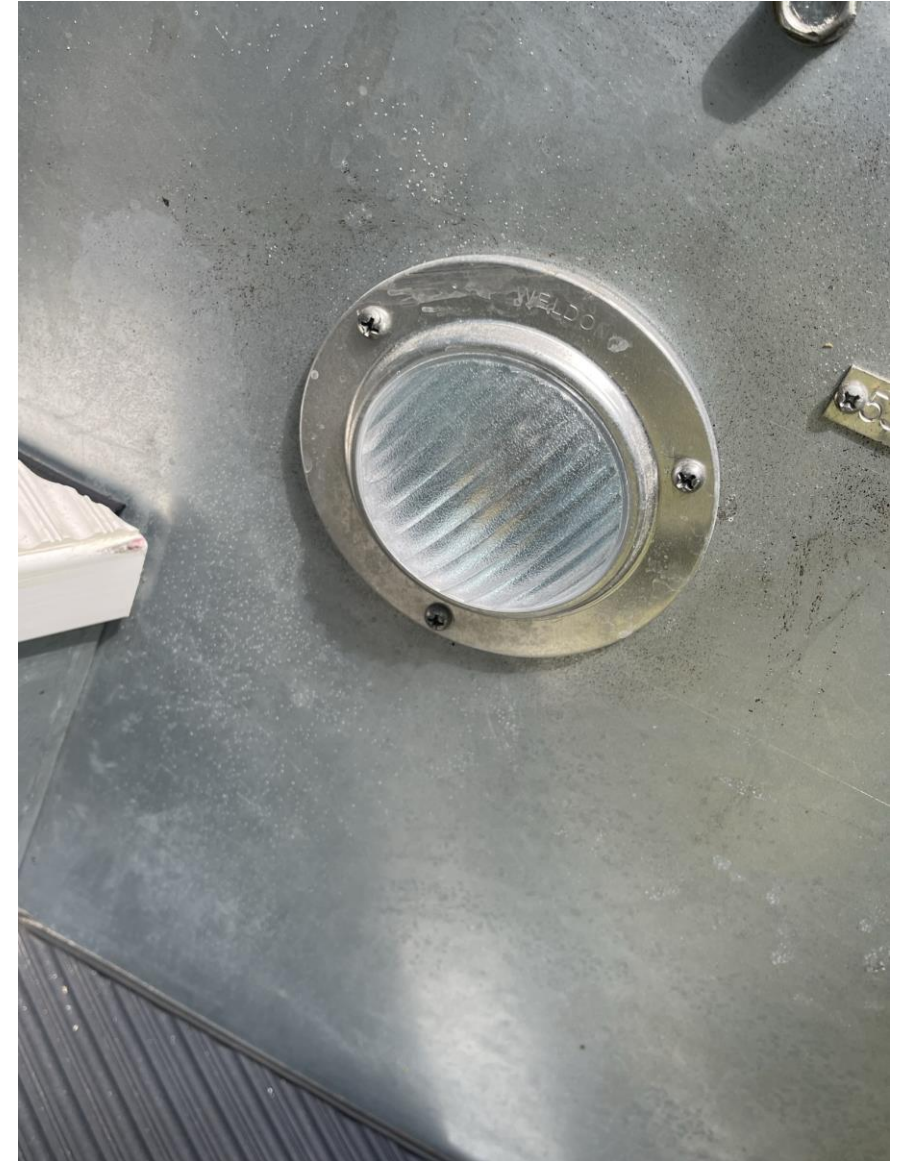
# Stairwell Light

- Stairwell light lens is not cracked or broken.
  - Light is functioning.
  - Good in color and there are no missing parts.

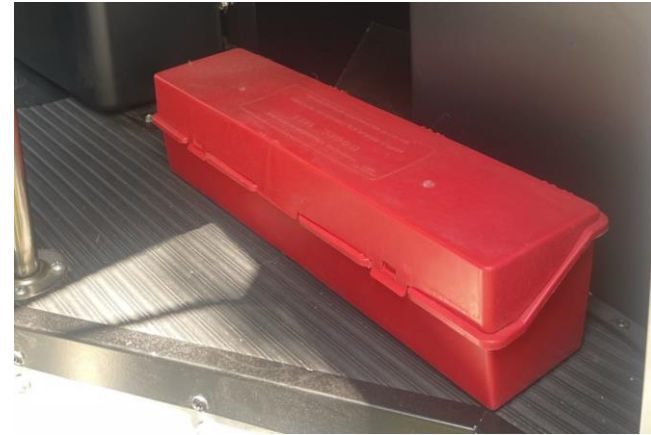
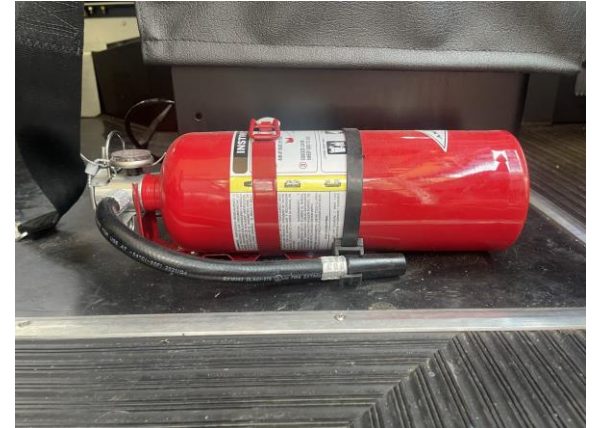
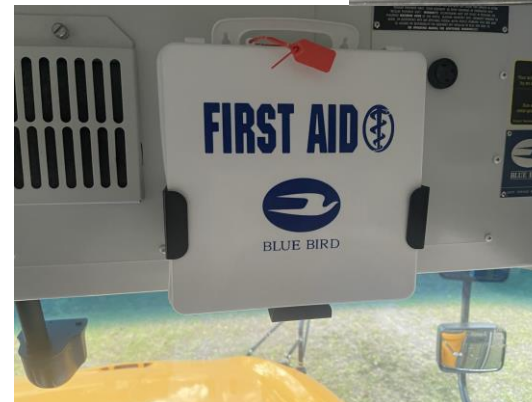
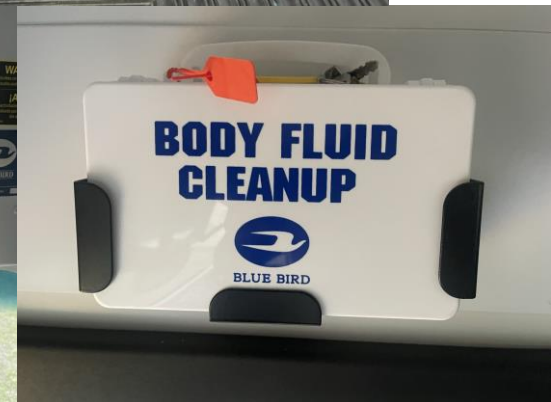
## **First Aid and Body Fluid Cleanup Kits**

Securely mounted and has adequate supplies

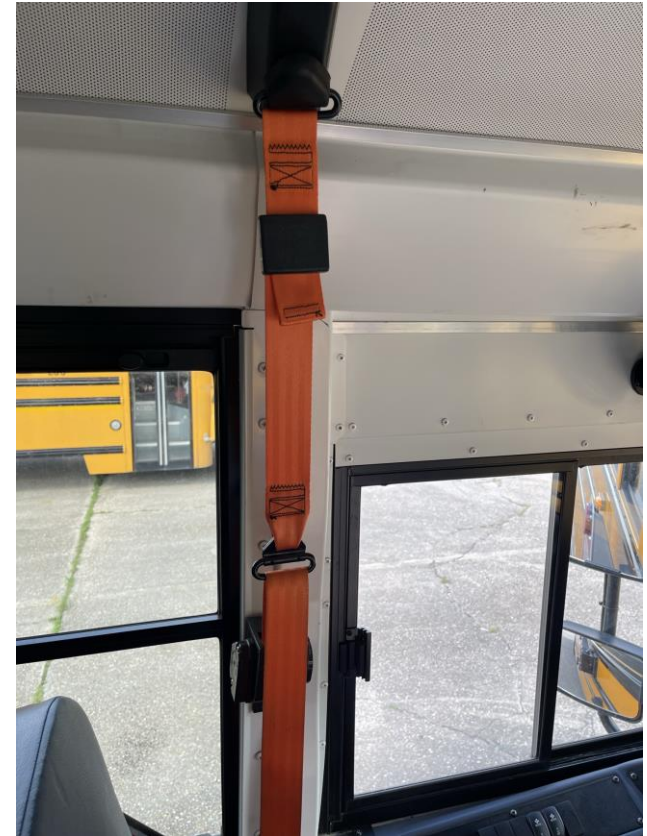
# Seat Belt

- Seat belt is mounted securely.
  - Adjusted properly
  - Not ripped or frayed.

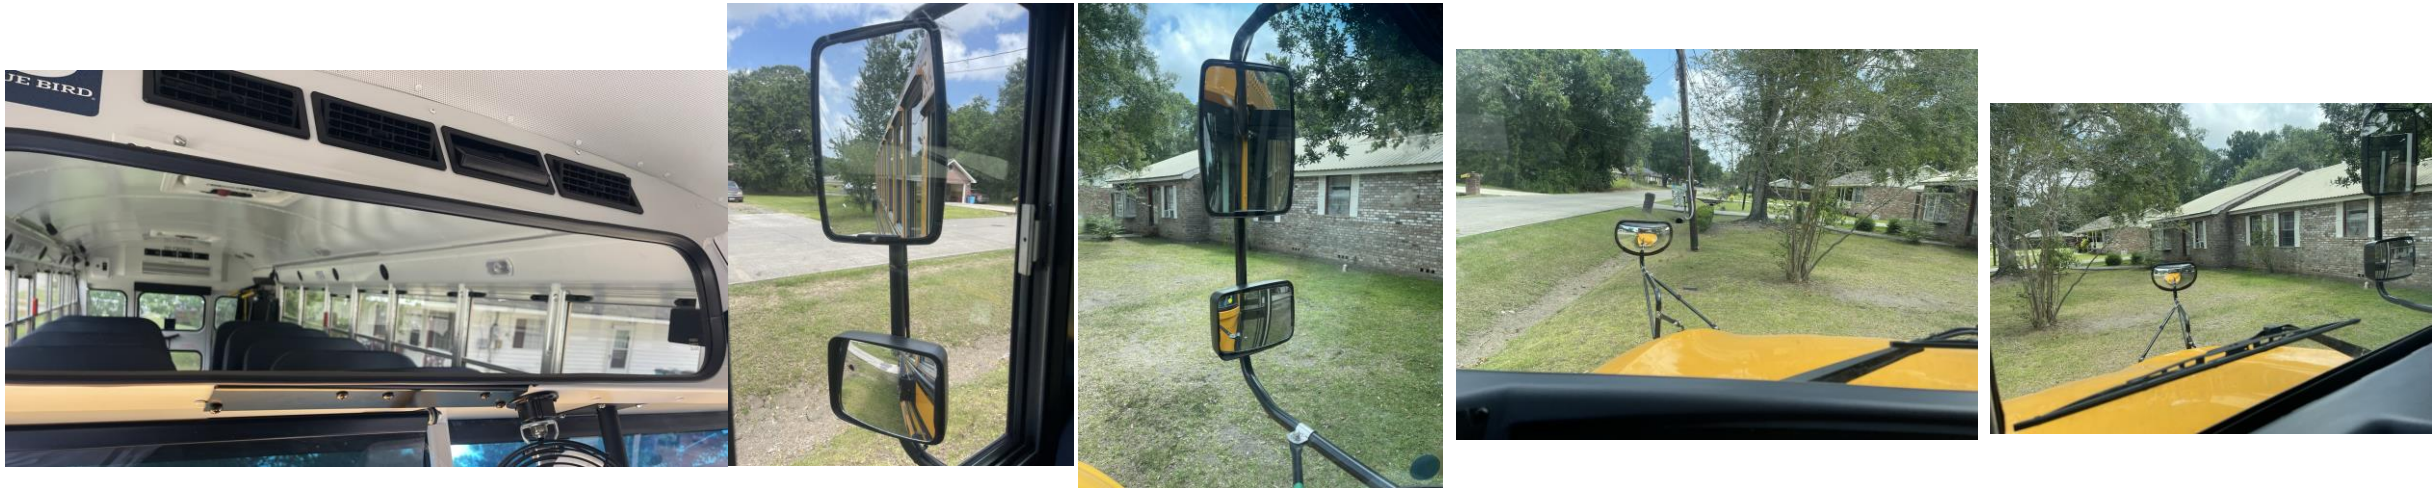
# Mirrors

- Student mirror, cross-view, and side external mirrors are all adjusted properly.
  - Mirrors are clean and good to see through.
  - Mirrors are not damaged and mounted securely.
  - No loose fittings or missing parts.
