# SCHOOL BUS PRE-TRIP INSPECTION VISUAL GUIDE

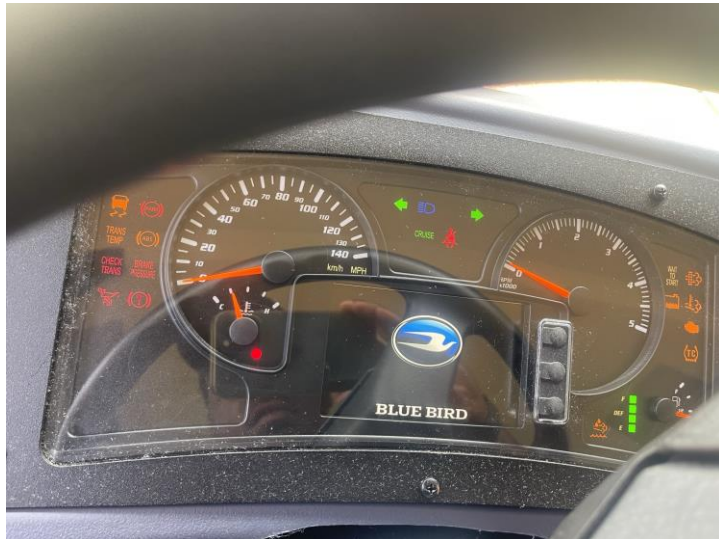
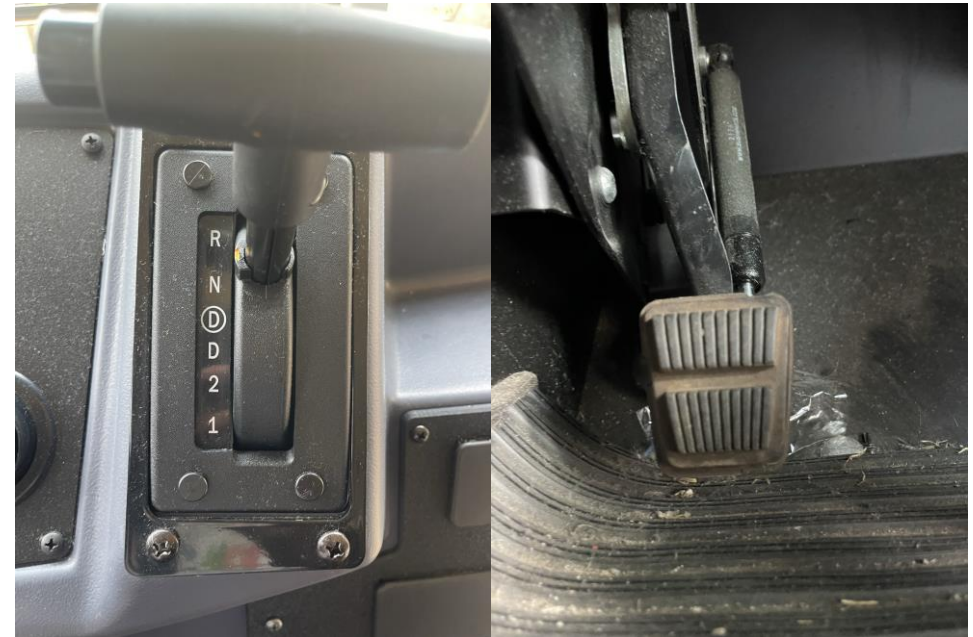
# Safe Start

- Gear shift is in neutral, and the parking brake is applied.
  - Turn the ignition switch and allow the gauges to stabilize.
  - Wait for the 'Wait to Start' lamp to illuminate.
    - Once cleared you can start the engine.

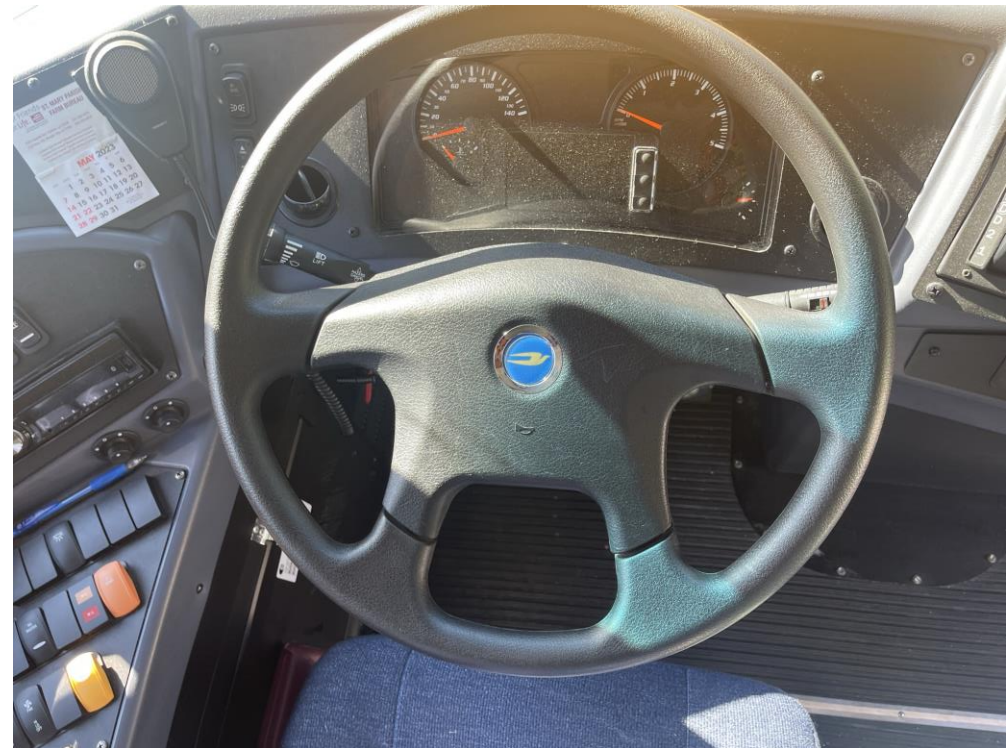
# Steering

- Steering wheel doesn't have any more than 2 inches of play in a 20-inch steering wheel.
- Electric Horn works properly.

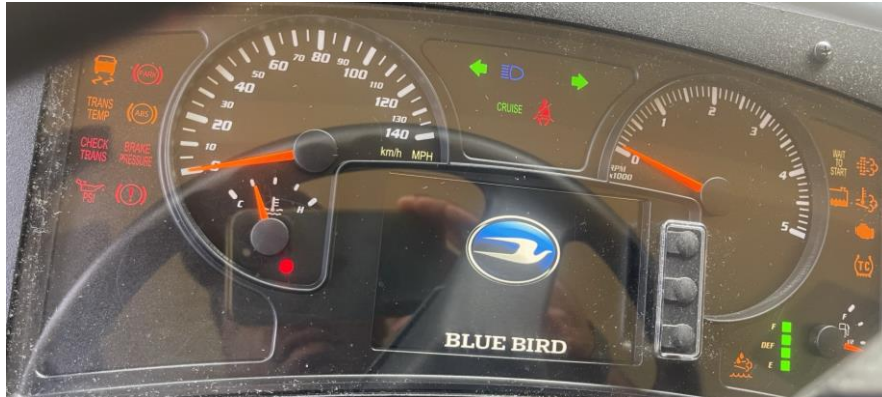
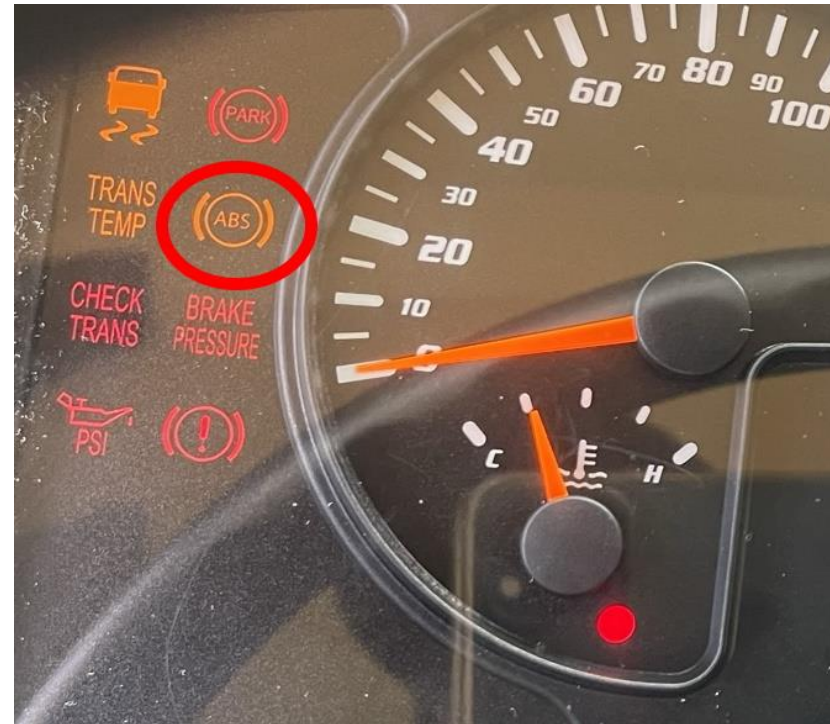
# ABS System (Anti-lock Brake System)

- When doing safe start, the ABS indicator will illuminate and then turns off.
  - If the ABS lamp remains illuminated, ABS is not functioning correctly and needs servicing.

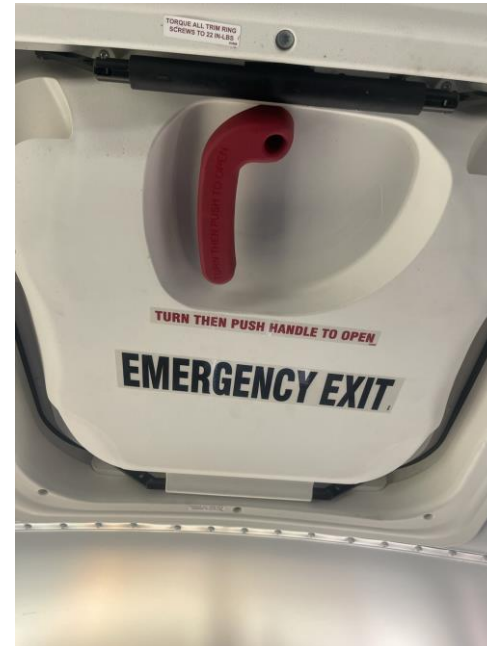
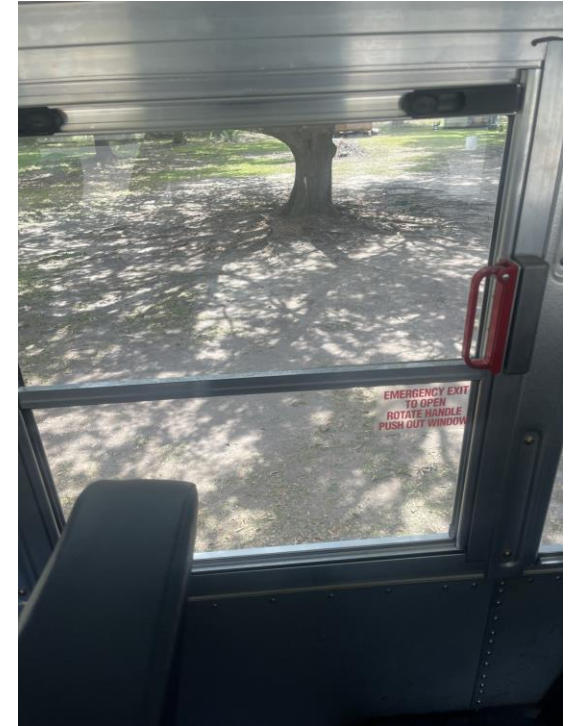
- There are different Emergency Exit devices:
  - 2 roof hatches.
  - At least 1 Emergency pushout window on each side of the bus.
  - 1 rear Emergency door.
- Each Emergency Exit device is working properly and free of obstruction.
  - Latches properly and is not damaged.

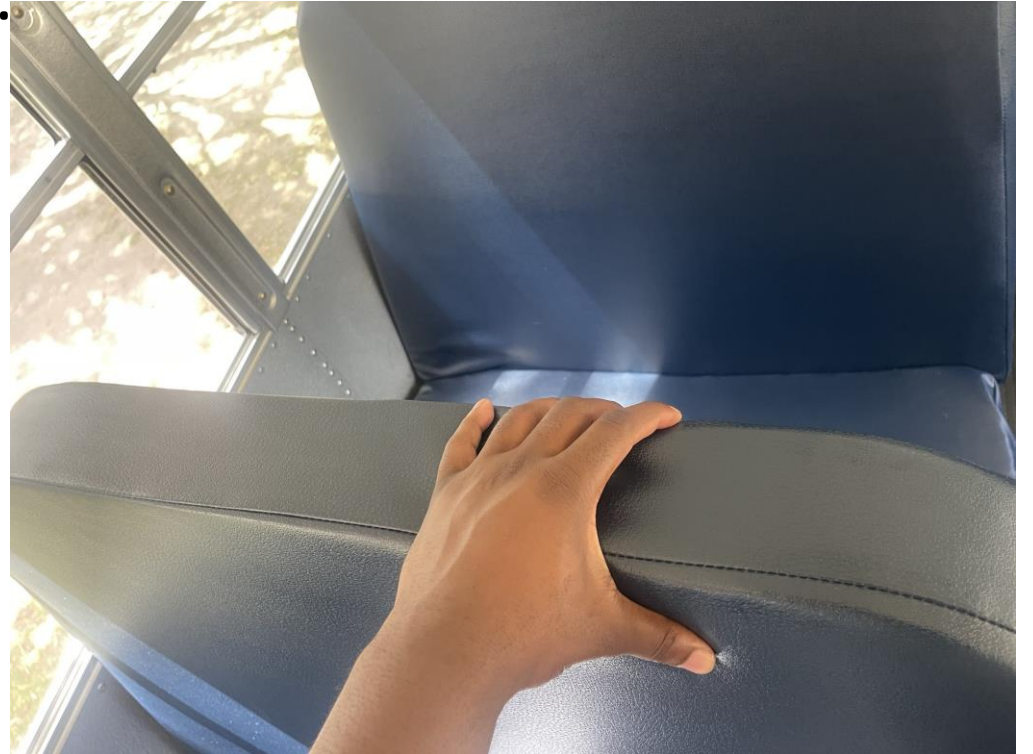
# Seating

- There are no broken seat frames.
- Seats are properly secured to the floor.
  - Cushions are attached to seat frames.
  - Seats are not cut or torn.

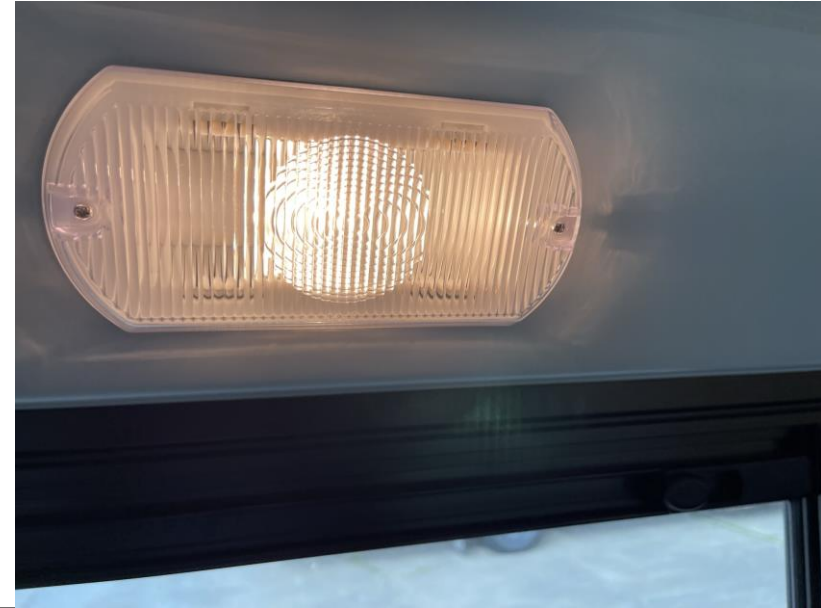
# Dome Lights

- Dome lights work properly.
  - Lens is not cracked or broken.
  - There are no missing parts.
  - All lights work.

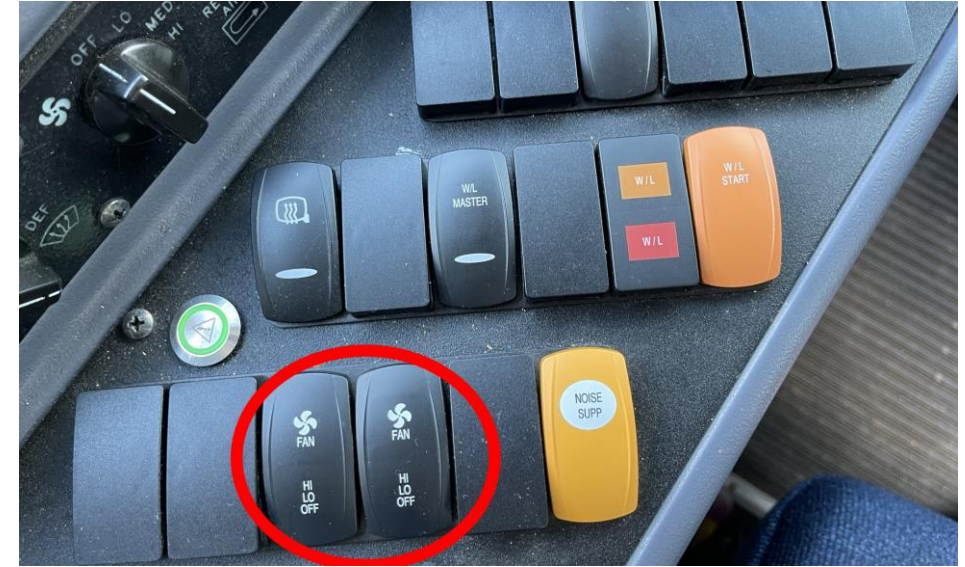
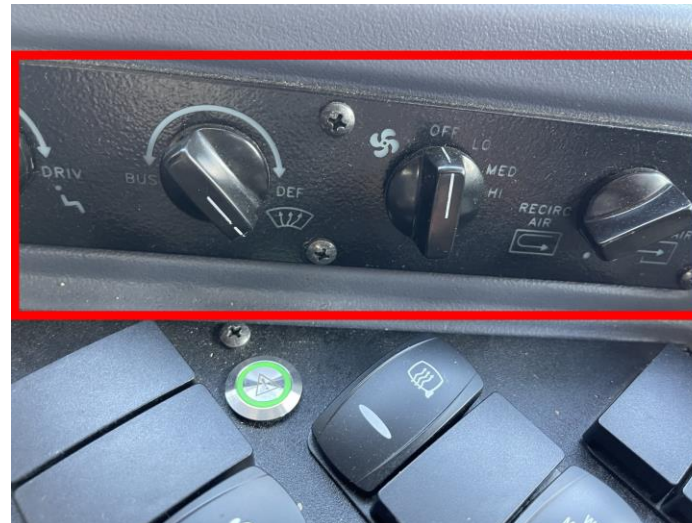
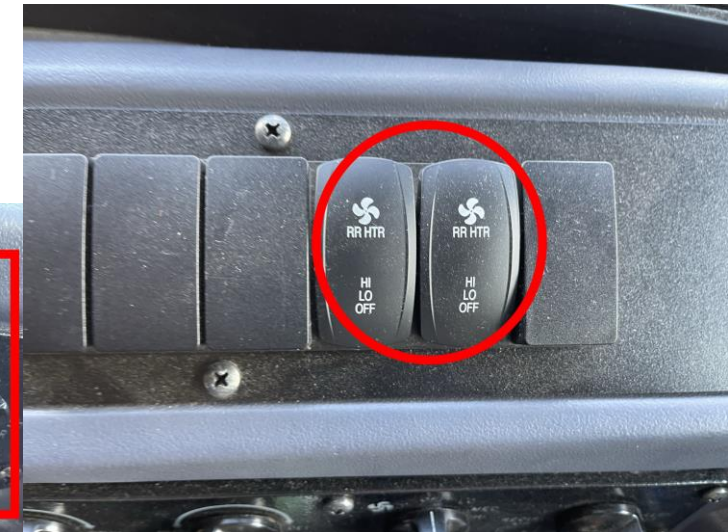
# Heater/Defroster/Fans

- **Heater** switch works properly when turned on.
  - You should hear heaters in the rear once turned on.
- **Defroster** is in working condition.
  - You can feel air flow once turned on.
- **Fans** are in working condition on each level.
  - There are no missing parts, and it is operable.

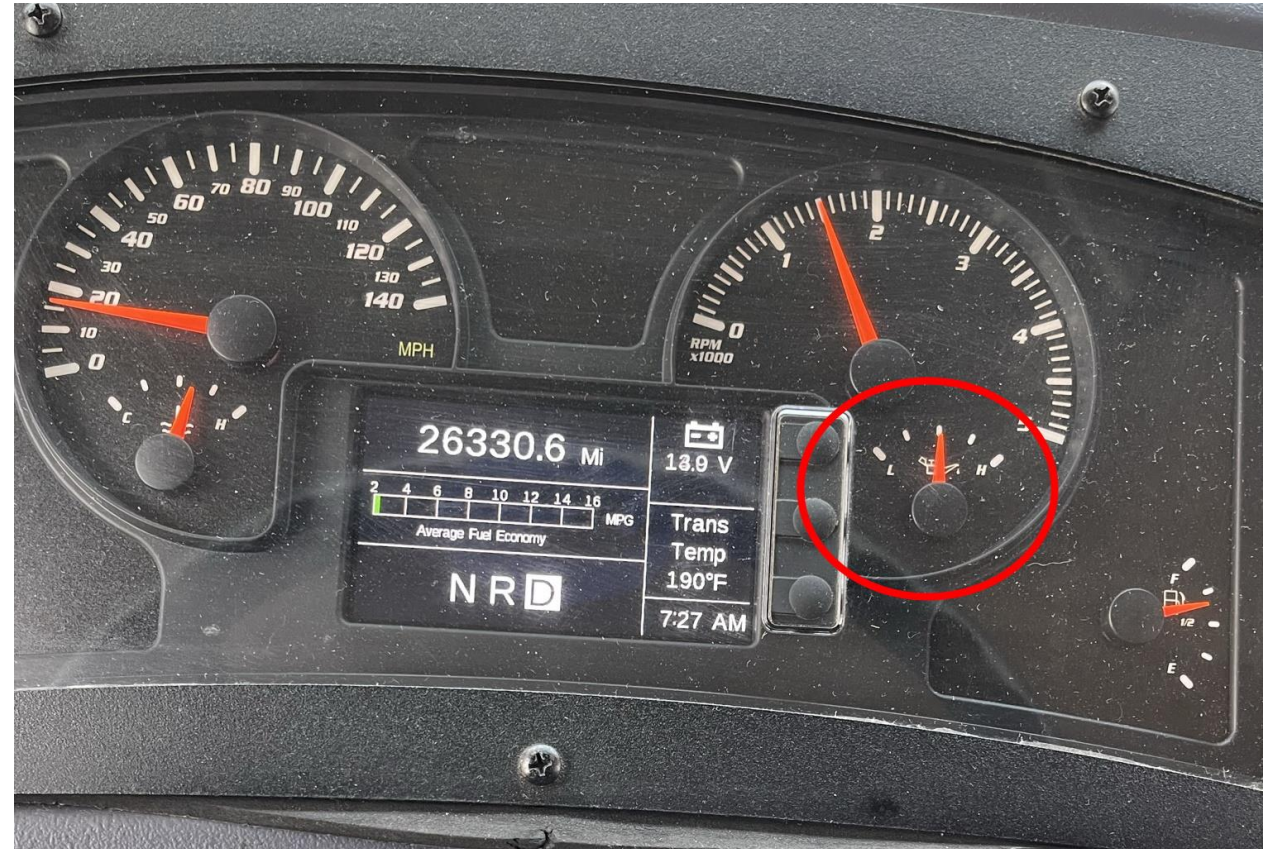
# Oil Pressure Gauge

- With the key on and the engine running, Oil pressure builds to normal level.
- Gauge will show increasing (normal) oil pressure.
  - Gauge should read in the 50 psi range.

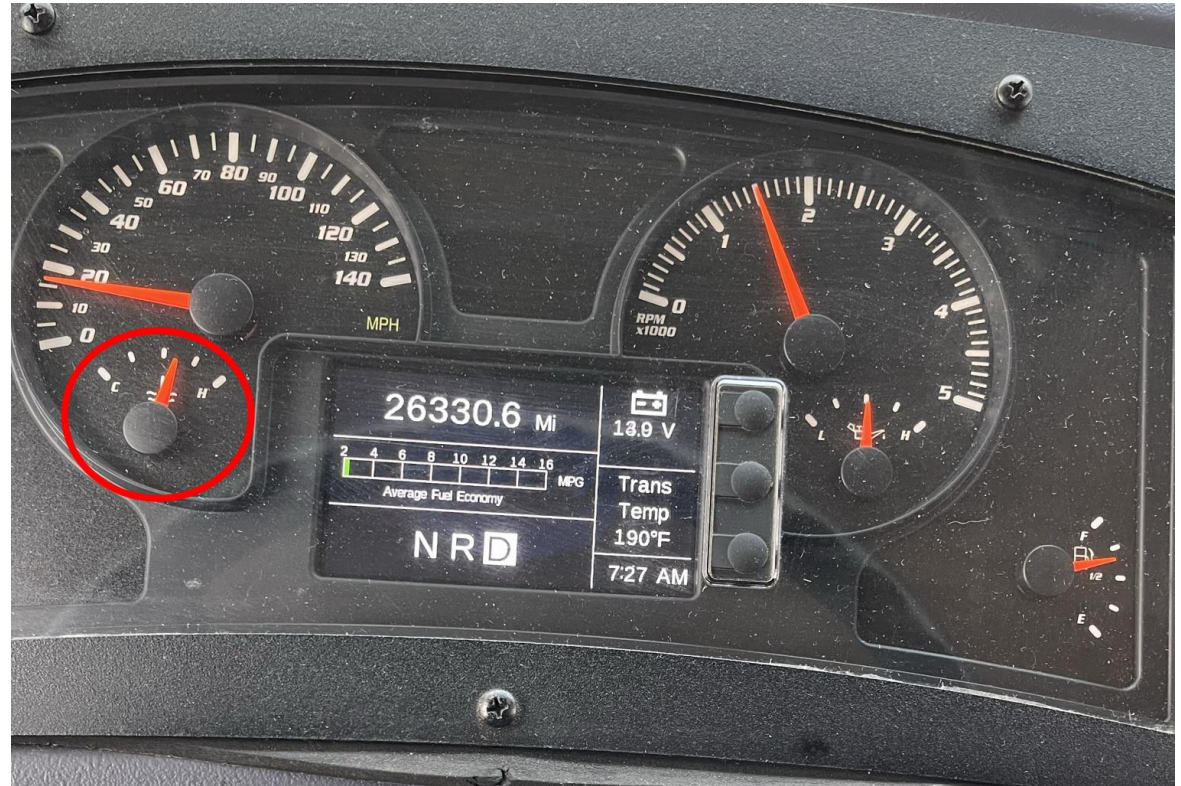
# Temperature Gauge

- Temperature Gauge is operating.
- With the engine running, the temperature will increase to normal temperature.

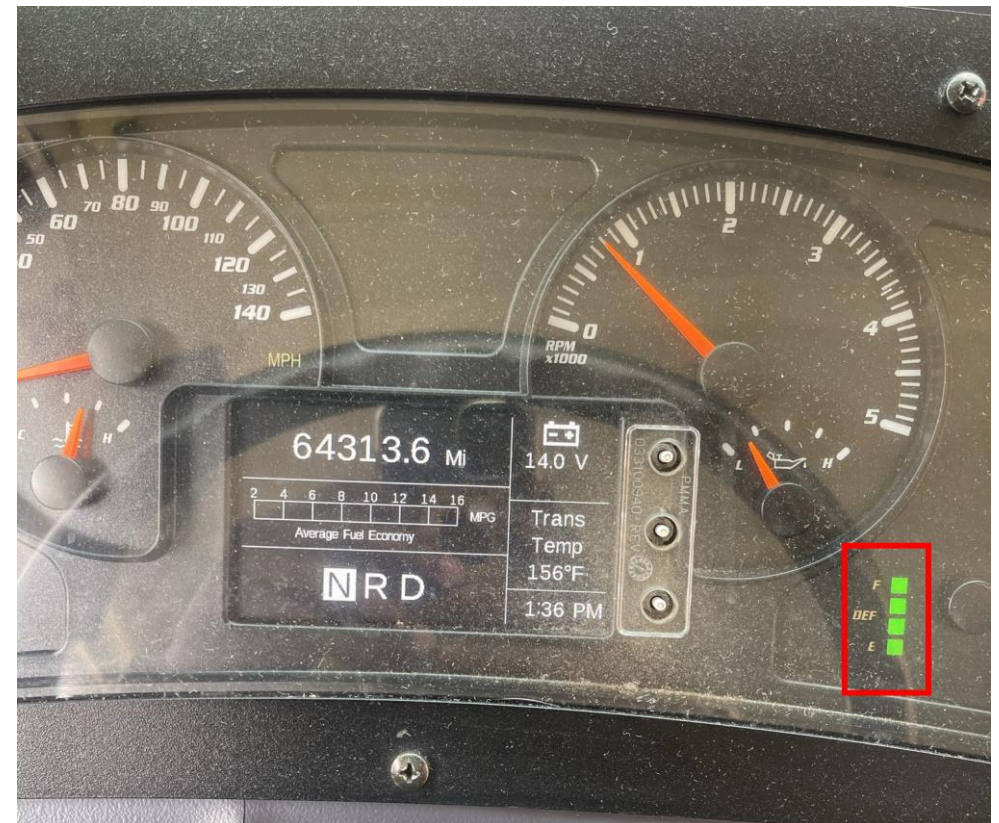
# DEF Guage (Diesel Exhaust Fluid)

- DEF reading are in working condition and has adequate levels of fluid.
  - Bus will become inoperable when DEF falls below safe operating levels.
  - DEF should be kept at 50% or higher.

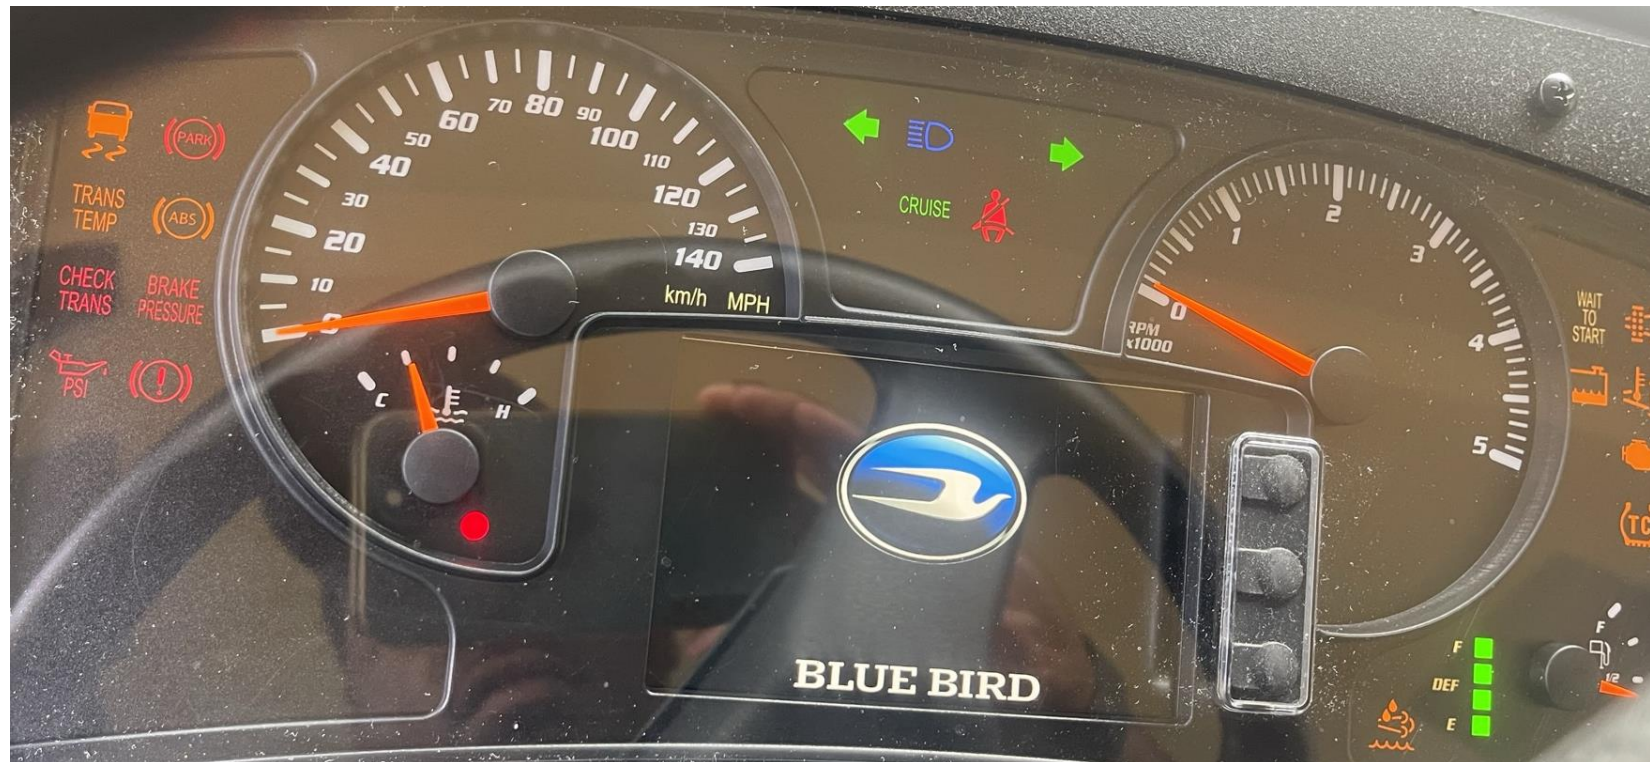
# Lighting Indicators

- Dash indicators illuminate correctly when corresponding lights are turned on.

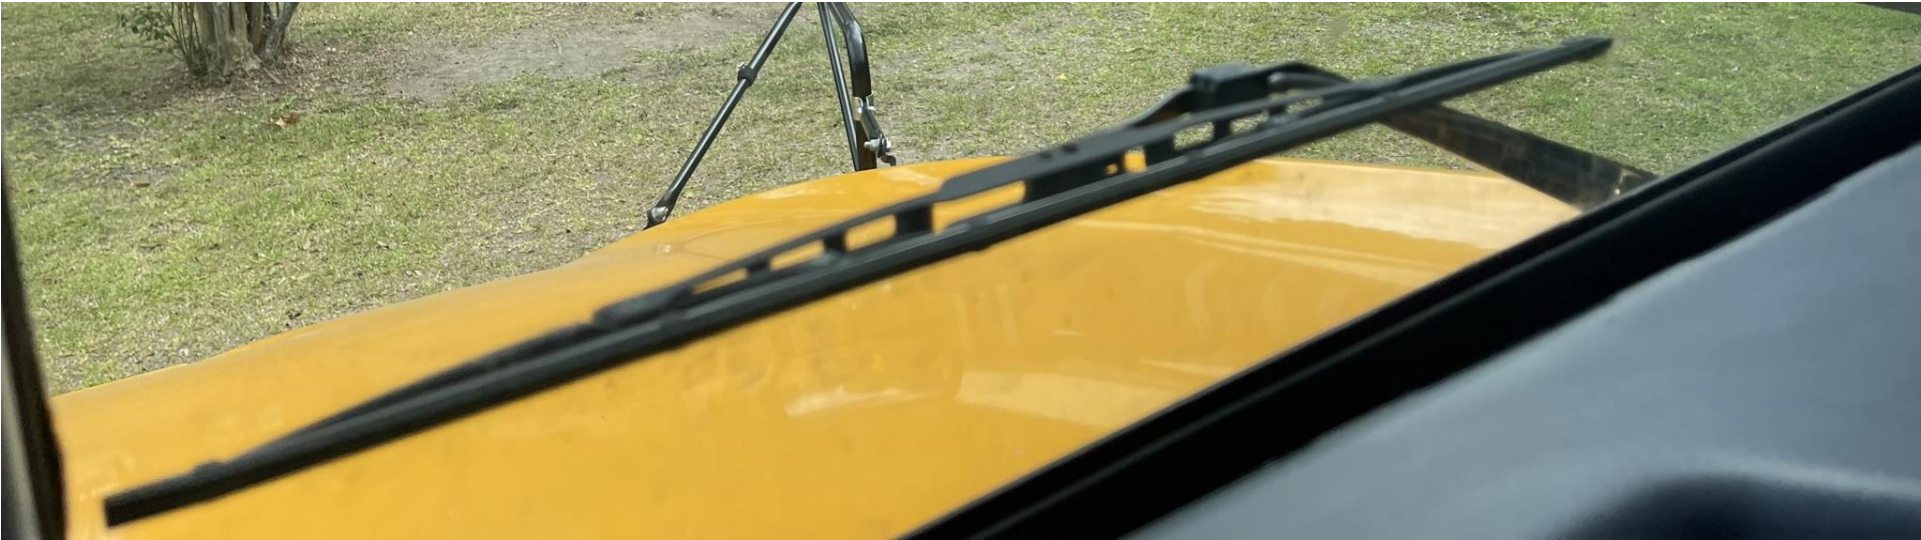
# Wipers

- Wipers and washers are in working condition.
  - Wipers operate properly at each level when turned on.

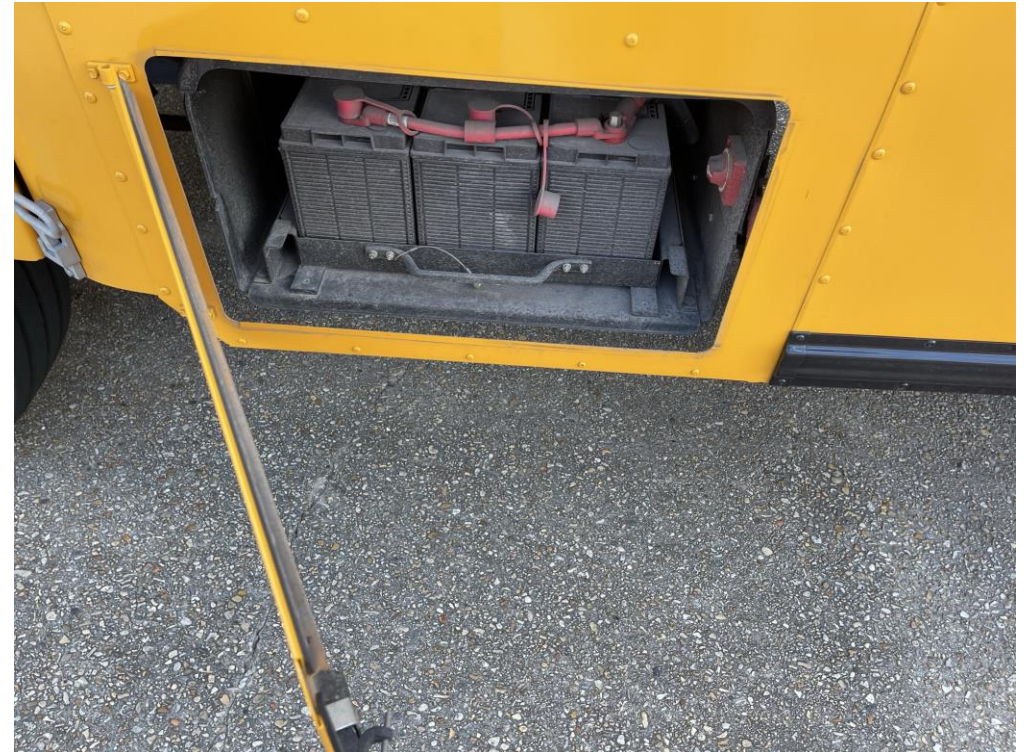
# Battery Box

- Batteries and wires are secure.
  - Wires are not cut, frayed, or torn.
- There is no excessive corrosion.
- Battery box is properly mounted and not missing any parts.
  - Latches are in working order.
  - Pull-out tray is in working order and free from obstruction.

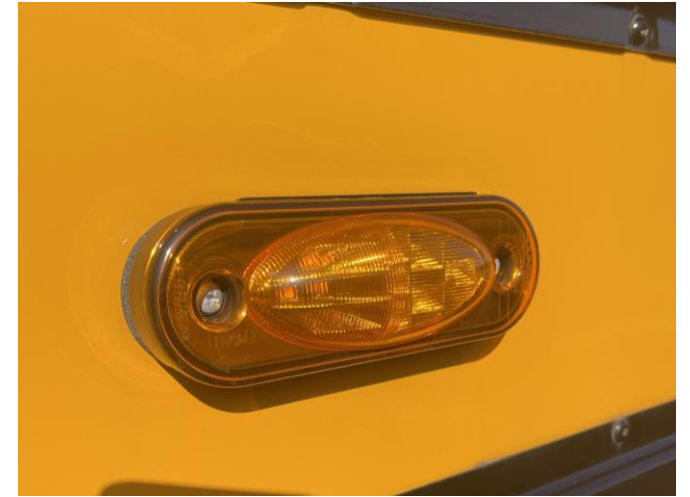
# Lights and Turn Signals/ Reflectors

- All lights are clean and not broken.  
(remember: red on rear and amber elsewhere.)
- Reflectors and reflector tape are clean, none or missing or broken, and they are the proper color.

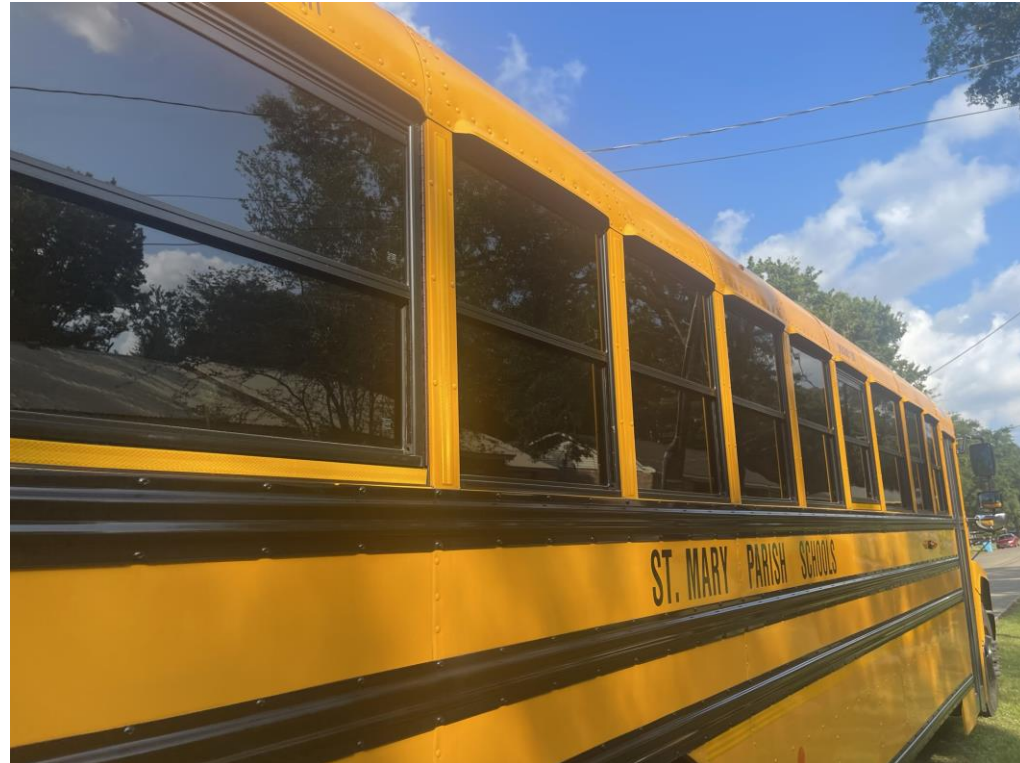
# Side Windows

- Side windows are clear and free of obstruction.
- Glass is in good condition, not cracked or broken.
- *No illegal stickers.*

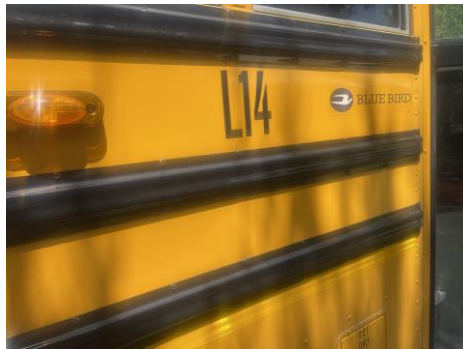
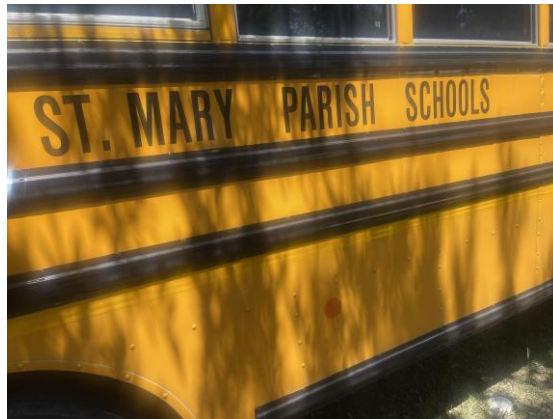
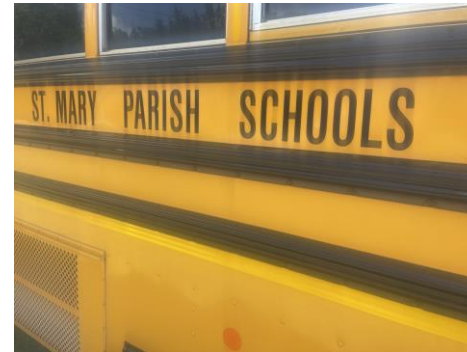
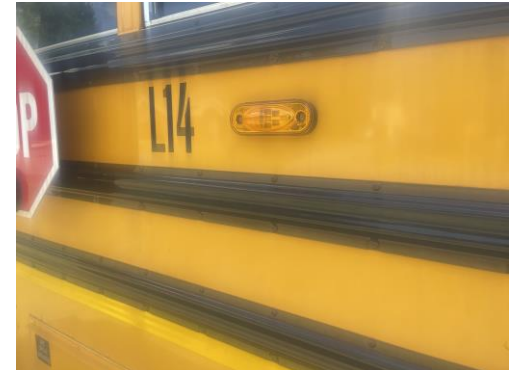
# Side Lettering & Student Decals

- Lettering is visible and not cracked or worn.
- Good in color and clean.

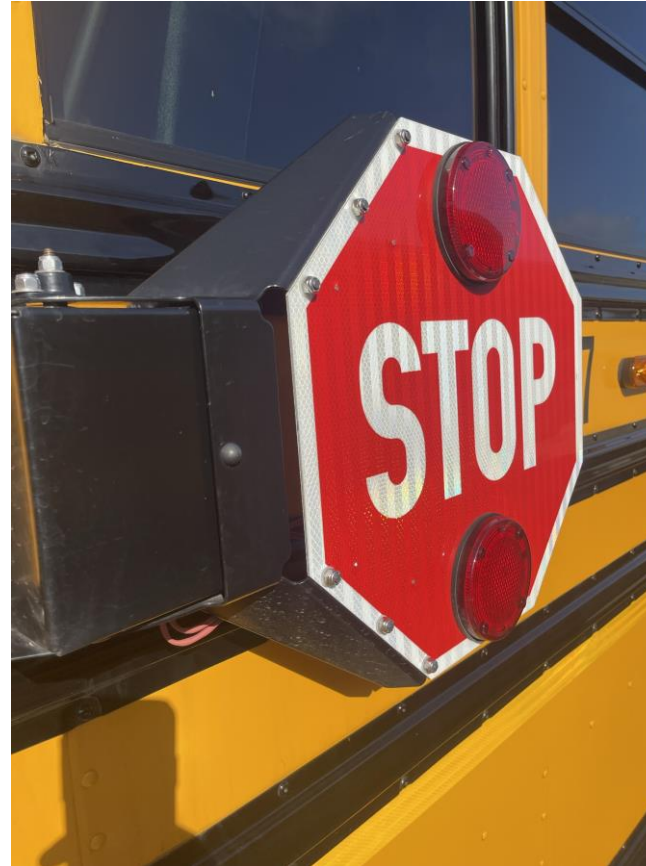
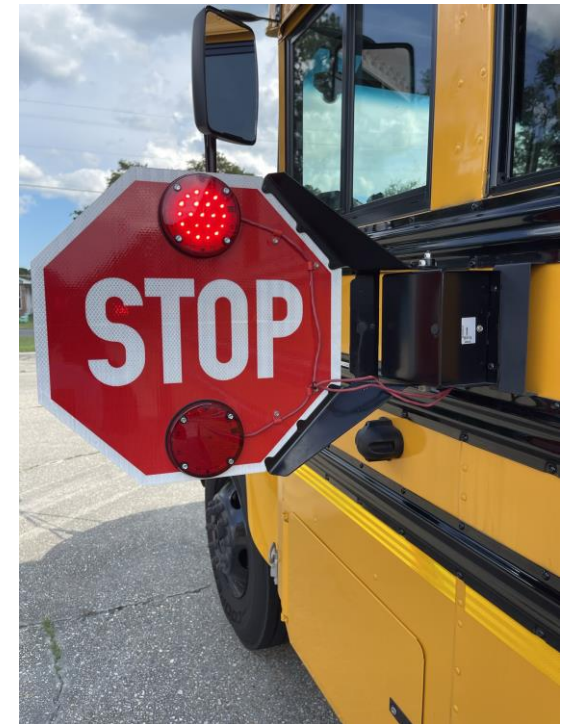
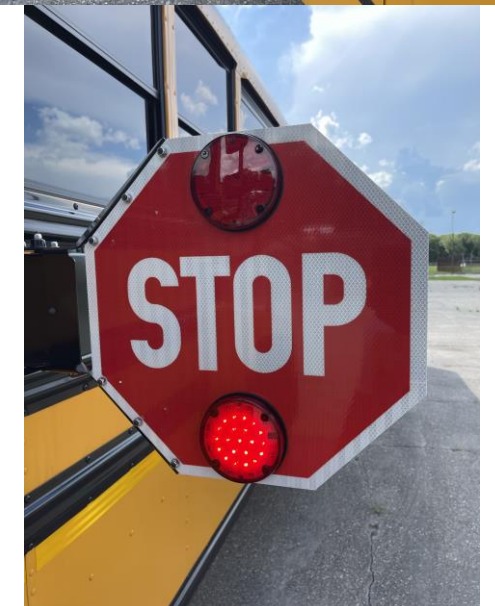
# Stop Signs

- Both stop signs are mounted securely.
- There are no loose fittings or damaged wires on either stop sign.
- Lenses are proper in color, clean, and not cracked or broken.

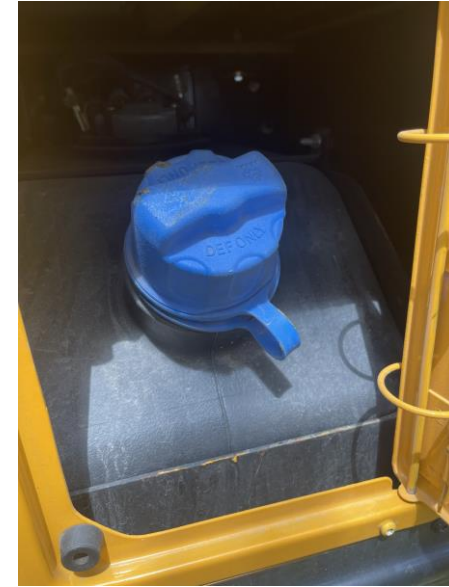
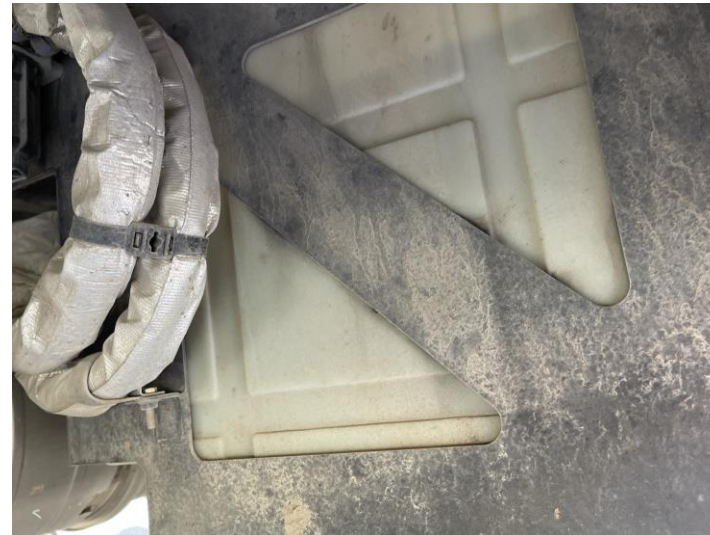
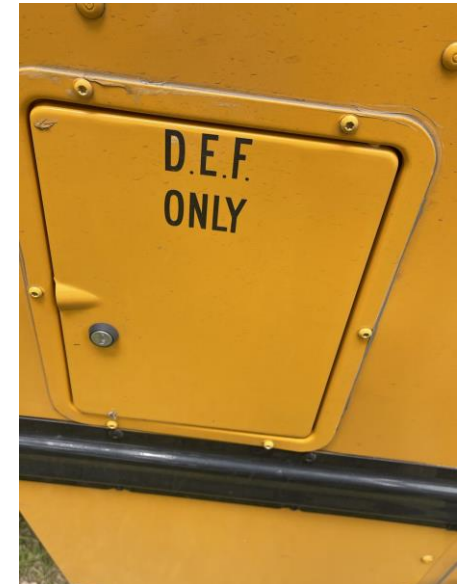
# DEF Cap and DEF Tank

- DEF tank is secure to the frame of the bus.
  - There are no cracks or leaks.
- DEF cap is tight and not leaking
- DEF door is not missing any hinges and is operational.

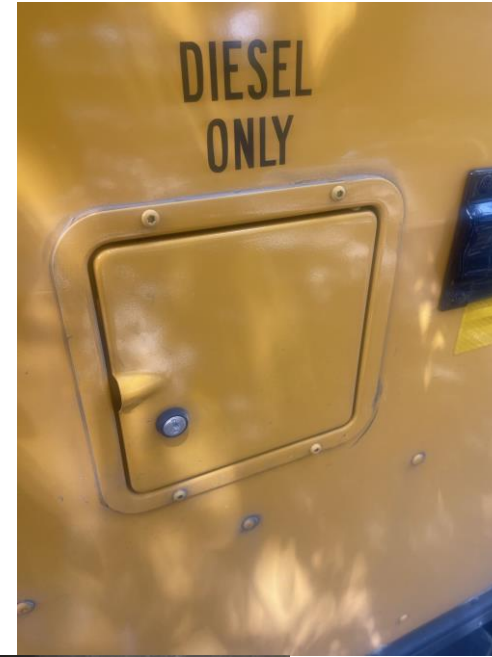
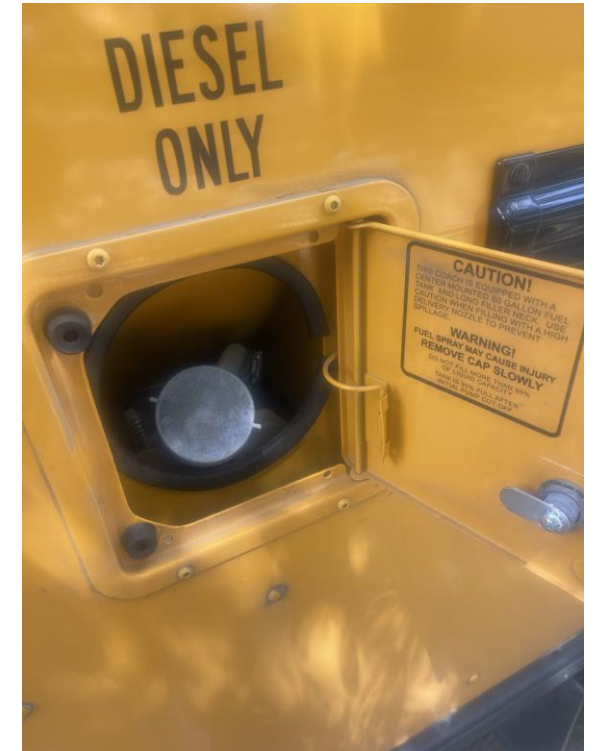
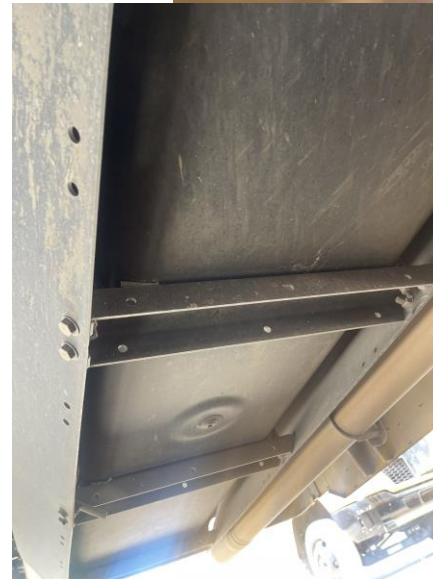
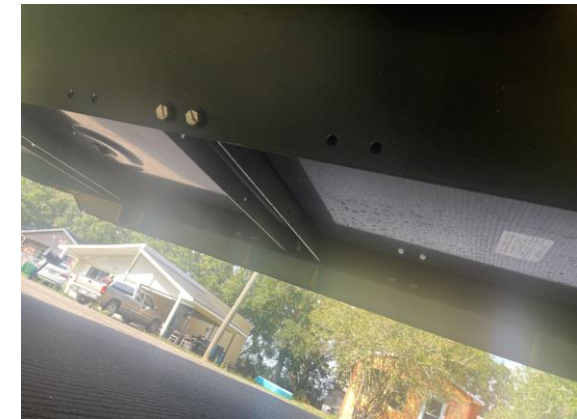
# Fuel Door/Tank

- Fuel tank is secured to the frame of the bus.
  - Not cracked or leaking.
- Fuel cap is tight and not leaking
- Fuel door has no missing hinges and is operational.

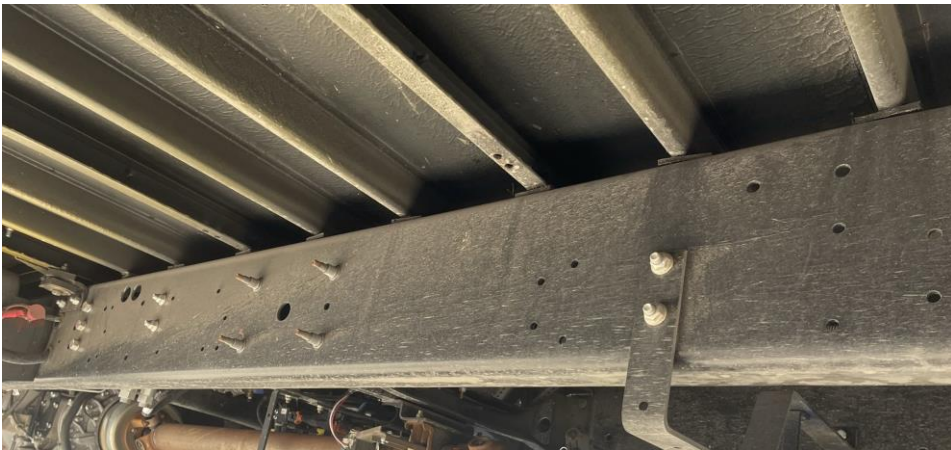
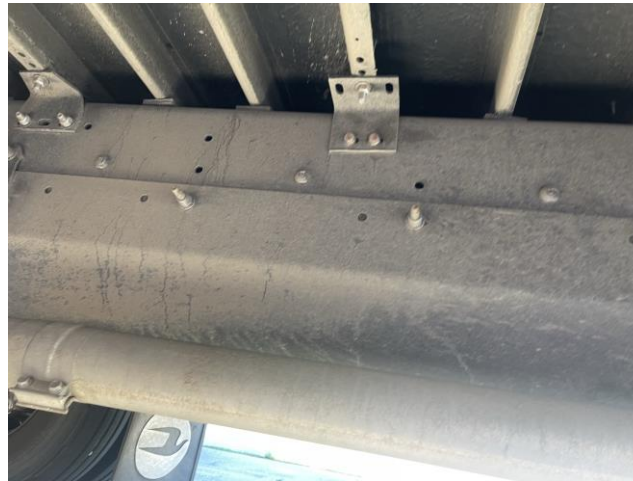
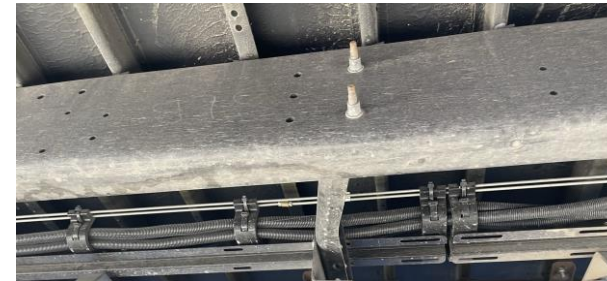
# Frame

- There are no cracks or bends in the longitude frame.
- Cross members are not loose, cracked, bent, or broken.
- No breaks or holes in the floor.
- Frame is straight and extends to rear of bus.

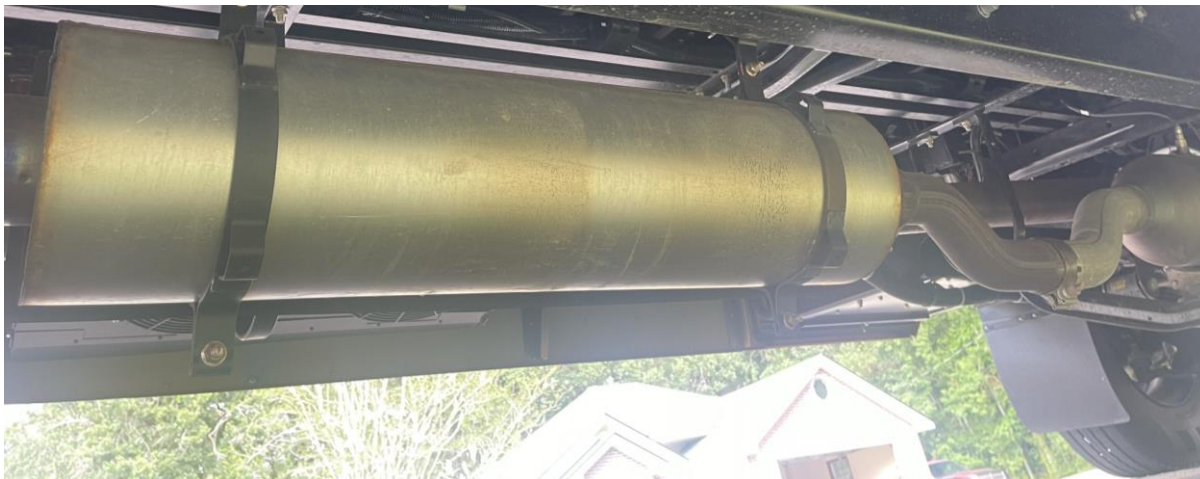
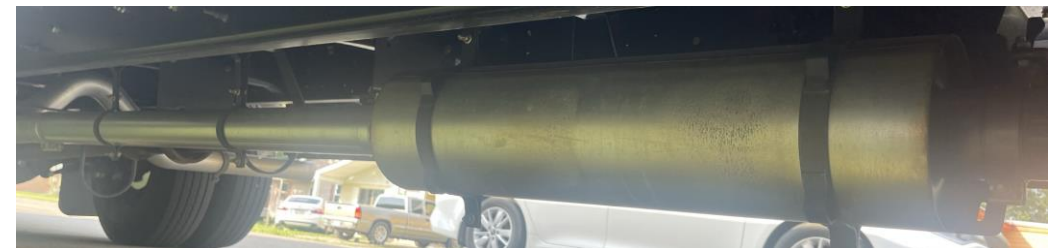
# Exhaust

- Exhaust system is connected tightly, mounted securely, and there are no loose clamps.
- There is no damage or signs of leaking.
  - There is no excessive carbon soot.
  - There is no rust.
- No cracks, holes, or severe dents.
- Exhaust extends to the rear of the bus.

Some buses are equipped with tailpipes that extend to the middle of the bus while others extend to the rear.

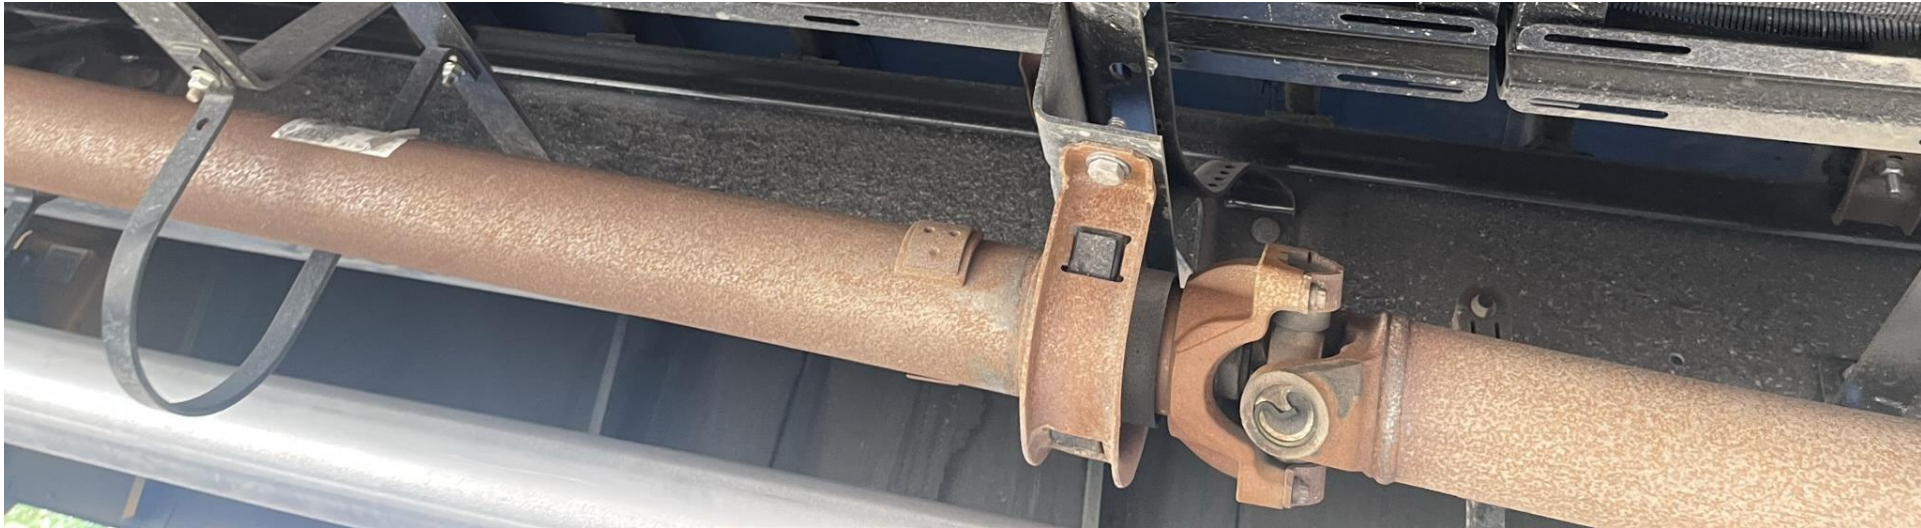
# Drive Shaft

- Drive shaft is not bent, twisted, or cracked.
- U-joints are secure and free of foreign objects.
  - Shaft is not resting on any hangers.
  - Hangers are properly mounted and missing any parts.

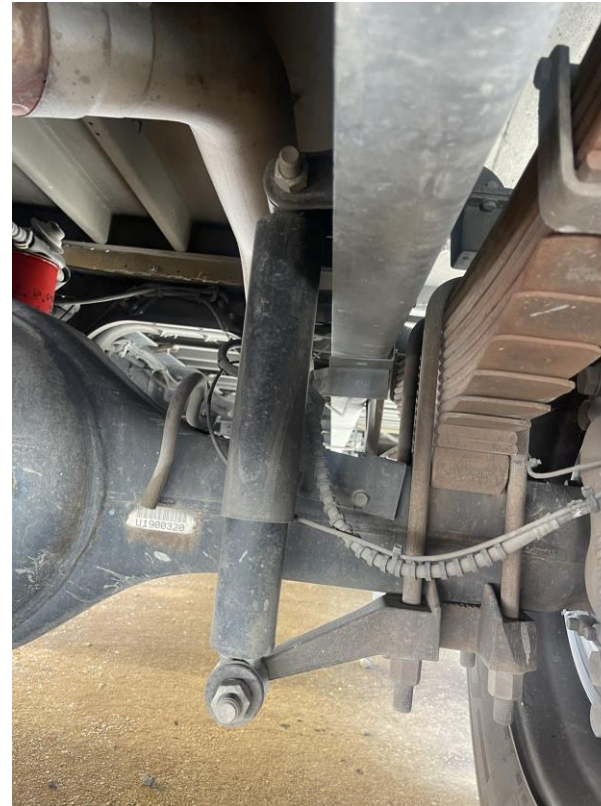
# Rear Shock Absorbers

- Shock Absorber is securely mounted to the frame of the bus and is not leaking.
- In good condition and not missing any parts.
- Absorber is not leaking.

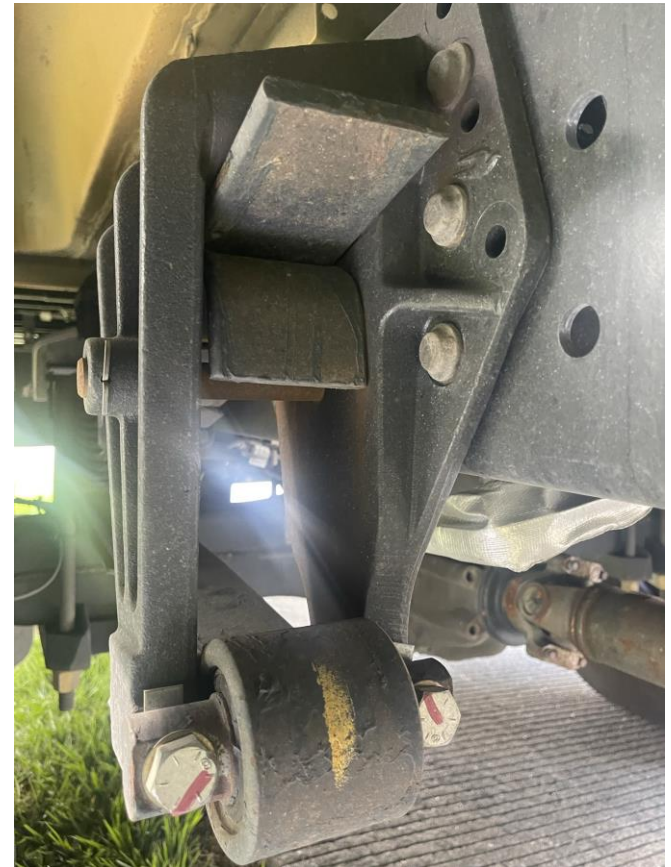
# Torque Spring

- There are no missing parts on the torque spring and is not cracked or damaged.
- Bushings are present and not damaged.
- Torque Spring is mounted properly.
