# SCHOOL BUS PRE-TRIP INSPECTION VISUAL GUIDE

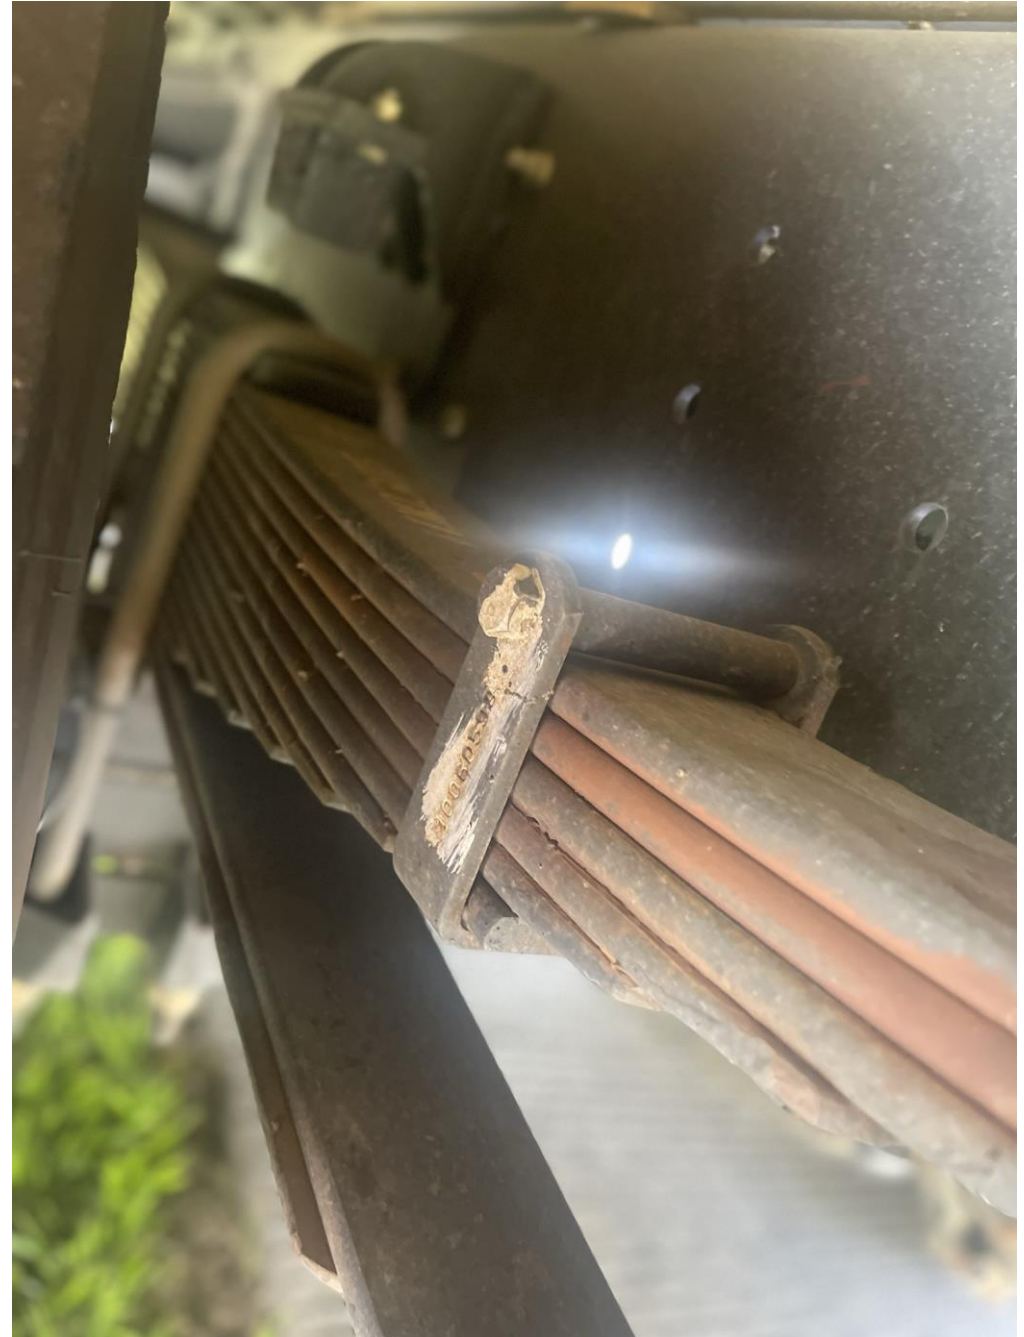
# Leaf Spring

- Ling Spring links are not missing, cracked, or shifted.
- There are no broken leaf springs.

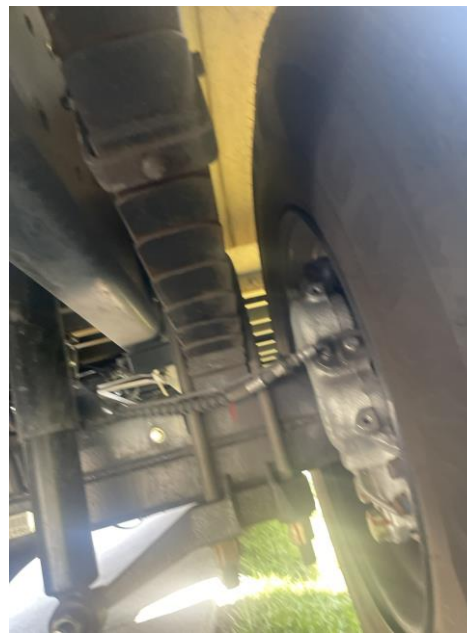
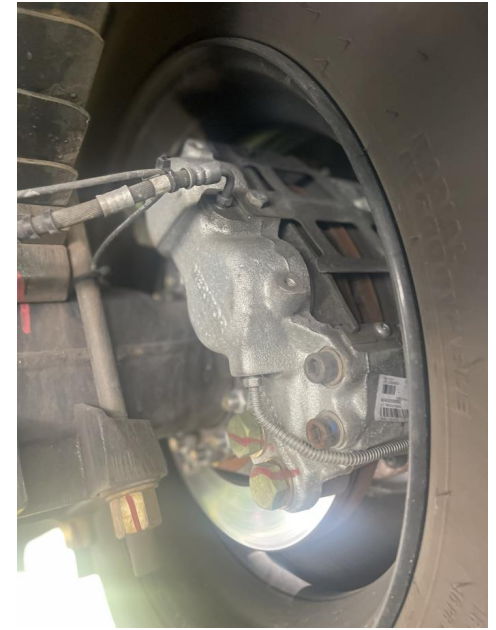
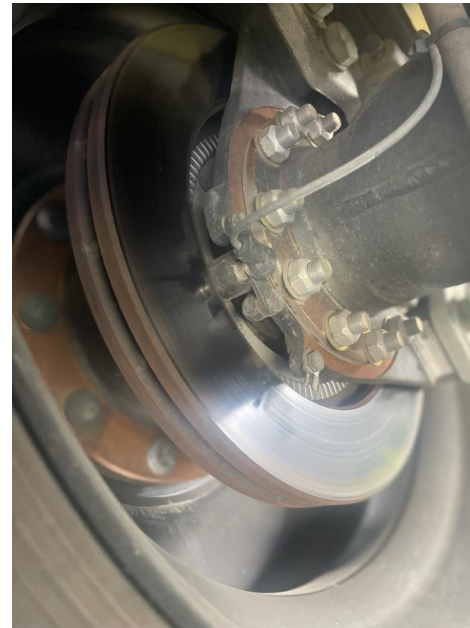
# Brake Lines/ABS

- Lines are not cut frayed or torn.
- Supplies Hydraulic Fluid to brakes.
- Hoses are in good condition and not cracked worn or frayed.
- There are no leaks
- Couplings and fittings are secure.

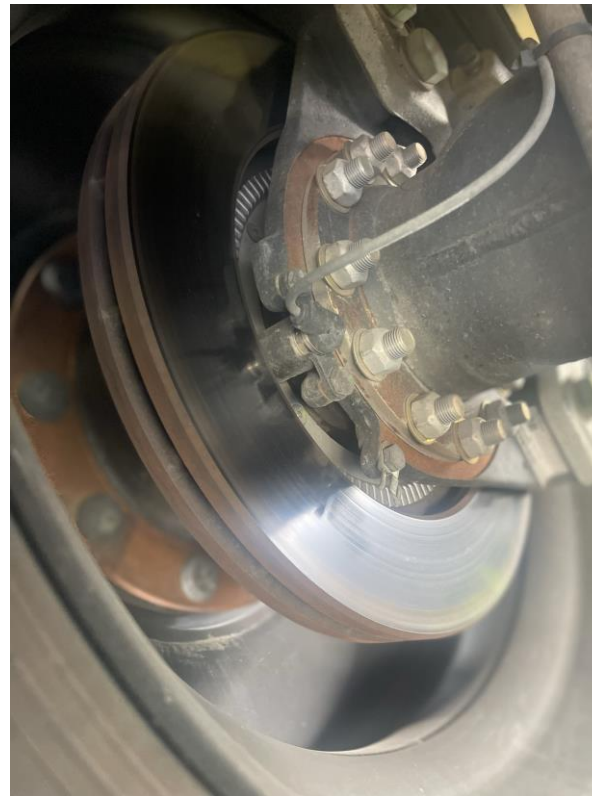
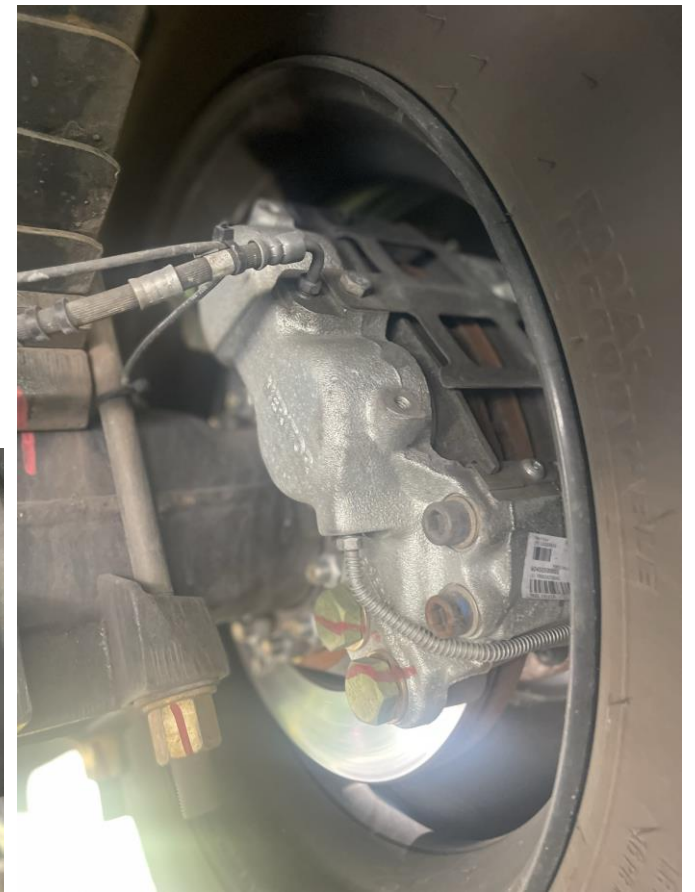
# Brake Discs and Lining

- Brake discs are not cracked, bent, or broken.
  - There are no dents or holes.
- Brake pads are in good condition and not worn dangerously thin.
- Brake caliper is securely mounted and in good condition.

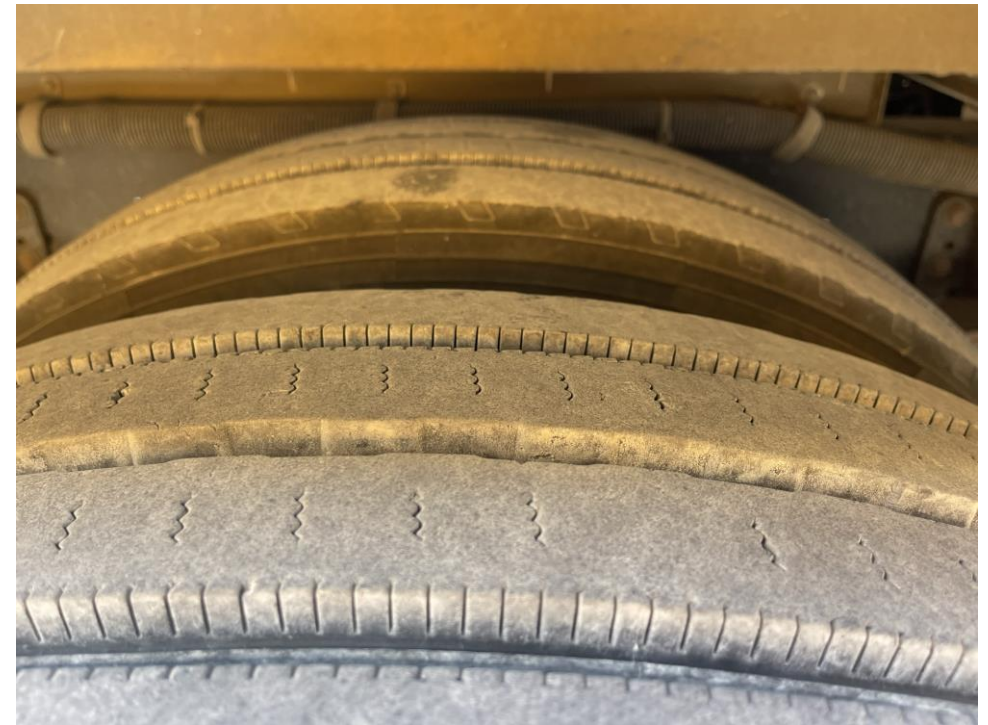
# Rear Tires (ICD)

- **Inflation:** The tire is properly inflated, and you would check for proper inflation with a commercial tire gauge.
- **Condition:**
  - Outside face of the Front tire is in good condition.
  - There are no cut or tears.
  - Inside face of the tire is in good condition and there are no cuts or tears.
- **Depth:** Tire tread is evenly worn across and there is a minimum of 2/32 of tread depth.

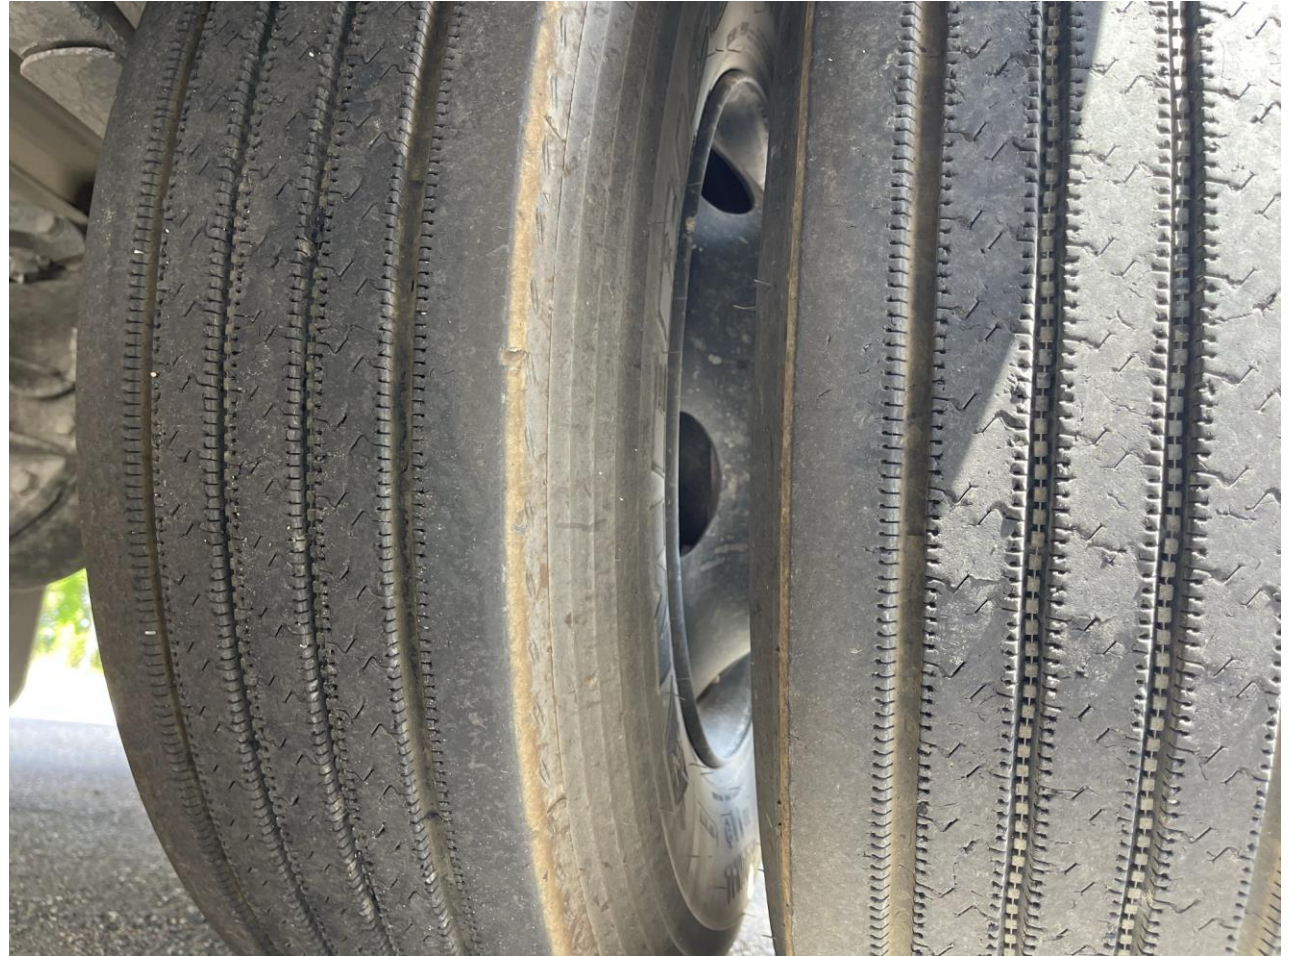
# Spacers

- Spaces are even between rear tires.
- There is no damage or foreign objects in between.

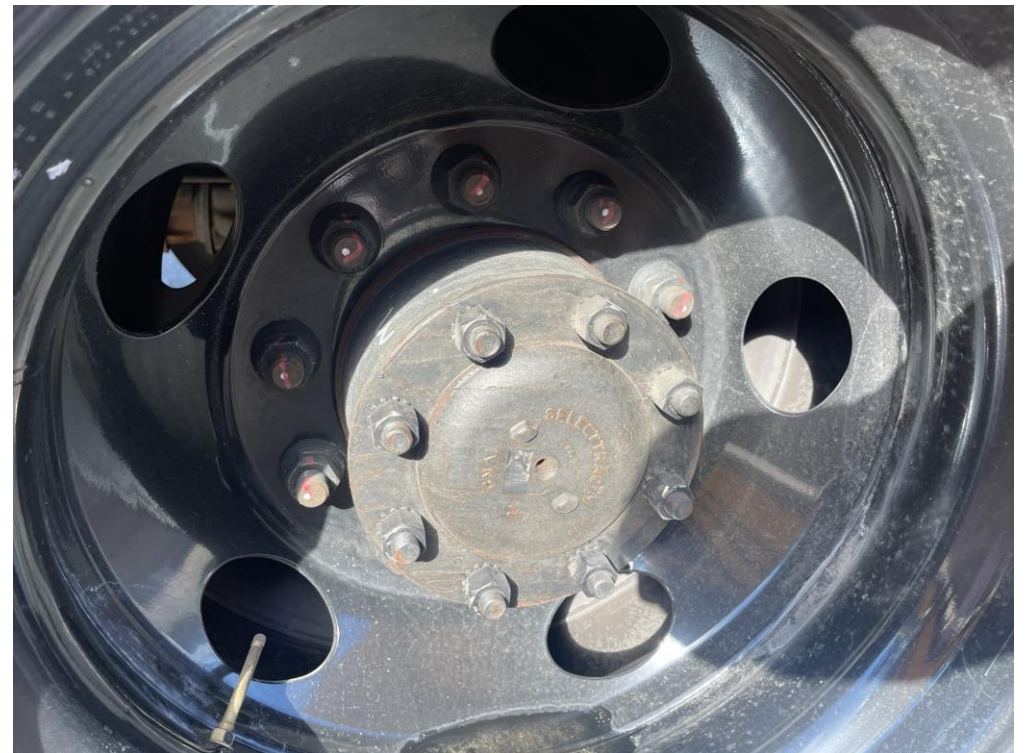
# Rims (rear)

- Not damaged or bent.
- There are no rust trails that may indicate the rim is loose on the wheel.
- There are no illegal welds.

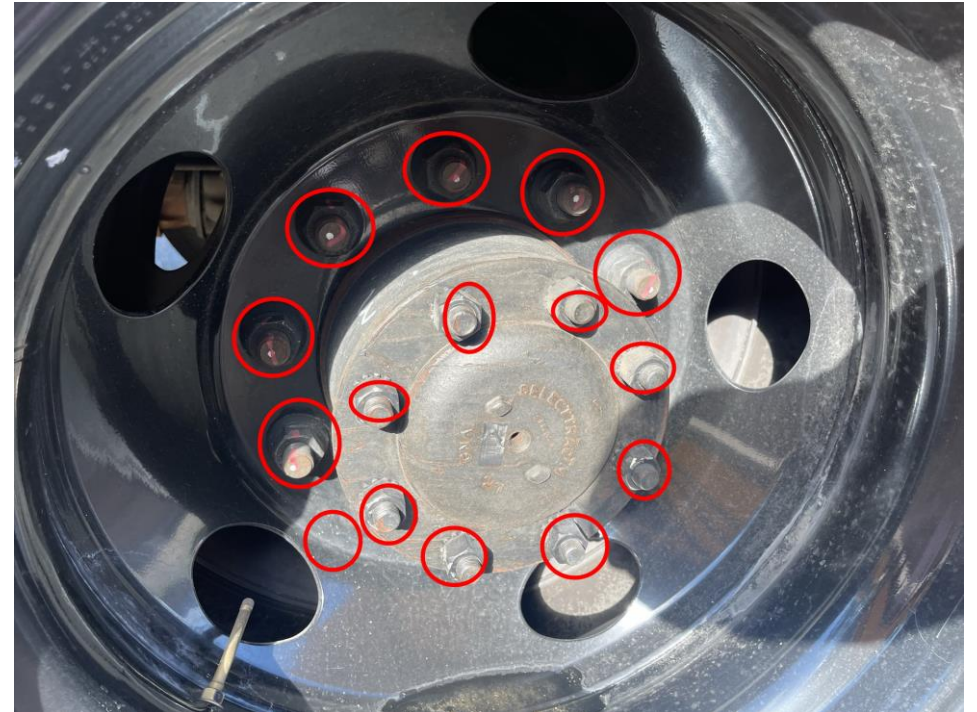
# Lug nuts

- Hub oil seal is securely mounted to the rim.
  - Seal is not leaking and has adequate fluid.
- Lug Nuts
  - All lug nuts are present.
  - Lugs are not loose.
  - There are no receding cracks around lug bolt holes.

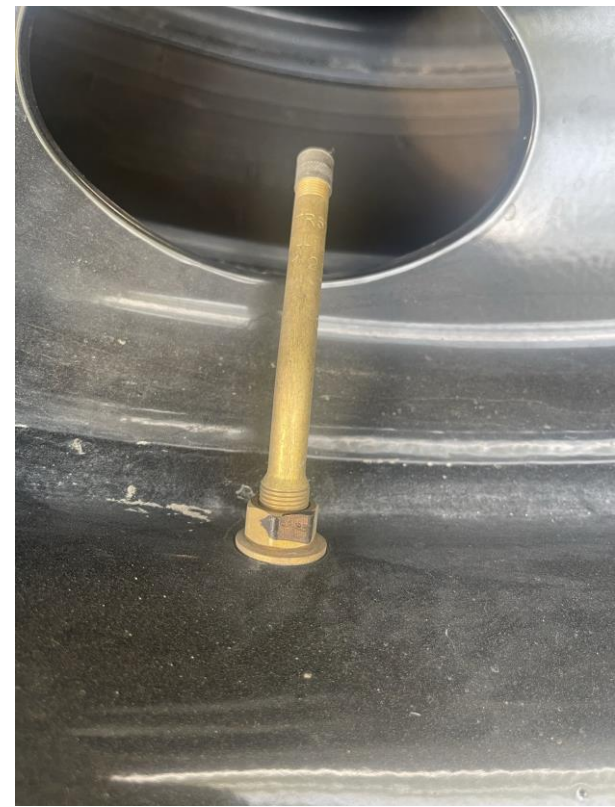
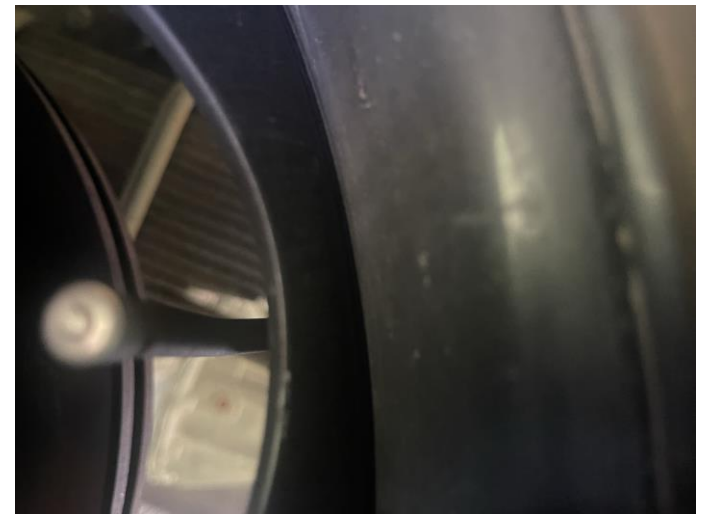
# Valve Stem

- Valve stem is straight and has cap.
  - Stem is not leaking , bent or broken.
- On rear tires there are two.
- Both are accessible.

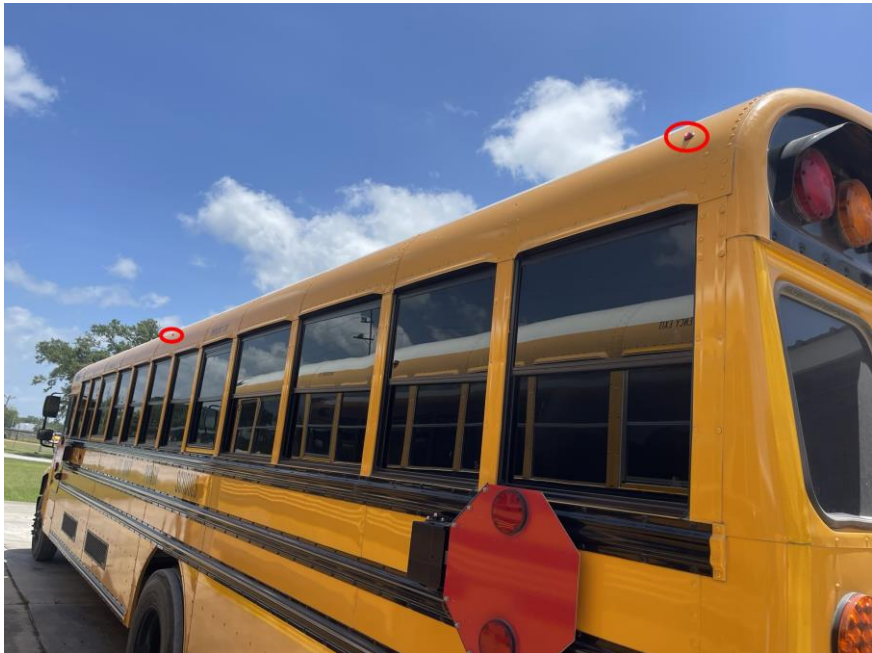
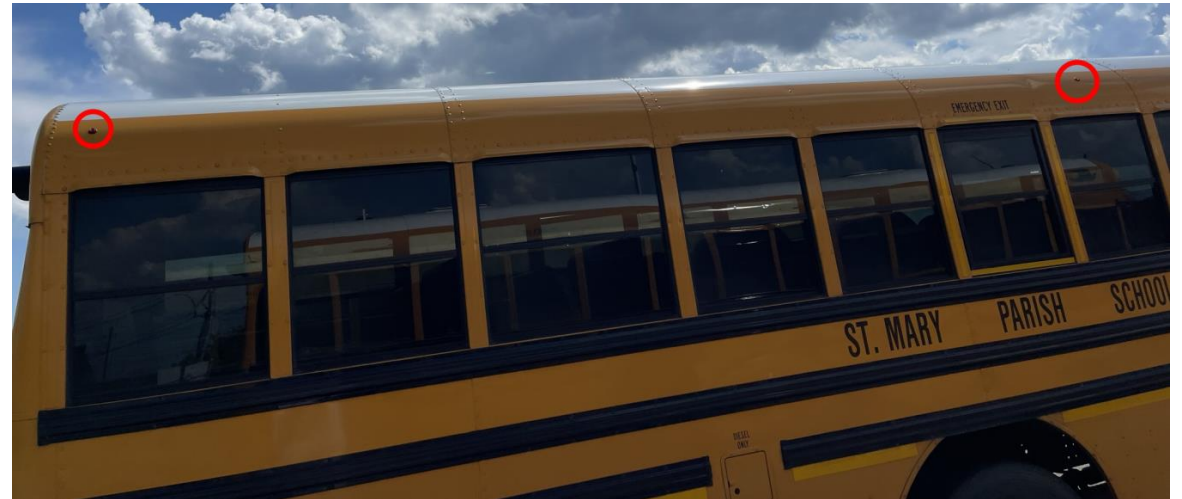
# Side Lights Operation

- Side clearance lights are operational.
  - Good in color and not cracked or broken.
- (amber in color to middle of bus, red on everything else.)*

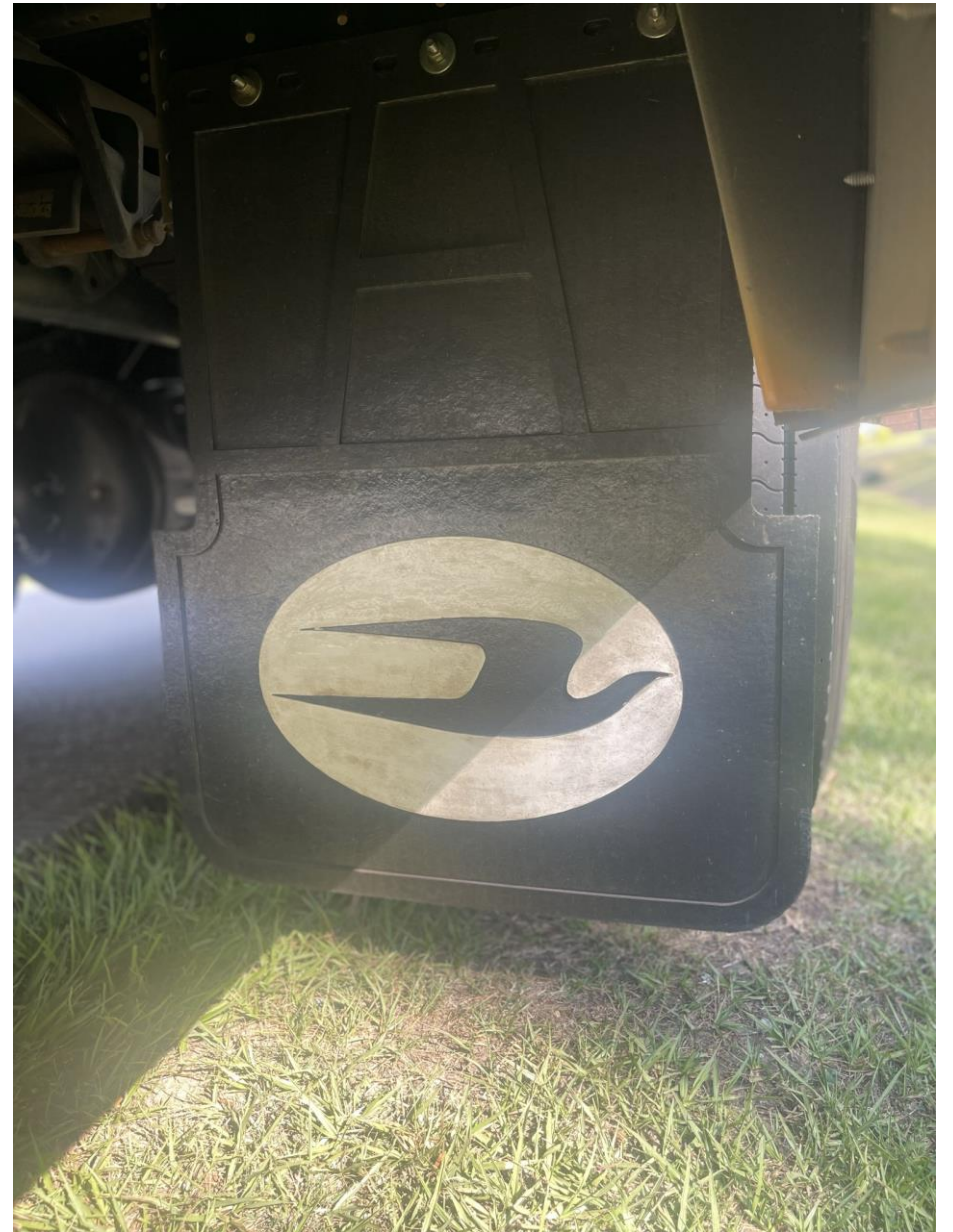
# Splash Guards (Mud Flaps)

- Mud flaps are not missing any parts.
- Flaps are not damaged and are mounted securely.

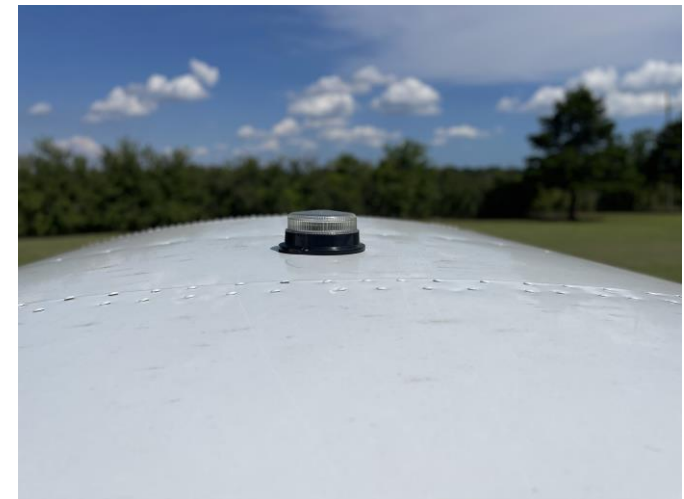
# Strobe

- Strobe light is mounted properly and not broken.
  - Some of our buses are equipped with cages over strobe lights.
  - Those with strobe brush guard: brush guard is properly mounted and securely protects strobe light.

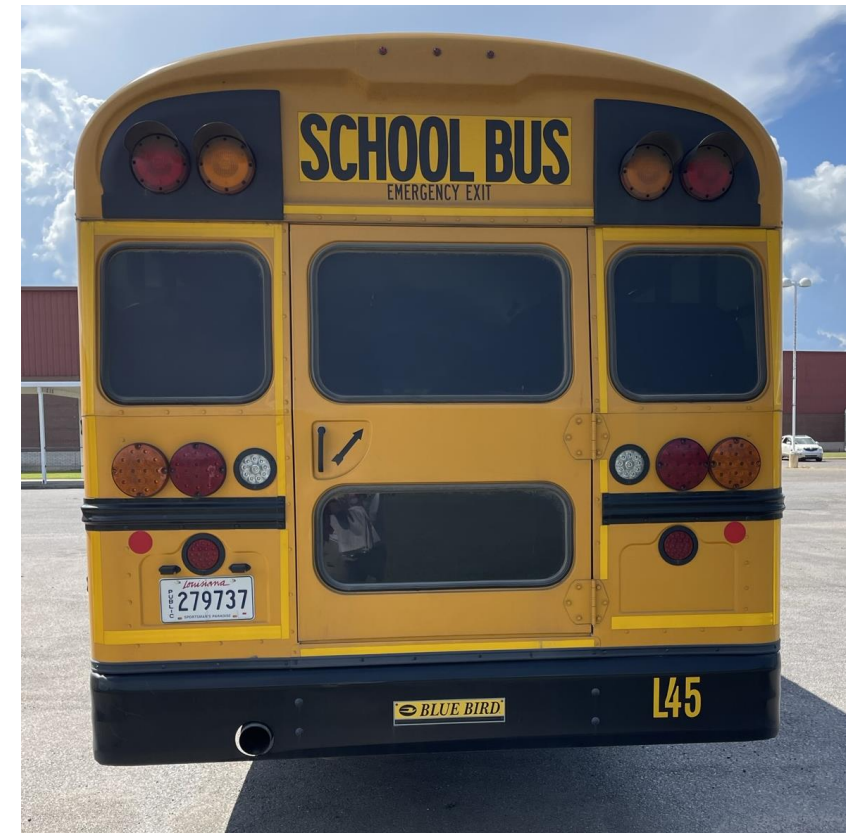
# Rear

- Clearance lights are red in color and not cracked or broken.
- School bus decal is visible and not worn or torn.
- Rear windows are good to see through and not cracked or broken.
- Warning Lights are good in color and not cracked or broken.
- Student decals are good in color and there are no cuts frays or tears.

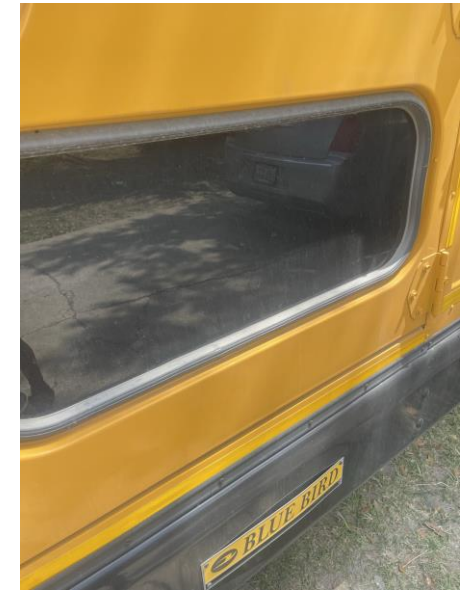
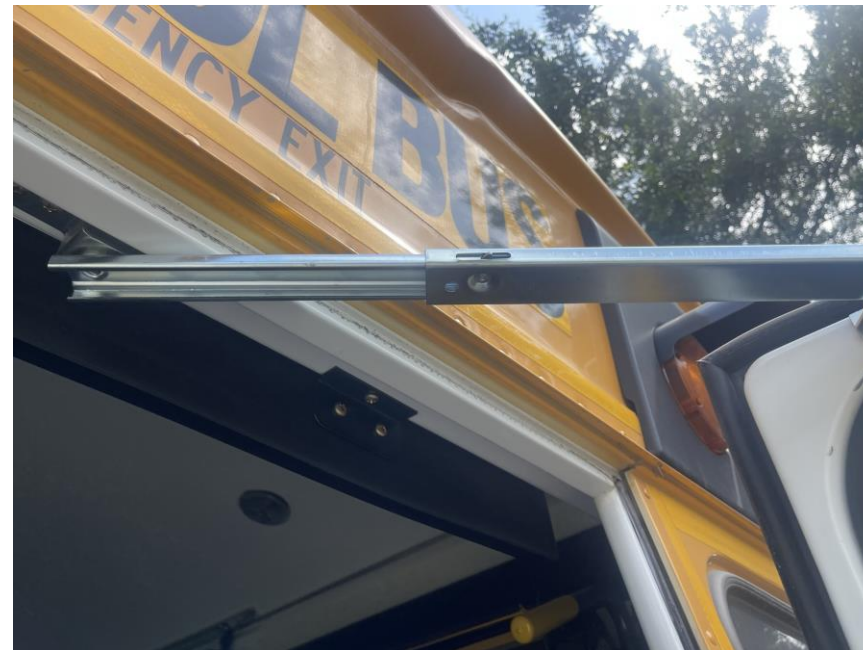
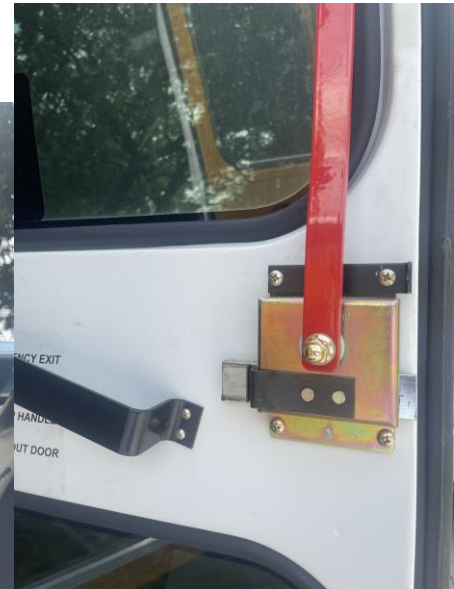
# Rear Emergency Door

- Door is not damaged and opens and closes properly.
- Window is not cracked or broken, and the glass is clean.
- Hinges are secure and seals are intact.
- Door holder locks in place and unlocks properly.

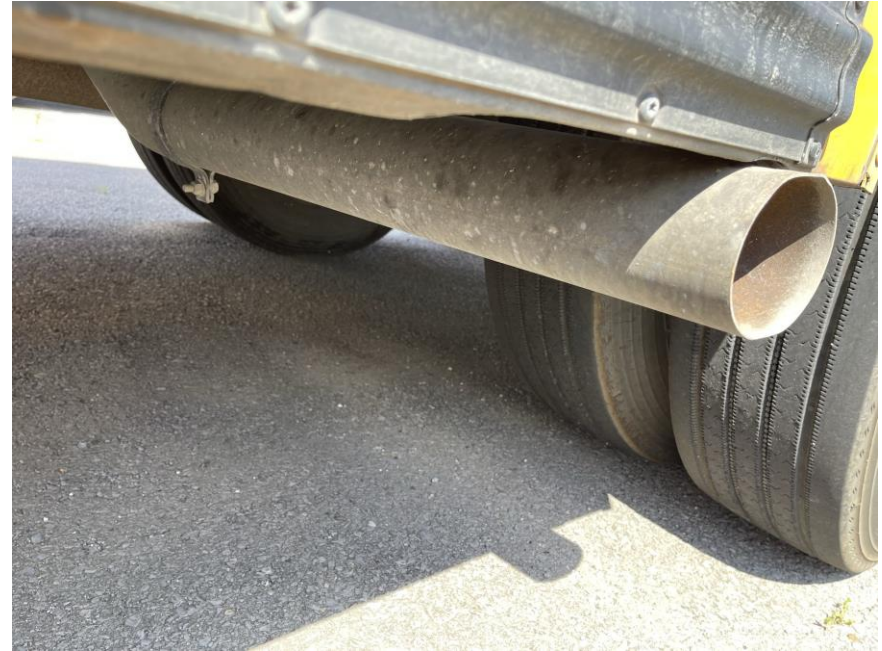
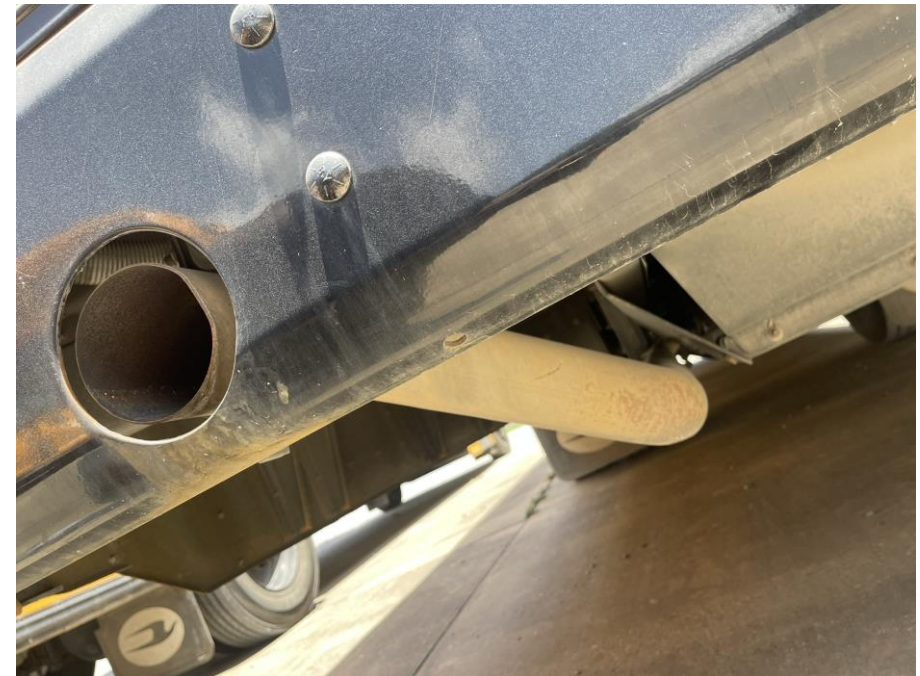
# Tailpipe

- Exhaust extends to the rear of the bus and on some buses, the tailpipe extends to the side of the bus.
- There are no obstructions inside and the tailpipe is not resting on any hangers.

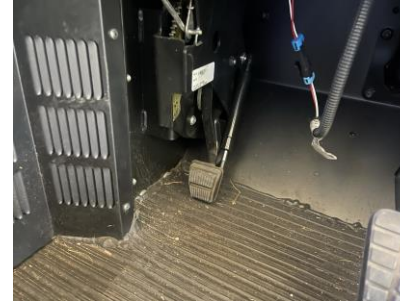
Brake Applied

- To set parking brake:  
Push down lever with left foot until pushed all the way forward.

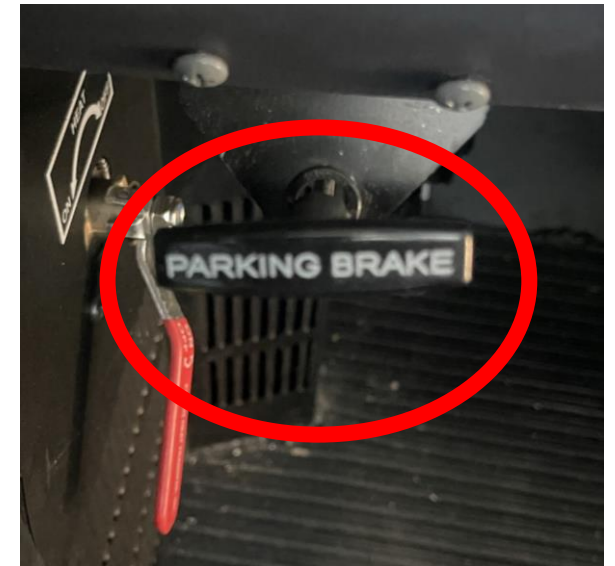
Brake Released

- To turn off parking brake:  
With service brake applied, pull Parking Brake release handle

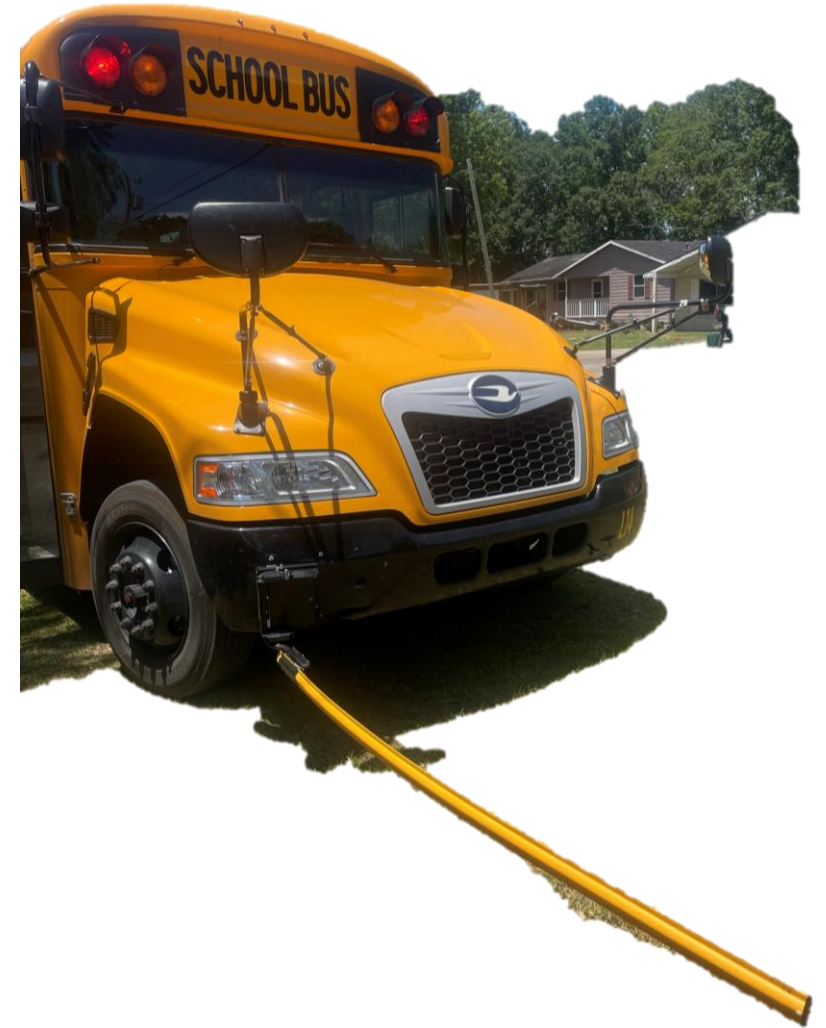
# Front Crossing Arm

- Stop Arm is fully extended and is operational.
  - There are no missing parts
  - Arm is straight and not bent or broken.
