July 9, 2024  
15.0166500.49

Re: Wetland Assessment and Delineation Letter Report  
Map 19, Lot 141 & Map 24, Lot 15, College Highway  
Southampton, MA

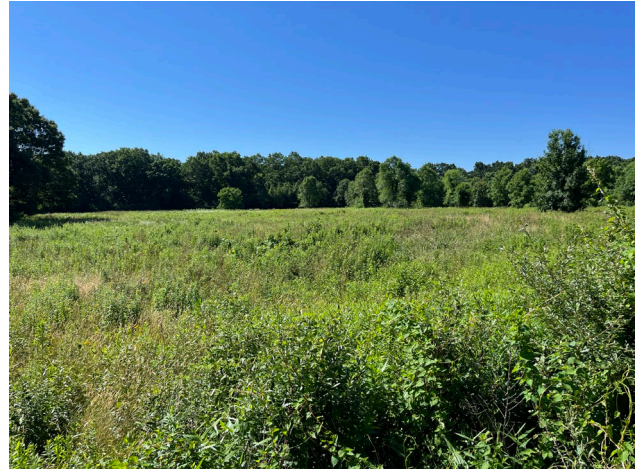
The Site consists of two lots. The northern portion of the Map 19, Lot 141 section generally consists of open fields that appear to be transitioning to shrub communities. The southern portion of that lot consists of a mature forest community and borders on a railroad right-of-way. A review of the MassMapper online portal indicated that there are no previously identified wetland resources present within this lot.

Figure 2: A typical view of the field portion of Map 19, Lot 141.

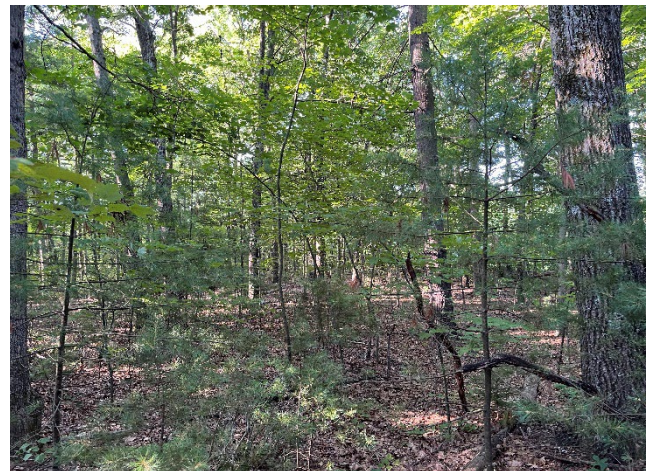
The portion of the Site located at Map 24, Lot 15 consists of a mature forest community with tree, shrub, and groundcover species including red oak, red maple, white oak (*Quercus alba*), sugar maple (*Acer saccharum*), black birch (*Betula lenta*), witch hazel (*Hamamelis virginiana*), white pine (*Pinus strobus*), lowbush blueberry (*Vaccinium angustifolium*), Pennsylvania sedge (*Carex pensylvanica*), mountain laurel (*Kalmia latifolia*), striped wintergreen (*Chimaphila maculate*), bracken fern (*Pteridium aquilinum*), and swallowwort (*Vincetoxicum sp.*). The topography is relatively flat in the central and northern portion of the property and slopes down at the southern end of the property. A review of the MassMapper online portal also indicated that there are no previously identified wetland resources present within this lot.

Figure 3: A typical view of Map 24, Lot 15.

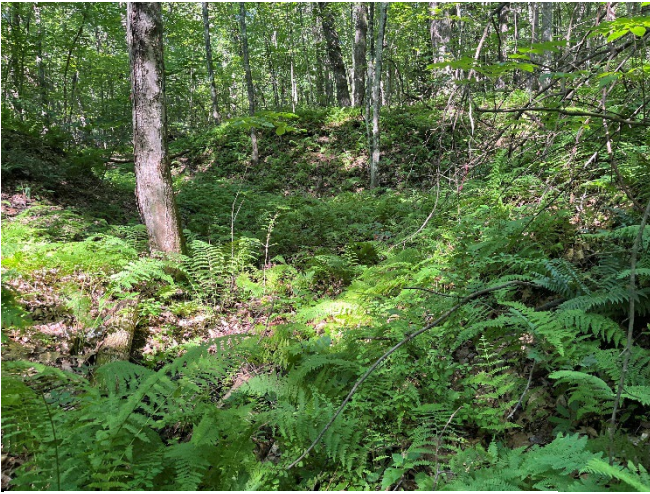
The A series wetland flags demarcate a BVW located near the railroad right-of-way (ROW) located in the eastern portion of the Site. The delineated BVW was observed to border on a granite block culvert that is assumed to convey flow under the railroad ROW and would qualify as a Bank resource. The Bank connects to an off-site wetland complex to the east. The predominant wetland vegetation was sparsely arranged and included wild raisin (*Viburnum cassinoides*), sensitive fern (*Onoclea sensibilis*), and cinnamon fern (*Osmundastrum cinnamomeum*). The wetland soils were observed to have hydric characteristics including a reduced soil matrix with obvious redoximorphic features that indicates periods of saturation within the upper part of the soil strata.

Figure 5: View of the A series BVW facing south.

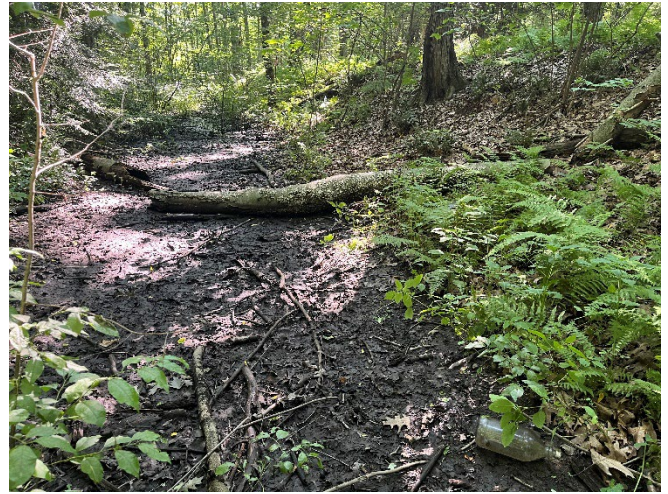
The B series BVW is in the eastern portion of the Site and extends off-property to the east. A Bank resource was identified within the B series BVW that may convey flow during periods of inundation. The predominant shrub community vegetation within the BVW is red maple (*Acer rubrum*), winterberry (*Ilex verticillata*), mountain laurel (*Kalmia latifolia*), and red oak (*Quercus rubra*). Ground cover species observed in the BVW include skunk cabbage (*Symplocarpus foetidus*), jewelweed (*Impatiens capensis*), interrupted fern (*Osmunda claytonia*), and cinnamon fern (*Osmundastrum cinnamomeum*). The wetland soils were observed to have hydric characteristics like those in the A series BVW.

Figure 4: View of the B series BVW facing east.
