Subject: Tacoma Public Schools – Lowell Elementary School
Traffic Analysis Memorandum

This traffic analysis memorandum was prepared for the Lowell Elementary School Replacement Project. The project site is located at 810 Mr Dahl Dr, Tacoma, Washington, bounded by N I St, N 12th St, N Yakima Ave, and Mr Dahl Dr, as shown in **Figure 1**. The site is being re-developed to replace several existing buildings with a single school building. Under existing conditions there are school buildings on the north side of the site which fronts Yakima Ave, with play areas and play fields on the south side of the site. This memorandum evaluates traffic operations and circulation, safety, and parking for a typical school day.

Cultural Resource Site Assessment and Management Plan

Lowell Elementary School

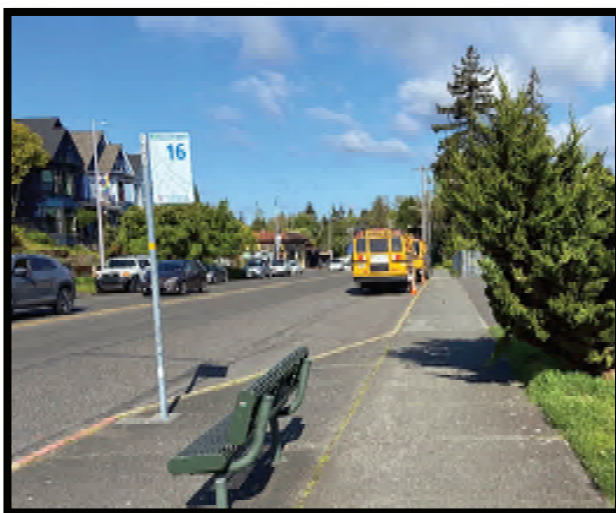
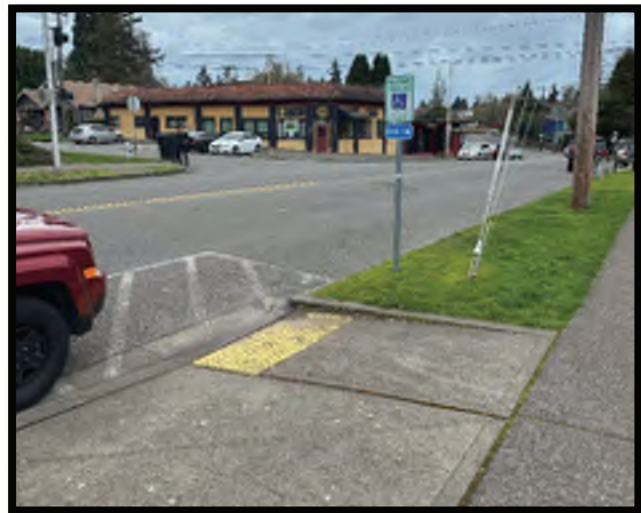
**Figure 2: School Bus Drop-Off on N I St (left)
& View of N 13th St Intersection/Roadway Curvature on N I St (right)**

N I St was used heavily for loading, with parents parking up to about 150 feet west of N 13th St on the north side. Parents also parked on the south side of N I St, with several groups observed crossing N I St at N 13th St or at midblock locations. Sight distance along N I St is limited in this area due to horizontal and vertical curvature of the road. There is a pullout loading zone on the north side of N I St, and part of this area is reserved for buses using traffic cones. The two buses that serve the school drop off two students at this location. PH observed that parents pull all the way up to the cones and space for buses to maneuver is limited. There is a flashing beacon to draw attention to the 20mph school zone on N I St.

4. PH observed several groups of parents/students crossing N I St at N 13th St as well as midblock locations, rather than at the signalized and marked crosswalk at N 12th St. As sight distance is a potential concern at N 13th St, PH recommends modifications that discourage crossing at this location.

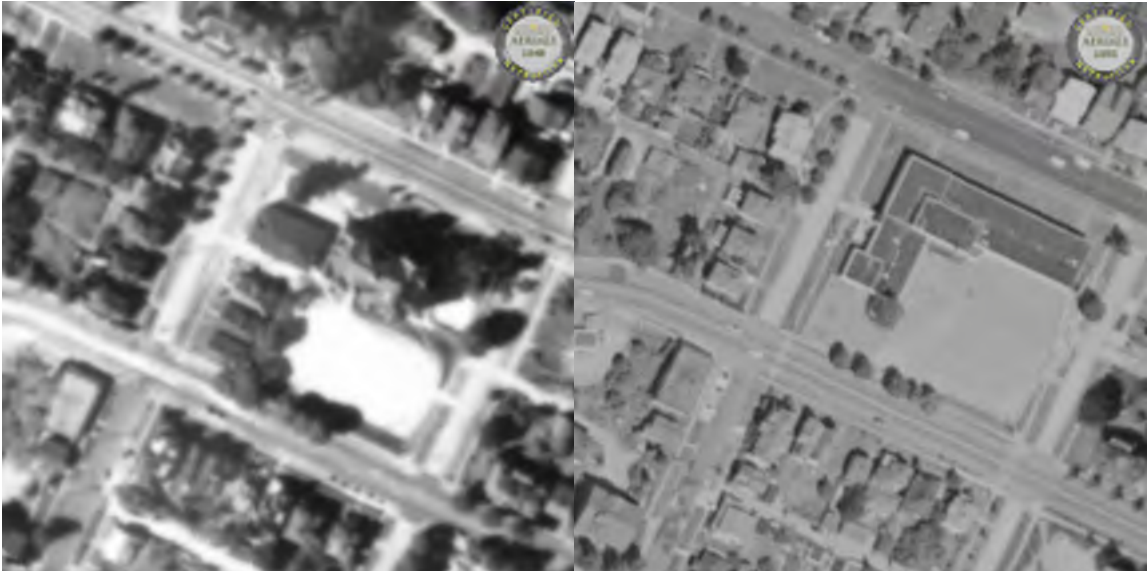
Figures 9 & 10: Side-by-side aerial photographs showing the building footprints of the old and new school buildings. Photos courtesy of NETRO.

By December of 1949, while crews were still removing the rubble from the old school, construction contractors were punching foundations for the new school. Despite the use of poured concrete, plywood, and some prefabricated wall panels, by September of 1950, Lowell ES was not ready to receive students. Again, Lowell students were shifted to other schools. Some classes met in homes on District-owned property where the Lowell annex now stands. But wide-eyed students got a taste of their new facilities by the first of December. However, only seven of the twelve classrooms were substantially finished.

Ten years later, three or four single family residences were demolished to make way for the annex structure. The buildings were necessary to expand the school’s program needs and brought the total number of classrooms at Lowell ES up to 16. The annex was constructed of similar materials and style as the 1950 structure.

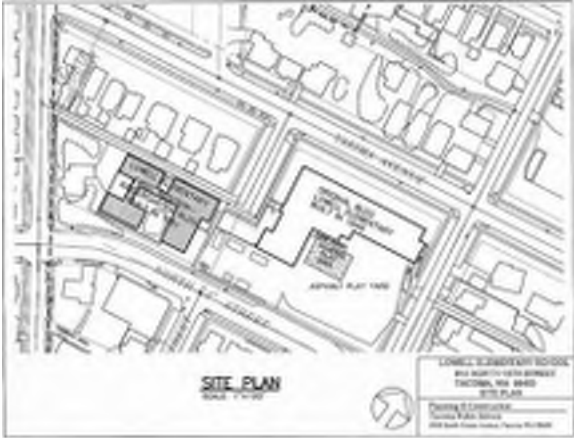
Figure 11: Site plan that includes the Lowell ES annex. Pierce County Assessor’s record.

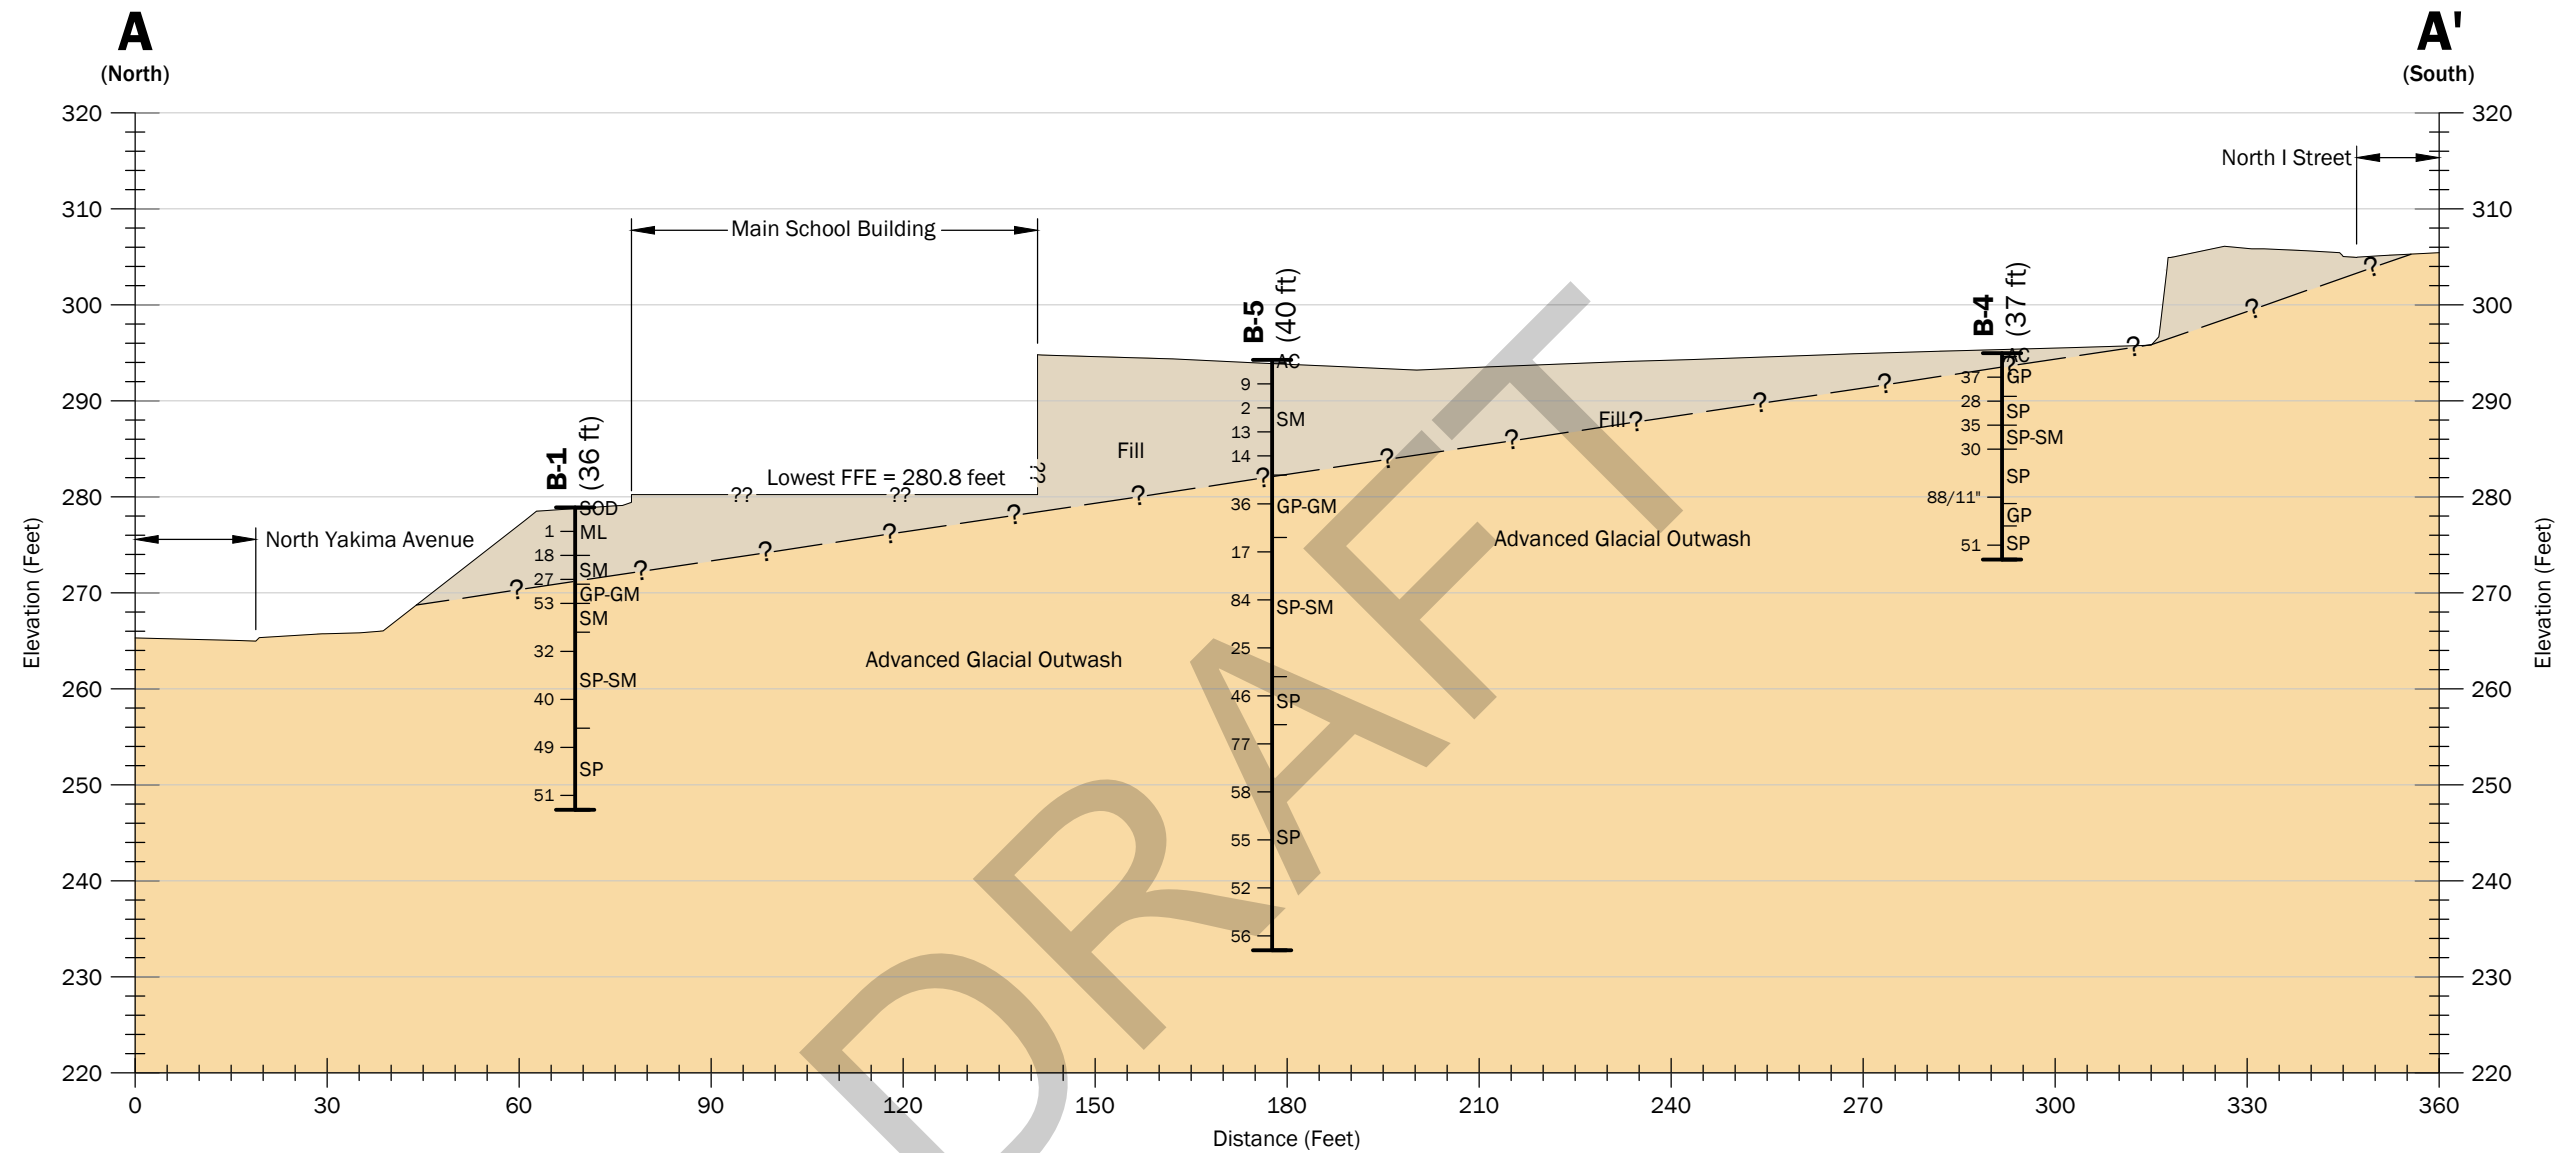
Cross Section A-A'	
Lowell Elementary School Replacement Tacoma, Washington	
GEOENGINEERS	Figure 3

- The subsurface conditions shown are based on interpolation between widely spaced explorations and should be considered approximate; actual subsurface conditions may vary from those shown.

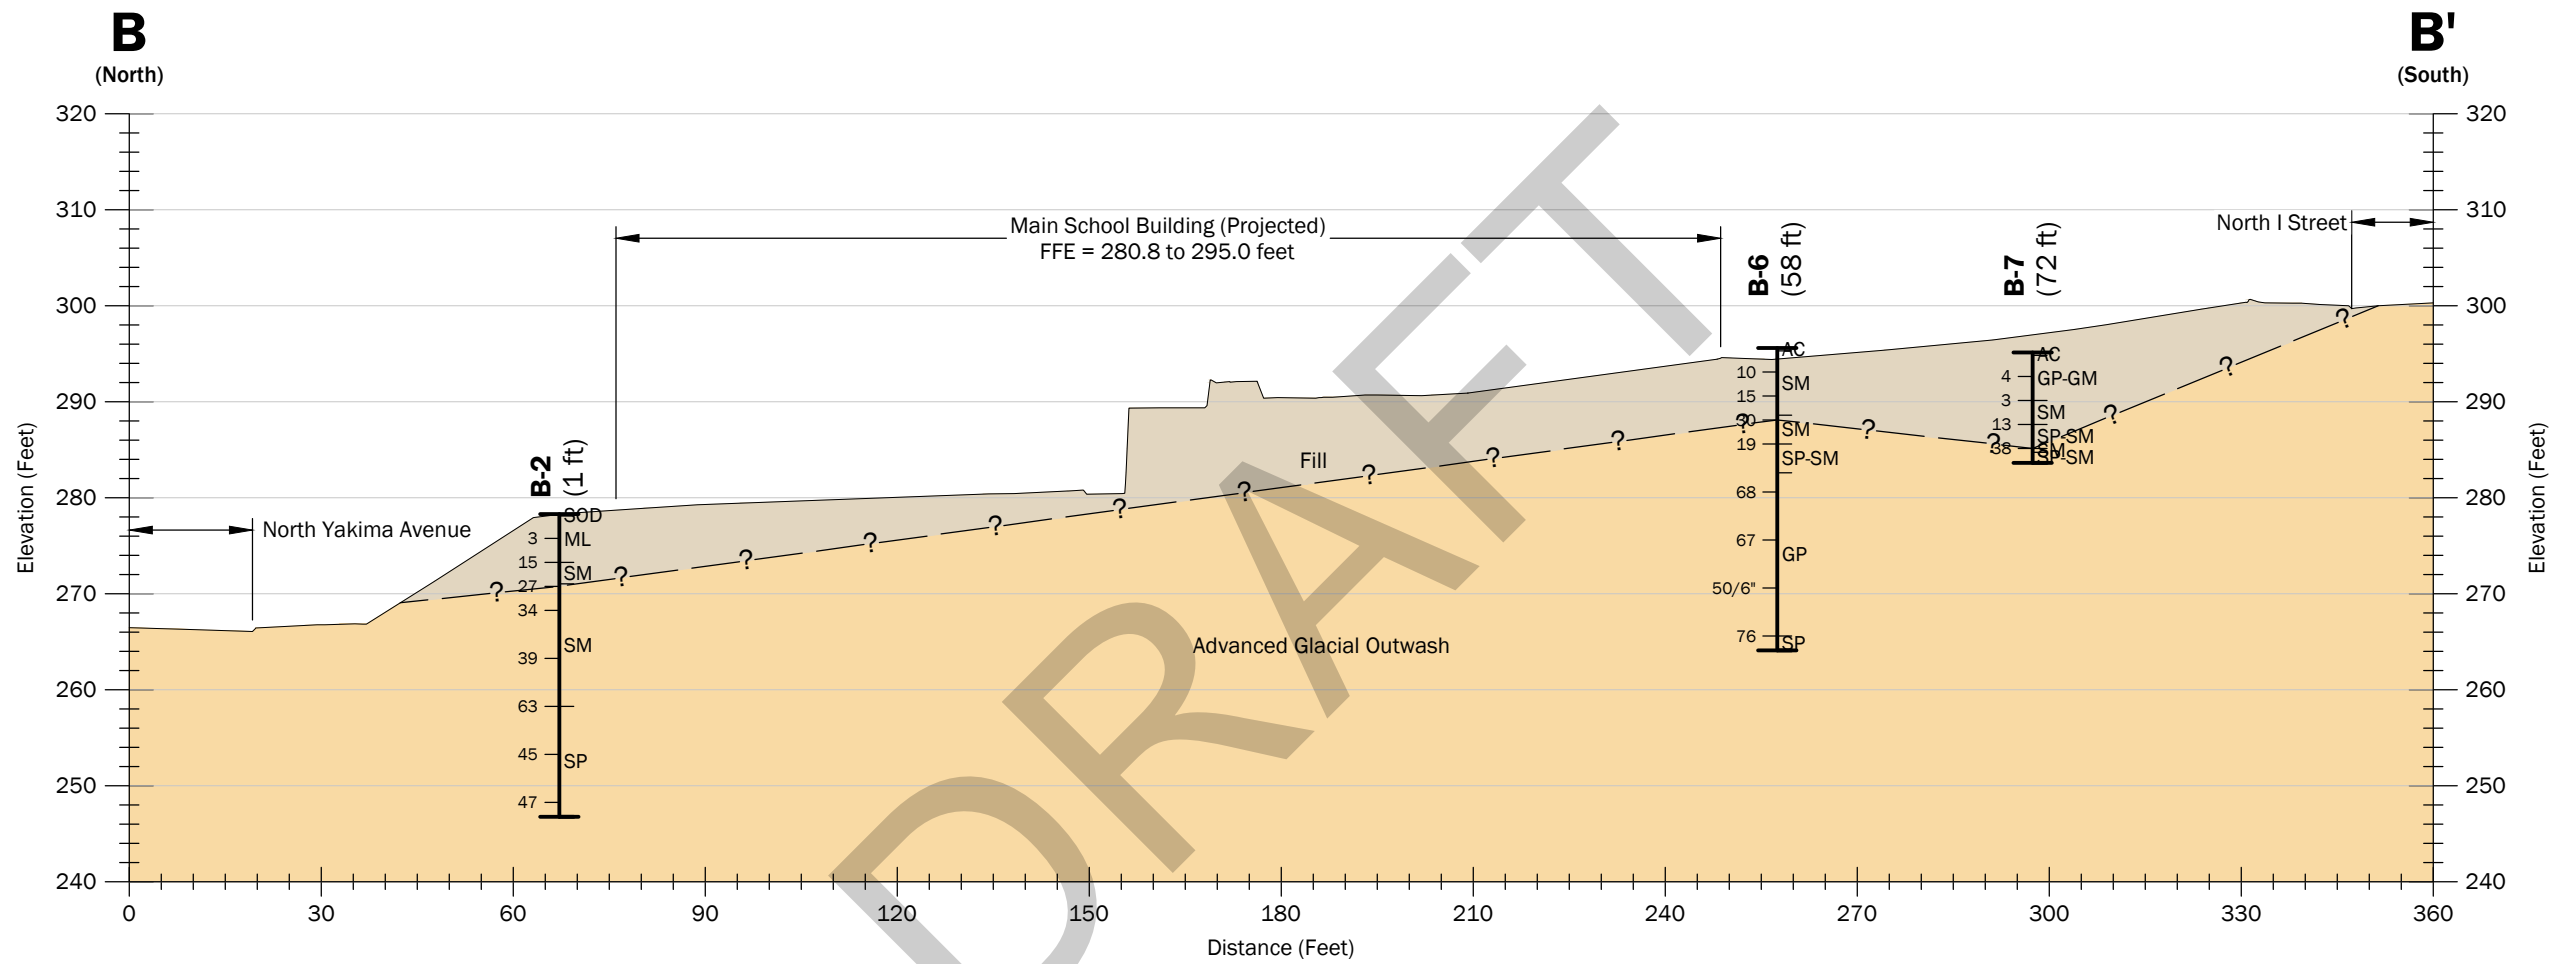
Cross Section B-B'	
Lowell Elementary School Replacement Tacoma, Washington	
GEOENGINEERS	Figure 4

- The subsurface conditions shown are based on interpolation between widely spaced explorations and should be considered approximate; actual subsurface conditions may vary from those shown.

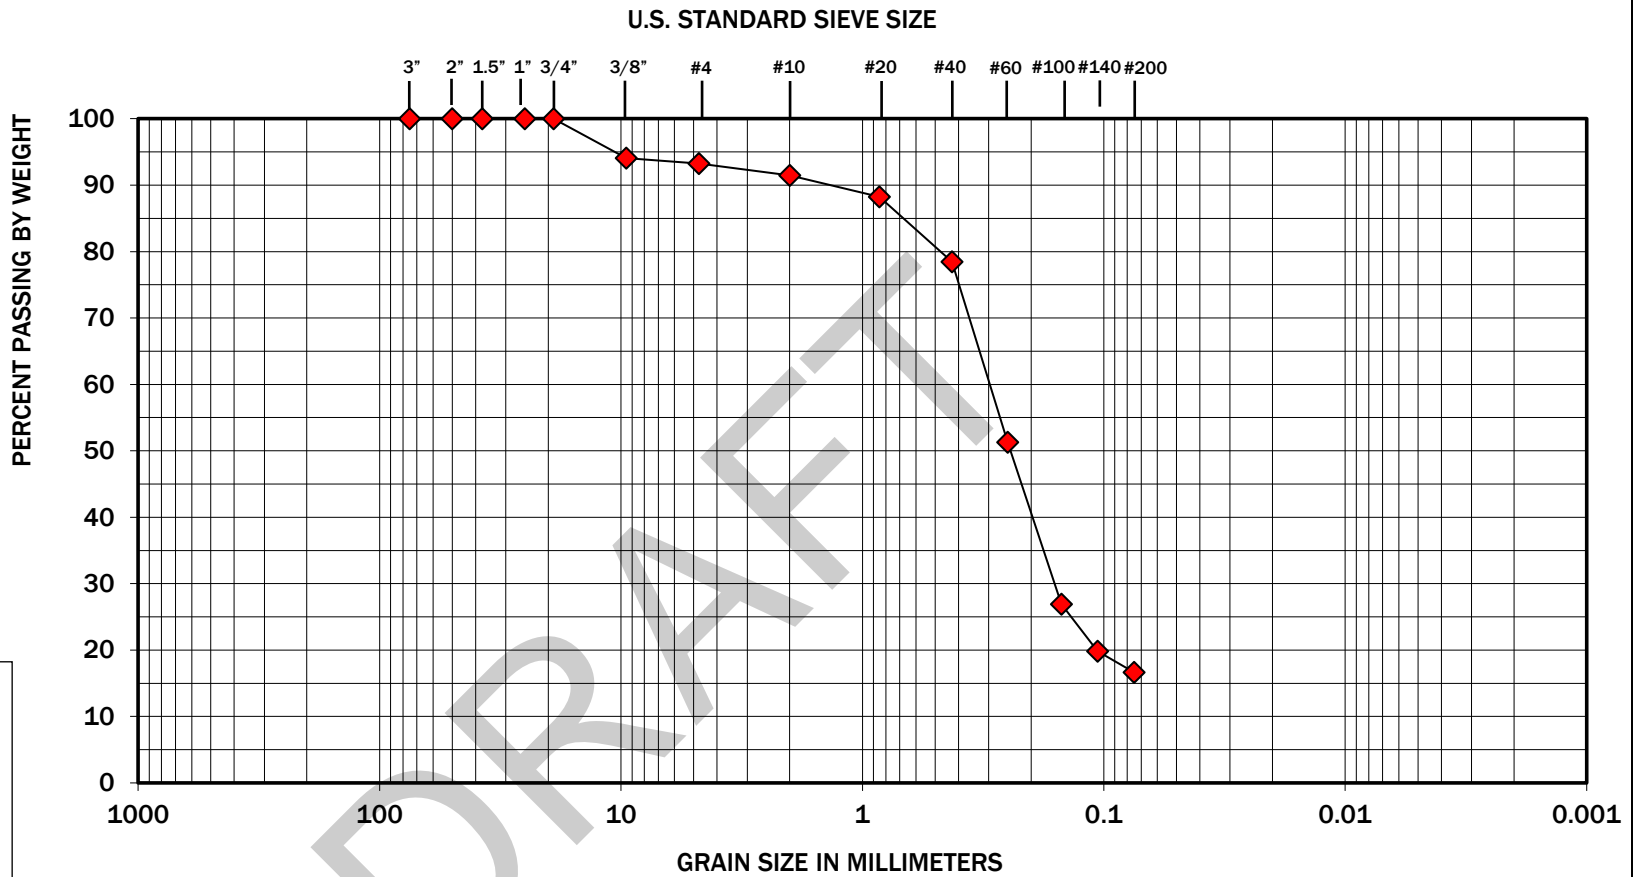
COBBLES	GRAVEL		SAND			SILT OR CLAY
	COARSE	FINE	COARSE	MEDIUM	FINE

Symbol	Boring Number	Depth (feet)	Moisture (%)	Soil Description
◆	B-7	10	14	Silty sand (SM)
