ALBEMARLE HIGH SCHOOL + WESTERN ALBEMARLE HIGH SCHOOL MASTERPLAN

ALBEMARLE COUNTY PUBLIC SCHOOLS

February 23, 2023

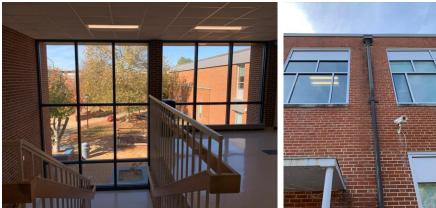
Exterior Windows

The building was built and added on to extensively over the course of its life, thus there are a variety of window and glazing types present.

Extensive window replacement has been carried out in many areas of the school. In these areas windows were replaced with aluminum storefront style frames with insulated glazing. There are still areas of the building where older windows are present that should be replaced to provide a more energy efficient and comfortable building envelope.

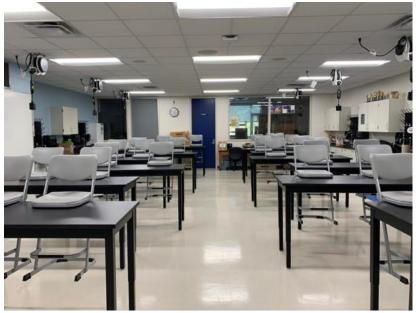
Science Lab Renovated

Condition: 7 of the 14 Science Labs have been renovated within the last 5 years. An additional 3 Science Labs (MESA) were constructed with the last ten years and in good modern condition. Unrenovated labs are in relatively good condition and are serviceable, but age is apparent.

Quality: Newly renovated labs are high quality spaces, representing current pedagogies relative to Project-based learning, team-teaching and combine lab space with collaborative workspace and furniture in one large space.

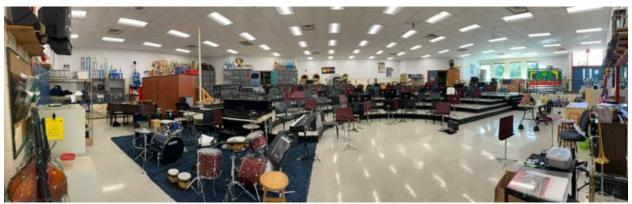
Music Lab

Condition: Conditions vary from room to room, but overall finishes appear to be aged and in need of replacing. Spaces are crowded with equipment real conditions are difficult to assess.

Quality: Spaces are large relative to the Virginia DOE guidelines but still appear to be overcrowded and disorganized. It is possible that the many smaller storage and practice spaces are not being utilized effectively or are not arranged in a useful way. Spaces also suffer from a lack of daylighting. Like the Fine Arts Suite, the Performing Arts Suite is separated from the main circulation path of the school creating a separation from the greater student body. Space reconfiguration could benefit the Performing Arts suite by providing more useful space and potentially creating opportunities for music to be on display and accessible to the entire student population.

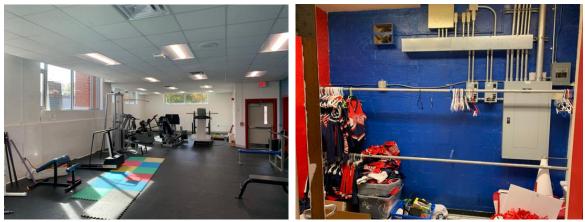
Weight Room

Condition & Quality: The space is well maintained with new lighting and adequate equipment. However, it is not easily accessed, with entry only through the Auxiliary Gym or a narrow entry from the corridor past small, ineffective storage rooms. An opportunity exists for improving the focus on health and wellness by improving access to and visibility of the Weight Room.

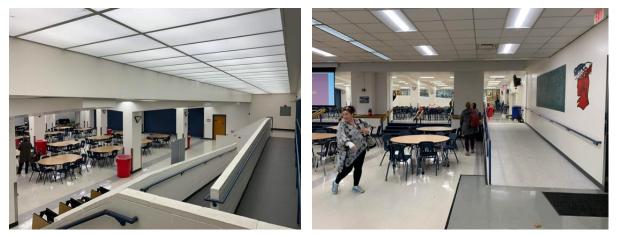
Dining Commons

Quality: Level changes within the cafeteria reduce the usable space. Currently the school has an open lunch policy allowing students to around the building, in part b/c of the small size of the cafeteria. Opportunities exist to transform the cafeteria into a commons that provides better functionality and versatility.

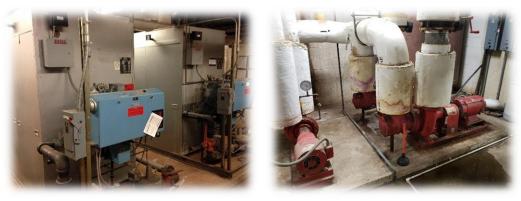
STEAM REPLACEMENT HOT WATER SYSTEM FLOW SCHEMATIC

Gas Fired Boilers

Hot Water Circulating Pumps

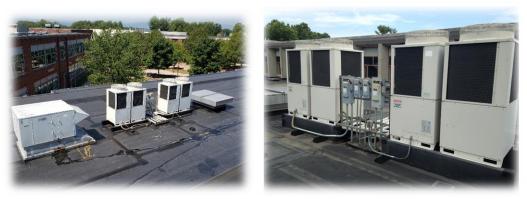
The administration area was renovated in 2009. A variable refrigerant flow and decoupled ventilation HVAC system was installed at that time. The system is in good condition and should remain in service for another 10 years; until 2029.

VRF Condensing Units Serving the Administration Area

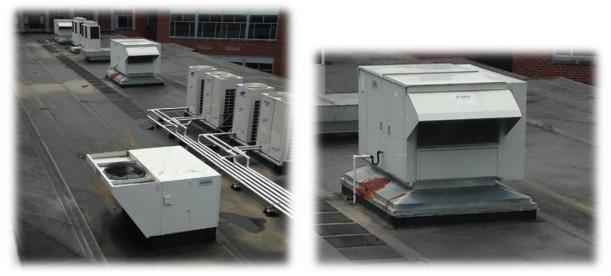
Media Center Rooftop Units (Typical of 3)

The media center is served by 3 packaged, single zone, rooftop air conditioning units that were installed in 2007. These units are in fair condition and should last another 5 years.

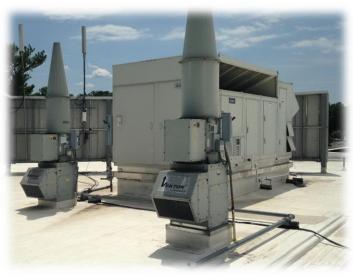
The MESA addition is served by a packaged rooftop variable air volume unit. The unit was installed in 2009 and is in good condition. This unit should continue to serve this area for another 10-15 years. The fume exhaust fans shown in the photo below are in good condition as well and should provide reliable operation for another 10-15 years.

Packaged VAV Rooftop Unit and High Plume Exhaust Fans

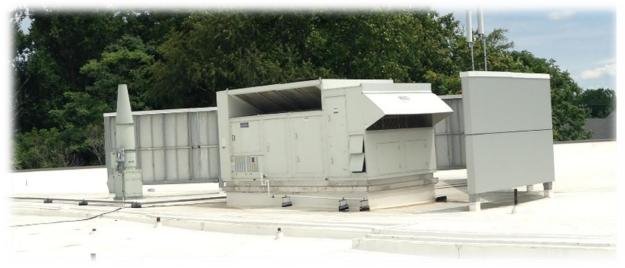
Packaged VAV Rooftop Unit

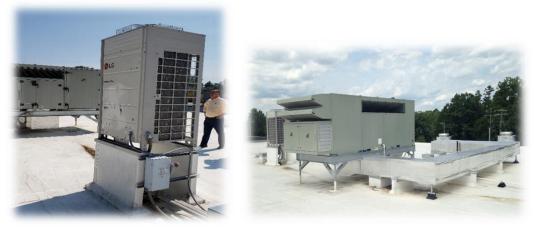
VRF Condensing Unit/Decoupled Ventilation Unit (FLW)

In 2017, the unit ventilator was replaced with new dual temperature unit ventilators. A decoupled rooftop ventilation unit was added to serve the entire wing. A small variable refrigerant flow system was provided to serve offices on the second floor. The mutlizone air handling unit was also replaced as part of this project.

These systems are in good condition and should serve the school for another 20 years.

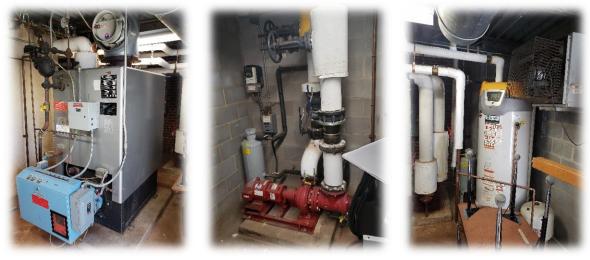
Gas Fired Boiler

Hot Water Pump

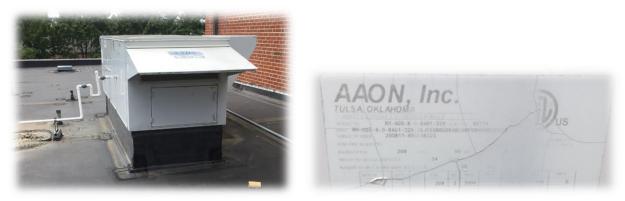
HVAC Rooftop Unit (100% OA)

The fitness room is served by a packaged rooftop 100% outside air ventilation unit with heat recovery energy wheels. The unit was installed in 2009 and is in good condition and should remain in service for another 10 years.

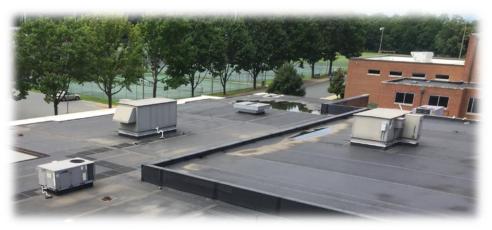
The cafeteria is served by two dual temperature air handling units. These units were installed in 2009 and are in fair condition. In addition, a packaged rooftop air conditioning unit serves the teacher's dining room.

Dual Temperature Air Handling Units and Packaged Rooftop Unit (2009)

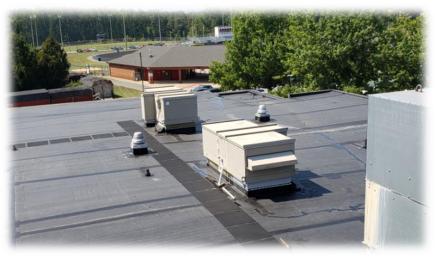
The Fine Arts Classrooms on the second floor are served by two dual temperature air handling units. The units are in fair condition.

Fine Arts Wing Dual Temperature Rooftop Units (2005)

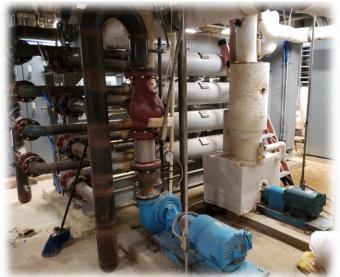
210 Ton Cooling Tower

210 Ton Water Cooled Chiller and Pumps (1998)

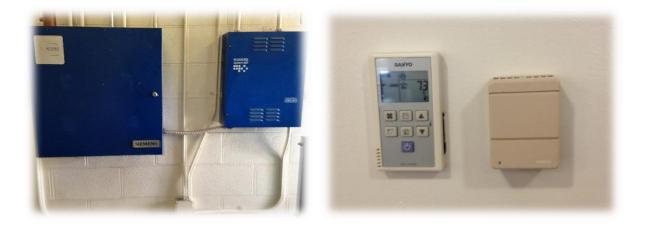
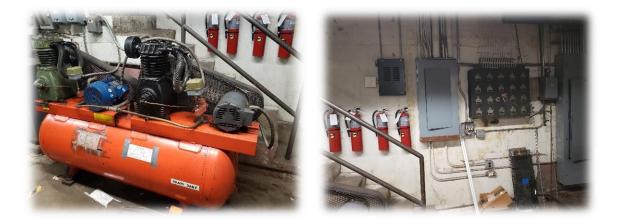
The building's automation system has been well maintained and upgraded as necessary. Typically, the upgrades occurred as part of a building addition or renovation. There is a combination of pneumatic and direct digital control systems. Upgrades will continue to occur throughout the life of the building as manufacture upgrades are required or as part of normal maintenance and repair. There are abandoned in place controls that should be removed.

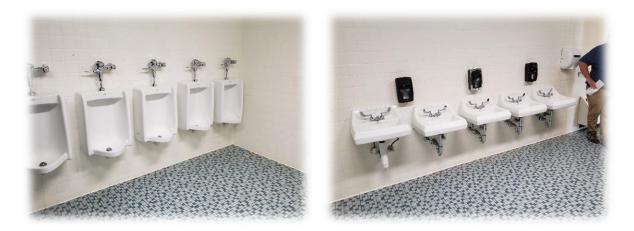
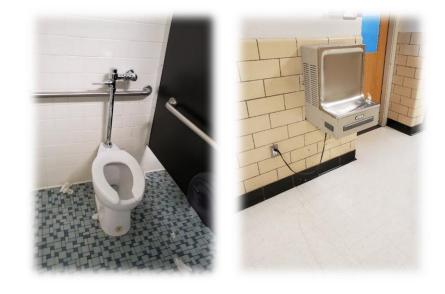
The plumbing systems throughout the building are in fair to good condition and have been well maintained. Unless the toilets require reconfiguration to meet ADA Standards or for other reasons, these fixtures should remain in service for another 15-20 years. It should be anticipated that plumbing fixture fittings (faucets and flush valves) may require replacement before the fixture replacement on an as needed basis as part of normal maintenance and repair.

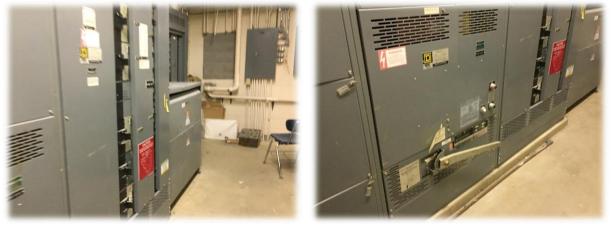
The electrical distribution system for this building consists of two electrical services. The first electrical service is a three section 2,000-amps, 480Y/277volt, 3 phase, 4 wire Main Distribution Switchboard (S1) located in the 1919 classroom addition. The Main Distribution Switchboard (S1) is manufactured by Square D and is fed from a Dominion Virginia Power pad mounted transformer via underground service lateral to a Current Transformer (CT) cabinet integral to the Main MDS. The bus for this MDS is braced for a short circuit current rating of 65,000 AIC. The Main Distribution Switchboard was built in 1991, is in good condition and replacement parts are available.

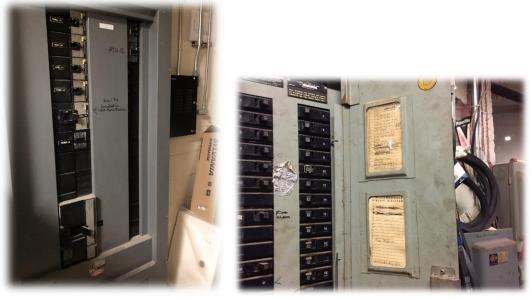
Typical Square D and Westinghouse Panelboards

The existing panelboards in this building consist of panelboards manufactured by Square D and Westinghouse companies. The Square D panelboards are in fair to good condition and replacement parts are available. The Westinghouse panelboards are in poor condition and we recommend replacing them. There is a lack of spare circuit breakers in most of the panelboards. We recommend adding new panelboards throughout the building to provide spare capacity for future loads.

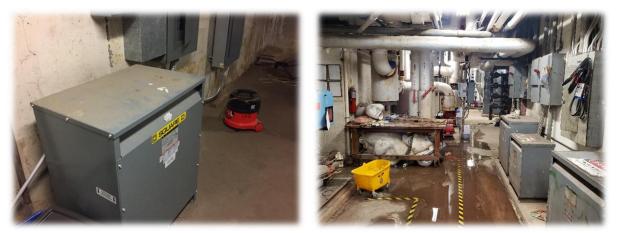
Typical Dry Type Transformer

- a. Dry type transformers in the original building are manufactured by Square D. These transformers are original to the building and are in fair to good condition. There are no moving parts in these pieces of equipment to be considered for replacement.
- b. Dry type transformers added during building additions are also manufactured by Square D. These transformers are in good to excellent condition.

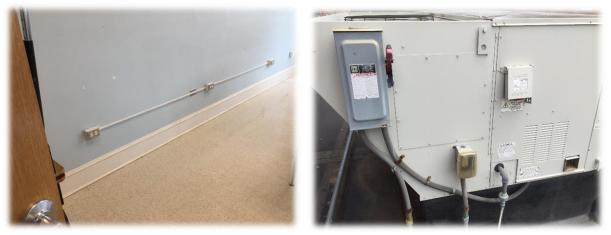
Typical Receptacle

- a. The original duplex receptacles are in fair condition.
- b. Surface mounted receptacles have been added throughout the years to provide power to computer systems. These receptacles are in good to excellent condition.
- c. The roof receptacles that supply power to the code required convenience receptacles are in good condition.

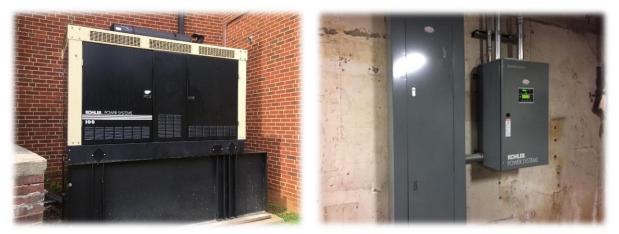
100KW Emergency Generator and Automatic Transfer Switch

The emergency power to this building is provided via a 100KW 480Y/277volt, 3 phase, 4 wire, emergency generator located adjacent to the 2009 auditorium addition. The Automatic Transfer Switch (ATS) is located in the existing boiler room. The emergency generator is well maintained and appears to be in good condition.

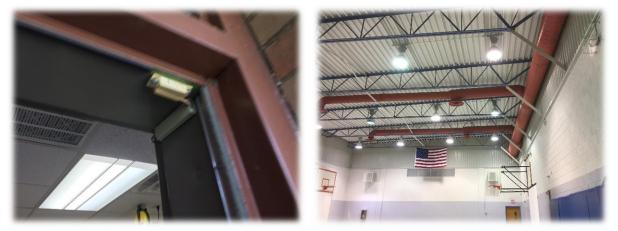
Typical Interior Light Fixtures

The interior lighting system for this building consists of recessed and pendant mounted LED type light fixtures. There are few fluorescent light fixtures in the electrical and mechanical rooms. They are scheduled to be changed to LED type light fixtures. All light fixtures appear to be in good condition. All exterior wall-mounted light fixtures have been replaced with new LED type light fixtures.

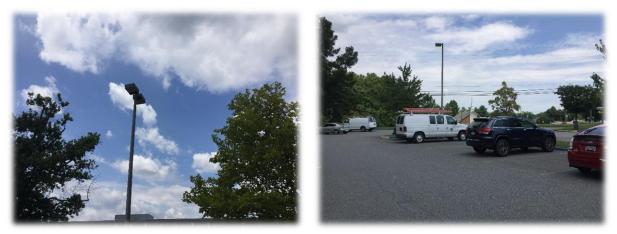
Typical Existing Exterior Pole Mounted Light Fixtures

The parking lot lighting system consists of pole mounted Metal Halide type light fixtures. These are the original light fixtures and we recommend replacing them (one for one) with LED type light fixtures.

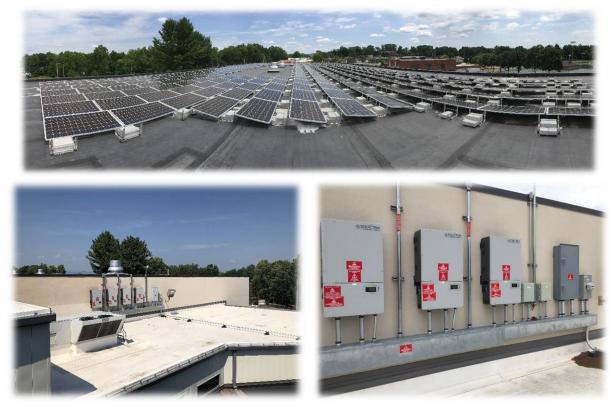
Solar PV System on Gymnasium Roof

The existing solar PV system on the existing 1978 gymnasium roof consists of 360 panels with inverters and a disconnect switch mounted on the exterior gymnasium wall. The system appears to be in good working condition.

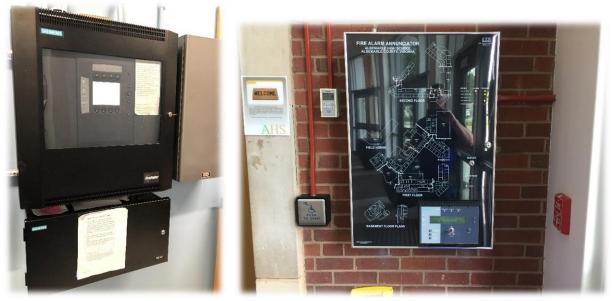
Siemens Fire Alarm System

The existing fire alarm control panel is FireFinder Series manufactured by Siemens and is in the main office. The addressable fire alarm system is in good condition and all observed areas had sufficient notification devices. The remote graphic annunciator is in the main lobby.

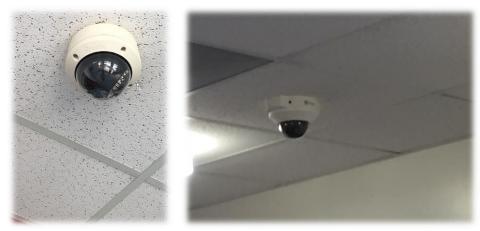
The existing video surveillance system was updated to an IP based video surveillance system. The updated system appears to be in good working condition.

Typical Video Surveillance IP Cameras

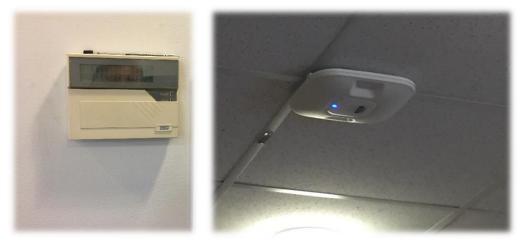
Intrusion Detection System

The existing intrusion detection system consists of a control panel, keypad, door contacts and motion detectors. The existing system appears to be in good working condition.

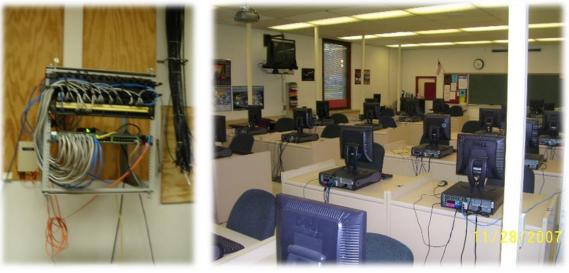
Typical Network Equipment

The existing network infrastructure system consists of data outlets, ceiling mounted wireless access points, and data cabling back to data racks and cabinets in Intermediate Distribution Frame "IDF" rooms and Main Distribution Frame "MDF" rooms. All equipment appears to be in good working condition.

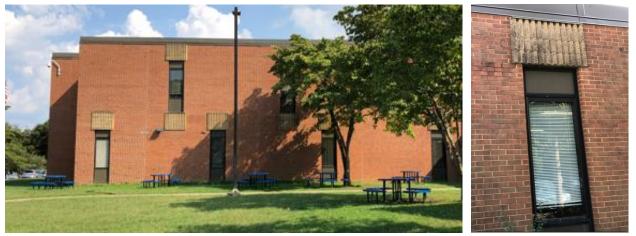
Exterior Windows

Typical windows are original to the era their respective portion of the building was built. Windows in classroom areas are small, limiting daylighting opportunities. Replacing windows with insulated and thermally broken and insulated systems would improve energy efficiency and provide more natural light into spaces.

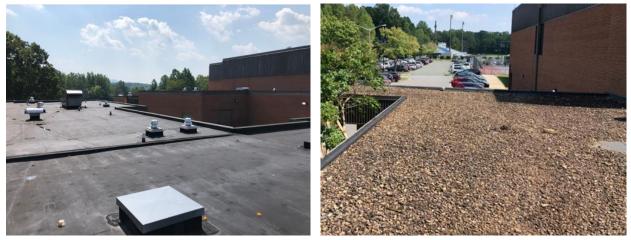
Existing Roof

Most of the roof is EPDM membrane installed in 1997 with a 20-year warranty. The wrestling and weight rooms are covered by an EPDM membrane installed in 2005 with a 15-year warranty. Additional insulation was added when current EPDM membranes were installed. Roof membrane age is outside the warranty period but is not necessarily in need of replacing.

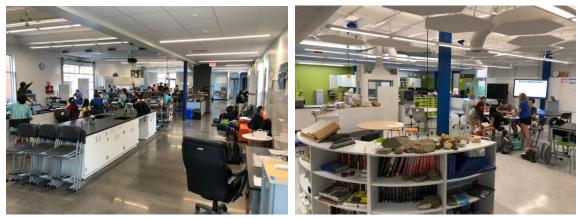
Science Labs

Quality: Newly renovated labs are up to date, represent current pedagogies relative to Project-based learning, team-teaching and large "double-size" labs combining lab space with collaborative workspace and furniture in one large room. Teachers report challenges working in some of the double-size lab spaces because of noise from adjacent classrooms. Curriculum models may not have caught up to the pedagogies that the labs have been designed around.

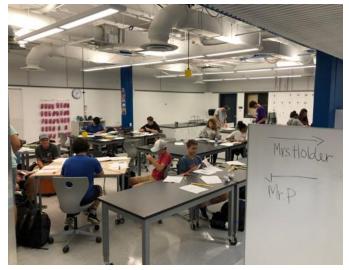
Career/Tech Lab

Several classroom spaces have been recently renovated and appear to include adequate space and technology for curriculum needs; finishes and lighting are new. Shop space is dated and crowded. Equipment such as welding booths occupy large areas, possibly taking up space that could be used for more current curriculum or modern equipment.

Quality: The renovated classroom spaces are designed for collaborative learning; however, spaces are remote and hidden from the corridor

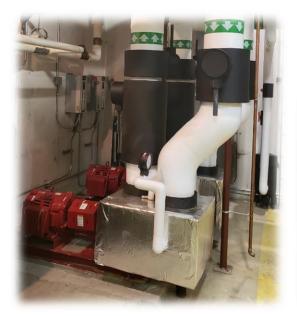
The chilled water system consists of a cooling tower, water cooled chiller and associated pumps. The chiller and pumps were replaced in 2019 and are in very good condition. This equipment should provide reliable service to the building for the next 20-25 years. The cooling tower was replaced in 2001 and is still in fair condition. We would anticipate the tower to last another 5 years.

Chilled Water Pumps (2019)

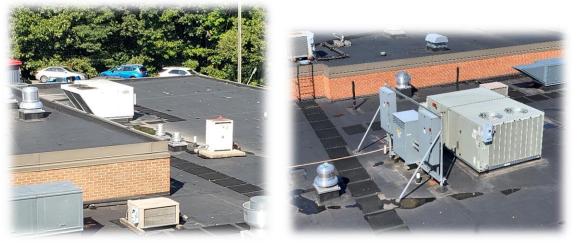
Packaged Rooftop Air Conditioning Unit (2007) Packaged Rooftop VAV Air Conditioning Unit (2007)

This area of the building is served by packaged rooftop air conditioning units serving single duct shut off variable air volume terminal units with hot water reheat coils. These units were installed in 2007 and are in fair condition. They should remain in service for another 5-10 years.

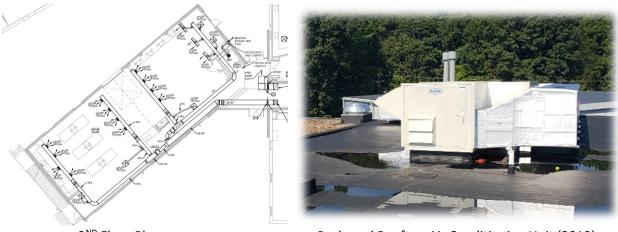
The science wing was constructed in 2019 and is served by a packaged rooftop air conditioning unit serving single duct variable air volume shut off terminal units with hot water reheat. The HVAC equipment serving this area is in excellent condition and should remain in service for another 15-20 years.

Packaged Rooftop Air Conditioning Unit (2019)

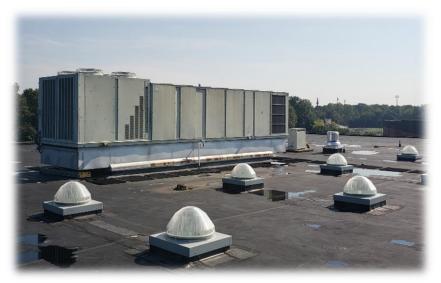
Packaged Rooftop VAV Air Conditioning Unit (2002)

The first floor administration area and second floor classrooms in B Wing are served by a packaged rooftop variable air volume air conditioning unit serving single duct variable air volume terminal units with hot water reheat coils. The rooftop unit and terminal units were replaced in 2002 and are in fair condition. Several of the terminal units were replaced in 2015 to satisfy a reconfiguration of the administration area. The rooftop unit and the original 1975 terminal units should be considered for replacement as soon as possible and within the next 5 years as this equipment is reaching the end of its useful life.

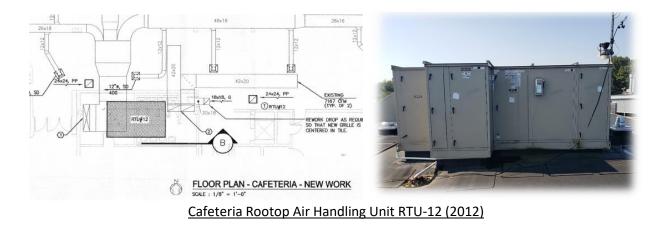
The cafeteria is served by a rooftop air handling unit with chilled and hot water coils. The unit was replaced in 2012 and is in good condition. This unit should remain in service for another 15 years.

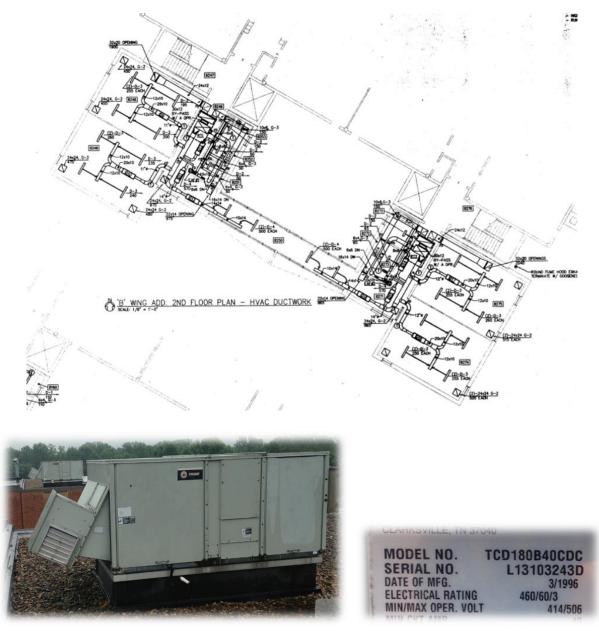
Packaged Rooftop Air Conditioning Unit Serving Hot Water Induction Boxes (Typical of 2) (1996)

The 1996 classroom addition to B Wing is served by 2 packaged variable air volume rooftop air conditioning units serving induction type terminal units with hot water heating coils. This equipment is original to the 1996 construction and should be considered for replacement as soon as possible as the equipment has reached the end of its useful life.

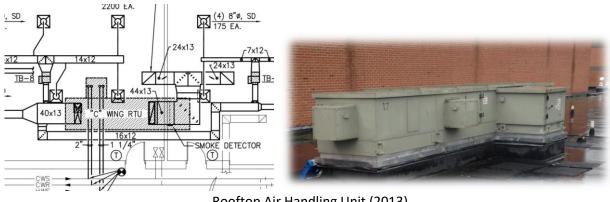
The C Wing classroom areas are served by a rooftop variable air volume air handling unit with hot and chilled water coils. The unit serves variable air volume terminal units with hot water reheat coils. The equipment was installed in 2013 and is in good condition. This equipment should remain in service for another 20 years.

Rooftop Air Handling Unit (2013)

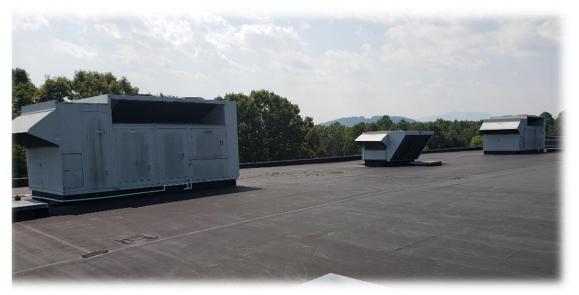
The main gymnasium is served by 3 packaged rooftop air conditioning units with DX cooling coils, hot water heating coils and energy recovery wheels. These units were installed in 2007 and are in good condition. These units should remain in service for another 5-8 years.

Gymnasium Packaged Rooftop Air Conditioning Units (2007)

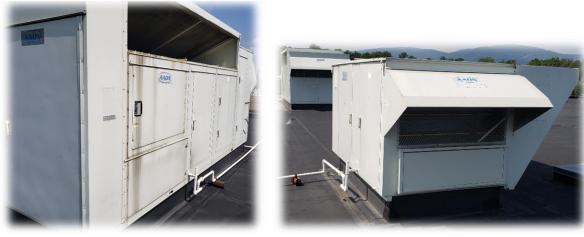
Gym Unit RTU-1 (2007)

Gym Unit RTU-2 (2007)

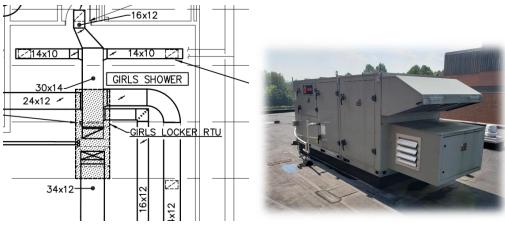
The locker rooms located in C Wing adjacent to the main gymnasium are served by packaged rooftop air conditioning units with DX cooling coils, hot water heating coils and energy recovery wheels. These units were installed in 2015 and are in good condition. These units should remain in service for another 15 years.

Girl's Locker Room Packaged Rooftop Air Conditioning Unit (2015)

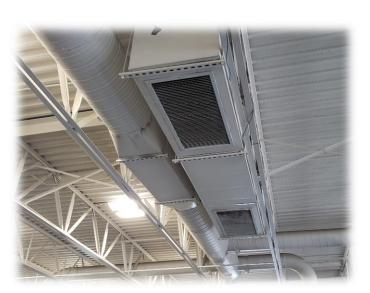
The weight room and wrestling room are served by individual packaged rooftop units with DX cooling coils and electric heating coils. These units are original to the 2005 construction and should be considered for replacement as soon as possible.

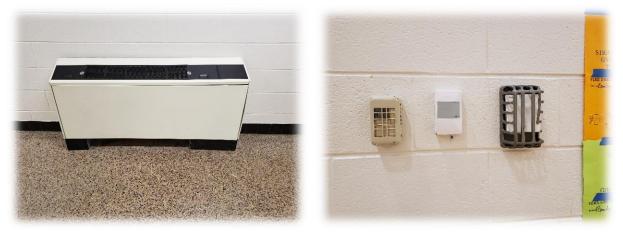
There are several split system air conditioning units, fan coil units, hot water and electric terminal heating units and exhaust fans serving isolated areas of the building. Their condition ranges from poor to good. Units should be replaced as needed. Most of the exhaust fans appear to be in good condition and may not need replacement for some time.

Fan Coil Unit

Hot Water Wall Convector

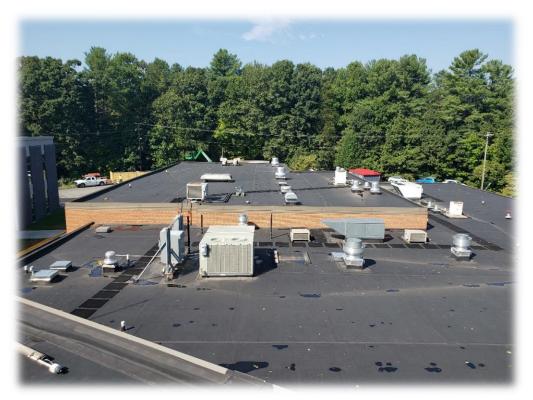
Various Exhaust and Make Up Air Fans

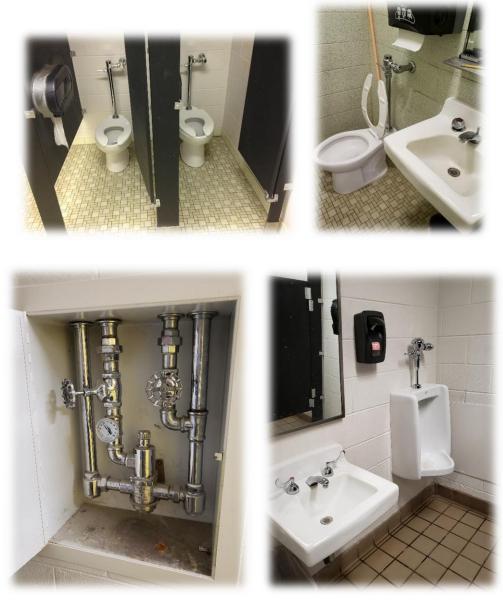
Gang Shower Water Tempering Valve

Gang Showers in Boy's Locker Room

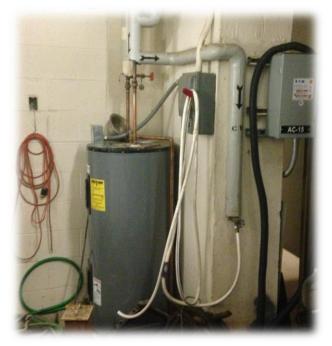
Electric Water Heater (2005)

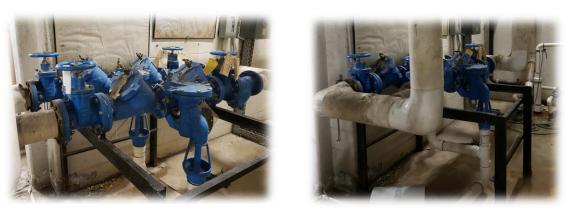
Backflow Preventer in Main Boiler Room

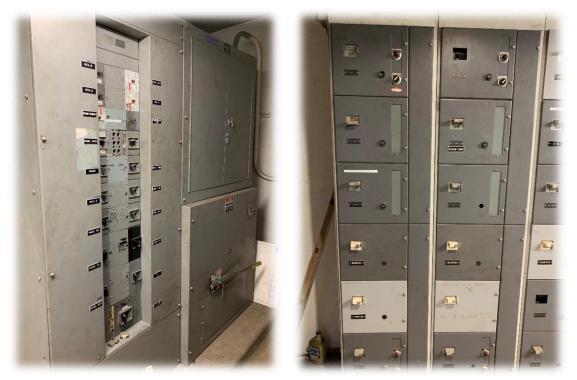
The electrical distribution system for this building consists of one electrical service. The electrical service is a 6 section 3,000-amps, 480Y/277volt, 3 phase, 4 wire Main Distribution Switchboard (MDS) located in the original building's mechanical room. The Main Distribution Switchboard (MDS) is manufactured by Westinghouse and is fed from a Dominion Virginia Power pad mounted transformer via underground service lateral to a Current Transformer (CT) cabinet integral to the Main MDS. The bus for this MDS is braced for a short circuit current rating of 65,000 AIC. The Main Distribution Switchboard was built in 1976 and is in good condition, but replacement parts are no longer available.

Main Distribution Switchboard (MDS)

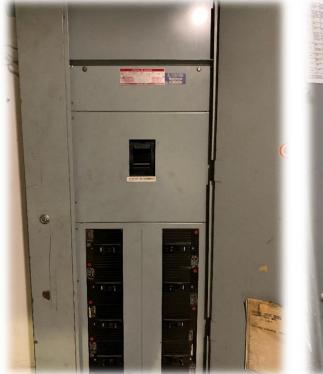
The existing panelboards in this building consist of panelboards manufactured by General Electric, Square D, Cutler-Hammer and Westinghouse companies. The Square D and Cutler-Hammer panelboards are in fair to good condition and replacement parts are available. The Westinghouse and General Electric panelboards are in poor condition and we recommend replacing them. There is a lack of spare circuit breakers in most of the panelboards. We recommend adding new panelboards throughout the building to provide spare capacity for future loads.

Typical General Electric Panelboards

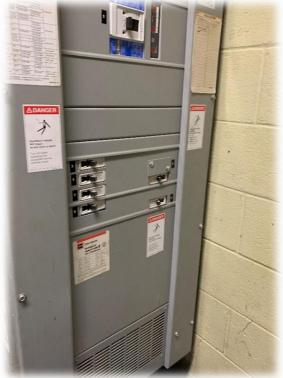
Typical Cutler-Hammer Panelboards

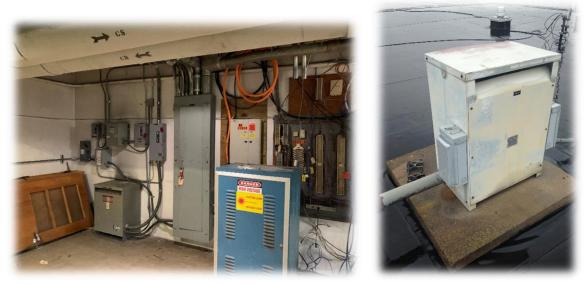
- a. Dry type transformers in the original building are manufactured by Westinghouse and General Electric. These transformers are original to the building and are in fair to good condition. There are no moving parts in these pieces of equipment to be considered for replacement.
- b. Dry type transformers added during building additions and installed on the roof are also manufactured by Square D and General Electric. These transformers are in good to excellent condition.

Typical Dry Type Transformer

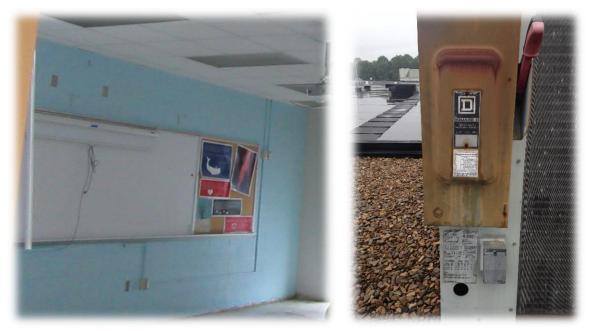
- a. The original duplex receptacles are in fair condition.
- b. Surface mounted receptacles have been added throughout the years to provide power to computer systems. These receptacles are in good to excellent condition.
- c. The roof receptacles that supply power to the code required convenience receptacles are in good condition.

Typical Receptacle in Classroom and on Mechanical Unit

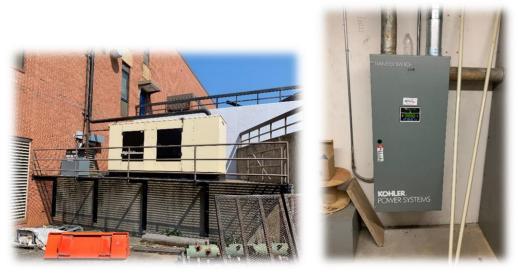
The emergency power to this building is provided via a 250KW 480Y/277volt, 3 phase, 4 wire, emergency generator located adjacent to the main mechanical room on the original building. The Automatic Transfer Switch (ATS) is located in the existing mechanical room. The emergency generator is well maintained and appears to be in good condition.

250KW Emergency Generator and Automatic Transfer Switch

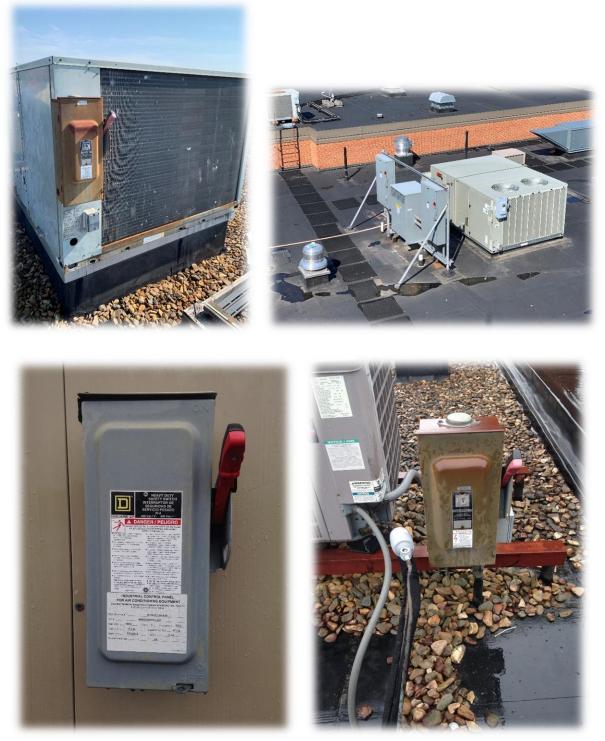
There are various pieces of electrical equipment serving the HVAC system for this building, all with equally varying degrees of condition. Few roof-mounted disconnect switches are covered with rust and corrosion.

Disconnect Switches Serving Roof Mounted HVAC Equipment

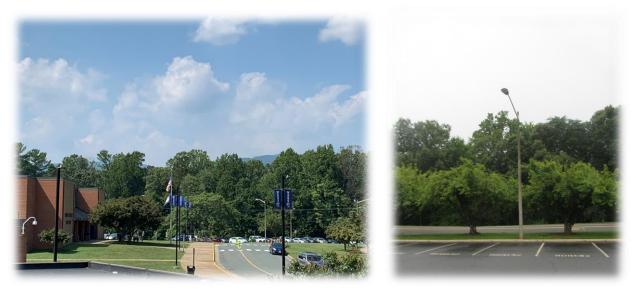
The parking lot lighting system consists of pole mounted Metal Halide type light fixtures. These are the original light fixtures and we recommend replacing them (one for one) with LED type light fixtures. Some of the parking lot pole mounted light fixtures are owned and maintained by Dominion Energy.

Typical Exterior Pole Mounted Light Fixtures

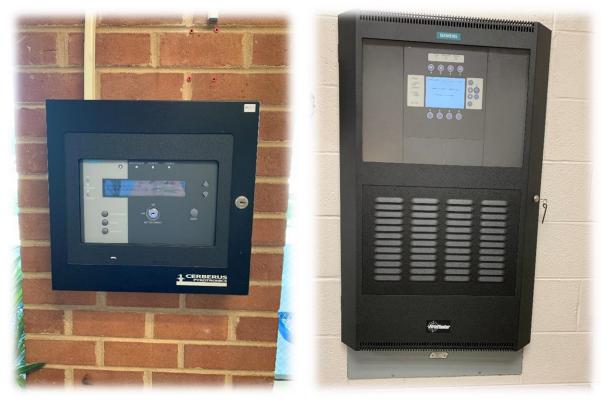
The existing fire alarm control panel is FireFinder Series manufactured by Siemens and is in the main office. The addressable fire alarm system is in good condition and all observed areas had sufficient notification devices. The remote graphic annunciator is in the main lobby.

Siemens Fire Alarm System

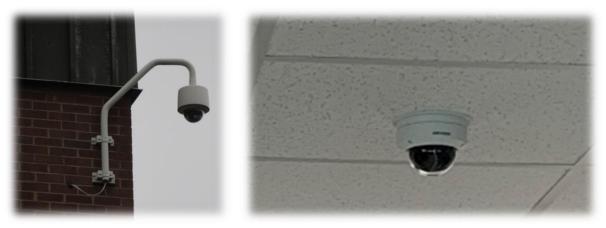
The existing video surveillance system was updated to an IP based video surveillance system. The updated system appears to be in good working condition.

Typical Video Surveillance IP Cameras

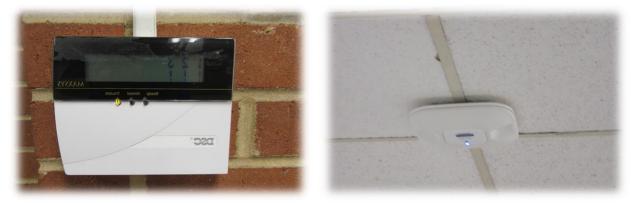
The existing intrusion detection system consists of a control panel, keypad, door contacts and motion detectors. The existing system appears to be in good working condition.

Intrusion Detection System
