## MACSA BUILDING REUSE OBSERVATIONS

FOR SOBRATO FAMILY FOUNDATION

SITE WALK FEBRUARY 16, 2024 - **UPDATE AUGUST 24, 2024**

COMPILED BY JIM SALATA

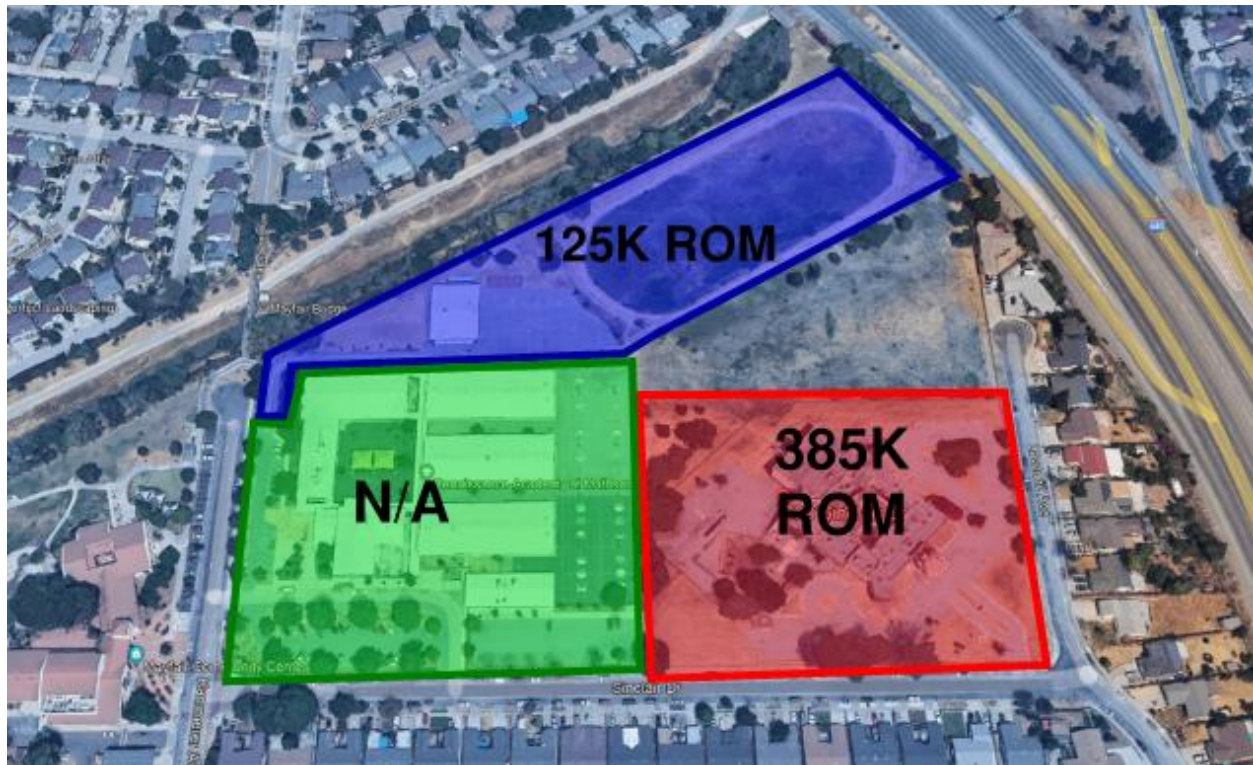
Coincidentally Buccaneer Demotion the subdivision of our company as noted above, had already provided ROM pricing for the demolition of the MACSA building and the parking lots to a developer in August of 2023. That ROM included an allowance for hazmat because; as of now, there doesn't appear to be a report. The ROM provided was bid at prevailing wages with reporting as required by law. The ROM for demolition was \$385,000.00 and the ROM for hazmat was \$150,000.00. Today Mr. Uribe confirmed the demo price is accurate but we both agree that the hazmat would likely be lower. The Freon in the HVAC units has been released into the atmosphere and given the reported age of the building (1994) extensive hazmat work is not likely. Nothing stood out at the job walk from a hazmat perspective. The scope he bid is outlined below.

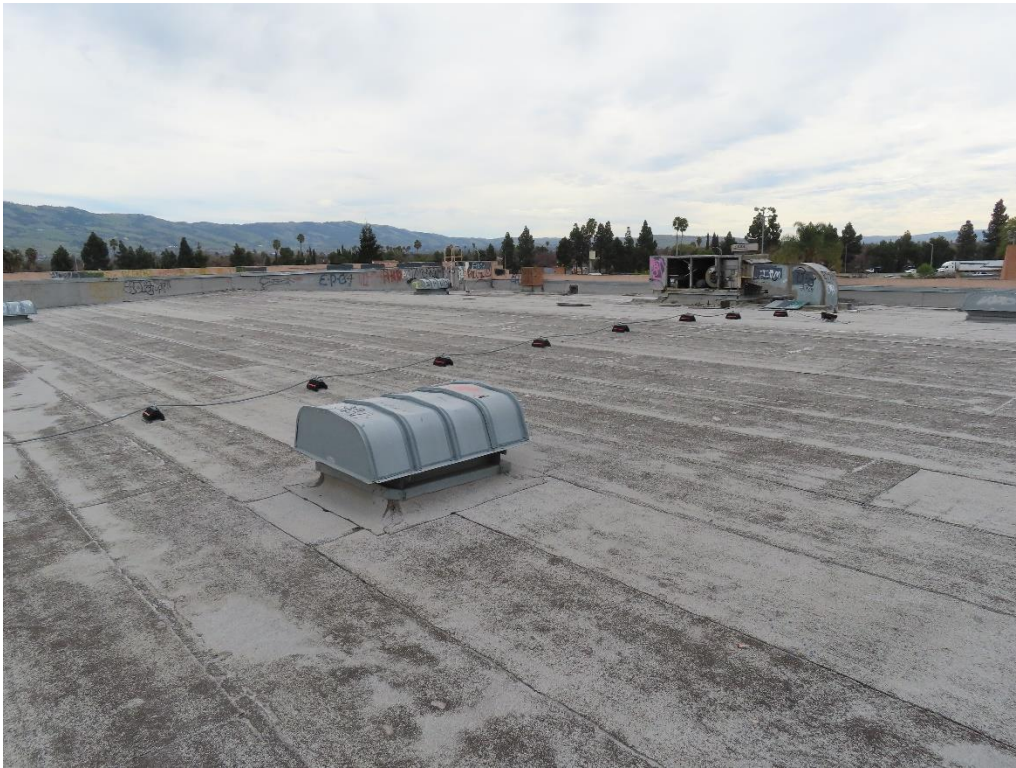
made a tremendous difference!!! An example below is the gym roof membrane. It's not great but it is holding well.

My recommendation at this time is to clean the roof of debris and perform minor patching to protect the building and cover areas where the EIFS is compromised as a temp measure. At some point skylights could be replaced. A qualified roof inspector should perform an inspection and make a recommendation. Without a lot of expense, the roof can be made to last while plans for renovation are being developed.

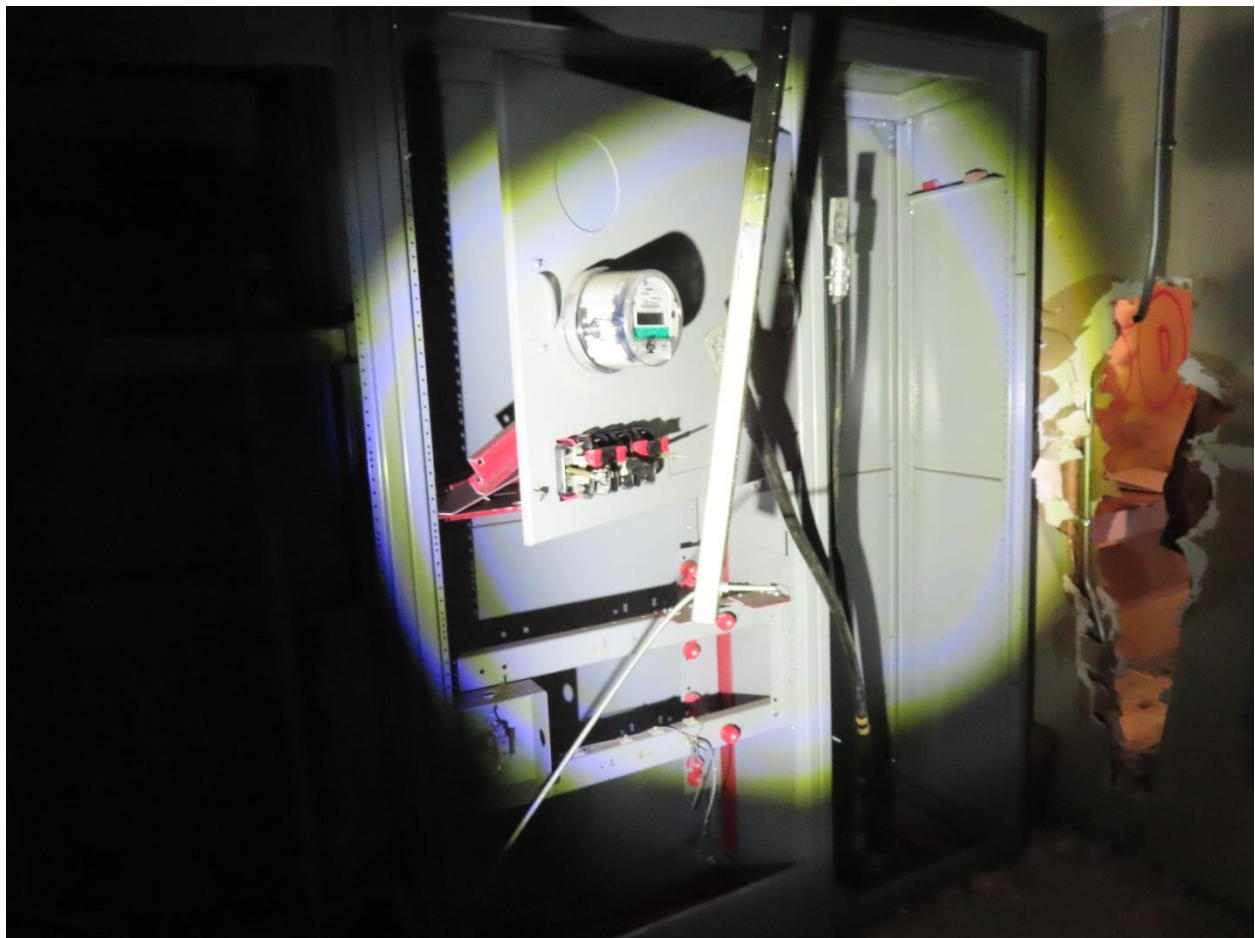
The main electrical service has been stripped of all wiring and the buss bars are missing. It may be possible to obtain the “guts” for the panel. We just ran into a similar situation at Keys and 3<sup>rd</sup> Streets but this panel is in far worse shape. I could not find the manufacturers label but need to look at all the panel covers strewn around on the floor. Subpanels are also stripped. As built drawings may be helpful. The secondary feeds are still there two of which have been cut and need to be replaced. Two are serviceable if the guts go back in the same juxtaposition.

Stripped Main Electric Service

As mentioned above the main electrical service and sub panels have been stripped of wiring. Existing conduits perhaps can be reused. Giving the timing of this report we have not been able to research this properly. No doubt the electrical system will be one of the greatest expenses.

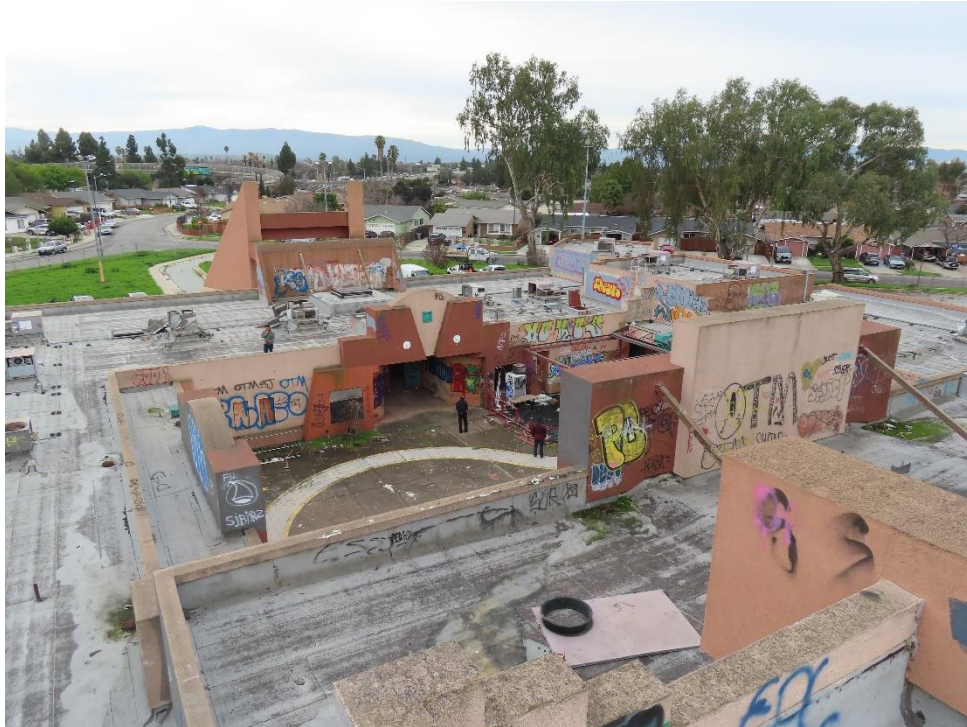
Shot from Gym Roof Ladder

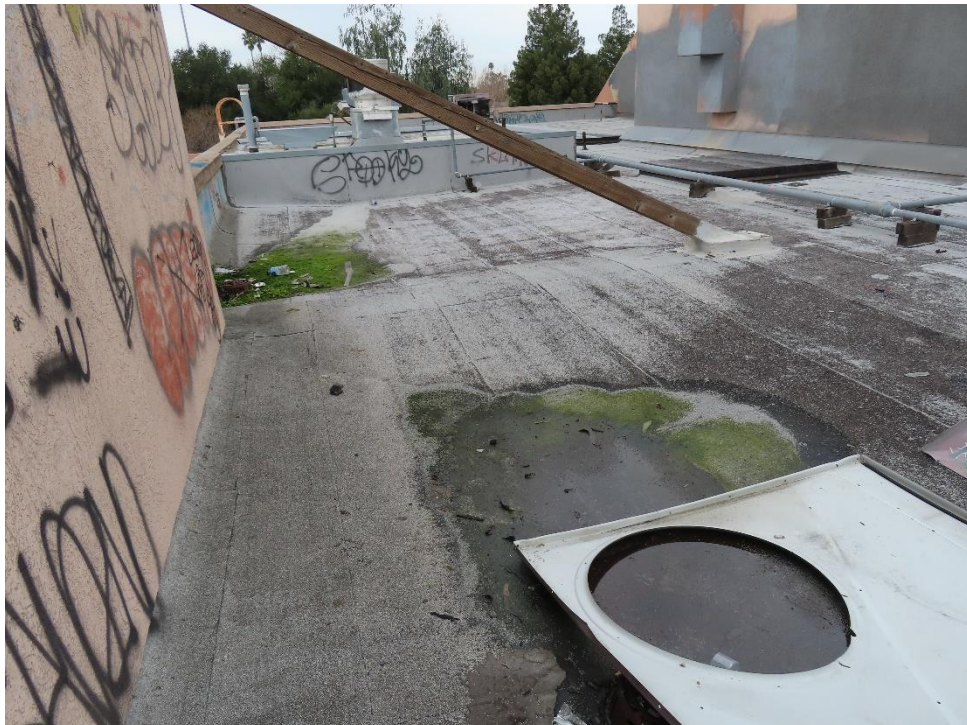
Area to Perform Roof Maintenance

- Roof maintenance and roof drain cleaning – of prime importance
- A quality board up of the building
- Security measures to prevent access to the roof
- Paint out graffiti
- Site maintenance

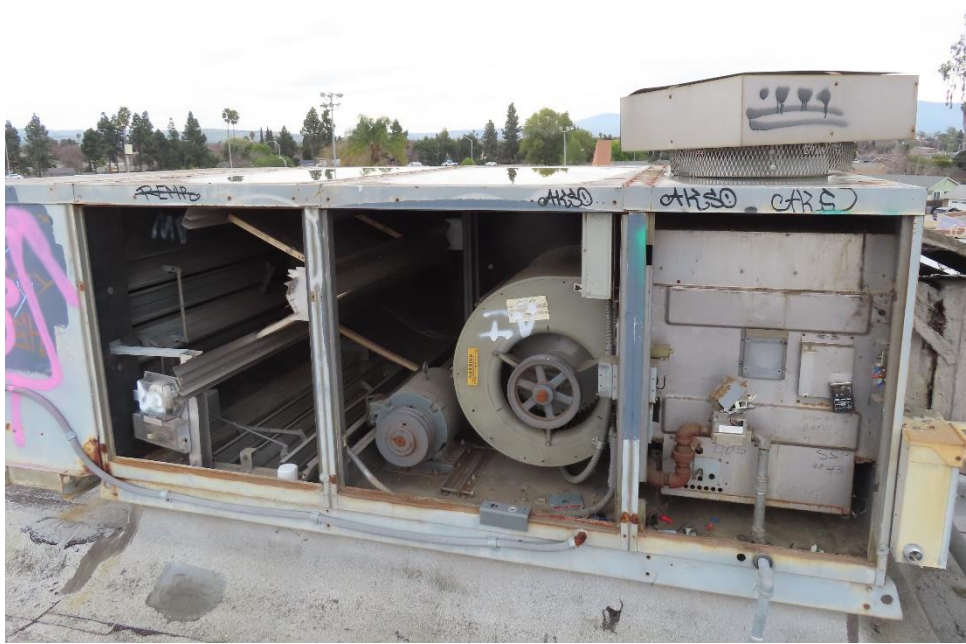
All of the HVAC systems need to be replaced. The Gym mechanical is an evaporative cooling/heating system. I have sent photos of the label and equipment to my mechanical sub to see if a similar unit is available. If as-built drawings are available a qualified sub or engineer can design a replacement system based on future programming of the building.

Gym Mechanical Unit

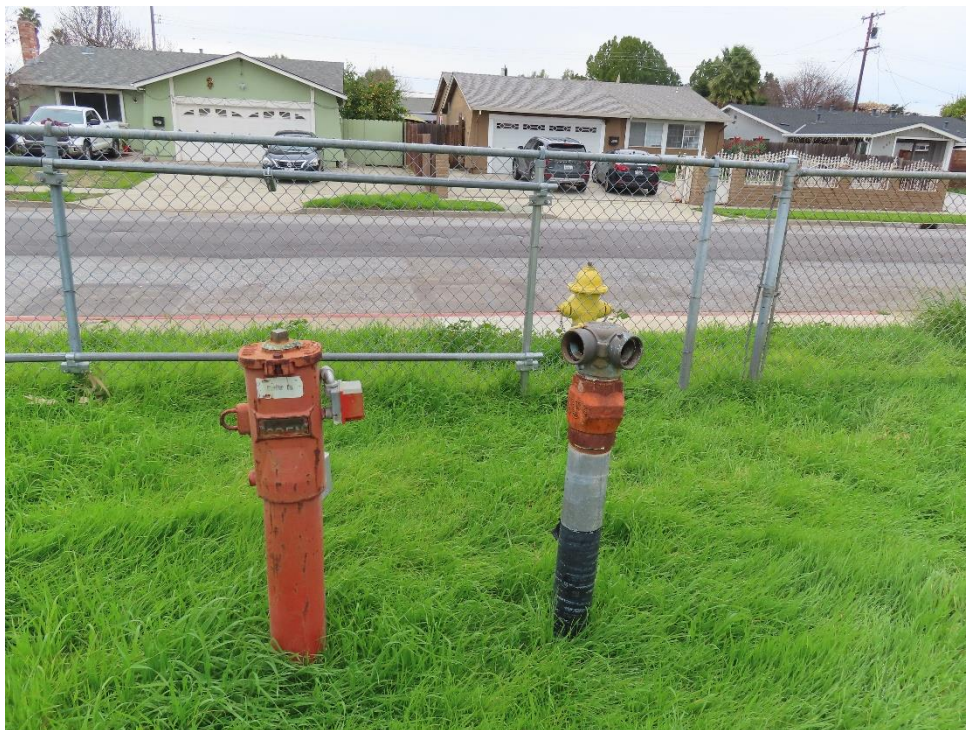
Existing PIV, Hydrant, Fire Dept. Connection

Have the system evaluated for reuse by a qualified contractor or engineer. Attempts should be made to reuse it. There seems to be two POC's for the building but we didn't have time to explore this thoroughly. The riser looks small to me for the size of the building but if there are two POC's that would explain it. If an acoustic ceiling is not installed then it may lessen the demand and it could be o.k. the way it is. I have sent out a photo to one of my contacts for an opinion.

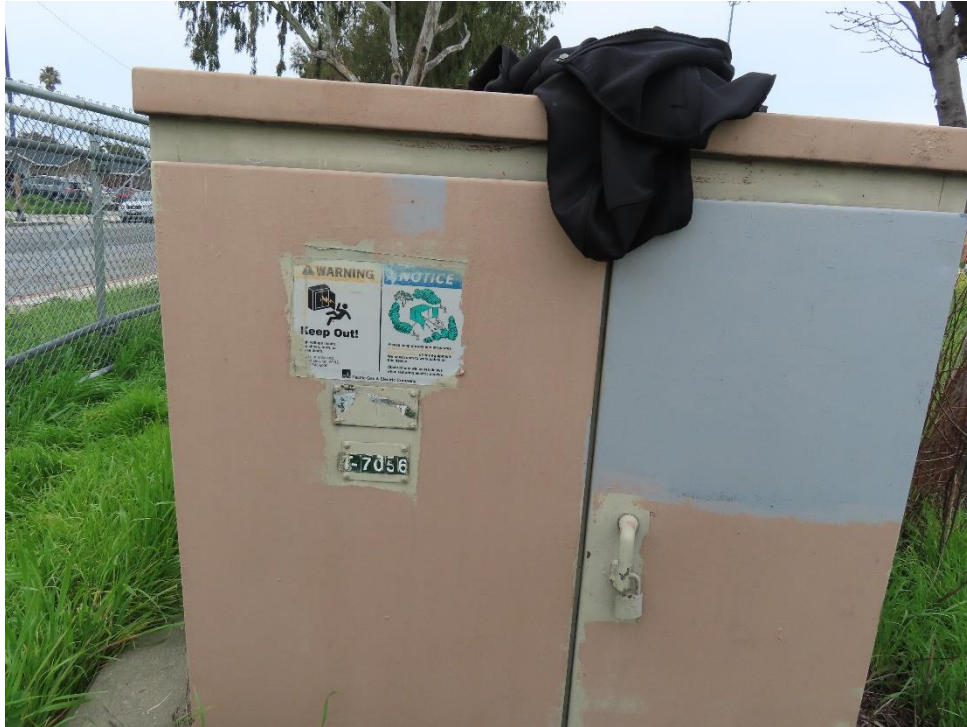
The gas meter is missing but the gas lines appear to be intact and will need to be tested. There are two pad mount transformers that appear to be undamaged but there is not a visible “NO PCB” sticker on them. Those transformers are owned by PGE and need to be tested. Obtaining transformer can be a lead-time issue of up to one year or more.

One of Two Existing Transformers

PGE should be contacted regarding the potential to reuse the existing transformers and gas service. The gas meter has been removed. I will be contacting a plumbing consultant for an opinion on the existing gas lines.

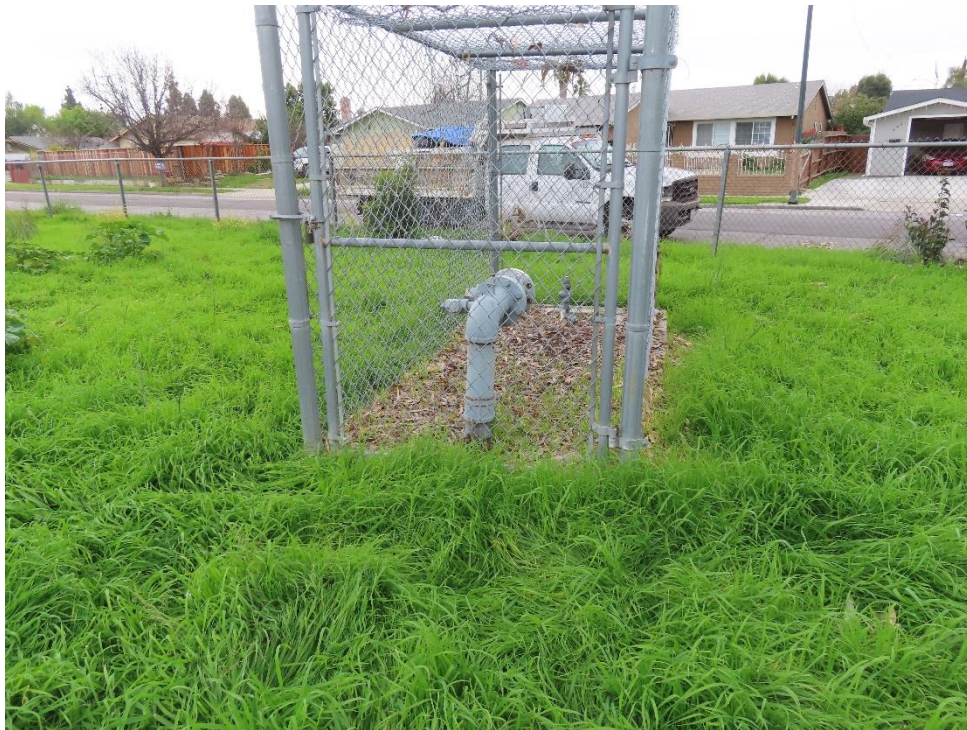
Gas Pad Area

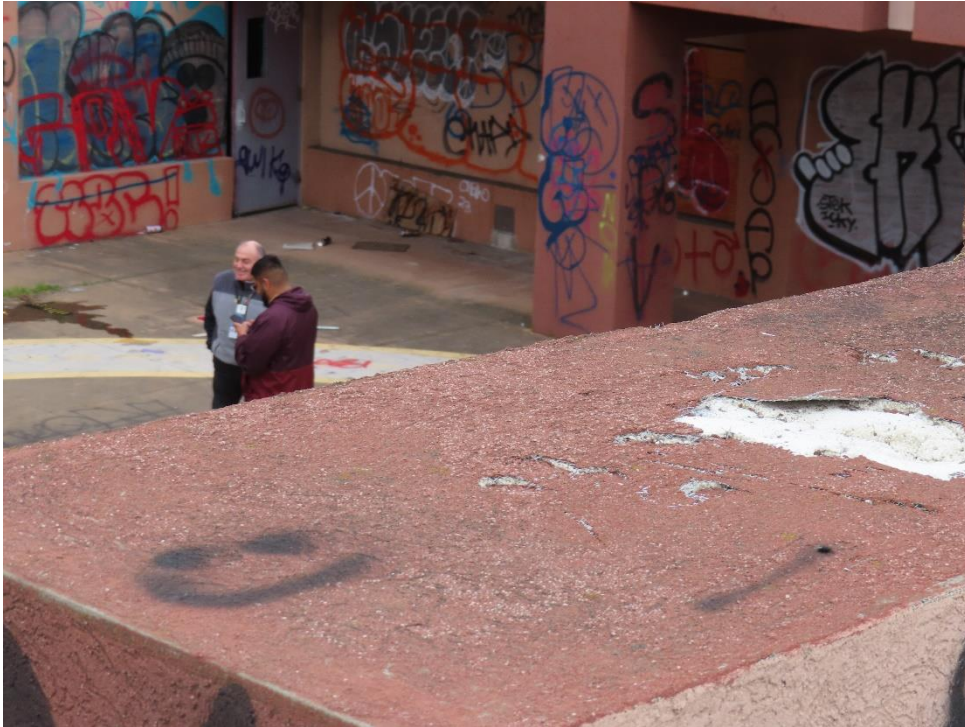
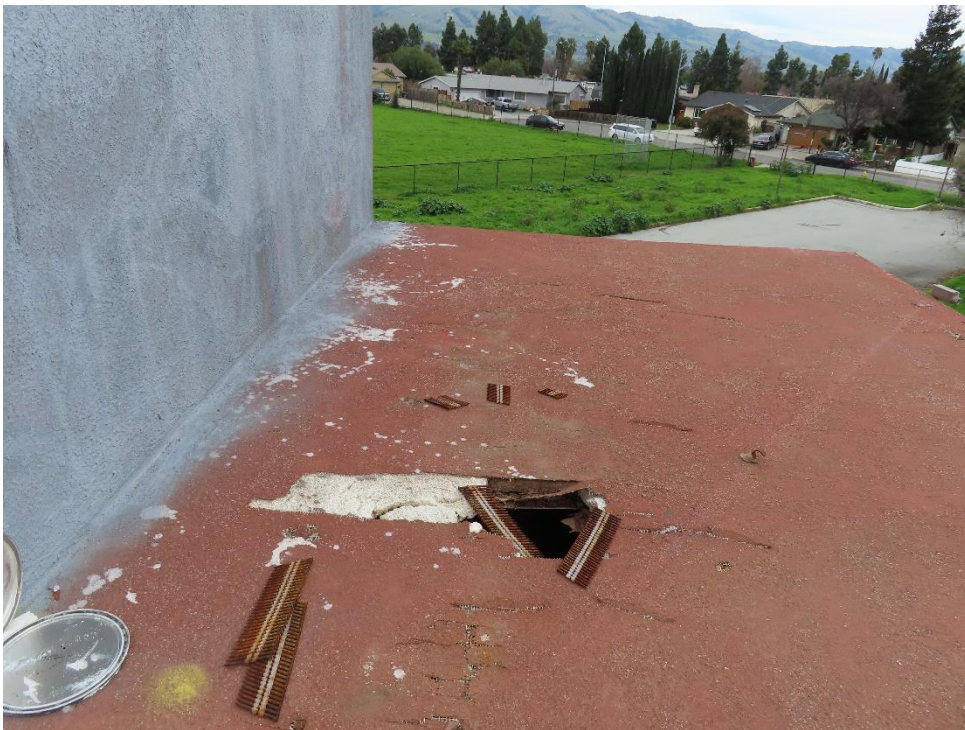
Although EIFS systems are historically problematic, I disagree with the assessment of the existing system. The system is damaged for the most part on the flat surfaces and where vandalized, and the vertical surfaces for the most part appear water tight. A simple fix would be adding sheet metal caps to all parapets and standing seam at large flat surfaces. Fortunately, we do not see a lot of leaking or gaps at the windows. Water tests would confirm this.

## Failing EIFS System on Horizontal Surfaces

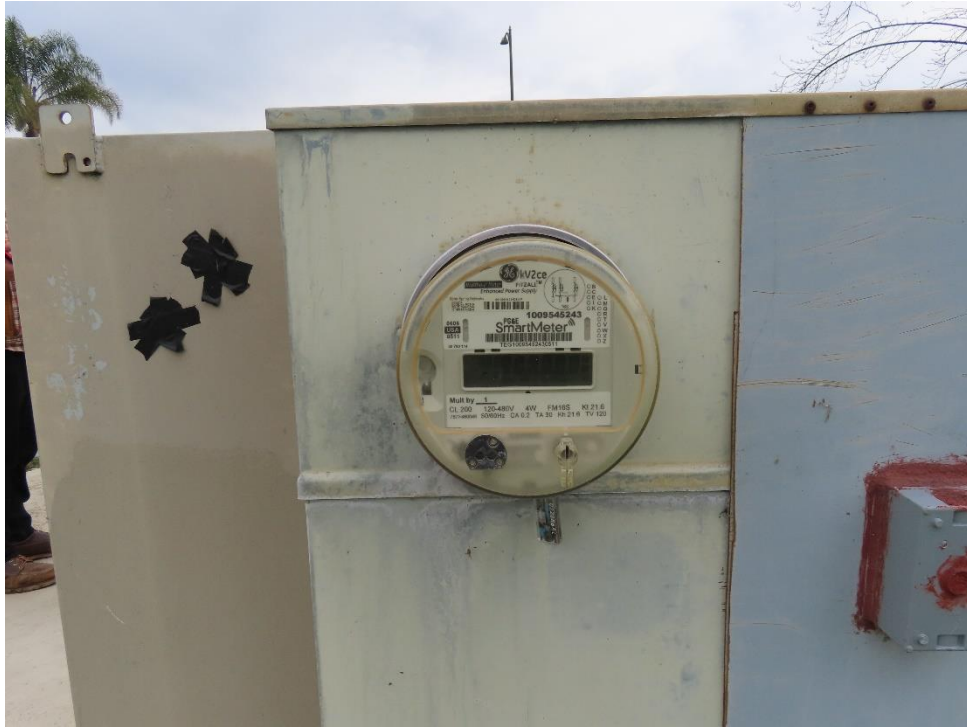
Electric Meter Still in Place

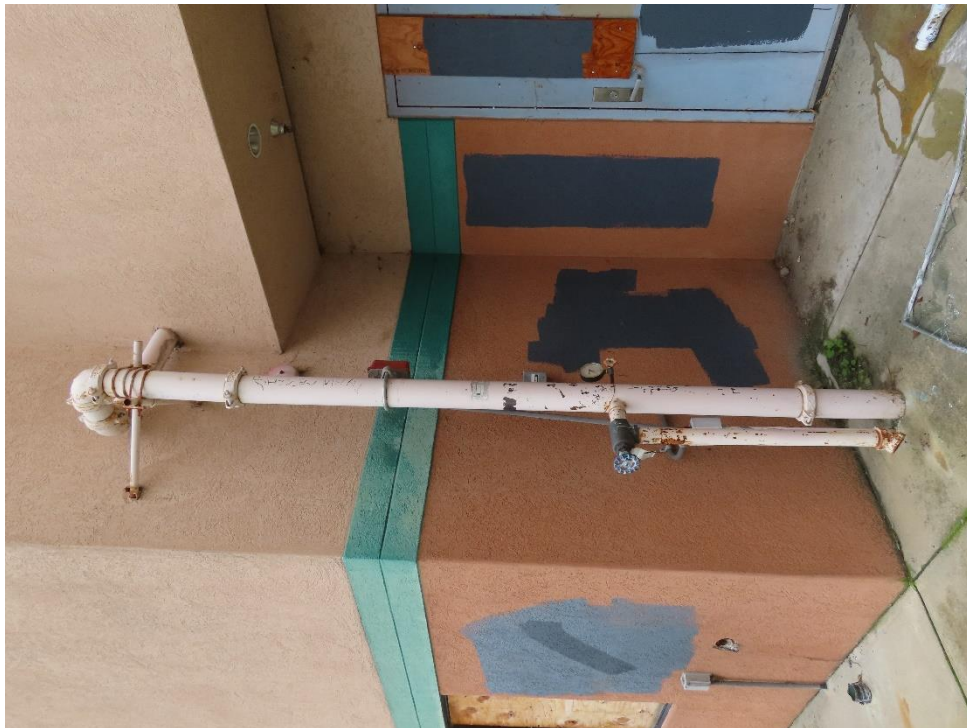
Fire Riser No Shut Off

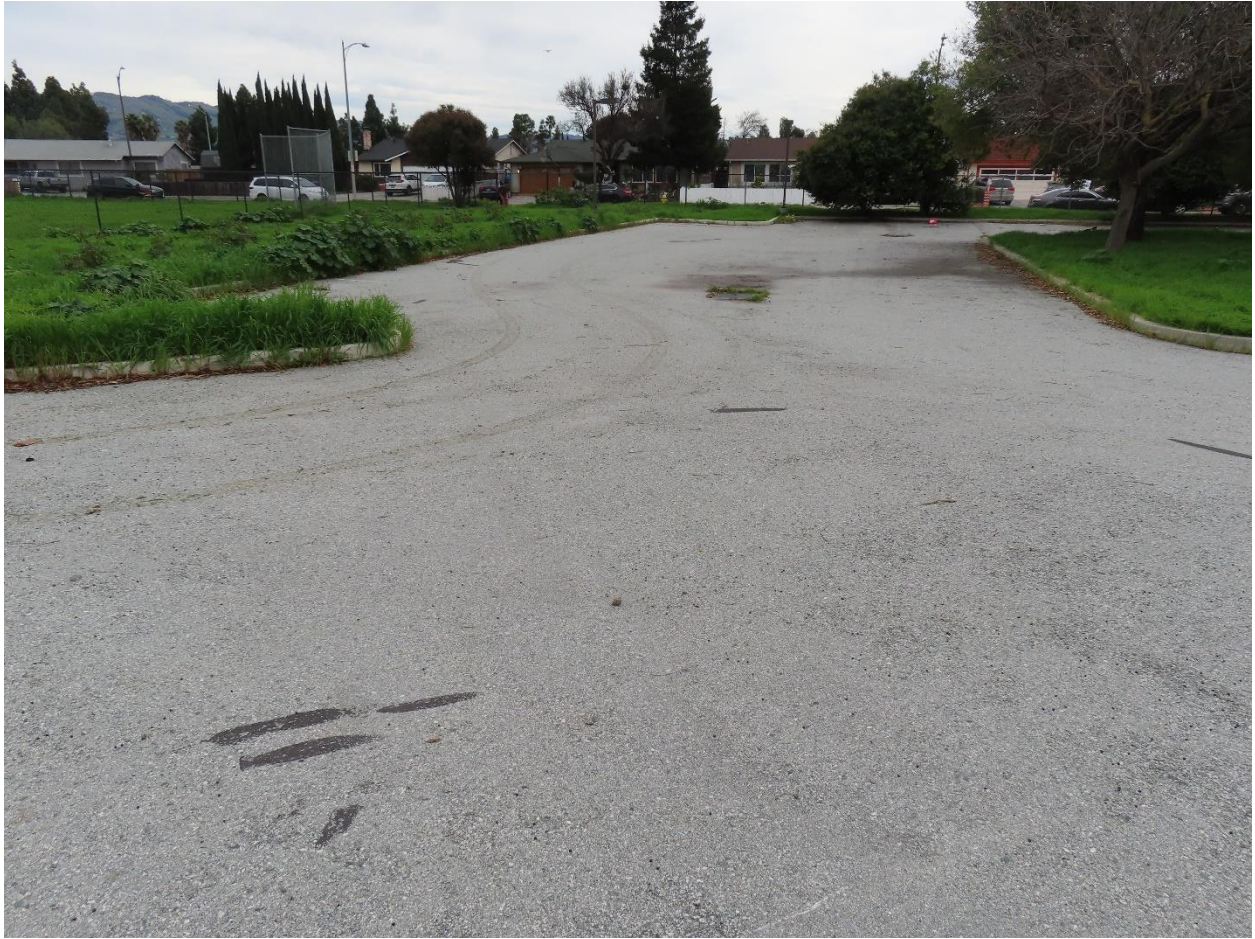
Parts of the parking lot are in excellent condition, parts need to be dug out and the asphalt replaced. The entire parking lot does NOT need to be resurface but patched, sealed, and striped and ensure that there are property ADA stalls and signage.

Excellent Asphalt Condition this Location
