Re: Wetland Assessment and Delineation Findings Report
354 College Highway
Southampton, MA 01073

**354 COLLEGE HIGHWAY WETLAND DELINEATION
354 COLLEGE HIGHWAY
SOUTHAMPTON, MA 01073**

WETLAND SKETCH MAP

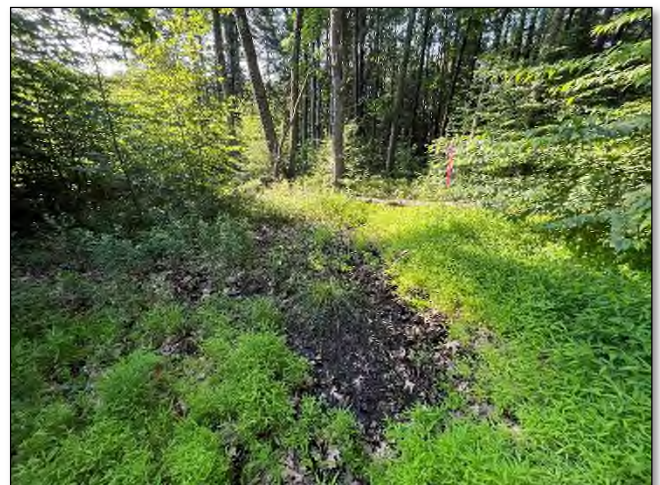
GZA identified an Isolated Vegetated Wetland (IVW) near the center of the Site (Photo 1). The IVW is surrounded by (particularly on the western side) and possibly the result of what is believed to be human transported material, likely compost or manure. The large quantity of organic material is likely contributing to the dominance of hydrophytic vegetation at this location by holding water and releasing it slowly. No hydrologic connections entering or exiting the IVW were observed nor was there any standing water present during the site visits. The IVW was flagged as Wetland A and identified in the field with flags A1 – A10. The predominant species within the herbaceous layer were Japanese stiltgrass (*Microstegium vimineum*), Canadian clearweed (*Pilea pumila*), long-beaked sedge (*Carex sprengei*), soft rush (*Juncus effusus*), false nettle (*Boehmeria cylindrica*), and pendulous sedge (*Carex pendula*). Isolated wetlands are not protected under the WPA unless they fall within other jurisdictional resource areas. Southampton's Chapter 264 Wetland

Photo 1: IVW-A facing south.

Protection Bylaw regulates isolated wetlands that are greater than 400 square feet in area. The wetland on site is approximately 660 square feet in area and therefore would be subject to review under the Town's Bylaw. Isolated wetlands are not federally protected by the Corps since they do not have a relatively permanent surface connection to waters of the U.S. Therefore, the wetland observed on the Site is presumed to not be under the jurisdiction of the Massachusetts Wetlands Protection Act (WPA; M.G.L. c. 131, § 40), its companion regulations (310 CMR 10.00), or Section 404 of the federal Clean Water Act as administered by the U.S. Army Corps of Engineers (Corps).

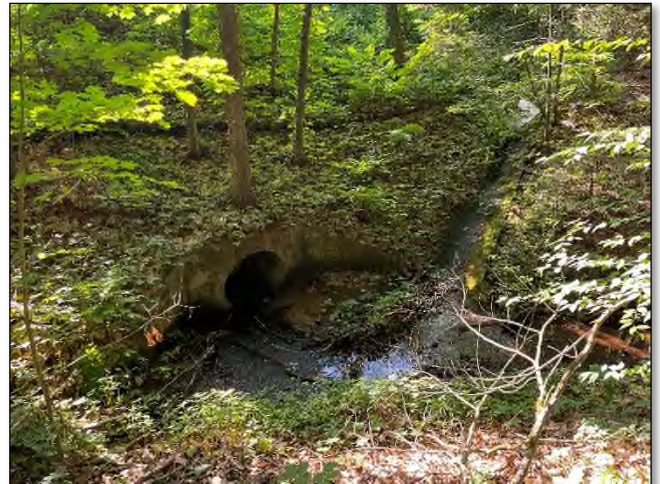
An intermittent stream was observed near the southeast corner of the Site boundary which conveys flow towards an approximately 36-inch diameter culvert that runs beneath College Highway (Photo 2). The off-property stream appears to qualify as an intermittent stream, consistent with the criteria defined at 310 CMR 10.58(2)(a)(1)(b) and (c) (i through ii). The stream channel varies in width from 6-8 feet wide and has a sandy/cobble substrate that includes small vertical drops along the length of the channel. The water depth at the time of our assessment in this area was observed to be approximately 2 to 10 inches. Observations within the channel indicated evidence of scouring and deposition of vegetation in the areas where there was low flow.

Photo 2: A culvert near the southeastern corner of the Site.

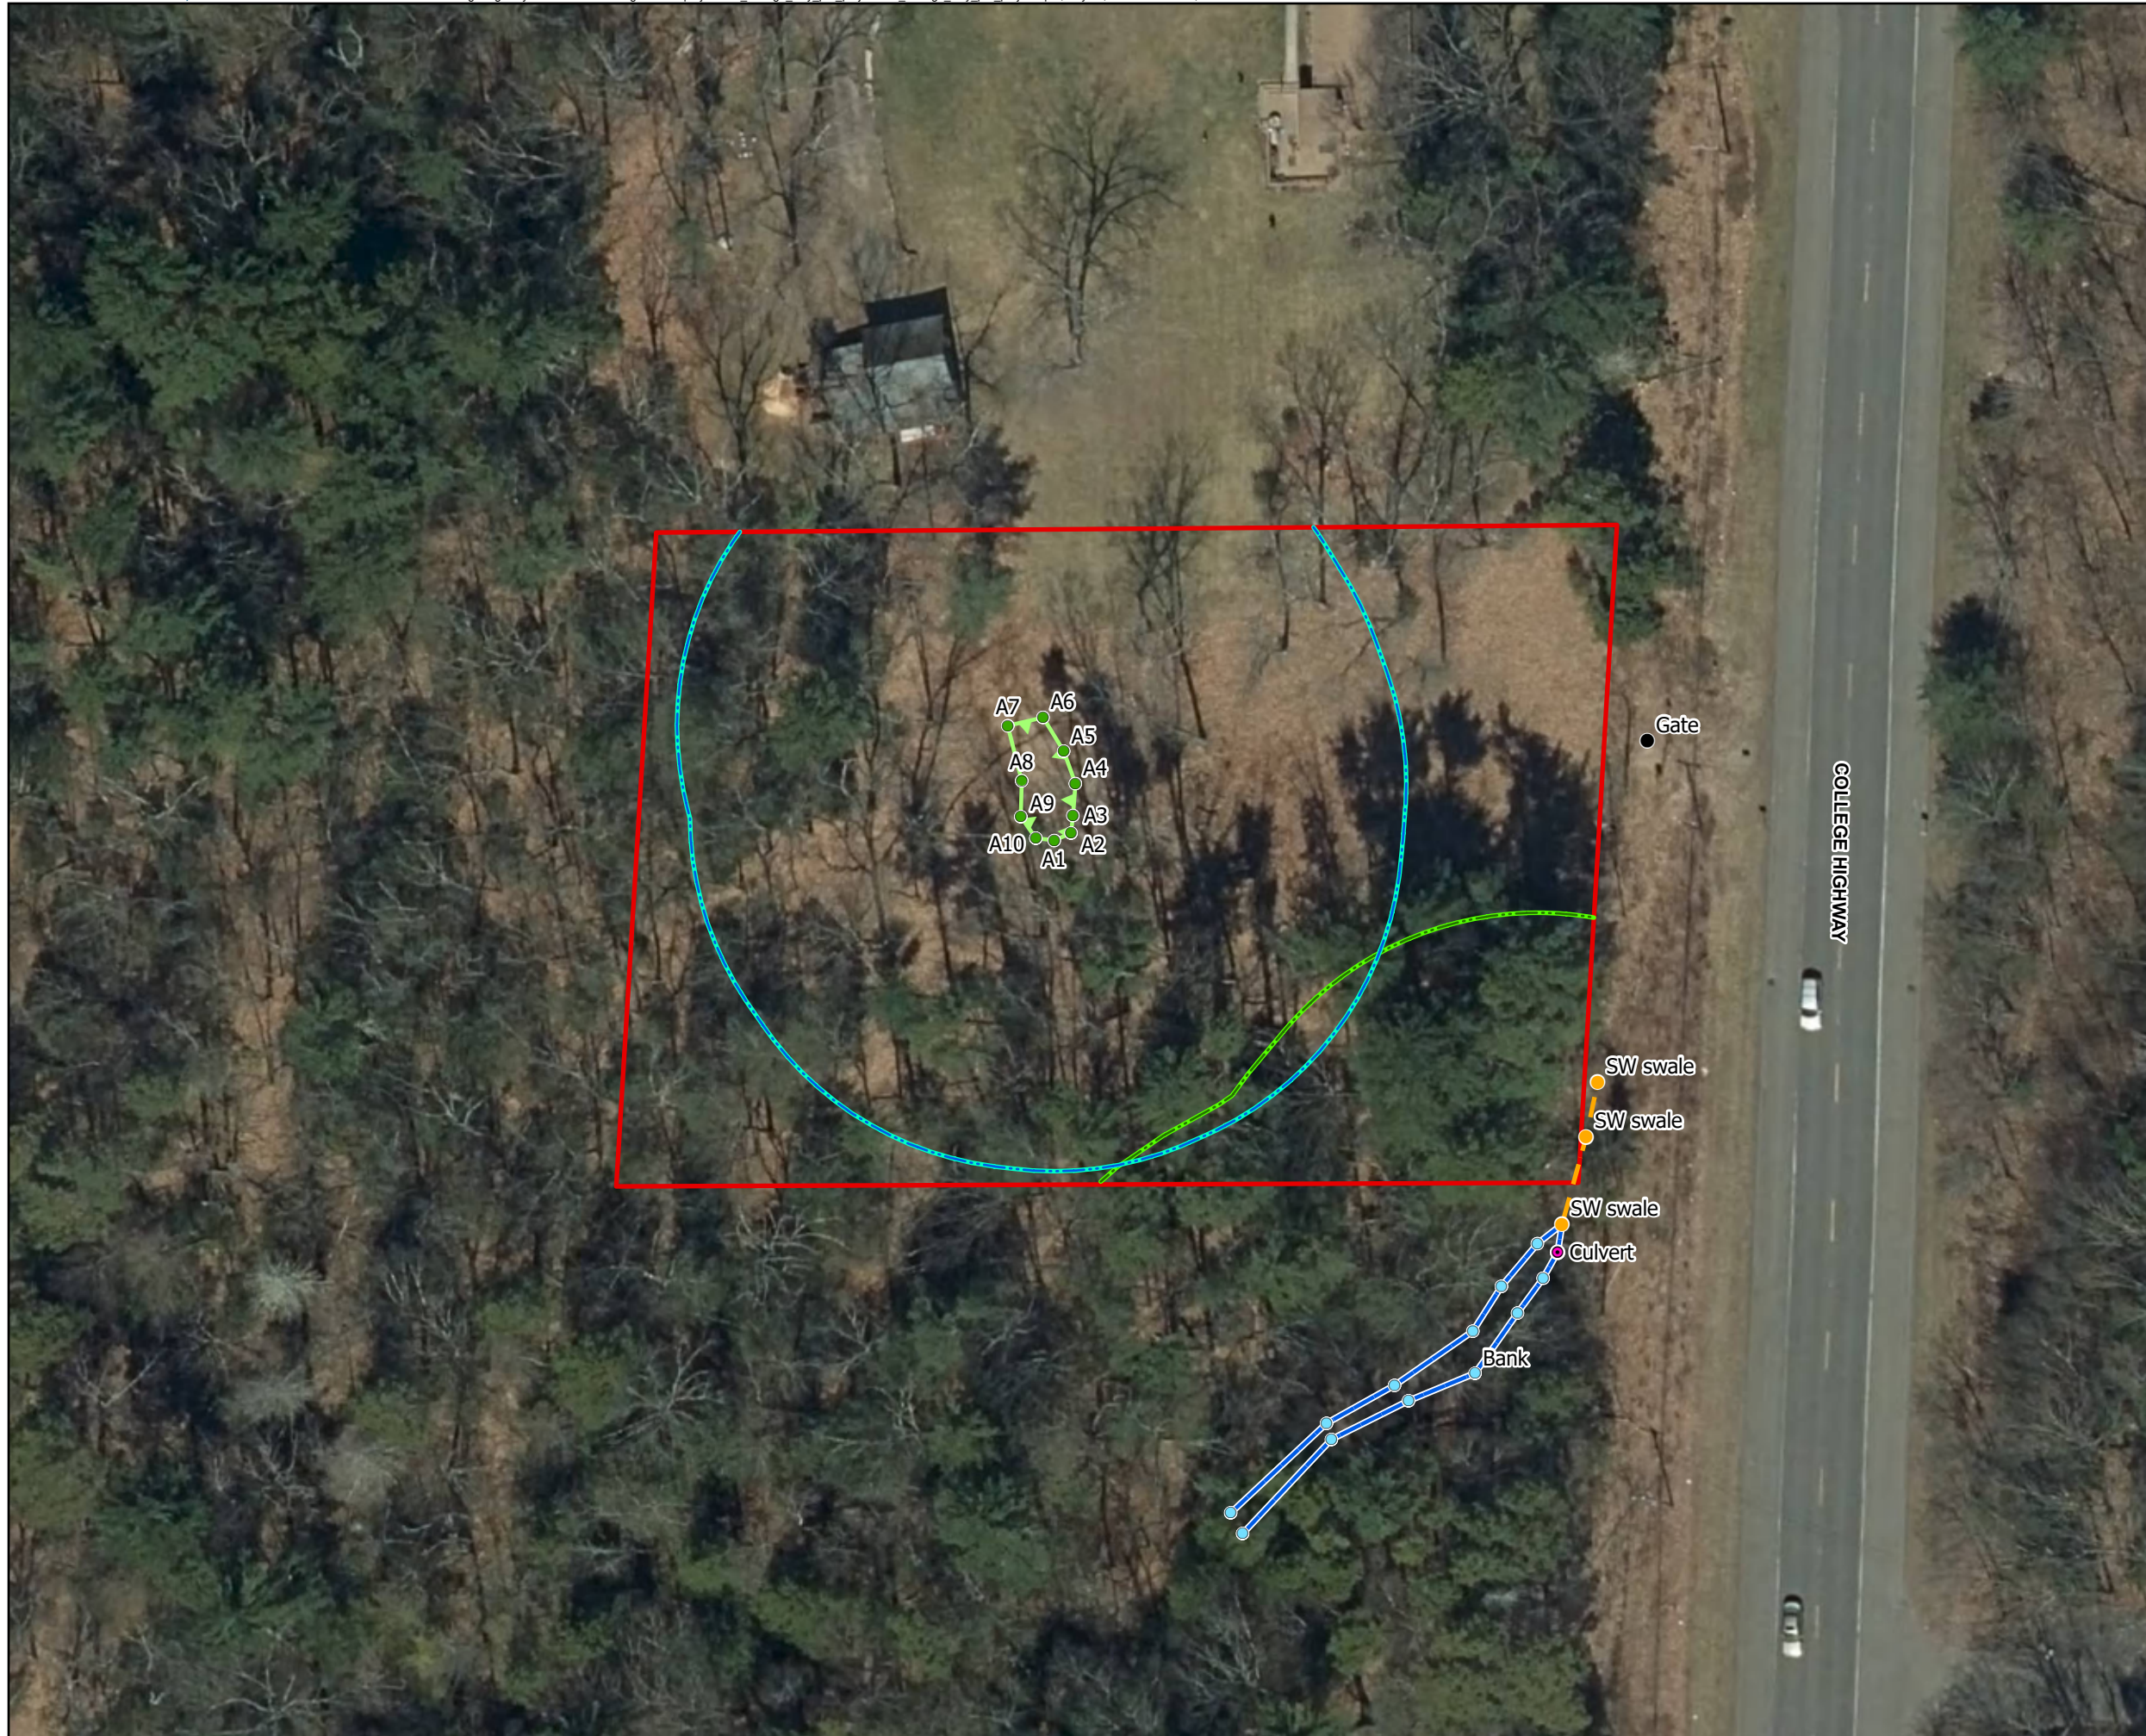
The bank of the intermittent stream as the was observed to be off-site and therefore no wetland flags were placed in the field. GZA estimated a portion of the stream bank's location using gps to project the stream's buffer zone onto the project Site as shown in the attached Wetland Sketch map.
