EAST HELENA PUBLIC SCHOOLS

FACILITIES MASTER PLAN

APPENDICES

East Helena, Montana Janurary 2024

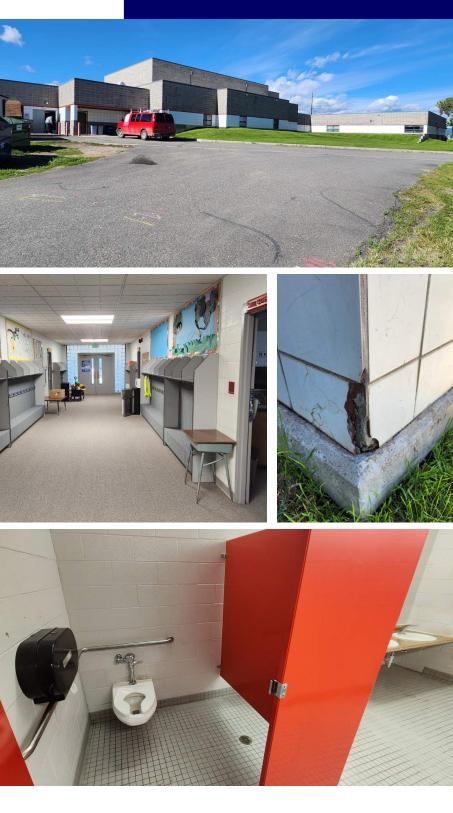
PRICKLY PEAR (1ST-2nd)

- Site Findings:
 - Site access and circulation is poor.
 - Playground space and equipment is limited.
- Building Exterior Findings:
 - Building exterior is in good condition.
- Building Interior Findings:
 - The building interior is in good condition. Some minor maintenance issues were observed.

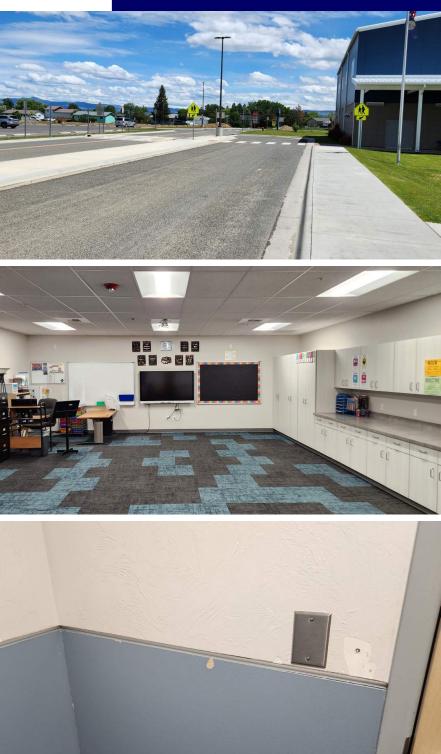
RADLEY (3RD-5TH)

- Site Findings:
 - Poor site drainage causes ice issues on site/playground.
 - Site access, playground and circulation improvements are needed. Signage and separation of traffic.
 - Need to address cracked/damages playground asphalt.

- Generally, the building exterior is in fair to good condition based on the age.
- Concerns over CMU foundations and leakage.
- Condition of the roofing and roof drainage are concerns.

- Interior finishes and fixtures are generally dated. Condition is fair to poor based on age.
- Ceilings are sagging and stained from roof leaks.
- ADA accessibility issues.

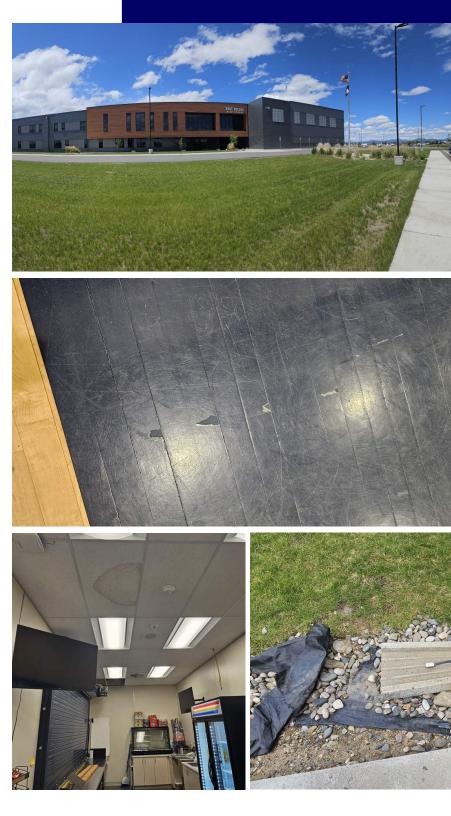
DISTRICT TRANSPORTATION & MAINTENANCE BUILDING & MILLER HOUSE

- Site Findings:
 - Site access and circulation is adequate, but shared access with Eastgate occasionally causes conflicts with parent pick-up / drop off.

- Building exterior fair condition. Building wall are not insulated and metal wall panels and doors have some minor denting, etc.
- Roof and site drainage on the south side of the building create ice issues.

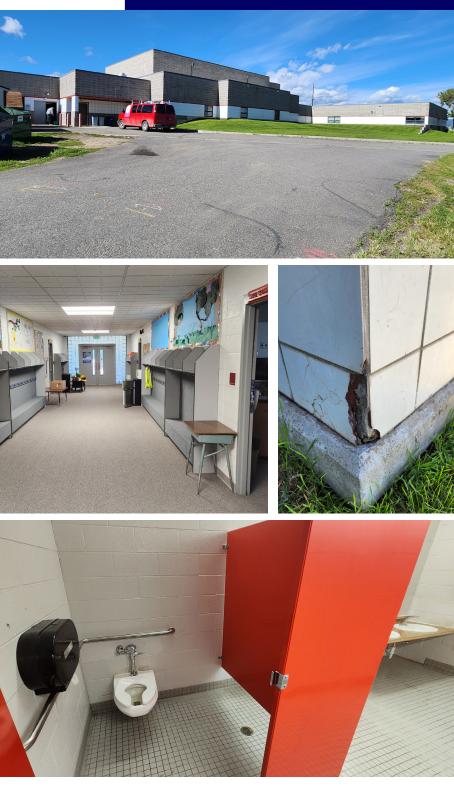
PRICKLY PEAR (1ST-2ND) 2018 BUILDING AGE

- Site Findings:
 - Site access and circulation is poor.
 - Playground equipment limited for the space that is available.
 - No site perimeter fence.
- Building Exterior Findings:
 - Building exterior is in good condition.
- Building Interior Findings:
 - The building interior is in good condition. Minor wear and tear was observed. Minimal windows and little exterior light.

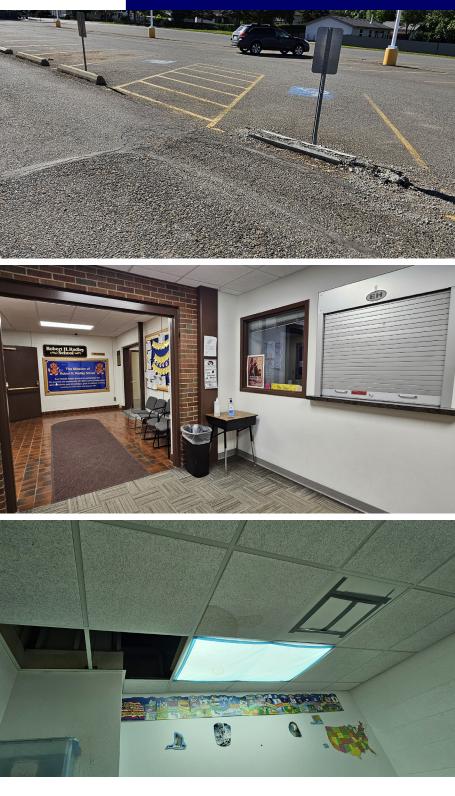
EVMS (6TH-8TH)

- Overall in fair to good condition based on age.
- There is damage to the exterior insulation and finish system (EIFS).
- Window screens are damaged.

- Exterior hollow metal doors are rusted and dented in some locations.
- Building Interior Findings:
 - Interior finishes condition is fair to good based on age.
 - Door hardware and locksets are inconsistent.
 - ADA accessibility issues.
 - Cafeteria capacity & gym connection.

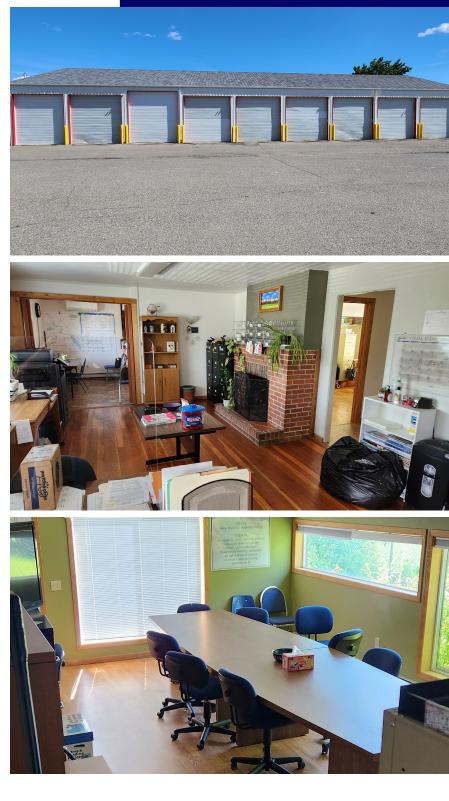
DISTRICT OFFICES

- Site Findings:
 - Shared site with Radley Elementary is small and limiting.
- Building Exterior Findings:
 - Building exterior in fair condition.
 - There is no exterior wall insulation.
 - Door hardware is not ADA accessible.
- Building Interior Findings:
 - The building interior is in fair to good condition.
 - The building is too small for its function.
 - Security issues: Not welcoming, no sight-lines to the entrance.
 - ADA Accessibility issues: Non-compliant restrooms and break area.
