**Subject: Report of Limited Mold Assessment Services
Northern Middle School – Room 227
Dillsburg, Pennsylvania
AETHER Project P24221**

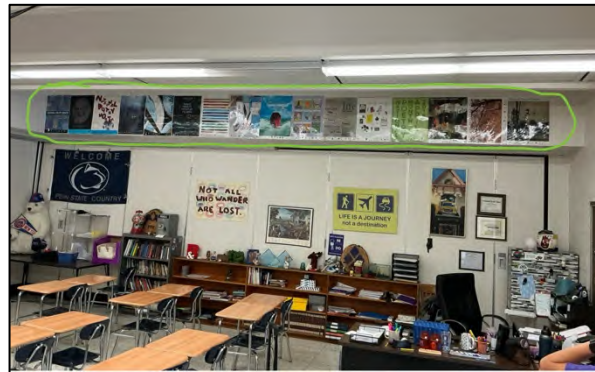
- Visible mold growth was observed behind laminated posters along the bulkhead. Only two posters had been peeled from the wall to allow for viewing before our services, so impacts appeared contained. Further viewing was done by gently peeling edges until impacts were observed to help prevent spreading particulates.

- Growth appeared to extend to most of the area covered by the posters. A cursory viewing behind other wall hangings in the room did not indicate other areas of visible growth.

- AETHER used a Flir MR-77 moisture meter to test representative materials. No elevated moisture content was detected in the impacted materials.
- Custodial staff said they use a wet mop to wash the upper walls each summer and that it was likely that water would run behind the posters where it could promote the observed impacts.

Room 227 - Approximate area of impact

Based on the anticipated extent of impacts, it was recommended that work be conducted in accordance with standard industry guidelines including the Institute of Inspection, Cleaning and Restoration Certification (IICRC) S520, the E.P.A. Guidelines for Mold Remediation in Schools and Commercial Buildings, and the US Occupational Safety and Health Administration (OSHA). These guidelines discuss isolation of work areas, detailed work practices, procedures and equipment that should be utilized to help ensure a prompt return to a normal indoor fungal ecology, as well as the prevent the migration of contaminants to adjoining areas.

As it relates to this project, some specific recommendations included removing contents from the work area, isolating a suitably sized work area using sealed polyethylene sheeting, deployment of High Efficiency particulate Air Filtration (HEPA) air filtration units (AFU) in a manner to establish negative pressure in the work area and others to air wash surfaces and help remove airborne particulates from

the surrounding room. It was also recommended that impacted posters and drywall be discarded and ultimately surfaces throughout the contained work area and surrounding classroom be cleaned.
